**MCCLOSKEY BUILDING  
MUNICIPAL CAMPUS**

# **McCloskey Building & Site Repurposing Study Final Report**

April 27, 2020

**Town of Uxbridge  
Uxbridge, MA 01569**

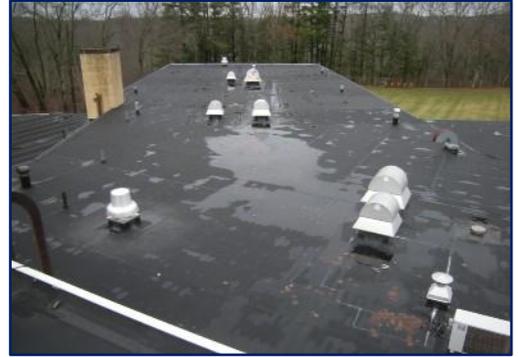
The current rubber membrane roof is in need of replacement; many roof leaks and large areas of ponding were visible during the assessment walk-through. The original copper flashing is over 80 years old and has exceeded its anticipated service life. There are a number of unused gravity vents and other roof penetrations that should be eliminated. As no test cuts were performed, it is unknown what lies between the current membrane roofing and the structural roof deck.

*Roof of Junior High School addition with areas of ponding*

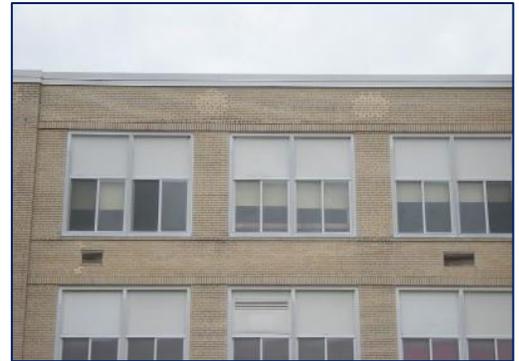
Many windows were observed with broken glazing seals and almost all of the windows appear to be at or near the end of their service life it is unknown if the aluminum-framed windows are thermally broken. Given the assumed poor thermal performance and the condition of the existing, their replacement should be included in any future renovation plans.

*Replacement windows at 1936 High School*

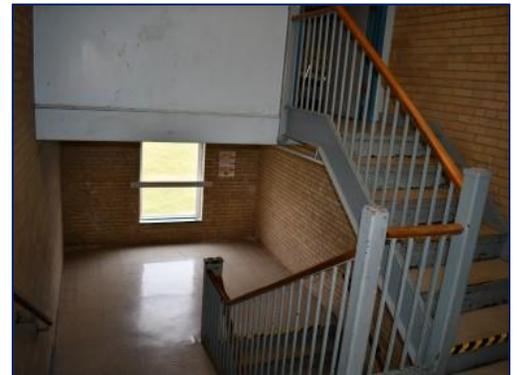
*Stairwell at 1936 High School with non-compliant handrails and tread nosings*

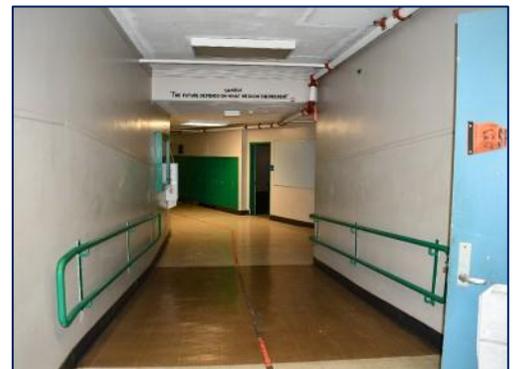
*Ramp between 1936 High School and 1952 War Memorial Gym addition with non-compliant slope*

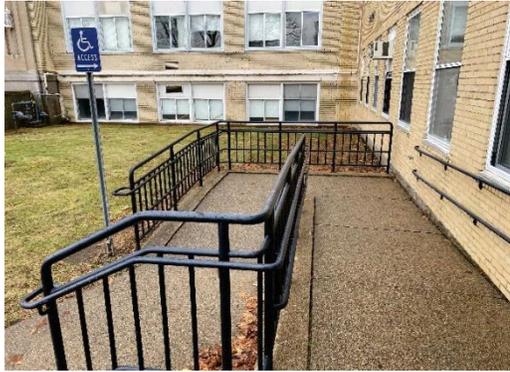
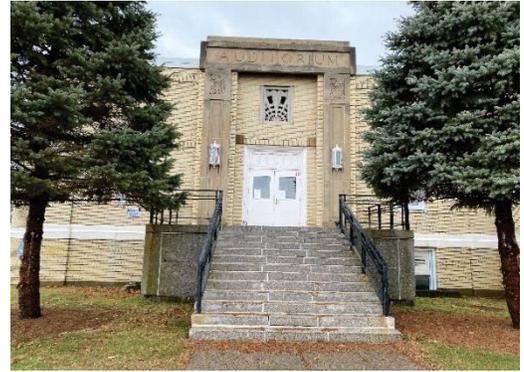
- Many of the interior and exterior handrails are not compliant due to lack of extensions, continuous inside rails, etc. (primarily in the original buildings) and would have to be replaced (521 CMR 27.4).

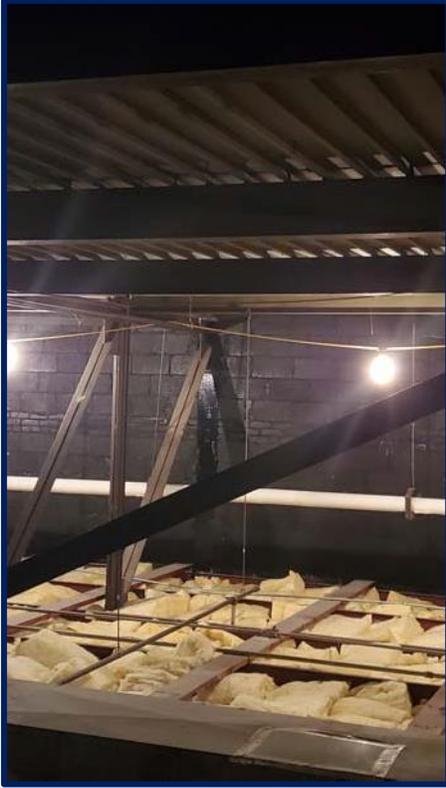
Photograph #1 – Lack of Masonry Wall Ties – 1952 Addition

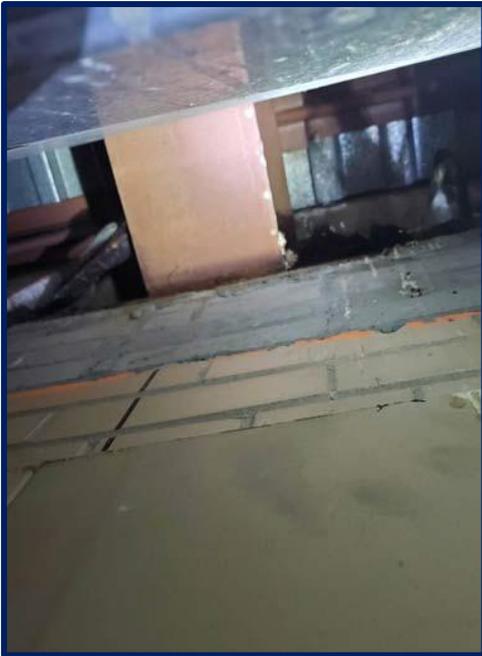
Photograph #2 – Beam From 1988 Addition Bearing on Original Masonry Bearing Wall  
– 1988 Addition and 1936 Original Structure

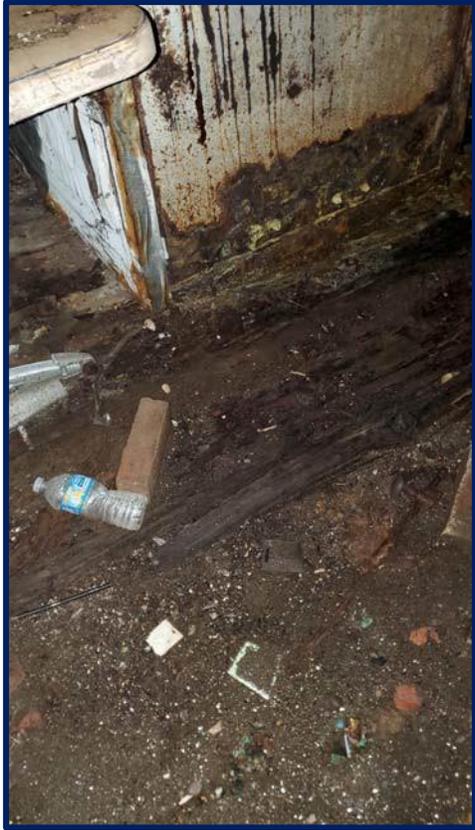
Photograph #3 – Water Damage in an “Unexcavated” Room – 1936 Original Structure

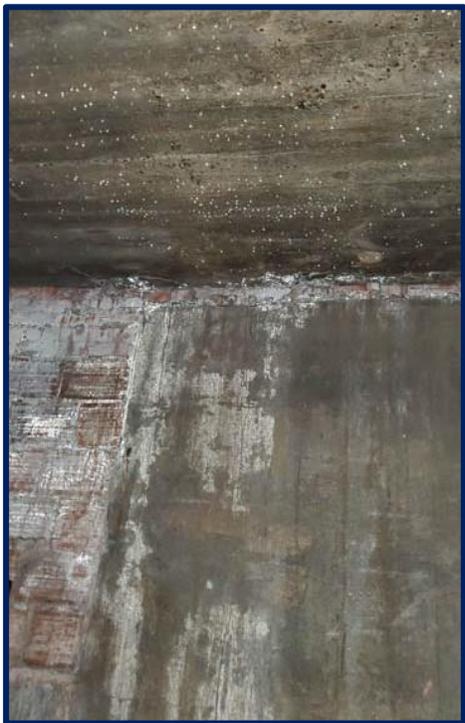
Photograph #4 – Cracked Concrete and Deteriorated Masonry in an “Unexcavated” Room – 1936 Original Structure

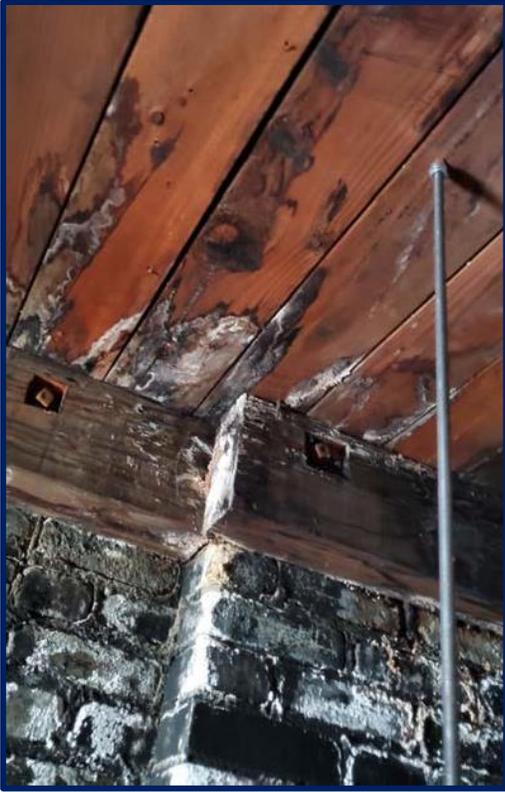
Photograph #5 – Water Damage in Loft Area – 1952 Addition

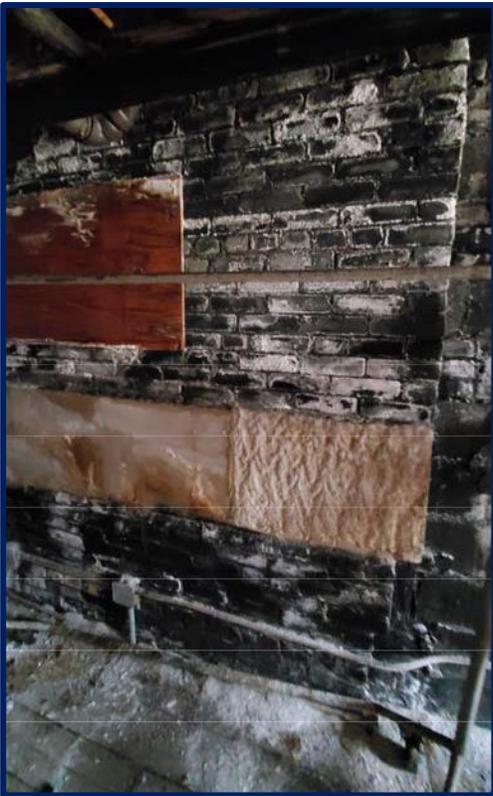
Photograph #6 – Efflorescence Masonry Wall in Loft Area – 1952 Addition

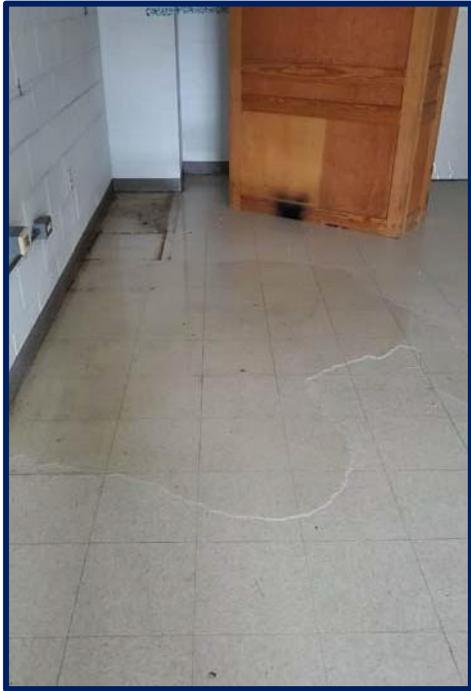
Photograph #7 – Water Damage in “Science” and “Math” rooms – 1988 Addition

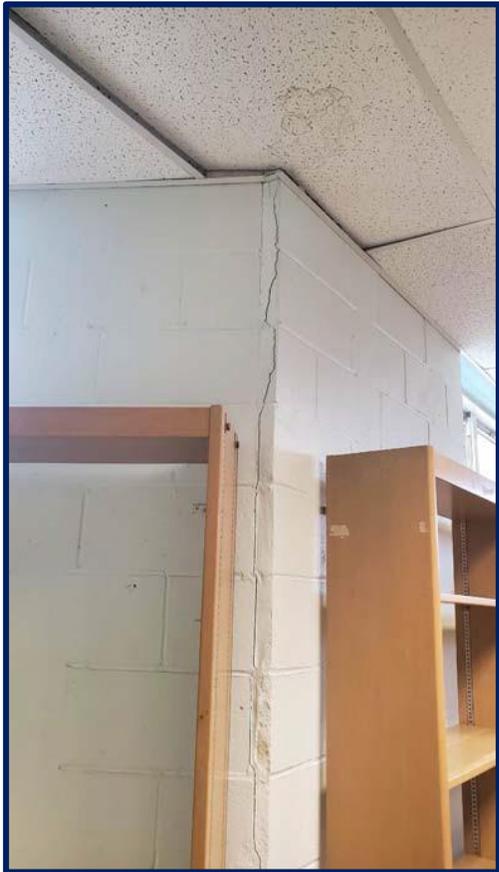
Photograph #8 – Vertical Cracks in Library Masonry Wall – 1988 Addition

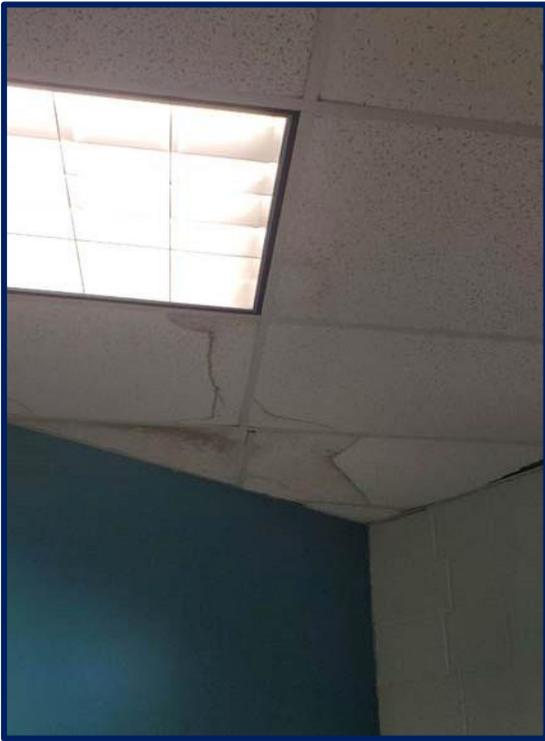
Photograph #9 – Water Damage in Library – 1988 Addition

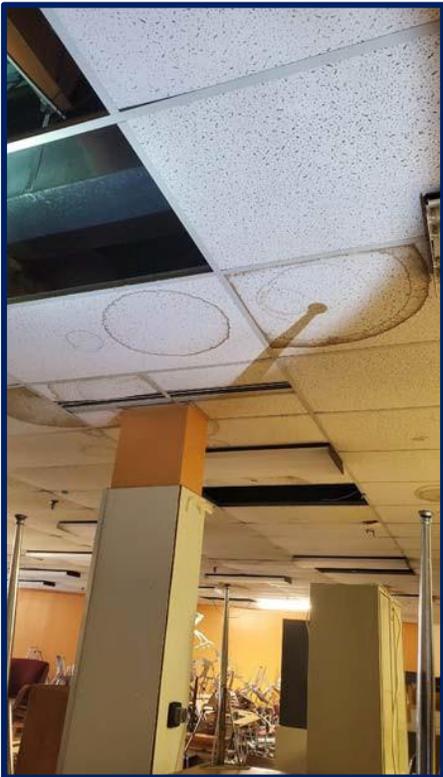
Photograph #10 – Water Damage in “Cafeteria” (1) – 1988 Addition

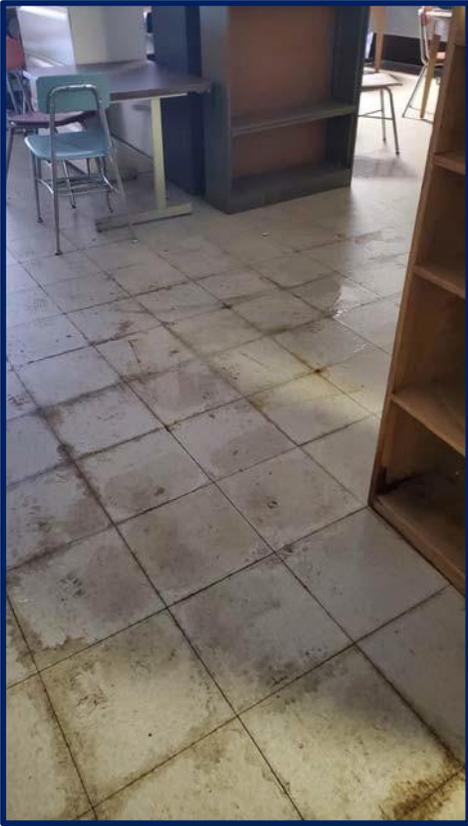
Photograph #11 – Water Damage in “Cafeteria” (2) – 1988 Addition

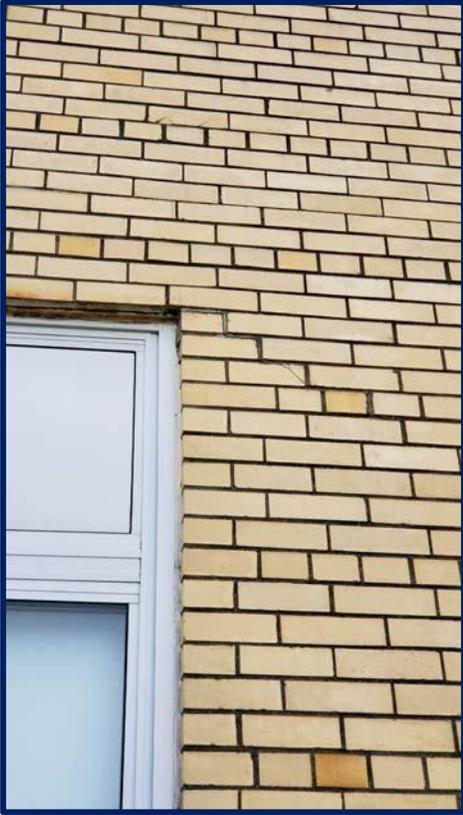
Some flaking paint and rust is evident on the steel window lintels. This should be addressed soon as some of the steel lintels on the original building are beginning to show signs of delamination and causing damage to adjacent masonry (see structural section). If this is allowed to continue, the lintels would need to be replaced.

Photograph #13 – Cracking Caused by Corroded Lintels – Multiple Locations

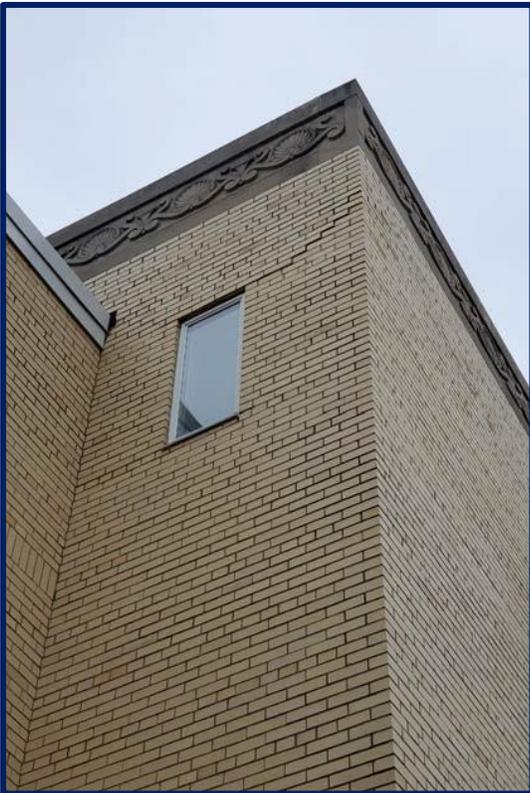
Photograph #14 – Shifting Masonry in Exterior Wall – Multiple Locations

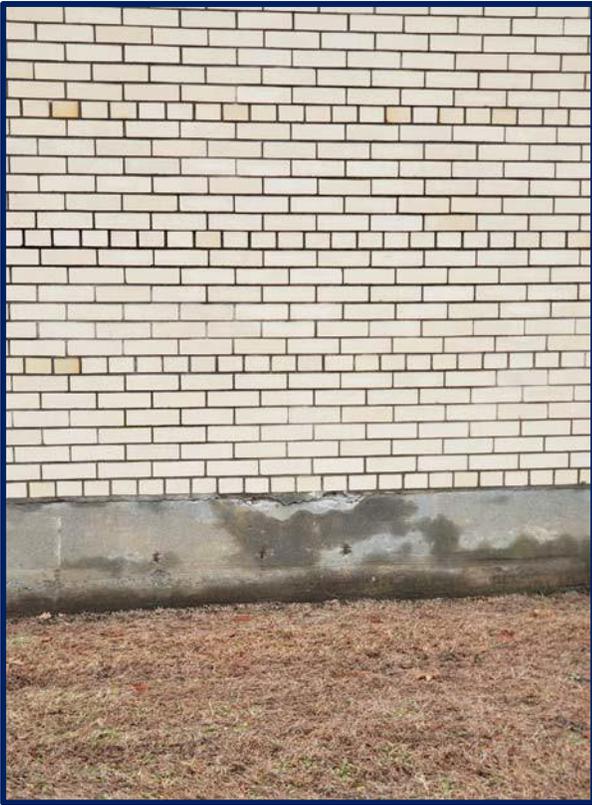
Photograph #15 – Cracked Concrete Foundation Wall – Multiple Locations

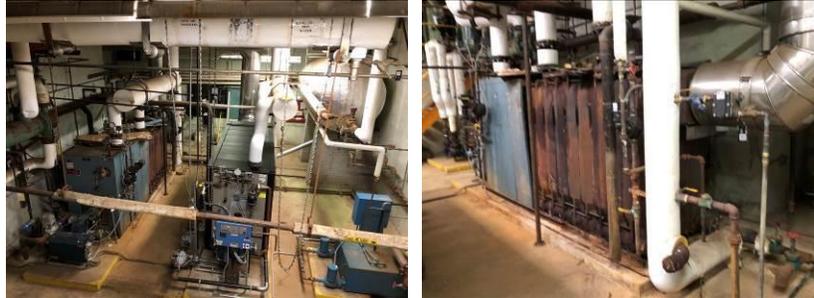
- a. The boiler plant is located in the Basement Level Boiler Room-032 in the 1952 Addition and consists of two (2) gas-fired steam boilers and provides heating to the entire building.
- b. Boiler B-1 is a Smith cast iron sectional boiler with 4,283 mbh heating capacity. The cover for boiler B-1 has been removed and not replaced suggesting sections may have been leaking.
- c. Boiler B-2 is a Weil-McLain Model 1688 cast iron sectional boiler with 4,283 mbh heating capacity.
- d. Boilers were replaced in 1996 and are now 14 years old.

(L - Steam Boilers B-1 and B-2, R - B-1 cover removed)

- m. To improve efficiency and address the antiquated steam system, recommendation is to replace the steam boilers and steam heating system with new high efficiency condensing boilers and a new hot water piping system.
- n. To improve efficiency and meet energy code requirements, new hot water pumps to be provided with variable frequency drives to create a variable pumping system.

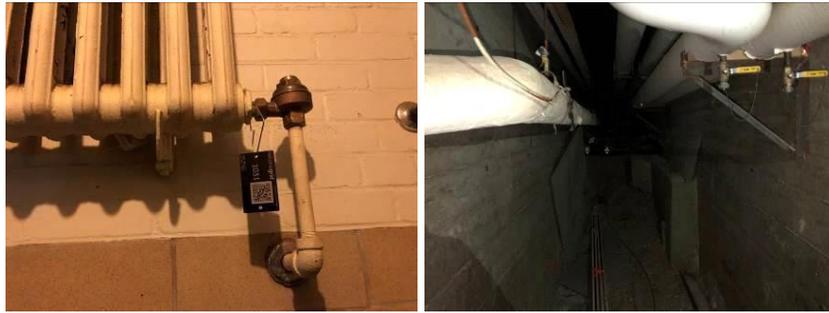
- a. Low pressure steam supply and condensate return piping run horizontally in pipe tunnels beneath the building.
- b. The original steam heating system piping are now 84 years old.

(L - Steam Radiator and Steam Trap, R - Steam Pipe Tunnel)

- c. Recommendation is to replace all steam system piping throughout with new hot water pipe mains from a new hot water heating plant.

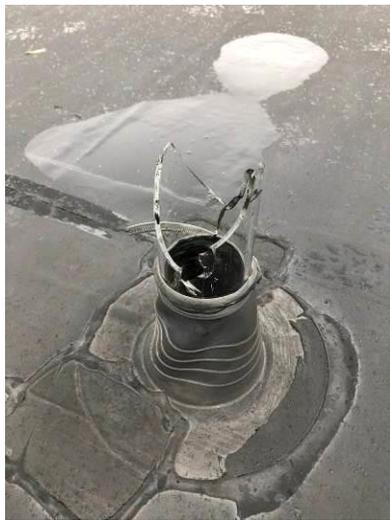
(L - Roof Leak at Damaged Glass Acid VTR, R - Emergency Eyewash/Shower Station)

1. Plumbing Recommendations are:
  - a. Repair the damaged glass acid VTR.
  - b. Install an interior grease trap at the Kitchen 2-compartment pot sink.
  - c. Replace all water, waste, vent, gas and rainwater leader piping that is over 50 years old with new.
  - d. Install a tempered water system(s) to serve the emergency eyewash/shower stations.

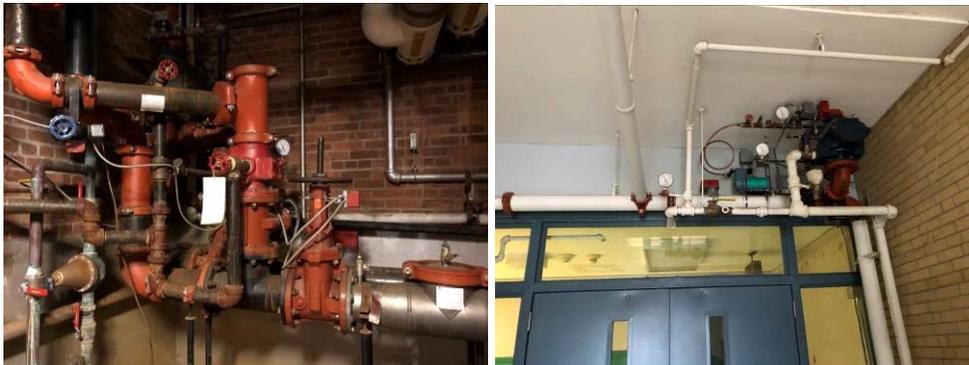
(L - Sprinkler Riser Station, R - Dry Sprinkler Valve)

5. Sprinkler piping and sprinkler heads in the original 1936 building are now 84 years old and well past their useful life.
6. Sprinkler piping and sprinkler heads in the original 1952 Addition are now 68 years old and well past their useful life.
7. Recommendation is to replace all sprinkler piping and sprinkler heads that are over 50 years old with new.
