Bridge/Culvert Management Plan

November 2011

Uxbridge
Massachusetts

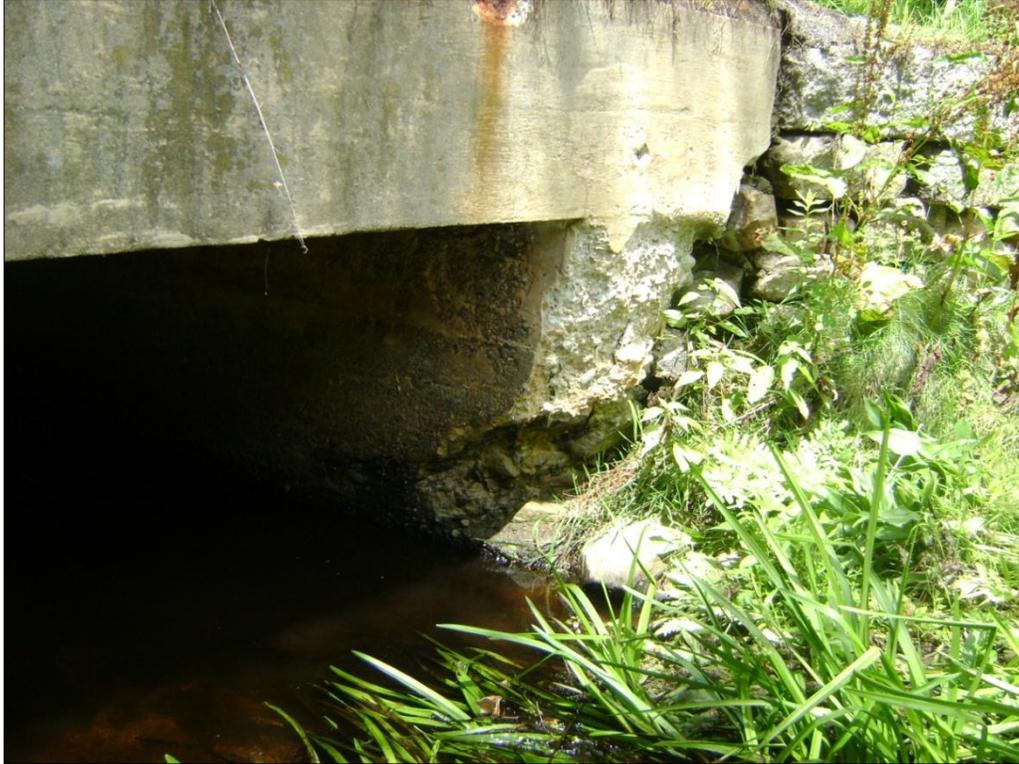
Photo 5 Looking Northwest: Spalling of North Abutment at Northeast Wingwall

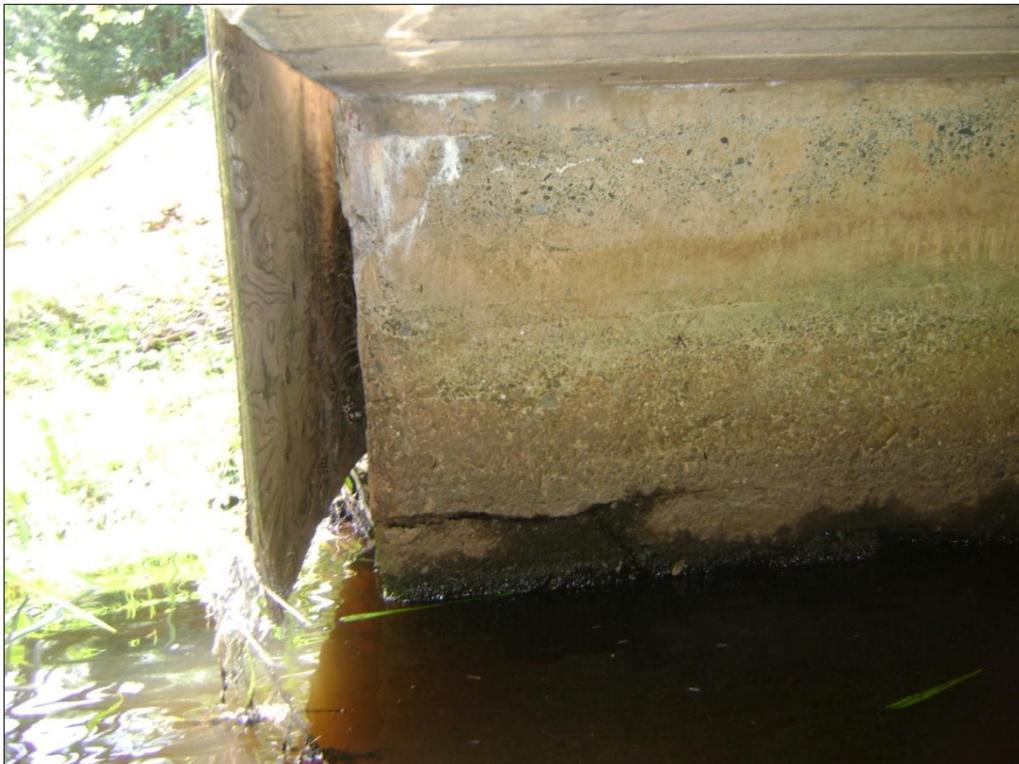
Photo 6 Looking South: Spalling of South Abutment at East Opening

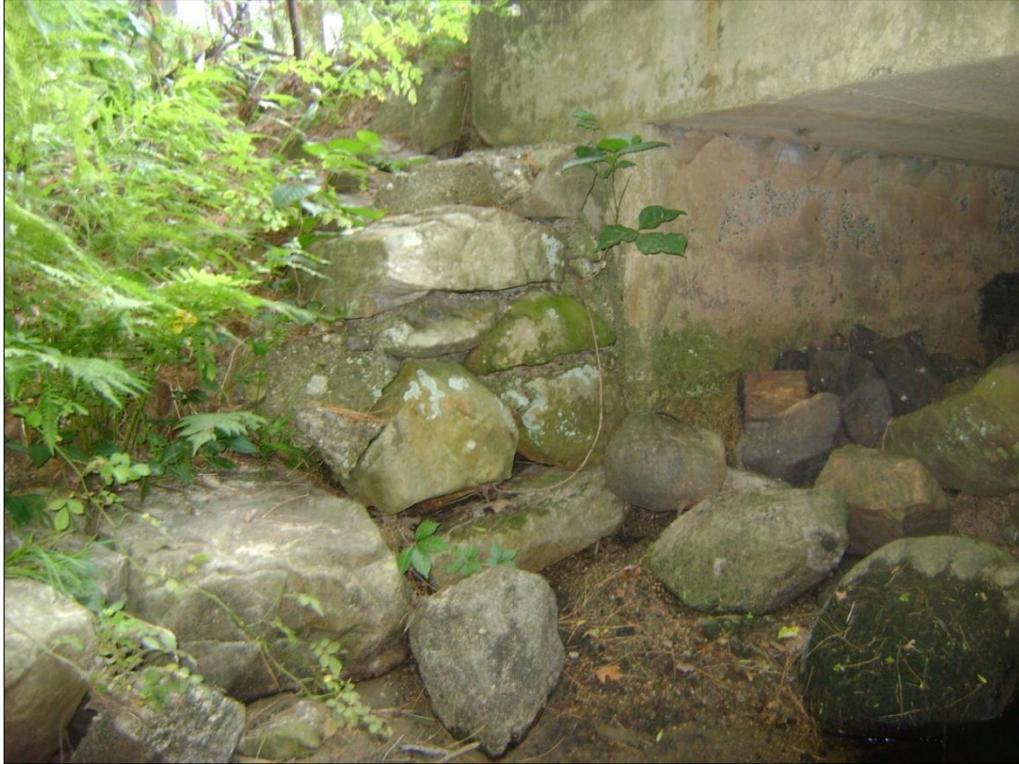
Photo 11 Looking Northeast: Crumbling Masonry at Northwest Training Wall

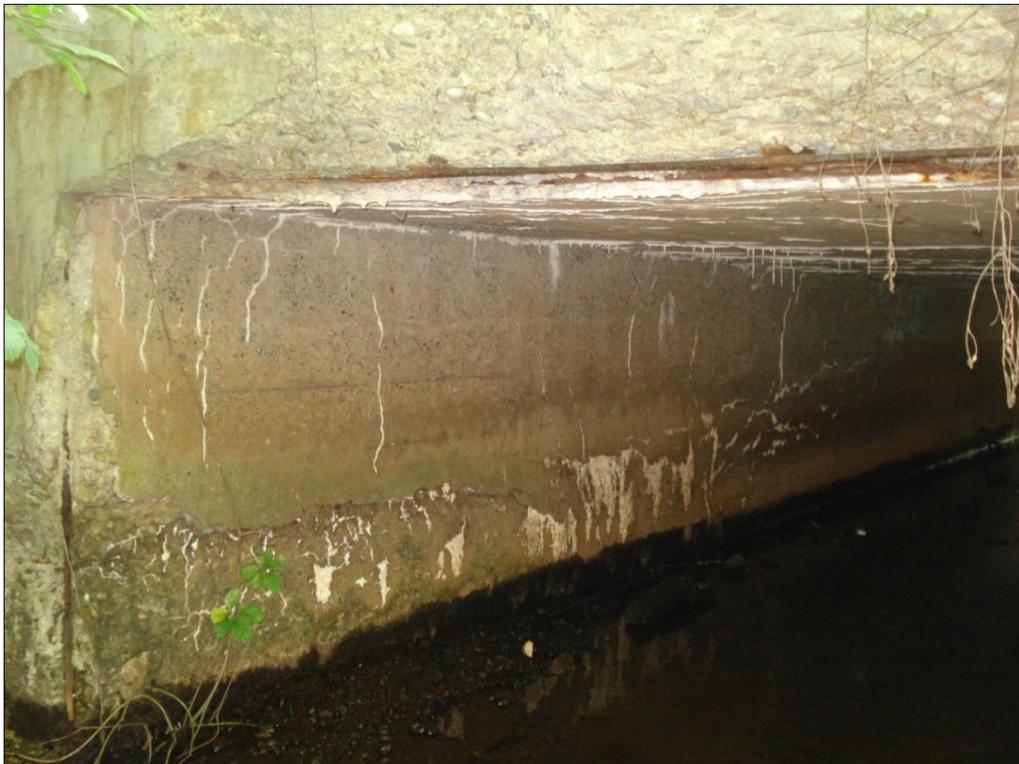
Photo 2 Looking Southwest: Deterioration of Southeast Abutment Corner

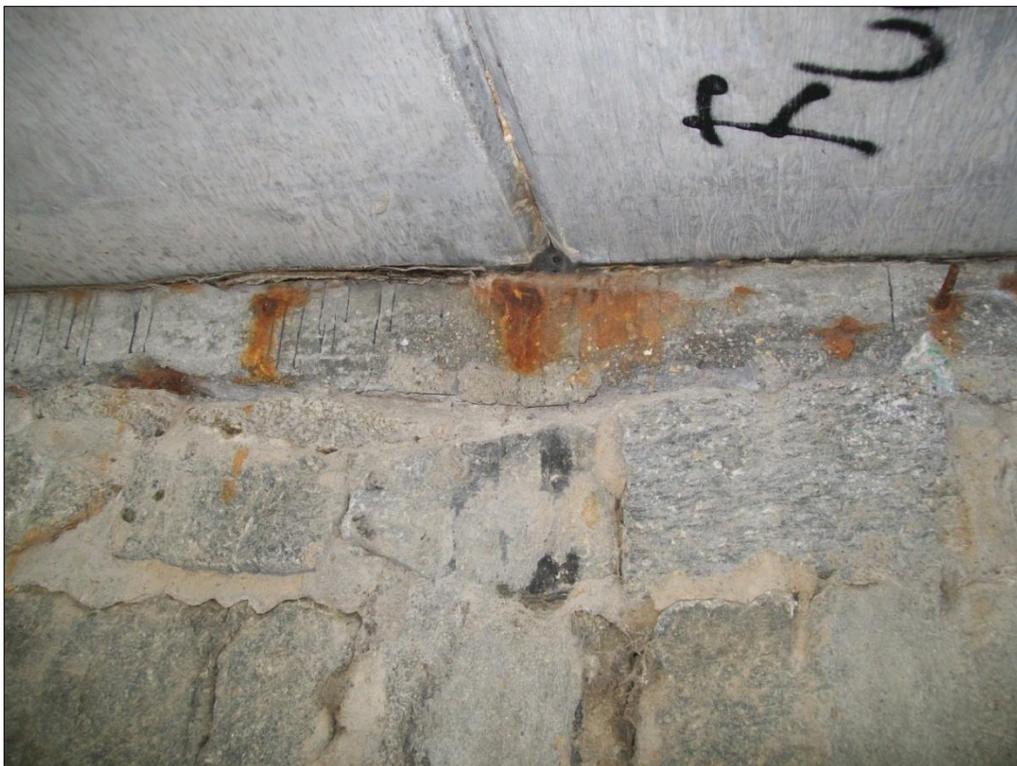
Photo 8 Looking East: Deterioration of East Abutment Concrete Cap

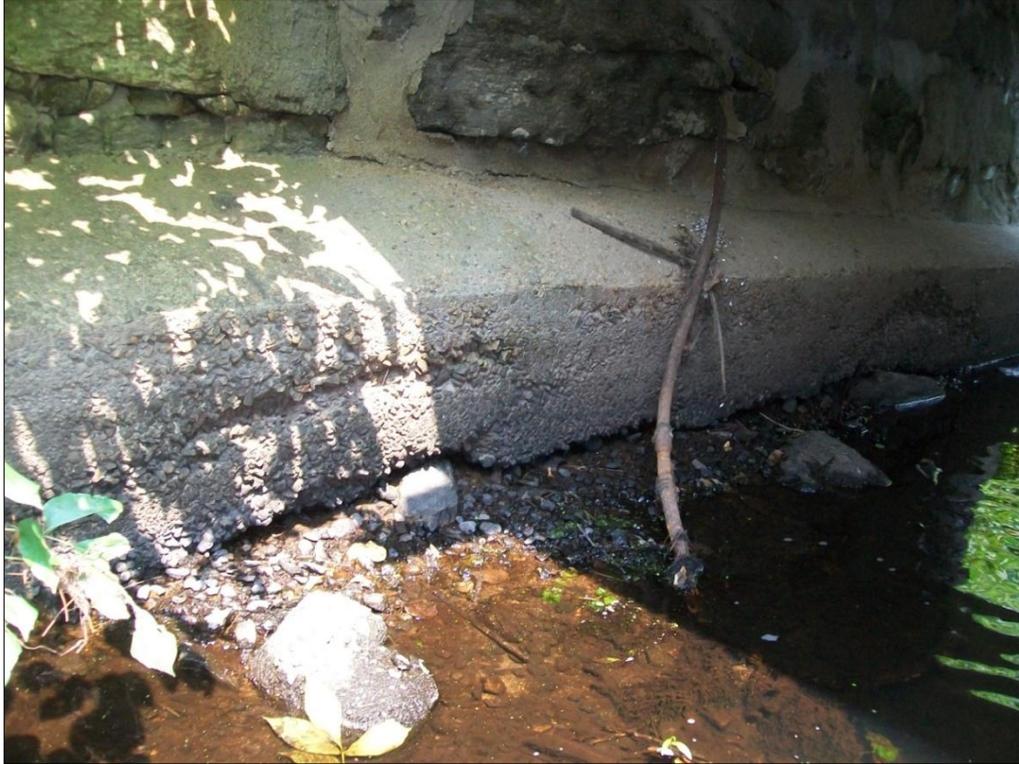
Photo 9 Looking Northwest: Scaling and Scour of West Abutment Footing

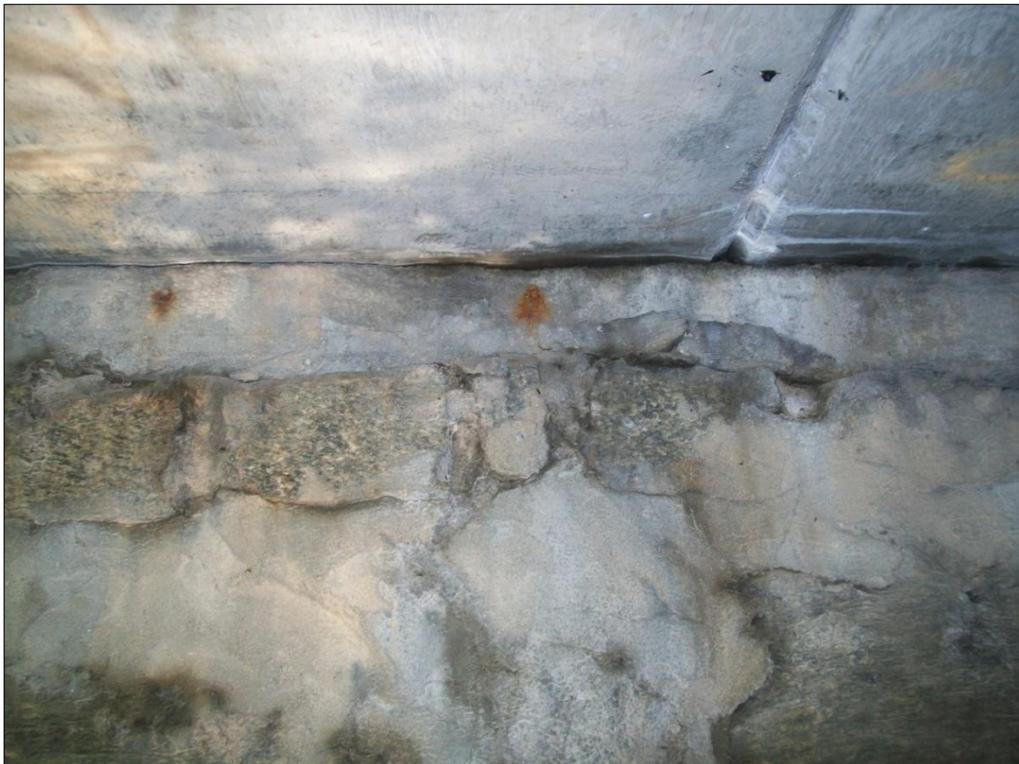
Photo 10 Looking West: Deterioration of West Abutment Concrete Cap

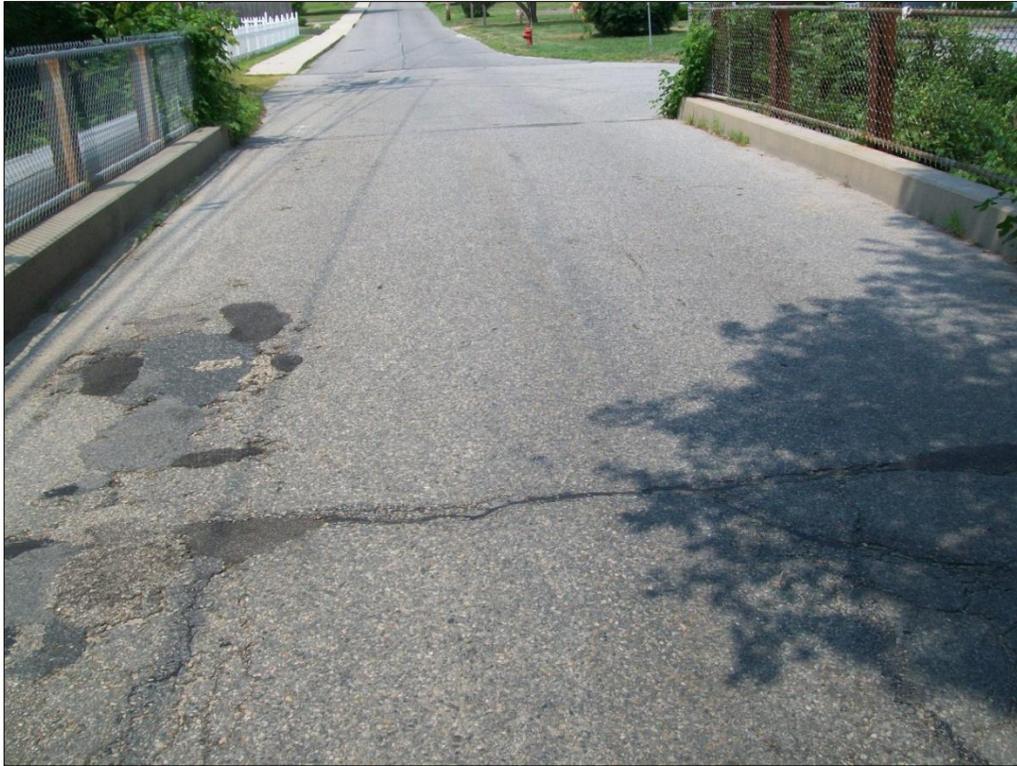
Photo 15 Looking West: Deterioration of Pavement Over Bridge

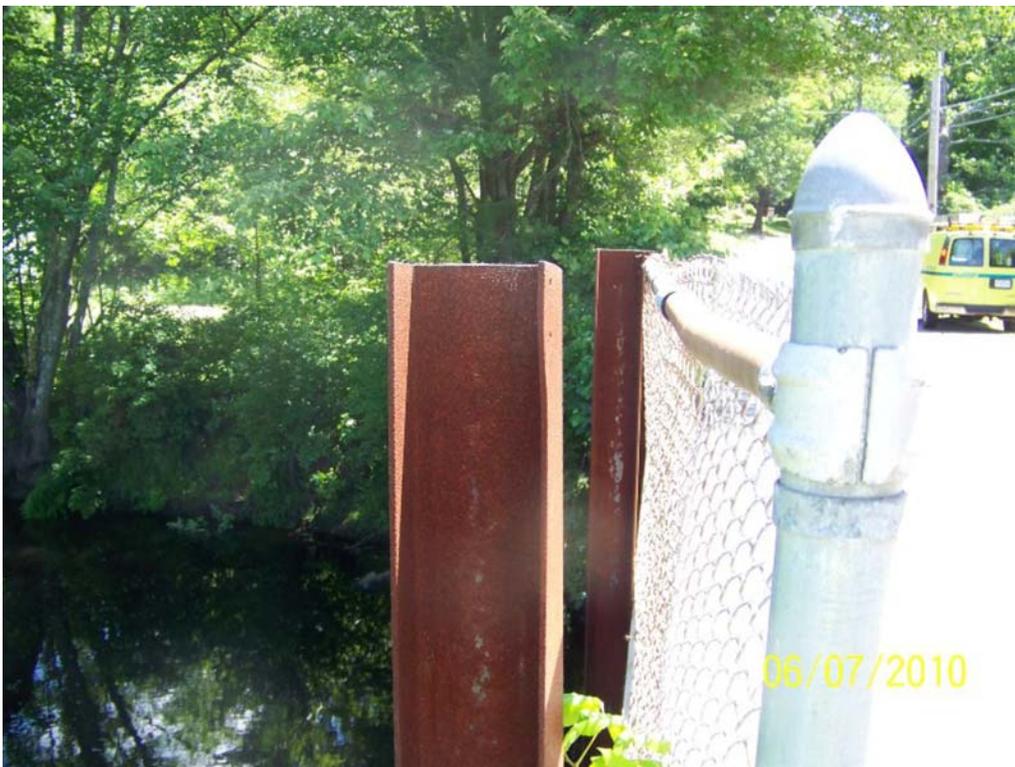
Photo 2: Northeast vertical with heavy surface rust and not connected to the horizontal.

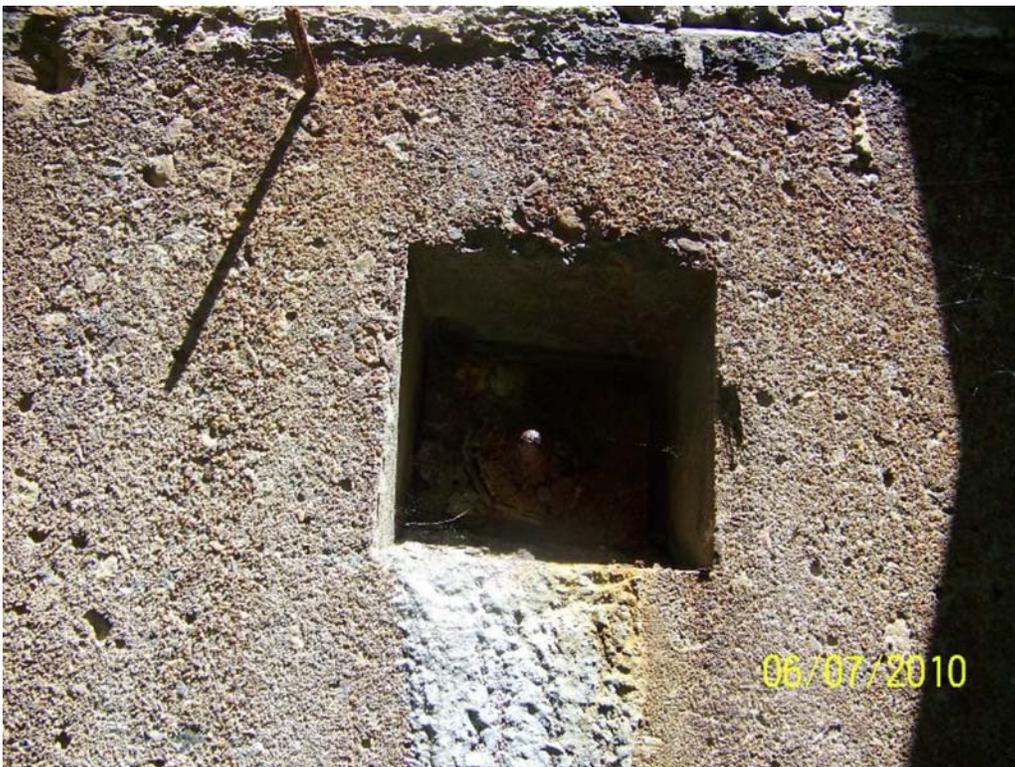
Photo 4: Rusting and corrosion to the Southeast post tensioning nut and bolt.

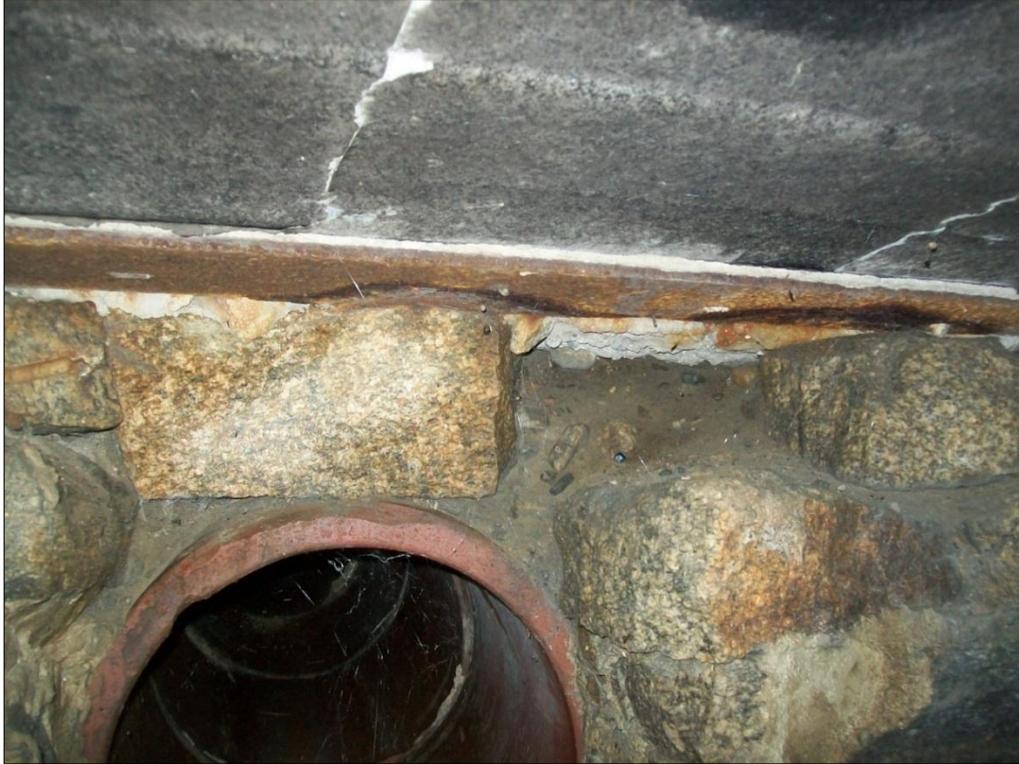
Photo 9 Looking South: Loss of Slab Bearing at South Apartment

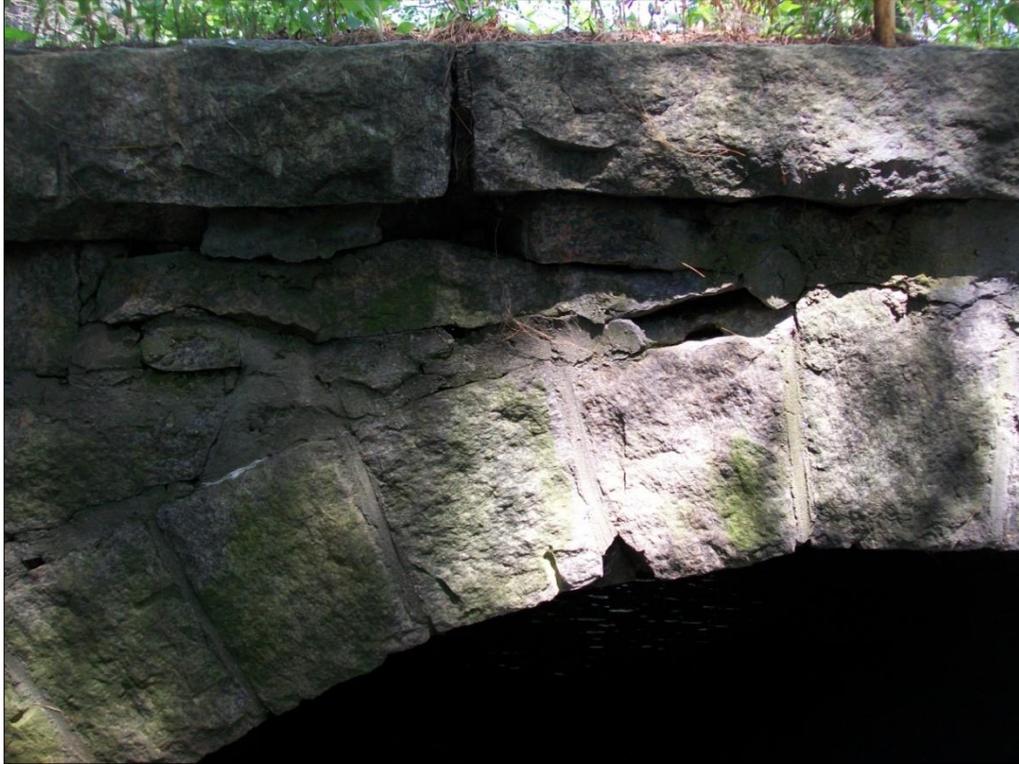
Photo 9 Looking North: Cracks in South Spandrel Wall

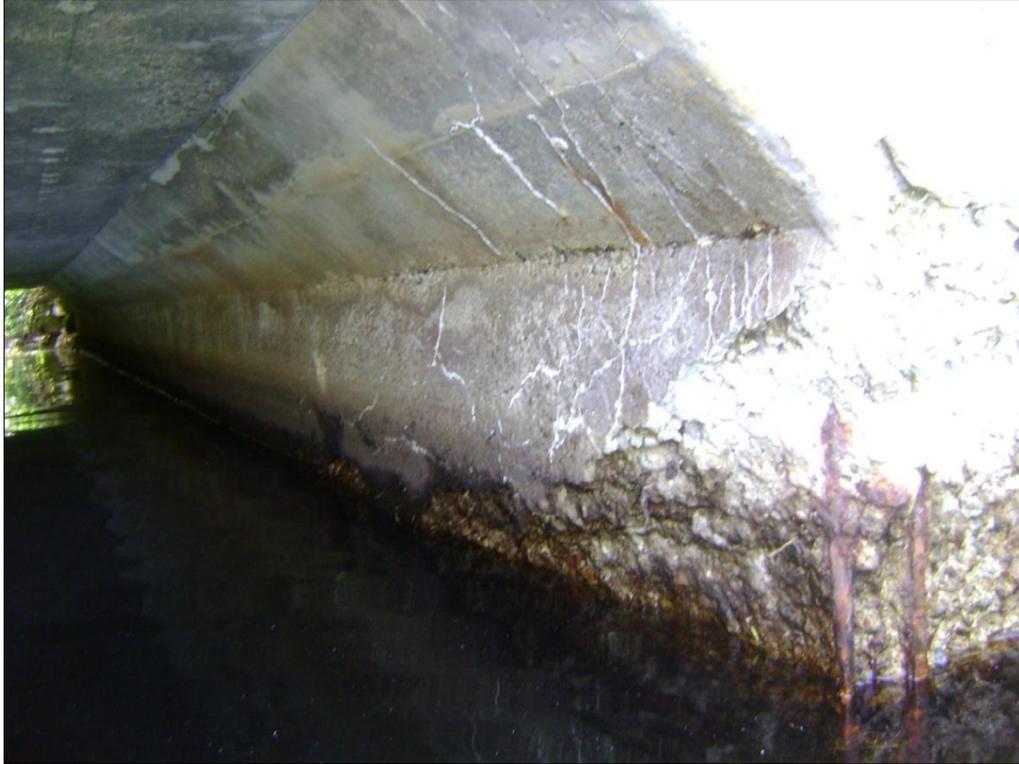
Photo 9 Looking South: West Culvert Wall Deterioration at North Corner

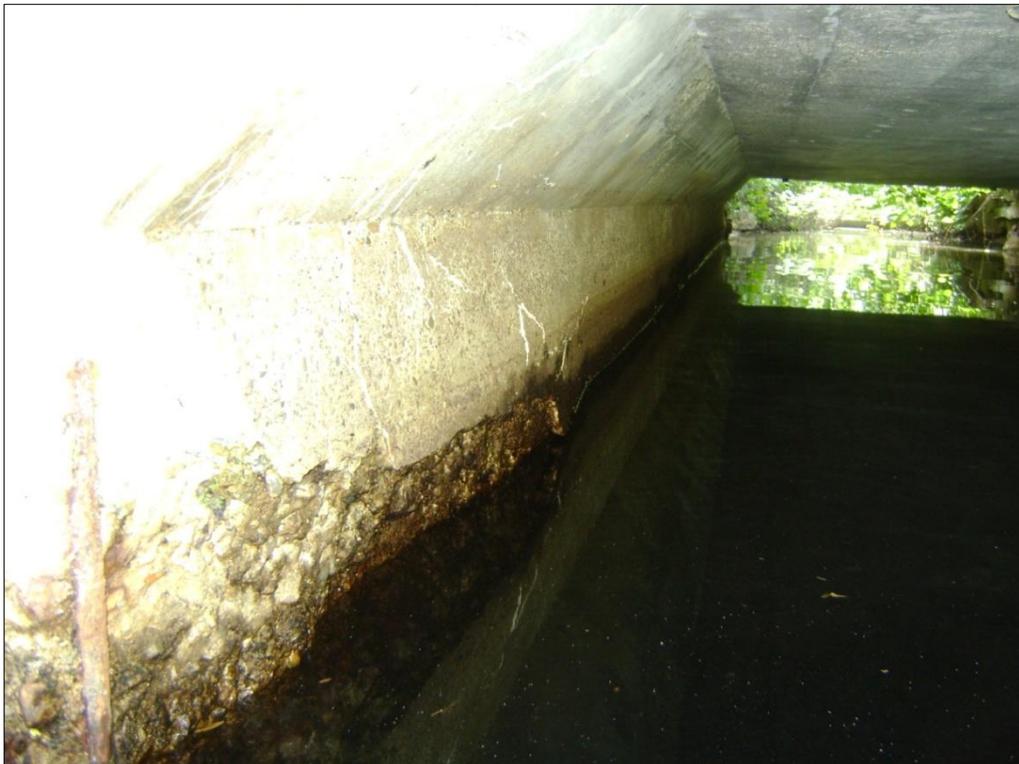
Photo 10 Looking South: East Culvert Wall Deterioration at North Corner

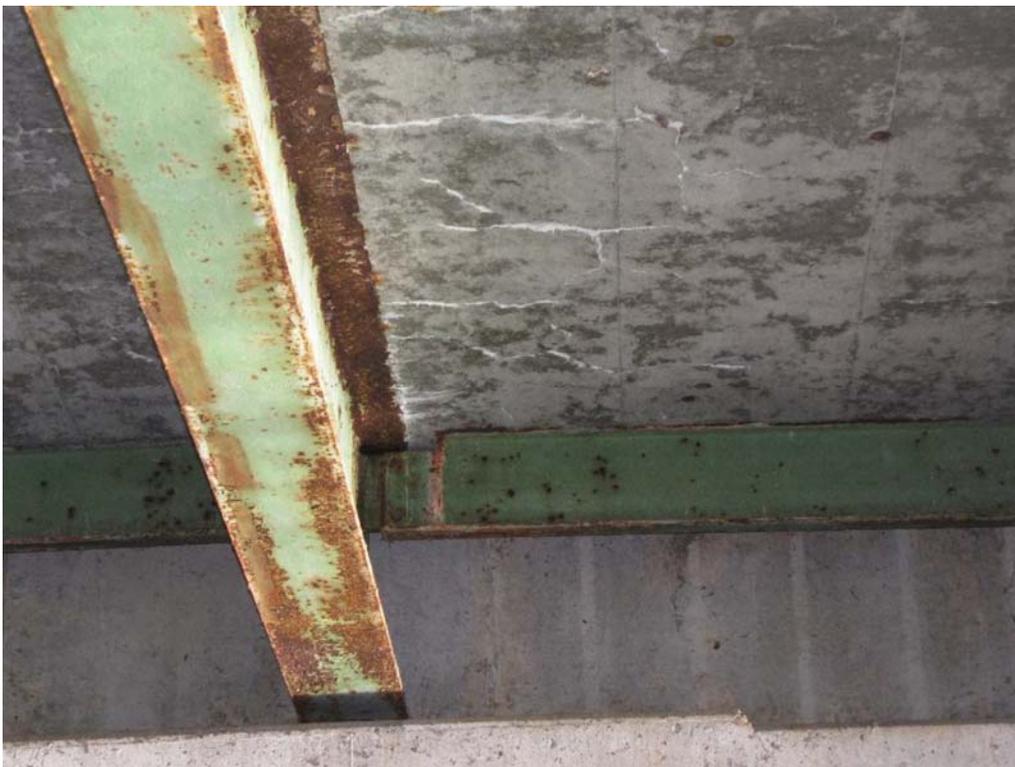
Photo 2: Typical deck cracks with efflorescence.

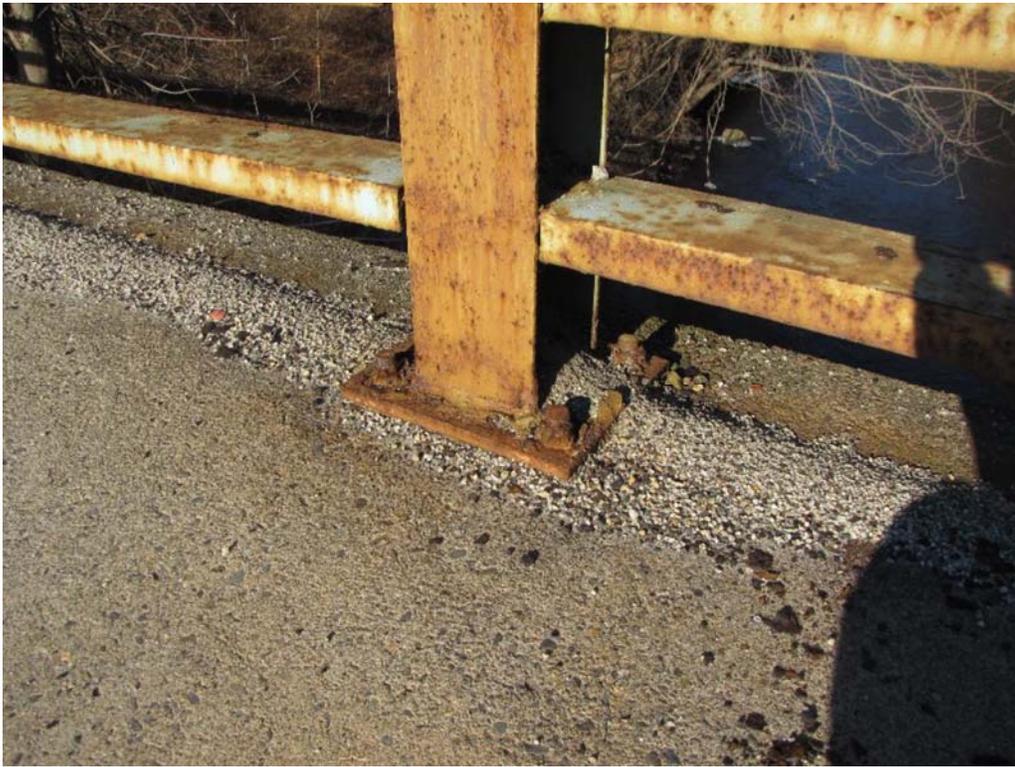
Photo 3: Typical bridge rail rust with section loss to anchor bolt nuts.

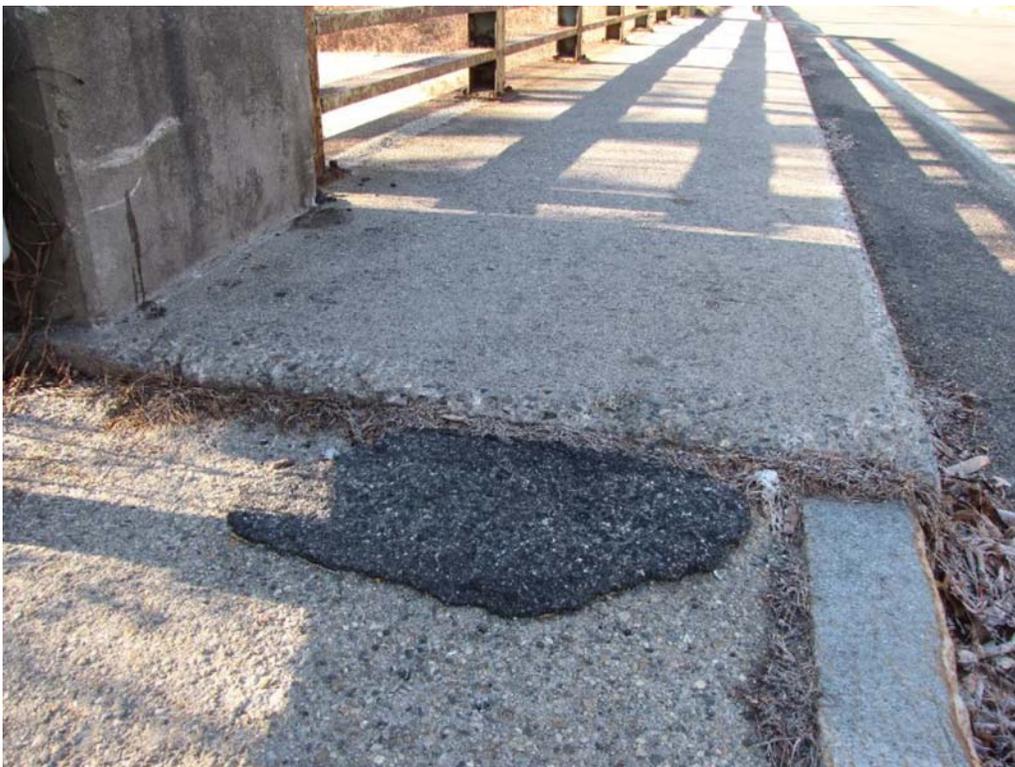
Photo 4: Southeast sidewalk settlement with partial bituminous ramp.

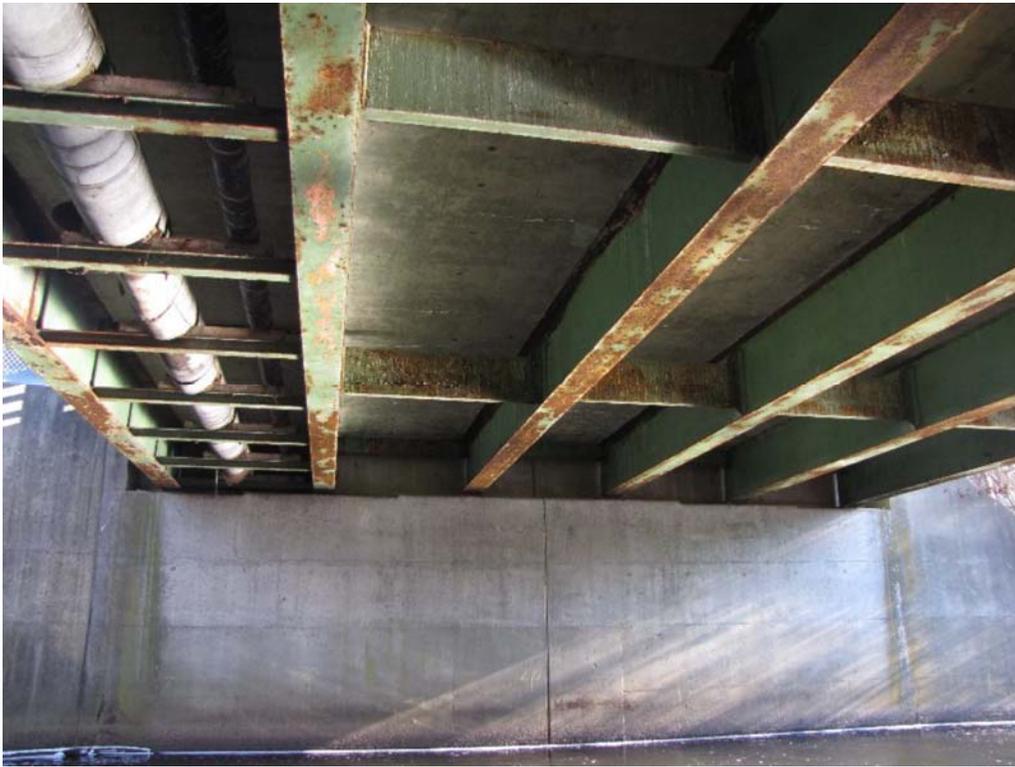
Photo 5: Superstructure paint peel and rust.

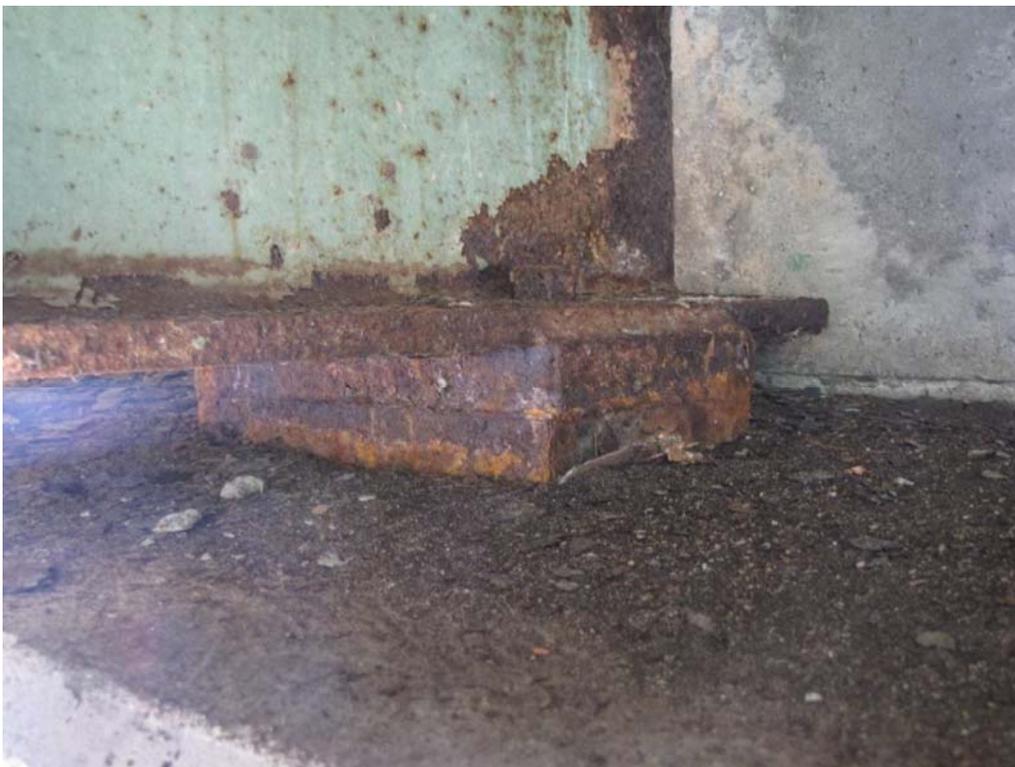
Photo 6: Typical bearing surface rust.

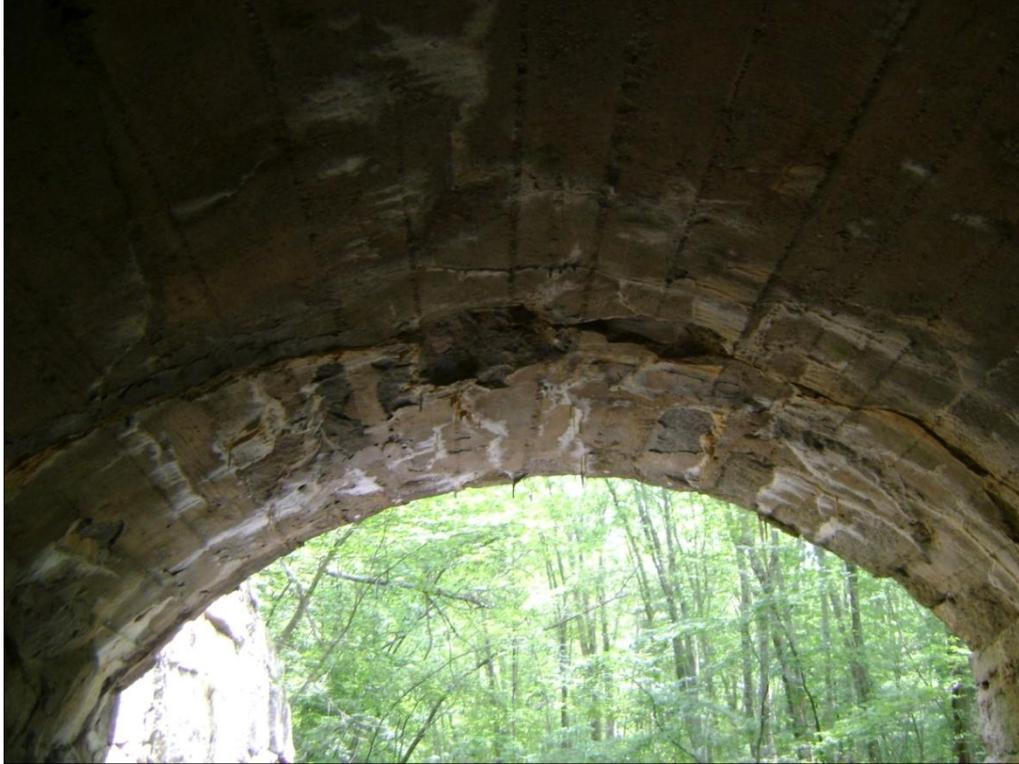
Photo 7 Looking South: Large Spalls at Arch Underside

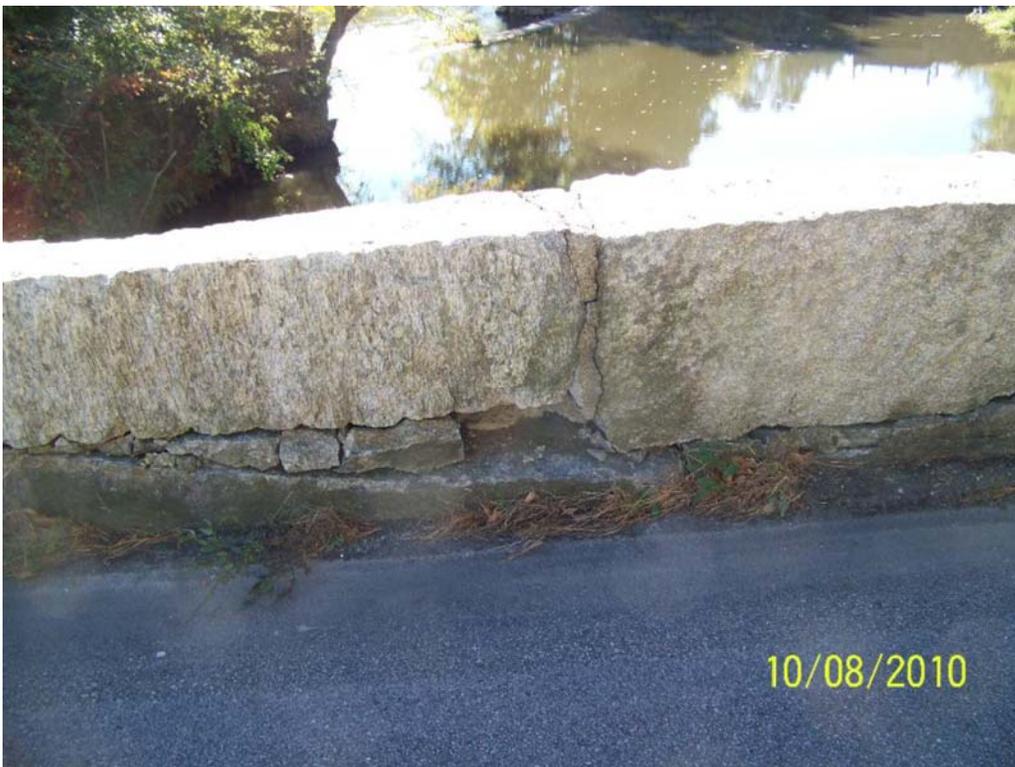
Photo 2: Missing chink stone to the South masonry bridge rail, typical of several throughout.

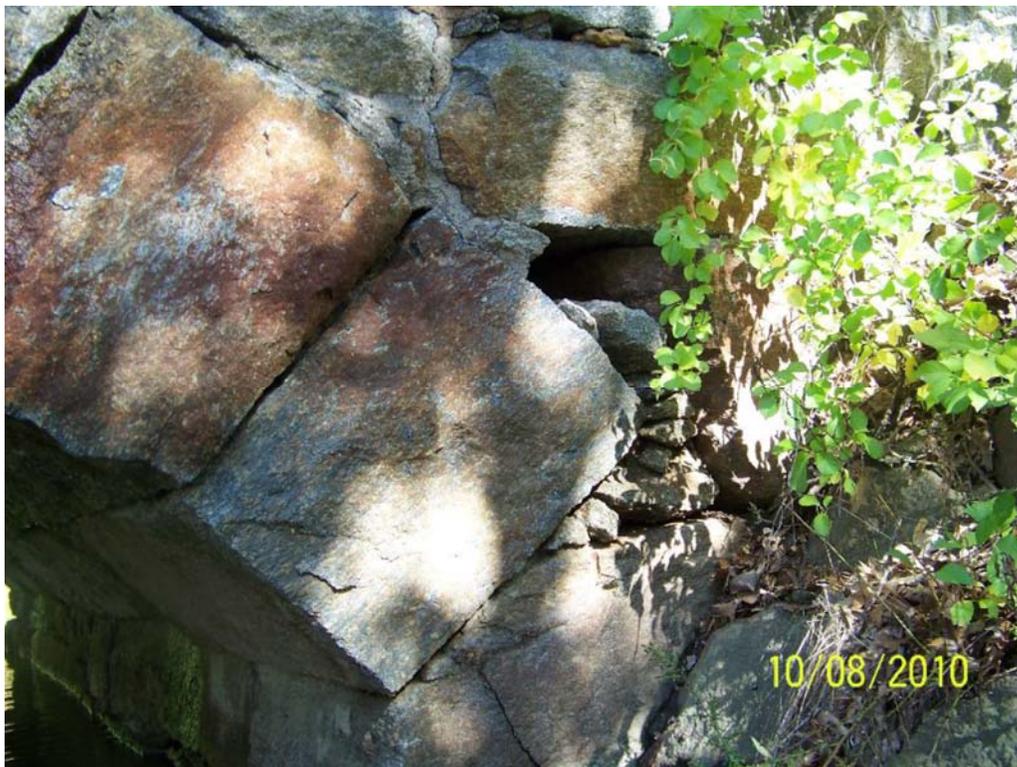
Photo 4: Void to the Southeast spandrel wall. Vegetation growth to the spandrel wall masonry joints, typical at all four corners.

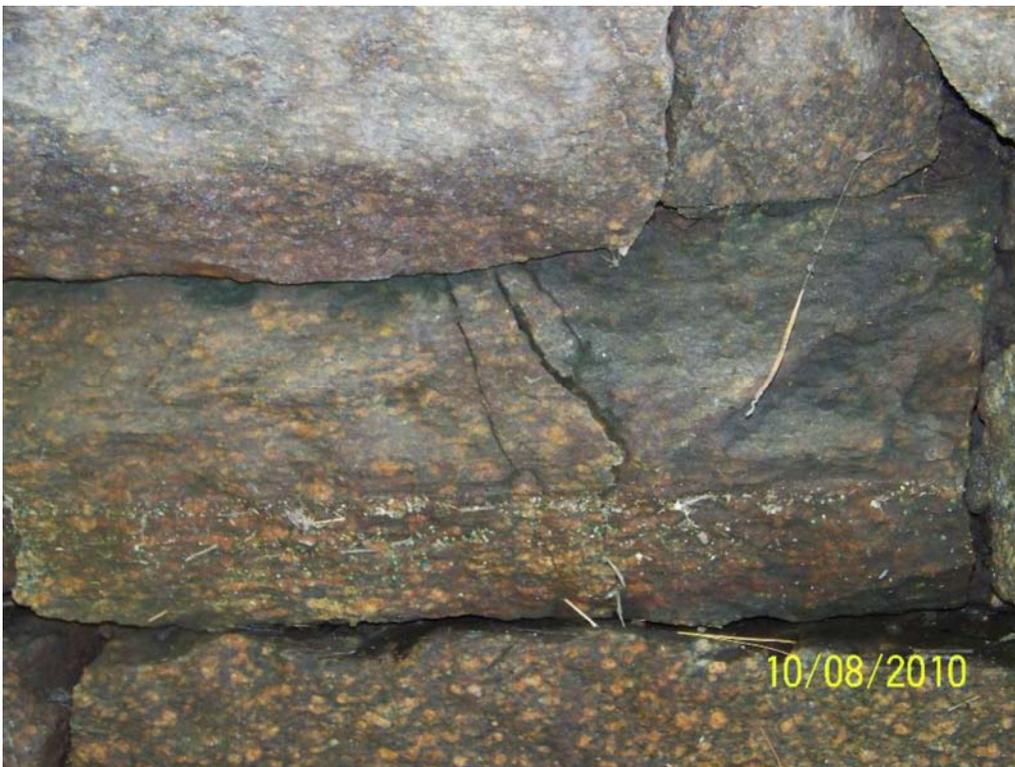
Photo 6: Fractured stone at the center of the East masonry breastwall.

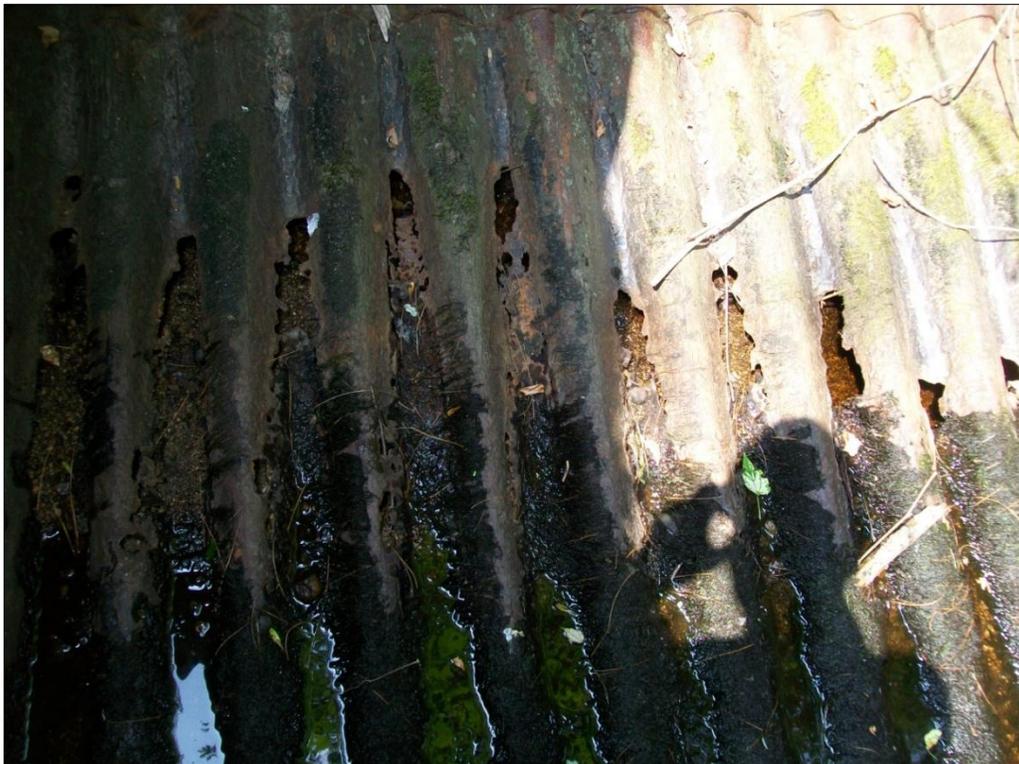
Photo 2 Looking Down: Corrosion in Culvert Floor

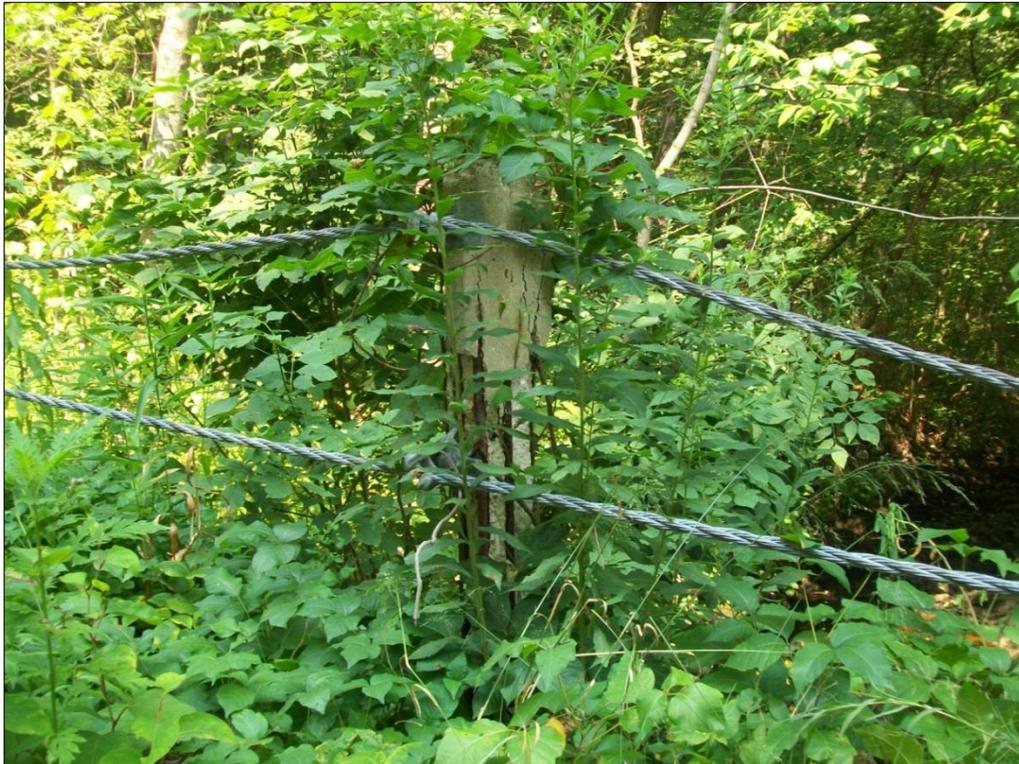
Photo 11 Looking East: Typical Spalling of Guardrail Post

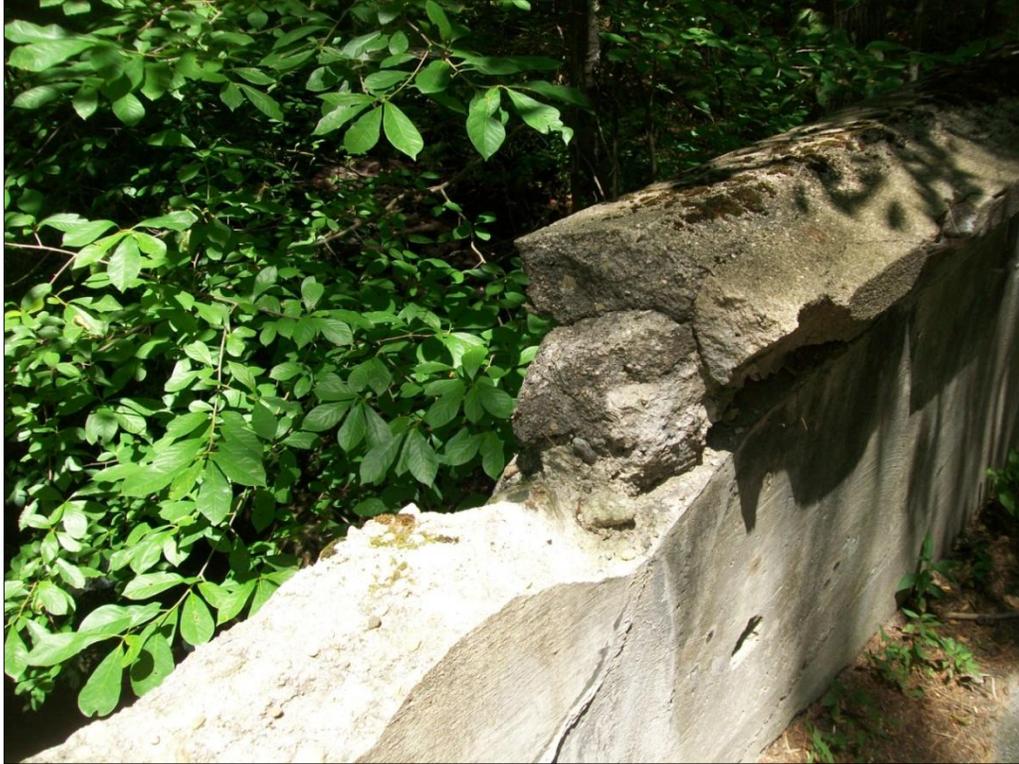
Photo 7 Looking Northwest: Deterioration of West Bridge Rail

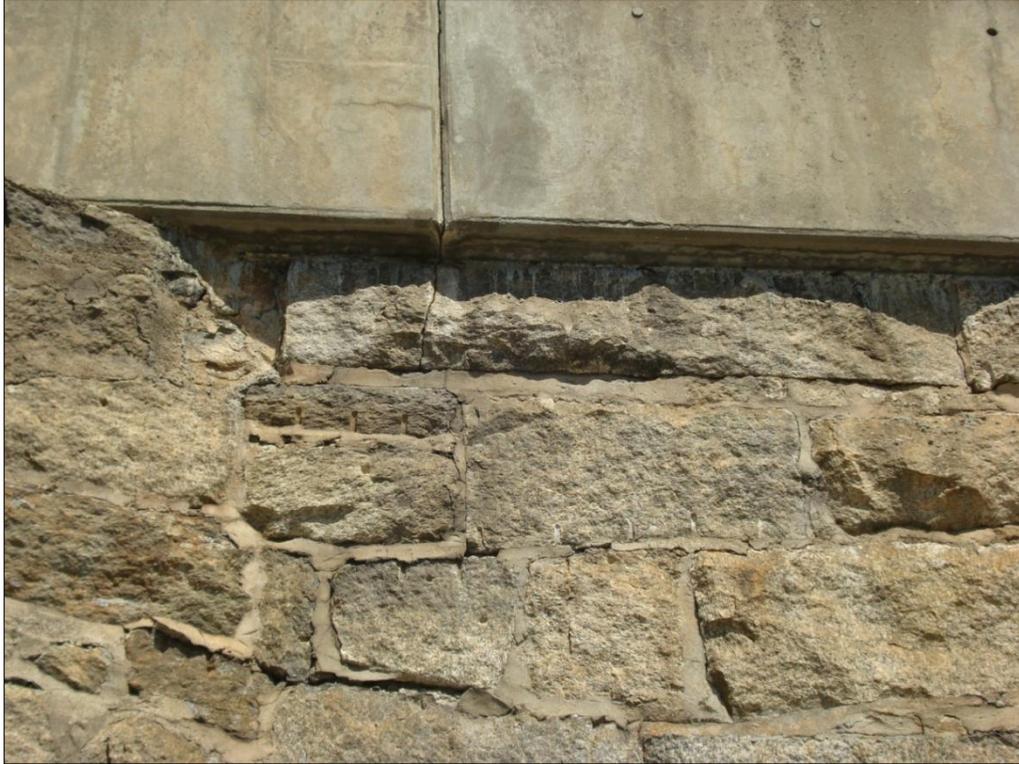
Photo 5 Looking North: Cracked Stone at Top of South Spandrel Wall

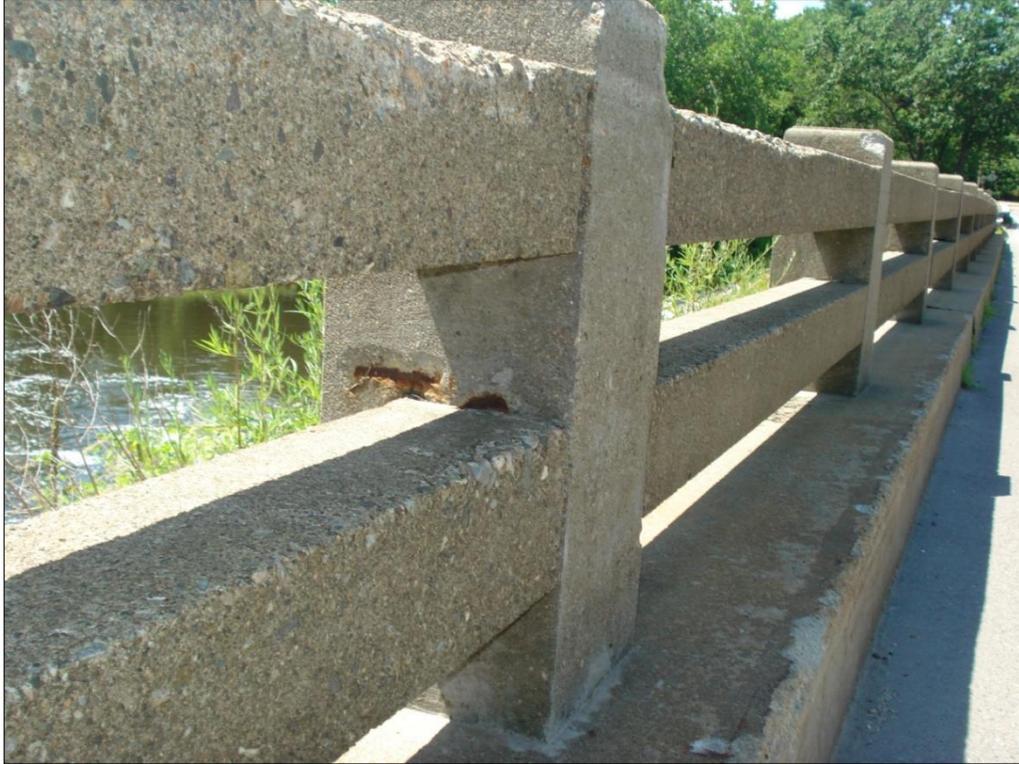
Photo 11 Looking Southwest: Typical Spall in South Bridge Rail

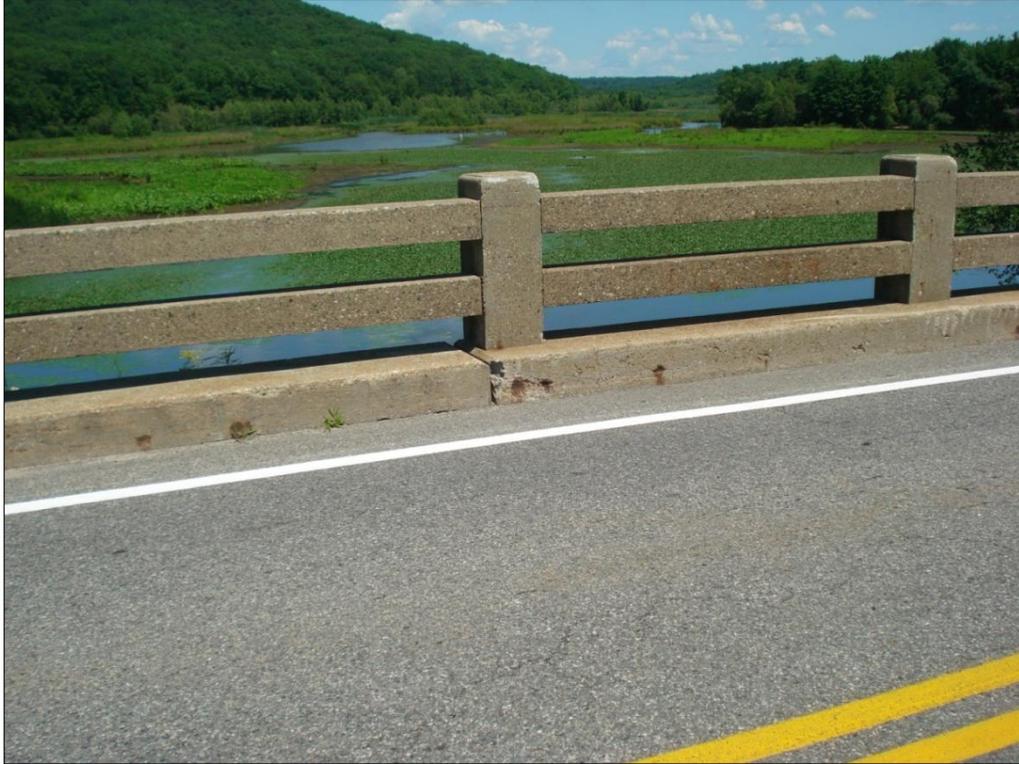
Photo 13 Looking North: Spalling and Cracking at North Bridge Rail Base
