Bridge/Culvert Management Plan

November 2011

Uxbridge
Massachusetts

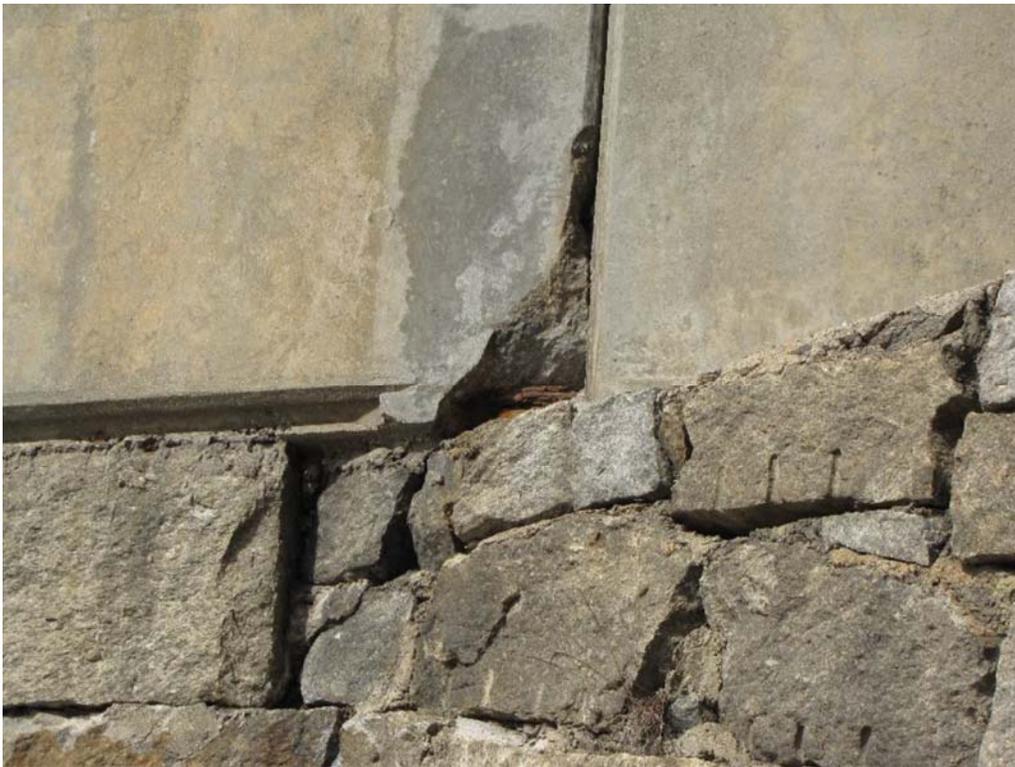
Photo 2: Spall with exposed rebar to the East end of the South parapet.

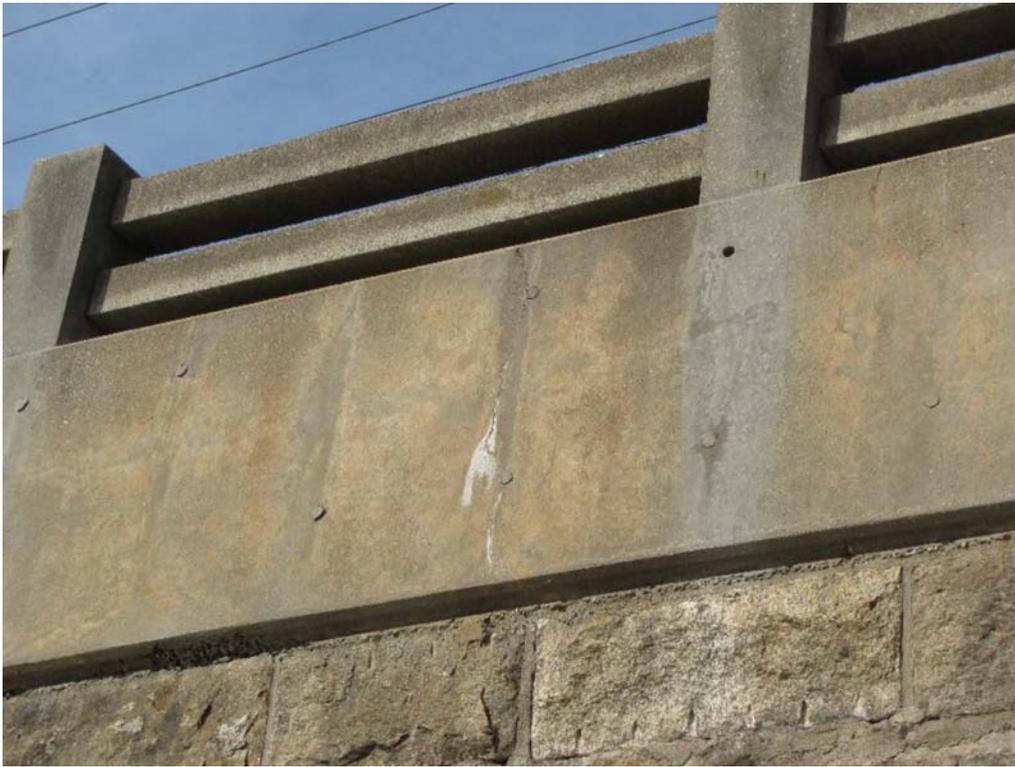
Photo 3: Typical cracking with efflo. to the South parapet.

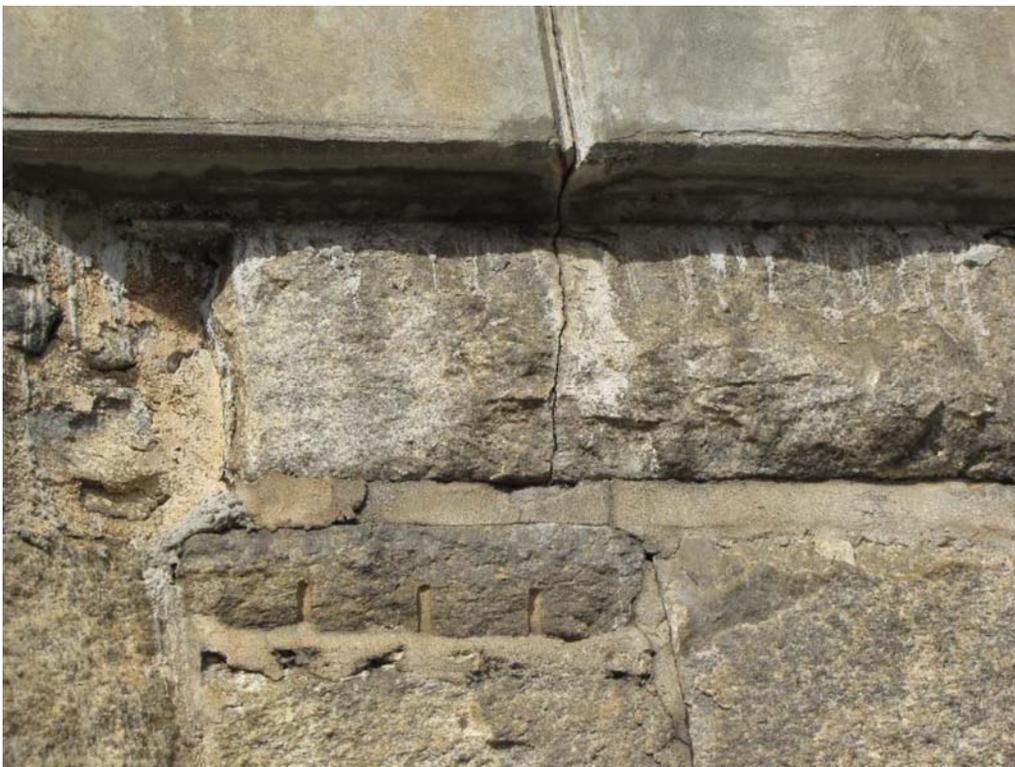
Photo 6: Cracked stone at the top West end of the South spandrel wall.

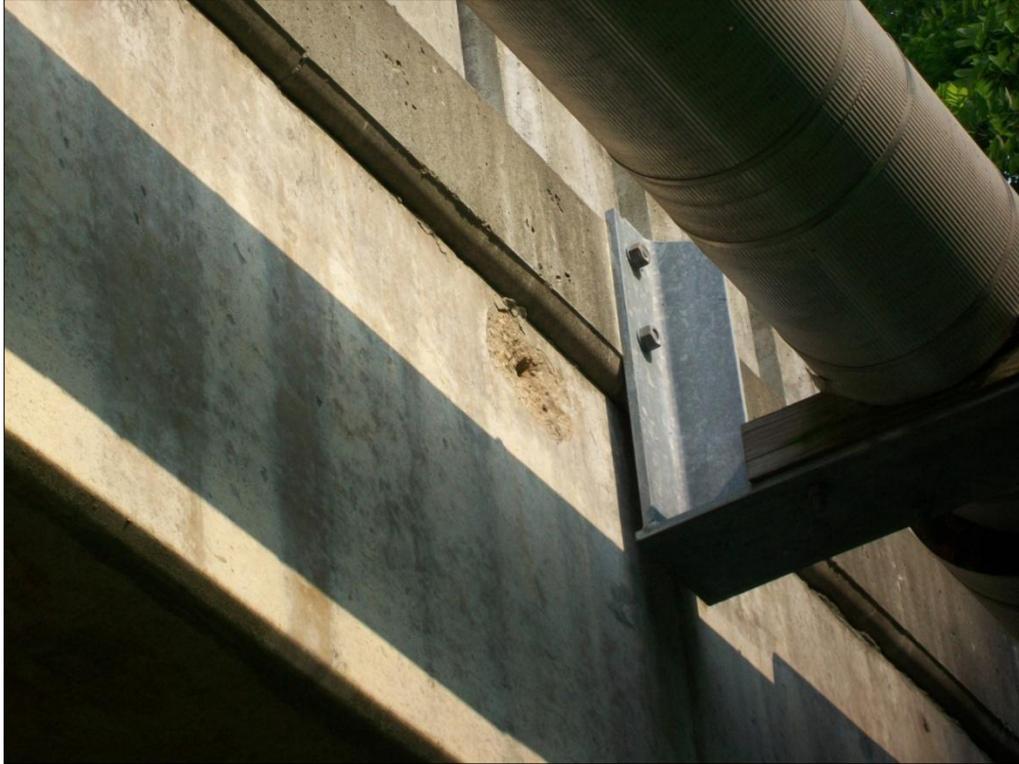
Photo 5 Looking Northwest: Spall in East Fascia of Beam #9
