TOWN OF UXBRIDGE

ADA SELF- EVALUATION AND TRANSITION PLAN

ADA SELF-EVALUATION AND TRANSITION PLAN

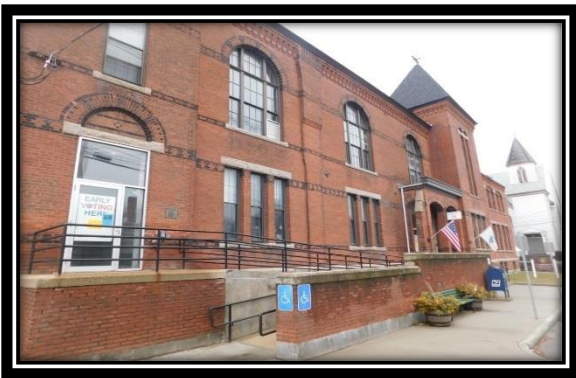
The Uxbridge Town Hall is substantially non-compliant with no vertical access to the second story, Board of Selectmen's Meeting Room, and Town Manager's Office. The accessible ramp exceeds the maximum length of 30' without a level landing but according to Town Officials, received a variance from the MA Architectural Access Board. In addition, the ramp has deteriorated and has abrupt changes in level surface, has sections which exceed the

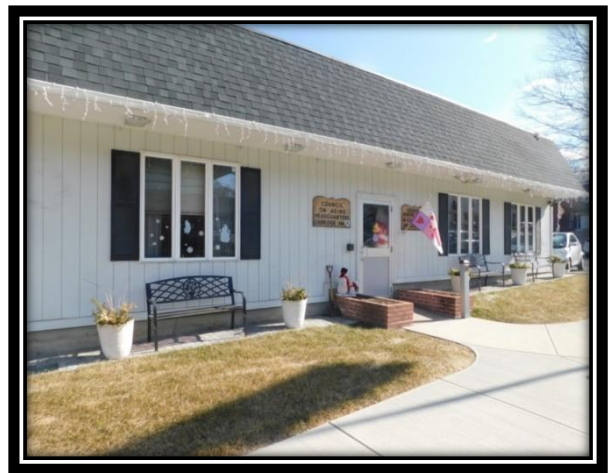
There is an abrupt change in level surface at the threshold of the rear side entrance. There is no level landing at the main entrance with running slopes varying from 8.4% to 9.0%. The three benches at the front of the building are not on an accessible route and do not provide a level area for a wheelchair. The walkway from the street has abrupt changes in level surface. The main entrance

interior door has an excessive operating force and too fast of a closing speed. The reception counter exceeds the maximum height requirement. The coffee/snack serving counter is within range for a forward and side reach. The food serving counter is not within reach range, but food is distributed by staff and/or volunteers. Switches, controls, and coat hooks exceed the maximum reach range. Interior doors lack compliant hardware and lack tactile accessible signage. Offices lack sufficient clear widths and maneuverability. The men's and women's bathrooms are substantially non-compliant. *Note: The Senior Center Director has indicated that it is intended to make one bathroom a compliant unisex accessible bathroom and one bathroom for staff only.*

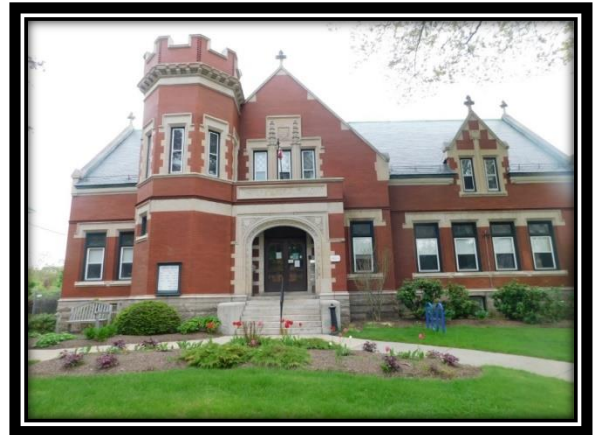
The designated accessible parking space is not van accessible, lacks striping, and has excessive cross slopes. There is no compliant accessible route to the library from the parking or from the public sidewalk to the library. The bench at the front of the library is not on an accessible route. The front entrance stairs have non-compliant railings (only one railing, not oval, no extensions). There is no directional signage at the front of the building noting the accessible entrance. The maneuvering clearance at the "accessible" entrance is reduced to only 36" due to the book drop and the door closing speed and operating force are non-compliant. Interior doors on all levels lack signage or the signage is not located on the latch side of the door. Most interior doors (all levels) have knob-style hardware. There are numerous protruding objects throughout the building. The lower level unisex accessible bathroom has a door lock that is not operable with a closed fist, a towel dispenser that requires pinching or grasping, a water closet with a flush control which required too much force to use, a urinal with a flush control on the wrong side and which required too much force to use, and a sink with piping that is not guarded or insulated. Lower level adult and children's tables do not provide adequate knee clearance. The electronic card catalogues on the lower and main levels lack knee clearance and are too high. The lower level emergency exit stairs lack railings on both sides, lack extensions, and have unbeveled nosings. The lower level stacks by the staff room do not provide the minimum required clear width between stacks. Interior sloped areas on the lower level near the entrance and the stairs to the second level have excessive running slopes. The spiral stairs to the main (second) level

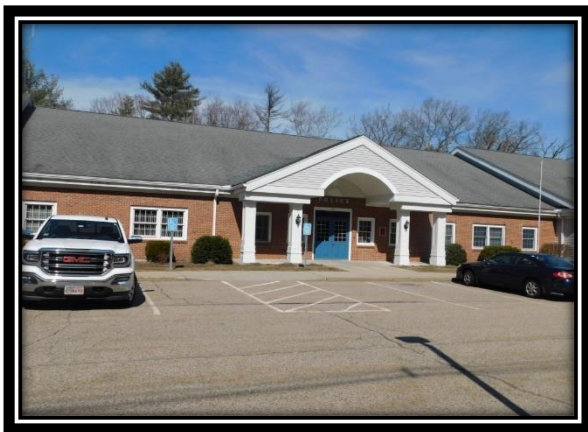
The Police Station is substantially compliant but does have some areas of non-compliance.

The accessible parking space is not designated as van accessible and the signage is too low. The curb ramp from the parking to the sidewalk is too steep and lacks a level landing at the top. There is an abrupt change in level surface from the asphalt parking lot to the concrete walkway. The 1st concrete pad of the sidewalk is too steep for a walkway. Exterior doors and interior doors with closers exceed the maximum operating force and do not adhere to the minimum closing speed.

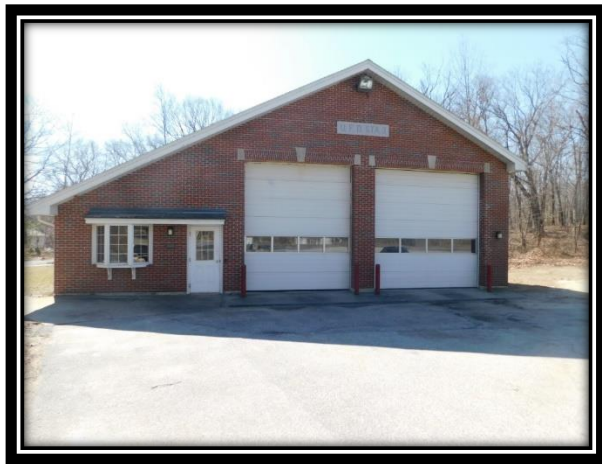
The South Fire Station does not comply with 521 CMR or the 2010 ADA Standards. There is no designated accessible parking. The entrances to the building and into the administrative

office each have a 3” to 4” abrupt change in level surface to gain access. Entrance, exit, and interior doors have excessive operating forces as well as closing speeds that are too fast. Interior doors lack tactile signage and have knob-style hardware. The bathroom (for firefighter/EMS use only) is wholly non-compliant.

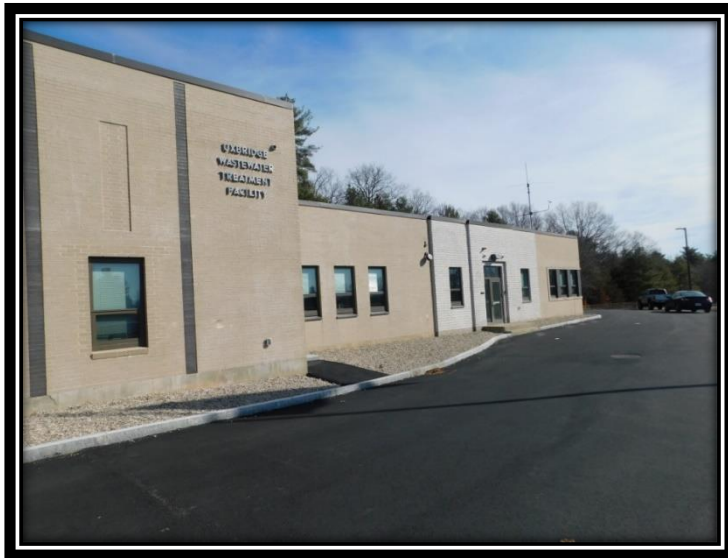
Although the Wastewater Division Building is substantially compliant under the 2010 ADA Standards for Accessible Design and 521 CMR Massachusetts Architectural Access Board Regulations, there are a number of areas of non-compliance. Employees who work out of the Water Division Building must meet strict physical requirements which a person with a mobility limiting disability would not be able to perform. Certain areas of the administrative building (laboratory) and the actual treatment facility are not intended for public use and therefore are not open to the public. These areas are limited to wastewater division employees who

presumably must meet strict physical requirements which a person with a mobility limiting disability would not be able to perform, accessible modifications to these areas will be triggered by either an employee reasonable accommodations request or the allowance of public access into these areas.

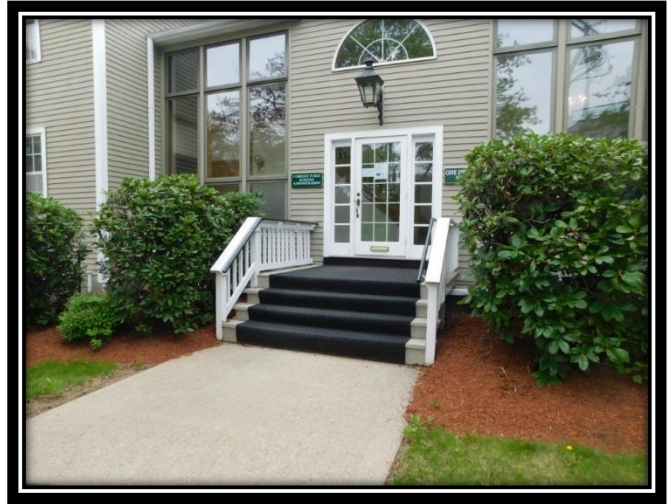
The Cove Building is substantially non-compliant. Although there are two designated parking spaces, there does not exist an accessible route of travel from the parking to the building (stairs only). There are no van accessible parking spaces and the accessible signage is too low. The entrance into the building can only be reached via stairs which have non-compliant railings. The hardware for the entrance door requires pinching and twisting and cannot be opened with a closed fist. The interior main stair railings to the second level lack extensions at the bottom and are provided on one side only. The interior rear stair railings between levels lack extensions at both the top and bottom and are provided on one side only. There are protruding objects in the second level hallway. The second level bathrooms are wholly non-compliant. Administrative office doors lack tactile designation signage and compliant door hardware. Note: At the time of assessment, the level 1 offices were locked and assessment was limited to visual from the hallway.

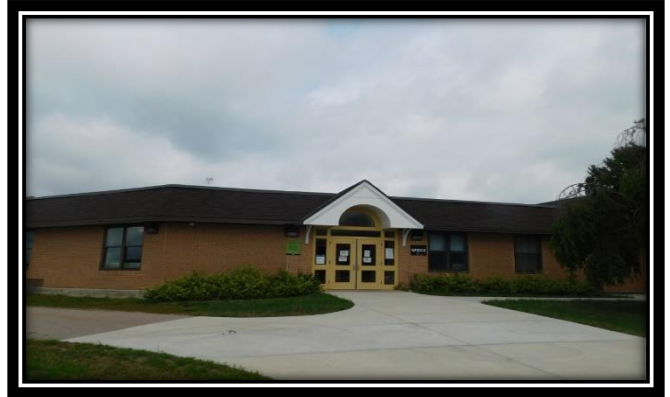
The signage for four of the five designated accessible parking spaces is too high with none of the spaces designated as van accessible. Some of the spaces have excessive cross slopes and access aisles that are too narrow. There is no level landing at the top of the curb ramp from the school parking to the walk way to the building. Running slopes vary up to 8.3% (which requires paired railings as a ramped approach) and exceed the maximum running length of 30' without a level landing. The landing in front of the main entrance door is not level and does not meet the required width requirement. Interior and exterior door operating forces and closing speeds exceed that allowed. Protruding objects exist in hallways. The running slope of the ramp between the gym and cafeteria is too steep. The upper segment of the ramp near Room #225 exceeds the maximum running length by 1½". Both ramps lack fully compliant railing extensions at the top and bottom of the ramps. Classroom sinks have water bubblers which are too high, set too far back from the front edge, and lack knee clearance. Some classrooms have unsecured rugs over the flooring creating a tripping hazard.

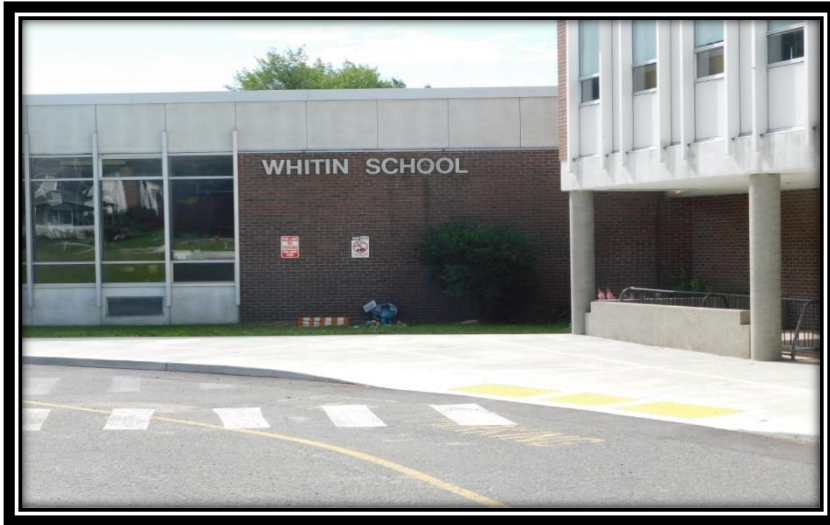
The three different designated accessible parking areas (rear, side, front) have a number of non-compliance issues including the lack of van accessible spaces, excessive running and/or cross slopes, parking spaces and access aisles that are too narrow, insufficient signage, and signage that is too far from the designated spaces. The designated rear parking lacks a level landing at the “curb ramp” and has areas of deterioration and abrupt changes in level surface

on the accessible route to the ramp. The rear ramp has running slopes that vary up to 8.5% (maximum allowed is 8.3%). The front side parking lacks a level landing at the curb ramp at the concrete accessible route of travel. In addition, the cross slopes of the concrete accessible route to the front entrance has excessive cross slopes that vary from 2.4% to 3.4%. Interior and exterior door operating forces and closing speeds exceed

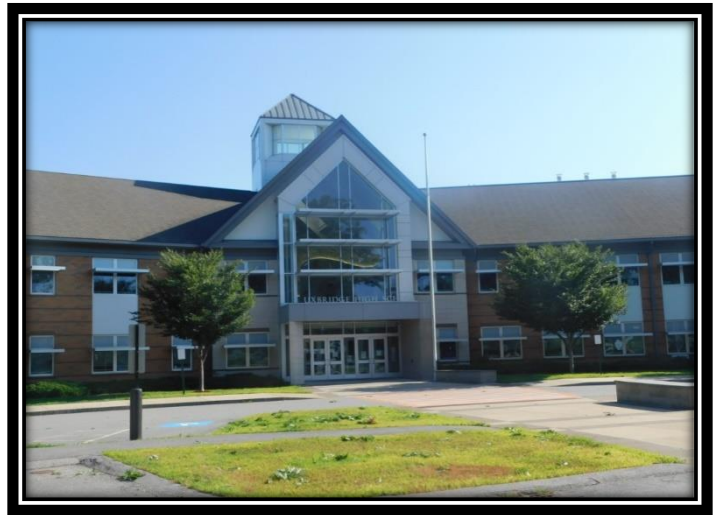
Interior and exterior door operating forces and closing speeds exceed that allowed. Protruding objects exist in the hallways and in some classrooms. Some interior doors lack tactile designation signage or have signage that is too high, too low, or is not on the latch side of the door. Hand sanitizers are too high under the 2010 ADA Standards. Student lockers have non-compliant combination locks which are not operable with a closed fist or with a loose grip. A number of doors have glass panes which are too high. In many instances, classroom and staff soap and towel dispensers were too high. Some of the classrooms with accessible sinks, including the science labs, use the knee space for storage. Items placed in the clear space of the accessible sink must be removed. Six wooden and metal picnic tables located outside the Commons do not provide the required knee clearance. The science classrooms have eyewash stations that are not functional for a wheelchair user and the adjacent pull chain is not within reach range.

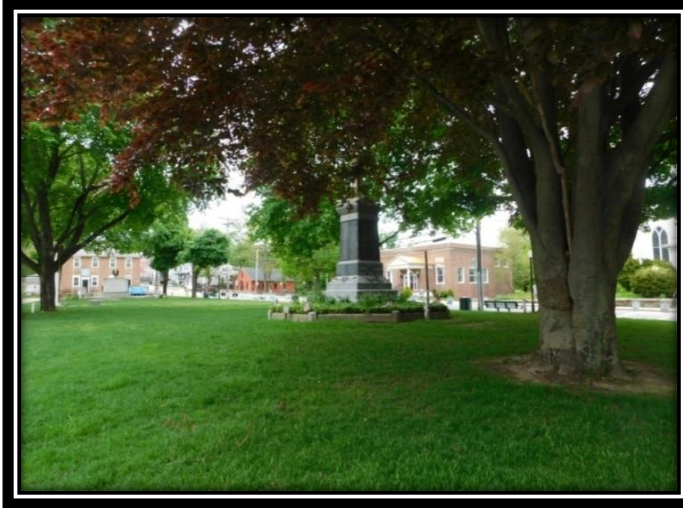
There is no accessible route of travel to and throughout the common to the Court Street benches, monuments, war memorials, trash bins, and commemorative features. The benches lack adjacent level spaces for wheelchairs. The telephone pole at North Main Street reduces the clear width to 26". Telephone pole guy wires at Douglas Street and across from the church have reduced head room clearance and serve as protruding objects. Crosswalks near the church and Unibank lack curb ramps on either side with 4" and 7" high granite curbs.

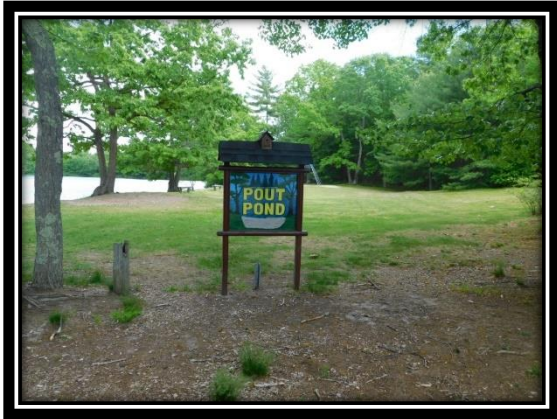
The designated “accessible” parking is non-compliant as there is no van accessible designated parking, the signage is too low, the cross slopes exceed the maximum allowed, and there are

no access aisles. In addition, the surface is deteriorated and not level (heaving). No accessible route of travel exists to any of the elements and activities at the beach including the picnic tables, concession stand, bathrooms, beach area, benches, tent/pavilion, and swings. The bathrooms are wholly non-compliant as they lack adequate clear width into the facilities, lack grab bars, and have non-compliant sinks, water closets, dispensers, and other elements. The storage room doors and concession door lack tactile signage, have

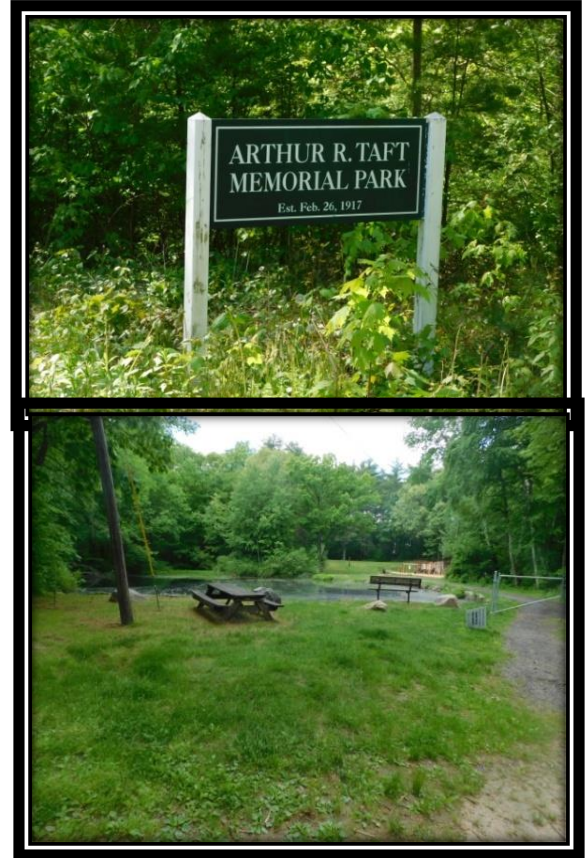
The Carney Street access has a paved parking area but no spaces are designated as accessible. As this area only provides access to an unimproved trail and no other amenities, no other action would be required unless the trail is improved and other amenities provided. The Marywood Extension parking also lacks designated accessible parking. There is no accessible route from the parking to the park/playground and no accessible route within the park to picnic tables, benches, or the playground area. There is no accessible route around or within the playground area including to the play components. The surface to the playground consists of woodchips. The picnic tables do not provide the required knee clearance and the benches lack an adjacent level area for a wheelchair.

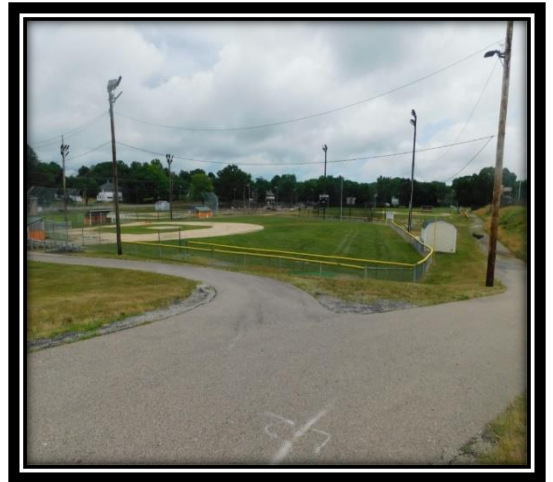
The wooden stairs (2 sets) to the lower fields are non-compliant as the risers are open and have unbeveled nosings, and the railings are not oval or round, lack extensions at the top and bottom, and are non-continuous. The concession stand has windows/counters that are too high, has a vertical rise of 9” to access the interior, knob-style door hardware and no tactile signage on the latch side of the door. The interior of the concession stand has a sink that is too high which lacks knee clearance and a set of stairs to an upper level (storage) that lacks railings. The men’s and women’s bathrooms were locked at the time of the assessment. Both bathrooms have a 1” to 2” abrupt change in level surface to access the interior and lack tactile accessible signage. The bathrooms must adhere to the requirements as specified in Table 1. A second story exists over the bathrooms which is also presumed to be for storage. The curb ramp at the parking lot to the accessible route to Taft School and the recreational facilities lacks a level landing. Running slopes of the concrete route of travel vary from 6.0% to 8.3% with no railings and exceed the maximum length allowed (30’) without a level landing. The cross slopes of the accessible route to the field(s) varies up to 5.6% with the running slope of the asphalt route to the field varying up to 11.7%. There is no fully accessible route of travel to all of the field, dugouts, bleachers, tennis courts, picnic tables, batting cages, action/skateboard park, player’s benches, etc. There are no level areas for wheelchairs at any of the bleacher seating. The dugouts at the Matthew P. Quigley Memorial Field have inadequate clear width to access the player’s seating. Chain link gates throughout the facility do not have a smooth surface at the base. The concrete pad walkway near Bev Clarke Field has numerous abrupt changes in level surface. Both the tennis courts and the action/skate park are not accessible from the concrete pad walkway due to the lack of an accessible route and abrupt changes in level surface at the facility entry points. The drinking fountain near the

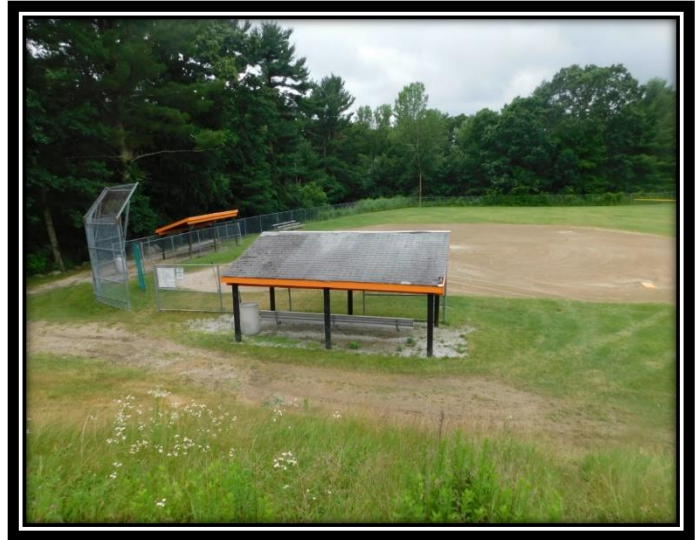
The parking for the recreation area is non-compliant as the spaces lack access aisles, are not van accessible, and have signage that is too low. There is no accessible route fully around or within the playground area. The playground lacks accessible play components with the playground surface consisting of non-compliant rubber chips. Picnic tables located in various locations around the school building do not meet accessibility requirements for depth. The chain link gate to the playground is not smooth at the base of the gate. There is no compliant accessible route of travel to the basketball court, concession stand, bathrooms, upper field spectator benches, bleacher's, player's benches, and to the 3 different ball fields. The concession stand windows/counters are too high and has other areas of non-compliance including non-compliant door hardware, lack of tactile signage, dispensers that are too high, and abrupt change in level surface at the door threshold, and a non-compliant sink. Both bathrooms have various non-compliant features including heights, set-backs, and clearances. There are no level areas for wheelchairs at any of the bleacher seating.

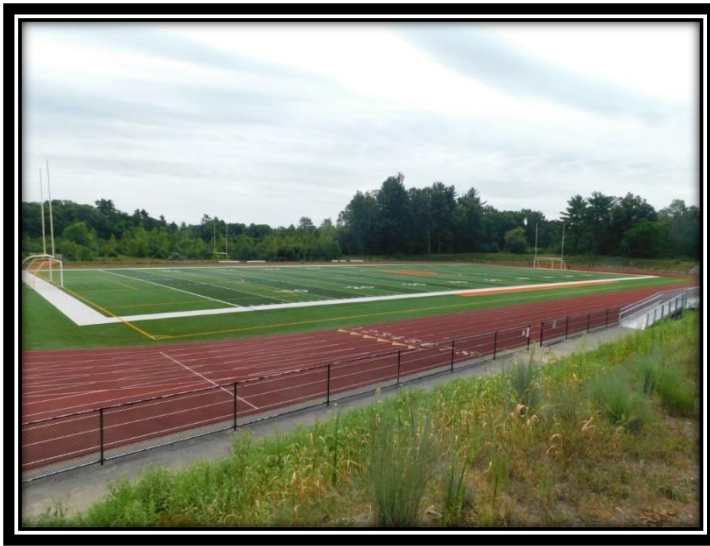
The drinking fountain near the track/multi-purpose field is not “high-low”. There is no designated accessible parking near the track/multi-purpose field entrance. According to staff, the parking near the broadcast booth is designated as “accessible” during games. However, this parking does not meet running and cross slope requirements, lacks striping and permanent signage, is not on an accessible route to the field, and is too far from the field entrance. Due to an 11” change in level surface into the broadcast booth, it is not part of an accessible route. In addition, the glass pane on the broadcast booth door is too high. The

ramp to the bleachers of the track/multi-purpose field is too steep and has bottom railings that are too low. The gate to the field is not smooth at the base.

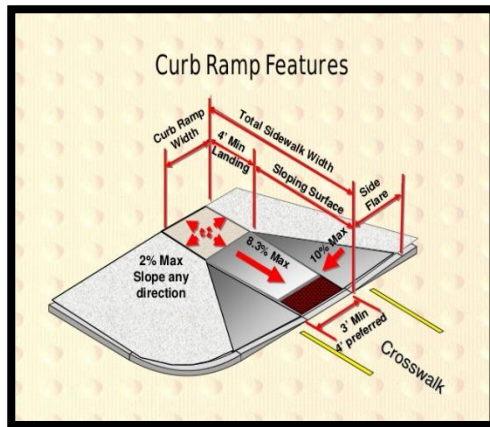
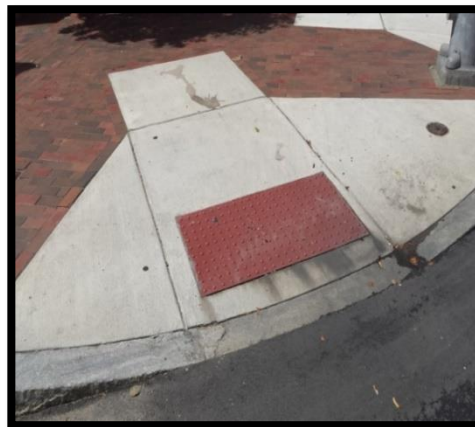
The crosswalk/curb ramps across Park Street lacks detectable warning strips on either side. The southern side of the crosswalk lacks a level landing at the top of the curb ramp with the curb ramp having a running slope of 19.2%, which is in far excess of the maximum allowed of 8.3%. Both sides have abrupt changes in level surface that far exceed 1/4".
