McCloskey Building & Site Repurposing Study Town of Uxbridge, MA

Final Report

April 27, 2020

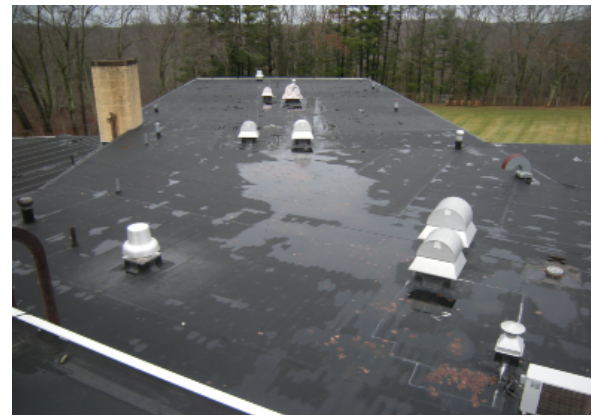
The current rubber membrane roof is in need of replacement; many roof leaks and large areas of ponding were visible during the assessment walk-through. The original copper flashing is over 80 years old and has exceeded its anticipated service life. There are a number of unused gravity vents and other roof penetrations that should be eliminated. As no test cuts were performed, it is unknown what lies between the current membrane roofing and the structural roof deck.

Roof at Junior High School addition with areas of ponding

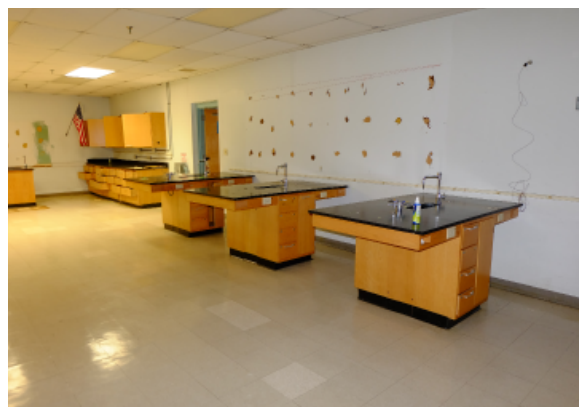
Windowless classroom at 1988 addition

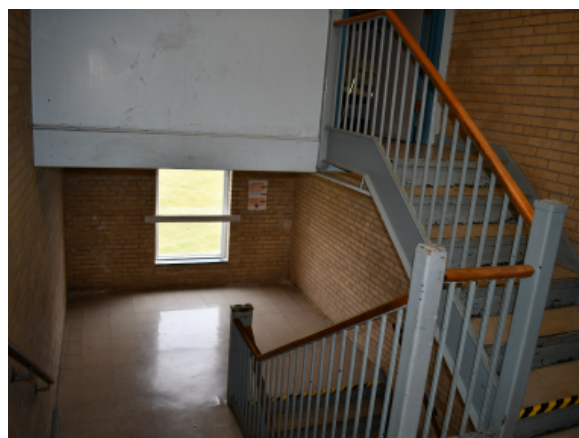
Stairwell at 1936 High School with non-compliant handrails and tread nosings

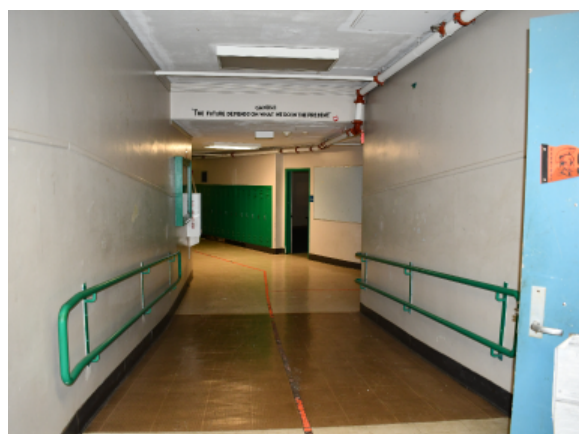
Ramp between 1936 High School and 1952 War Memorial Gym addition with non-compliant slope

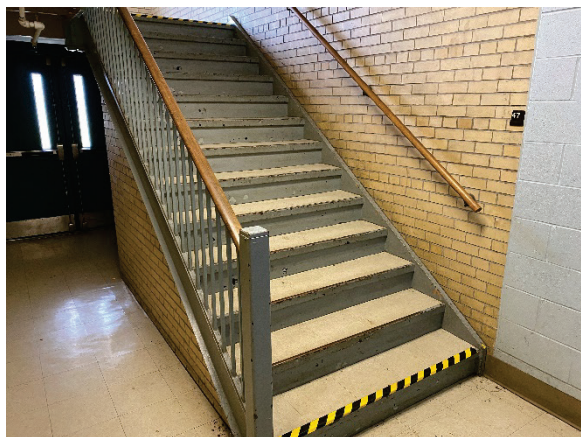
- Many of the interior and exterior handrails are not compliant due to lack of extensions, continuous inside rails, etc. (primarily in the original buildings) and would have to be replaced (521 CMR 27.4).

Non-Compliant Interior Handrail

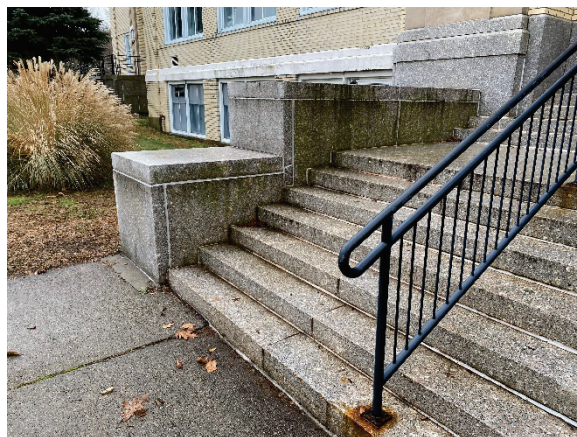
**Main Entrance Lacking Handrails
on Both Sides of Stair**

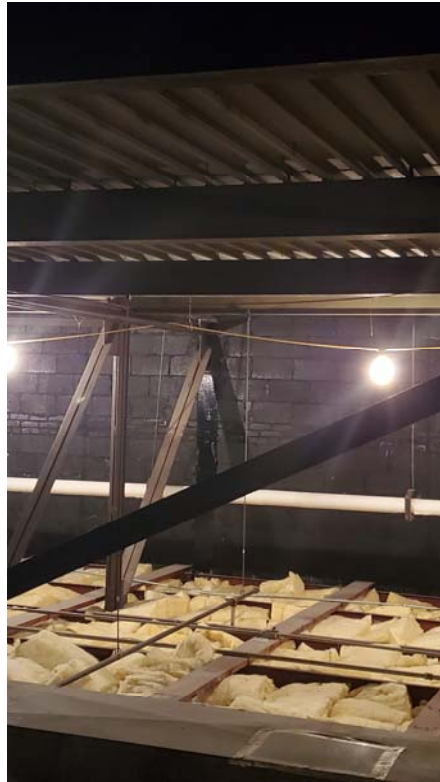
Photograph #1 – Lack of Masonry Wall Ties – 1952 Addition

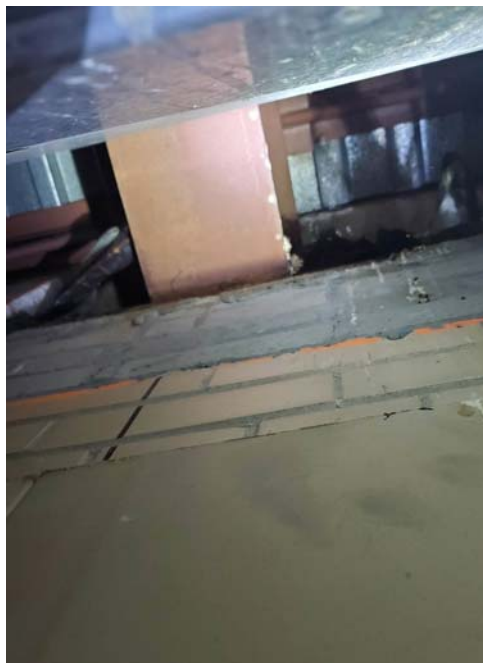
Photograph #2 – Beam From 1988 Addition Bearing on Original Masonry Bearing Wall
– 1988 Addition and 1936 Original Structure

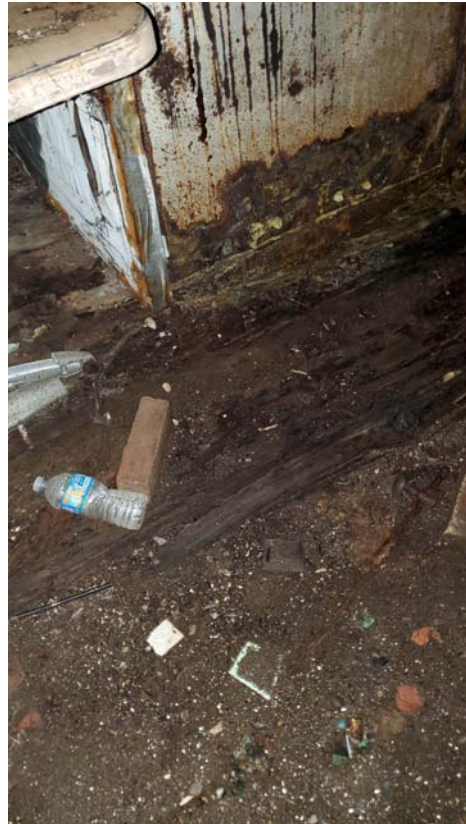
- In the basement of the original 1936 structure, an “Unexcavated” titled room beneath the auditorium main entrance stairs has large amounts of water damage, cracks in the foundation wall, and deteriorating masonry (photographs #3 and #4). The cracked and deteriorated masonry should be replaced and masonry joints repointed. All loose concrete should be removed back to sound material and the areas of deteriorated concrete should be repaired with the appropriate Sika concrete repair product to prevent further degradation to the exposed concrete. Further investigation should be performed to verify if there are ongoing water leaks.

Photograph #3 – Water Damage in an “Unexcavated” Room – 1936 Original Structure

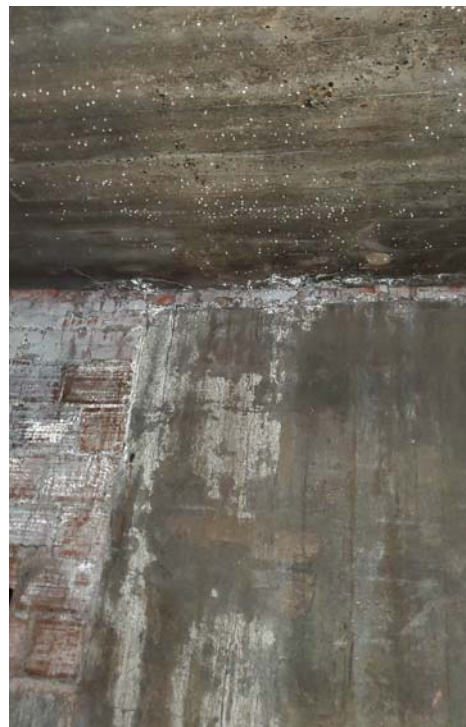
Photograph #4 – Cracked Concrete and Deteriorated Masonry in an “Unexcavated” Room – 1936 Original Structure

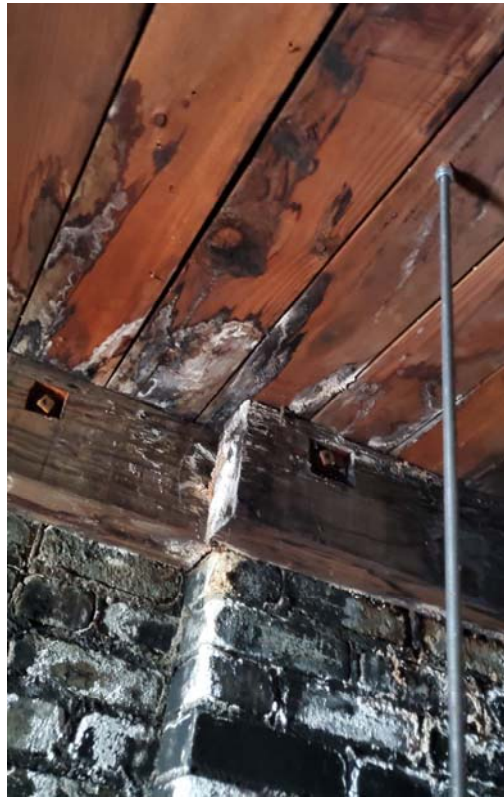
- In the loft area above the gym in the 1952 addition, there is water damage to the wood planking and ledger along with substantial efflorescence and deterioration along the exposed brick beneath (see photographs #5 and #6). Further investigation should be performed to verify if there are ongoing water leaks. The rotted / deteriorated wood planking will need to be replaced. The deteriorated masonry should be repaired and masonry joints repointed.

Photograph #5 – Water Damage in Loft Area – 1952 Addition

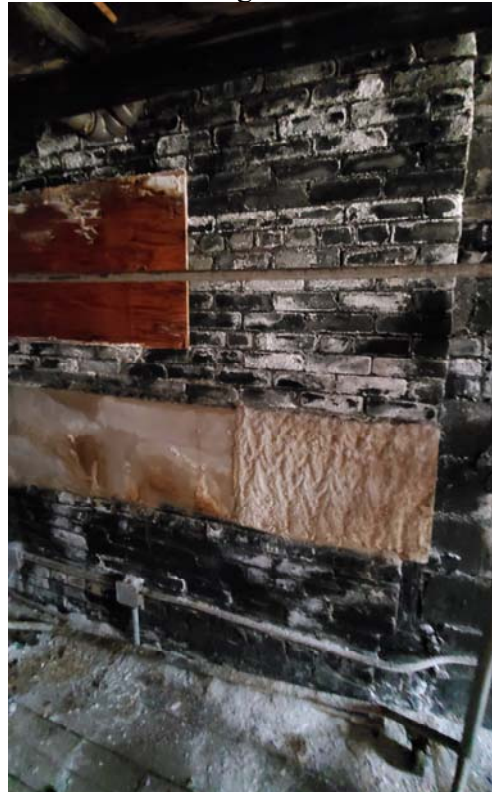
Photograph #6 – Efflorescence Masonry Wall in Loft Area – 1952 Addition

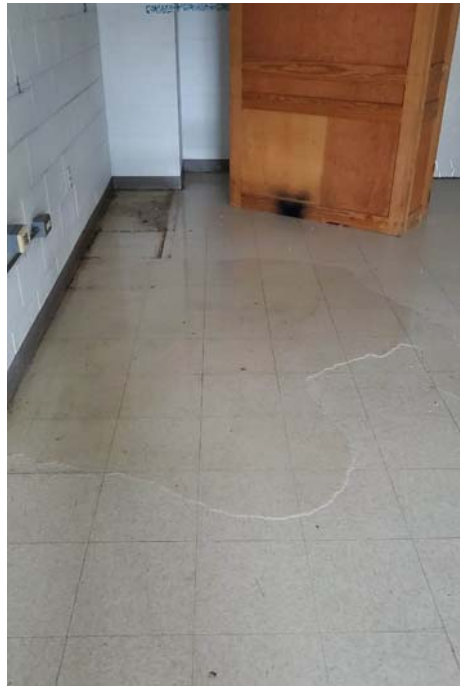
- In the second-floor “Science” and “Math” rooms at the rear of the 1988 addition there are large areas of water damage in the ceiling (see photograph #7). Further investigation should be performed to verify if there are ongoing water leaks coming from the roof.

Photograph #7 – Water Damage in “Science” and “Math” rooms – 1988 Addition

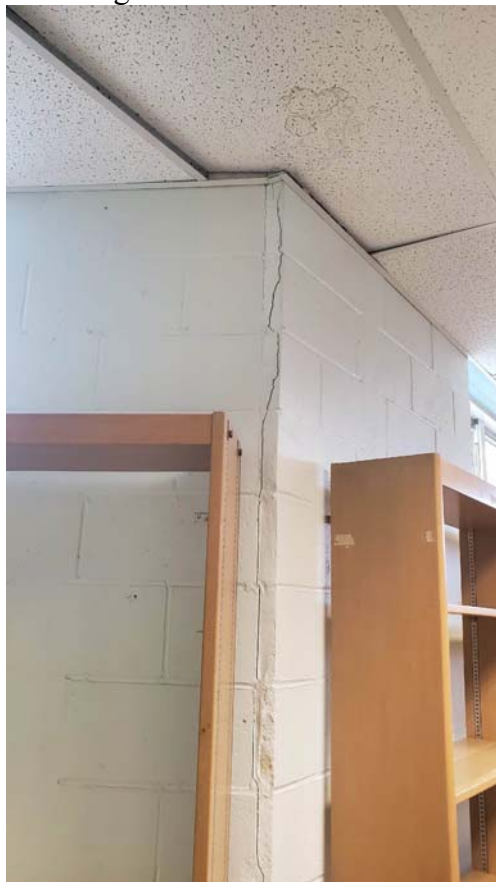
Photograph #8 – Vertical Cracks in Library Masonry Wall – 1988 Addition

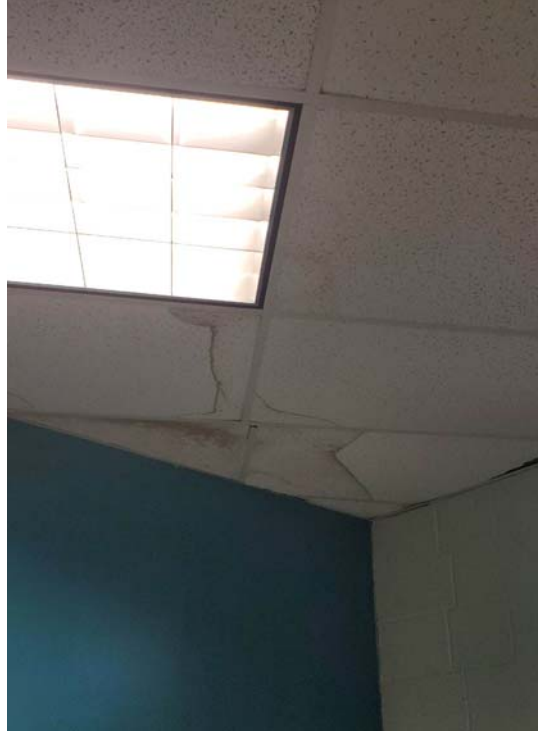
Photograph #9 – Water Damage in Library – 1988 Addition

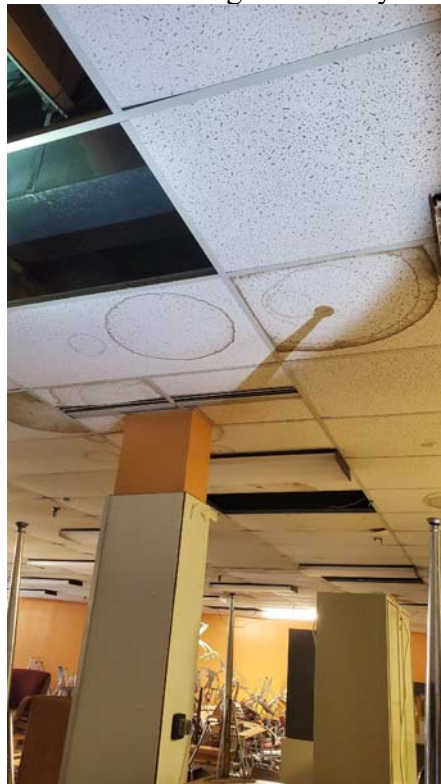
Photograph #10 – Water Damage in “Cafeteria” (1) – 1988 Addition

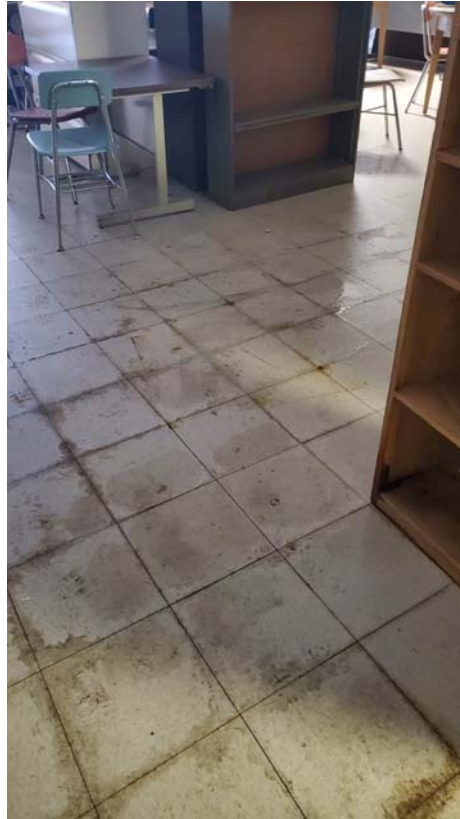
Photograph #11 – Water Damage in “Cafeteria” (2) – 1988 Addition

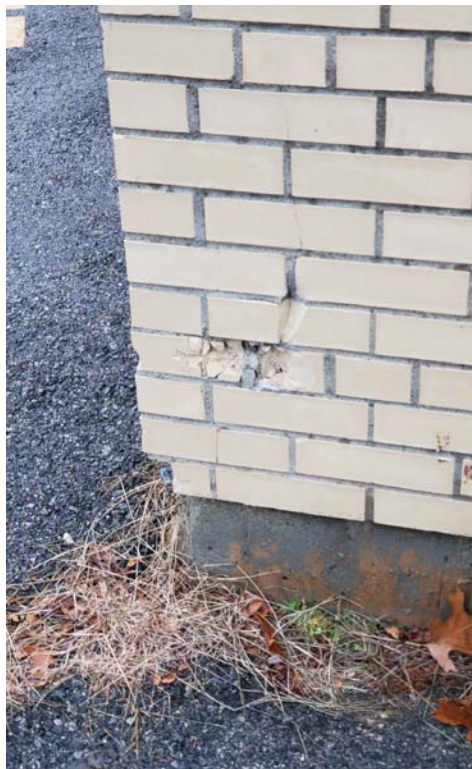
Photograph #12 – Broken Out Masonry in Exterior Wall – Multiple Locations

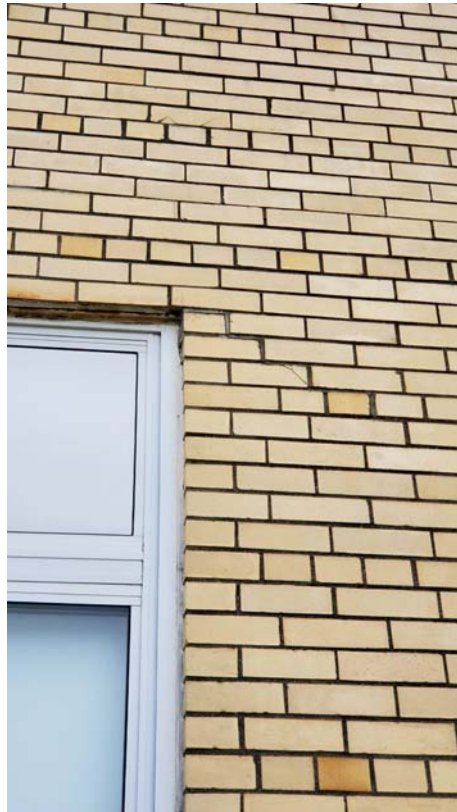
Some flaking paint and rust is evident on the steel window lintels. This should be addressed soon as some of the steel lintels on the original building are beginning to show signs of delamination and causing damage to adjacent masonry (see structural section). If this is allowed to continue, the lintels would need to be replaced.

Photograph #13 – Cracking Caused by Corroded Lintels – Multiple Locations

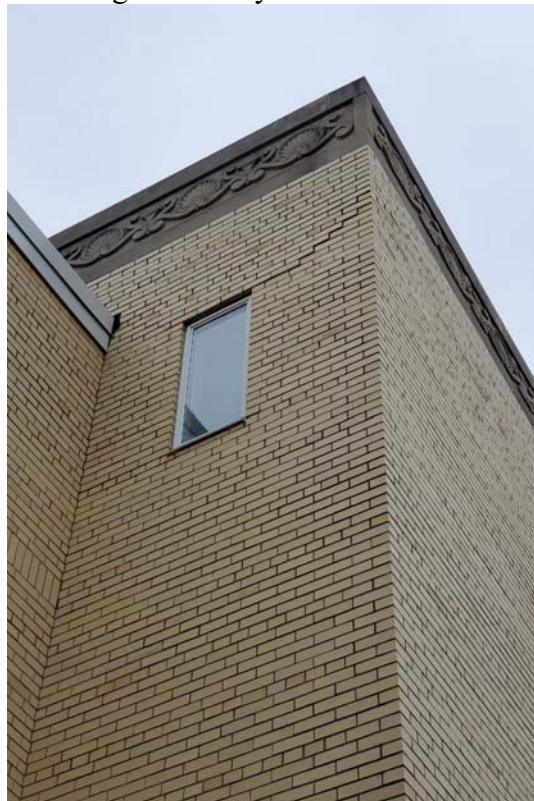
Photograph #14 – Shifting Masonry in Exterior Wall – Multiple Locations

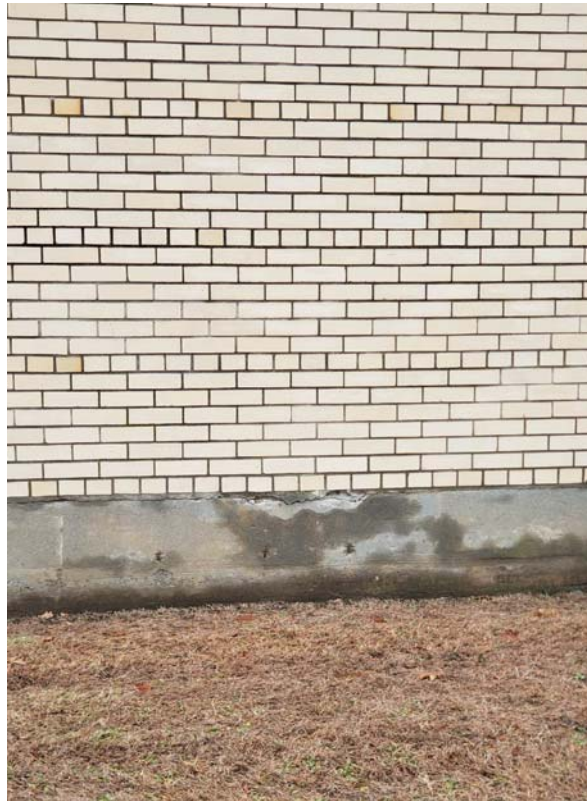
- Along the exterior foundation wall there are large cracks beneath the masonry bearing wall at multiple locations (see photograph #15).

Photograph #15 – Cracked Concrete Foundation Wall – Multiple Locations

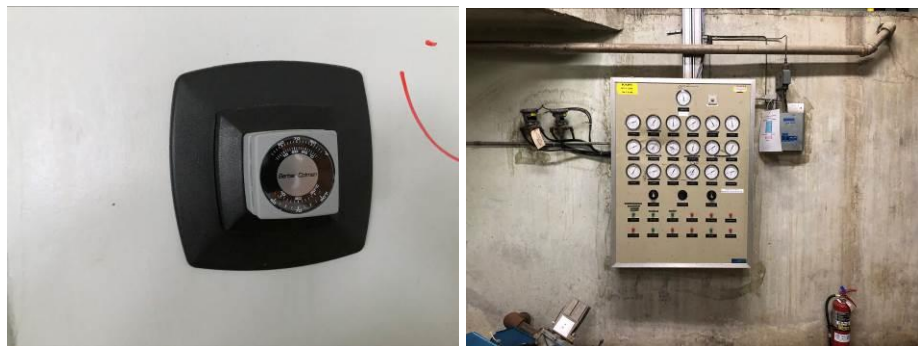
- a. Existing controls are original antiquated pneumatic controls.
- b. An air compressor serving the pneumatic control system is located in Basement Level Mechanical Room-019 in the original 1936 building.

(L - Pneumatic Thermostat, R - Pneumatic Control Panel)

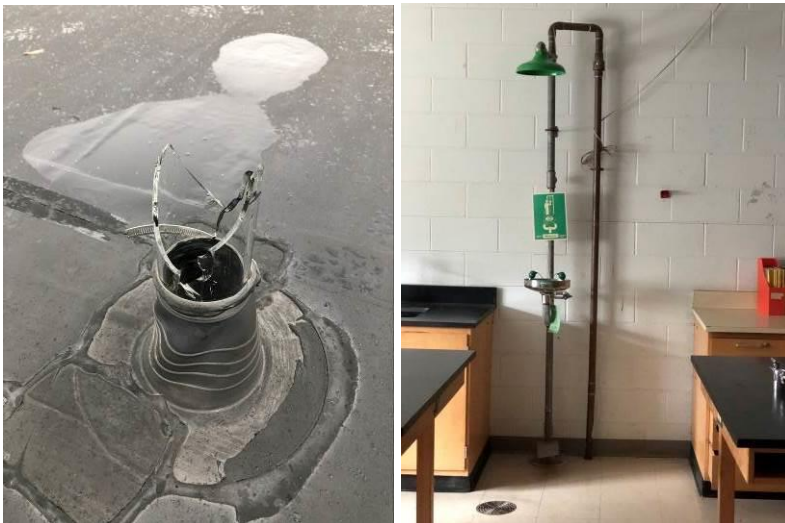
(L - Roof Leak at Damaged Glass Acid VTR, R - Emergency Eyewash/Shower Station)

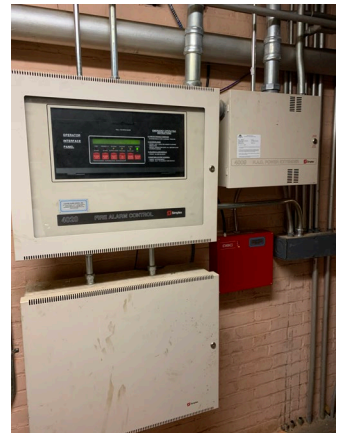
The fire alarm device coverage and system are inadequate for a school building and is not compliant with current codes for voice evacuation and notification.

Fire Alarm Control Panel

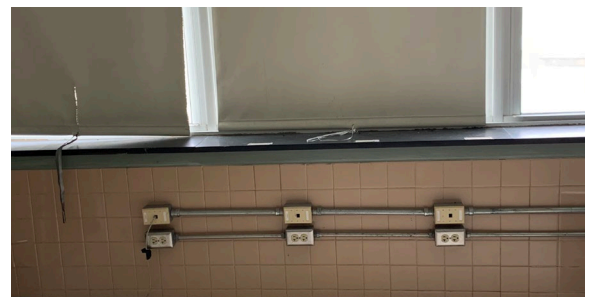
On average, there are approximately eight (8) receptacles installed in typical Classrooms. The devices appeared to be old and in poor condition.

Surface receptacles and data devices
