Spencer, Sullivan & Vogt

ARCHITECTURAL SURVEY & FEASIBILITY STUDY for the CORNET JOHN FARNUM HOUSE

44 MENDON STREET, UXBRIDGE, MASSACHUSETTS • 13 AUGUST 2021

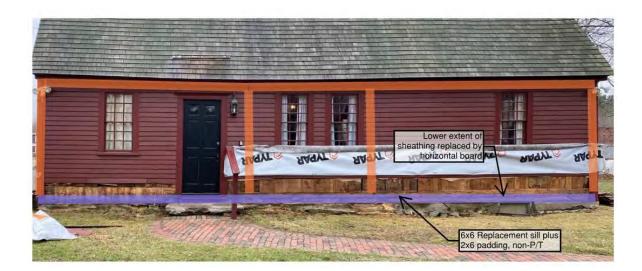
**North Elevation**

The posts should be jacked to as close as their original heights as possible and the damaged and undersized portions of the sill need to be replaced with appropriately sized members, preferably using white oak, which is naturally rot resistant. The damaged bottoms of the planking, which are commonly rotted, should be cut off and re-spliced with new wood. This will likely involve the addition of a stiffening ribbon atop the sills to laterally brace the cut-off planks.
