SPACE PLANNING STUDY  
REPORT OF TOWN HALL

Town of Uxbridge, Massachusetts

McGinley Hart & Associates LLP  
Architects & Planners  
324 Broadway  
Somerville, MA 02145

September 2002

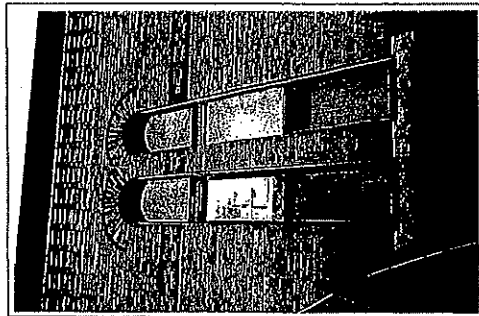
The building has its original wood windows, which are in fairly good condition considering their lack of maintenance. The windows, as with most of the wood on the exterior, have not been painted for many years. The windows should be rehabilitated and the addition of interior or exterior storm windows should be considered.

1. Detail of windows on the West Elevation requiring rehabilitation

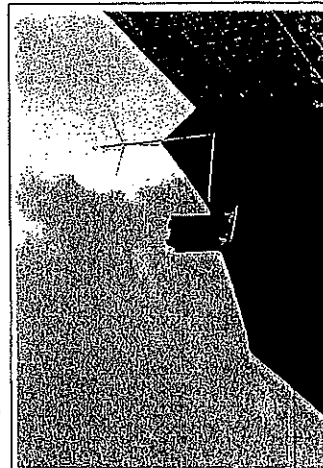
5. Detail of South Chimney, illustrating the need for repair

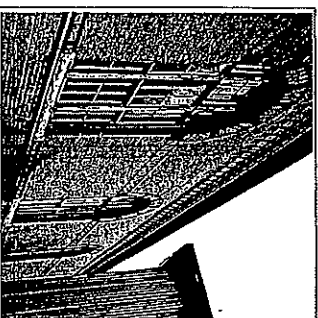
10. Detail of windows at West Elevation requiring rehabilitation
