## MEMORANDUM

DATE: May 11, 2020

RE: Dams Assessment  
Integrated Water Infrastructure Vulnerability Assessment and Climate Resiliency Plan  
MVP Action Grant – Town of Uxbridge

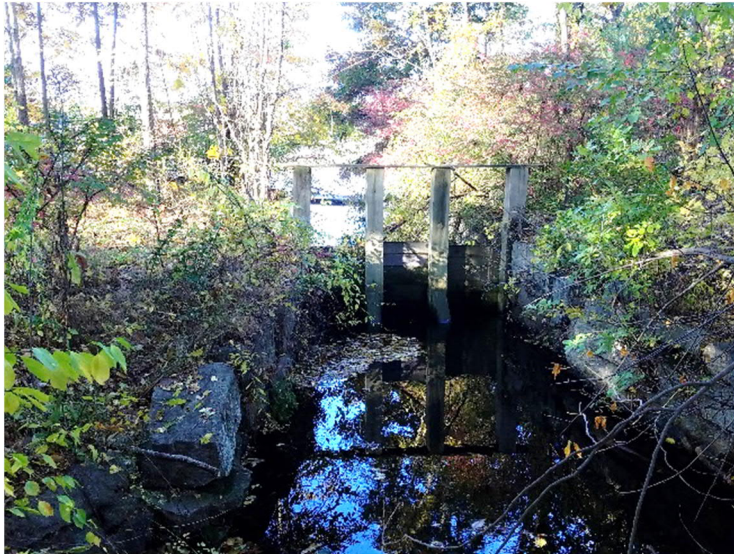
Auxiliary spillway at Whitin Pond Dam.

- Consider removal of Whitin Pond Dam to improve flood resiliency and eliminate the need for maintenance.
  - Contact and coordinate with the dam owner to complete engineering design and permitting and removal of the dam.
  - Leverage grant funding and partnerships with state and federal agencies and non-profit organizations to streamline dam removal.
- Alternatively, repair and maintain the dam if dam owner is not in support of removal.

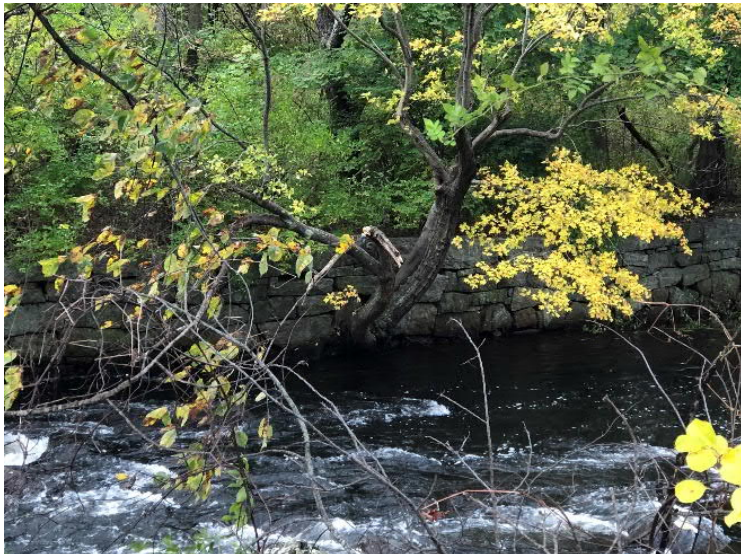
Tree growth through a training wall at Whitin Pond Dam.

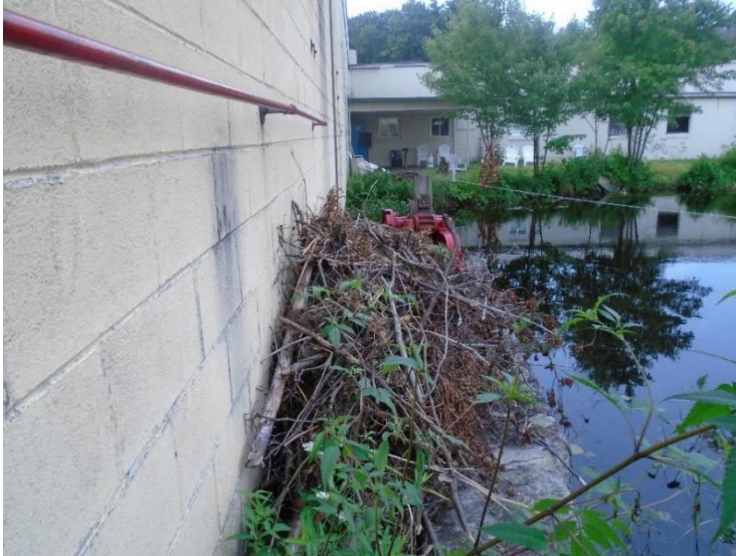
Pile of beaver debris removed from the spillway at Rivulet Village Pond Dam. This was one of multiple piles of debris observed during the assessment.

- Consider removal of Rivulet Village Pond Dam to improve flood resiliency and eliminate the need for maintenance.
  - Contact and coordinate with the dam owner to complete engineering design and permitting and removal of the dam.
  - Leverage grant funding and partnerships with state and federal agencies and non-profit organizations to streamline dam removal.
- Alternatively, repair and maintain the dam. Develop a comprehensive beaver management plan to address the issue of beaver activity leading to flooding.

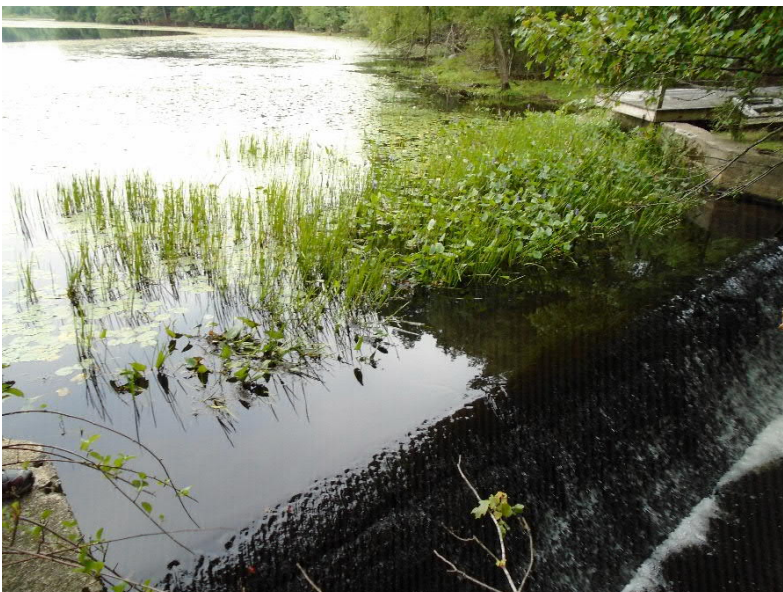
Spillway at Ironstone Reservoir Dam.

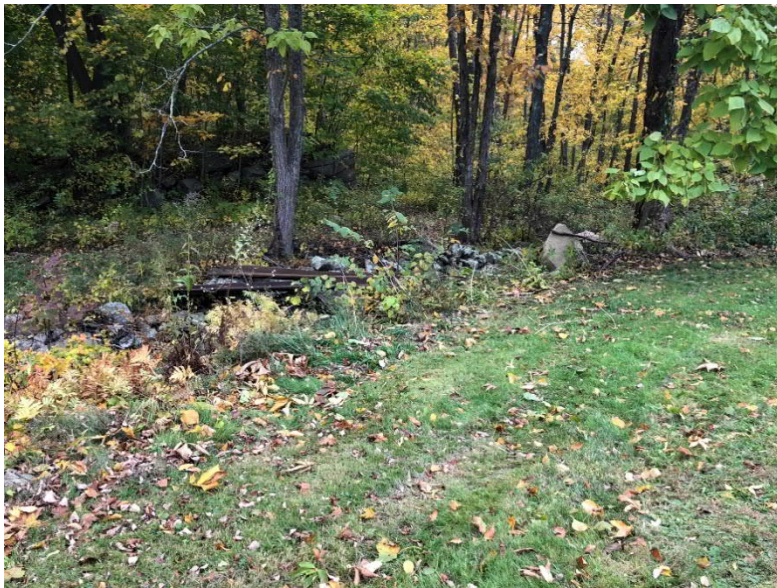
Trees growing on the embankment of the dam at 371 Aldrich Street.

- Remove the dam in conjunction with replacement of the in-line culvert under Aldrich Street/Route 98 to increase resiliency and reduce the risk of flooding of Aldrich Street/Route 98.
  - Contact and coordinate with the dam owner to complete engineering design and permitting and removal of the dam and replacement of the culvert.
  - Leverage grant funding and partnerships with state and federal agencies and non-profit organizations to streamline dam removal and culvert replacement.
- Alternatively, if the dam cannot be removed, register the dam with ODS and repair and maintain the structure.

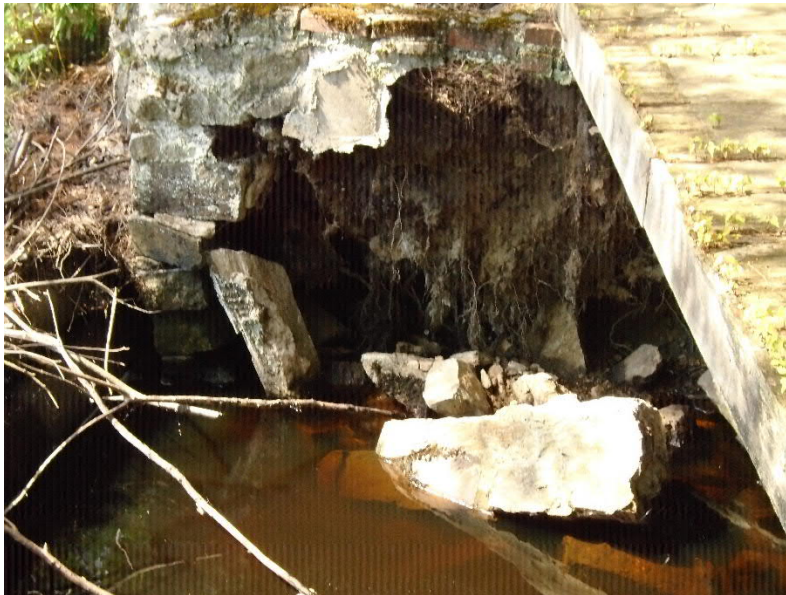
Collapsed left training wall of the auxiliary spillway at the Home Brew Dam.
