MEMORANDUM

RE: Dams Assessment
Integrated Water Infrastructure Vulnerability Assessment and Climate Resiliency Plan
MVP Action Grant – Town of Uxbridge

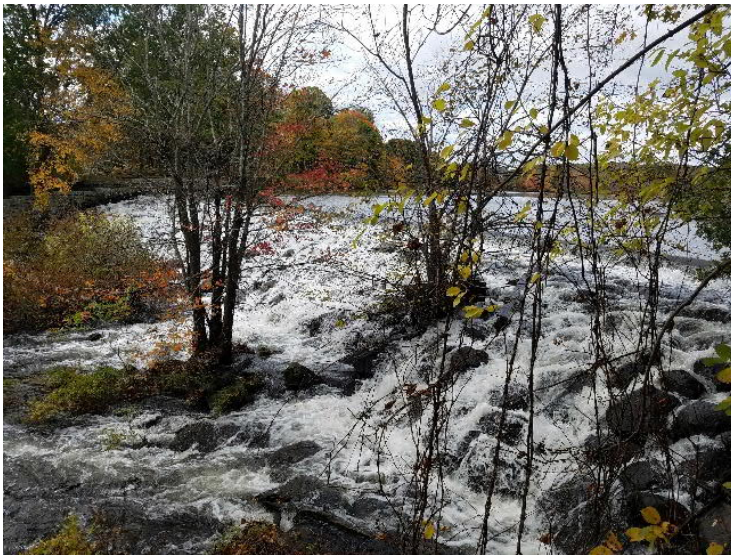
- The structure is currently considered to be in poor condition due to voids in the stone of the primary and auxiliary spillways and vegetation overgrowth on the training walls (with a tree growing through one wall).
- Trees, brush, stumps, and other vegetation are present on the embankment.
- The dam is currently used for flood control and recreation.
- The dam has a low stream continuity potential as measured by DER's Restoration Potential Model tool.
- The dam is classified as Significant hazard potential dam.
- The dam is privately owned by the Mumford River Condominium Trust.

Primary spillway at Whitin Pond Dam. Note the growth of trees and woody vegetation in the spillway.

- Consider removal of Whitin Pond Dam to improve flood resiliency and eliminate the need for maintenance.
 - Contact and coordinate with the dam owner to complete engineering design and permitting and removal of the dam.
 - Leverage grant funding and partnerships with state and federal agencies and non-profit organizations to streamline dam removal.
- Alternatively, repair and maintain the dam if dam owner is not in support of removal.

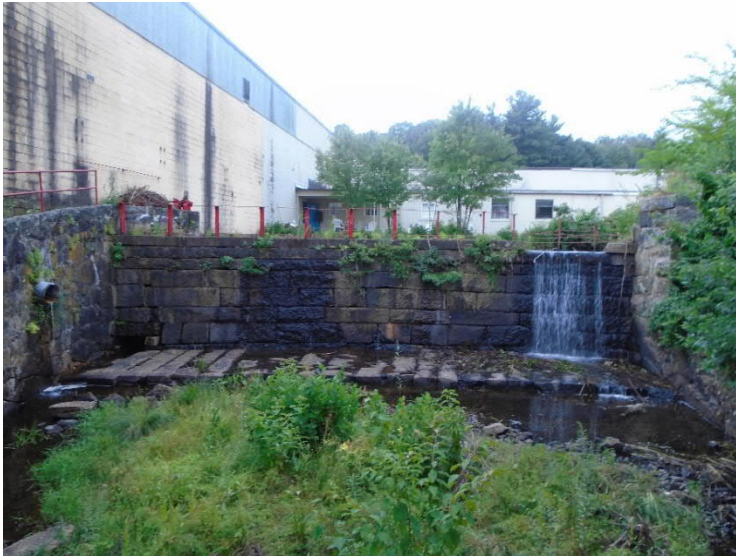
- The structure was determined to be in fair condition due to potential leakage through stones in the primary spillway, stones in need of repointing on the auxiliary spillway, and seepage (flowing and non-flowing) through the downstream walls.
- Small trees, brush, and other vegetation are present on the embankment.
- Beavers regularly build dams on the primary spillway, requiring factory staff to clean out the debris on a near daily basis.
- The impoundment is currently used for recreation. The dam was originally built for water supply for the mill complex.
- The impoundment has a low flood mitigation potential.
- The dam has a low stream continuity potential as measured by DER's Restoration Potential Model tool.
- The dam is classified as High hazard potential dam.

Rivulet Village Pond Dam spillway. Note the vegetation growing through the walls and downstream face of the spillway.

- Consider removal of Rivulet Village Pond Dam to improve flood resiliency and eliminate the need for maintenance.
 - Contact and coordinate with the dam owner to complete engineering design and permitting and removal of the dam.
 - Leverage grant funding and partnerships with state and federal agencies and non-profit organizations to streamline dam removal.
- Alternatively, repair and maintain the dam. Develop a comprehensive beaver management plan to address the issue of beaver activity leading to flooding.

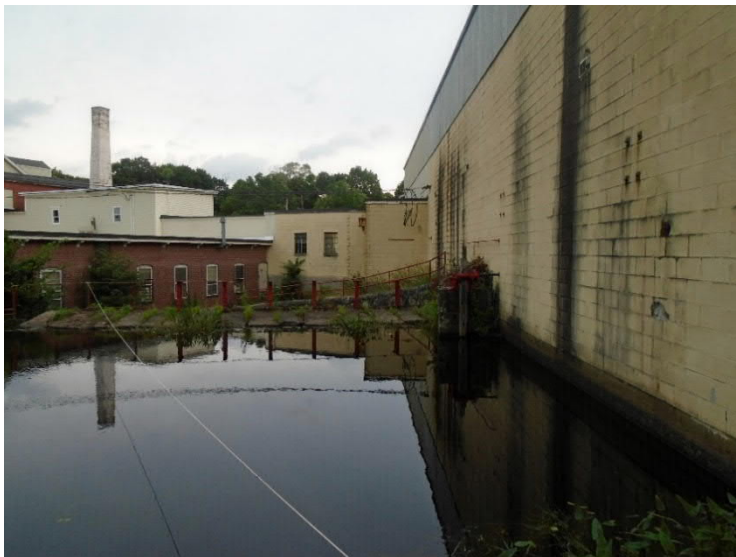
View facing downstream at the Rivulet Village Pond Dam spillway from the impoundment. The mill building has flooded multiple times during high flow events.

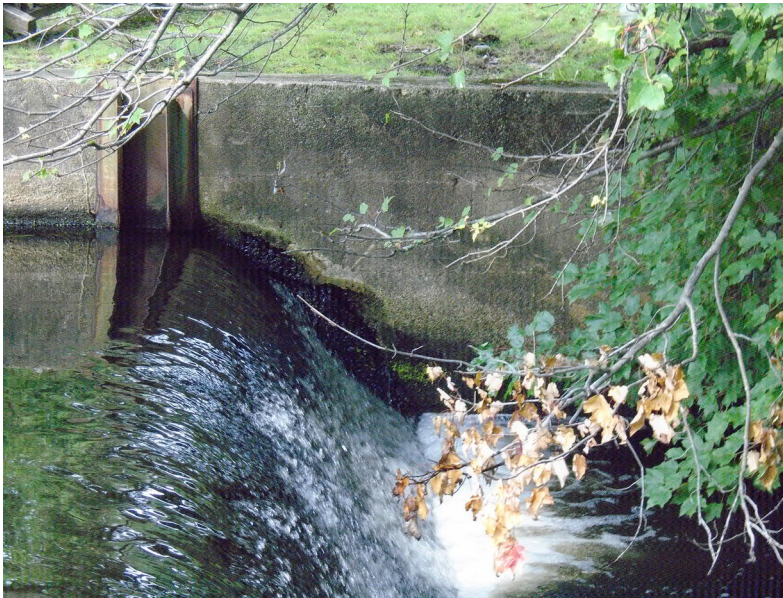
- The Ironstone Reservoir dam is considered to be in poor condition due to large cracks in both training walls, seepage through the left training wall downstream face of the spillway, and scouring along the right training wall. The approach area is heavily sedimented, and large woody debris has become trapped downstream of the spillway.
- The impoundment was originally used as an ice pond and is currently used for recreation.
- The impoundment has low flood mitigation potential.
- The dam has a high stream continuity potential as measured by DER's Restoration Potential Model tool.
- The dam is classified as a Significant hazard potential dam.

Left training wall at Ironstone Reservoir Dam. Note the seepage along the training wall just above the spillway.

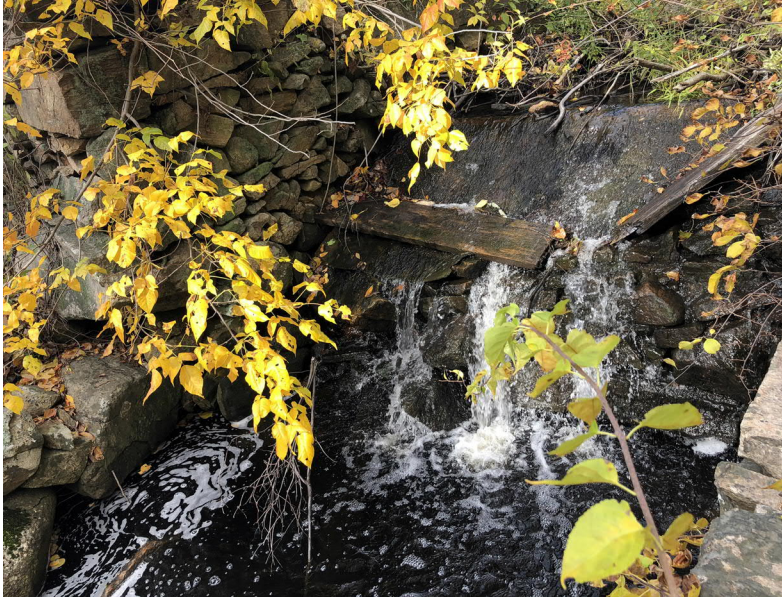
- The dam at 371 Aldrich Street was assessed as being in fair condition due to voids in the training walls and heavy vegetation growing in the training walls. The spillway was blocked by debris and broken weir-boards. Medium-sized trees were observed growing on the embankment.

Spillway of dam at 371 Aldrich Street. Note broken weir boards and voids in the spillway and training walls.

- Remove the dam in conjunction with replacement of the in-line culvert under Aldrich Street/Route 98 to increase resiliency and reduce the risk of flooding of Aldrich Street/Route 98.
 - Contact and coordinate with the dam owner to complete engineering design and permitting and removal of the dam and replacement of the culvert.
 - Leverage grant funding and partnerships with state and federal agencies and non-profit organizations to streamline dam removal and culvert replacement.
- Alternatively, if the dam cannot be removed, register the dam with ODS and repair and maintain the structure.

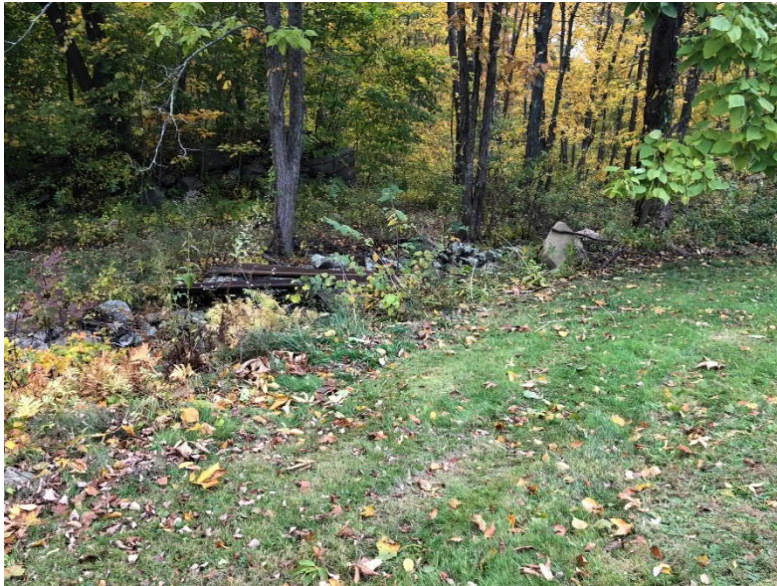
Trees growing on the embankment of the dam at 371 Aldrich Street.

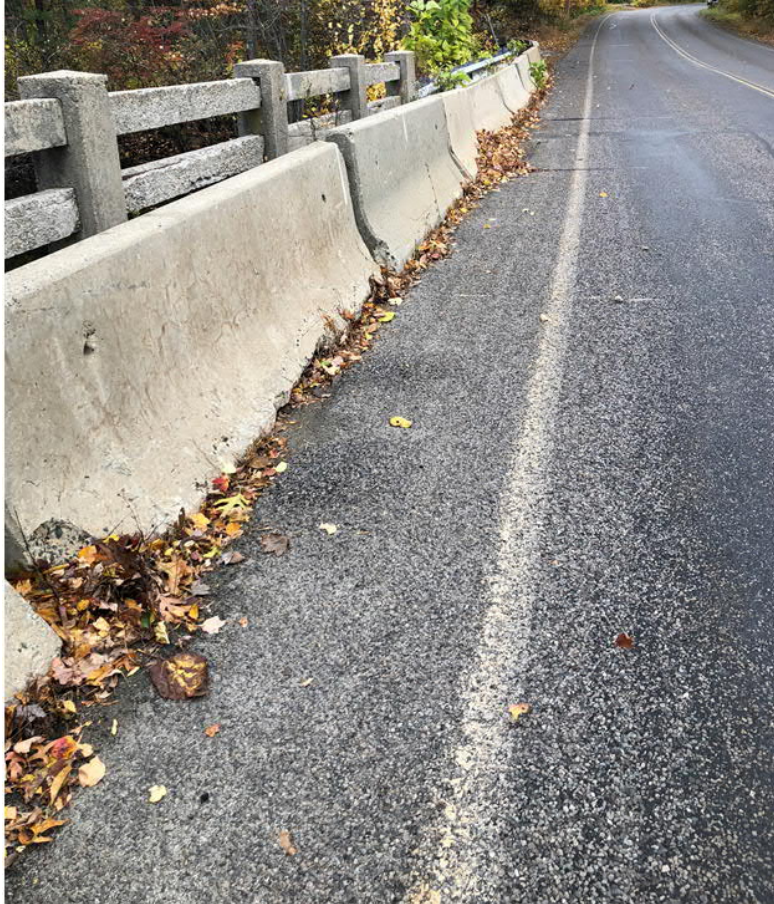
Jersey barriers at the crossing upstream of the dam at 371 Aldrich Street.

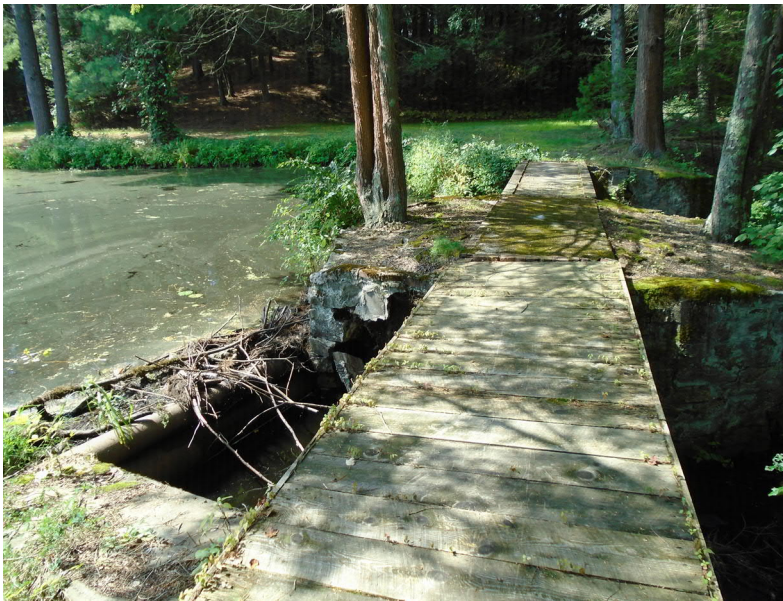
- The dam was determined to be in unsafe condition due to numerous structural deficiencies, including minor soil loss at the right abutment, vertical misalignment/roots/undulation of the embankment, and large cracks in the central wall with a one-foot void due to a missing stone at the base of the wall. The upstream wall also appears to be undermined. There is a one-inch crack in the primary spillway and sediment deposition at the top of the weir, with water flowing under the right training wall onto the spillway, which is eroding the base of the wall. The left

training wall of the auxiliary spillway has collapsed due to a sinkhole approximately 18-inches in diameter behind the wall. The auxiliary spillway approach area is clogged with debris and sediment. The right abutment is eroding due to the tilting of the concrete block forming the right training wall of the auxiliary spillway and its separation from the dam's right abutment.

View of the Home Brew Dam from the right abutment. Note the debris accumulated behind the pipes immediately upstream of the auxiliary spillway and the collapsed left training wall of the auxiliary spillway.

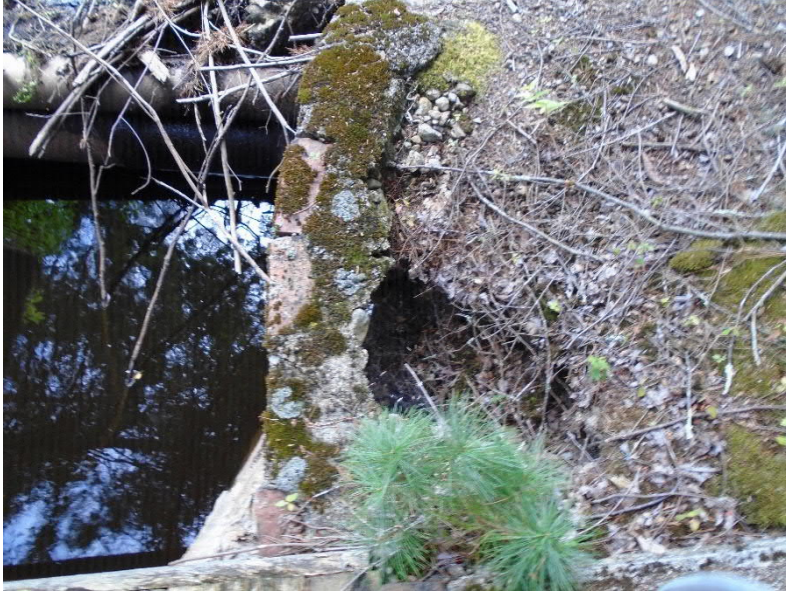
Sinkhole behind the left training wall of the auxiliary spillway at the Home Brew Dam.

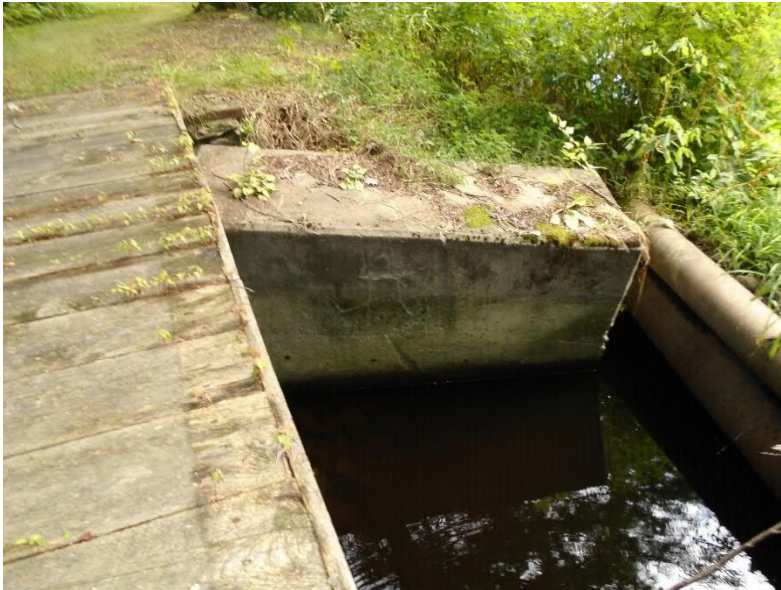
Separation of the right training wall of the auxiliary spillway from the right abutment of the Home Brew Dam.

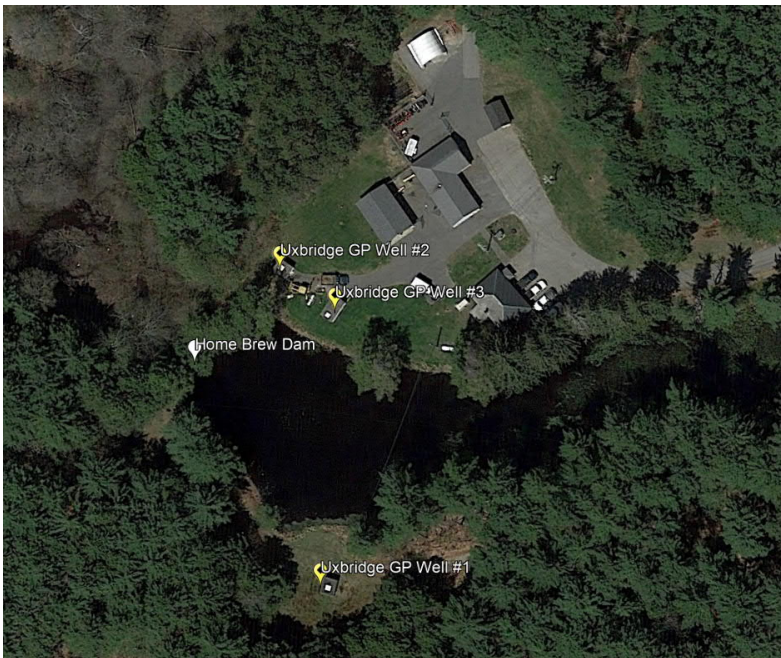
Location of Home Brew Dam relative to three wells owned and operated by the Uxbridge Water Division.
