Uxbridge, Massachusetts Evaluation Report

Project Number: 7533 June 2021

BRIDGE / CULVERT MANAGEMENT PLAN

Hartford Avenue East over the Mumford River (Bridge No. U-02-020)

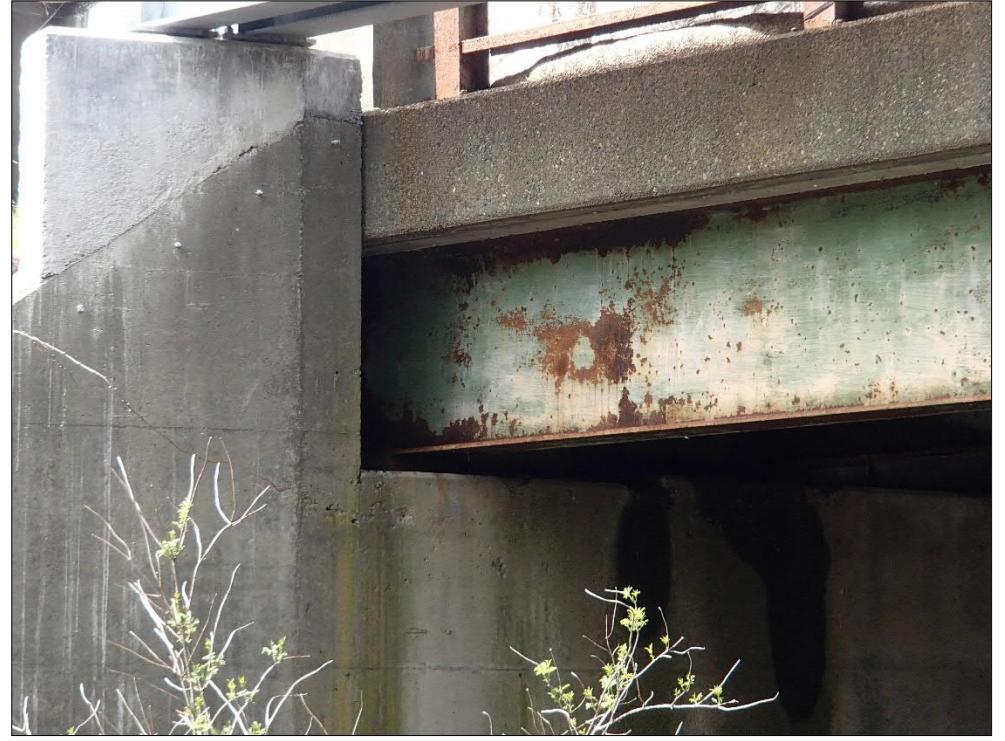
Photo 11 Looking Northwest: Beam End 1 Corrosion

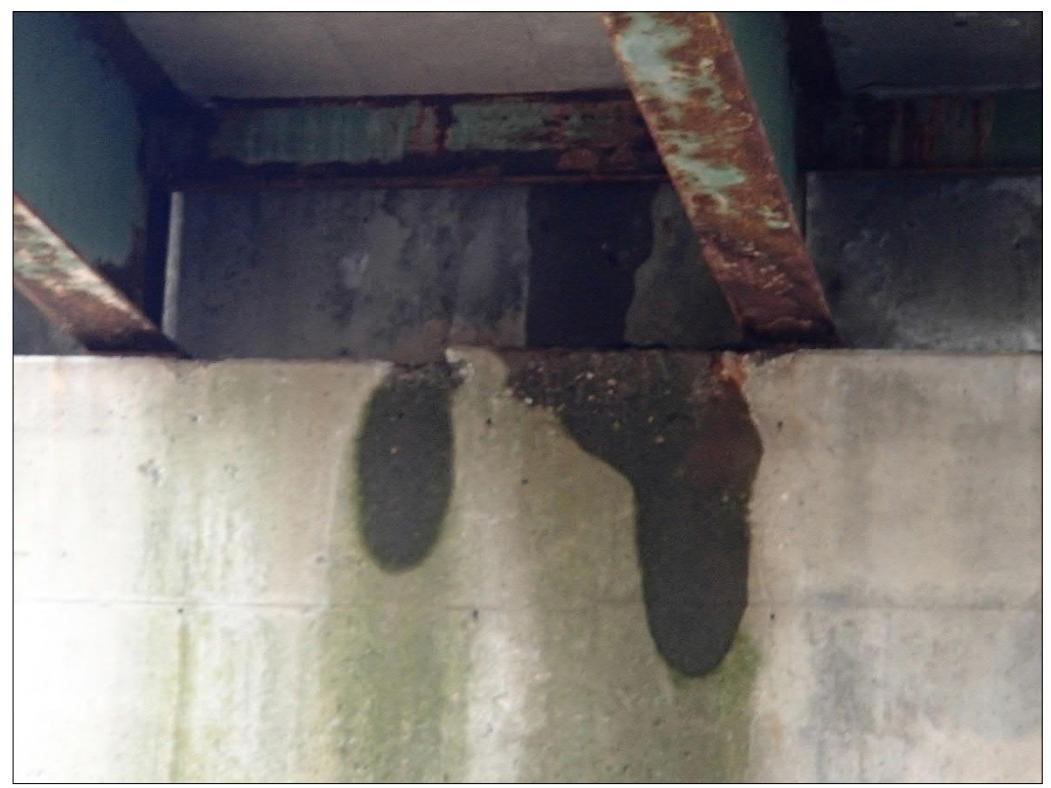
The abutment concrete is in good condition with only minor problems noted. An area of water staining was present at bay 1 on the west abutment, which continues over the beam seat onto the abutment face (Photo 12). Full height water stains are also present under bay #5. Moderate amounts of debris were typically found on the beam seats. The east abutment has minor honeycombing throughout as well as minor scaling at the waterline. The channel has shifted and flows swiftly in front of the east abutment, leaving most of the abutment susceptible to scour.

Photo 12 Looking West: West Abutment Water Staining in Bay 1

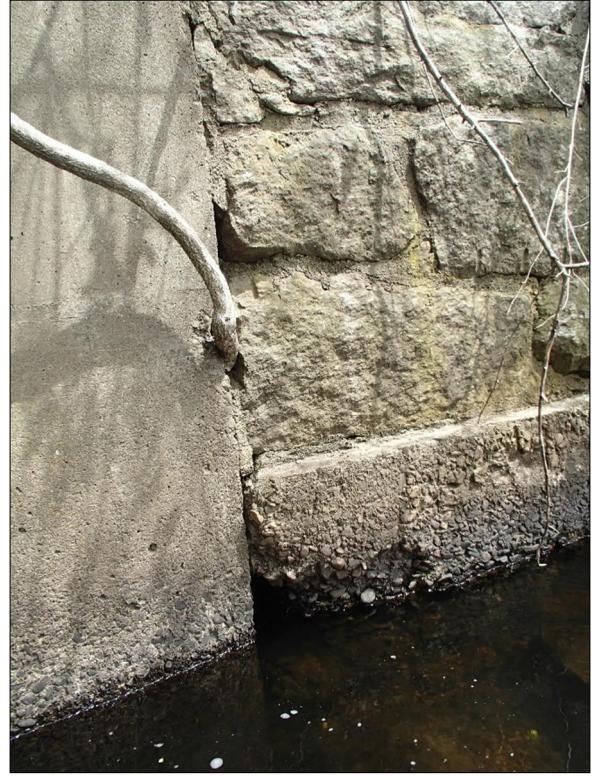
Photo 13 Looking Southeast: Southeast Wingwall Spall

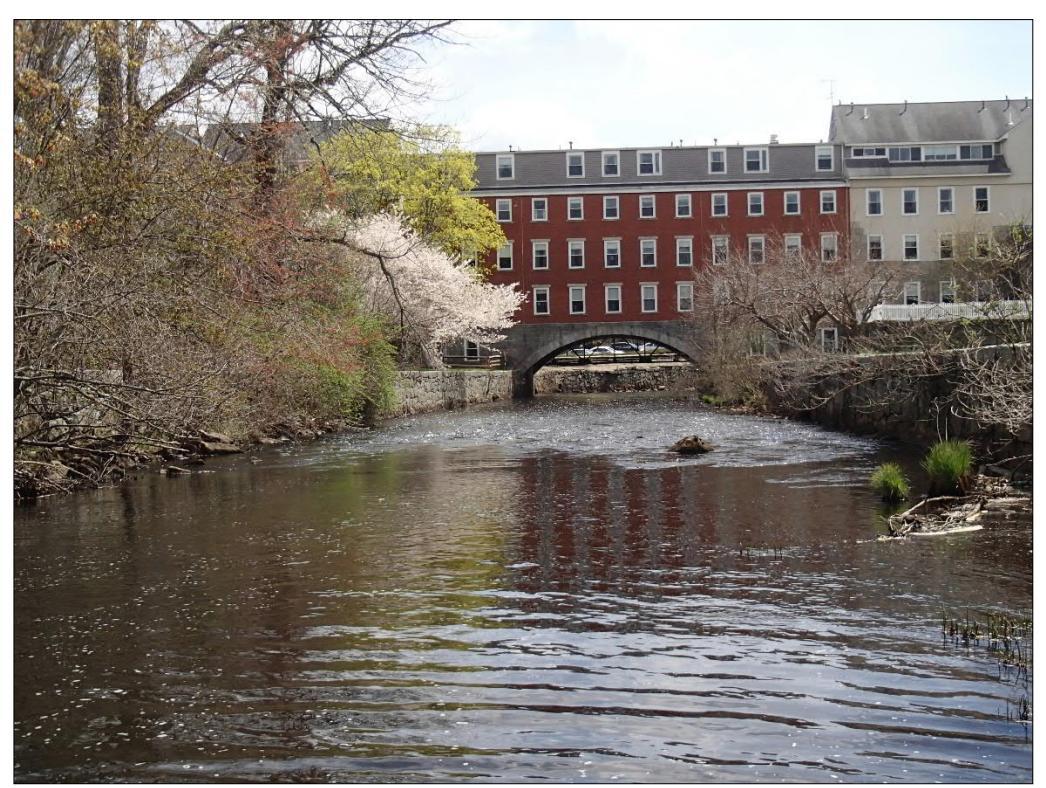
The northeast and northwest training walls show loss of pointing and chinking stones at the waterline. Approximately 60' upstream, the northeast wall has a 6'x3'x2' deep void at the base that is causing the wall above it to crumble (Photo 6). The southeast and southwest walls exhibit heavy loss of mortar and chinking stones along with heavy vegetation growth. The southeast wingwall corner has a spall and vegetation growth at the joint (Photo 13). The southeast training wall is also crumbling at the end (Photo 14).

Photo 14 Looking South: South Training Walls

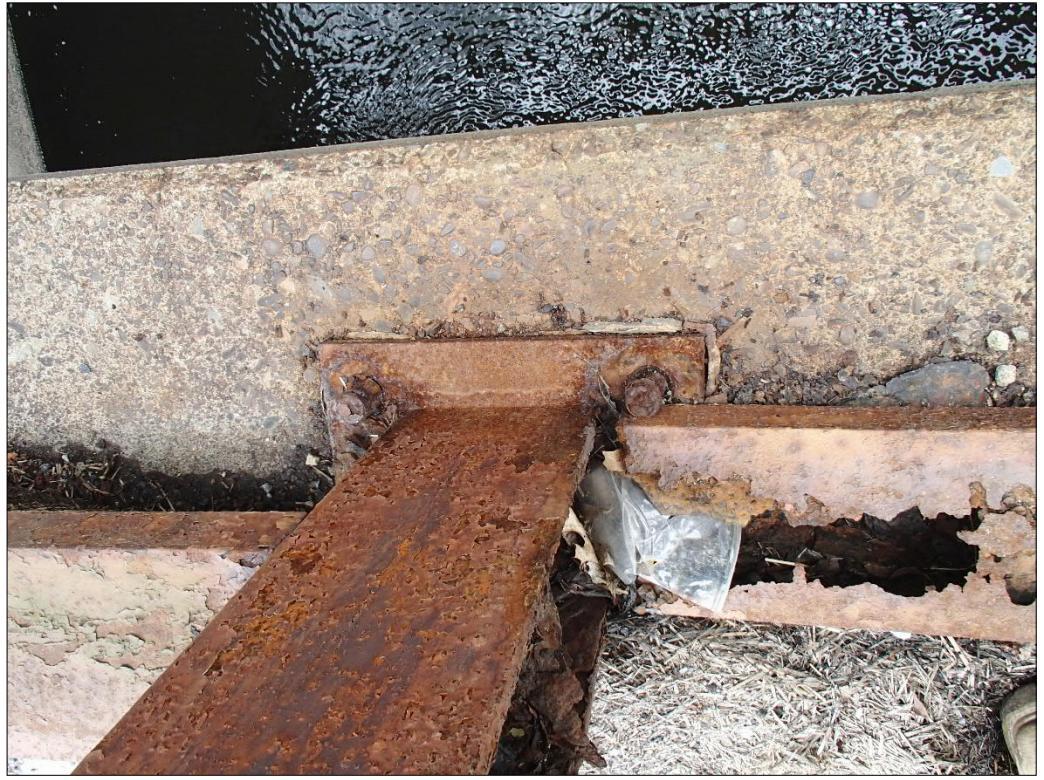
The roadway appears to be newly paved and is in good condition. The guardrail is in poor condition with heavy surface rusting and paint failure. Additionally, the railing post plates and bolts show heavy corrosion up to 100% (Photo 19). Also, the approach guard rail ends at a terminal section rather than a standard transition.

Photo 19 Looking South: Deterioration of Rail Base

With the eventual superstructure replacement, it is recommended that the guardrail be fully replaced with a MassDOT approved rail.

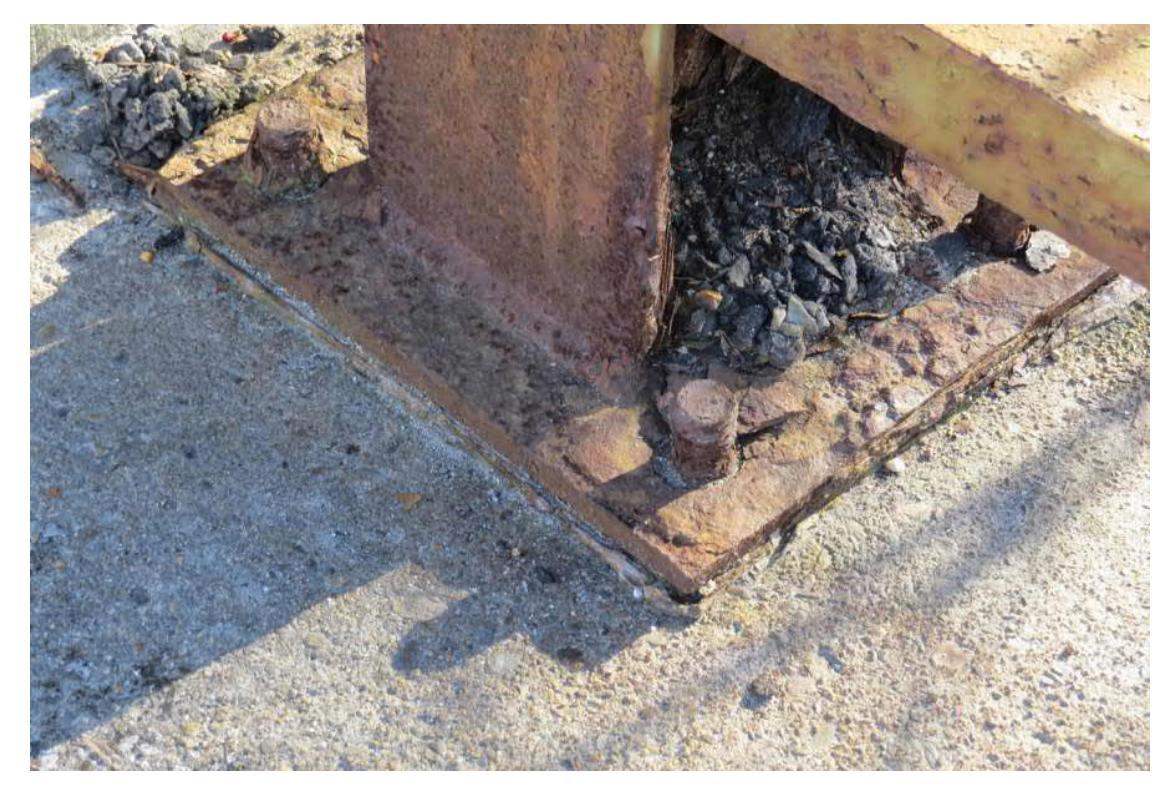
Both bridge rails have moderate paint peeling, surface rusting, and pitting throughout. There is severe corrosion with up to 100% section loss to the anchor bolt nuts on both rails. **See photo 2.**

Photo 2: Typical 100% section loss to the nuts at the base plates of both railings.

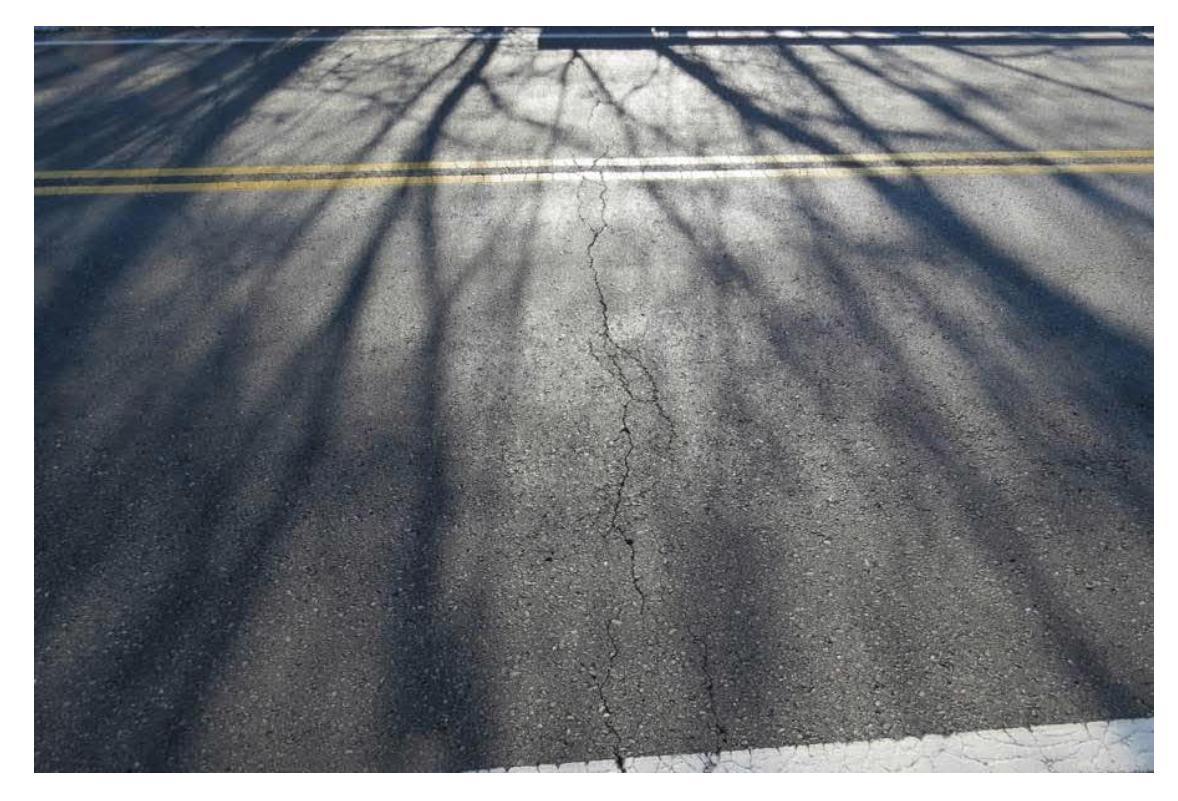
The East approach to deck transition has full width transverse cracking. **See photo 4.** The West approach has heavy cracking, breakup, bit. conc. patches and settlement throughout. This area of deterioration begins 12 feet out from the approach to deck transition. **See photo 5.**

Photo 4: Full width transverse cracking to the East approach to deck transition.

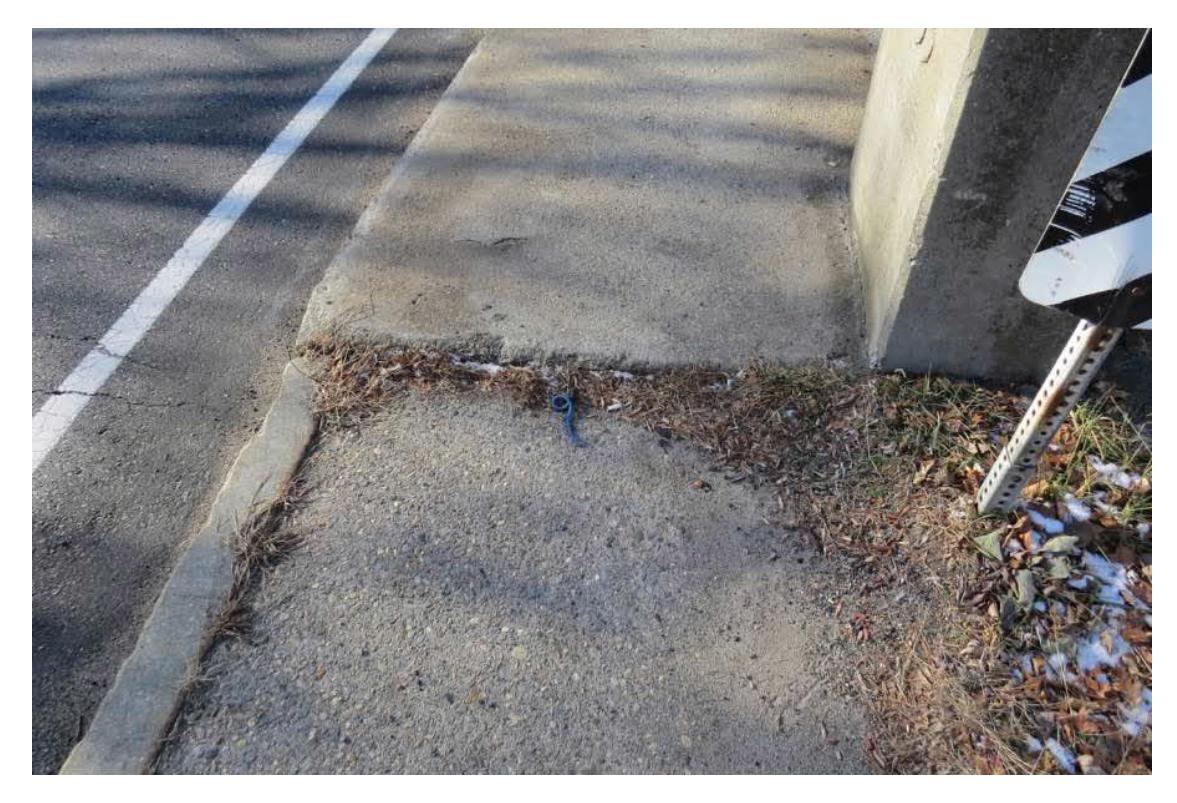
Photo 6: Typical settlement of the Northeast (shown) and Northwest approach sidewalks.

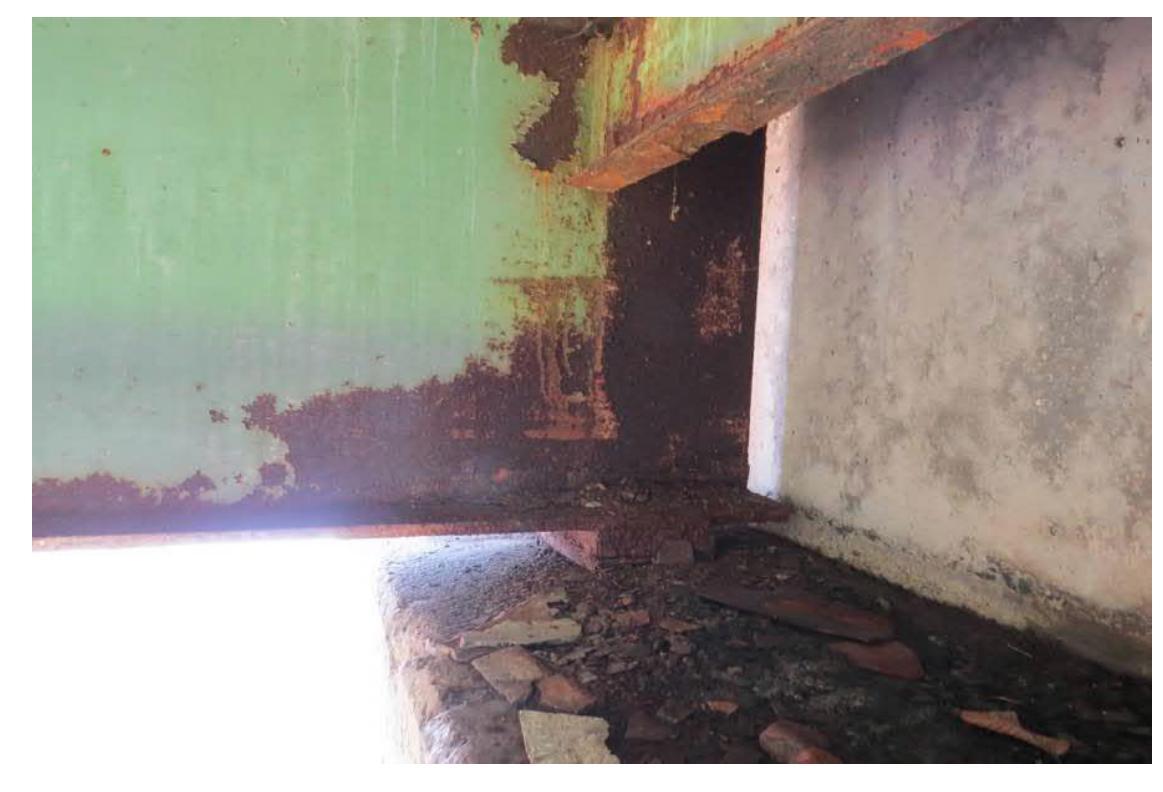
There is heavy surface rusting and minor rust flaking to the West end of beam #1, North face. See photo 8.

Photo 8: Heavy surface rusting and minor rust flaking to the West end of beam #1, North face.

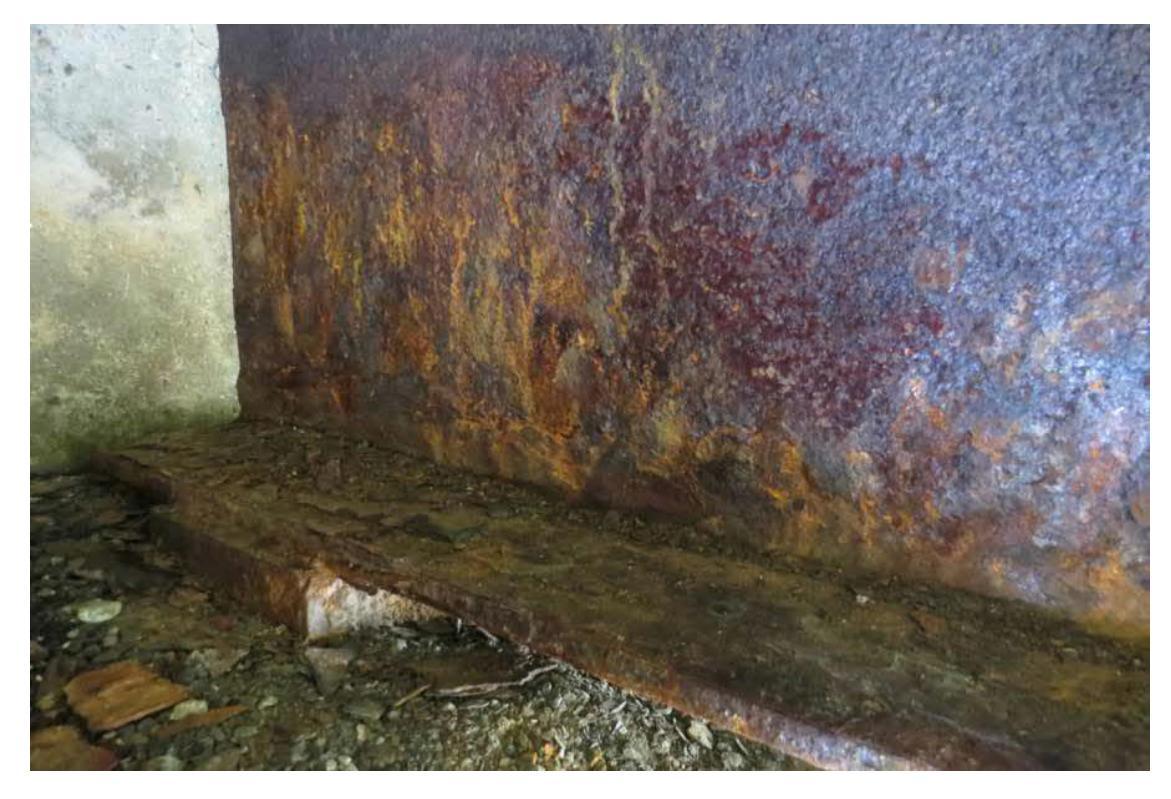
The South face of beam #2 at the West end has an up to 5 foot long x full height area of heavy rust flaking and section loss. There is a 14 inch high area at the end of the web that has 0.40 inches remaining and tapers back to original thickness 5 feet out from the end. The South side of the bottom flange has 0.60 inches remaining at the face of the bearing and tapers back to original thickness 4 feet out from the end. **See photos 9 & 10**.

Photo 10: Heavy rust flaking and section loss to the West end of beam #2, South face.

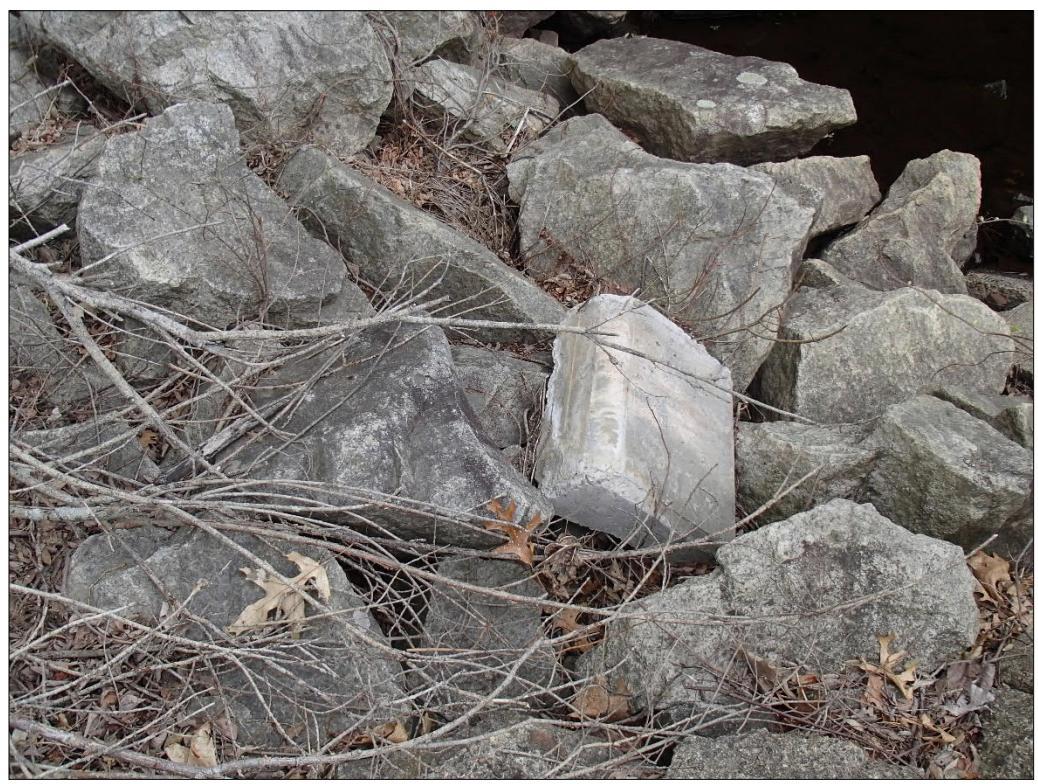
Photo 6 Looking Down: Spall in Rip Rap on Northwest Side

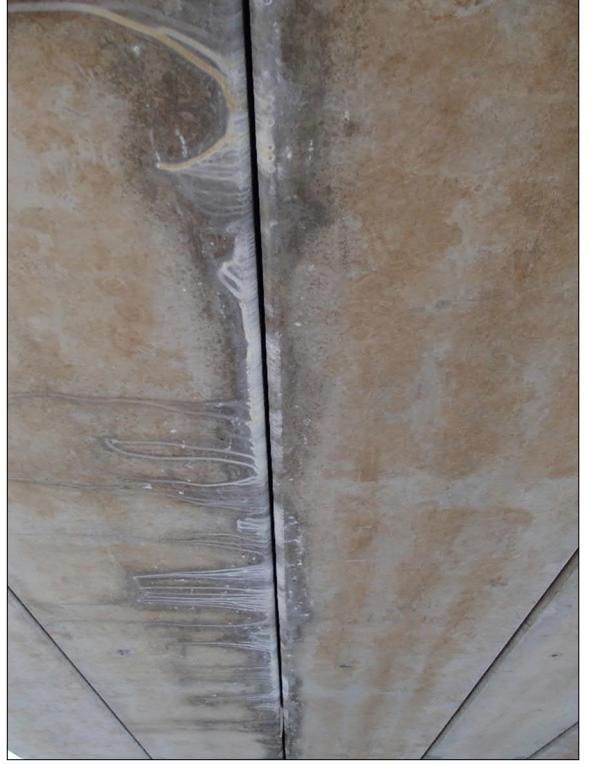
Photo 7 Looking South: Efflorescence at Joint 7

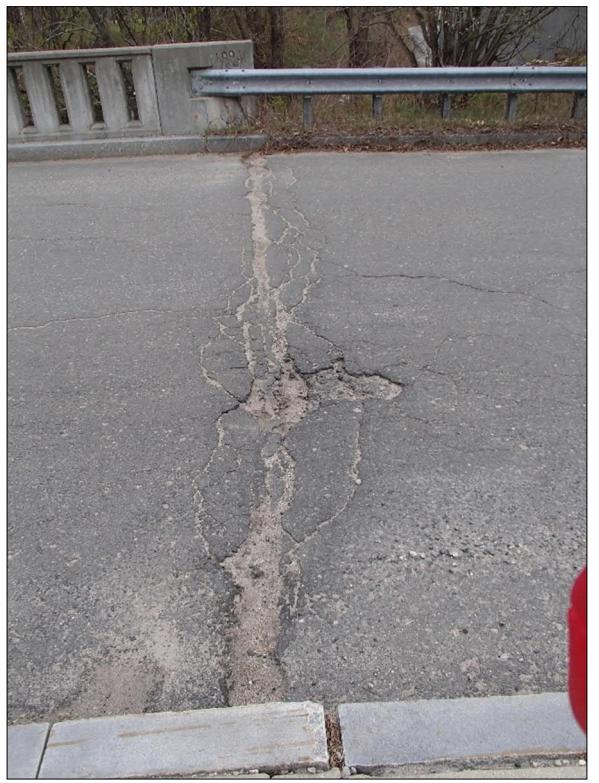
Photo 12 Looking East: Cracking at South Joint

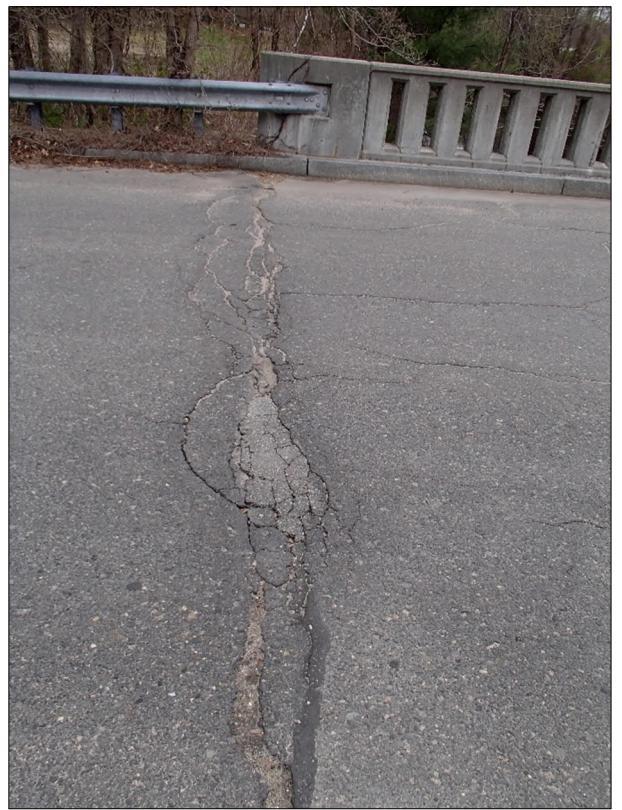
Photo 13 Looking East: Cracking at North Joint

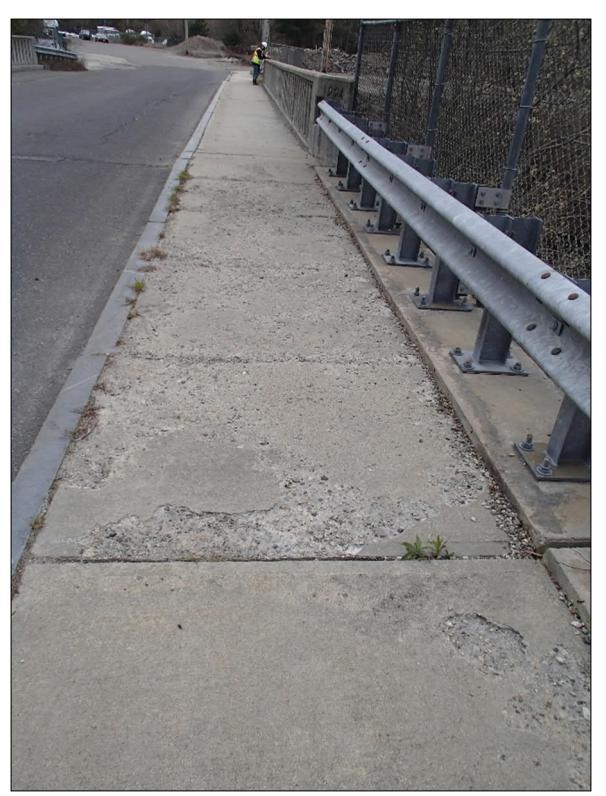
Photo 16 Looking South: Sidewalk Deterioration at Northwest Side

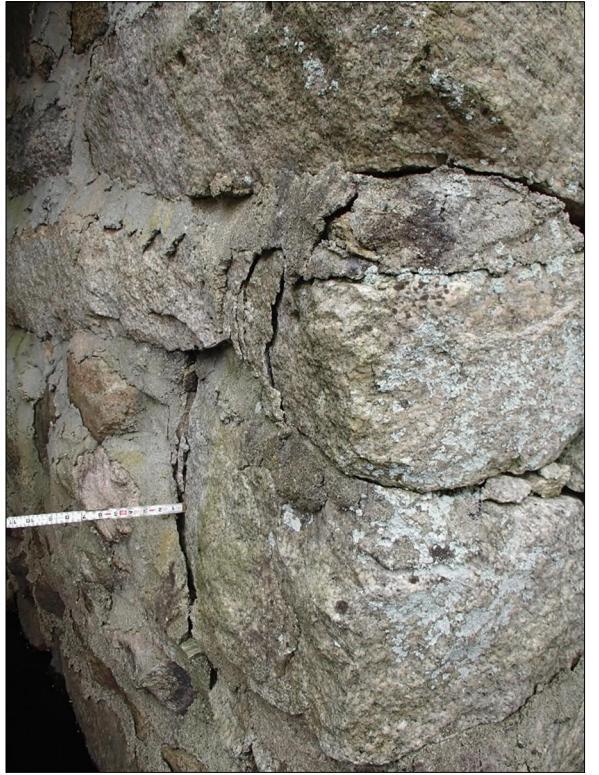
Photo 9 Looking South: Cracking at Northwest Abutment Corner

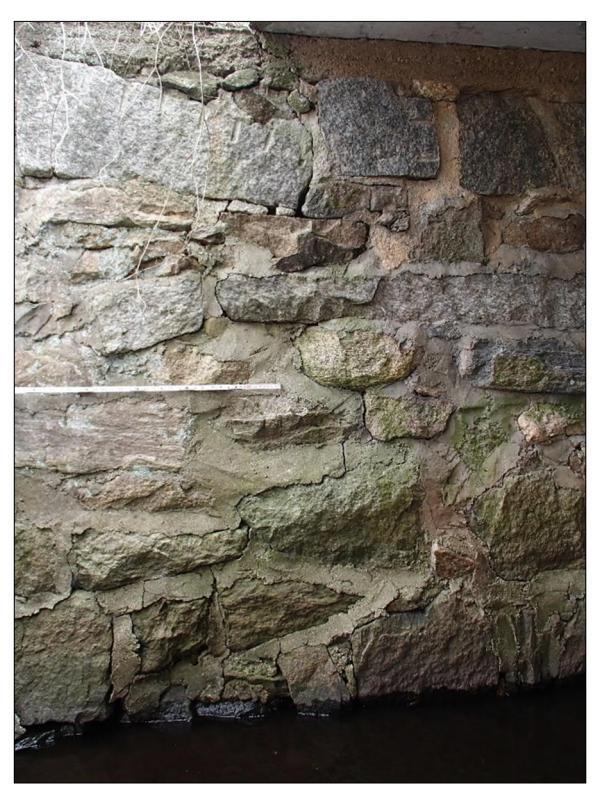
Photo 10 Looking East: East Abutment Cracking on Face

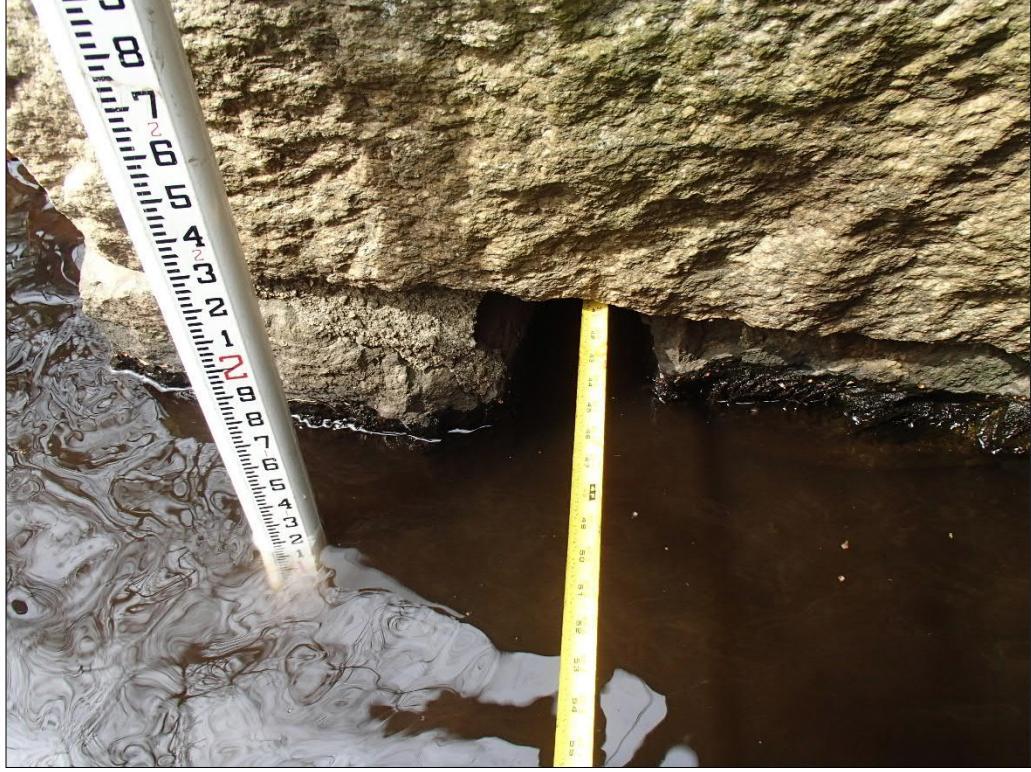
Photo 11 Looking West: Void at West Abutment

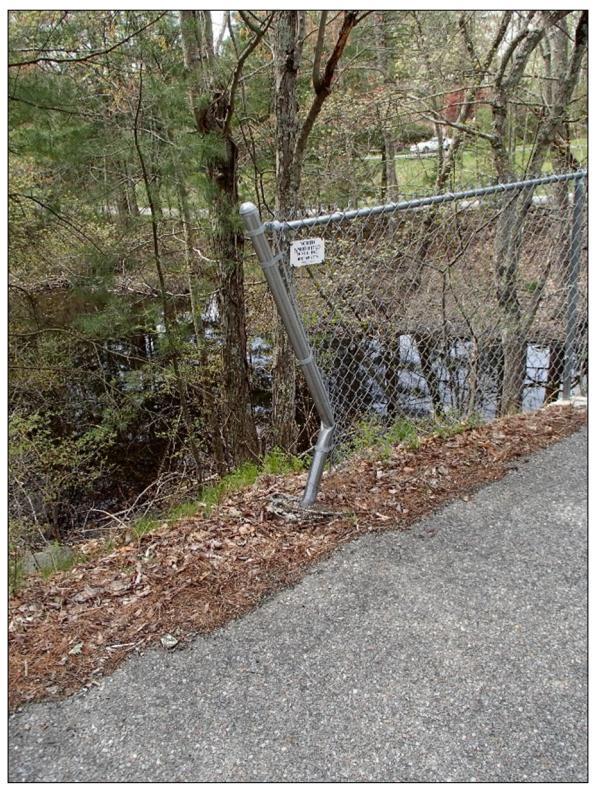
Photo 15 Looking South: Collision Damage at Southeast Fence

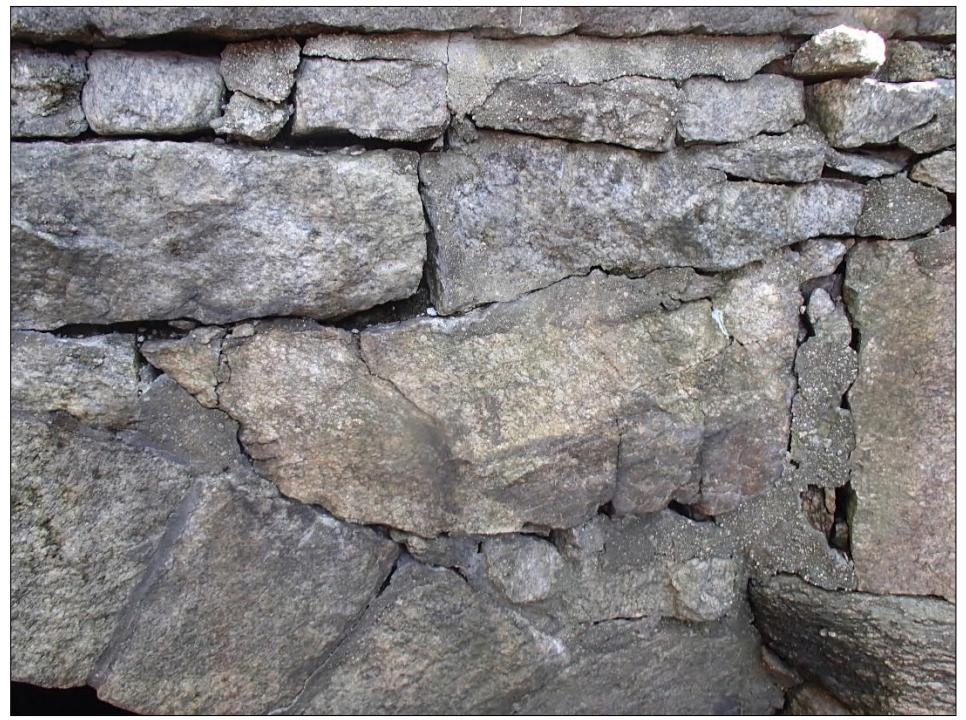
Photo 8 Looking South: Cracks and Voids on North Face

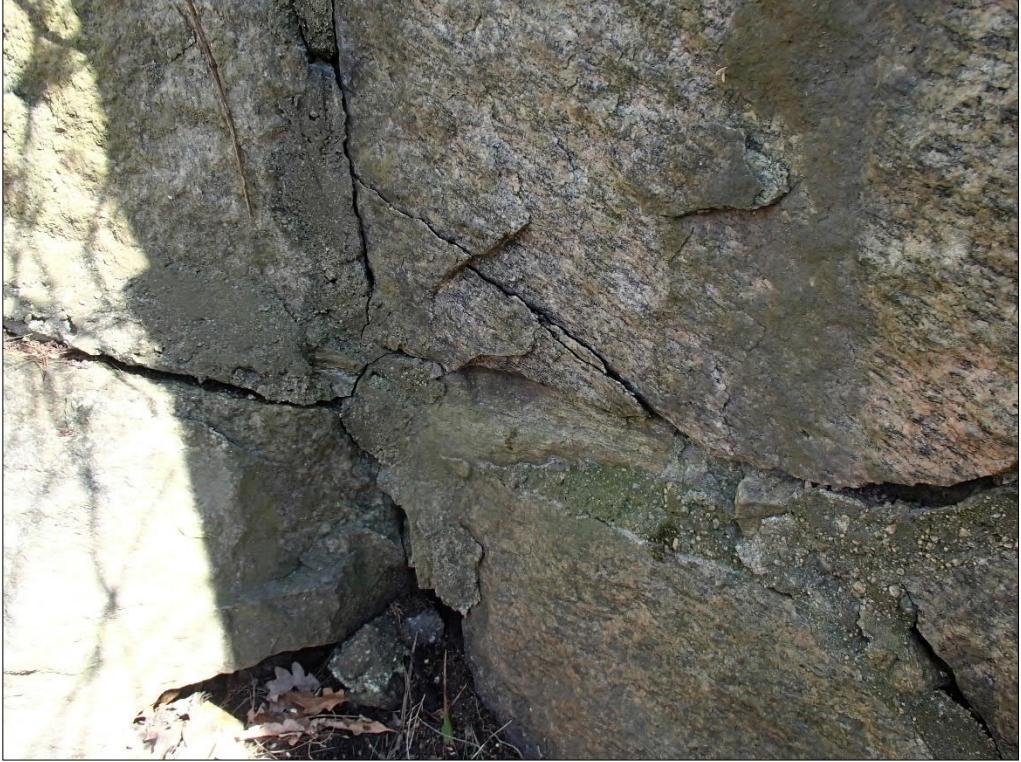
Photo 9 Looking East: Cracking at Northeast Wingwall Connection

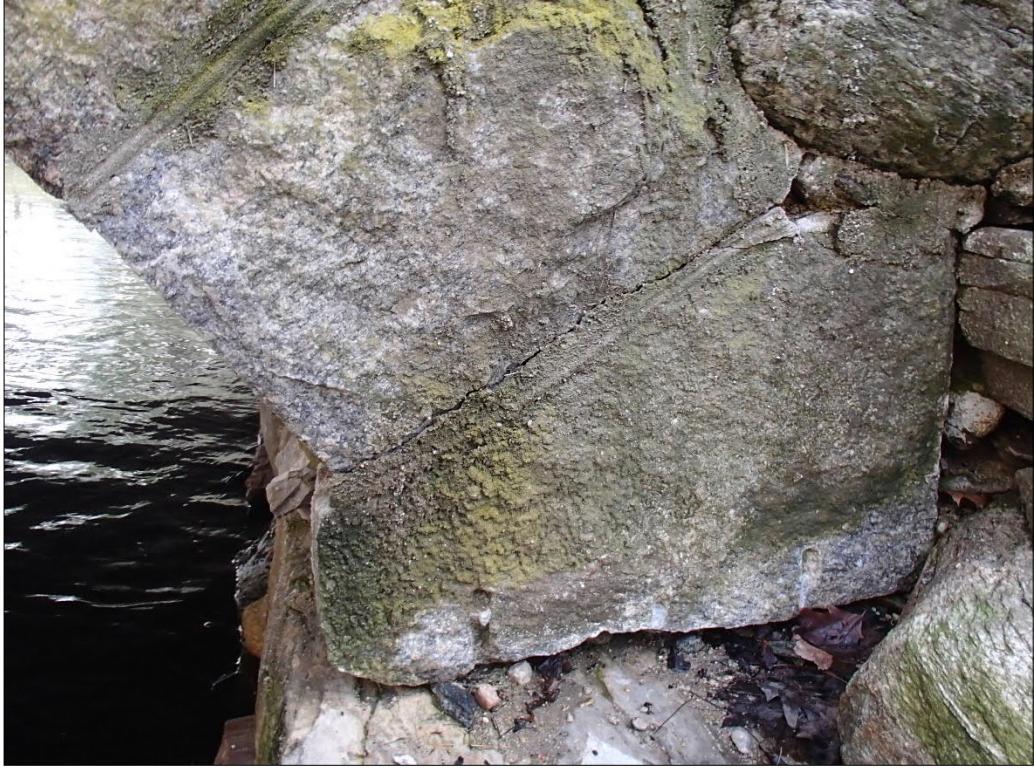
Photo 13 Looking East: Cracked Mortar at Southwest Arch Corner

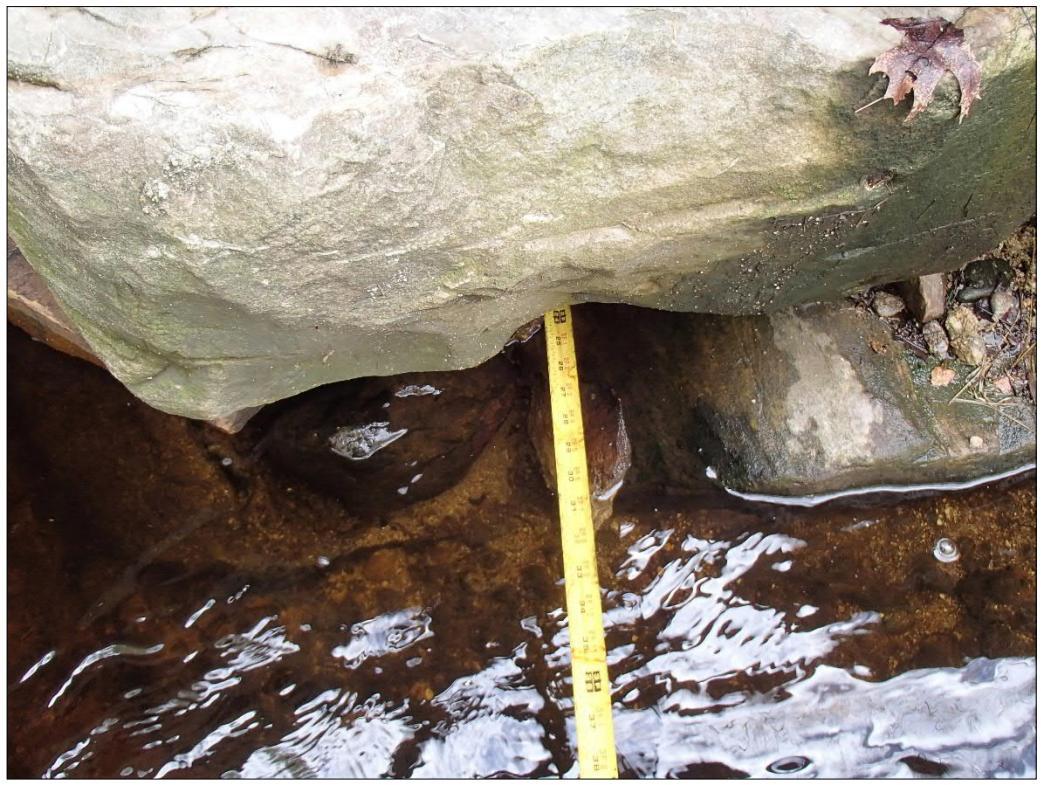
Photo 14 Looking East: Southwest Corner Void

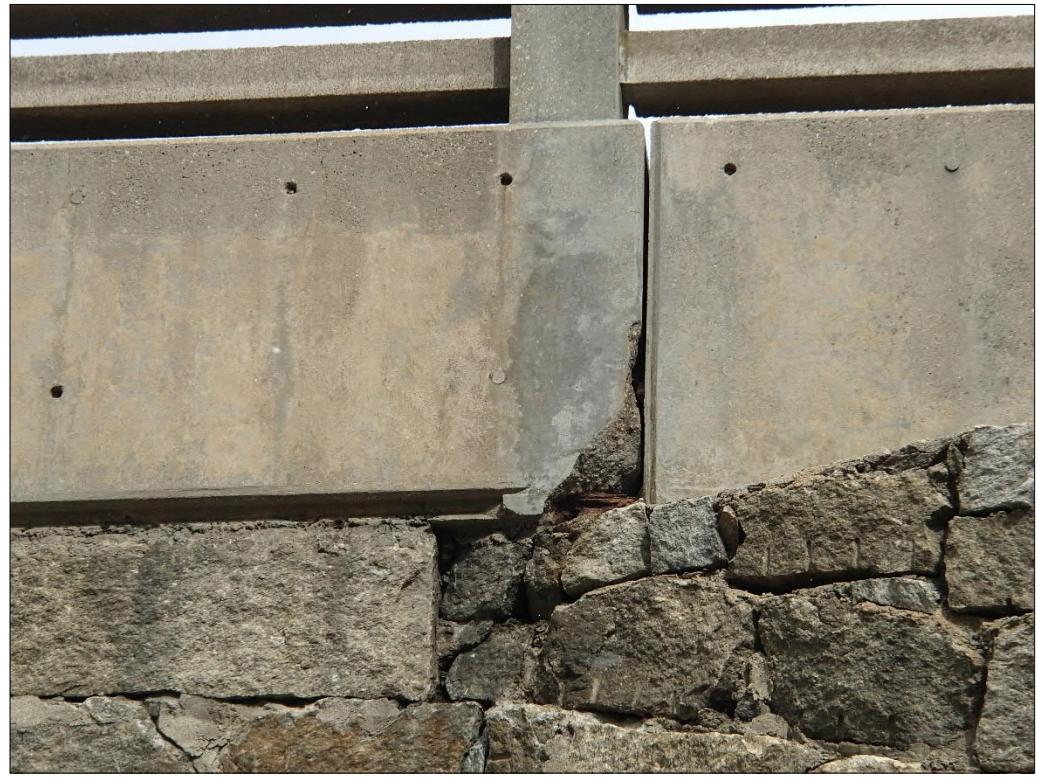
Photo 10 Looking North: South Parapet Spall

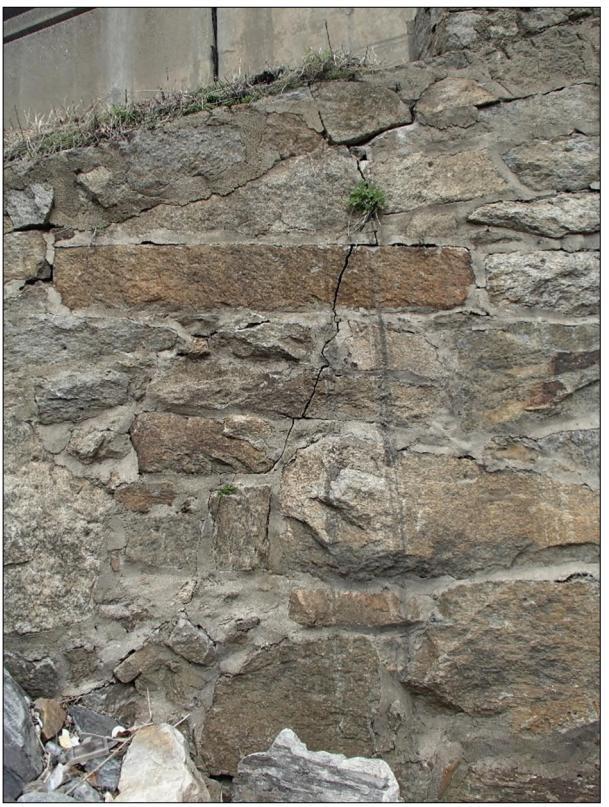
Photo 12 Looking Northwest: Southwest Wingwall Crack

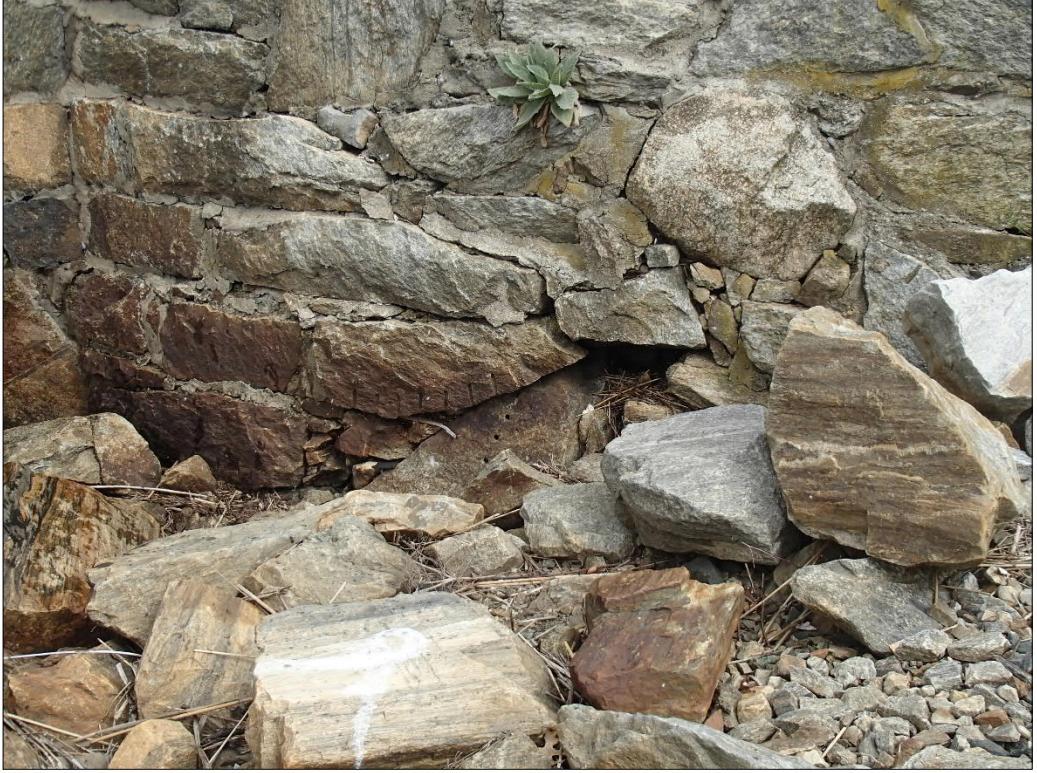
Photo 13 Looking North: Southeast Wingwall Voids

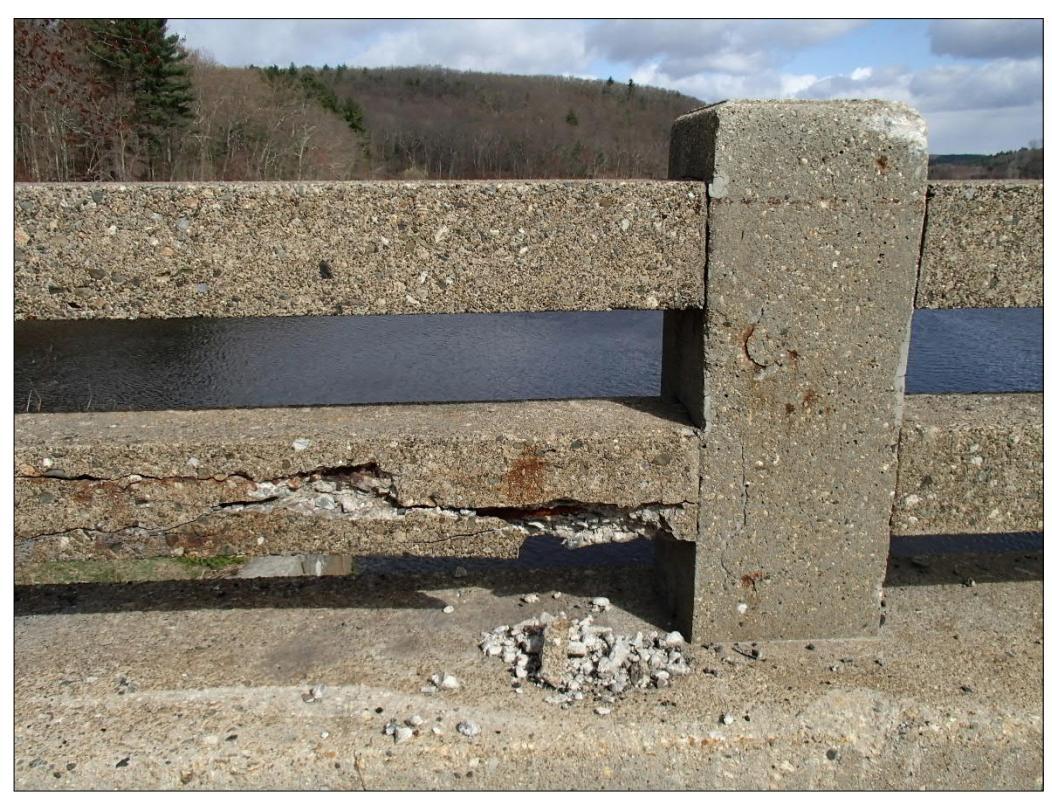
Photo 18 Looking North: North Barrier Deterioration

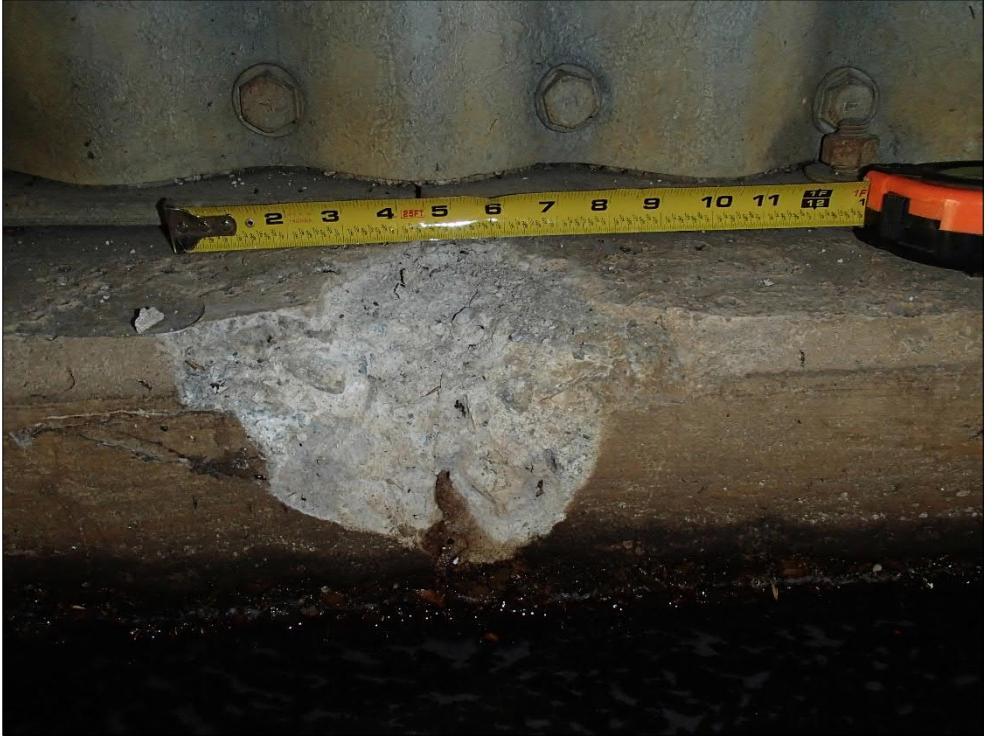
Photo 11 Looking South: Spall at Midspan

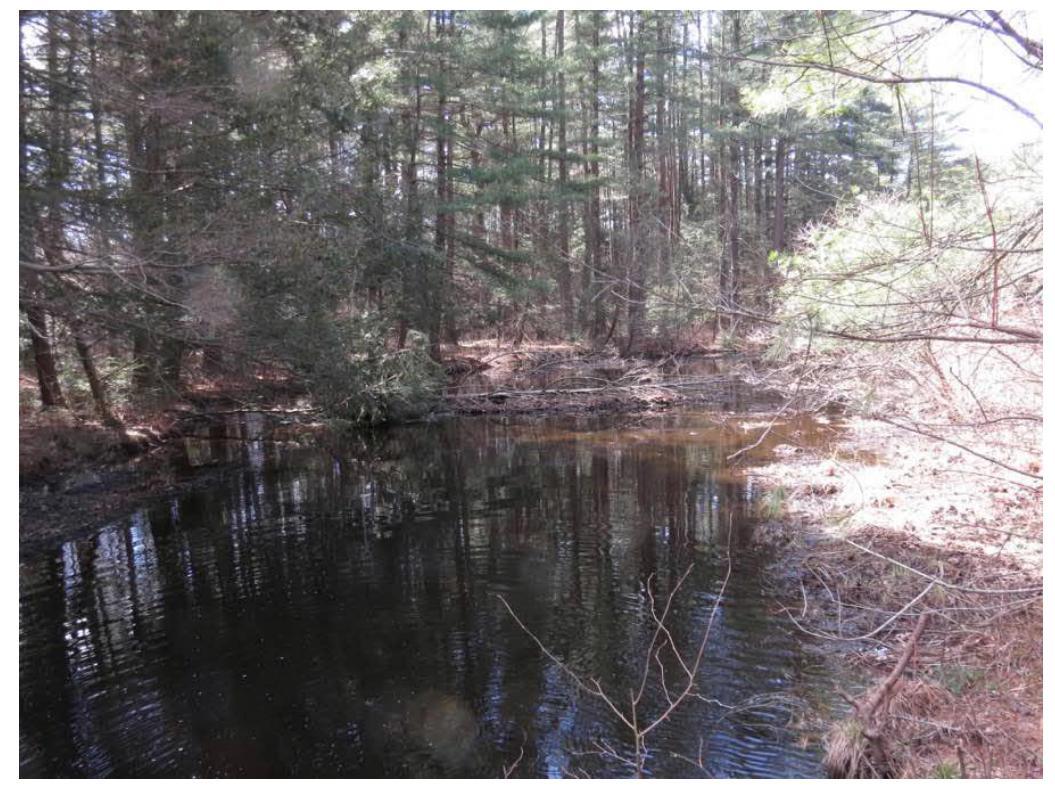
Photo 4: Felled tree in downstream channel.

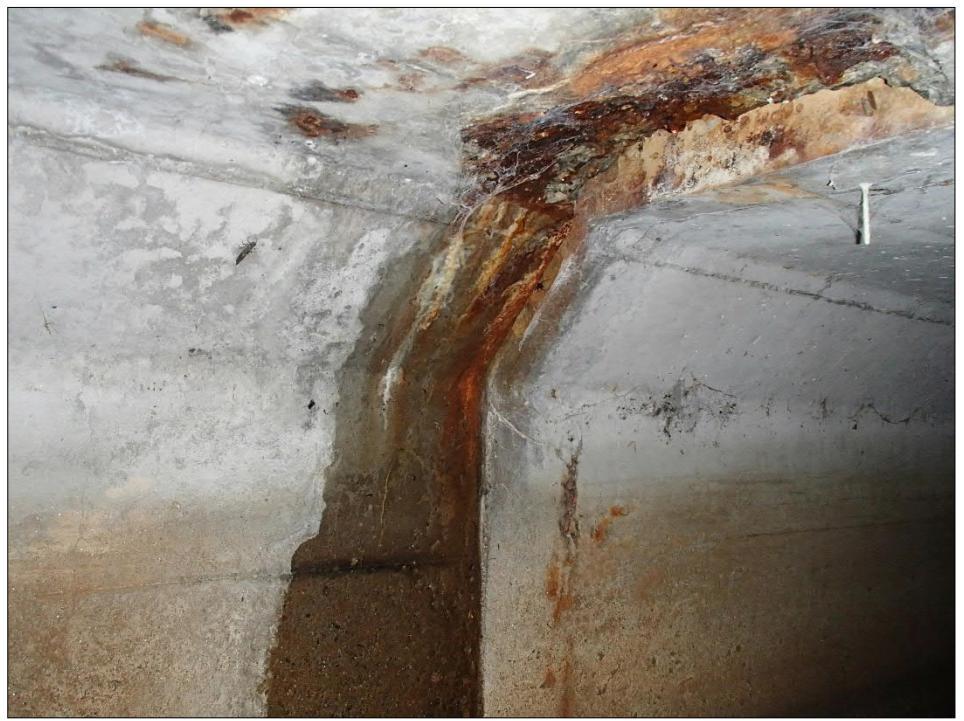
Photo 8 Looking East: Box 1 Joint #8 Rust Staining with Efflorescence
