Uxbridge, Massachusetts Evaluation Report

Project Number: 7533 June 2021

BRIDGE / CULVERT MANAGEMENT PLAN

Hartford Avenue East over the Mumford River (Bridge No. U-02-020)

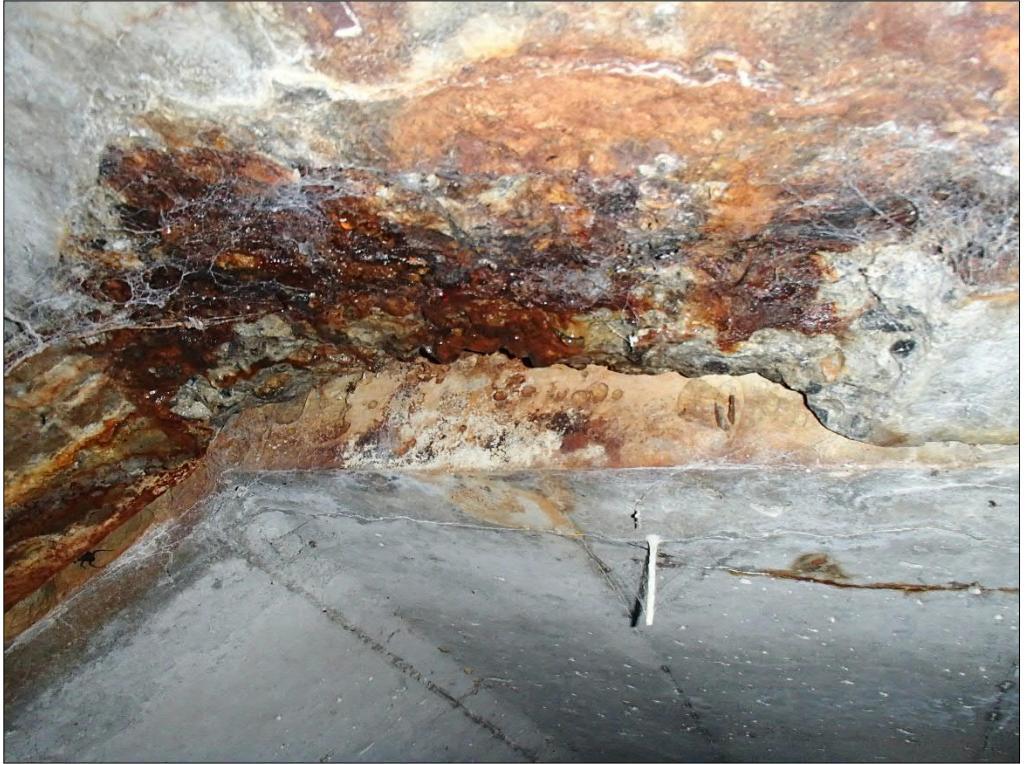
Photo 9 Looking East: Box 1 Joint #8 Rust Staining with Efflorescence

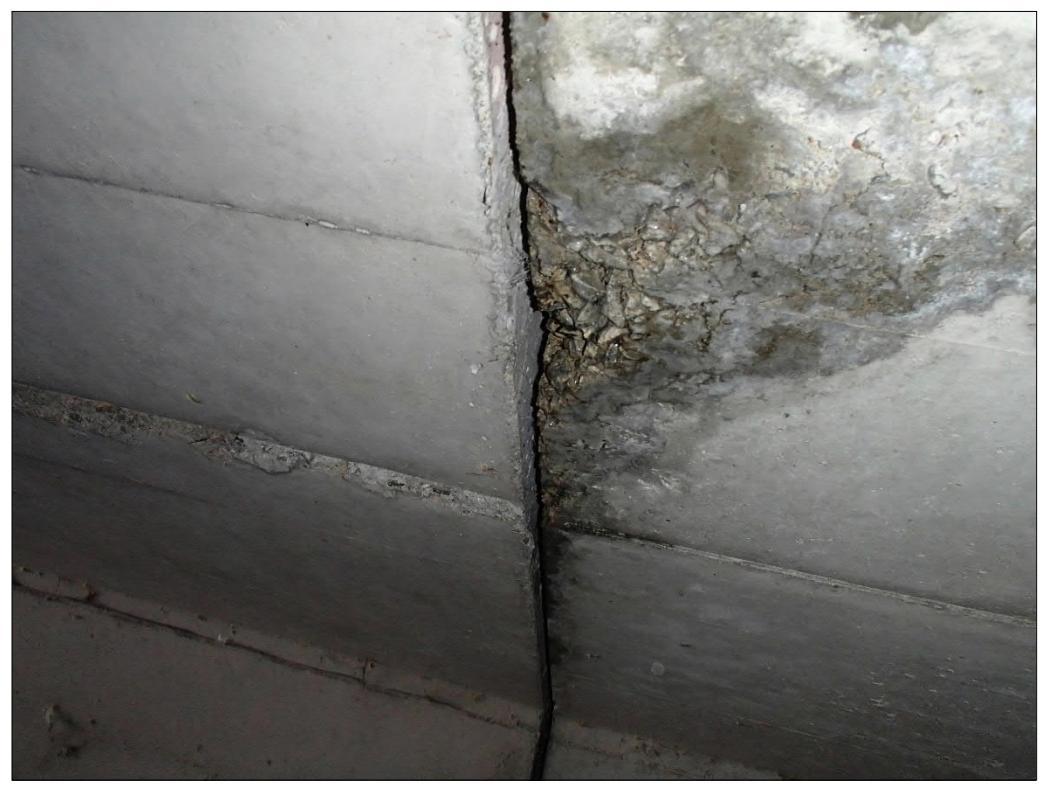
Photo 10 Looking East: Box 1 Joint #3 Spaling at Midspan

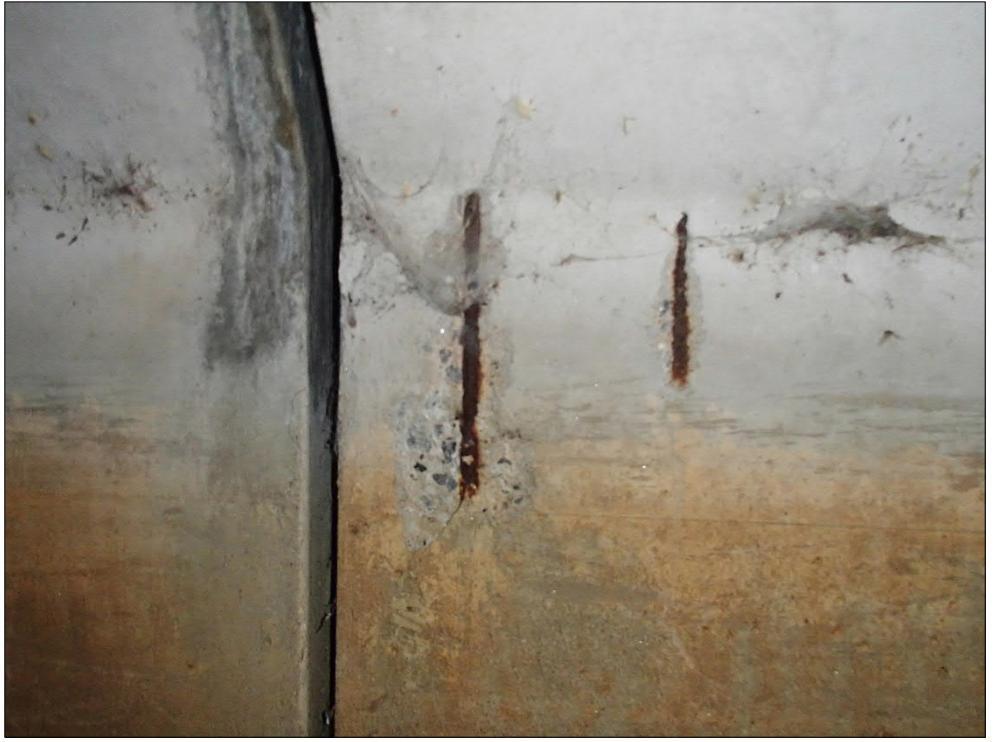
Photo 11 Looking West: Box 2 Spalls near Joint #3

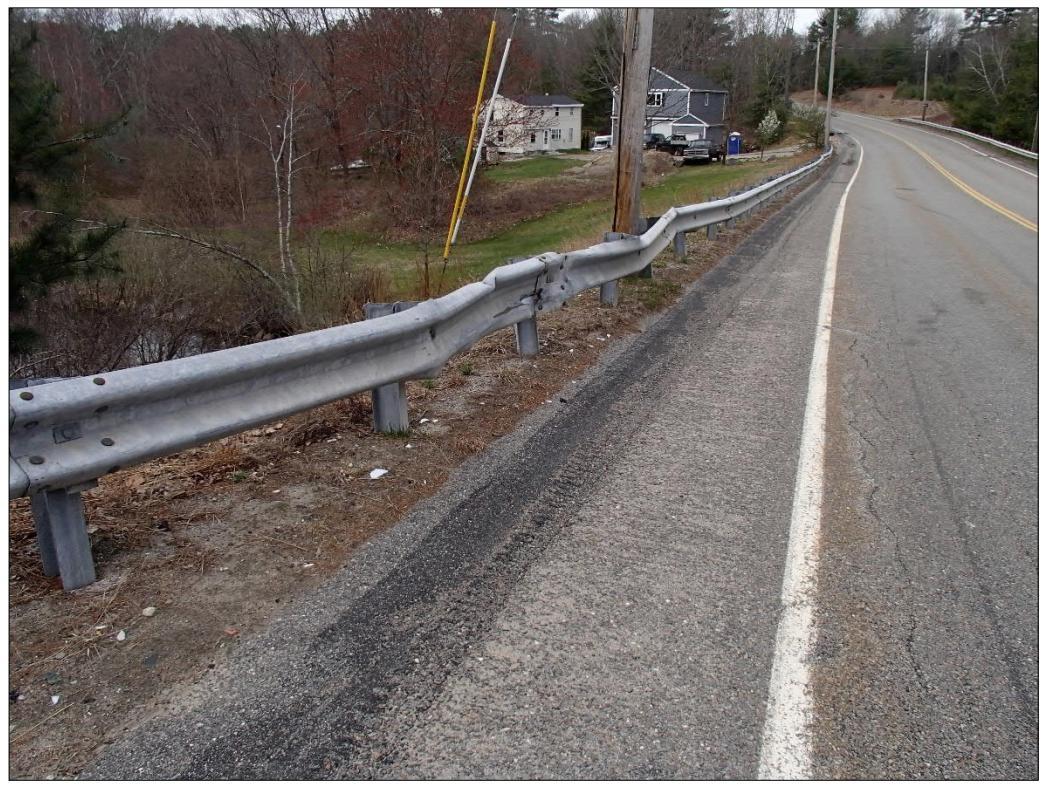
Photo 15 Looking Southwest: Southeast Guardrail Collision Damage

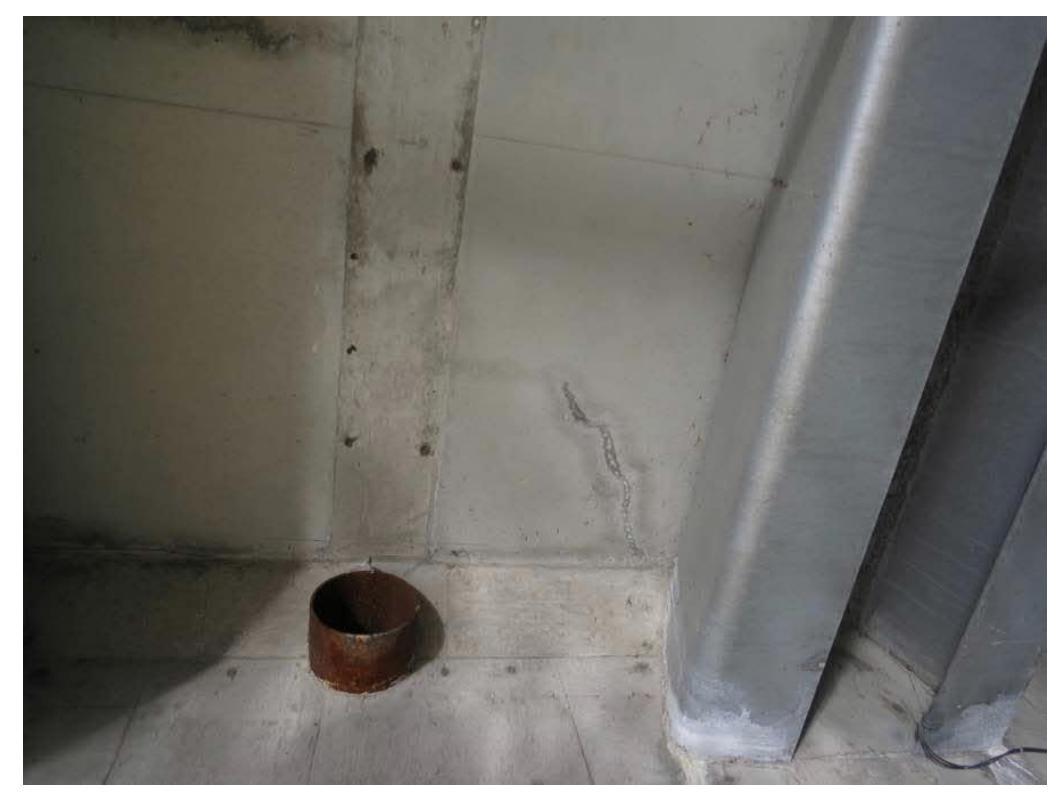
Photo 1: Typical Wearing Surface crack.
