MEMORANDUM

DATE: June 30, 2020

RE: Road-Stream Crossing Assessment
Integrated Water Infrastructure Vulnerability Assessment and Climate Resiliency Plan MVP
Action Grant – Town of Uxbridge

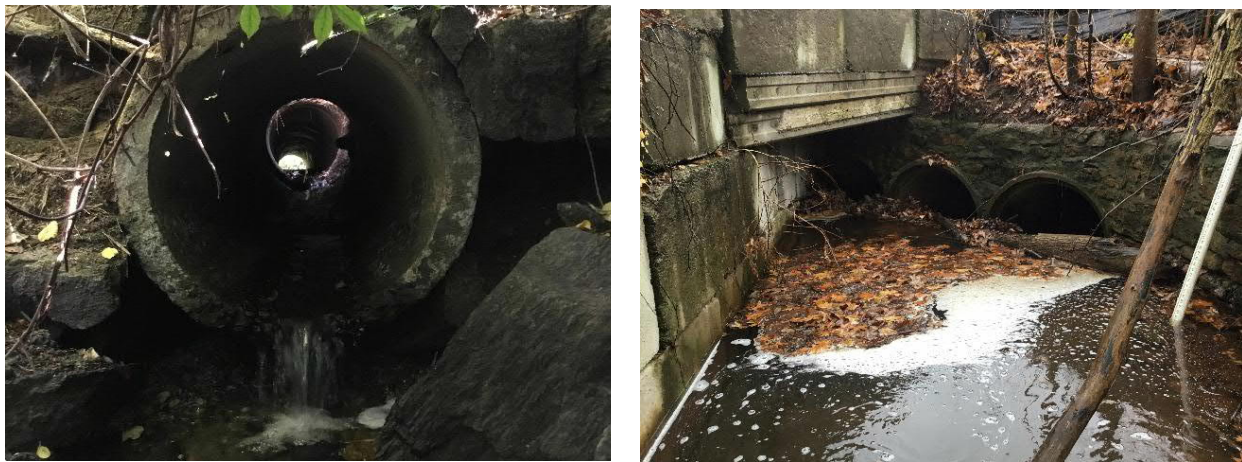
- **Poor Structural Condition:** The majority (80%) of the crossings assessed were observed to be in poor condition and in need of significant repairs or replacement. Deterioration of headwalls, and/or wingwalls, armoring, and joints and seams was common at many of these crossings, as was evidence of embankment piping. Invert deterioration and footing deterioration were also relatively common among crossings in the Town. Photos showing examples of structural deficiencies observed at Uxbridge crossings are provided in Figure 2.

Figure 2. Examples of crossing structures in poor structural condition observed at various locations during field assessments. Left: Structure exhibiting a sinkhole, critical structural integrity, and critical joints and seams. Right: Severely blocked culvert inlets.

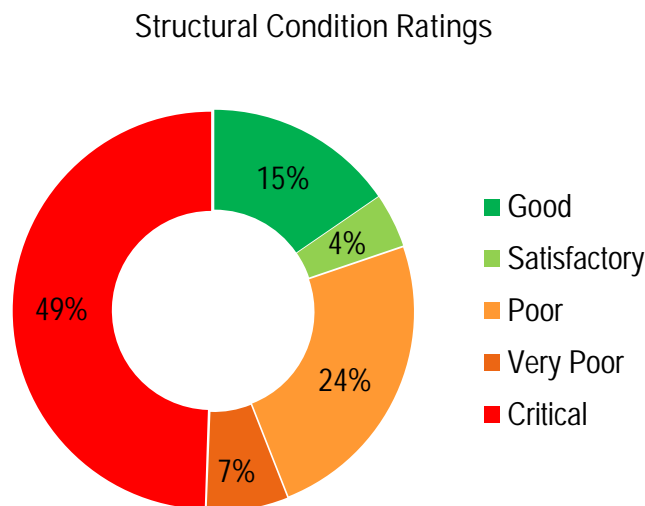
Structural risk is an even more common problem at road-stream crossing sites in Uxbridge, with 49% of assessed crossings rated as “Critical” for structural condition and a further 31% rated as “Very Poor” or “Poor” (Figure 7). Only 19% of crossings received ratings of “Good” or “Satisfactory.” Of the nineteen crossings that rated highest for structural risk based on structural condition and potential for flooding impacts (with scores of 20 to 25 out of 25), all are also among the top priority crossings overall (Table 1). Several crossings rated as having severe structural risk are located along State Route 16 and other high-traffic roads in the Town of Uxbridge (Figure 9).

Figure 7. Distribution of structural condition ratings across all assessed crossings.

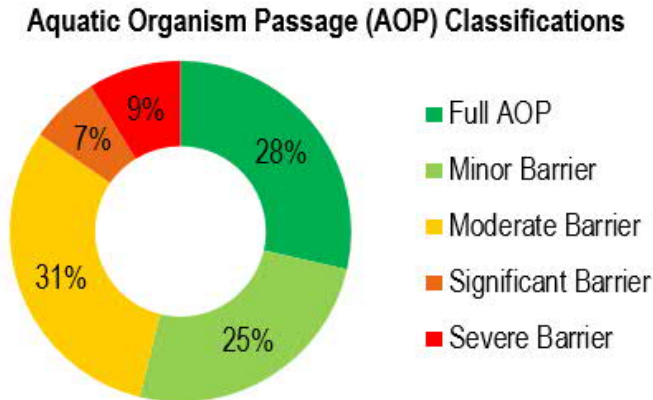
The majority of crossings assessed were rated as providing full passage (28%) or as only minor barriers (25%) to aquatic passage (Figure 10). Only 16% of barriers were considered significant or severe barriers to aquatic organism passage. However, of the 16 crossings receiving the highest AOP Benefit Scores (scores of 10-25), over half received High Relative Priority Ratings overall. Figure 12 depicts the spatial distribution of the AOP Benefit Scores.

Figure 10. Distribution of aquatic organism passage classifications across all assessed crossings.

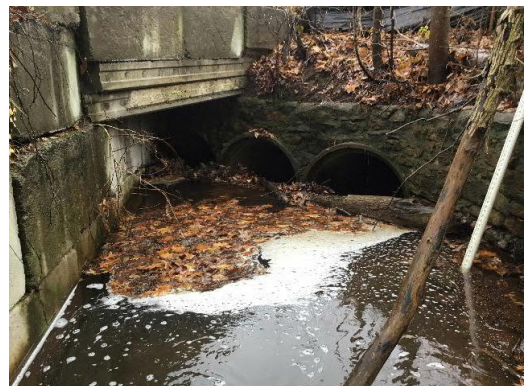
One of many road-stream crossings located along Route 16, this crossing is located approximately 0.2 miles northeast of the intersection of Route 16 and Route 146 and consists of three round concrete pipes each approximately 3 feet in diameter (Figure 16). The inlet area is blocked by over 50%, reducing the structure's aquatic passability and contributing to the crossing's structural condition rating of severe. The overall crossing condition is also negatively impacted by deficiencies in the structure's integrity, joints and seams, armoring, and headwalls and wingwalls as well as evidence of embankment piping. The structure is adequately sized hydraulically for both existing and future predicted 100-year flood flows, if the debris blocking the structure inlets is removed and the crossings are maintained in a condition free of debris. Although the crossing is not severely constricted, the combined widths of the three structures is sufficient to span only the channel and not the streambanks.

Figure 16. The inlet at crossing xy42069387166088 on Route 16/Douglas Street.

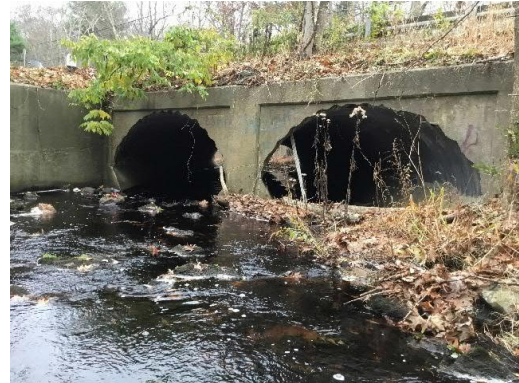
The crossing of Rock Meadow Brook on Route 16/Mendon Street is located approximately 0.15 miles southwest of the Uxbridge-Mendon town boundary. The crossing consists of twin 77-foot-long corrugated metal pipe arches (Figure 17). The cascade condition at the outlet and the blockage of one of the structure inlets with sediment and debris results in a “severe barrier” rating for the crossing. The structure is adequately sized hydraulically for both existing and future predicted 100-year flood flows, if the debris blocking the structure inlets is removed and the crossings are maintained in a condition free of debris. Structurally the crossing is considered critical due to blockage of the inlet as well as the poor condition of the armoring and the headwall/endwall and wingwalls and the presence of signs of embankment piping. Geomorphic risk is rated significant due to a number of factors, including the presence of an outlet drop, a significant amount of bank erosion, and the poor alignment of the crossing with the channel.

Figure 17. The inlet at crossing xy42090197159787 on Route 16/Mendon Street.

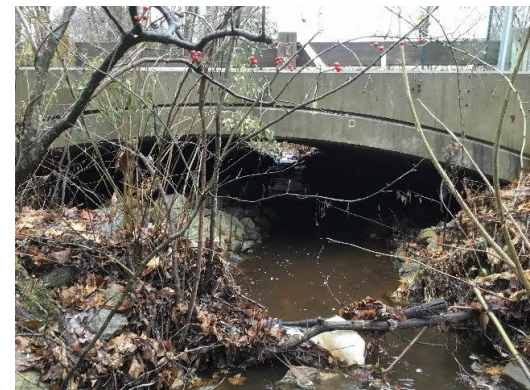
Taft Hill Lane crosses Cold Spring Brook within 200 feet of the Route 16/Douglas Street crossing described in Section 4.1.1. The crossing consists of a 17-foot wide concrete arch (Figure 19) and appears to have been recently reconstructed according to the Massachusetts Stream Crossing Standards. However, the crossing is rated high priority mainly due to the severe structural risk score which it received due to a single factor: the level of blockage within the structure, which obstructs more than 50% of the structure’s cross-sectional area.

Figure 19. The outlet at the crossing on Taft Hill Lane (xy42069427166042). Note the accumulation of debris on banks that appear to have been incorrectly constructed within the crossing.

Because the structure has been recently reconstructed and appears to be adequately constructed to encompass the full bed and banks, full replacement is not recommended for this structure. Instead, the blockage of this structure can be addressed by removing the materials blocking the structure and reconstructing the banks through the structure according to best design practices.

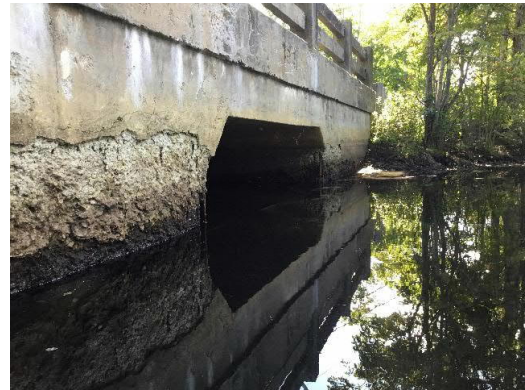
Route 98/Aldrich Street crosses an unnamed tributary to the Blackstone River approximately 1.7 miles west of Route 146. The crossing consists of a 6-foot by 10-foot concrete box culvert. The structure is partially submerged because of its location within the impoundment and immediately upstream of a dam (Figure 20).

Figure 20. The outlet at the crossing on Route 98/Aldrich Street (xy42027767164059).

The structure received only a Medium Relative Priority Rating, but is structurally integrated with the dam located immediately downstream, which has been recommended for removal. Replacement of the crossing according to the Massachusetts Stream Crossing Standards is recommended in coordination with removal of the dam.

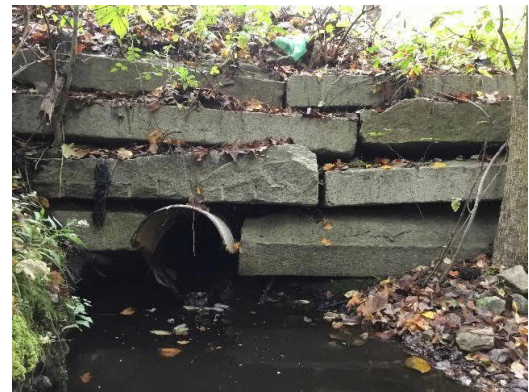
Albee Road crosses an unnamed tributary to the Blackstone River 0.2 miles southeast of the intersection of Albee Road with East Street. The crossing's outlet consists of a 1-foot diameter round corrugated metal pipe with a small free fall above the downstream water surface. The structure is integrated with a dam formed by the road embankment and was possibly built as the outlet structure of the dam. The crossing received moderately high hydraulic, structural, and geomorphic risk ratings.

Figure 21. The outlet at the crossing on Albee Road (xy42040747159721). Note the misalignment of the stone blocks forming the culvert endwall.

The structure received only a Medium Relative Priority Rating, but is a known flooding location. Replacement of the structure is recommended according to the Massachusetts Stream Crossing Standards such that the embankment no longer forms a dam.
