Town of Uxbridge, MA 2020 Flow Metering Program and I/I Analysis

Updated - Final

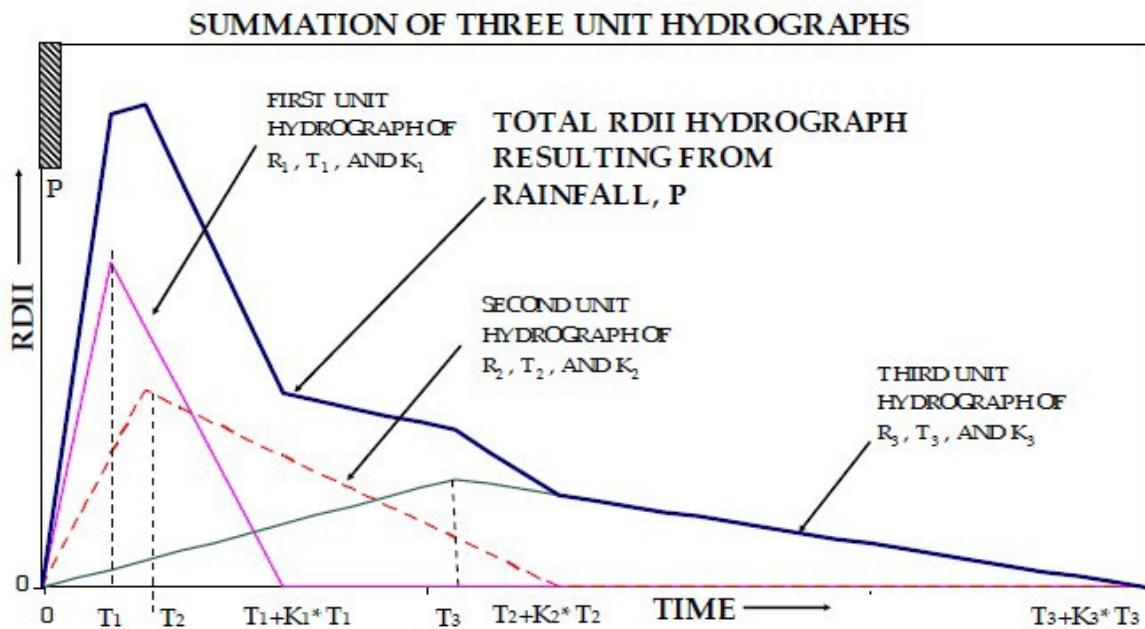
Figure 4.1 RTK Unit Hydrograph Definition

Wet weather flow was modeled using the RTK hydrograph method. This model is a unit hydrograph method (Figure 4.1) that was derived for modeling infiltration and inflow (I/I) in sanitary sewer systems and was incorporated into SWMM in version 5. The key assumption in this method is that the majority of runoff in a sanitary sewer system does not enter the sanitary sewer system and preferentially enters storm sewers, streams, or ponds. The flow that does enter the sewer system can be approximated as a three-part hydrograph that is comprised of a "fast" (direct inflow), "medium" (slower runoff), and "slow" (infiltration) response. The total hydrograph is combined to approximate the overall wet weather response of the sewer system. When combined, the convoluted hydrographs create an approximation of measured flow in the system.

A benefit of this method compared to the standard SWMM RUNOFF subroutine is that the storm response is quantified using measured flow data instead of estimated using the physical characteristics of the watershed. This prevents the modeler from needing to “force” parameters intended for runoff modeling in storm sewers and natural systems to sanitary sewers. A drawback is that these hydrographs can change based on antecedent conditions. To account for this, different unit hydrographs may be defined for different seasonal patterns.

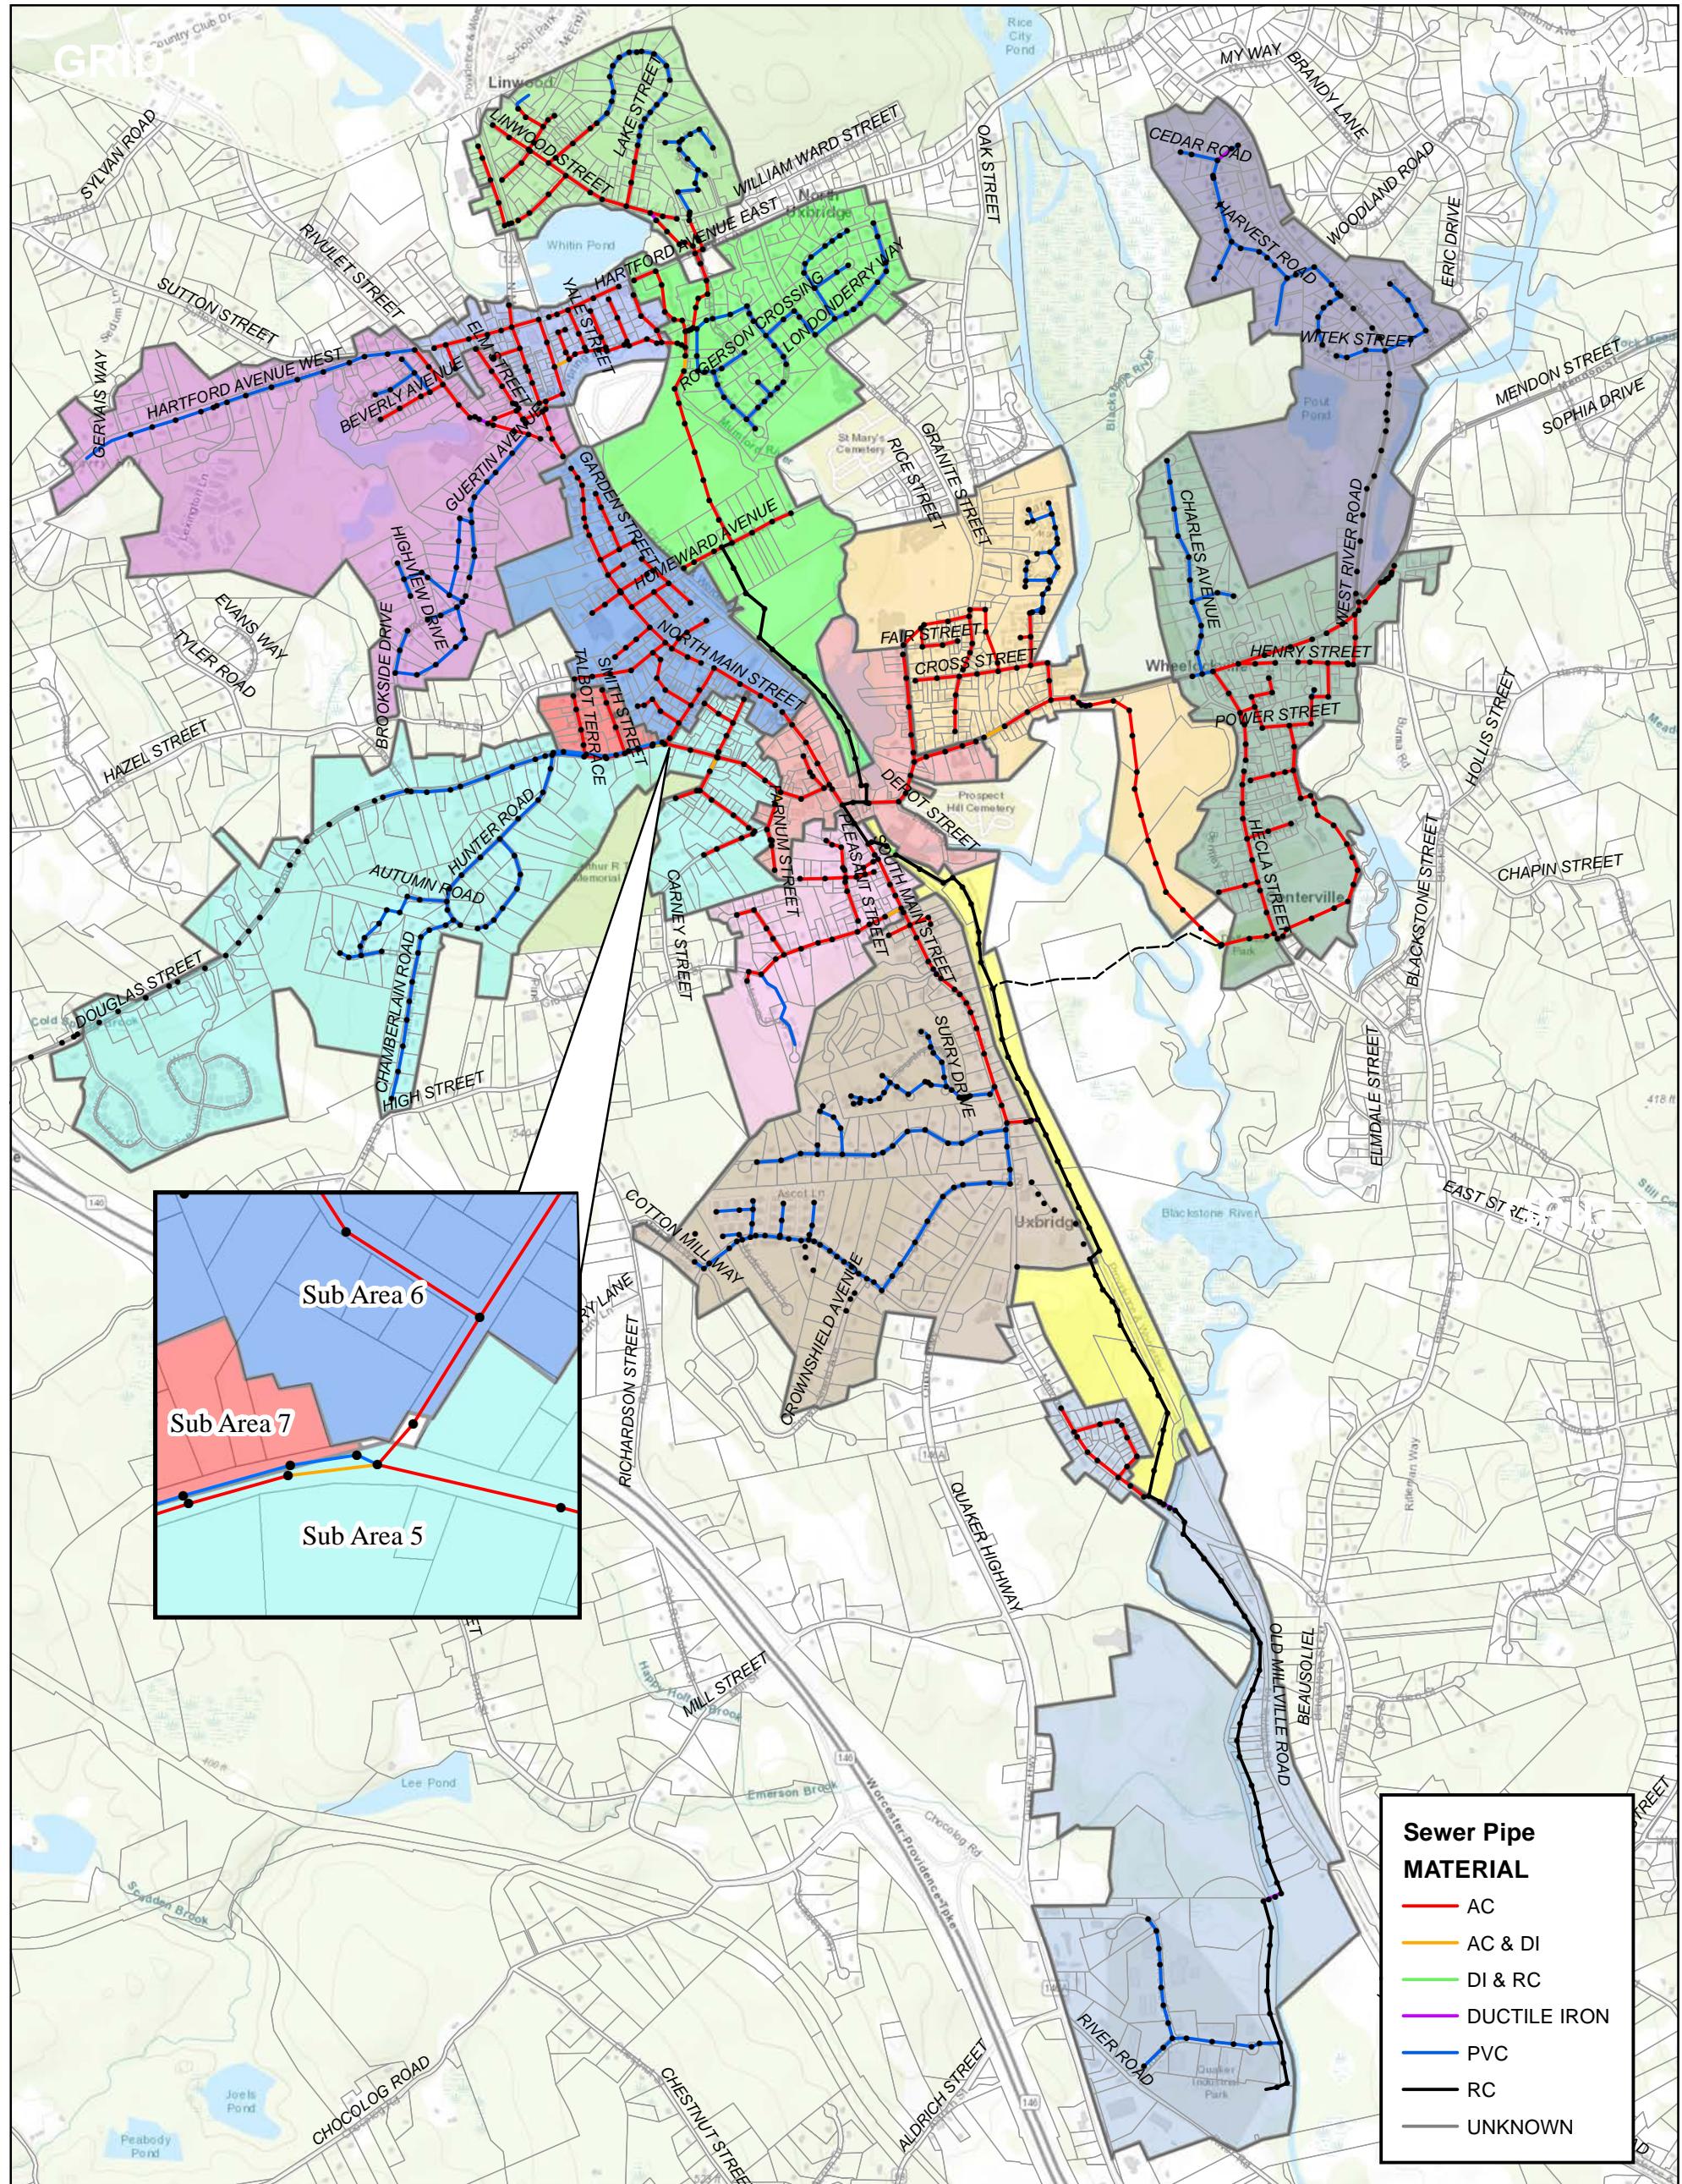
Figure 6

UXBRIDGE COLLECTION SYSTEM PIPE MATERIAL

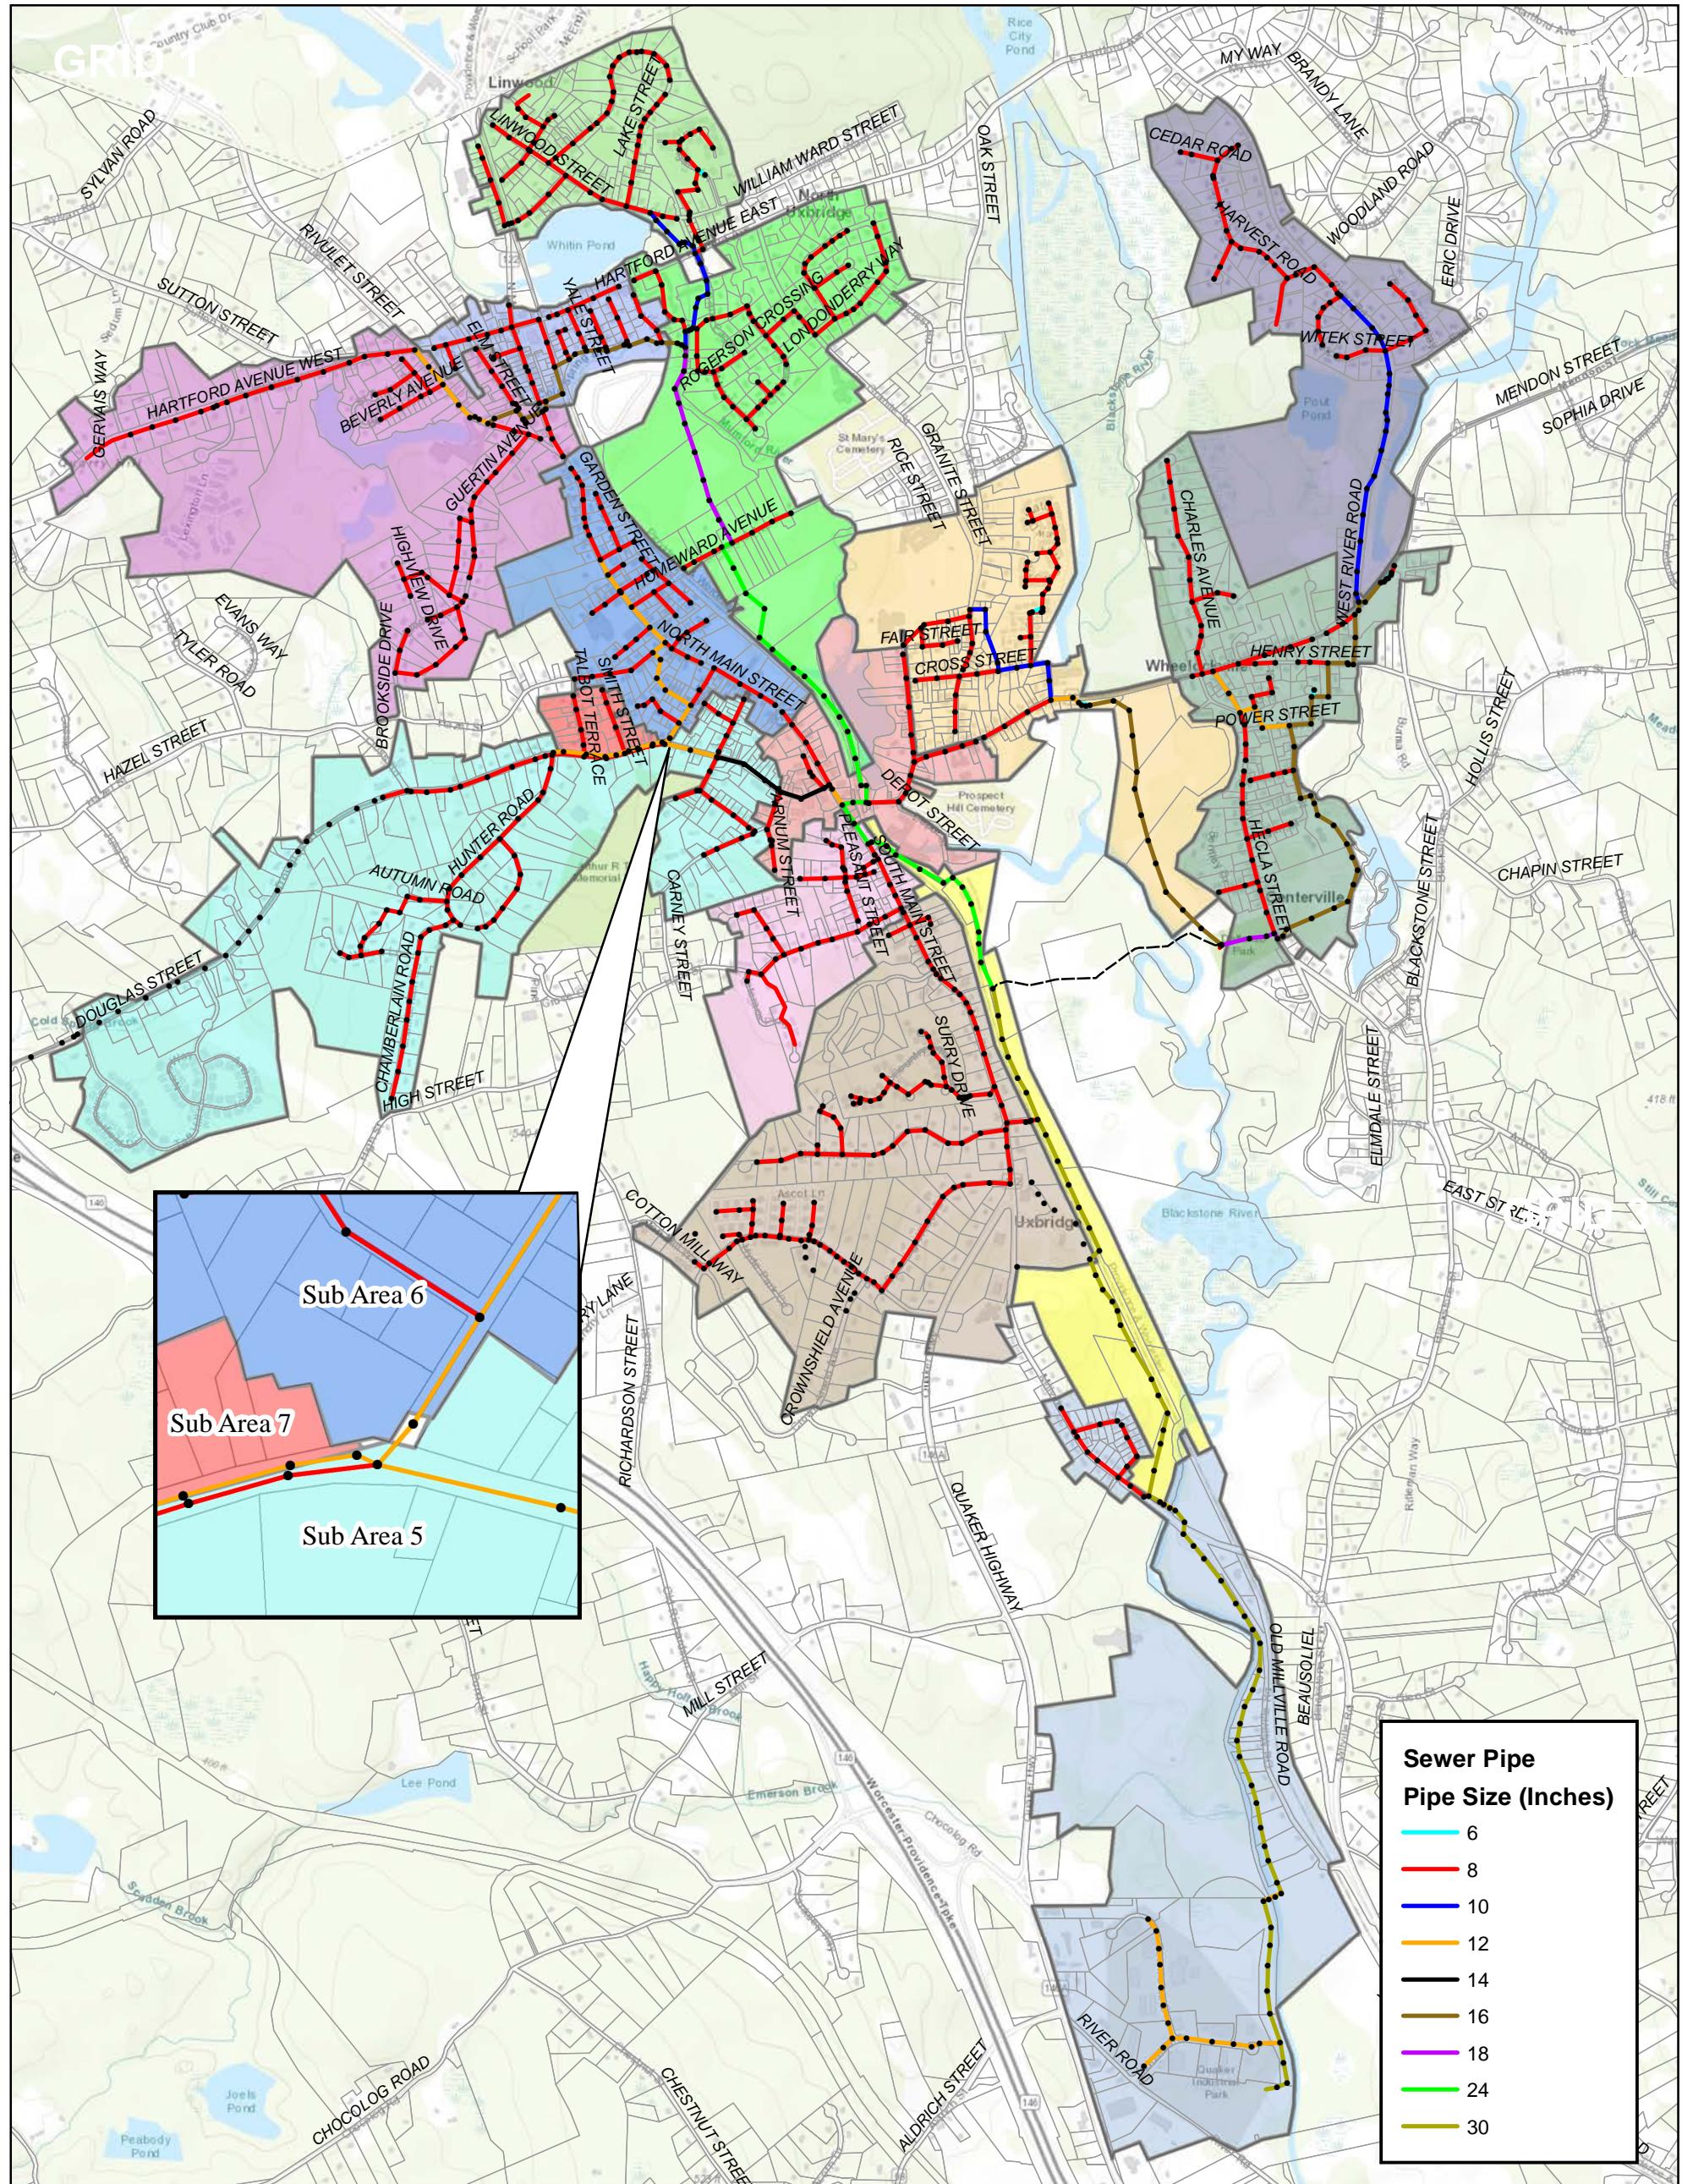
Figure 5

UXBRIDGE COLLECTION SYSTEM PIPE SIZE

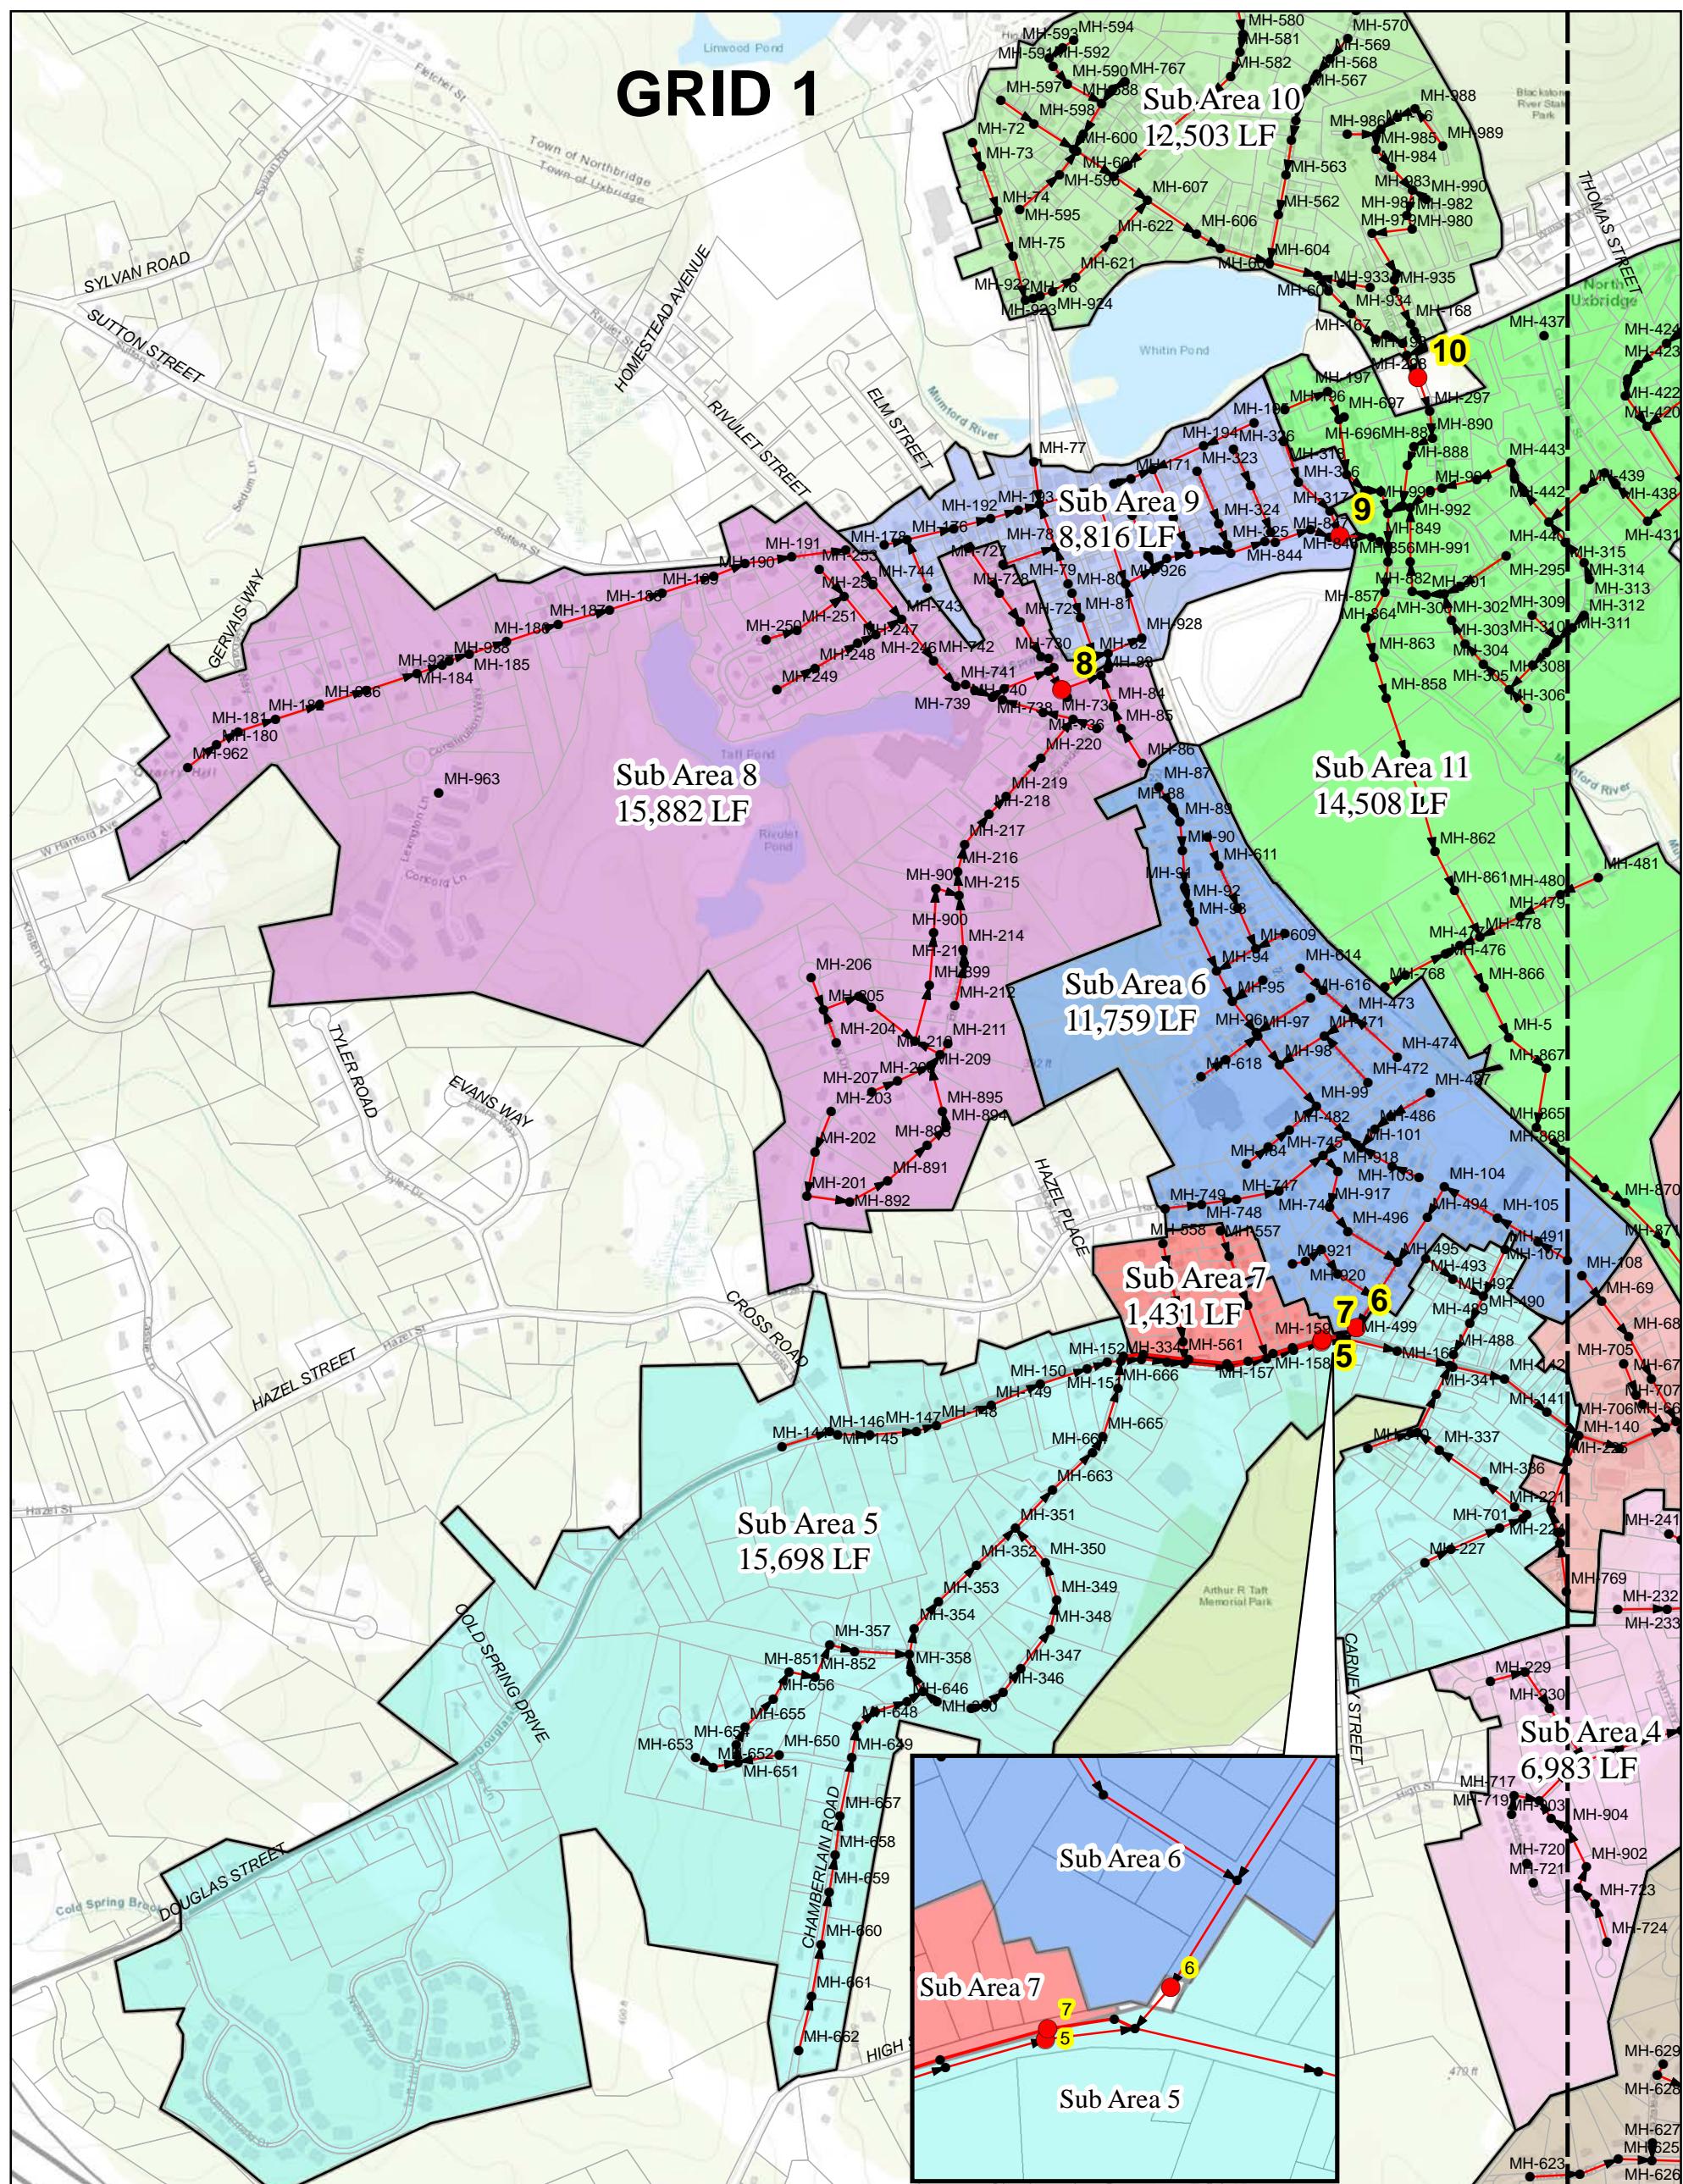
Figure 2

SUB AREA, FLOW METER LOCATIONS & FLOW DIRECTION - GRID 1

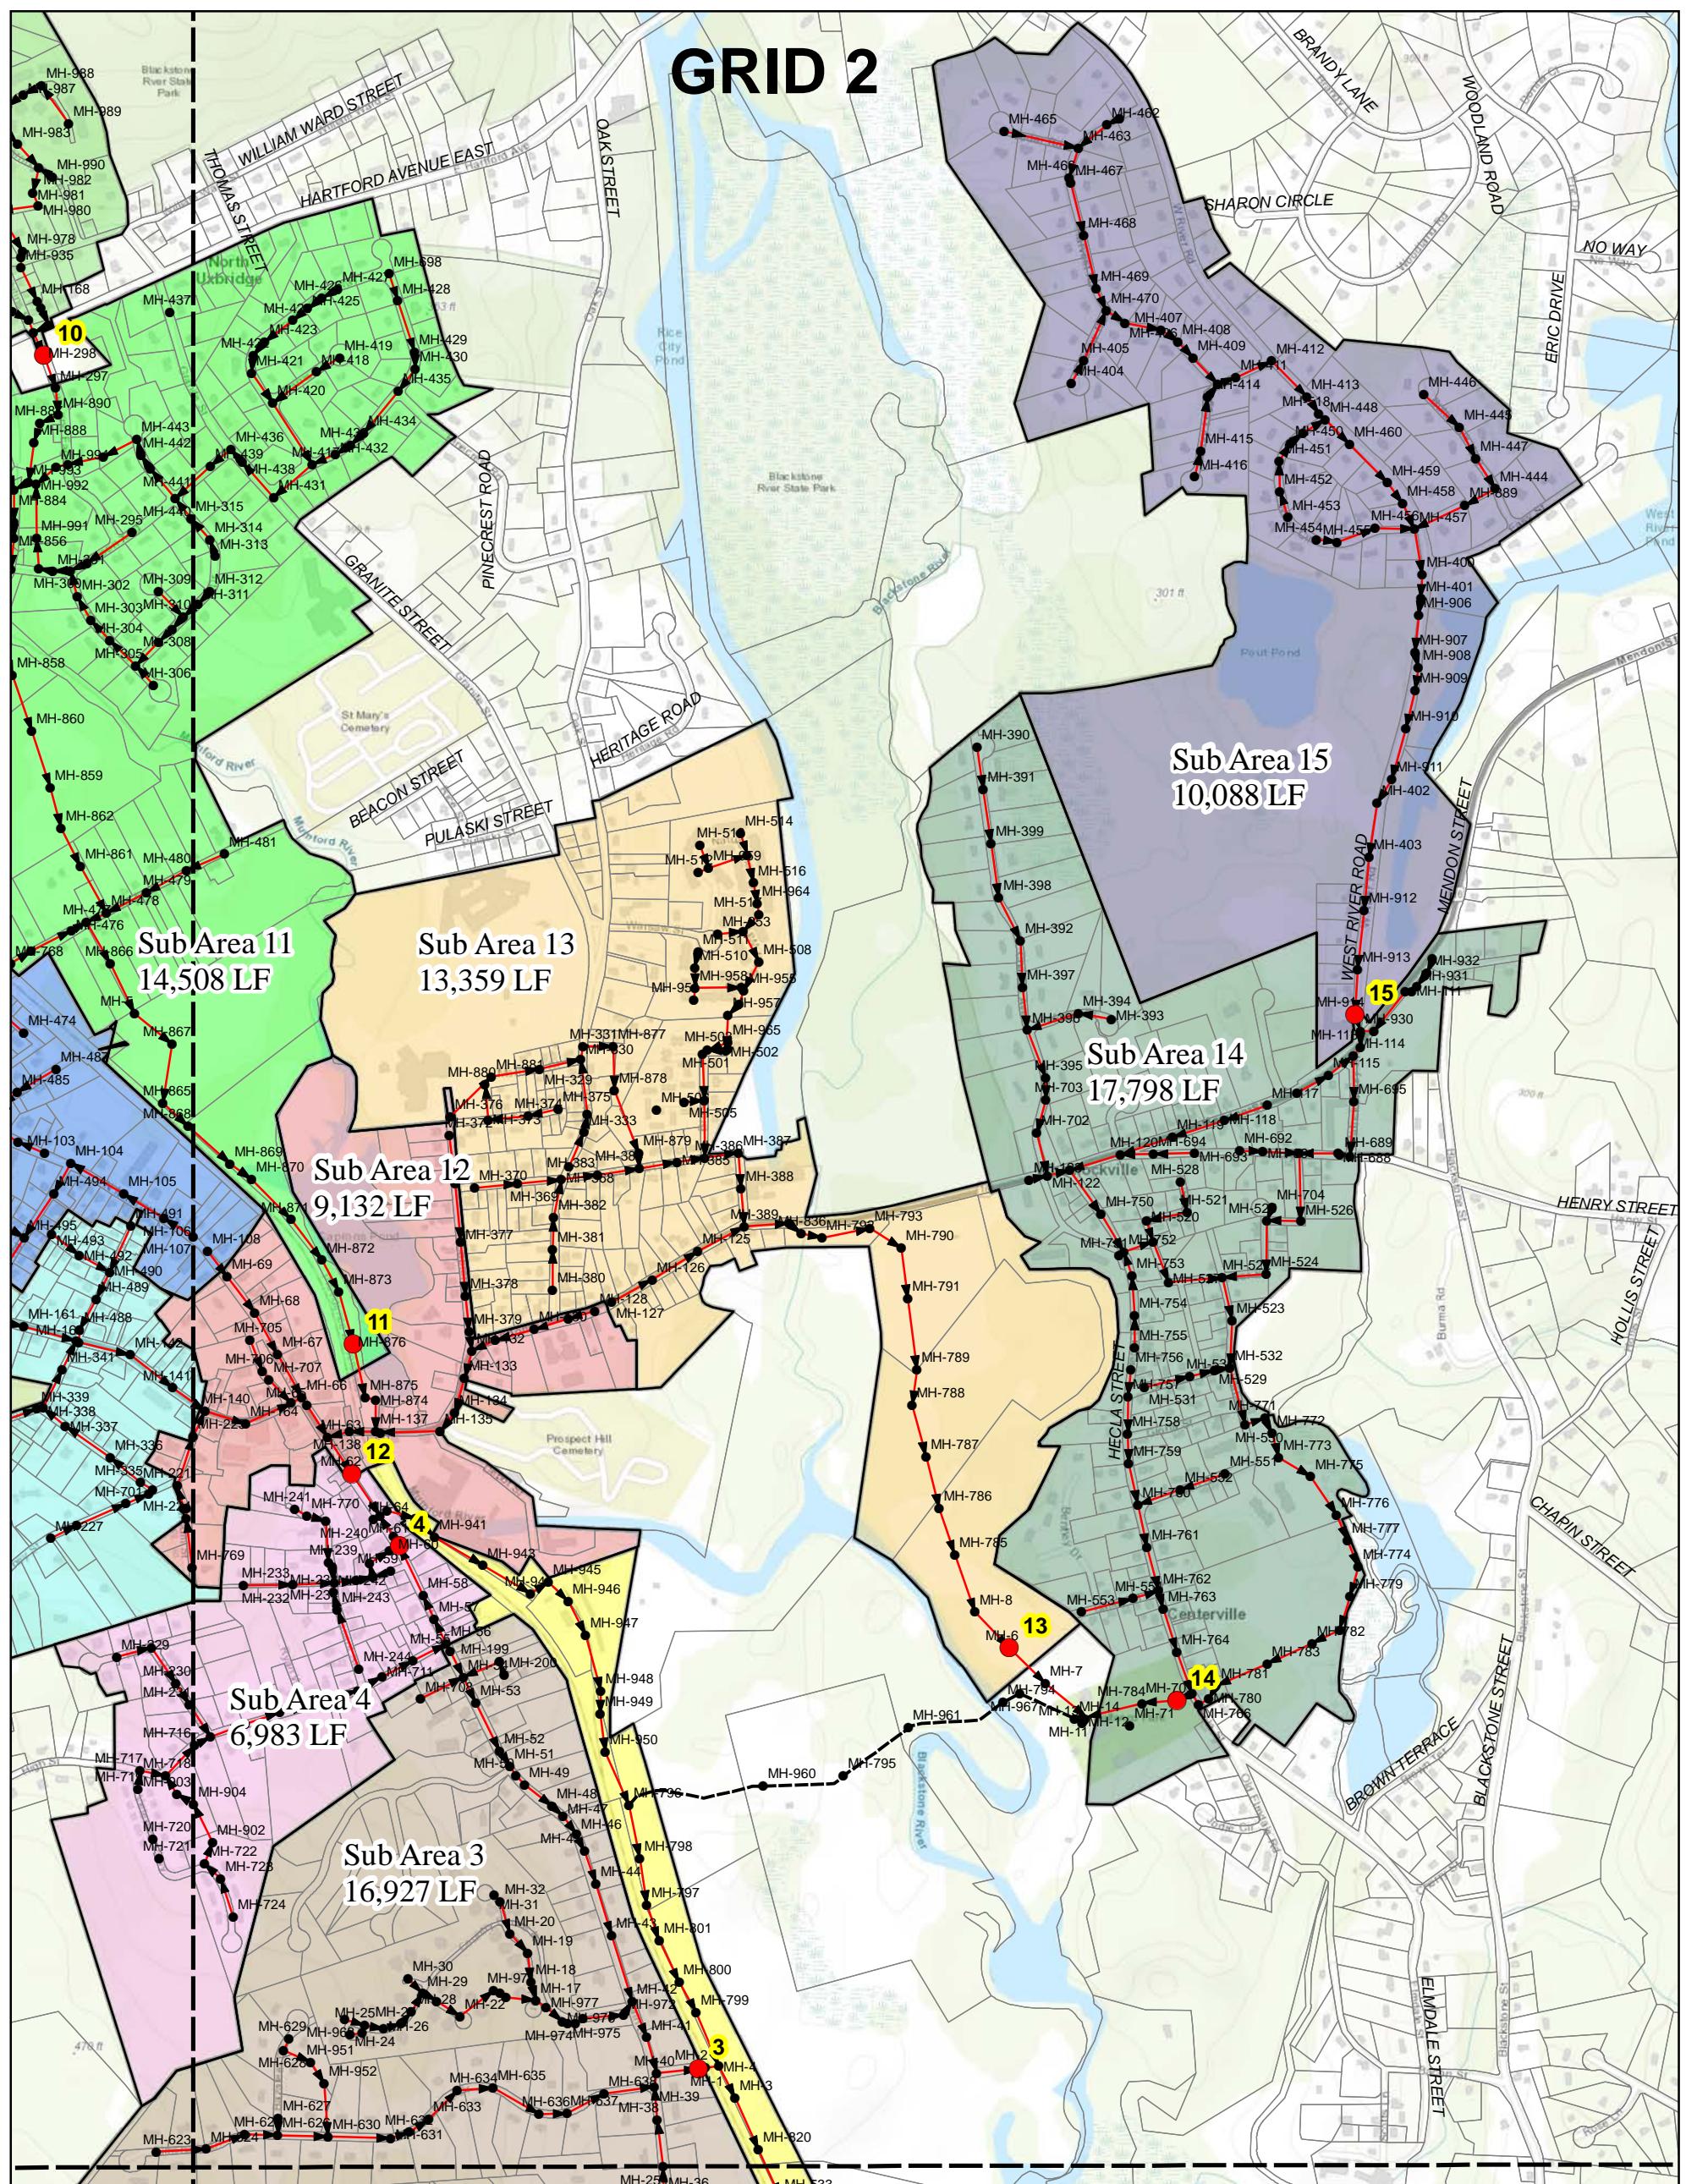
Figure 3

SUB AREA, FLOW METER LOCATIONS & FLOW DIRECTION - GRID 2

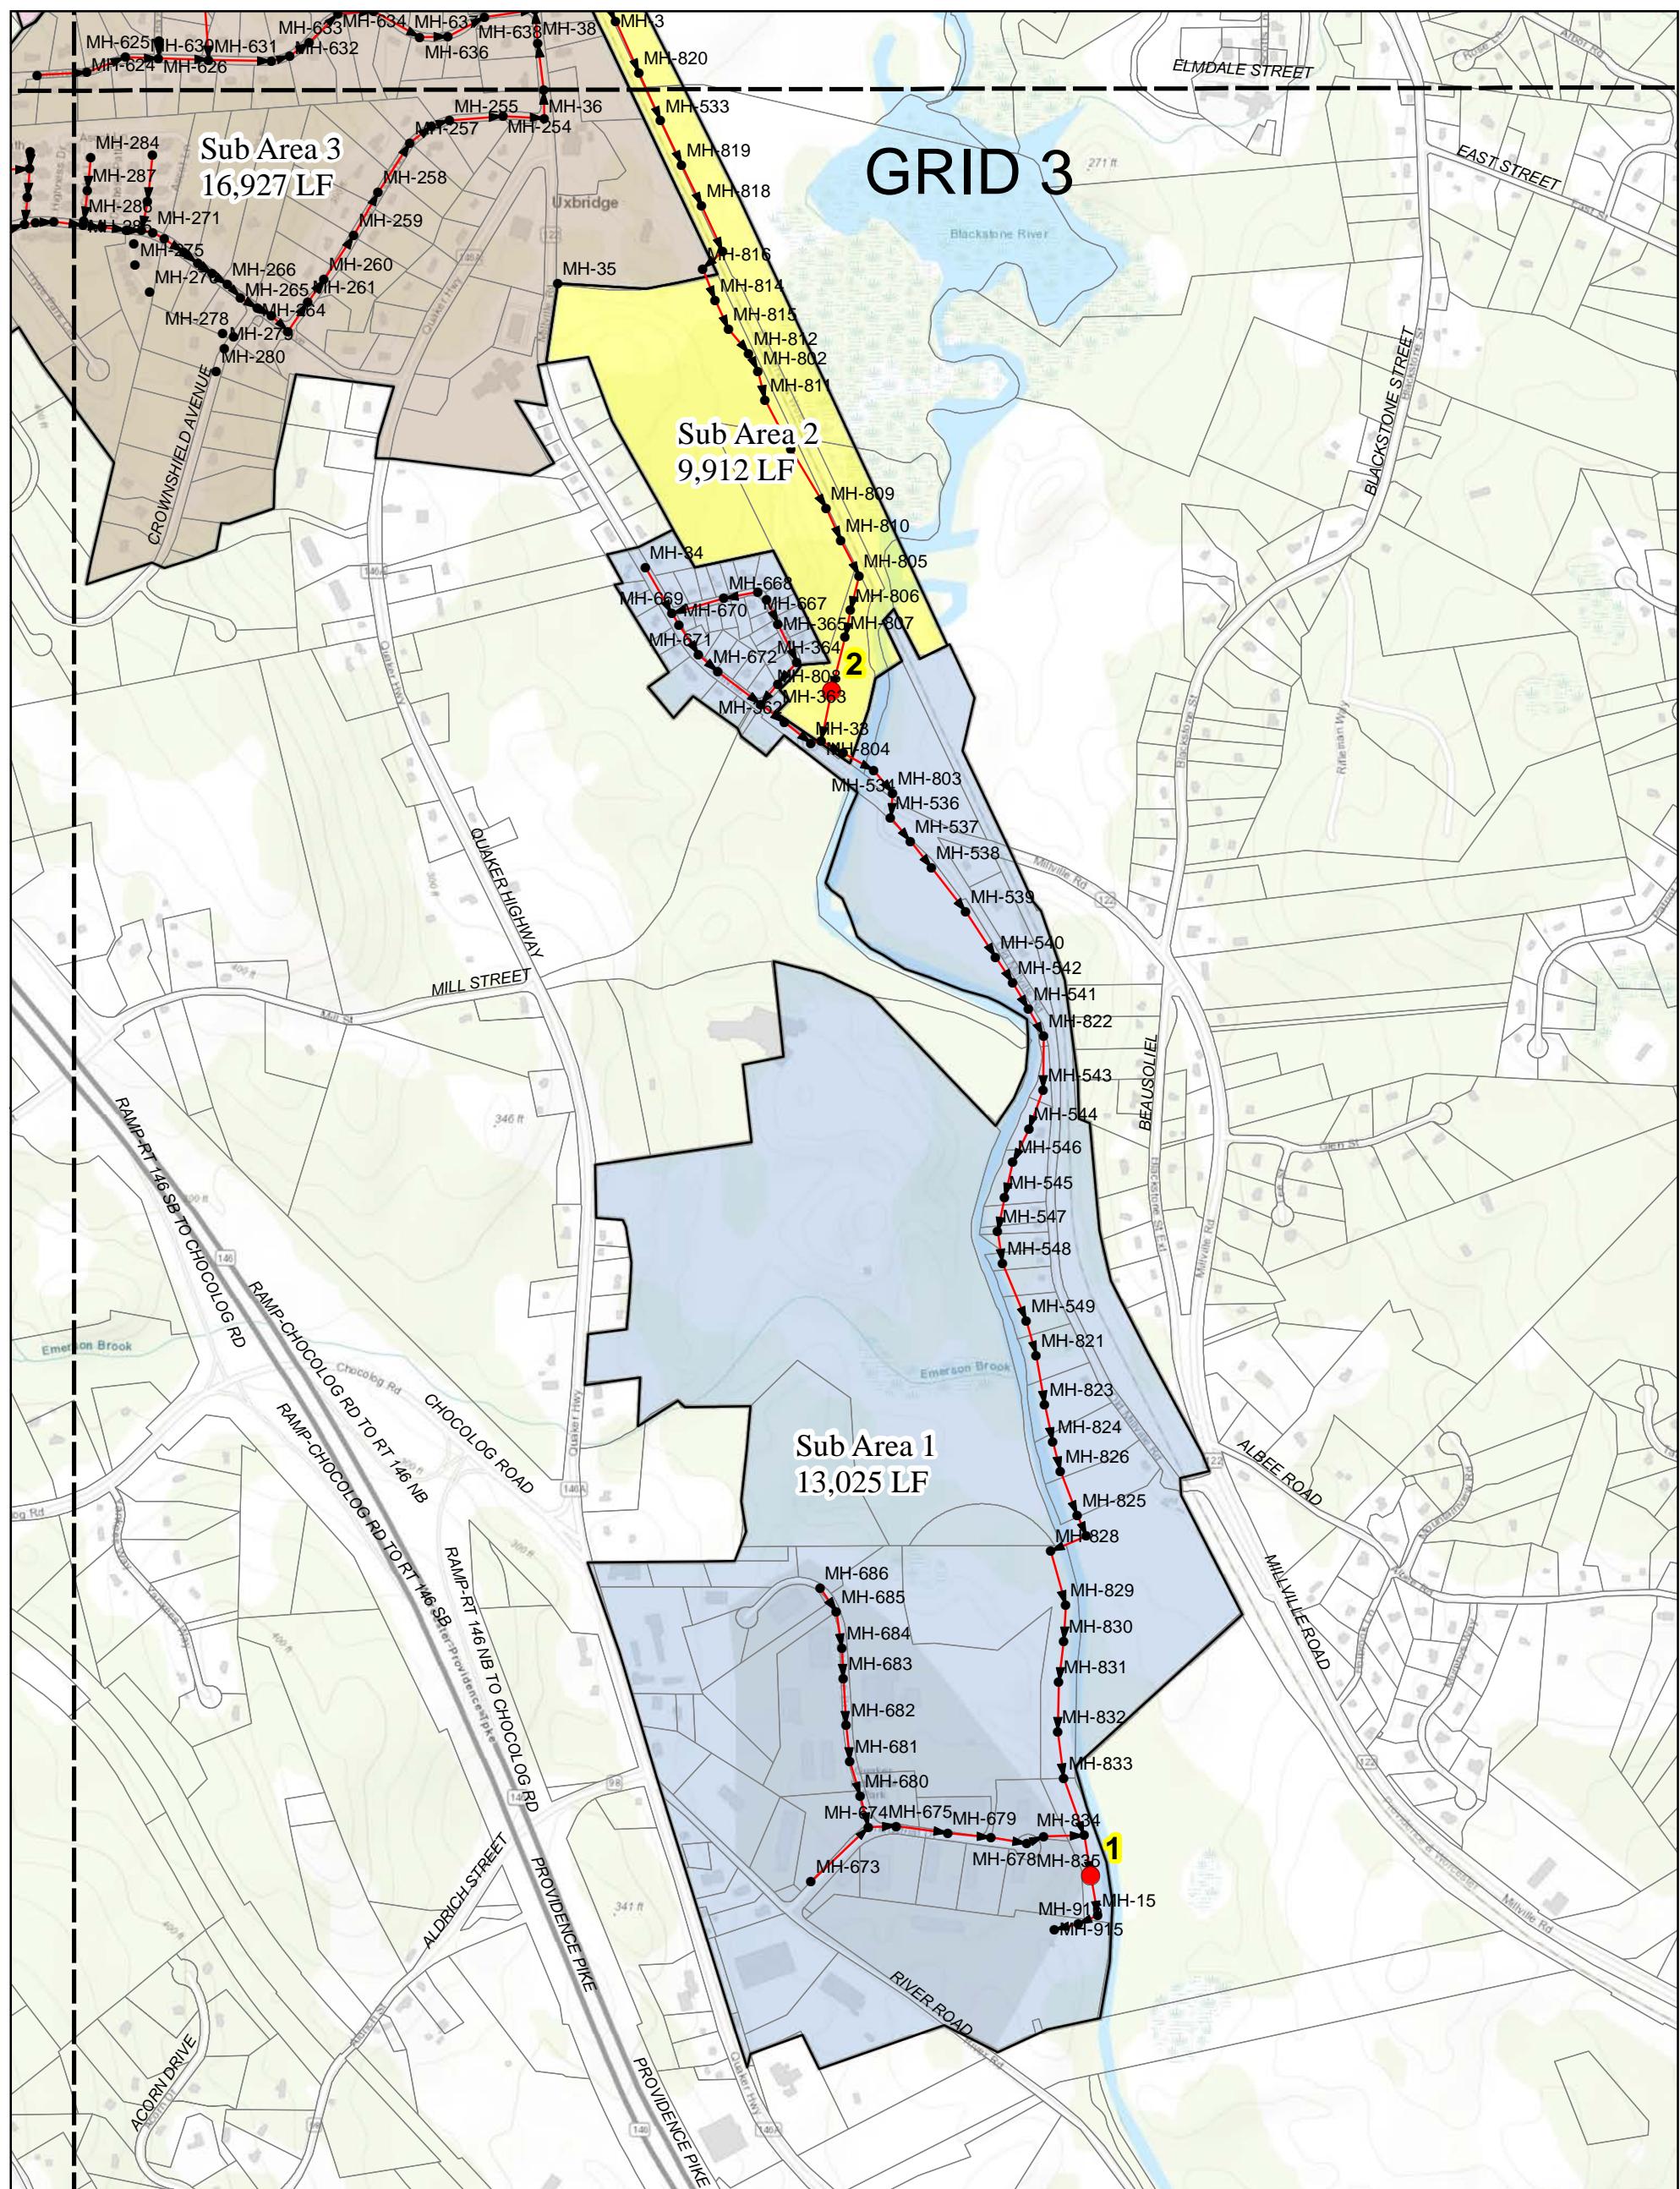
Figure 4

SUB AREA ,FLOW METER LOCATIONS & FLOW DIRECTION - GRID 3
