**MCCLOSKEY BUILDING  
MUNICIPAL CAMPUS**

# **McCloskey Building & Site Repurposing Study Final Report**

April 27, 2020

**Town of Uxbridge  
Uxbridge, MA 01569**

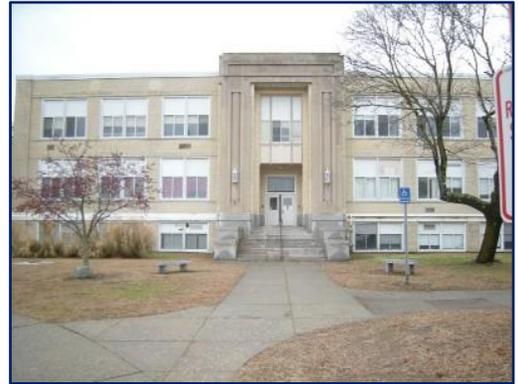
*Exterior of original 1936 High School building*

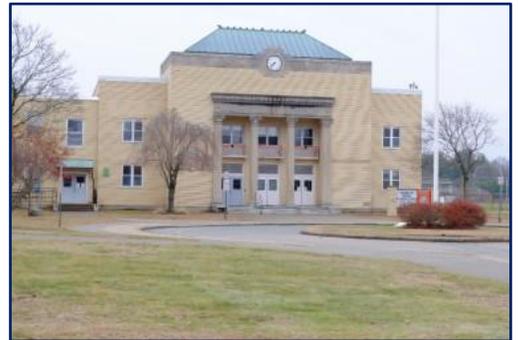
*Exterior of 1952 War Memorial Gym*

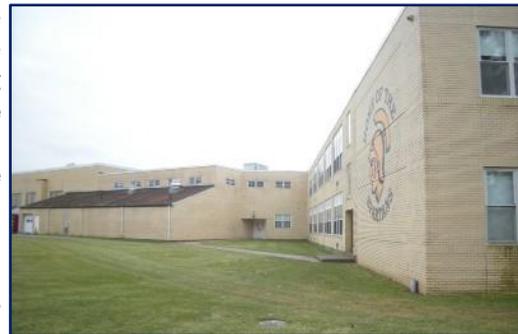
*View with 1952, 1988, and 1998 additions all visible*

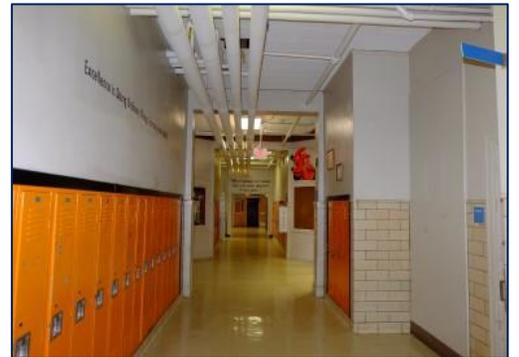
*Typical corridor at 1936 High School*

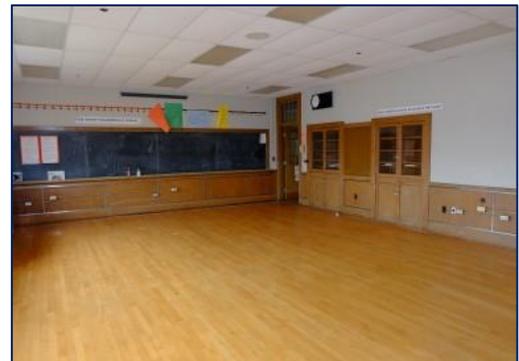
*Typical upper-level classroom at 1936 High School*

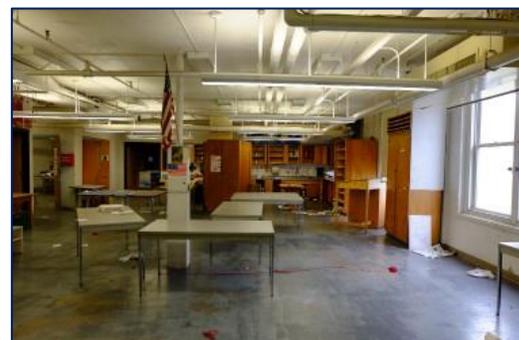
*Typical basement level classroom at 1936 High School*

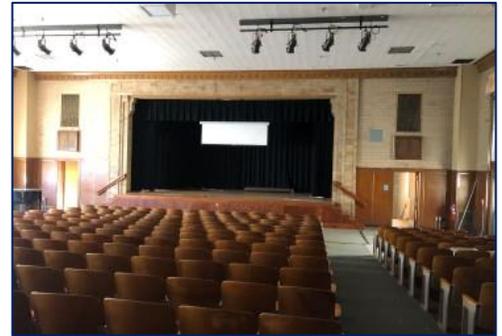
*Interior of 1936 Auditorium*

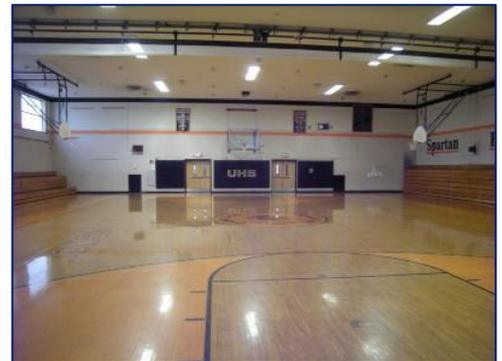
*Interior of 1952 War Memorial Gym*

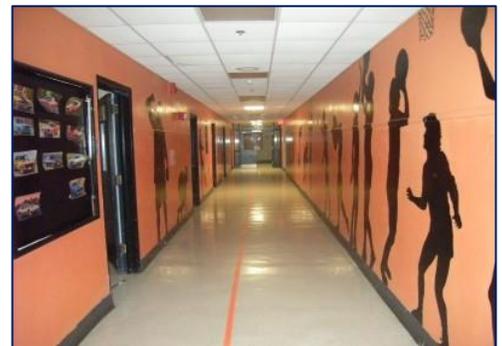
*Typical corridor at 1952 War Memorial Gym*

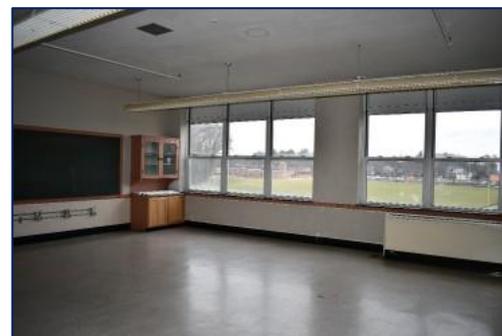
*Typical classroom at 1952 Junior High School*

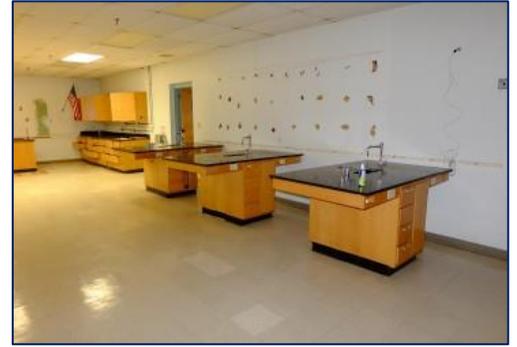
*Windowless classroom at 1988 addition*

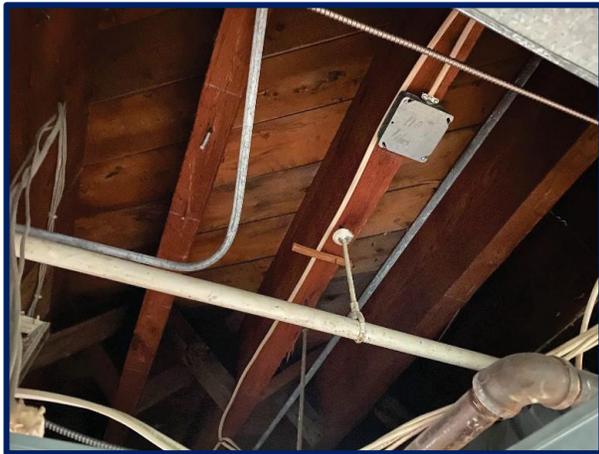
**Example Original Building Floor Framing**

Based on field observations and past building plans, the building appears to be a mix of construction types. The original buildings (Classroom, Auditorium & Gym) are classified as Type III construction based on the loadbearing masonry exterior wall construction and at least partial wood-framed interior construction. The additions are classified as Type IIB based on unprotected non-combustible structure.

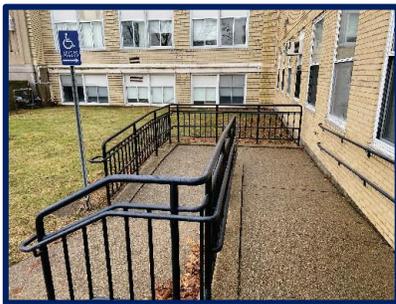
**Accessible Entrance**

The building has an existing accessible entrance, toilet rooms, and drinking fountains and therefore would comply if the renovation cost exceeds \$100,000 but is less than 30% of the building's assessed value.

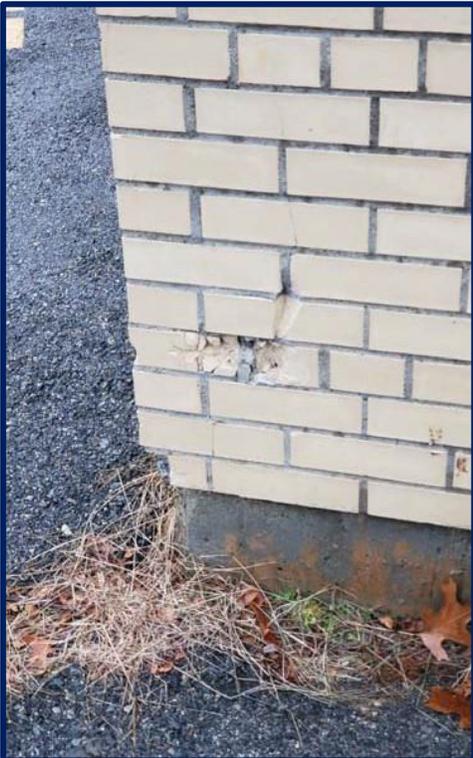
Photograph #13 – Cracking Caused by Corroded Lintels – Multiple Locations

- Some of the exterior window lintels are corroded. It appears that the corroded lintels have caused cracking to occur in the masonry at multiple locations (see photograph #13). The corroded lintels should be cleaned to remove all debris and surface corrosion in preparation for a new coat of paint.

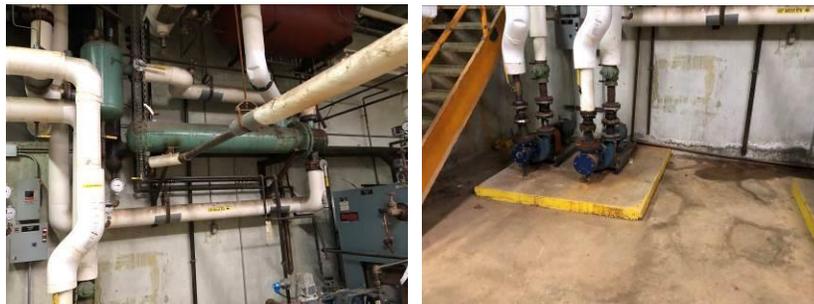
- e. A steam-to-hot water heat exchanger and duplex hot water pumps are provided in Boiler Room-032.
- f. Hot water pump P-6 is a Taco FE-2508 frame mounted end suction pump selected for 250 gpm and 60' Head.
- g. Hot water pump P-7 is a Taco FE-3008 frame mounted end suction pump selected for 400 gpm and 50' Head.
- h. Hot water pumps P-6 and P-7 were replaced in 1996 and are now 14 years old.

(L - Steam-to-Hot Water Heat Exchanger, R - Hot Water Pumps)

- m. To improve efficiency and address the antiquated steam system, recommendation is to replace the steam boilers and steam heating system with new high efficiency condensing boilers and a new hot water piping system.
- n. To improve efficiency and meet energy code requirements, new hot water pumps to be provided with variable frequency drives to create a variable pumping system.

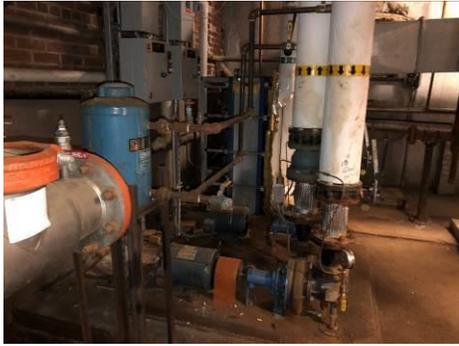
Hot Water Pumps P-1 and P-2

- i. A second hot water pumping system is located in Basement Level Mechanical Room-019 in the original 1936 building. The system consists of a steam-to-hot water heat exchanger and duplex hot water pumps.
- j. Hot water pumps P-1 and P-2 are Taco FE-2508 frame mounted end suction pump selected for 145 gpm and 75' Head.
- k. Hot water pumps P-1 and P-2 were installed in 1996 and are now 14 years old.
- l. The hot water pumping system serves 4-pipe unit ventilators in the classrooms.

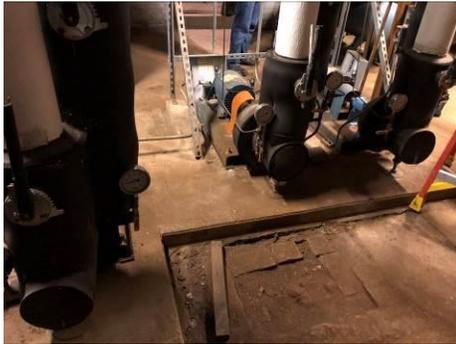
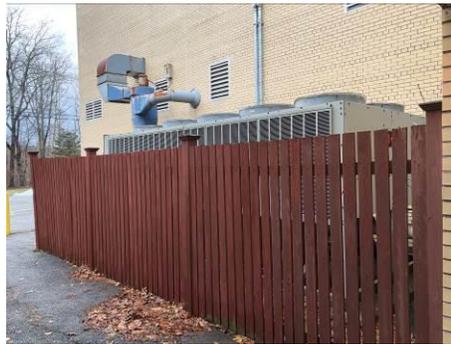
- a. The building is partially air conditioned. Cooling is provided to the First and Second Floor classrooms. The cooling plant consists of a 100-ton Trane air-cooled chiller located outdoors on grade and triplex chilled water pumps located in Basement Level Mechanical Room-019 in the original 1936 building.
- b. Chilled water pumps P-3, P-4 and P-5 are Taco Model FE-2510 frame mounted end suction pump selected for 220 gpm and 60' Head.
- c. The cooling plant was installed in 1996 and is now 14 years old.

(L - Air-Cooled Chiller, R - Triplex Chilled Water Pumps)

- d. To improve efficiency and meet energy code requirements, new chilled water pumps to be provided with variable frequency drives to create a variable pumping system.

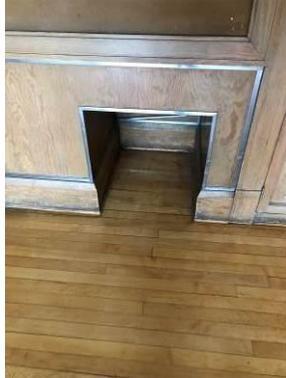
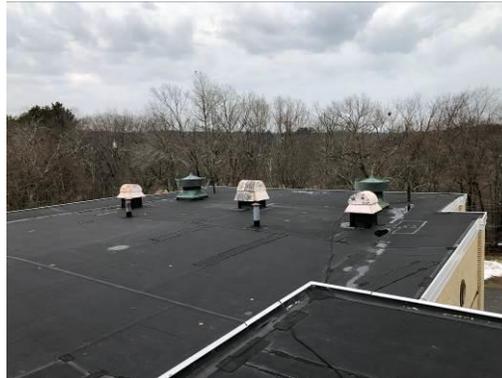
- e. Classroom air is exhausted through wall exhaust openings, vertical exhaust ducts and roof mounted exhaust fans.
- f. Roof exhaust fans are original and are now 84 years old (original 1936 building) and 58 years old (1952 Addition).

(L - Typical Classroom Exhaust Opening, R - Roof Exhaust Fans)

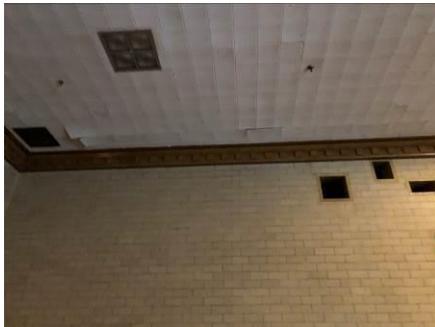
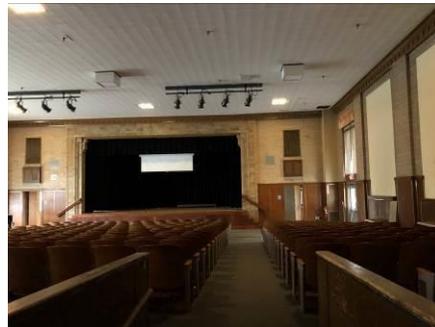
(L - Auditorium, R - Auditorium Ceiling and Wall Grilles)

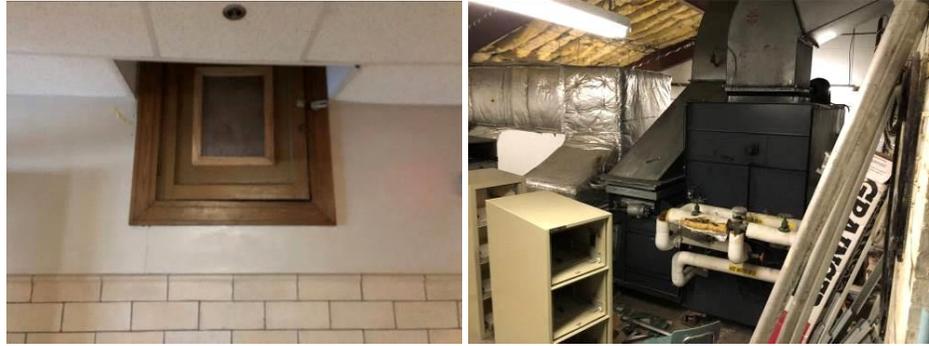
- b. The Auditorium HVAC system consists of a heating and ventilating unit located in a penthouse mechanical room above the stage. Access to the mechanical room is through a small wall access door.
- c. The heating and ventilating unit is a Trane central station air handling unit with a hot water heating coil and 3-way pneumatic automatic control valve.
- d. The heating and ventilating unit is assumed to be 58 years old.

- a. Supply ductwork is not insulated.
- b. The Auditorium is not air conditioned.

(L - Mechanical Room Access Door, R - Heating and Ventilating Unit)

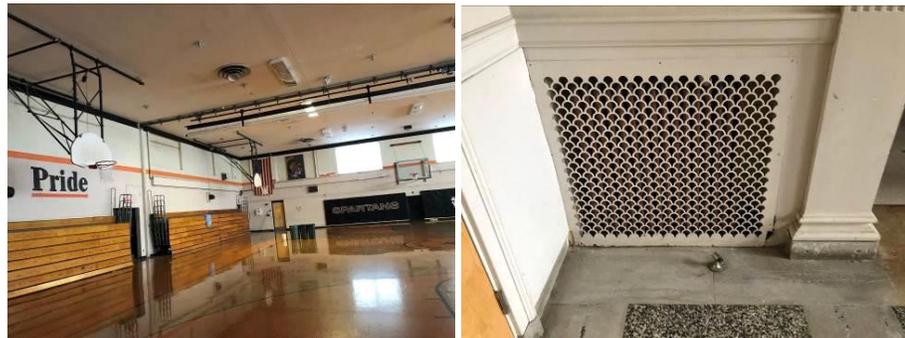
- a. The Gymnasium is located on the First Floor of the 1952 Addition.
- b. The Gymnasium HVAC system consists of two (2) heating and ventilating units located in the Attic space above. Supply and return ductwork run horizontally above the ceiling of the Gymnasium. Return air is via low return grilles.
- c. The heating and ventilating units are assumed to be 58 years old.
- d. Supply ductwork is not insulated.
- e. The Gymnasium is not air conditioned.

(L - Gymnasium, R - Low Gymnasium Return Grille)

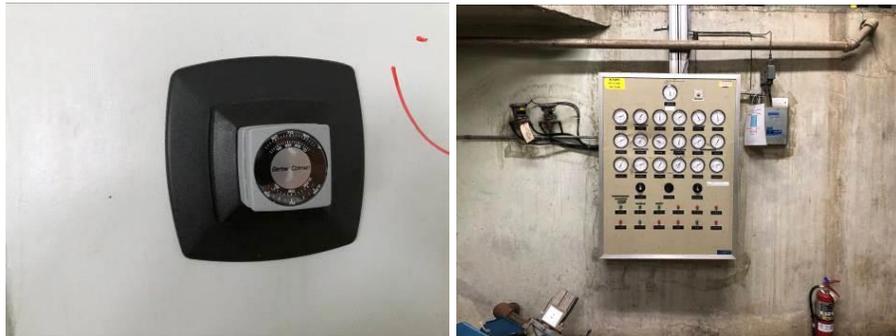
- a. Existing controls are original antiquated pneumatic controls.
- b. An air compressor serving the pneumatic control system is located in Basement Level Mechanical Room-019 in the original 1936

(L - Pneumatic Thermostat, R - Pneumatic Control Panel)

- c. Recommendation is to replace the entire pneumatic control system with a new DDC (Direct Digital Control) control system.

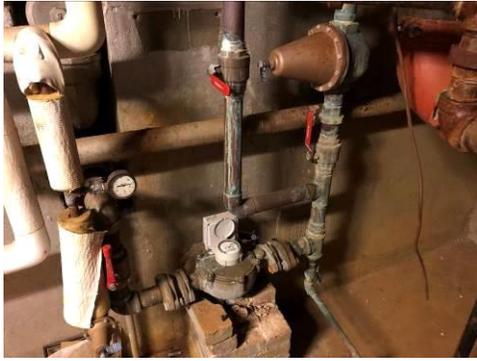
(L - Domestic Water Service, R - Handicap Accessible Plumbing Fixtures)

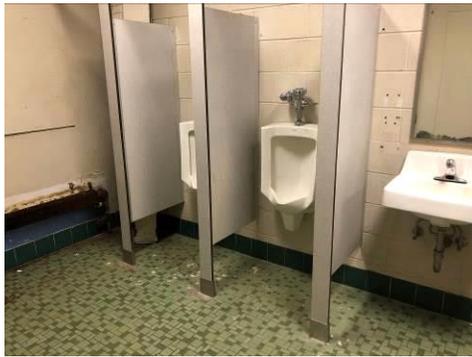
(L - Wall-hung Urinals, R - 2-compartment pot sink without interior grease trap)

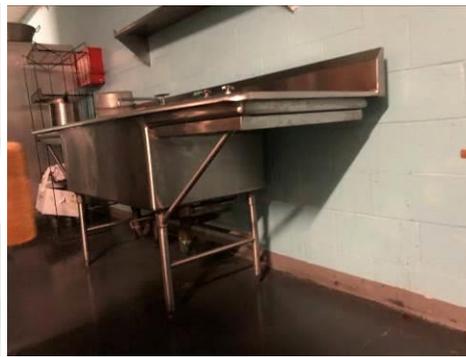
5. There are a number of roof leaks. One of the roof leaks is associated with a damaged glass acid vent-thru-roof.
6. In the Kitchen, an interior grease trap is missing from a 2-compartment pot sink.

1. Plumbing Recommendations are:
  - a. Repair the damaged glass acid VTR.
  - b. Install an interior grease trap at the Kitchen 2-compartment pot sink.
  - c. Replace all water, waste, vent, gas and rainwater leader piping that is over 50 years old with new.
  - d. Install a tempered water system(s) to serve the emergency eyewash/shower stations.

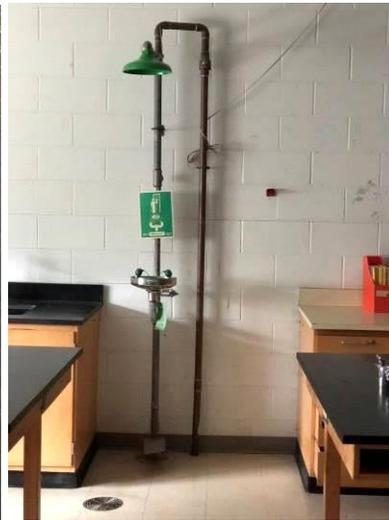
7. In Science Rooms, emergency eyewash/shower stations are fed from cold water (not tempered water).
8. Mechanical System Remaining Useful Life (as per BOMA):

(L - Roof Leak at Damaged Glass Acid VTR, R - Emergency Eyewash/Shower Station)

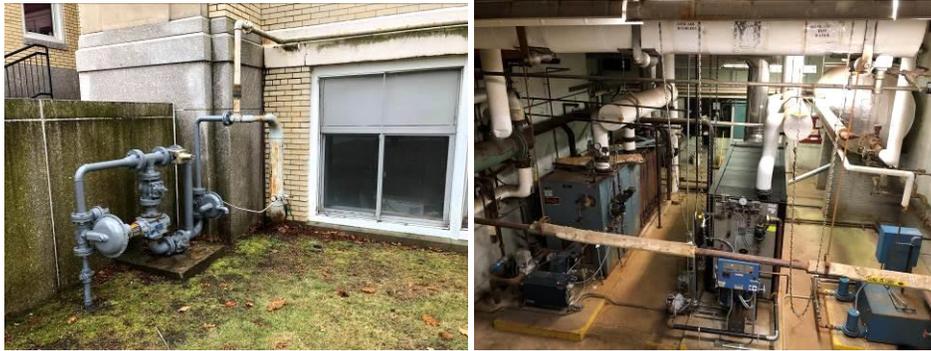
(L - Gas Service and Gas Meter, R - Horizontal Domestic HW Storage Tank)

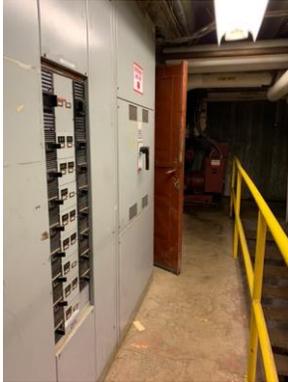
*Main Switchboard*

The main switchboard and most of the sub-panels appear old and in poor condition. The main board does not have proper clearance in the Boiler Room.

*The main service equipment installed appears to be original to the building and the equipment appears to be in poor condition. Replacement parts for this equipment are very difficult to purchase. It is evident that the equipment has not been maintained or tested over the years. At a minimum, the main distribution board and related breakers should have an infrared scan performed to ensure that the components are not deteriorating and are still capable of operating in the manner for which they were designed. The breakers should be cleaned and load tested for failure analysis. The grounds should be tested as well as the branch circuit conductors reviewed to ensure that they are still structurally sound. All connections should be tightened in accordance with manufacturer's recommendations. In accordance with the National Electric Code (NEC) Article 110.26, an electric service rated 1200 ampere and above is to have the capability of having two means of egress or be capable of allowing for a person to safely egress the room to avoid being trapped. Currently the room does not allow a minimum of three feet clearance in front of the board. It is recommended that the board and secondary feeder be replaced.*

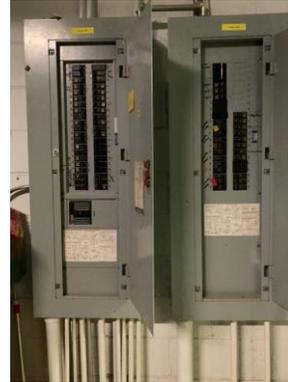
The panelboards located throughout the building provide power to lighting, receptacles, mechanical equipment and miscellaneous loads. Most panels appeared to be at capacity.

*Feeder Circuit Breakers Panels*

*The sub-panels throughout the building are a mixture of old to fairly new (1990's). It appears that panels and feeders are at their end of life cycle. At a minimum, all branch circuit panels should have an infrared scan performed to ensure that the components are not showing signs of overloading as well as deterioration. Each panel should be properly balanced per phase. It is recommended that the panels and associated feeders be replaced.*

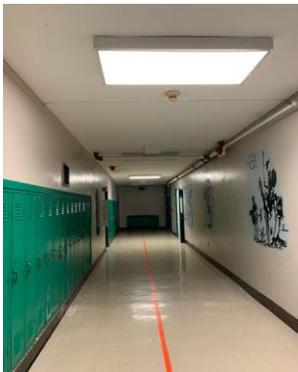
The lighting consists mostly of recessed-mount and surface-mount, 4-lamp, acrylic lens, fluorescent light fixtures. They appeared to be 32-watt T8 lamps installed. The fixtures throughout appeared to be in poor condition. Classrooms, Corridors and large public areas appeared to be poorly lit. The lighting does not meet the energy conservation code, as stipulated in Article 13 of the Massachusetts State Building Code, 8<sup>th</sup> Edition. Local wall mounted switches are used for lighting control. There is no occupancy sensor control observed. The corridor lighting is controlled with key switches at each end of the corridors. The Gymnasium lighting appeared to be fairly new. The lights consisted of surface 1'x4' – (6) T5 lamp fluorescent light fixtures. The lamps were protected with cages. The light fixtures were controlled via ceiling occupancy sensors and manual wall switches. The space appeared to be adequately lit.

*Corridor surface 4'x4' –  
4 lamp fluorescent light fixtures*

*The majority of the lighting throughout appears to be old and in poor condition in the building. Due to the age of the fixtures, they are showing signs of deterioration and will require maintenance or replacement. The lighting should be replaced with a more efficient lighting system which will properly illuminate the spaces, meet the energy conservation code as stipulated in Article 13 of the Massachusetts State Building Code 9<sup>th</sup> Edition and meet the standards of the Illuminating Engineering Society (IES). Incorporate occupancy/vacancy sensor controls in all applicable areas to automatically control the lighting during occupied and unoccupied times. Add photo-control sensor controls near perimeter windows for day-light harvesting. Replace all light fixtures with more energy efficient light fixtures to meet the energy conservation code, as stipulated in Article 13 of the Massachusetts State Building Code and the standards of the Illuminating Engineering Society (IES). If the light fixtures were to be replaced with LED energy efficient fixtures, then the power consumption would be reduced by at least fifty percent. It is recommended that all light fixtures and associated branch circuitry be replaced.*

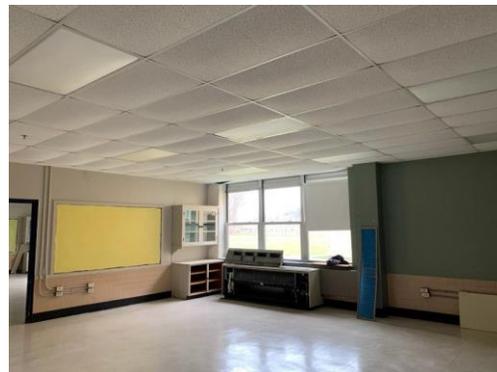
*Classroom recessed 2'x4' –  
4 lamp fluorescent lensed light fixtures*

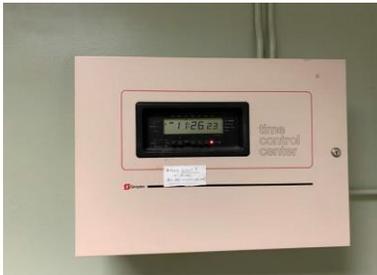
The clock system, manufactured by Simplex Company, with bell/chime features, is located at the main reception desk. Most of the clocks throughout the building have been removed. The main sound system has been removed from the building. Therefore, the systems are not operational.

*Clock Panel in Main Office Area*

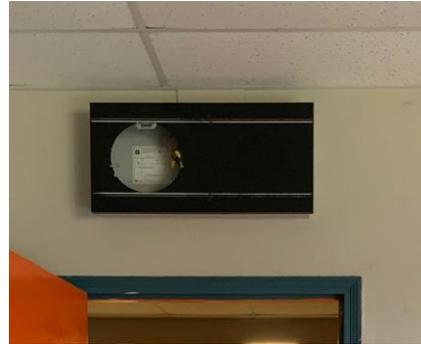
*Empty Chime/Clock Casing*

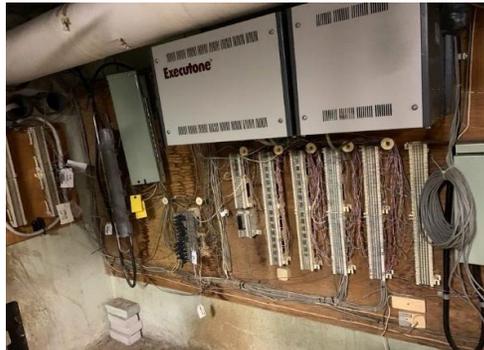
There is a Telecommunications Room located on the Second Floor of the 1980's addition . There are a minimum amount of devices in each classroom; it appears that most devices were added(surface-mount) during the 1980's and 1990's renovations. The components in the Telecommunications Room have been removed, therefore the system is not operational. The telephone system in the room behind the Boiler Room appears to be old and non-functioning.

*Telephone Punch-downs*
