TOWN OF UXBRIDGE

ADA SELF- EVALUATION AND TRANSITION PLAN

ADA SELF-EVALUATION AND TRANSITION PLAN

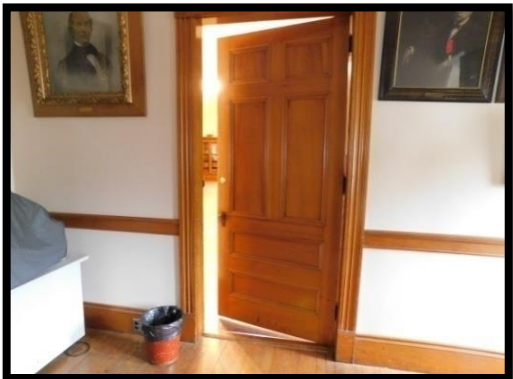
Photo: Public Library 6

(703 ADA Standards).				
Door Hardware							
See Photo Library 6							
Nine doors on the lower level, four doors on the main level, and six doors on the upper level have non-compliant knob-style hardware.	404.2	26.11	Replace the existing hardware with lever style that is operable with one hand, a closed fist, or loose grip. Lower the children's room door pull to no more than 48" a.f.f.	2	2	I	\$1,425
Lower Level Unisex Accessible Bathroom							
See Photo Library 7							
The sink piping is not wrapped, insulated, or guarded.	606.5	30.9.5	Wrap and/or insulate piping.	3	2	I	\$25
The door locking mechanism is 1" too high under the 2010 ADA Standards but falls within the allowed tolerance. The mechanism requires pinching and twisting of the wrist and more than 5 lbs. of force to operate.	309	39.5	Replace the locking mechanism with one that does not require pinching or twisting of the wrist and can be operated with a closed fist. The device should not require more than 5 lbs. to operate.	3	2	I	\$75

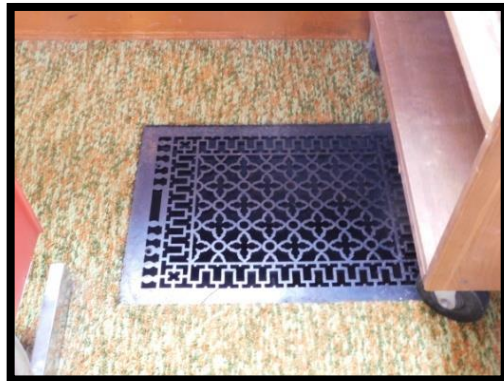
Photo: Public Library 10

room has only 24½” of knee clearance Lower level “children’s” tables have only 20” of knee clearance Lower level table near check-out counter has only 25½” of knee clearance							
Floor Grates							
See Photo Library 10							
Three floor grates have 1” square openings and two floor grates have varied openings with some up to 2+” in size. Grate openings cannot exceed ½” and must be perpendicular to the route of travel.	302.3	25.4	Replace or modify grates to comply with maximum ½” opening requirement.	4	3	N	Up to \$1,250
Card Catalogues							
See Photo Library 11							
The lower level and main card catalogue keyboards are 2” too high and the location of the mouse(s) are 4½” to 5” too high and lack knee clearance.	227 902	12.2	Relocate the card catalogues or provide an additional one which is no more than 34” a.f.f. with at least 27” knee clearance and has a depth of 19” with a 30” clear width.	2	1	I	Up to \$500

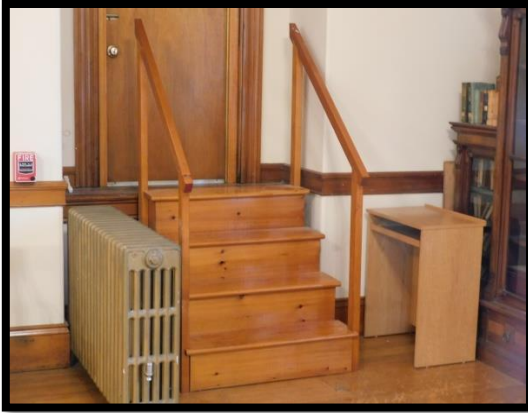
Photo: Public Library 19

Upper Level Stairs to Fire Exit							
See Photo Library 19							
The stairs to the fire exit in the assembly room lack compliant railings (shape, no extensions), have risers that are more than 7" high, and nosings that vary from ¾" to 1¼".	504 505	27	As these are "moveable" stairs that serve solely as a means of egress, seek a variance to retain the current stairs as "egress only in case of an emergency".	4	1	N	\$0
Main Level Bathroom							
See Photo Library 20							
The main level bathroom is wholly non-complaint with inadequate clearances for wheelchair	603 604 606	30	Option 1: Modify and expand the existing bathroom into a single user accessible toilet room to meet the 2010 ADA	3	4	L	Up to \$50k

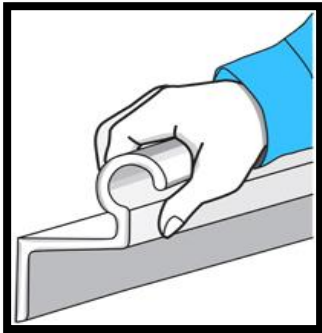
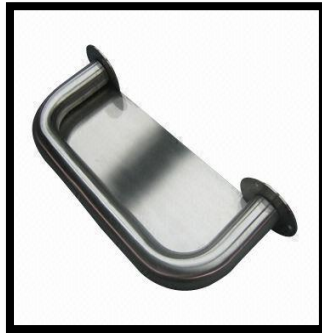
Both the 2010 ADA Standards (S. 604.5 Exception #3) 521 CMR (S. 15.8) provide exceptions for the requirement of grab bars in cells that are specifically designed without protrusions for purposes of suicide prevention. However, in recent years grab bars have been designed so they do not increase suicide risk. As shown, there are several ways for grab bars to be designed with adequate gripping surfaces, while ensuring that nothing can be tied onto them (see below). Consideration should be given to installing suicide proof grab bars in the accessible cell.

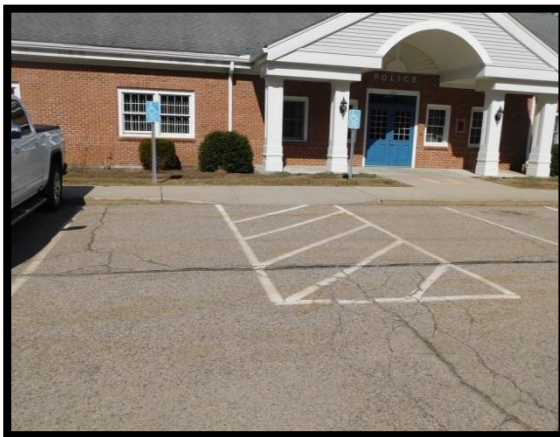
Photo: Police 1

Police Station Accessibility Assessment							
General Description of Obstacle	2010 ADAAG	MAAB 521 CMR	Type of Action to be Taken	P	F	TF	Cost Estimate
Main Entrance Parking							
See Photo Police 1							
Neither of the two accessible parking spaces are designated as van accessible. The existing signs are 5" to 7" too low.	502	23.6	Signage must be set such that the signage height should be a minimum of 60" high at the bottom (2010 ADAAG Standards) and a maximum of 96" at the top (MAAB 521 CMR) and located in front of the space. Provide a sign noting one space as van accessible.	1	2	I	\$25
Accessible Route to Main Entrance							
See Photo Police 2							
The transition from asphalt to the concrete curb ramp has an abrupt change in level surface of greater than 1/4".	303.2 303.3 403.4	21.4	Patch or modify to create a level surface.	1	2	I	\$25
The curb ramp has a running slope of up to 11.3% which exceeds the maximum allowed by 3.0%.	405.2 406.4 403.3	21.3 21.6 22.3	Reconstruct the curb ramp and walkway/accessible route to the building so the curb ramp running slope is no more than	1	3	N	Up to \$1,200

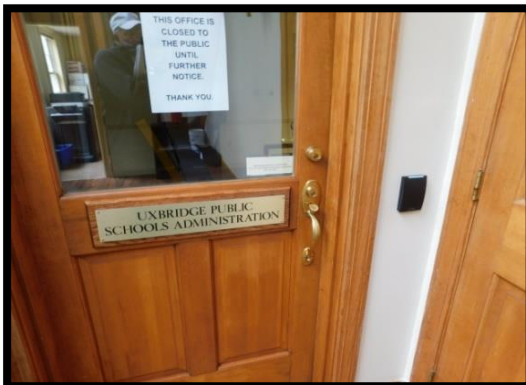
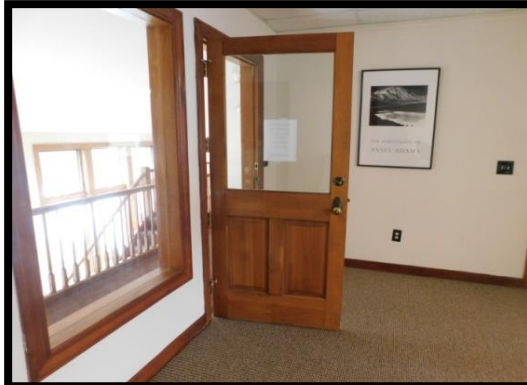
Door Hardware							
See Photos Cove 5 & 6							
Interior doors on both levels have non-compliant knob-style hardware. The main entrance door and 1 st level administrative door has hardware that requires pinching to open.	404.2	26.11	Replace the existing hardware with lever style that is operable with one hand, a closed fist, or loose grip.	1 2	2	N	Up to \$1,500

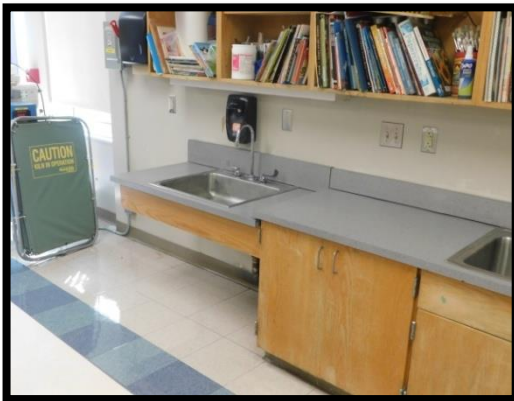
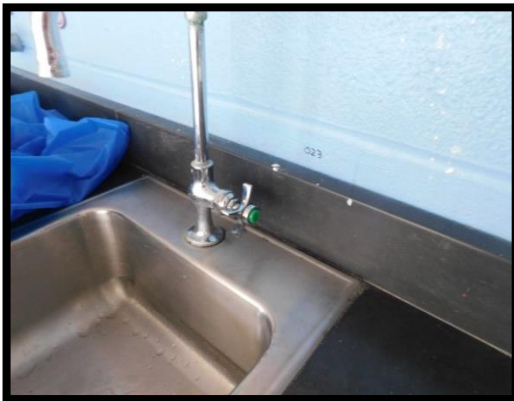
Photo: Whitin Elementary 15

Student Sinks							
See Photos Within 15 & 16							
Although classroom sinks are not specifically addressed in 521 CMR or the 2010 ADA Standards, there are specifications for children's sinks in general.	606	32 30.16	Modify the sink aprons so there is a minimum of 25" knee clearance.	2	3	N	\$150
The "accessible" music room (#111) and art room (#113) sinks lack sufficient knee clearance as the bottom of the sink apron is only 21" a.f.f.	606	32 30.16	Modify or replace the sink cabinet to create a minimum of 25" knee clearance.	2	3	N	\$350
The sinks in Room #110 lack knee clearance.	606 309	32 30.16 39.5	Modify or replace one sink cabinet in each room so that the top of the sink rim/counter is no more than 30" a.f.f with a minimum of 25" knee clearance. Replace the faucets in Room #101 so they are operable with one fist.	2	3	N	Up to \$1,200
Science Rooms #101 and 103 each have two (2) sinks that are 6" too high and lack knee clearance. In addition, the faucet hardware requires pinching and twisting of the wrist.

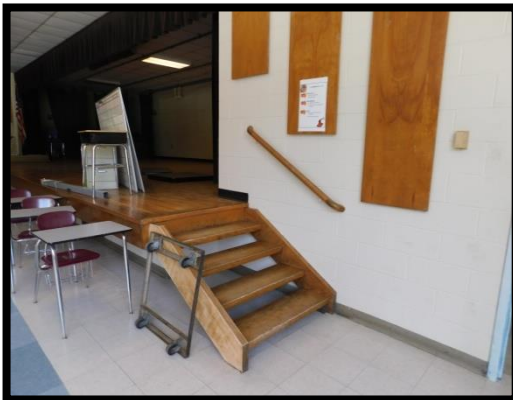
Photo: Whitin Elementary 23

The lift door at the stage opens into a curtain which obstructs the accessible route and the curtain gets caught in the door open closing.	403	22	Remove or relocate the curtain.	2	2	I	\$0
Stage Stairs from Cafeteria							
See Photo Within 23							
The two sets of stairs to the stage from the cafeteria floor have open risers; have a railing on only one side of the stairs and lack extensions on both the top and bottom of the stairs; and the existing railings are ¼” too wide.	504 505	27	Enclose the risers so they are not open. Replace the existing railings and replace with railings that are circular in x-section, are no more than 2” in outside diameter, and have extensions 12” parallel to the floor at the top and the slope distance of one tread then 12” parallel to the floor at the bottom.	2	3	N	Up to \$2,500+

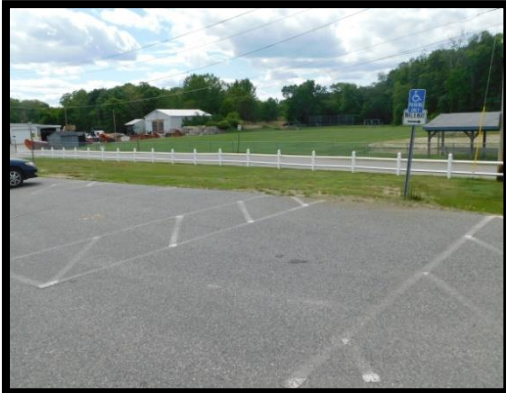
Photo: D'Alfonso Park 1

D'ALFONSO PARK ACCESSIBILITY ASSESSMENT							
General Description of Obstacle	2010 ADAAG	MAAB 521 CMR	Type of Action to be Taken	P	F	TF	Cost Estimate
Parking							
See Photo D'Alfonso Park 1							
The designated accessible parking (four spaces) lack compliant access aisles as they are too	502 703.7	23	Create a compliant van accessible parking space and three passenger vehicle accessible parking spaces. To accommodate both types of	1	2	N	Up to \$650

narrow and lack a designated van accessible space. The striping is worn and deteriorated. There is only one accessible sign for the four spaces.			spaces, stripe and designate a van accessible parking space and a passenger vehicle accessible space at widths of 8' with a shared 8' access aisle. The remaining two passenger vehicle spaces should be 8' wide with a 5' (shared) access aisle. Van accessible signage must be provided. Accessible designation signage must be set such that the signage height should be a minimum of 60" high at the bottom (2010 ADAAG Standards) and a maximum of 96" at the top (MAAB 521 CMR) and located in front of each space.				
--	--	--	--	--	--	--	--

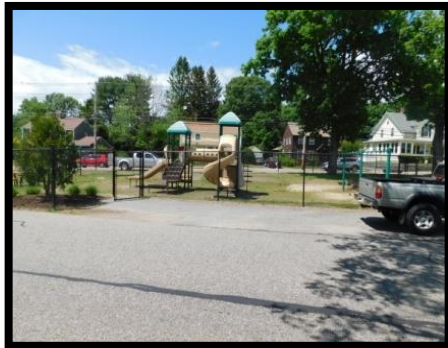
Photo: Wheelock Memorial 1

WHEELOCK MEMORIAL PARK ACCESSIBILITY ASSESSMENT							
General Description of Obstacle	2010 ADAAG	MAAB 521 CMR	Type of Action to be Taken	P	F	TF	Cost Estimate
Parking							
See Photo Wheelock Memorial 1							
There is no designated accessible parking.	502 703.7	23	Create a minimum of one van accessible space as follows: stripe and designate a van accessible parking space with van accessible signage. The van space s/b at a width of 8' with a 8' access aisle (parallel may be required due to lot configuration); signage must be set such that the signage height should be a minimum of 60" high at the bottom (2010 ADAAG Standards) and a maximum of 96" at the top (MAAB 521 CMR) and located	1	3	N	Up to \$100

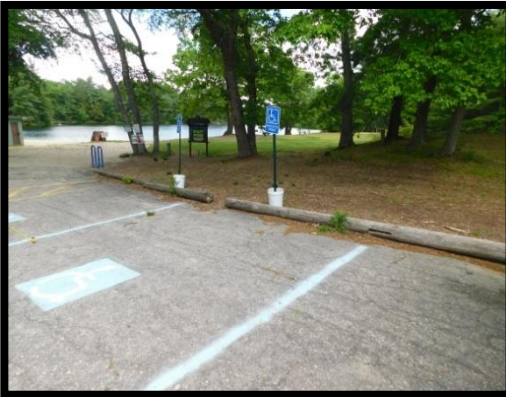
Photo: Pout Pond Beach 1

no access aisles. In addition, the surface is deteriorated and not level (heaving). No accessible route of travel exists to any of the elements and activities at the beach including the picnic tables, concession stand, bathrooms, beach area, benches, tent/pavilion, and swings. The bathrooms are wholly non-compliant as they lack adequate clear width into the facilities, lack grab bars, and have non-compliant sinks, water closets, dispensers, and other elements. The storage room doors and concession door lack tactile signage, have

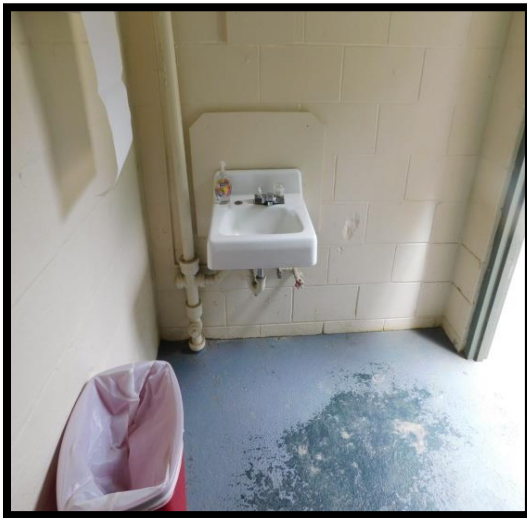
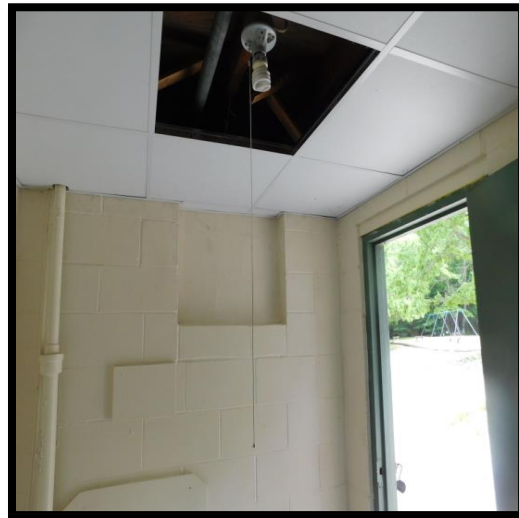
Men's and Women's Bathrooms							
See Photo Pout Pond Beach 7, 8 & 9							
The door entry clear width is 3" too narrow.	404.2.3	26.5	Modify openings and replace doors with a 36" wide door to achieve the minimum required clear width of 32".	3	3	N	Up to \$10K
The sink knee clearance is 1¼" to 2" too low.	306	30.9	Raise the sinks so the minimum required 27" knee clearance is achieved. The rim of the sinks cannot exceed 34" a.f.f.	3	3	N	Up to \$1,000
The light switches are on overhead pull strings that are at 6" to 14" too high and non-compliant.	308.2	6.5	Relocate light switches to no more than 48" a.f.f	3	3	N	Up to \$500

308.3	6.6		3	3		
The sink piping is not wrapped, guarded, or insulated.	606.5	30.9.5	Wrap or insulate piping.	3	2	N	\$100
The sink hardware is non-compliant as the faucets require pinching or twisting of the wrist.	309	30.9.6 39.5	Replace existing hardware with lever-style or self-metering faucets to comply with operable parts standards.	3	3	N	Up to \$350
The towel dispensers are 14" too high under 521 CMR.	308.2 308.3	30.12	Lower the dispensers to a max. of 42" a.f.f. (521 CMR) and within the zone of reach.	3	2	N	\$0
The coat hooks are 14½" to 15½" too high under the 2010 ADA Standards.	308.2 308.3	30.6	Lower the coat hooks to no more than 48" a.f.f.	3	2	N	\$0
The toilet paper dispensers are 0" to 2" o.c. from the front of the water closet and 29" to 30" a.f.f.	604.7	30.7.6	Toilet paper dispenser s/b 7" minimum and 9" maximum in front of the water closet measured to the centerline of the dispenser. The dispenser s/b a minimum of 24" a.f.f. and not mounted above the grab bars under 521 CMR and between 14" – 19" a.f.f under the 2010 ADA Standards. There should be a minimum of 1½" clearance under the grab bars.	3	2	N	\$0

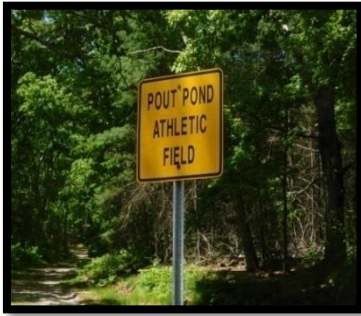
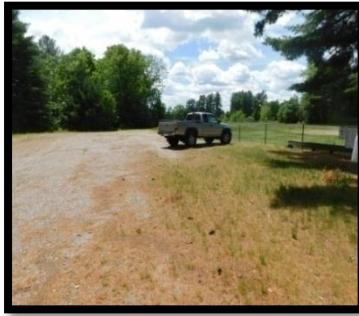
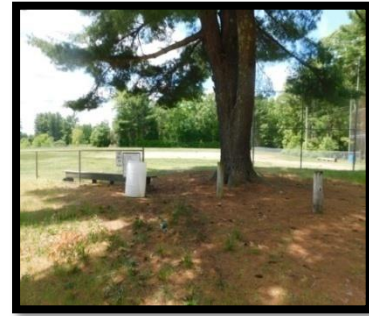
There is no designated accessible parking and no accessible route of travel to the ball field or benches.

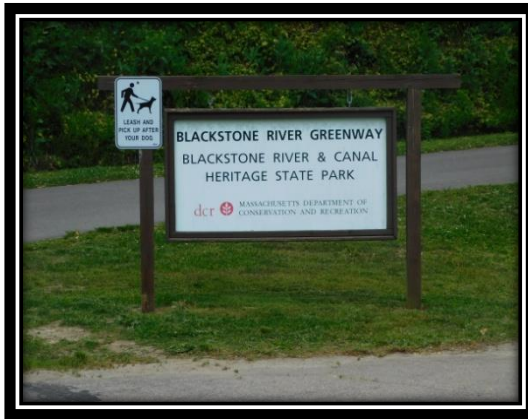
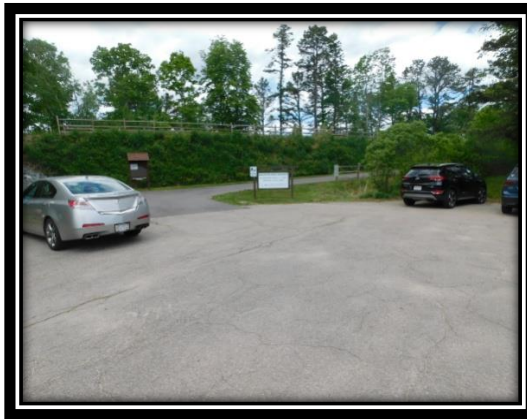
There are no designated accessible parking spaces at the parking area.

Rail Trail Accessibility Assessment							
General Description of Obstacle	2010 ADAAG	MAAB 521 CMR	Type of Action to be Taken	P	F	TF	Cost Estimate
Parking							
There is no designated accessible parking space inclusive of access aisle and signage. The designated accessible parking space must also be van accessible.	502	23.4 23.6	Stripe and designate a van accessible parking space with van accessible signage at a width of either 11' with a 5' access aisle or 8' with and 8' access aisle (2010 ADA Standards). Signage must be set such that the signage height should be a minimum of 60" high at the bottom (2010 ADAAG Standards) and a maximum of 96" at the top (MAAB 521 CMR) and	1	2	I	\$150

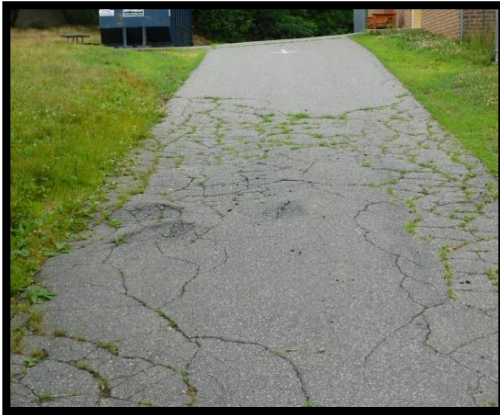
Photo: Whitten Recreational 1

Route of Travel to Basketball Court							
See Photo Whitin Recreation 1							
The running slope of the asphalt way to the basketball court has running slopes of up to 11.4% and cross slopes of up to 3.0%. The asphalt surface is deteriorated and heaving.	403 405	22 24	Option 1: Construct an accessible route/ramp to the basketball court. The accessible route may require the construction of a switch-back ramp system with railings in full compliance with S. 405 of the 2010 ADA Standards and S. 24 of 521 CMR. Option 2: Construct a new van accessible parking space with access aisle or designate and stripe an area on the existing asphalt near the basketball court	2	3	N	Up to \$15K

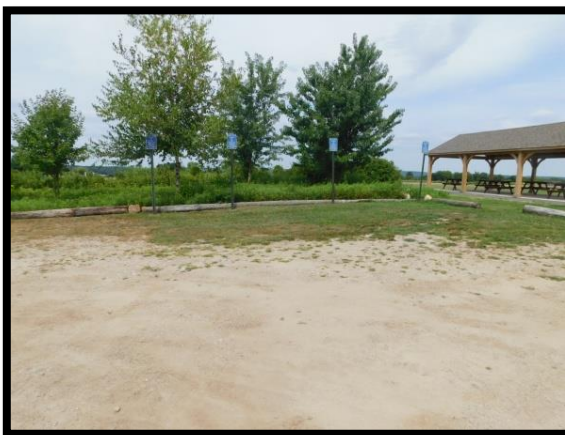
Photo: Sutton Street Fields 1

SUTTON STREET FIELDS ACCESSIBILITY ASSESSMENT							
General Description of Obstacle	2010 ADAAG	MAAB 521 CMR	Type of Action to be Taken	P	F	TF	Cost Estimate
Parking							
See Photo Sutton Street Fields 1							
The four designated “accessible” spaces are wholly non-compliant. Two signs are 2” too high. The parking is located on grass and on a sloped terrain. No formal striping exists.	208 502 703.7.2 302 206	23.0 20.0	Reconstruct parking to comply with slope requirements of no greater than 2.0% and surface requirements of uniform, hard packed or paved, and slip resistant. Provide striping for parking spaces and access aisles such that at least one is van accessible (11’ wide - 5’ access aisle or 8’ wide – 8’ access aisle) and the other 3 car accessible (8’ wide – 5’ access aisle). Provide signage (one must also include van) at a height of at least 60” a.f.f. to the sign bottom nor more than 96” to the sign top and no more than	1	3	I	Up to \$7,500

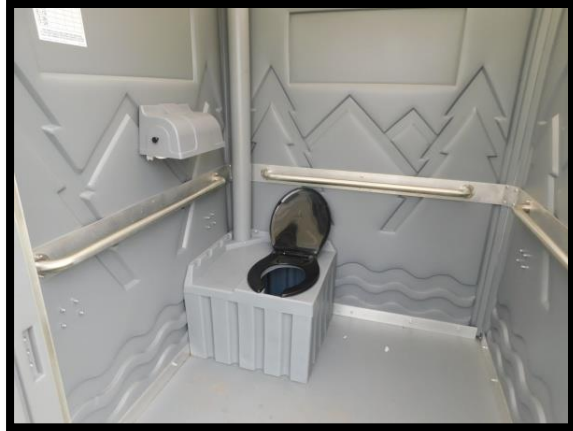
Photo: Sutton Street Fields 4

Portable Accessible Toilet							
See Photo Sutton Street Fields 4							
The “accessible” toilet is not ADA compliant as the door operating force exceeds 15 lbs. and has a closing speed of less than 6 seconds; the toilet paper dispenser is located over the grab bars and is 0” o.c. to the front of the toilet; the rear grab bar is 2” too far from the interior corner; the coat hook is 23” too high; and there is only 34” clearance in front of the toilet, which is 8” too short.	404 603 604 308.2 308.3	30 26.8 26.9	Replace the existing “accessible” toilet with an “ADA Compliant” toilet such that the toilet paper dispenser is a minimum of 24” a.f.f. and s/b 7” min. to 9” max. in front of the water closet measured to the centerline of the dispenser and not over the grab bars; the water closet s/b 42” from the front of the water closet to the nearest wall or fixture; the coat hook s/b no more than 48” a.f.f.; the rear grab bar s/b no more than 6” from the interior corner; and the door operating force should not exceed 15 lbs and should take at least 6 seconds to close.	3	2	I	TBD

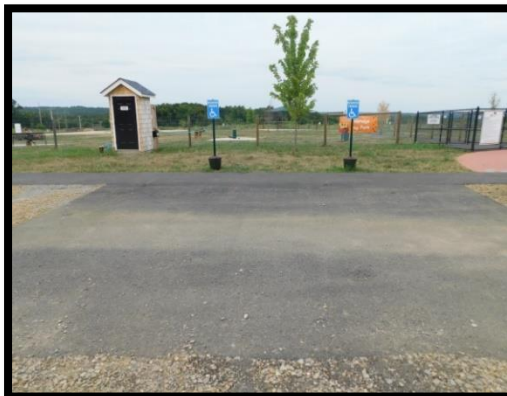
Photo: Dog Park 1

UXBRIDGE DOG PARK ACCESSIBILITY ASSESSMENT							
General Description of Obstacle	2010 ADAAG	MAAB 521 CMR	Type of Action to be Taken	P	F	TF	Cost Estimate
Parking							
See Photo Dog Park 1							
The designated “accessible” parking lacks striping for the spaces and parking. There is no designated van accessible space. The signage is 7½” to 8” too low and is not permanently mounted.	208 502 703.7.2	23.0	Provide striping for the parking spaces and access aisles such that at least one is van accessible (11’ wide - 5’ access aisle or 8’ wide – 8’ access aisle) and the other 3 car accessible (8’ wide – 5’ access aisle). Provide permanent signage (one must also include van) at a height	1	2	I	\$150

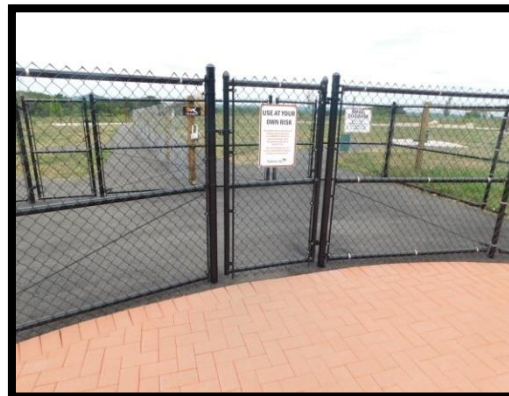
Photo: Dog Park 2

of at least 60" a.f.f. to the sign bottom nor more than 96" to the sign top and no more than 10' in front of the space.				
Chain Link Gates							
See Photo Dog Park 2							
The chain link gates (3) to the dog park do not comply with the 2010 ADA Standards for a smooth surface within 10 inches of the ground on the push side for the full width of the gate.	404.2	NA	Remove gates or install smooth plating at the base of gate.	1	2	I	\$200
The opening/closing latches for the 3 gates to the park(s) can be opened with a loose grip or closed fist but cannot be closed without pinching and twisting of the wrist.	404.2 309.4	26.11 39.5	Adjust latch so it can be closed with one fist or replace the latch mechanisms.	1	2	I	\$0 to \$300
Accessible Route							
No accessible route exists to the shed building containing the first aid kit and miscellaneous items for use in the park(s).	303 402 403	20 22	An accessible route of travel needs to be provided to the building. Construct an accessible route compliant with width (48" per 521 CMR) and slope (2% max. cross, 5% max. running) requirements. There should be no greater than a ¼" change in level surface along the route. Construction options include compacted stone dust, asphalt or similar surfaces that meet the requirement of stable, firm, and slip resistant with no abrupt changes in level surface. Costs will vary depending on material used.	2	3	N	\$250 to \$500

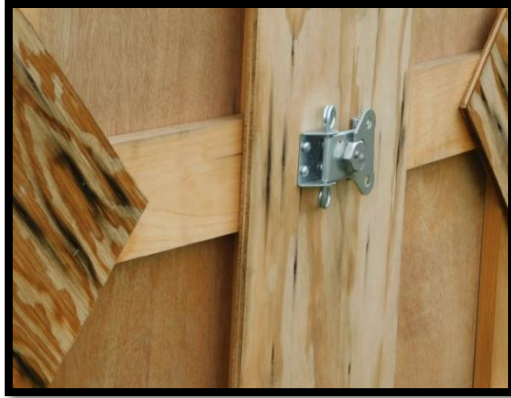
Photo: Dog Park 3

Storage Shed							
See Photo Dog Park 3							
The storage shed adjacent to the pump building has hardware/latches that require twisting of the wrist and are not operable with a closed fist. Two of the three latches are not within the acceptable reach range.	404.2 309.4 308.2 308.3	26.11 39.5 6.5 6.6	Replace the hardware/latches with ones that can be operated with one fist and which does not require pinching or twisting of the wrist. The hardware/latches should be between 15" to 48" a.f.f.	2	2	I	\$50
Benches							
See Photo Dog Park 4							
The two single benches in both the large dog park and the small dog park have only 24" wide x 36" deep space for an adjacent wheelchair.	802.1	14.0	Construct at a minimum a 36" wide x 48" deep wheelchair area with compliant slope requirements (no more than 2% slopes in any direction) next to each single bench in both the large and small dog parks (4 areas total). The wheelchair areas must be on an accessible route.	2	3	N	Up to \$800

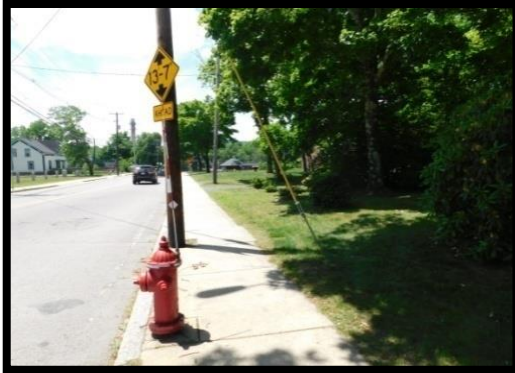
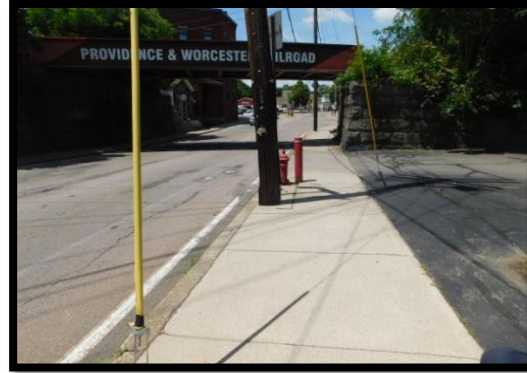
<p>severely deteriorated. .</p> <p>The crosswalk across Mendon Street at Mendon/Oak Streets near St. Mary's Church lacks a level landing on the south side of Mendon Street (at St. Mary's Church). Both sides have excessive accumulation of debris at the base of the curb ramp making it difficult for wheelchair users.</p> <p>The guy wires near #60/62 Mendon Street, near #2 Capron Street/Farnum House, and near Brothers Liquors (2) have restricted headroom. The guy wires should be reconfigured to eliminate the headroom obstruction.</p> <p>The curb ramp position and cross walk striping are awkwardly placed such that curb ramp is directed to Mendon Street not across Capron Street and the cross walk is at a severe angle across Capron Street. The curb ramp at 2 Capron Street (north side) is not level and is only 3' wide.</p> <p>The crosswalk across Mendon Street at Mendon/North-South Main Streets near Honey Farms lacks a level landing.</p>	<p>Sidewalks 13</p> <p>See Photo</p> <p>Sidewalks 14</p> <p>See Photos</p> <p>Sidewalks 15 & 16</p> <p>See Photo</p> <p>Sidewalks 17</p>

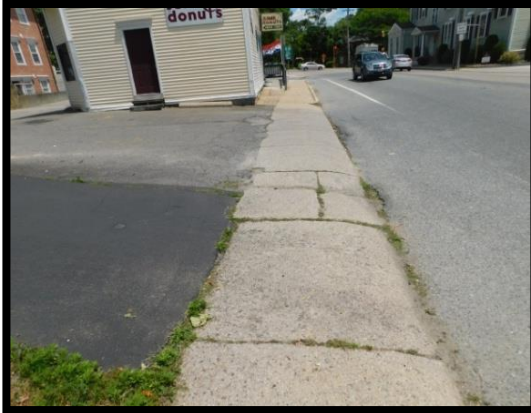
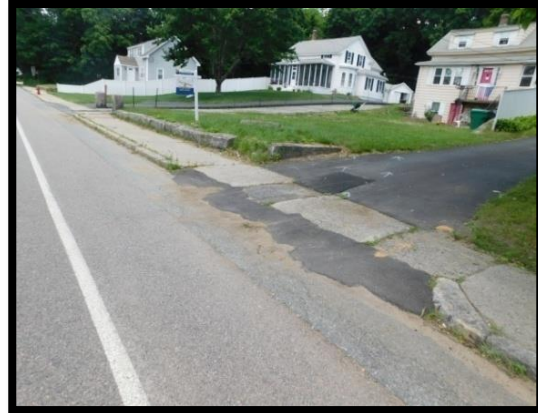
Douglas Street	
<p>The crosswalk across Douglas Street at Douglas/North Main Streets lacks a compliant level landing on the Town Common as it has an excessive slope and is only 3' wide. The level landing on the Saver's Bank side (south side) is only 3' wide which is 1' too narrow.</p> <p>The Douglas Street concrete sidewalks in the vicinity of Jumbo Donuts and going west to #23 Douglas Street and beyond are in extremely deteriorated condition with cracking, heaving, abrupt changes in level surface, missing concrete and inadequate level clear width (less than 36").</p> <p>The crosswalk across Carney Street lacks both curb ramps and detectable warning strips on both sides. The westerly side has a running slope of up to 22.0% with abrupt changes in level surface of 1"+. The easterly side has running slopes of up to 9.9% with a 3"+ "gap" to the sidewalk.</p>	<p>See Photos</p> <p>Sidewalks 21 & 22</p> <p>See Photos</p> <p>Sidewalks 23, 24 & 25</p>
