McCloskey Building & Site Repurposing Study Town of Uxbridge, MA

Final Report

April 27, 2020

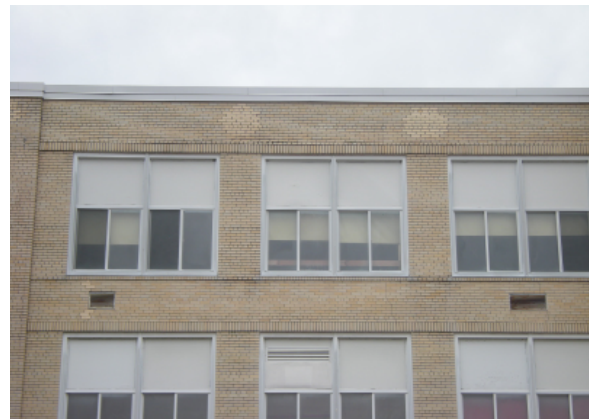
About half of the original window openings in the 1936 High School were blocked in as part of the 1989 addition. The remaining window openings are generous and provide excellent natural light. The windows are a mix of replacement aluminum double hung and slider units. The windows have either double pane insulated glazing or fixed spandrel panels. A number of windows have louvers or vents inserted in the spandrel panels. Many windows were observed with broken glazing seals and almost all of the windows appear to be at or near the end of their service life. It is unknown if the aluminum-framed windows are thermally broken. Given the assumed poor thermal performance and the condition of the existing windows, their replacement should be included in any future renovation plans.

Replacement windows at 1936 High School

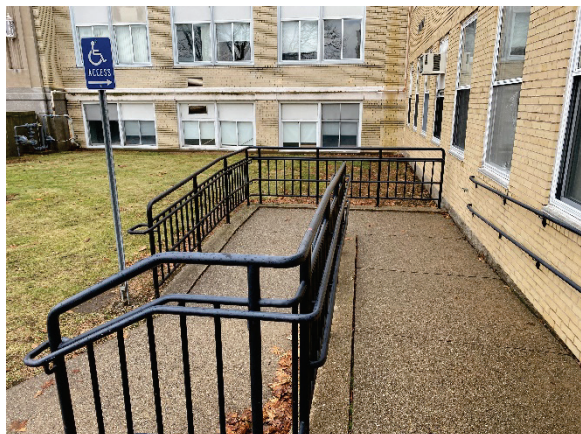
Accessible Entrance

The building has an accessible entrance, however all entrances are not accessible (i.e. the main entrance to the original building and direct entrances into the Auditorium and Gymnasium are not accessible).

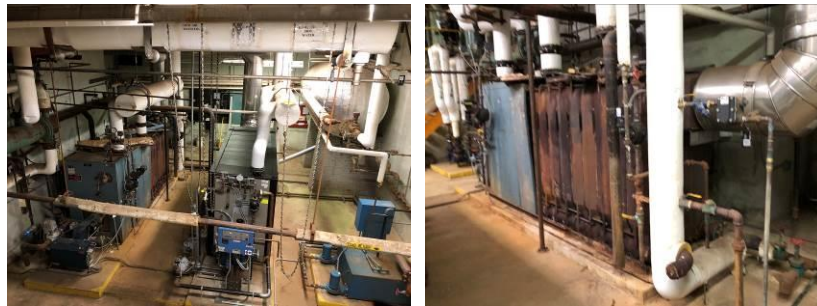
- a. The boiler plant is located in the Basement Level Boiler Room-032 in the 1952 Addition and consists of two (2) gas-fired steam boilers and provides heating to the entire building.
- b. Boiler B-1 is a Smith cast iron sectional boiler with 4,283 mbh heating capacity. The cover for boiler B-1 has been removed and not replaced suggesting sections may have been leaking.
- c. Boiler B-2 is a Weil-McLain Model 1688 cast iron sectional boiler with 4,283 mbh heating capacity.
- d. Boilers were replaced in 1996 and are now 14 years old.

(L - Steam Boilers B-1 and B-2, R - B-1 cover removed)

- m. To improve efficiency and address the antiquated steam system, recommendation is to replace the steam boilers and steam heating system with new high efficiency condensing boilers and a new hot water piping system.
- n. To improve efficiency and meet energy code requirements, new hot water pumps to be provided with variable frequency drives to create a variable pumping system.

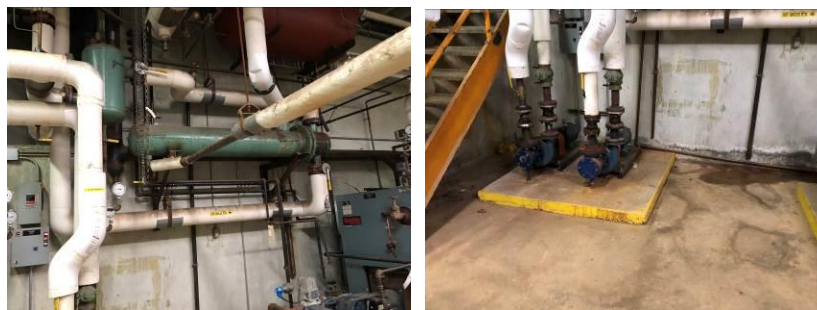
- e. A steam-to-hot water heat exchanger and duplex hot water pumps are provided in Boiler Room-032.
- f. Hot water pump P-6 is a Taco FE-2508 frame mounted end suction pump selected for 250 gpm and 60' Head.
- g. Hot water pump P-7 is a Taco FE-3008 frame mounted end suction pump selected for 400 gpm and 50' Head.
- h. Hot water pumps P-6 and P-7 were replaced in 1996 and are now 14 years old.

(L - Steam-to-Hot Water Heat Exchanger, R - Hot Water Pumps)

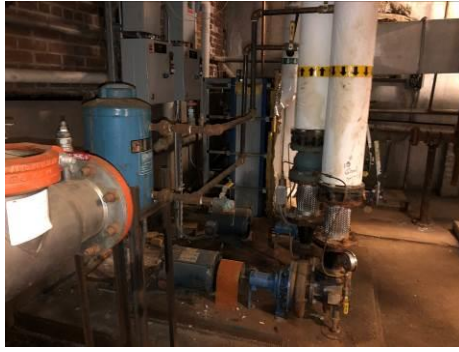
Hot Water Pumps P-1 and P-2

- i. A second hot water pumping system is located in Basement Level Mechanical Room-019 in the original 1936 building. The system consists of a steam-to-hot water heat exchanger and duplex hot water pumps.
- j. Hot water pumps P-1 and P-2 are Taco FE-2508 frame mounted end suction pump selected for 145 gpm and 75' Head.
- k. Hot water pumps P-1 and P-2 were installed in 1996 and are now 14 years old.
- l. The hot water pumping system serves 4-pipe unit ventilators in the classrooms.

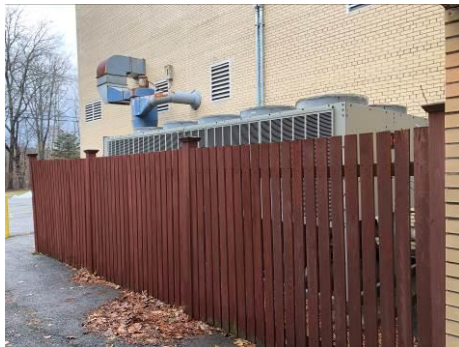
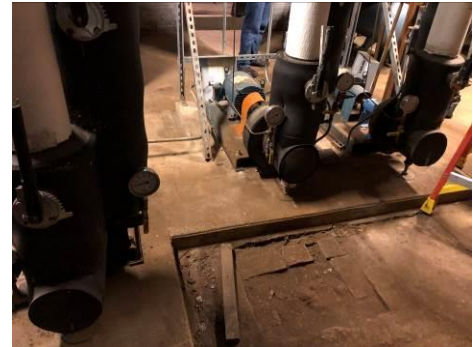
- a. The building is partially air conditioned. Cooling is provided to the First and Second Floor classrooms. The cooling plant consists of a 100-ton Trane air-cooled chiller located outdoors on grade and triplex chilled water pumps located in Basement Level Mechanical Room-019 in the original 1936 building.
- b. Chilled water pumps P-3, P-4 and P-5 are Taco Model FE-2510 frame mounted end suction pump selected for 220 gpm and 60' Head.
- c. The cooling plant was installed in 1996 and is now 14 years old.

(L - Air-Cooled Chiller, R - Triplex Chilled Water Pumps)

- d. To improve efficiency and meet energy code requirements, new chilled water pumps to be provided with variable frequency drives to create a variable pumping system.

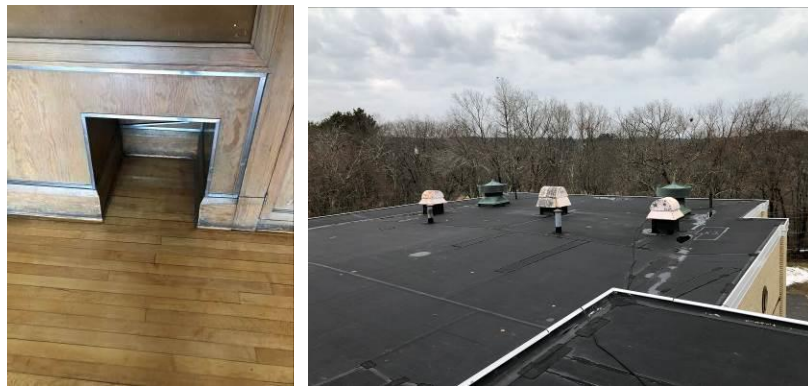
- e. Classroom air is exhausted through wall exhaust openings, vertical exhaust ducts and roof mounted exhaust fans.
- f. Roof exhaust fans are original and are now 84 years old (original 1936 building) and 58 years old (1952 Addition).

(L - Typical Classroom Exhaust Opening, R - Roof Exhaust Fans)

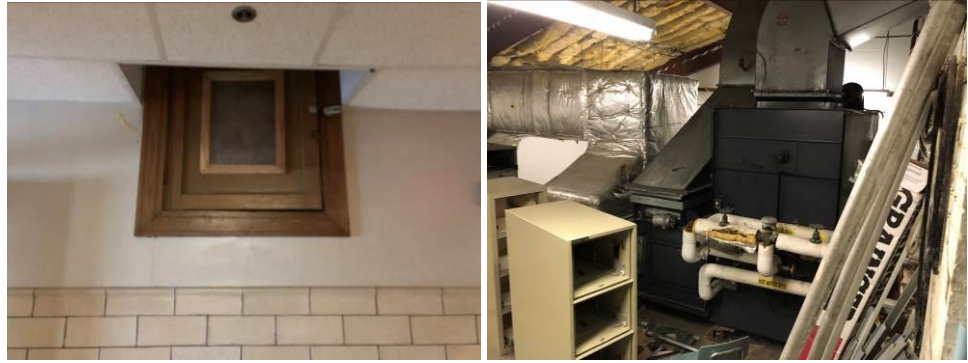
- b. The Auditorium HVAC system consists of a heating and ventilating unit located in a penthouse mechanical room above the stage. Access to the mechanical room is through a small wall access door.
- c. The heating and ventilating unit is a Trane central station air handling unit with a hot water heating coil and 3-way pneumatic automatic control valve.
- d. The heating and ventilating unit is assumed to be 58 years old.

- e. Supply ductwork is not insulated.
- f. The Auditorium is not air conditioned.

(L - Mechanical Room Access Door, R - Heating and Ventilating Unit)

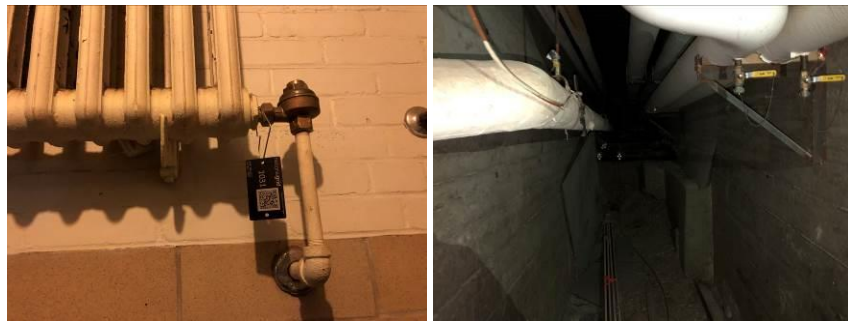
- a. Low pressure steam supply and condensate return piping run horizontally in pipe tunnels beneath the building.
- b. The original steam heating system piping are now 84 years old.

(L - Steam Radiator and Steam Trap, R - Steam Pipe Tunnel)

- c. Recommendation is to replace all steam system piping throughout with new hot water pipe mains from a new hot water heating plant.

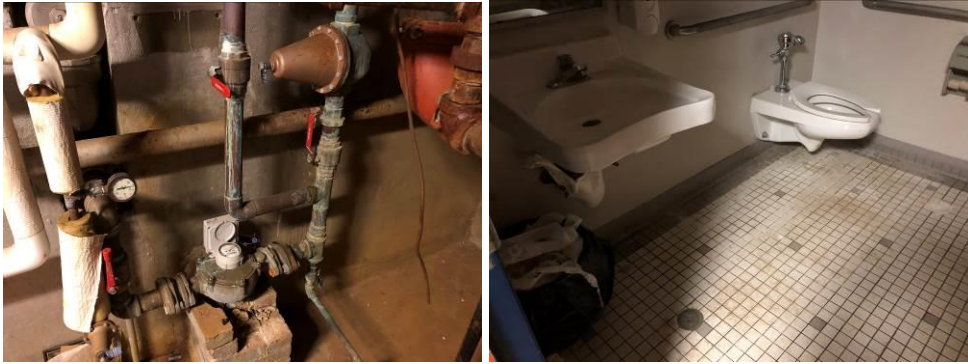
(L - Domestic Water Service, R - Handicap Accessible Plumbing Fixtures)

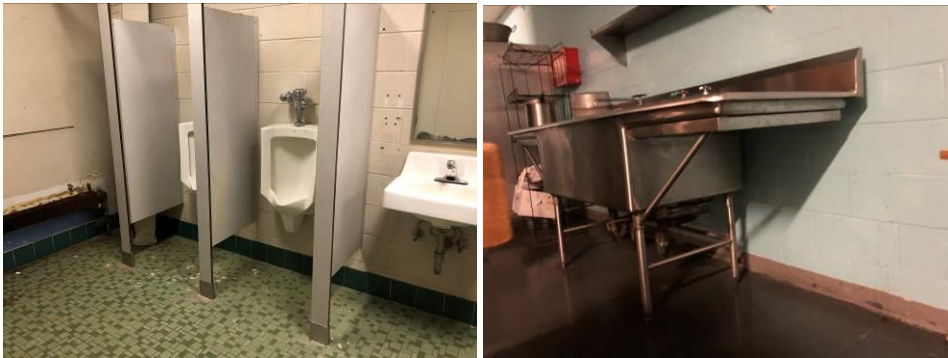
- There are a number of roof leaks. One of the roof leaks is associated with a damaged glass acid vent-thru-roof.
- In the Kitchen, an interior grease trap is missing from a 2-compartment pot sink.

(L - Wall-hung Urinals, R - 2-compartment pot sink without interior grease trap)

9. Plumbing Recommendations are:
 - a. Repair the damaged glass acid VTR.
 - b. Install an interior grease trap at the Kitchen 2-compartment pot sink.
 - c. Replace all water, waste, vent, gas and rainwater leader piping that is over 50 years old with new.
 - d. Install a tempered water system(s) to serve the emergency eyewash/shower stations.

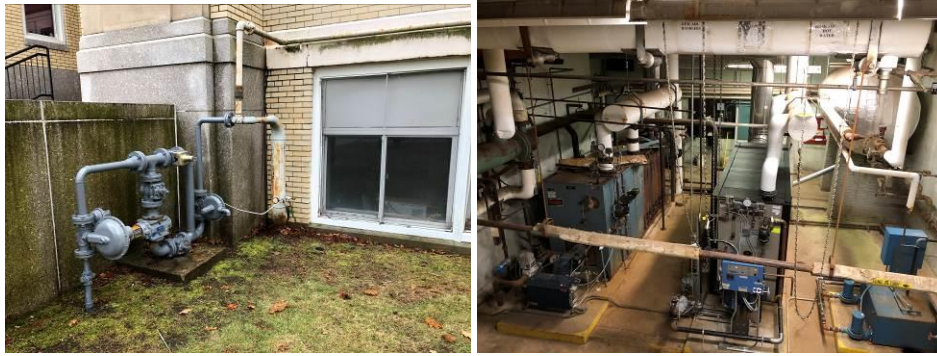
(L - Gas Service and Gas Meter, R - Horizontal Domestic HW Storage Tank)

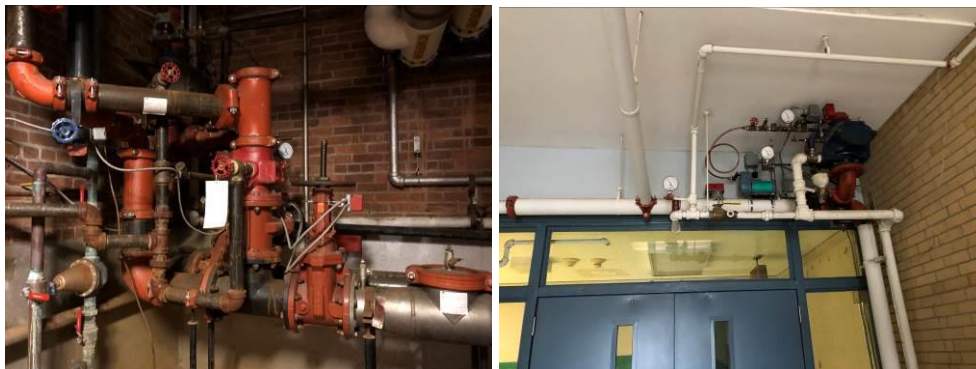
(L - Sprinkler Riser Station, R - Dry Sprinkler Valve)

5. Sprinkler piping and sprinkler heads in the original 1936 building are now 84 years old and well past their useful life.
6. Sprinkler piping and sprinkler heads in the original 1952 Addition are now 68 years old and well past their useful life.
7. Recommendation is to replace all sprinkler piping and sprinkler heads that are over 50 years old with new.

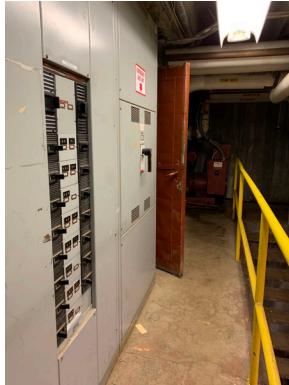
Main Switchboard

The main switchboard and most of the sub-panels appear old and in poor condition. The main board does not have proper clearance in the Boiler Room.

The main service equipment installed appears to be original to the building and the equipment appears to be in poor condition. Replacement parts for this equipment are very difficult to purchase. It is evident that the equipment has not been maintained or tested over the years. At a minimum, the main distribution board and related breakers should have an infrared scan performed to ensure that the components are not deteriorating and are still capable of operating in the manner for which they were designed. The breakers should be cleaned and load tested for failure analysis. The grounds should be tested as well as the branch circuit conductors reviewed to ensure that they are still structurally sound. All connections should be tightened in accordance with manufacturer's recommendations. In accordance with the National Electric Code (NEC) Article 110.26, an electric service rated 1200 ampere and above is to have the capability of having two means of egress or be capable of allowing for a person to safely egress the room to avoid being trapped. Currently the room does not allow a minimum of three feet clearance in front of the board. It is recommended that the board and secondary feeder be replaced.

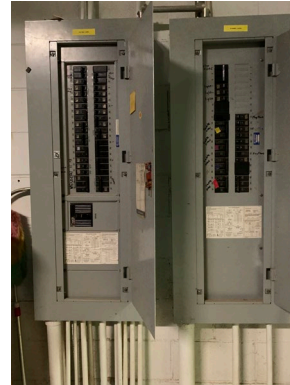
The panelboards located throughout the building provide power to lighting, receptacles, mechanical equipment and miscellaneous loads. Most panels appeared to be at capacity.

Feeder Circuit Breakers Panels

The sub-panels throughout the building are a mixture of old to fairly new (1990's). It appears that panels and feeders are at their end of life cycle. At a minimum, all branch circuit panels should have an infrared scan performed to ensure that the components are not showing signs of overloading as well as deterioration. Each panel should be properly balanced per phase. It is recommended that the panels and associated feeders be replaced.

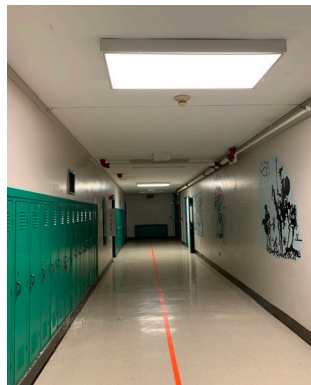
The lighting consists mostly of recessed-mount and surface-mount, 4-lamp, acrylic lens, fluorescent light fixtures. They appeared to be 32-watt T8 lamps installed. The fixtures throughout appeared to be in poor condition. Classrooms, Corridors and large public areas appeared to be poorly lit. The lighting does not meet the energy conservation code, as stipulated in Article 13 of the Massachusetts State Building Code, 8th Edition. Local wall mounted switches are used for lighting control. There is no occupancy sensor control observed. The corridor lighting is controlled with key switches at each end of the corridors.

*Corridor surface 4'x4' –
4 lamp fluorescent light fixtures*

The majority of the lighting throughout appears to be old and in poor condition in the building. Due to the age of the fixtures, they are showing signs of deterioration and will require maintenance or replacement. The lighting should be replaced with a more efficient lighting system which will properly illuminate the spaces, meet the energy conservation code as stipulated in Article 13 of the Massachusetts State Building Code 9th Edition and meet the standards of the Illuminating Engineering Society (IES). Incorporate occupancy/vacancy sensor controls in all applicable areas to automatically control the lighting during occupied and unoccupied times. Add photo-control sensor controls near perimeter windows for day-light harvesting. Replace all light fixtures with more energy efficient light fixtures to meet the energy conservation code, as stipulated in Article 13 of the Massachusetts State Building Code and the standards of the Illuminating Engineering Society (IES). If the light fixtures were to be replaced with LED energy efficient fixtures, then the power consumption would be reduced by at least fifty percent. It is recommended that all light fixtures and associated branch circuitry be replaced.

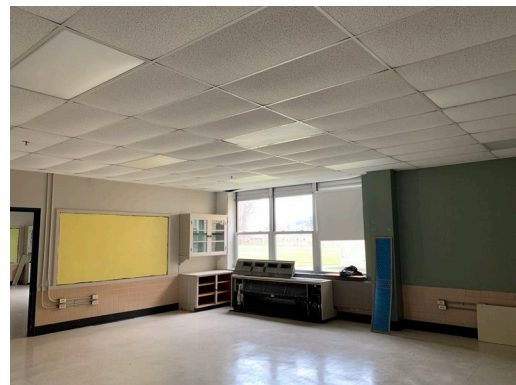
*Classroom recessed 2'x4' –
4 lamp fluorescent lensed light fixtures*

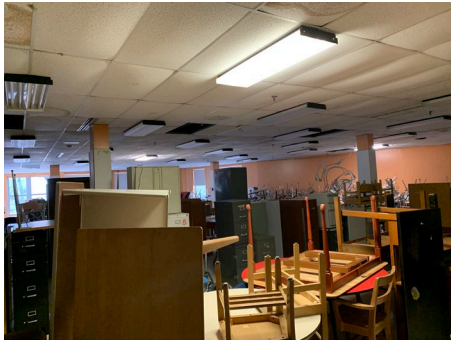
*Cafeteria surface 1'x4'-
4 lamp fluorescent lensed light fixtures*

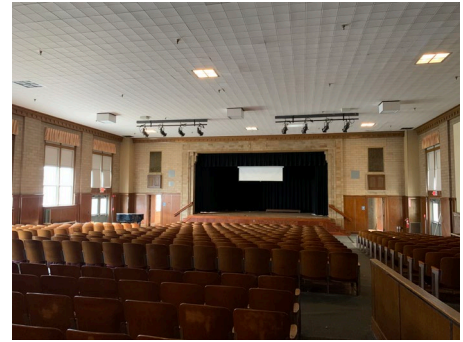
*Auditorium surface 1'x4' –
4 lamp fluorescent lensed light fixtures*

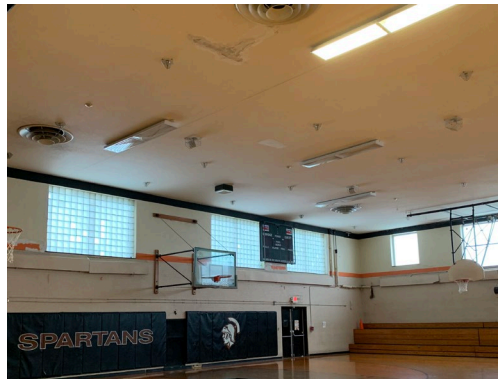
The Gymnasium lighting appeared to be fairly new. The lights consisted of surface 1'x4' – (6) T5 lamp fluorescent light fixtures. The lamps were protected with cages. The light fixtures were controlled via ceiling occupancy sensors and manual wall switches. The space appeared to be adequately lit.

*Gymnasium surface 1'x4' –
6 lamp T5 fluorescent light fixtures with cages*

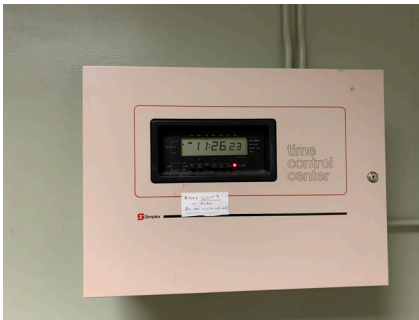
The clock system, manufactured by Simplex Company, with bell/chime features, is located at the main reception desk. Most of the clocks throughout the building have been removed. The main sound system has been removed from the building. Therefore, the systems are not operational.

Clock Panel in Main Office Area

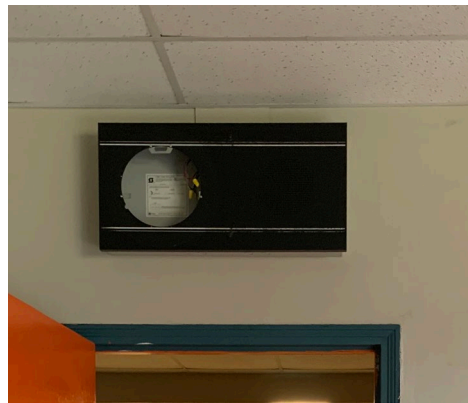
Empty Chime/Clock Casing

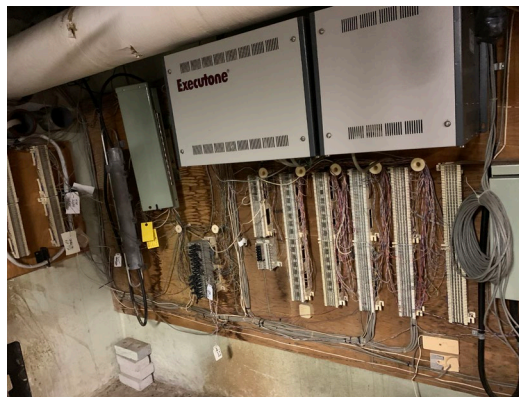
There is a Telecommunications Room located on the Second Floor of the 1980's addition . There are a minimum amount of devices in each classroom; it appears that most devices were added(surface-mount) during the 1980's and 1990's renovations. The components in the Telecommunications Room have been removed, therefore the system is not operational. The telephone system in the room behind the Boiler Room appears to be old and non-functioning.

Telephone Punch-downs
