Spencer, Sullivan & Vogt

ARCHITECTURAL SURVEY & FEASIBILITY STUDY for the CORNET JOHN FARNUM HOUSE

44 MENDON STREET, UXBRIDGE, MASSACHUSETTS • 13 AUGUST 2021

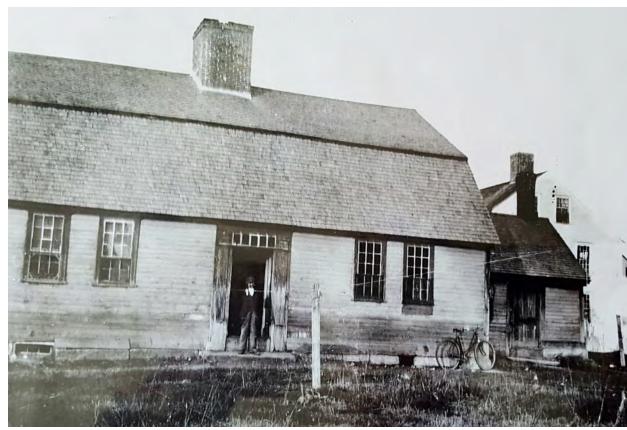
Fig. 1 - Ca. 1890s photograph showing the original entry and 9/6 windows. The east ell is visible on the extreme right. Courtesy of Uxbridge Historical Society

- In the later 19<sup>th</sup>-century photographs (see Figs. 1 and 2, p. 62), the clapboards and front entry appear to be in weathered condition with much of the paint worn off. In the 1901 photograph, the clapboards and trim look freshly painted and in good condition, suggesting they were replaced ca. 1900. The current clapboards and trim appear to date to that renovation. Most are 4' to 8' long, circular sawn, with butt end joints and a 4" exposure.

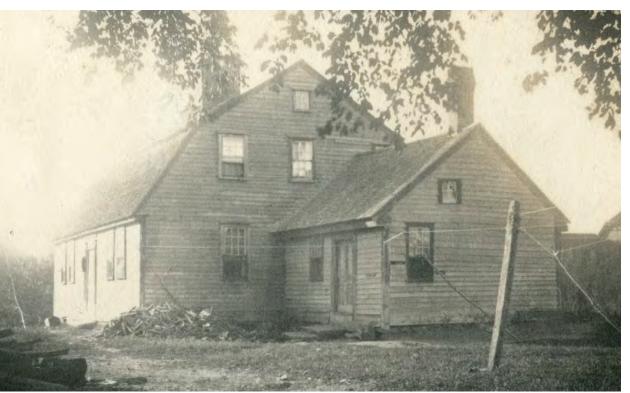
Fig. 2 - Later 19th century photograph showing the east ell. Courtesy of Uxbridge Historical Society

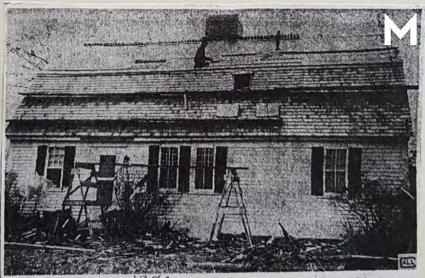
# Farnum House Roofing Near Completion

UXBRIDGE - John Baca, installing the new cedar shake roof on Uxbridge's historic Cornet John Farnum House, said that only one to two days of work remain on the project being supervised by the Uxbridge Historical Commission. Funds were raised

The house, which had its chimney rebuilt earlier, is said to be one the best examples of 'early architecture in the area. It is the site of the town's incorporation and first town meeting almost 21/2 centuries

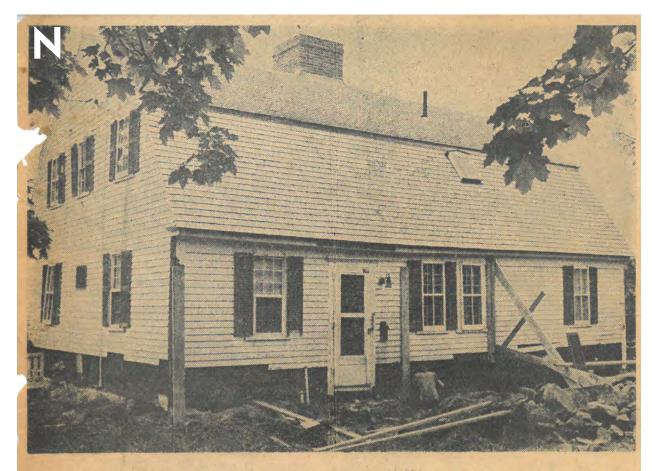
# Uxbridge House Built in 1710 Restored

UXBRIDGE — Another phase in the restoration of the cent John Farnum House was begun recently under rection of the Uxbridge Historical Commission, Control John Baca will replace the rotted sill around the

building and rebuild the stone foundation that was beginning to collapse. The town-owned structure was built in 1710 and has had it's roof and chimney rebuilt in recent years. Plans call for a fresh coat of paint.

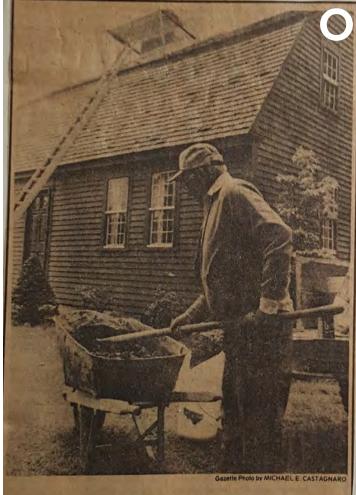
# **Energy Conservation**

UXBRIDGE — Five top sealing dampers were installed on the John farnum House yesterday by Arthur Sabatinelli, a mason. The work was done to conserve energy and keep rain from entering the chimney. The house is owned by the town and administered by the Historical Commission. It was recently added to the National Register of Historical Places. There are five fireplaces in the house.
