Bridge/Culvert Management Plan

November 2011

Uxbridge
Massachusetts

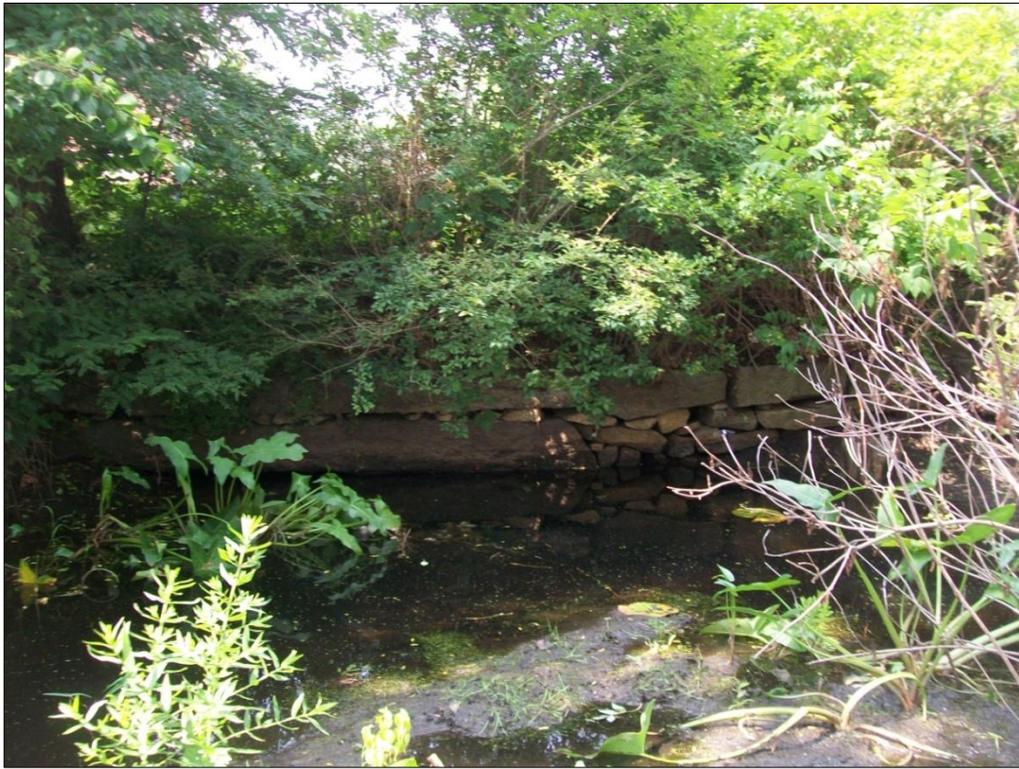
Photo 1 Looking North: South Headwall Elevation

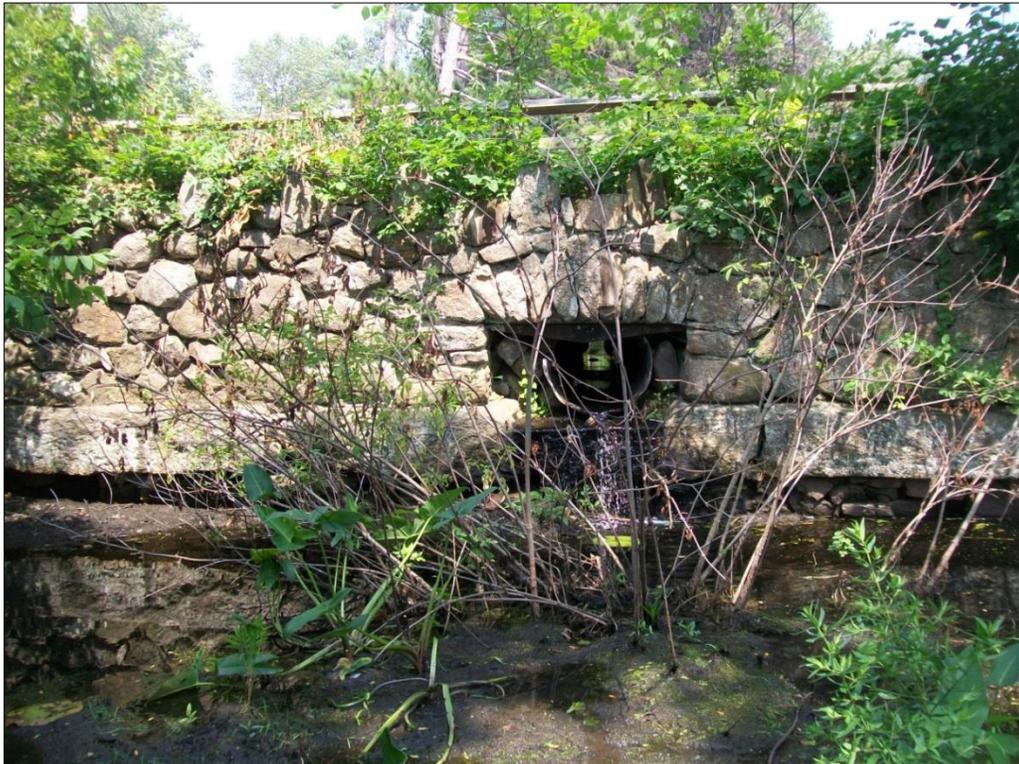
Photo 2 Looking East: Southeast Training Wall Elevation

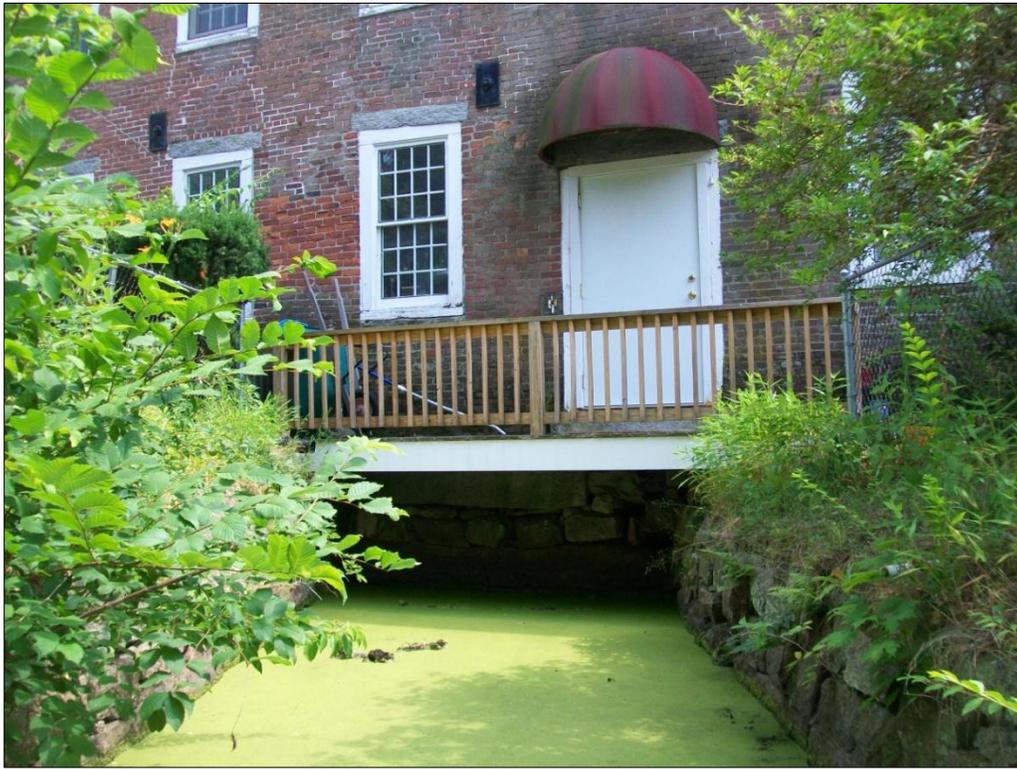
Photo 3 Looking South: North Headwall Elevation Under Private Building

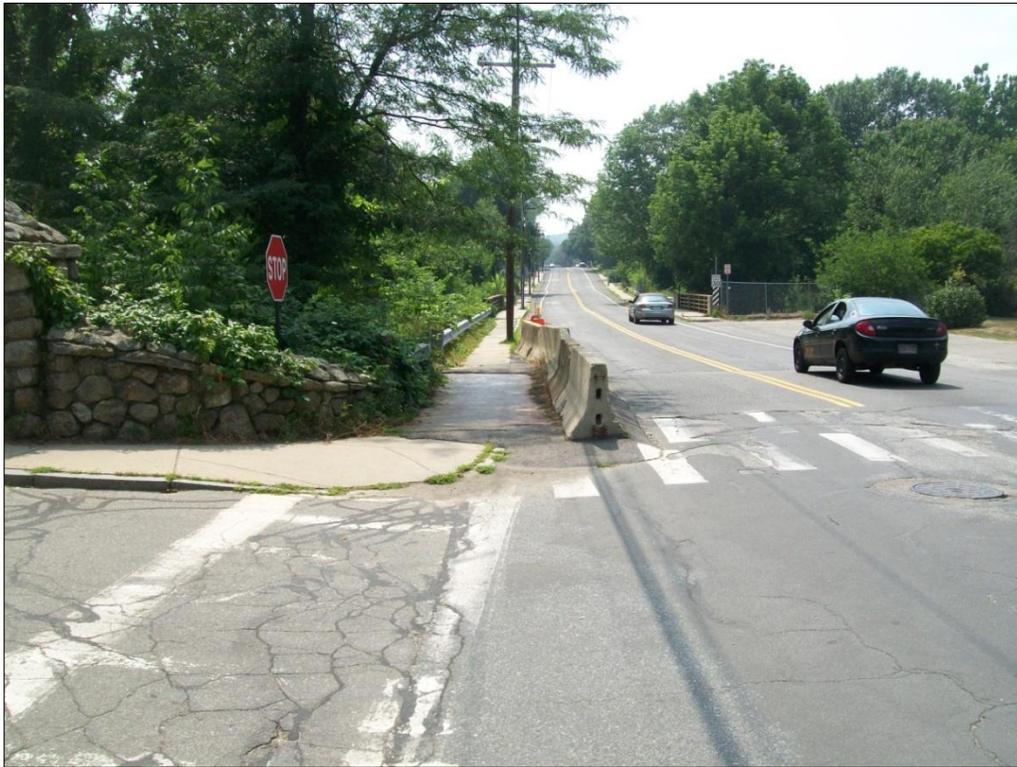
Guard Rail Notes: Metal plates and jersey barriers indicate past culvert failure.

Photo 5 Looking West: Jersey Barriers and Steel Plates at South Sidewalk

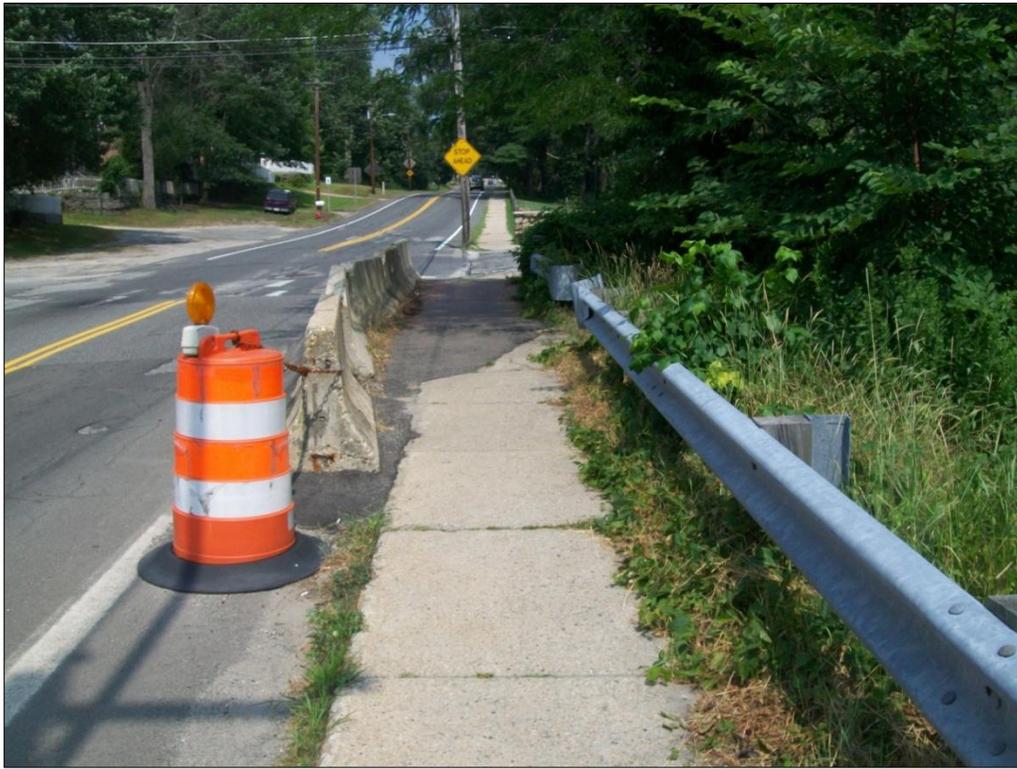
Photo 7 Looking East: Jersey Barriers and Steel Plates at South Sidewalk

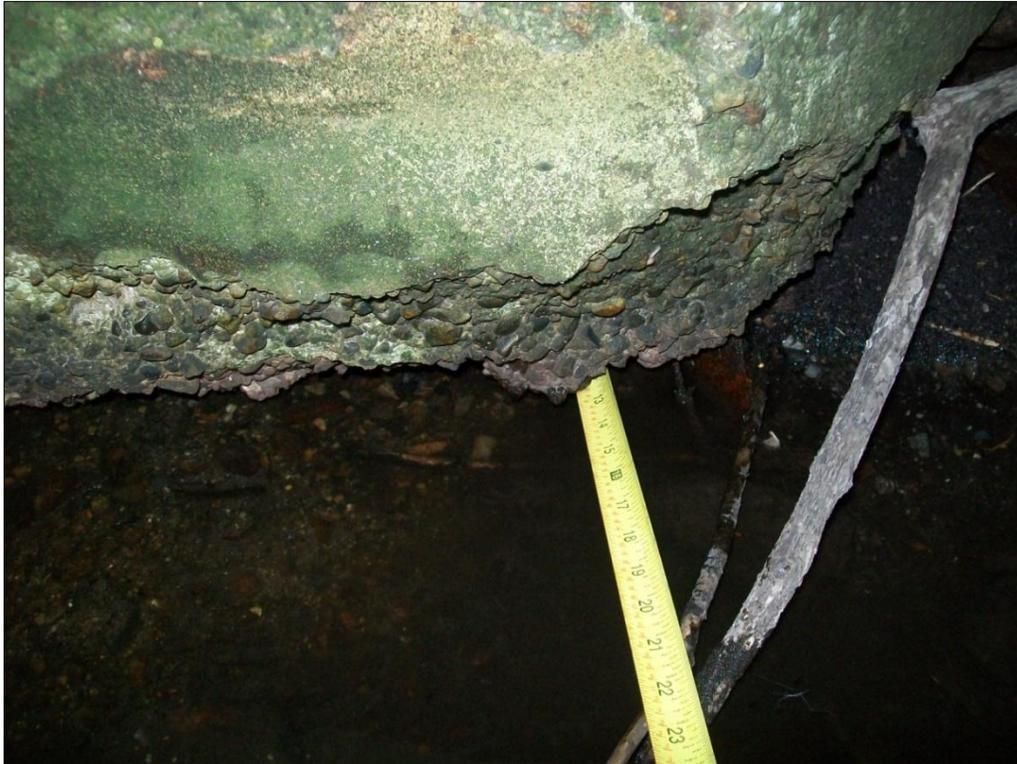
Marywood Street Bridge is a concrete slab structure spanning Drabbletail Brook. This structure is in poor condition with substantial deterioration and undermining at both abutments as a result of scour. The bridge has been closed to vehicular traffic as a result of the inspection performed for this report. The Town is moving forward with plans to replace this structure with a new concrete box culvert.

Photo 3 Looking South: Scour at West End of South Abutment

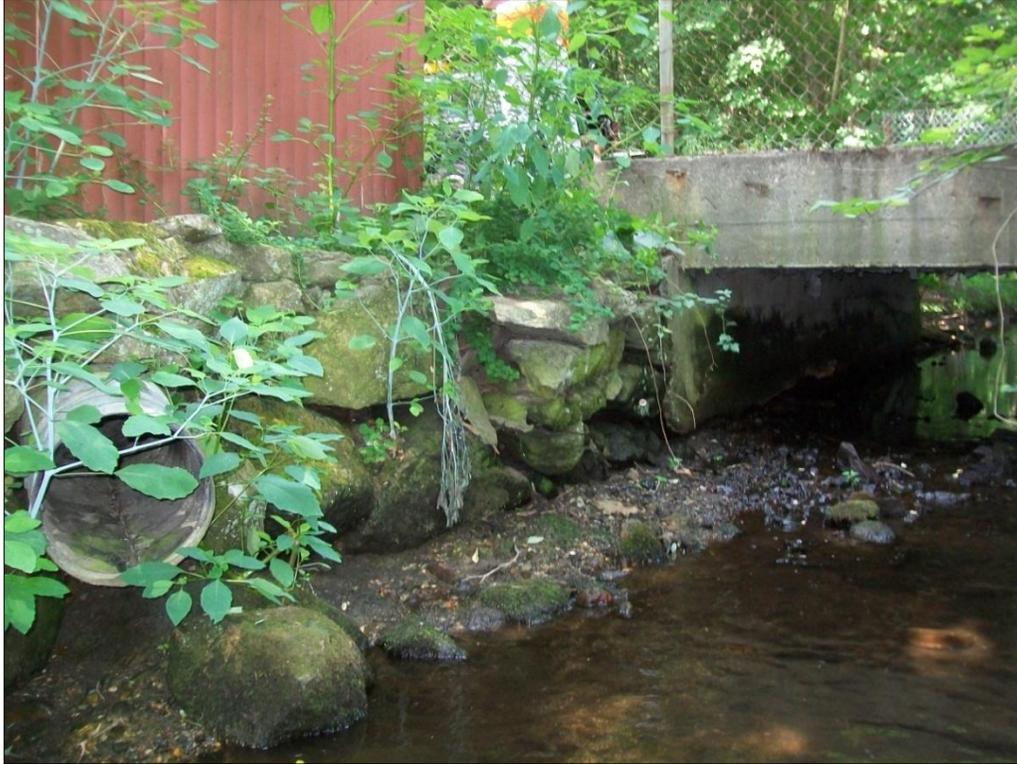
Photo 7 Looking Southwest: Crumbling of Southeast Training Wall

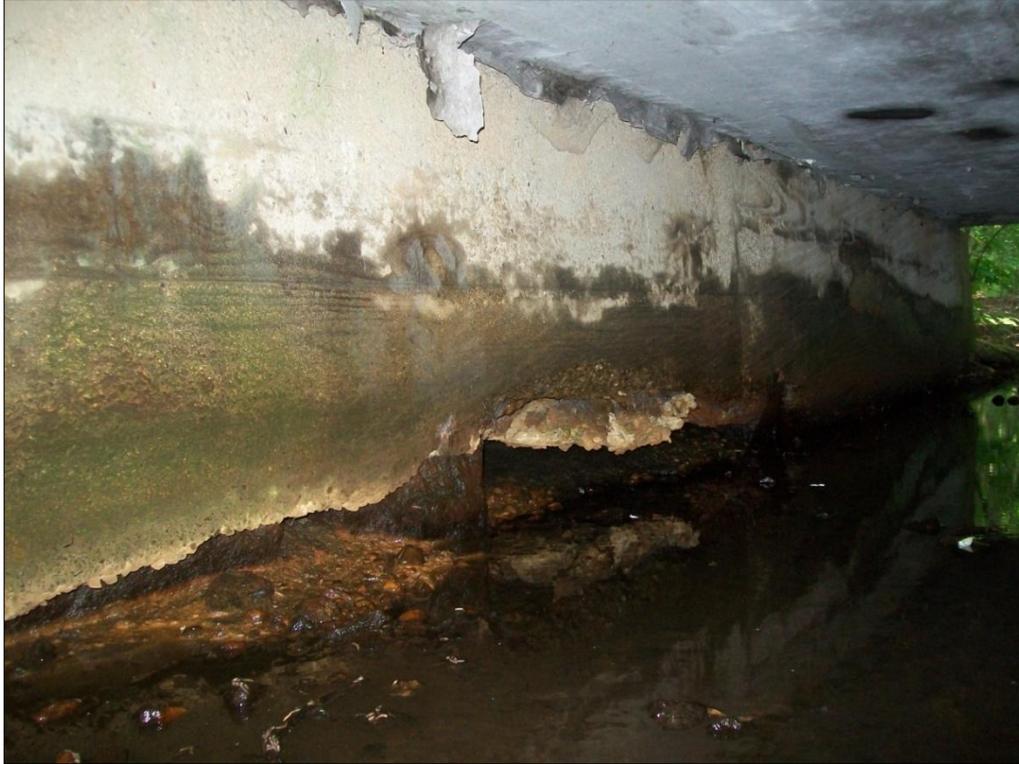
Photo 9 Looking Southwest: Severe Scour in South Abutment

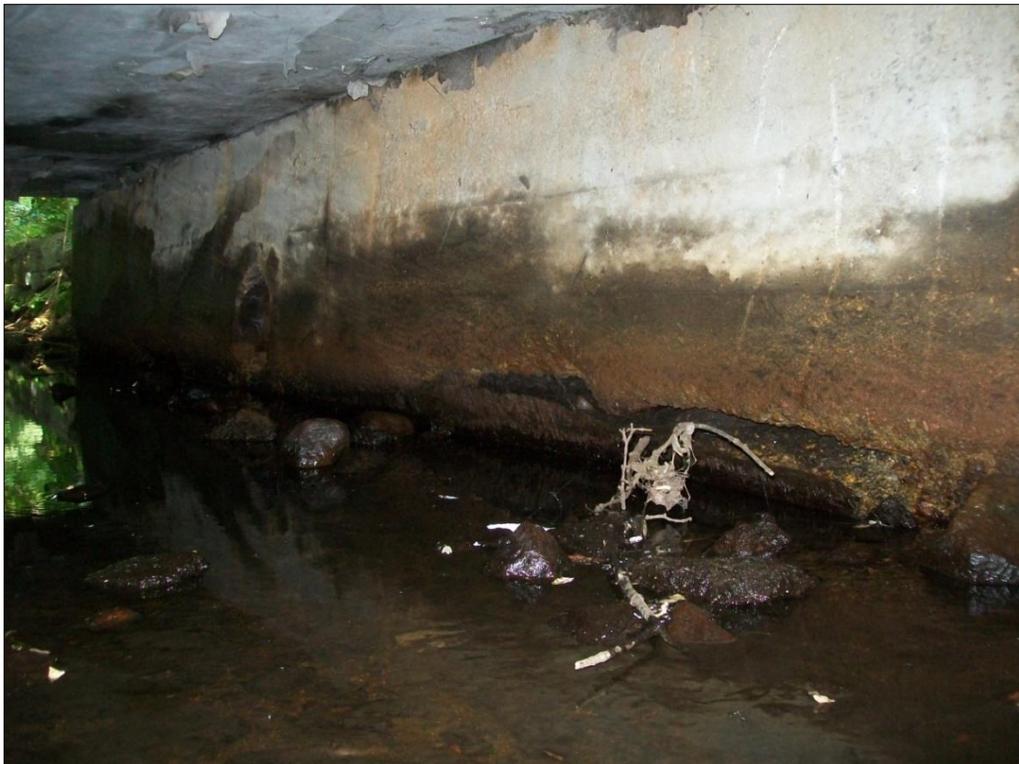
Photo 10 Looking Northwest: Severe Scour in North Abutment

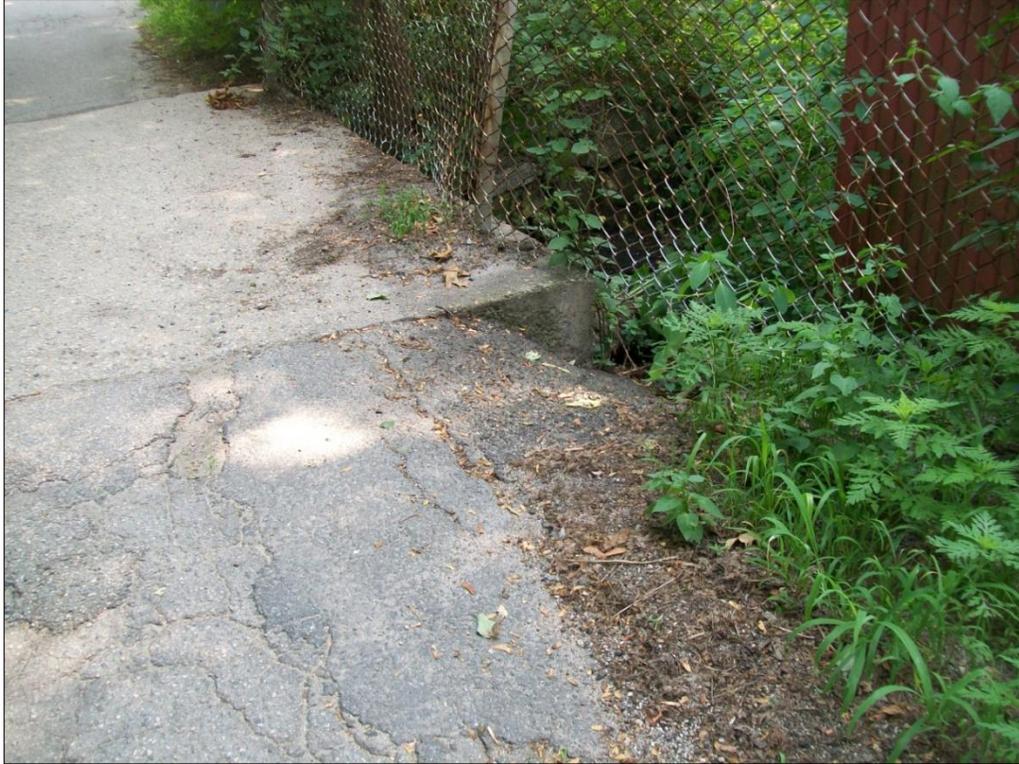
Photo 11 Looking Northeast: Typical Exposed Slab Corners

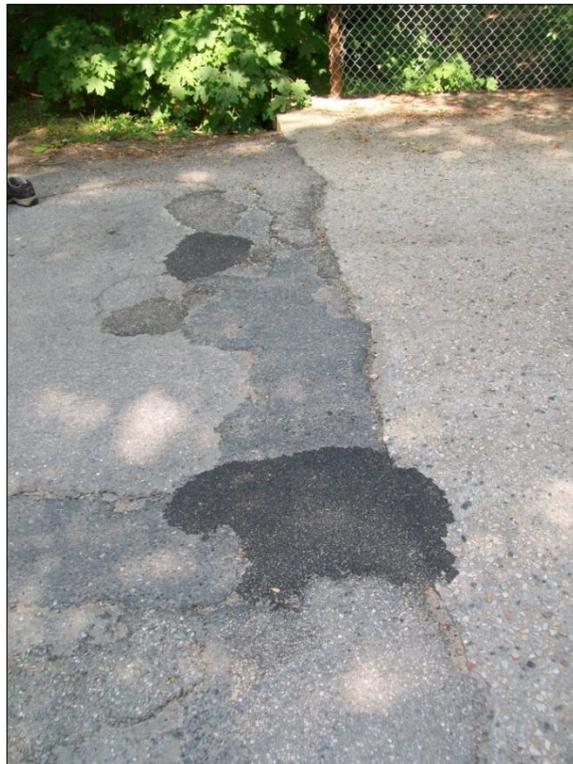
Photo 12 Looking West: Pavement Deterioration at South Bridge Joint

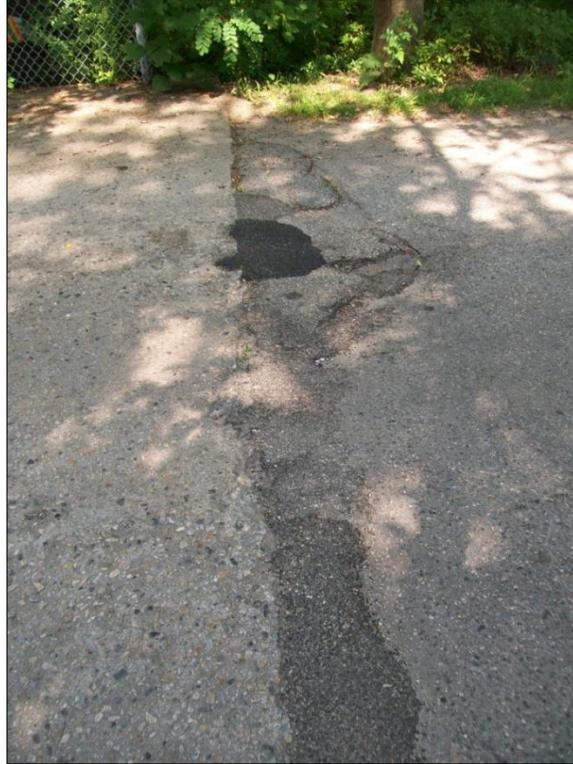
Photo 13 Looking East: Pavement Deterioration at North Bridge Joint

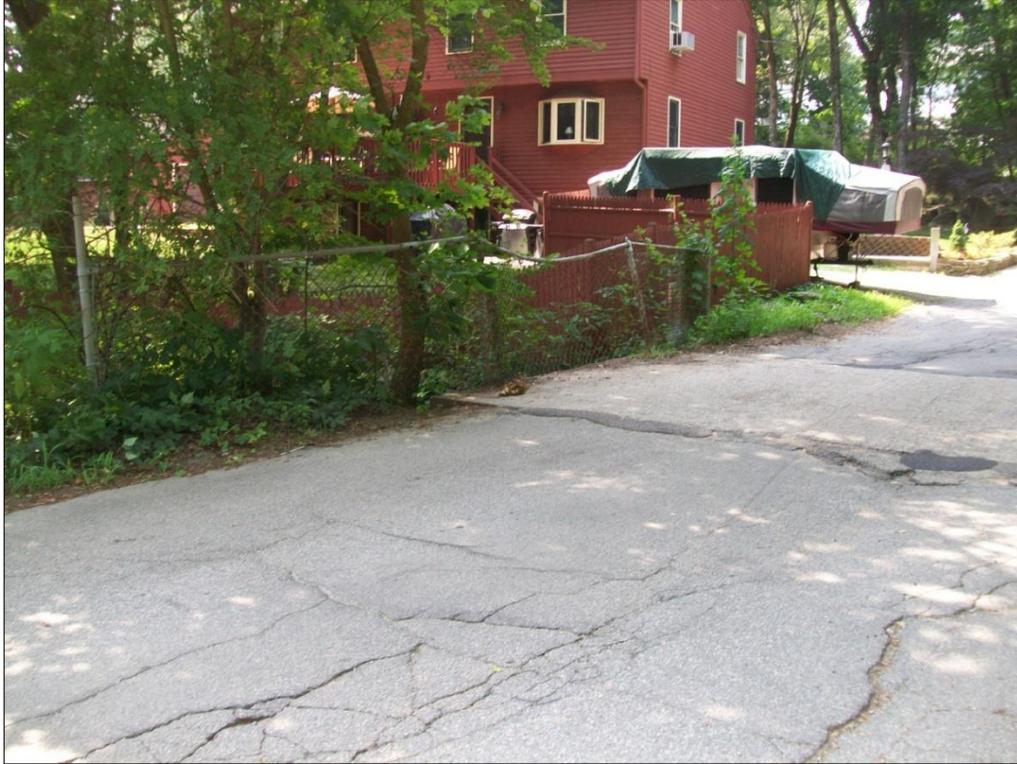
Guard Rail Type:	Chainlink fence. No approach rail.
Guard Rail Condition:	Fence bent and leaning away from roadway on both sides. Safety hazard
Guard Rail Rating:	1
Guard Rail Notes:	None

Photo 15 Looking Southeast: East Bridge Rail Elevation

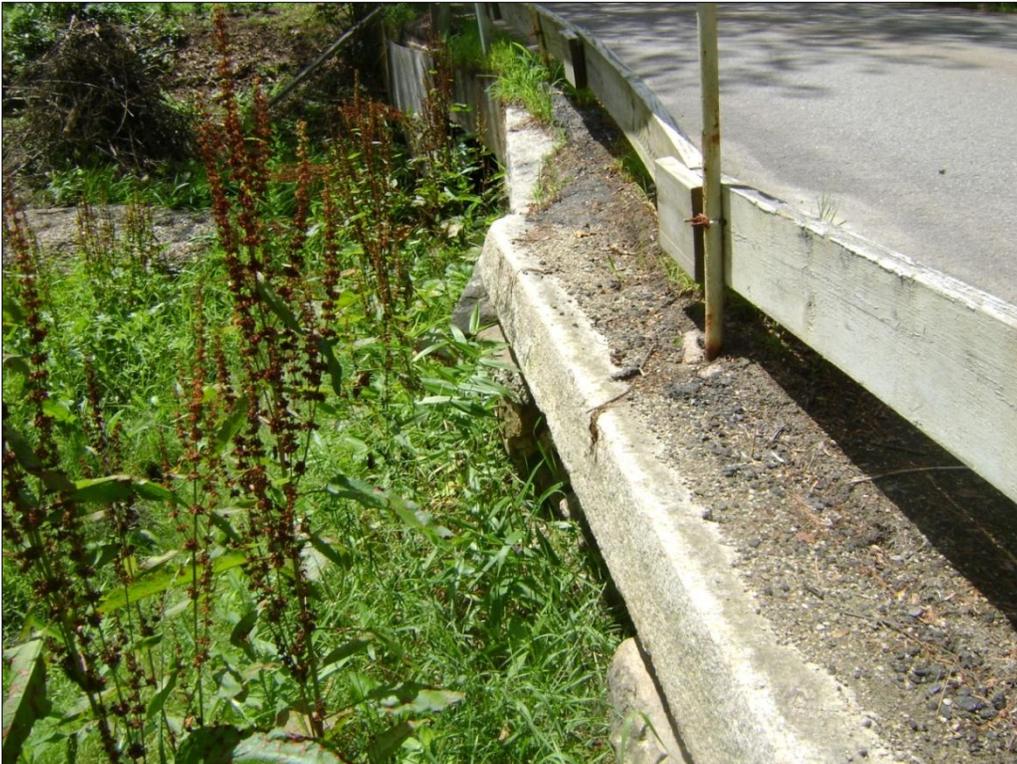
Photo 8 Looking South: Lateral Movement of Northeast Wingwall

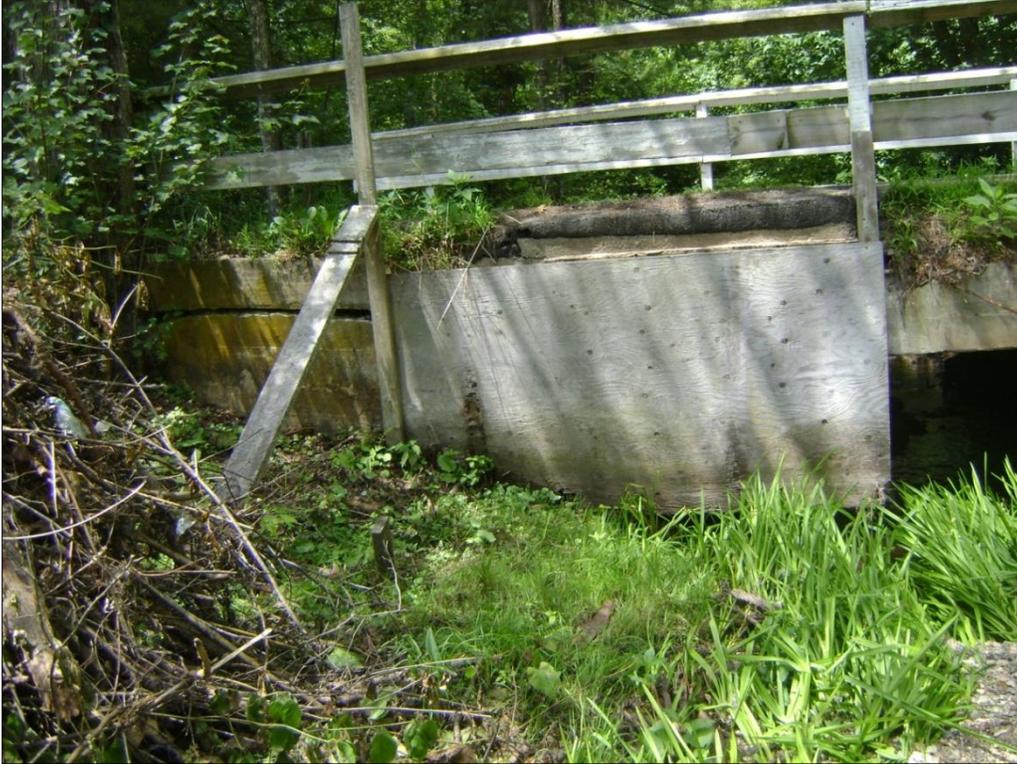
Photo 9 Looking West: Southeast Wingwall Elevation with Timber Shoring

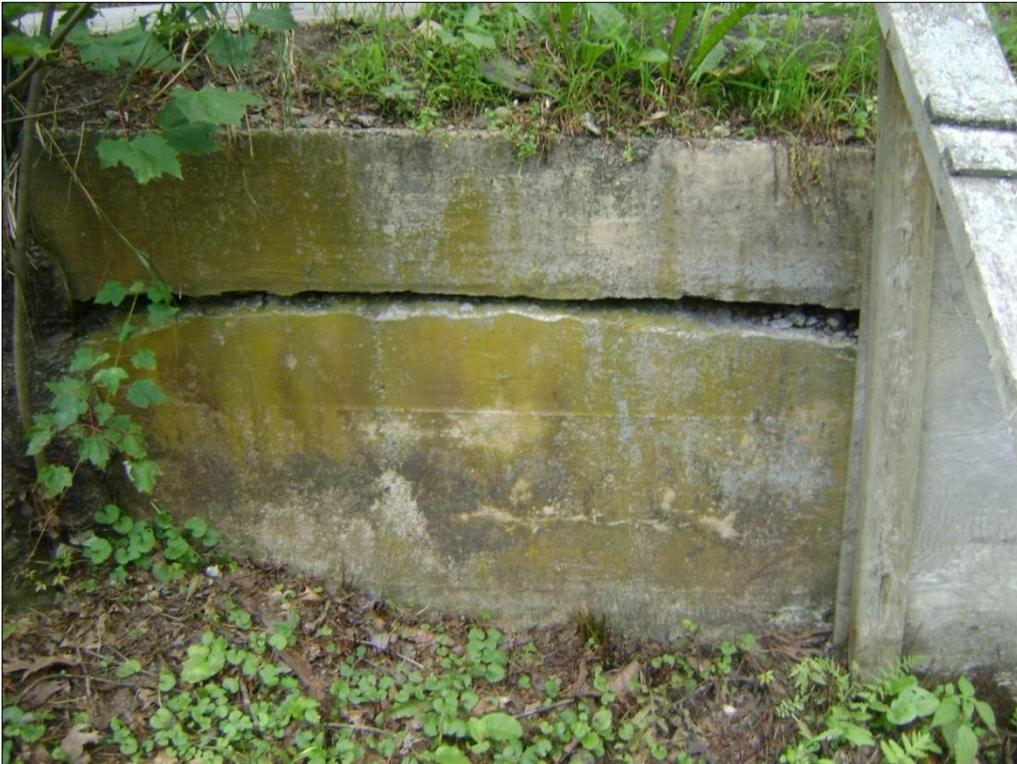
Photo 10 Looking West: Wide Horizontal Crack in Southeast Wingwall

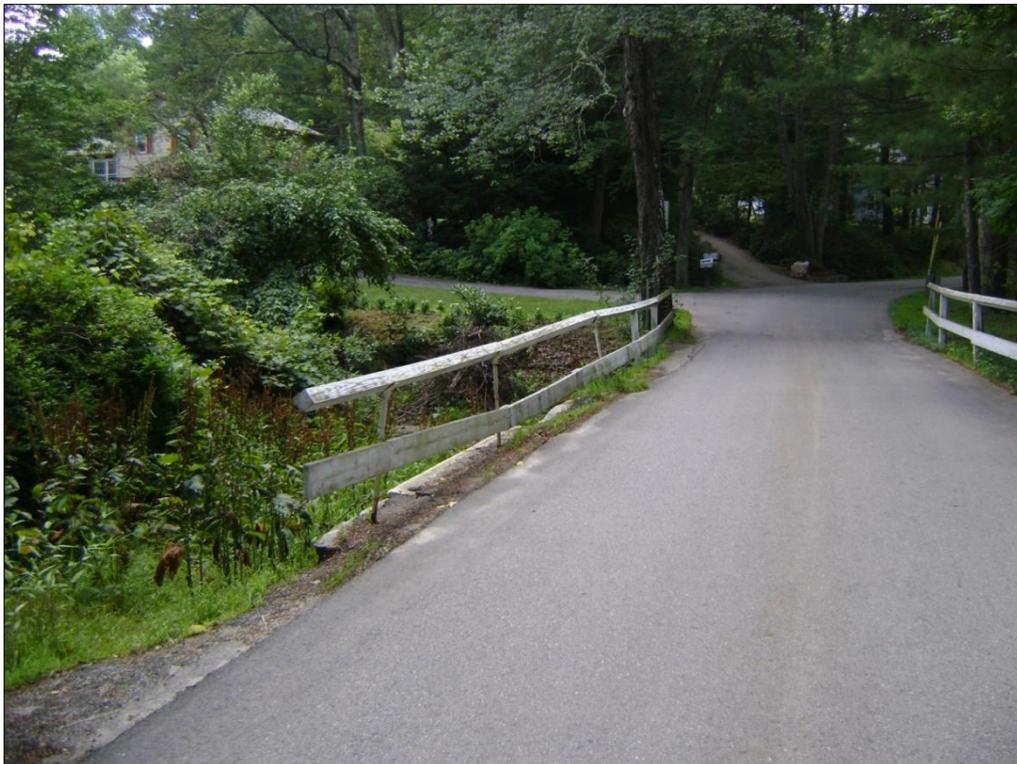
Guard Rail Type:	Metal and wooden posts w/timber rail.		
Guard Rail Condition:	Mounted to top of headwall. Very poor shape (crooked). Leaning away from roadway. SE end mounted to tree.		
Guard Rail Rating:	1		
Guard Rail Notes:	No approach rail. Safety hazard. South approach has skid marks heading toward brook. Approach ratings low due to lack of approach guard rails.

Photo 14 Looking South: Northeast Approach Rail

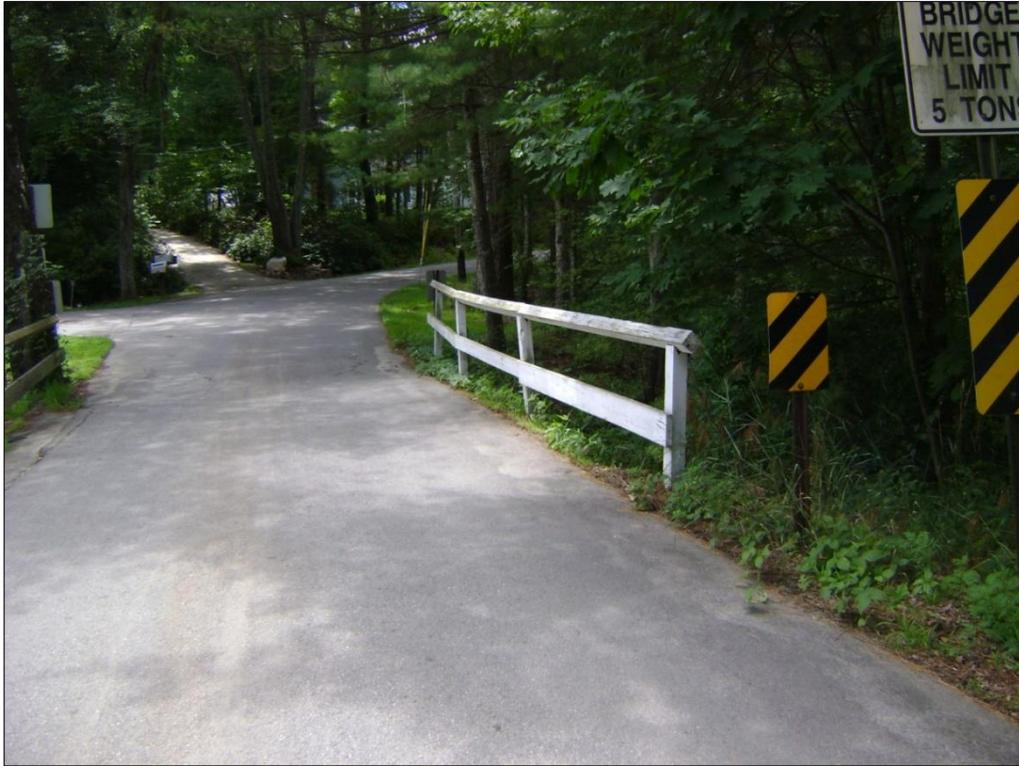
Photo 15 Looking South: Northwest Approach Rail

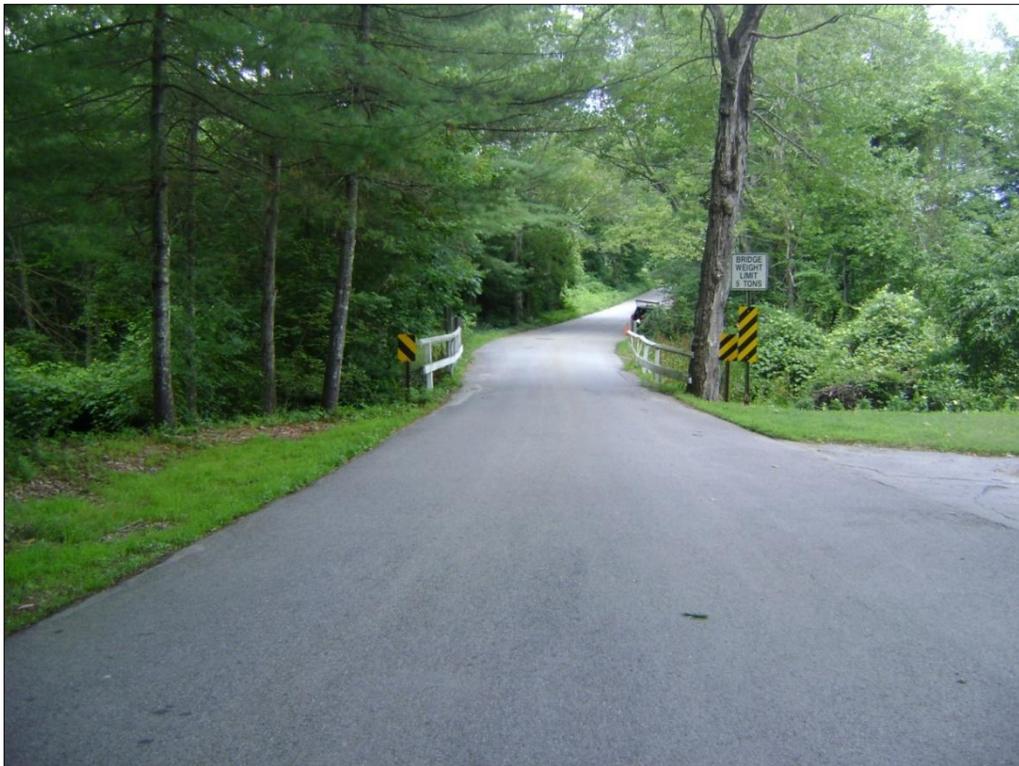
Photo 16 Looking North: South Approach

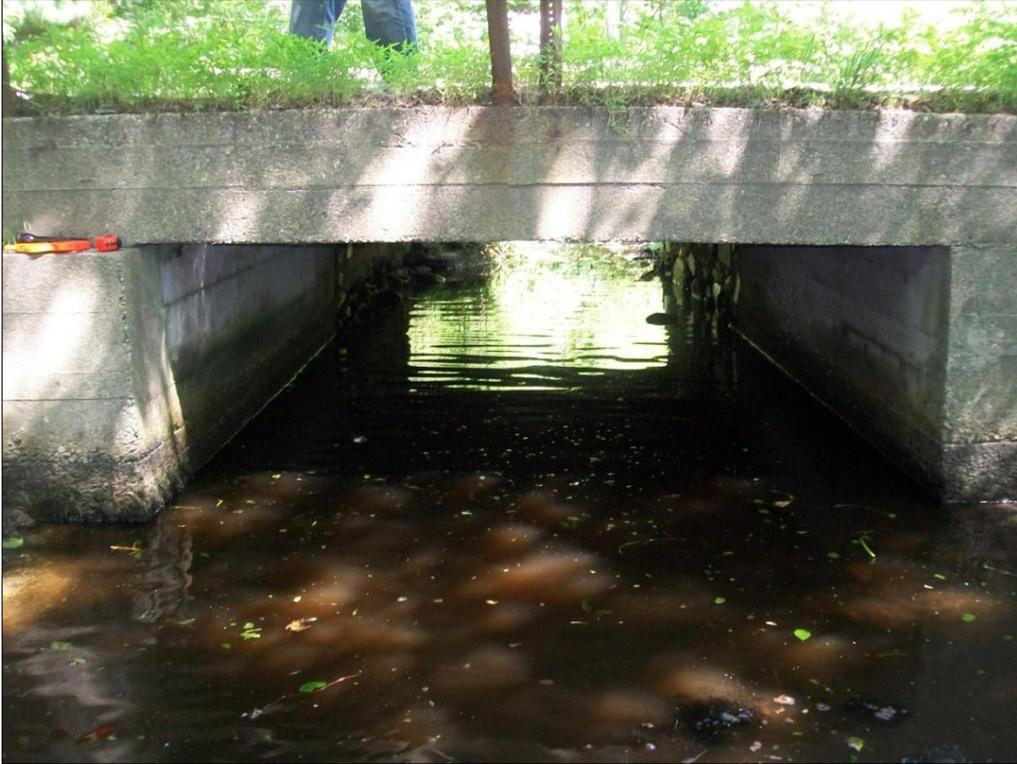
Photo 1 Looking North: South Culvert Elevation

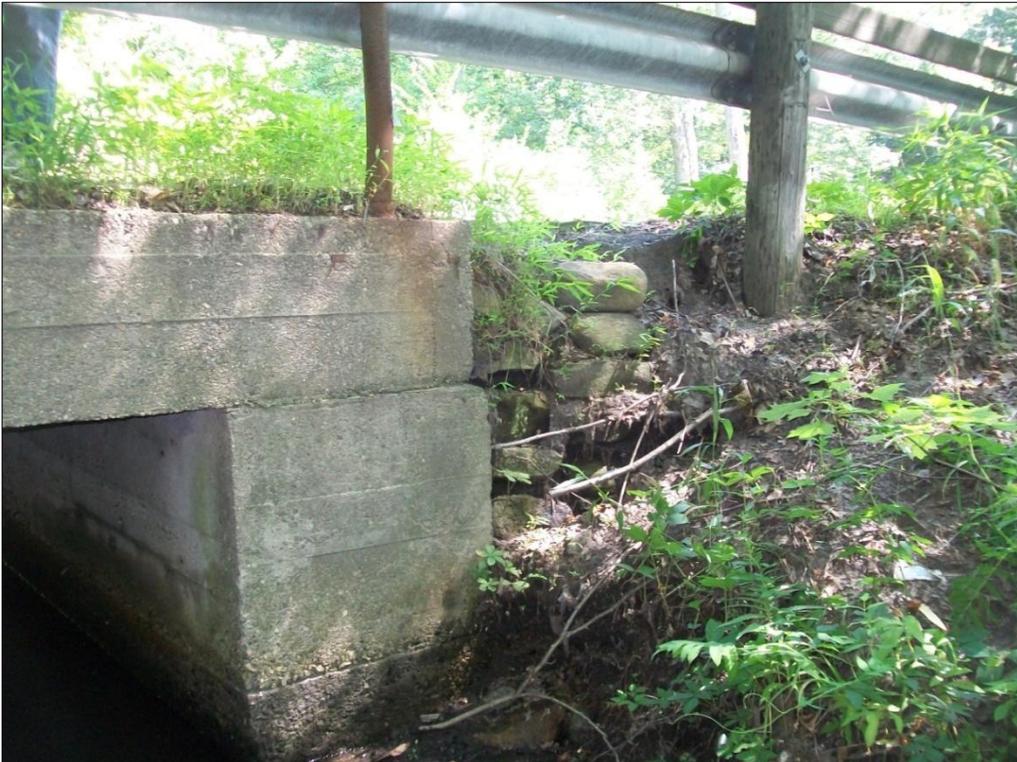
Both wingwalls on the north side of the structures are mortared masonry and are completely covered with heavy vegetation but are in good condition with minor areas of missing pointing and chinking stones. The wingwalls on the south side of the structure are dry-laid masonry with large voids. The walls are starting to crumble causing erosion of the embankment immediately adjacent to the roadway (Photo 2).

Photo 2 Looking Northeast: Southeast Wingwall Elevation

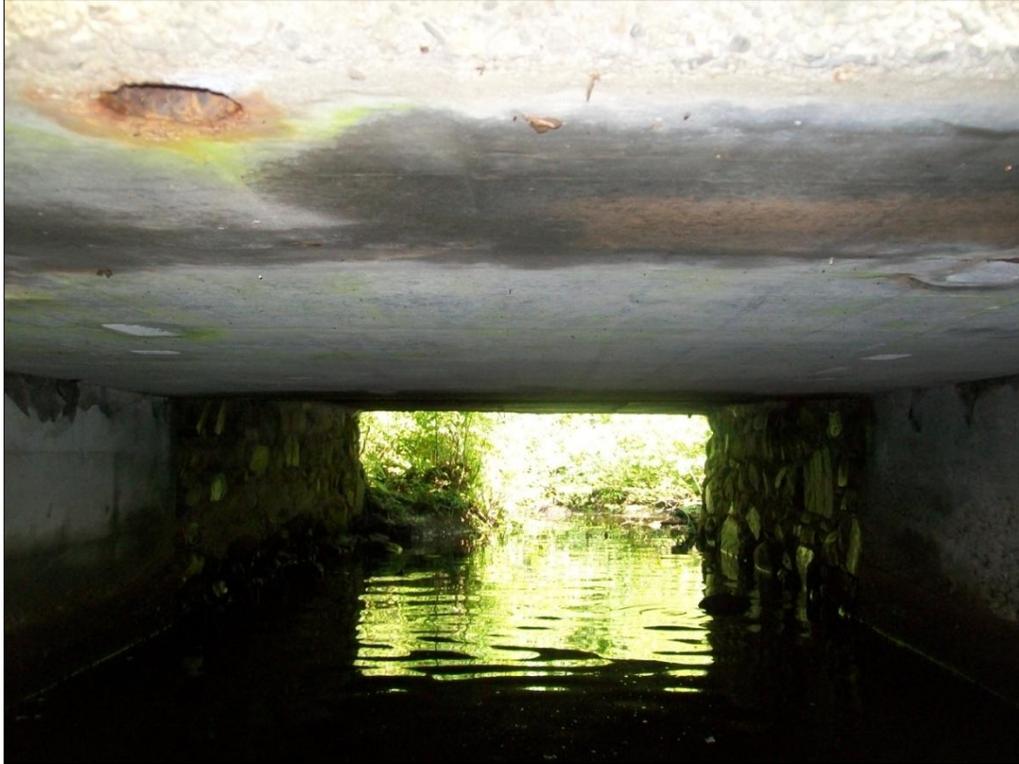
Photo 3 Looking North: Structure 2 Underside of Slab

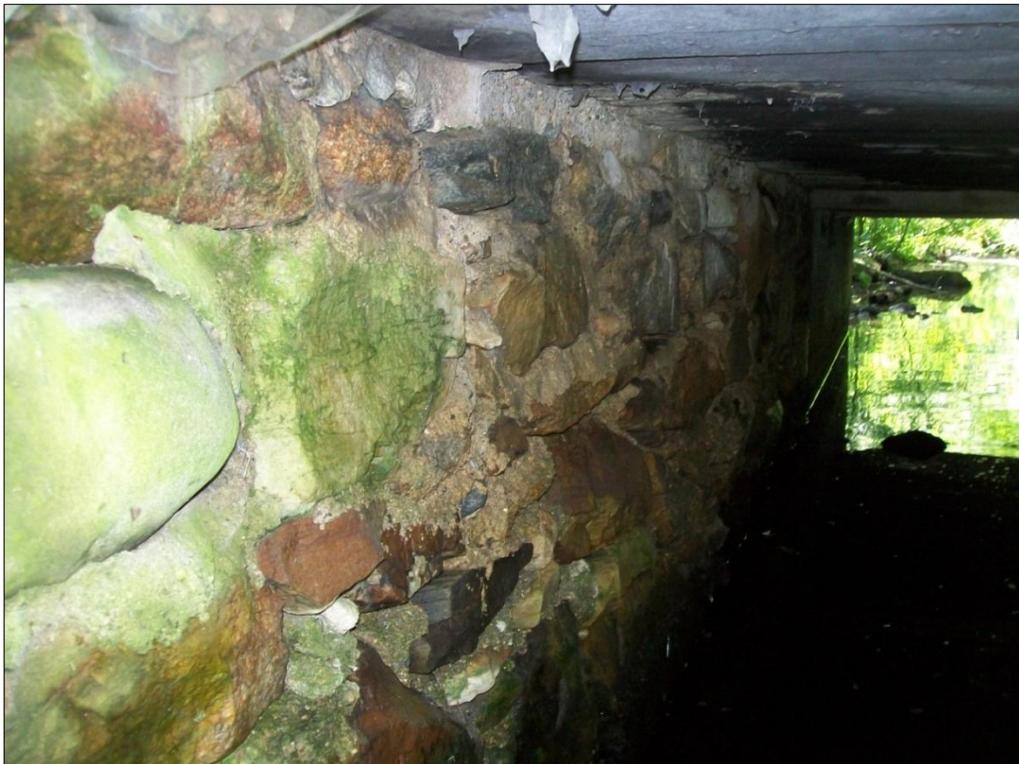
Photo 4 Looking South: Structure 1 East Abutment Elevation

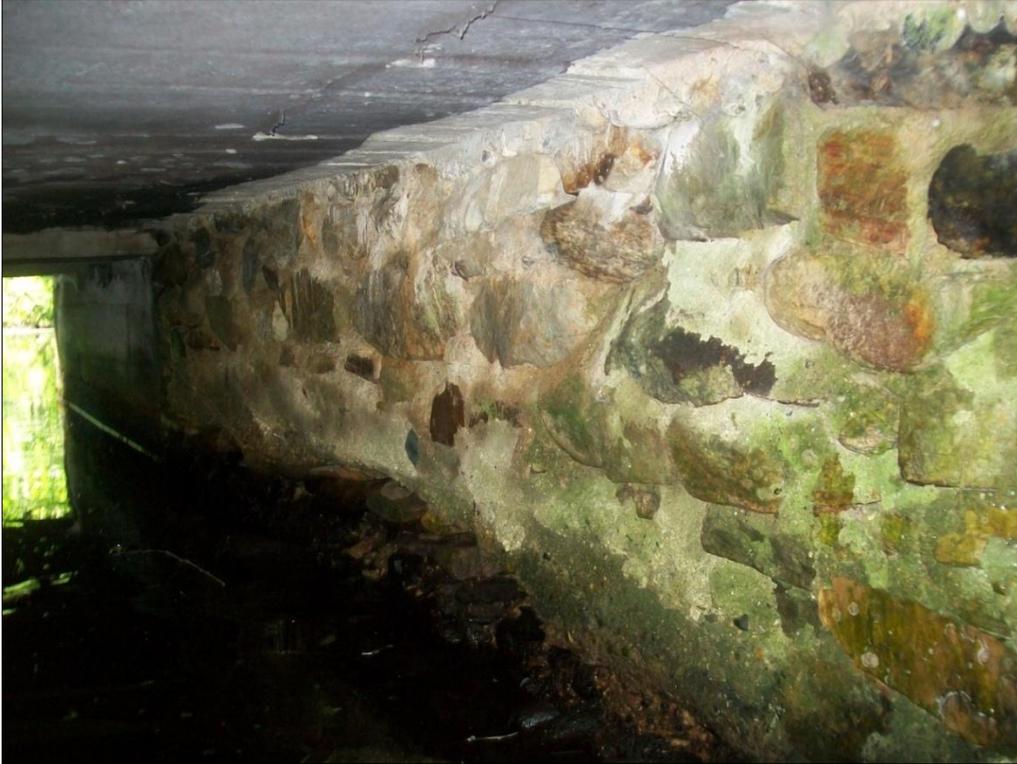
The underside of slabs 1 and 2 are in fair condition. Slab 1 underside is covered with black felt with few exposed areas. Random depressions in the damp proofing indicate minor spalling (See Photo 5). Slab 2 has random areas of rust staining and dampness. Few areas of concrete repair suggest past deficiencies.

The west abutment of structure 1 is in poor condition. The stone masonry abutment exhibits severe scour along its entire base. Excessive voids are present and were measured up to 12" deep (Photos 5 and 6). The east abutment is in fair condition with random

Photo 5 Looking South: West Abutment Elevation

- Scour voids noted in the existing stone masonry abutment should be filled. All other voids, in both stone masonry abutments, should be filled and the abutments re-faced with cast-in-place concrete to reduce risk of future scour. **This should be considered a high priority.**
- Wingwalls voids should be filled to prevent further loss of roadway fines and possible structural failure. The southern dry-laid wingwalls may require complete reconstruction to prevent further erosion due to roadway runoff.

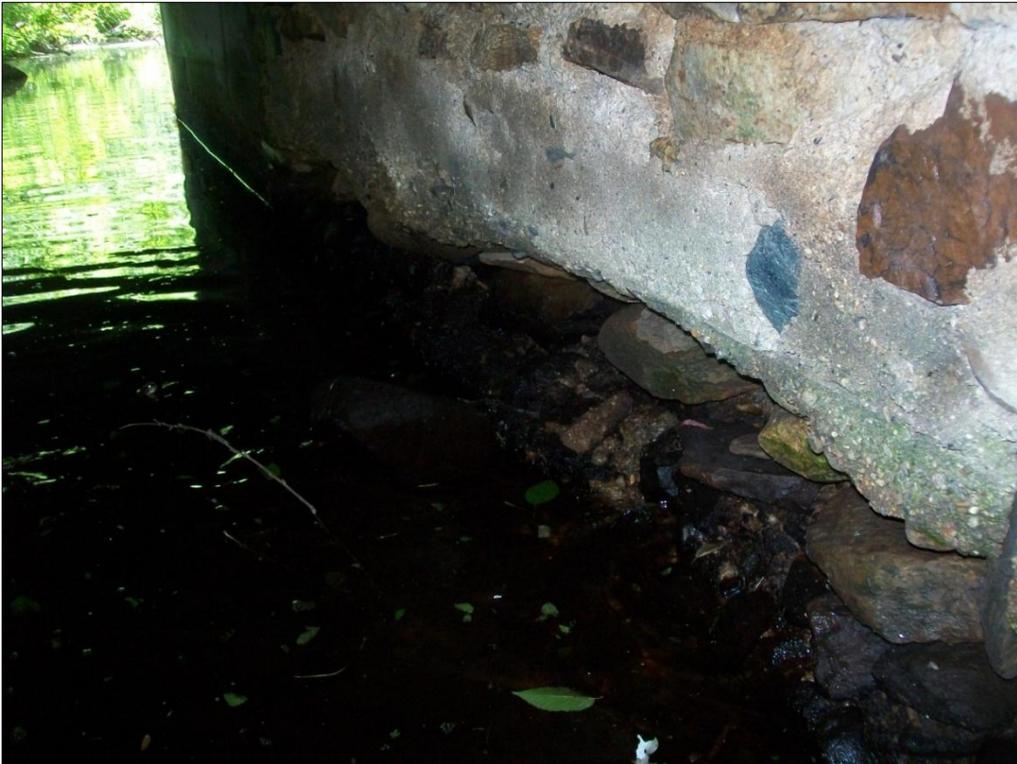
Floor Notes: Wall has crumbled + stones are missing (see photo) > Very large scour/void hole @ base of entire length > Immediate repair required. Some stones are intact but majority of wall base is missing.

Photo 6 Looking South: Large Void at Base of Structure 1 West Abutment

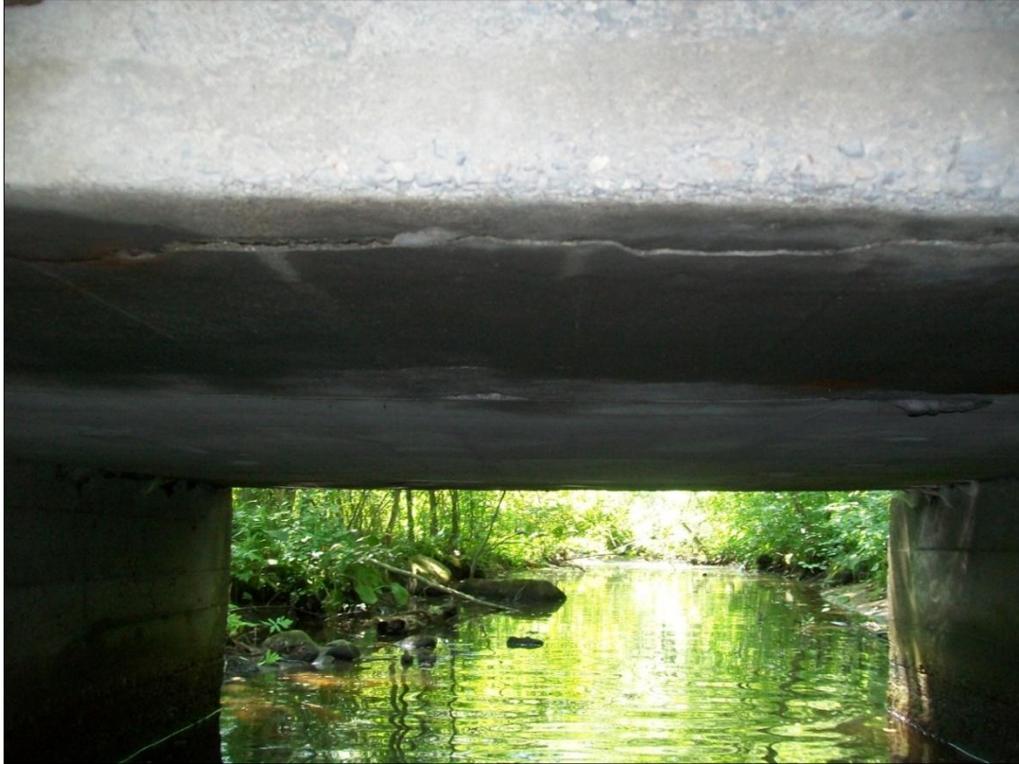
Photo 7 Looking South: Structure 2 Underside of Slab

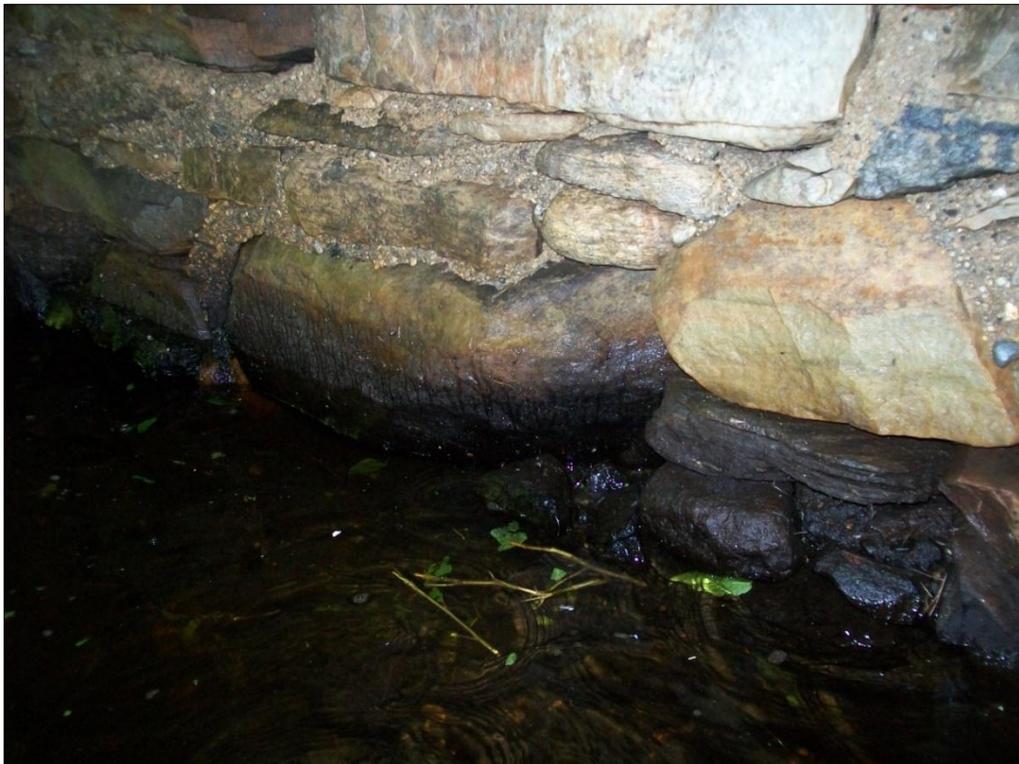
Photo 8 Looking Northeast: Void at Base of Structure 1 East Abutment

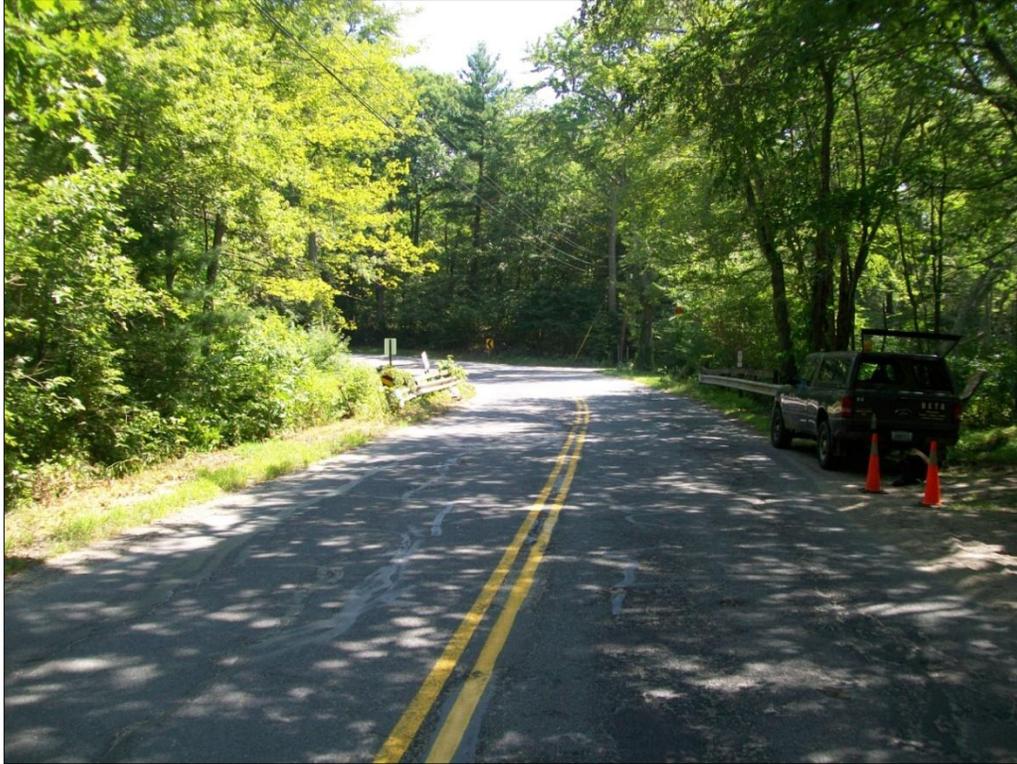
The pavement over the culvert shows moderate linear cracking, patching, and debris in the shoulders. The sharp horizontal curve in the east approach greatly reduces visibility (Photo 9). The north guardrail over the culvert is leaning away from the roadway due to past vehicular collision (Photo 10). No approach guardrail is present.

Photo 9 Looking East: West Approach
