Bridge/Culvert Management Plan

November 2011

Uxbridge
Massachusetts

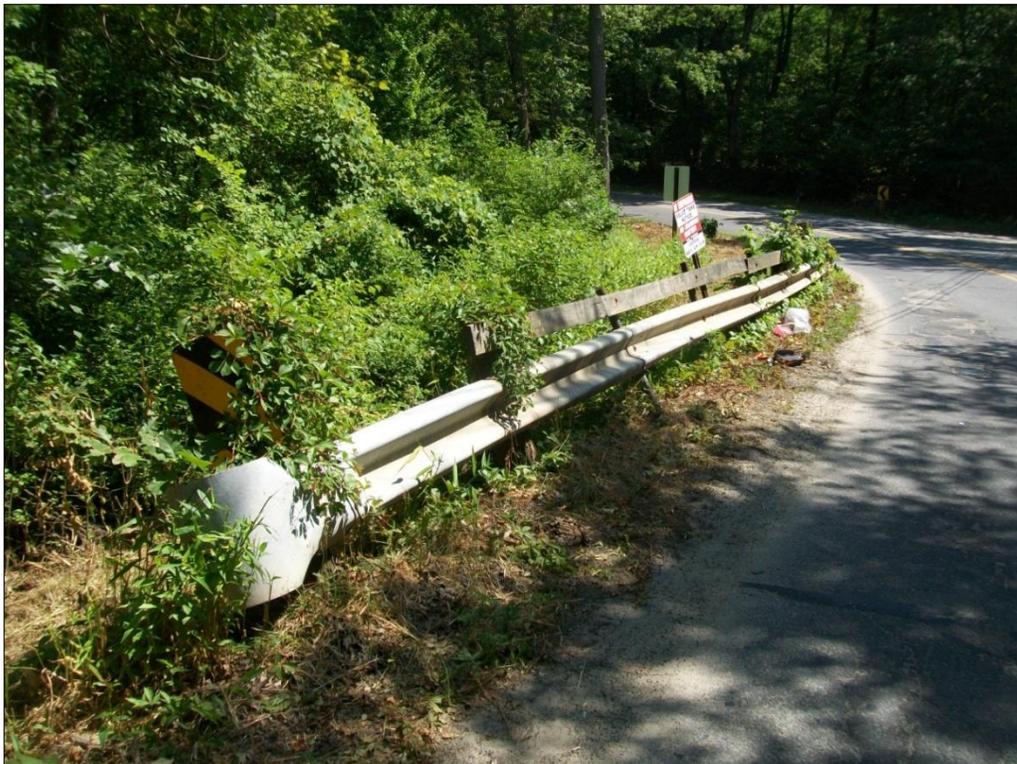
The pavement over the culvert shows moderate linear cracking, patching, and debris in the shoulders. The sharp horizontal curve in the east approach greatly reduces visibility (Photo 9). The north guardrail over the culvert is leaning away from the roadway due to past vehicular collision (Photo 10). No approach guardrail is present.

Photo 10 Looking Northeast: North Bridge Rail

The west abutment at structure 1 is exhibiting sever scour and section loss. Also, the existing safety railing is substandard for protection of vehicular traffic. While other components of the overall structure do not deem replacement, BETA recommends a complete replacement of this structure as a long-term solution. We recommend that the culvert be replaced with a precast concrete box culvert or similar structure. The new structure should also incorporate precast wingwalls at both the upstream and downstream entrance. In the interim, the scour void at structure 1's west abutment requires immediate repair. Similarly, all voids to the stone masonry abutments should be filled and both abutments re-faced with cast-in-place concrete. BETA also recommends the addition of guardrail at both approaches in accordance with current AASHTO design standards.

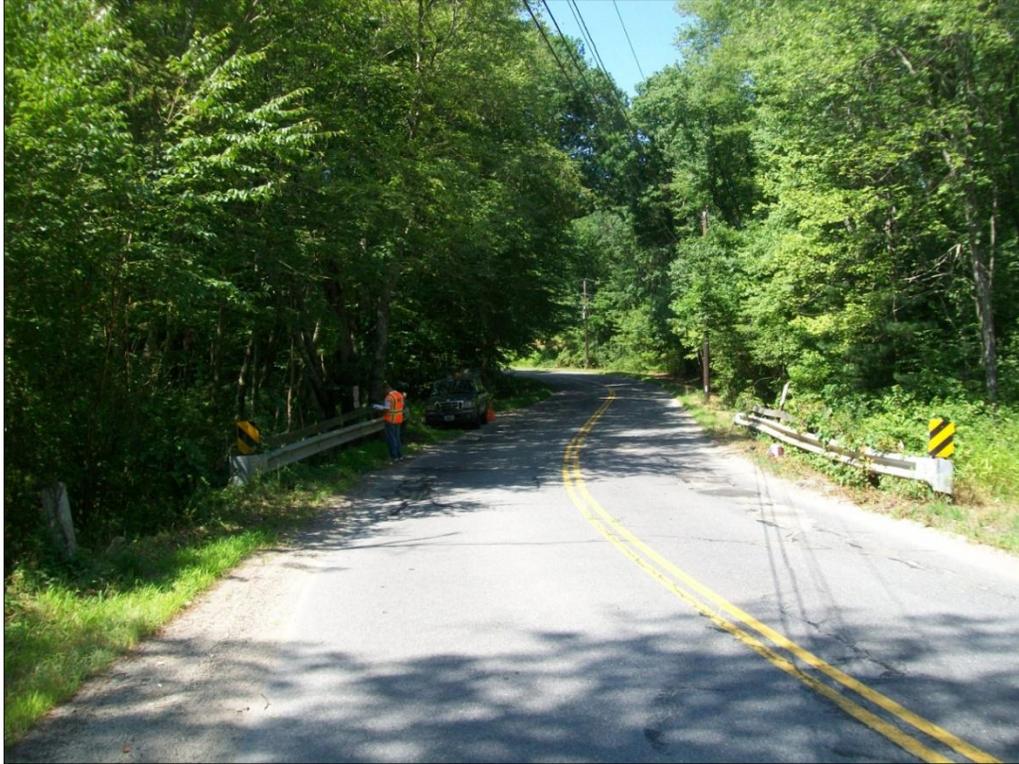
Photo 11 Looking West: East Approach

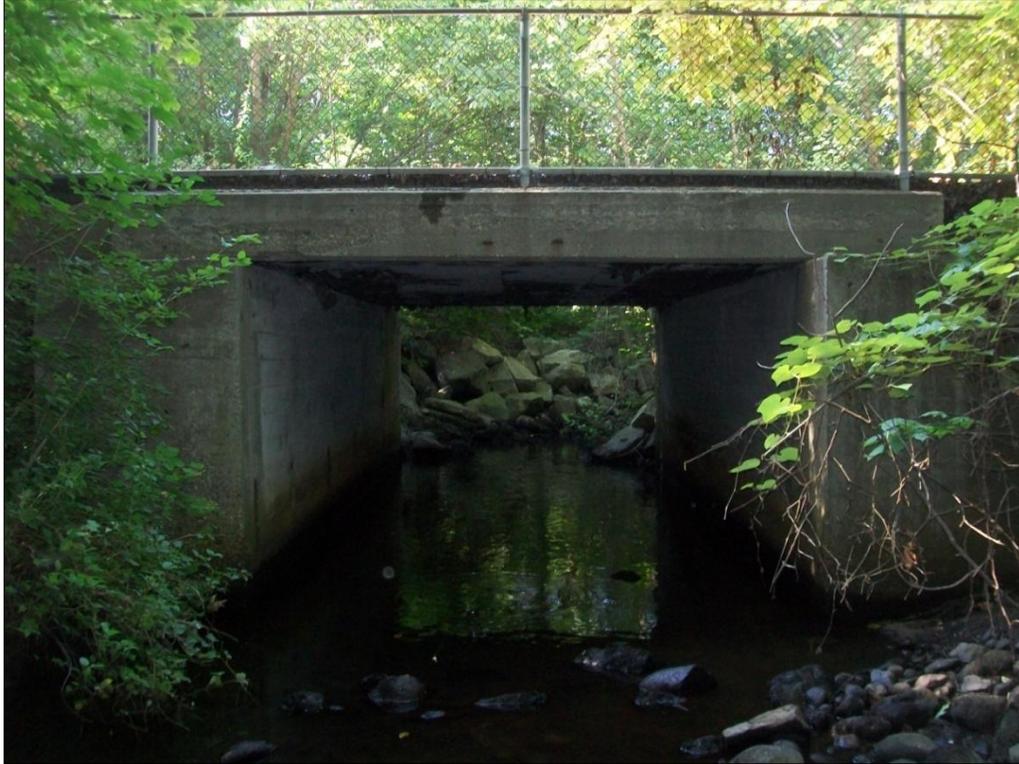
Photo 1 Looking South: North Bridge Elevation

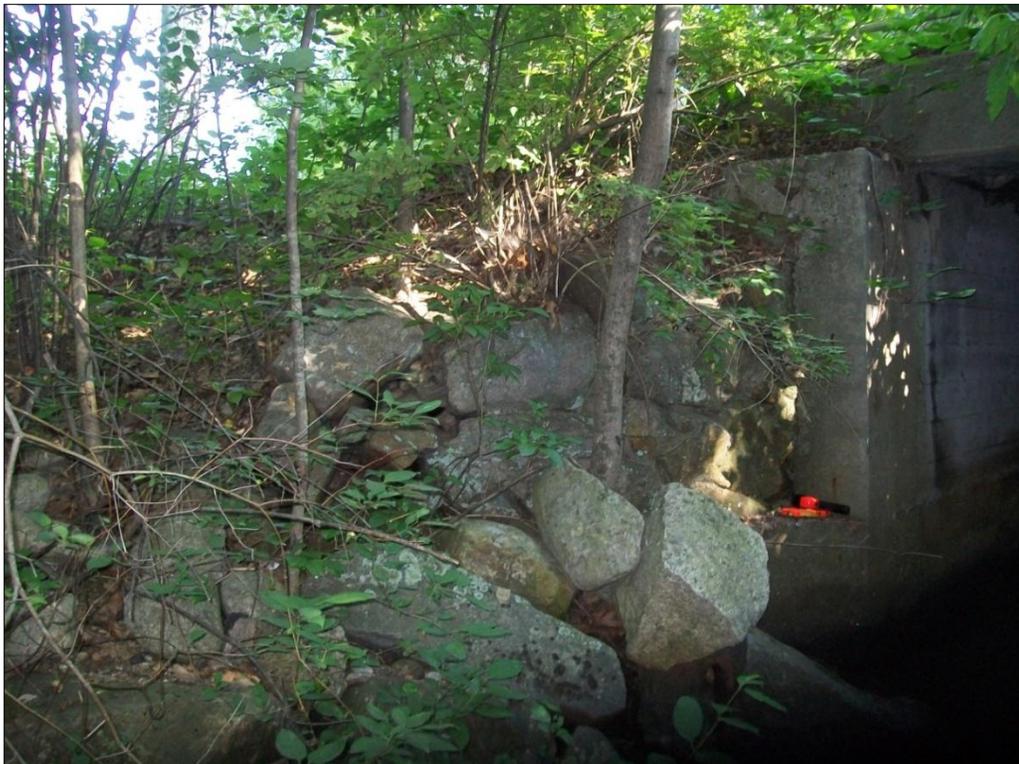
Photo 2 Looking South: Northwest Wingwall Elevation

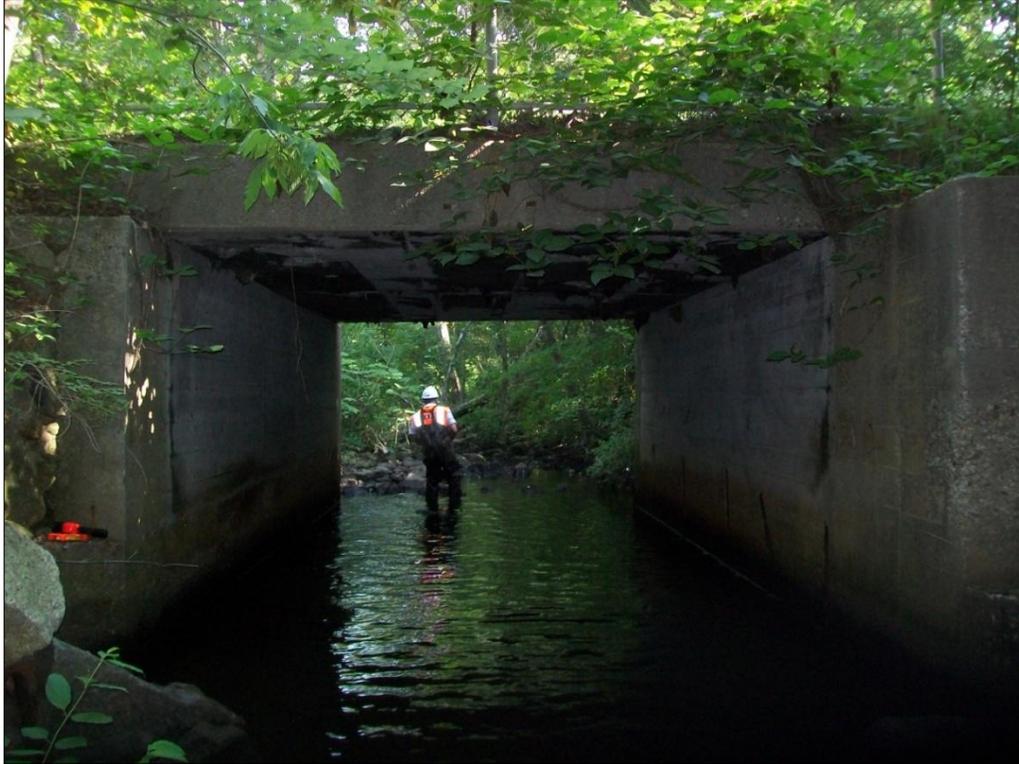
Photo 3 Looking North: South Bridge Elevation

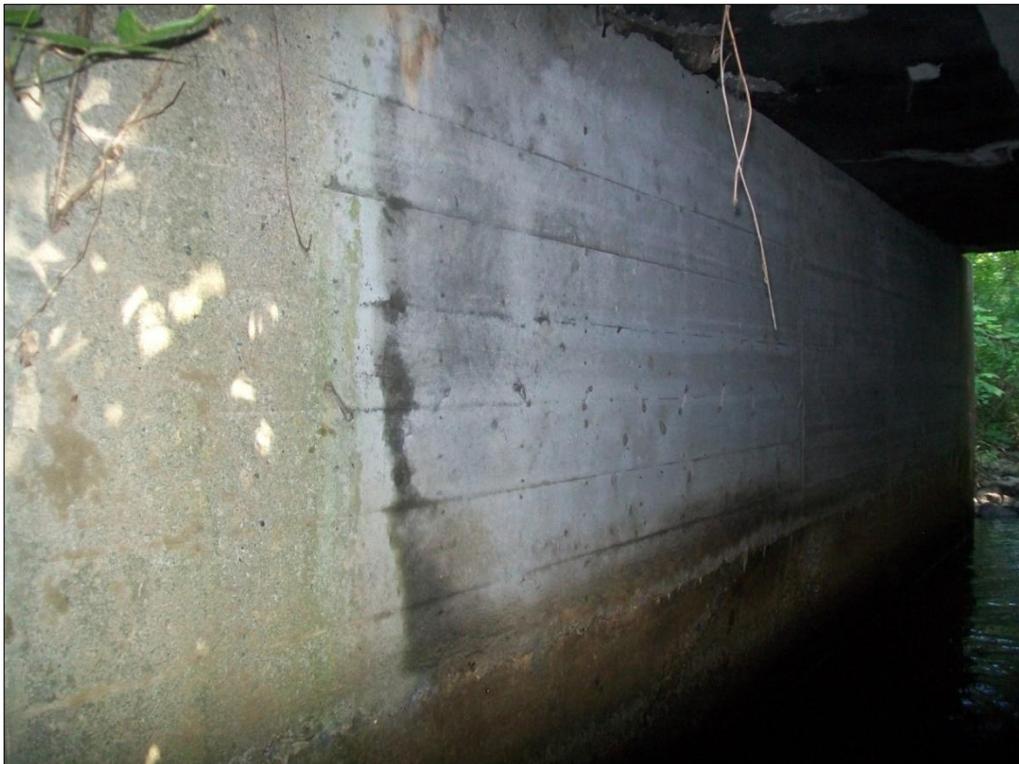
Photo 4 Looking Northwest: West Abutment Elevation

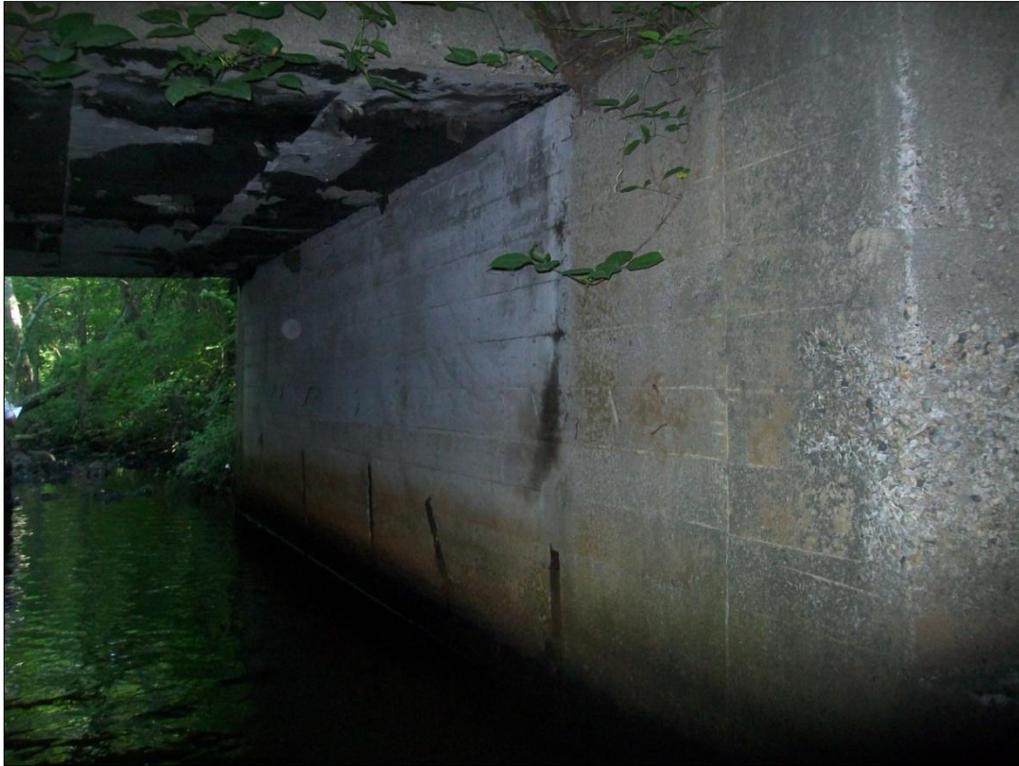
Photo 5 Looking Northeast: East Abutment Elevation

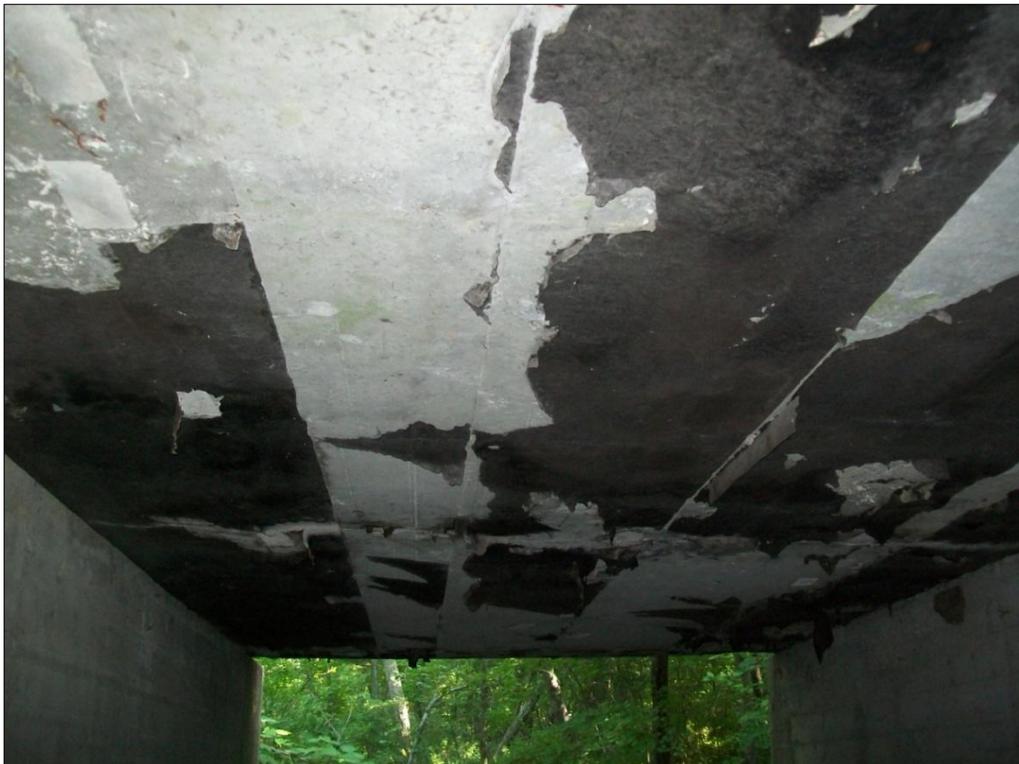
Photo 6 Looking North: Underside of Deck

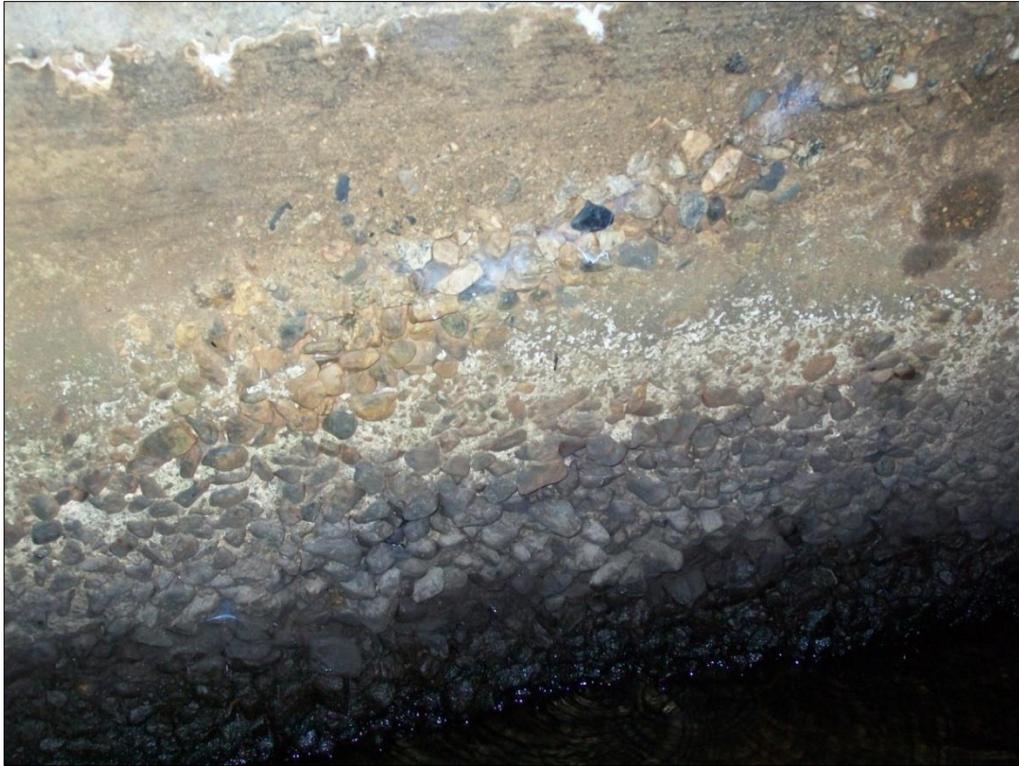
Photo 7 Looking West: Typical Scaling of Culvert Walls

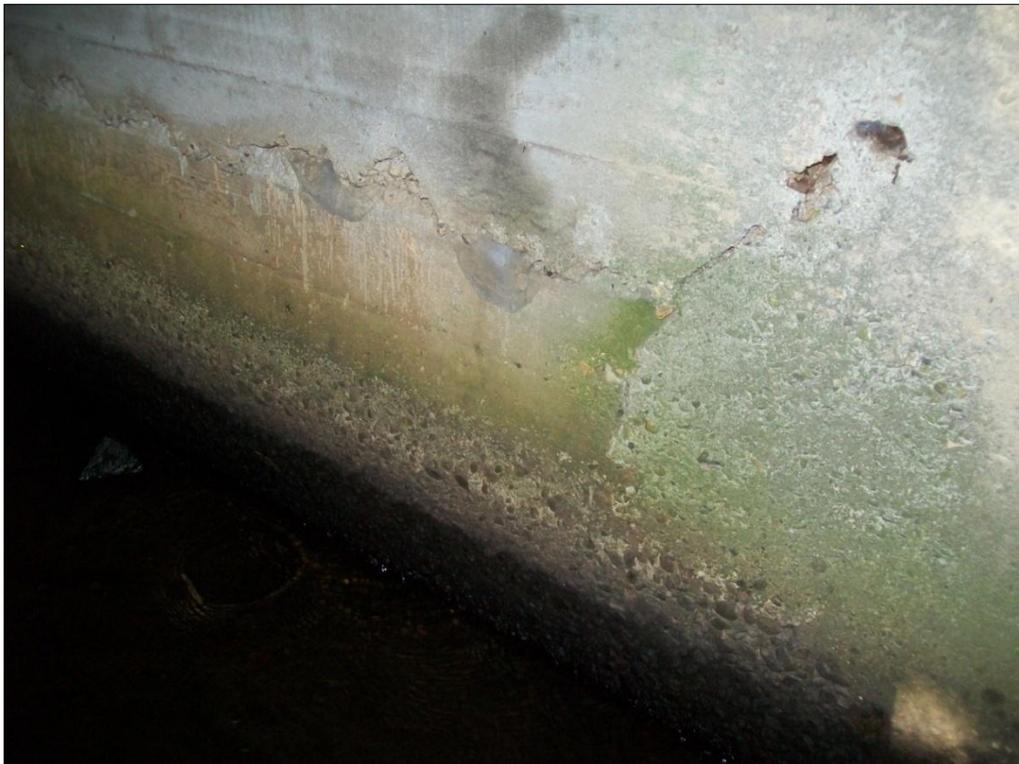
Photo 8 Looking Southwest: Concrete Facing on West Abutment

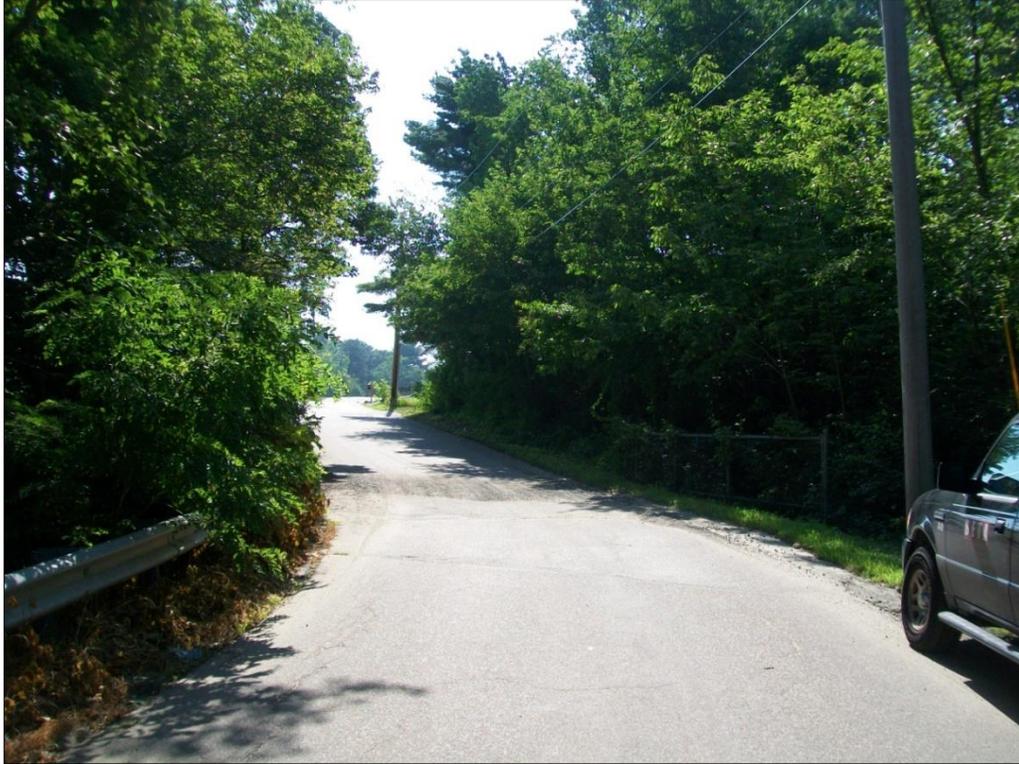
Photo 9 Looking East: West Approach

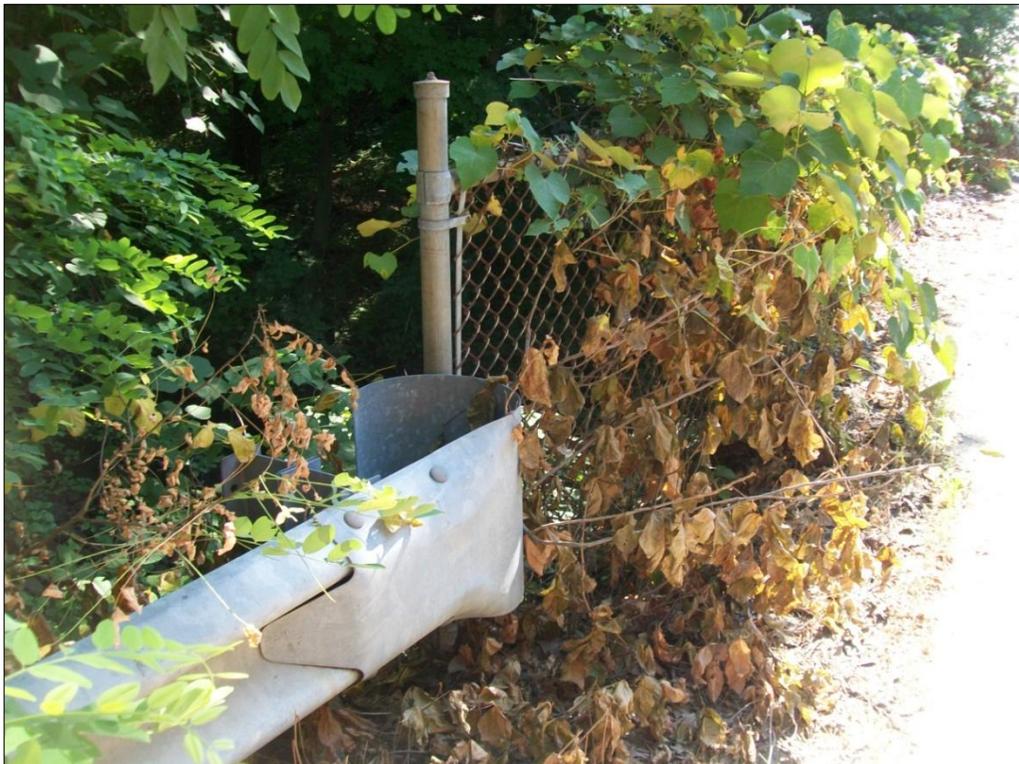
Photo 10 Looking East: Typical Guardrail Transition

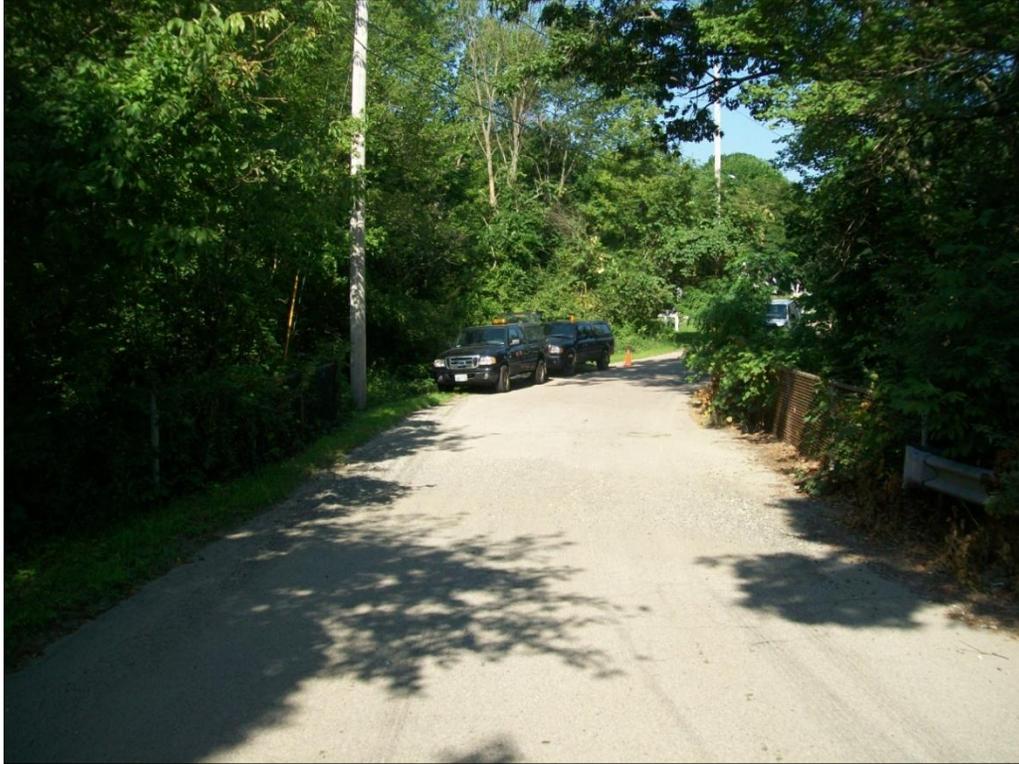
Photo 11 Looking West: East Approach

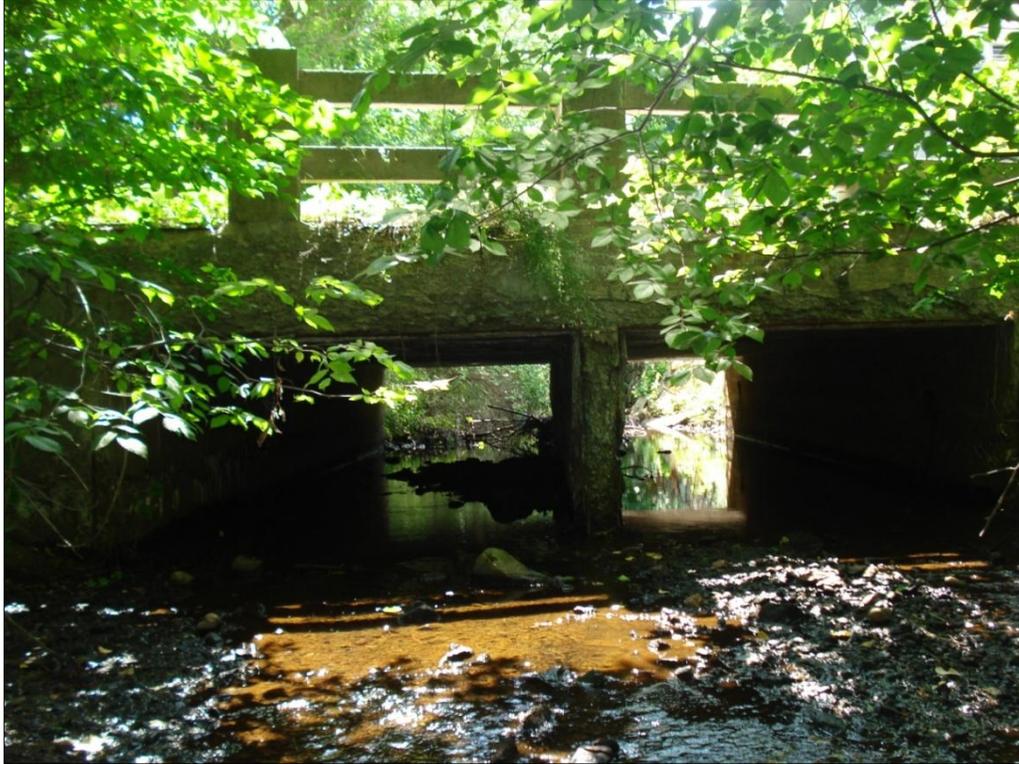
Photo 1 Looking West: East Bridge Elevation

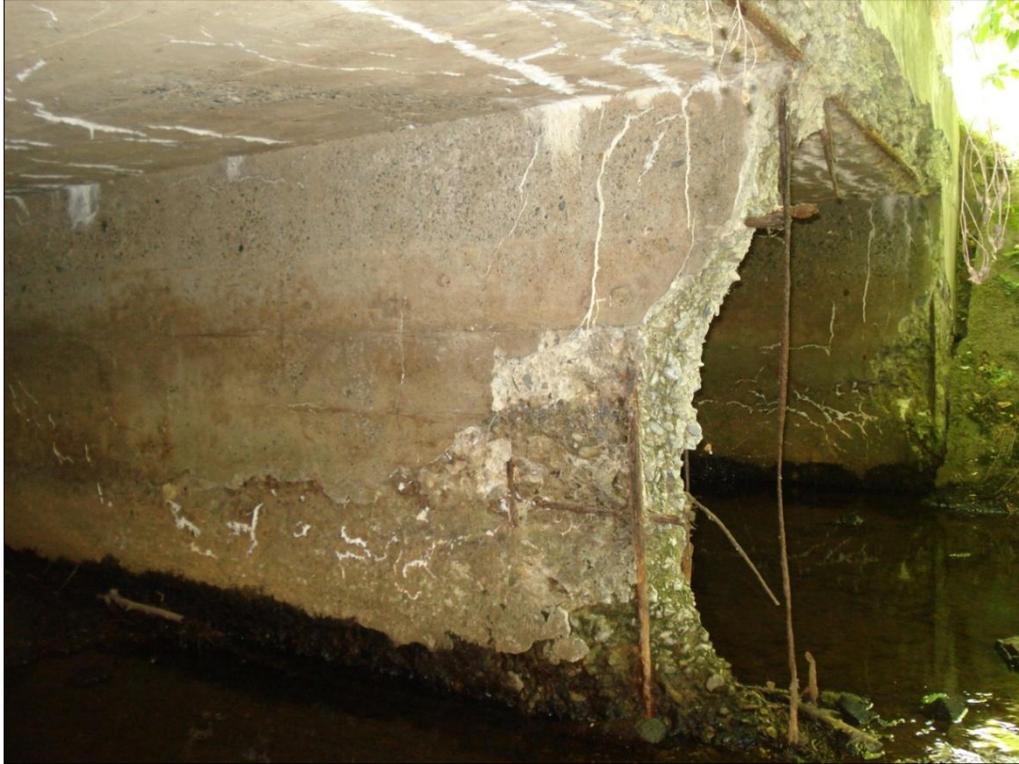
Photo 3 Looking North: East End of Center Pier

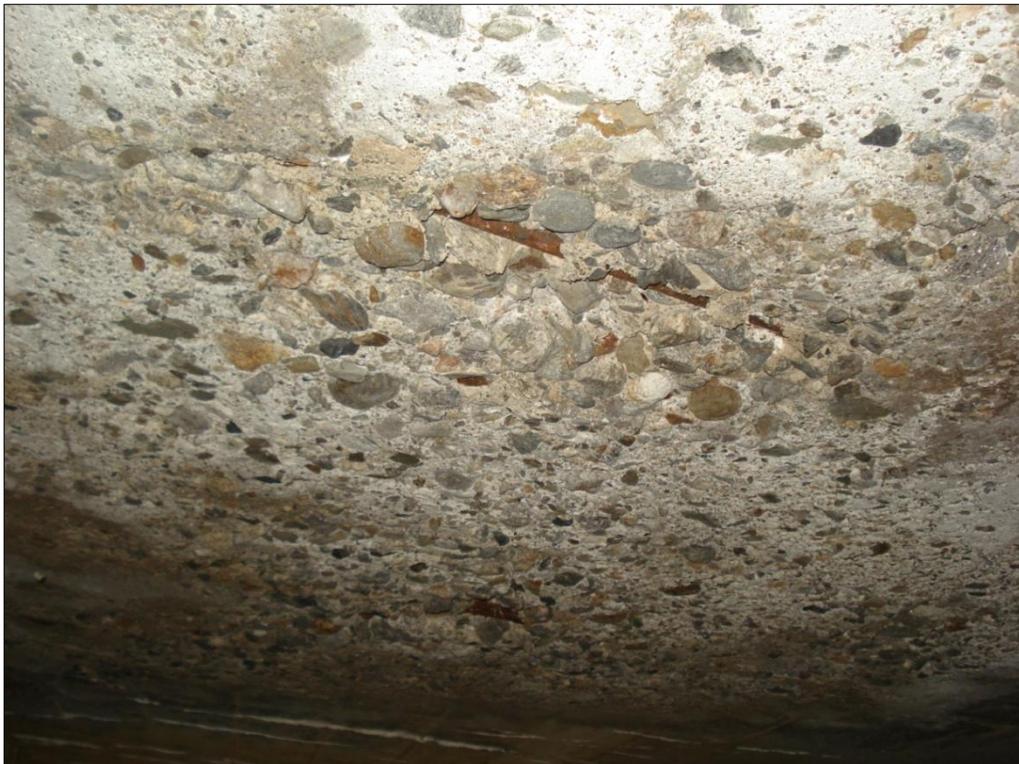
Photo 4 Looking Northwest: Scaling on Underside of Slab in South Span

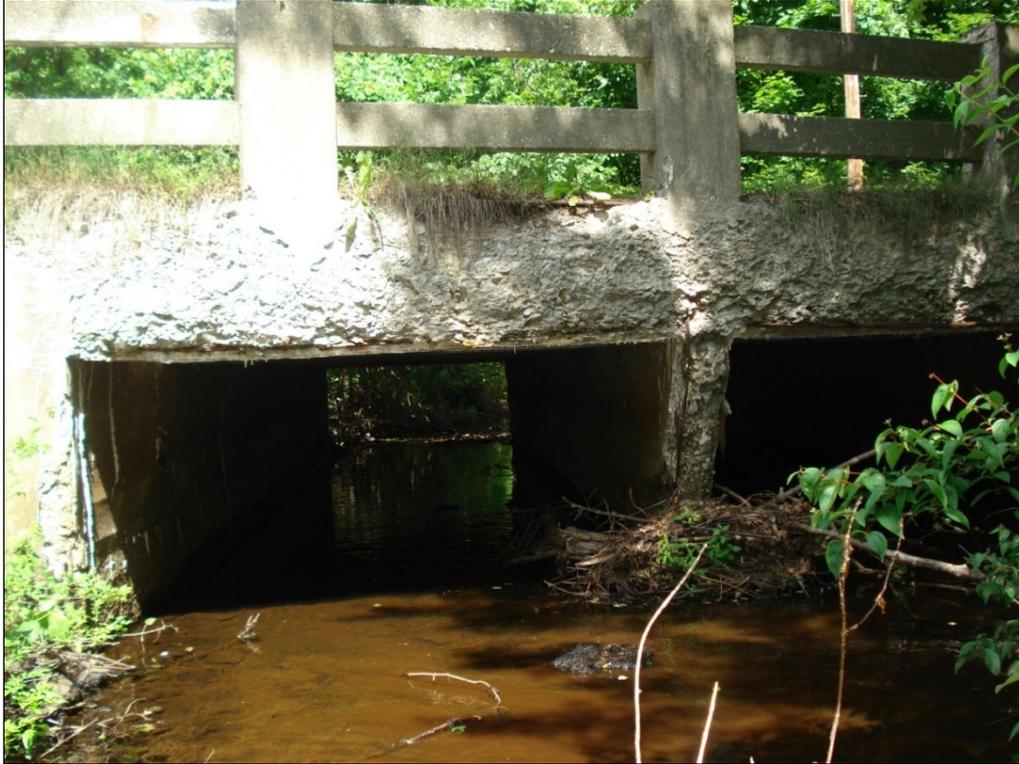
Photo 5 Looking East: West Bridge Elevation

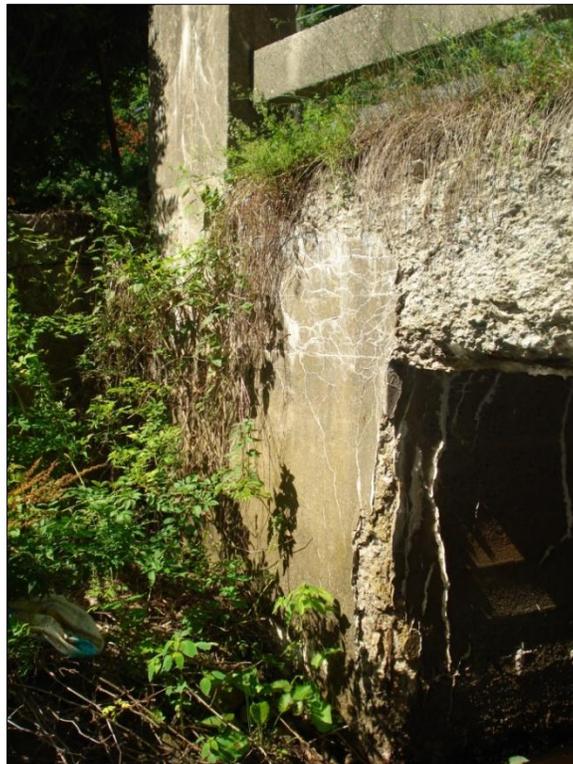
Photo 6: Typical Wingwall Elevation

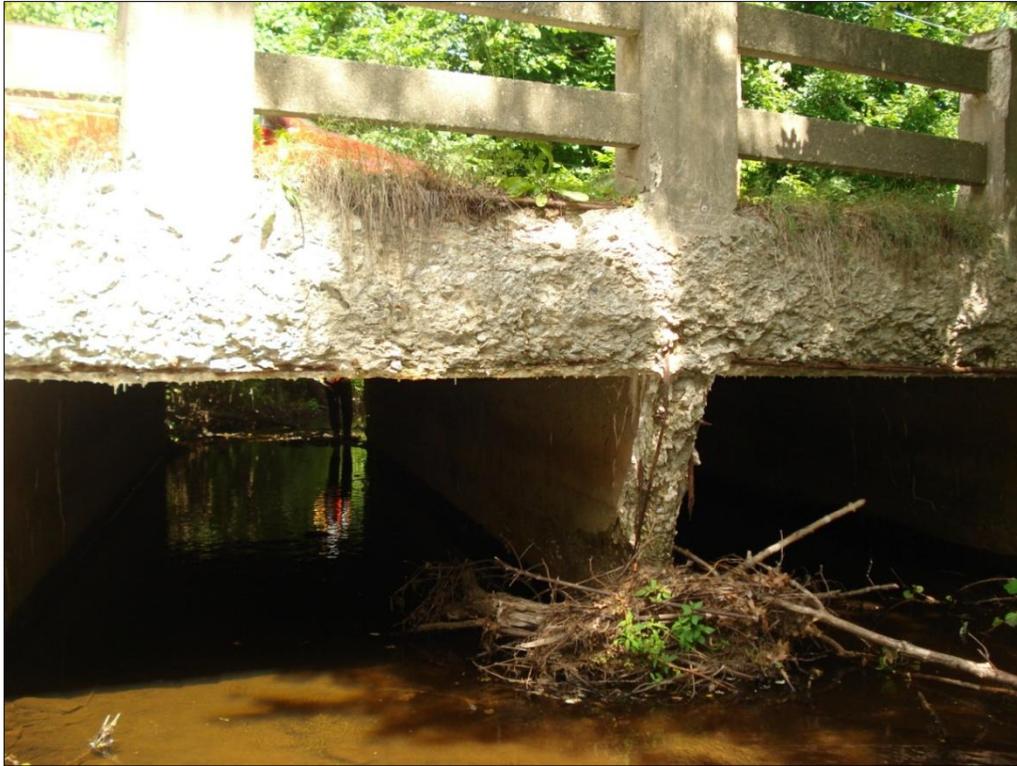
Photo 7 Looking East: West Headwall Elevation

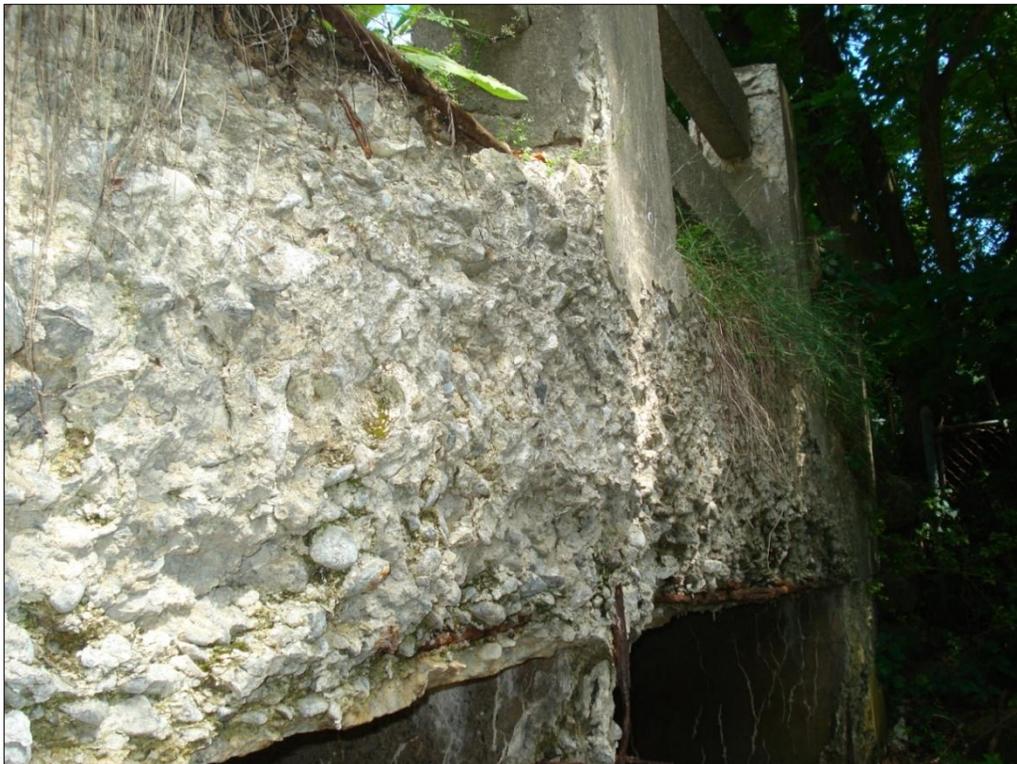
Photo 8 Looking South: Deterioration of West Headwall

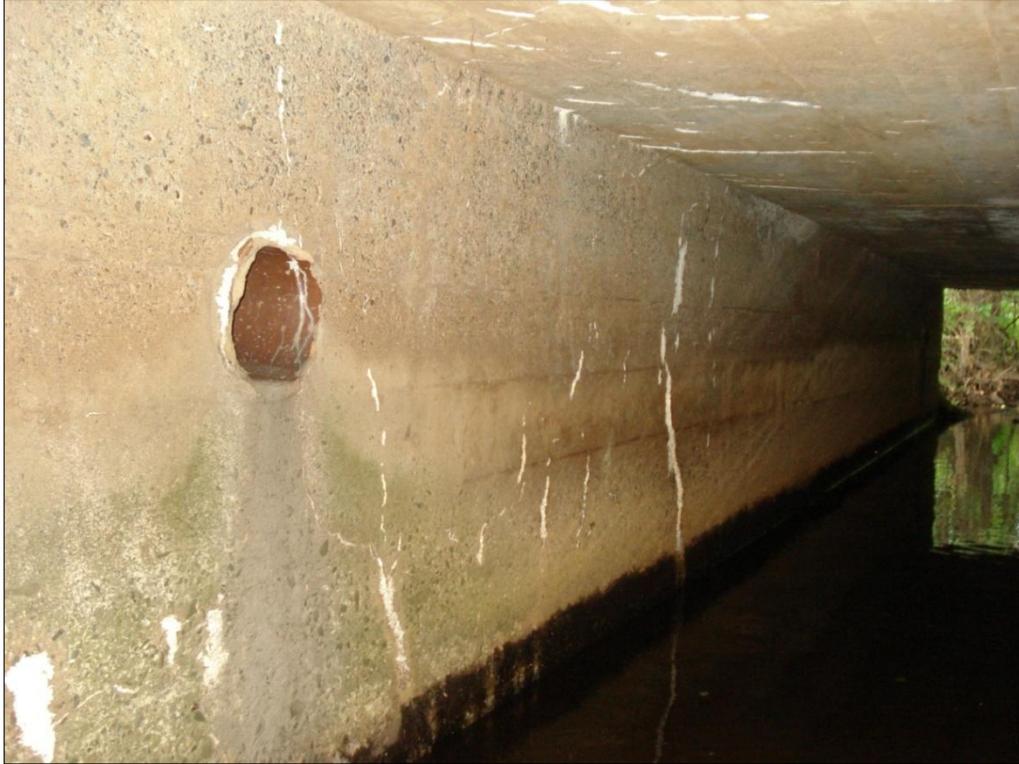
Photo 9 Looking Northeast: North Abutment Elevation

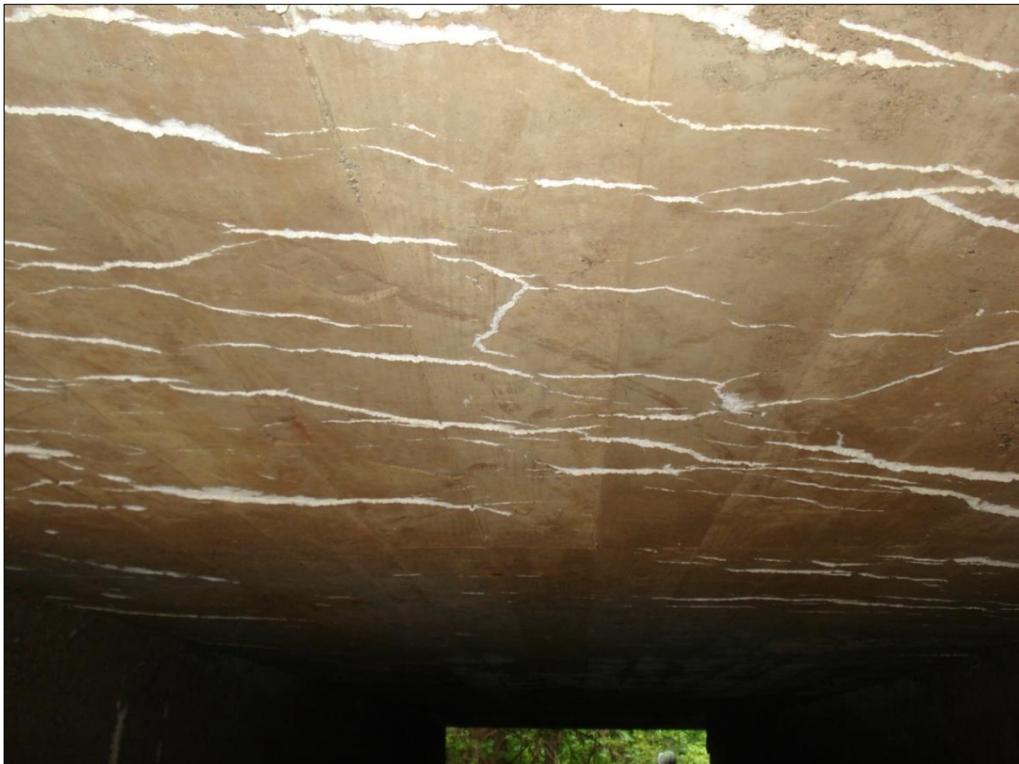
Photo 10: Typical Underside of Slab

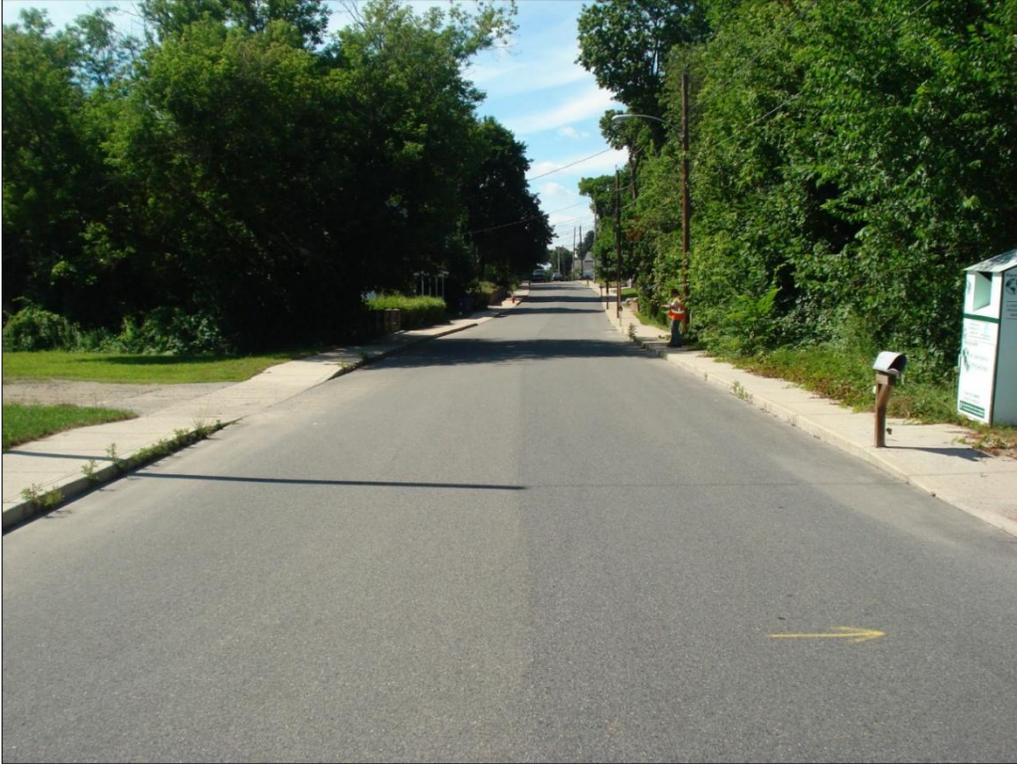
Photo 11 Looking North: South Approach

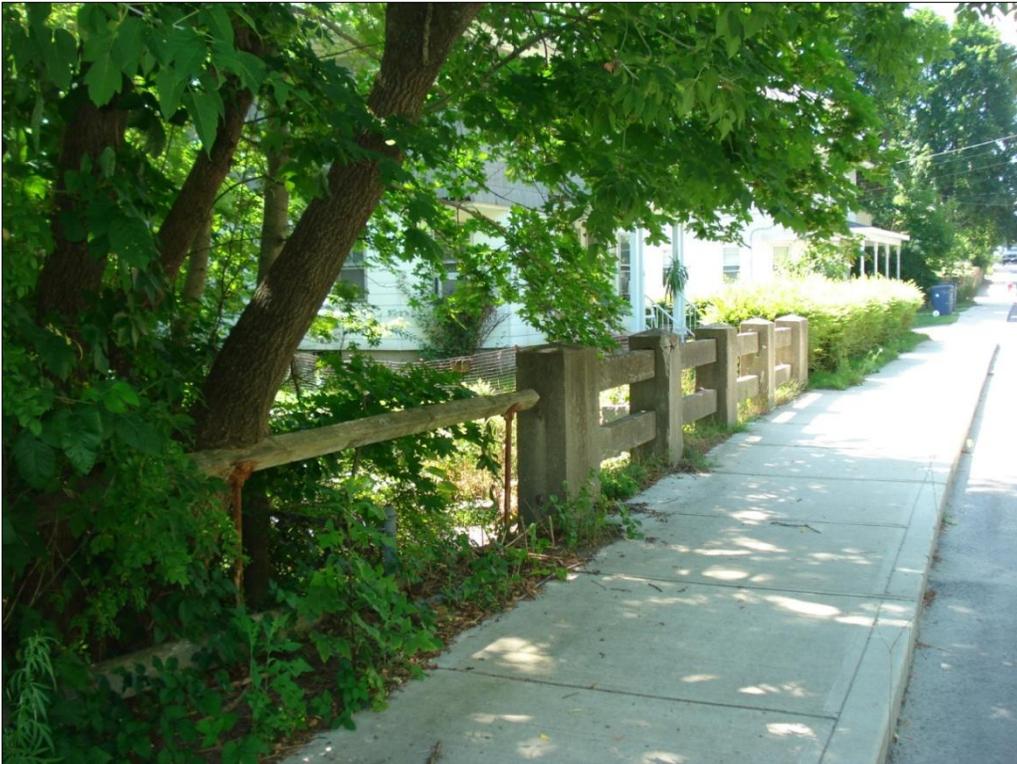
Photo 12: Typical Bridge Rail

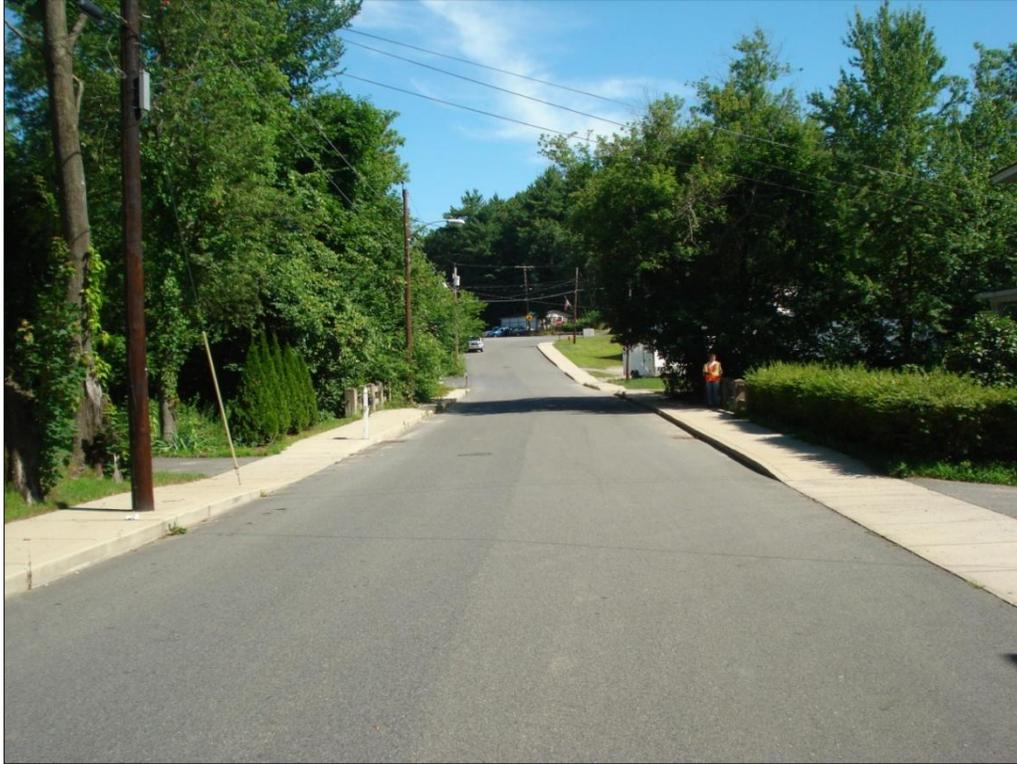
Photo 13 Looking South: North Approach

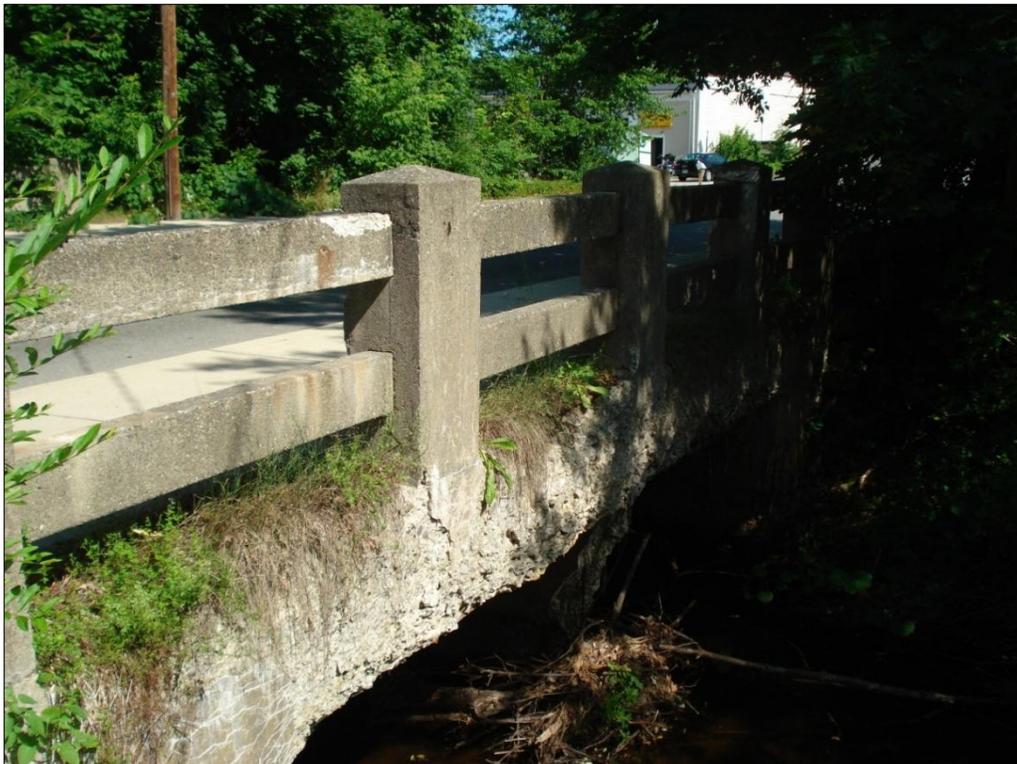
Photo 14: Typical Bridge Rail Base Deterioration

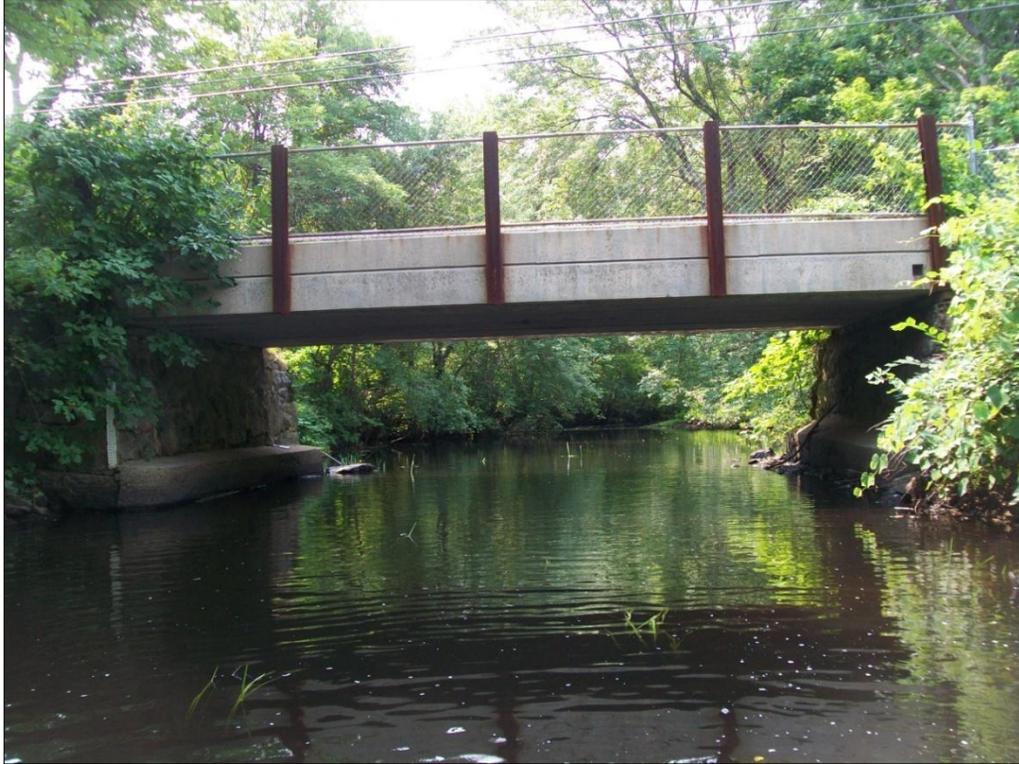
Photo 1 Looking South: North Bridge Elevation

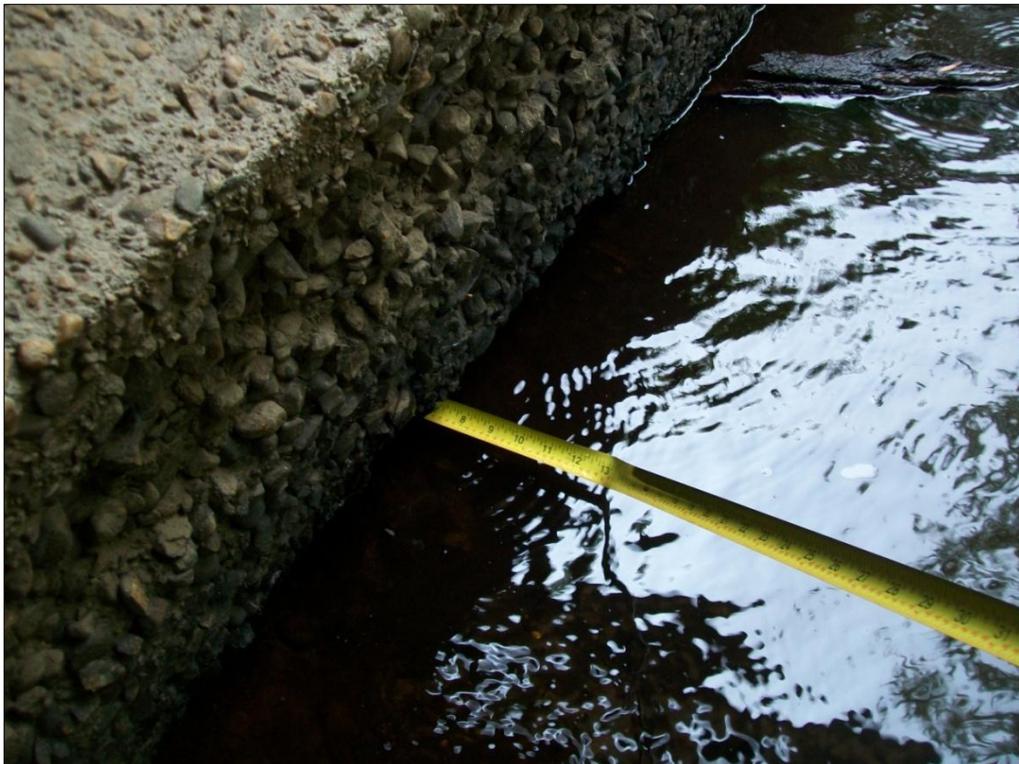
Photo 2 Looking Down: Scour at Base of East Abutment Footing

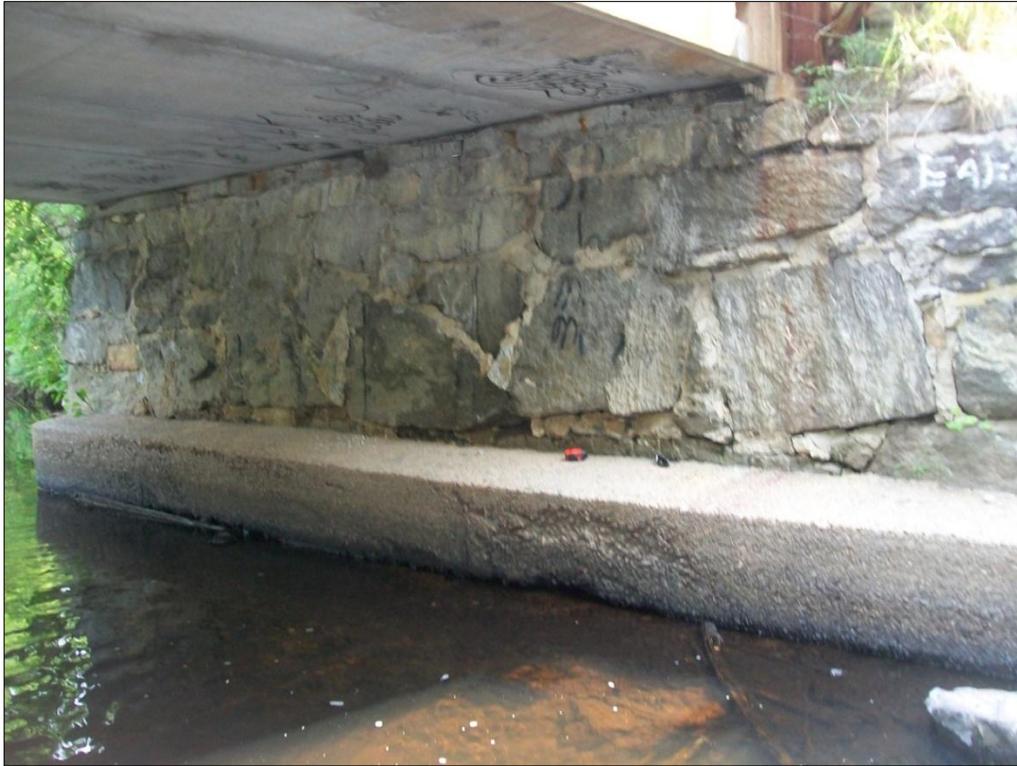
Photo 3 Looking East: East Abutment Elevation
