Bridge/Culvert Management Plan

November 2011

Uxbridge
Massachusetts

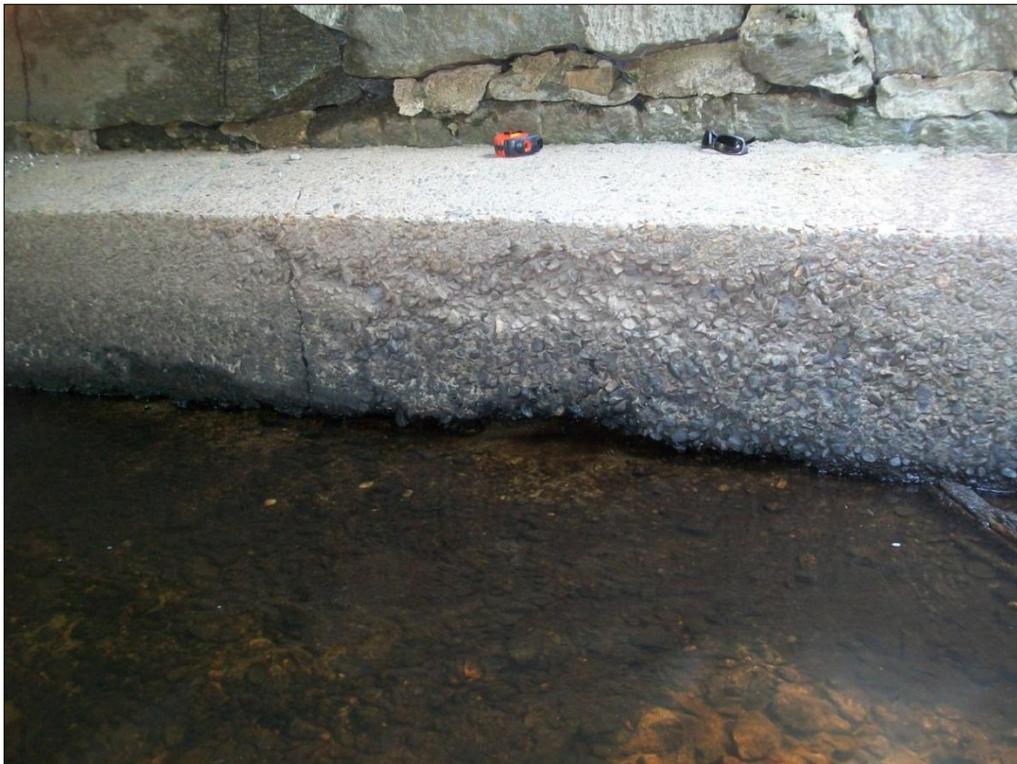
Photo 4 Looking East: Scaling and Scour of East Abutment Footing

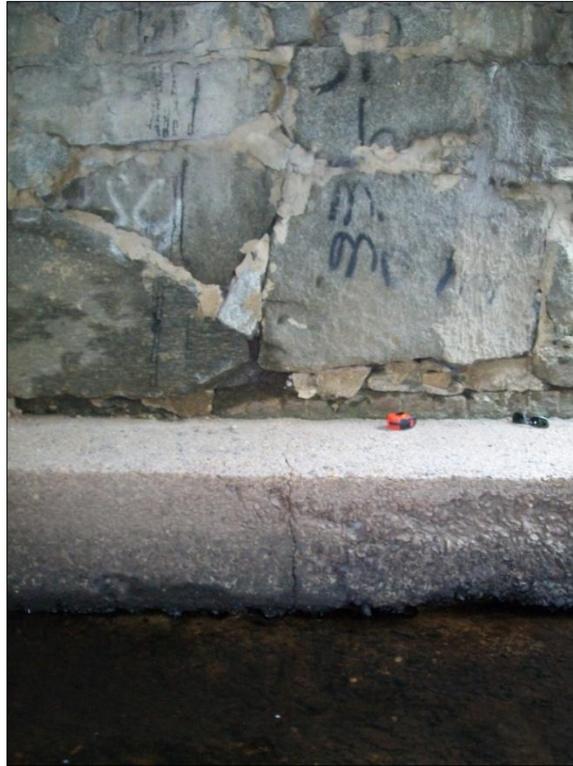
Photo 5 Looking East: Vertical Crack in East Abutment Footing

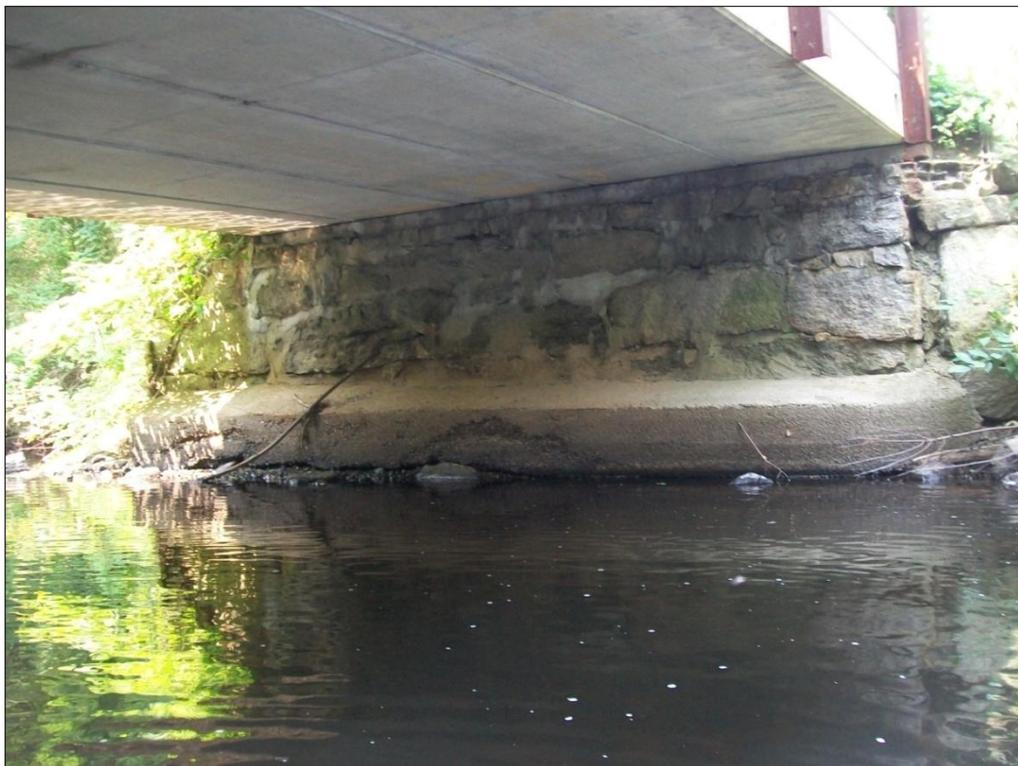
Photo 6 Looking West: West Abutment Elevation

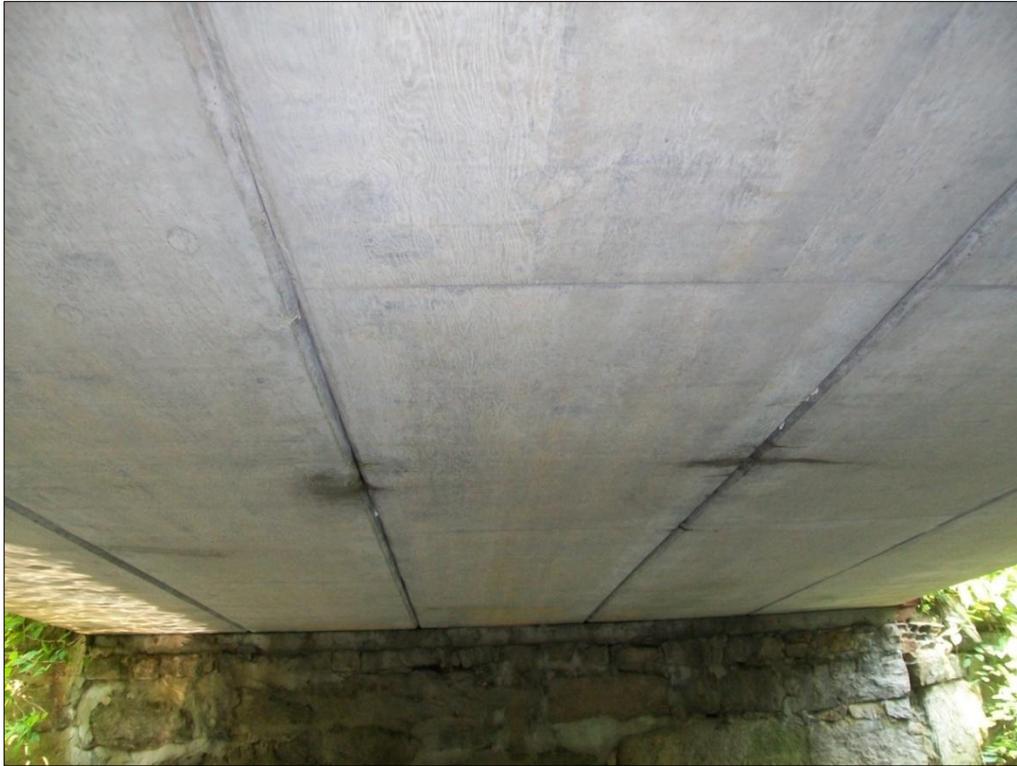
Photo 7 Looking West: General Underside of Deck

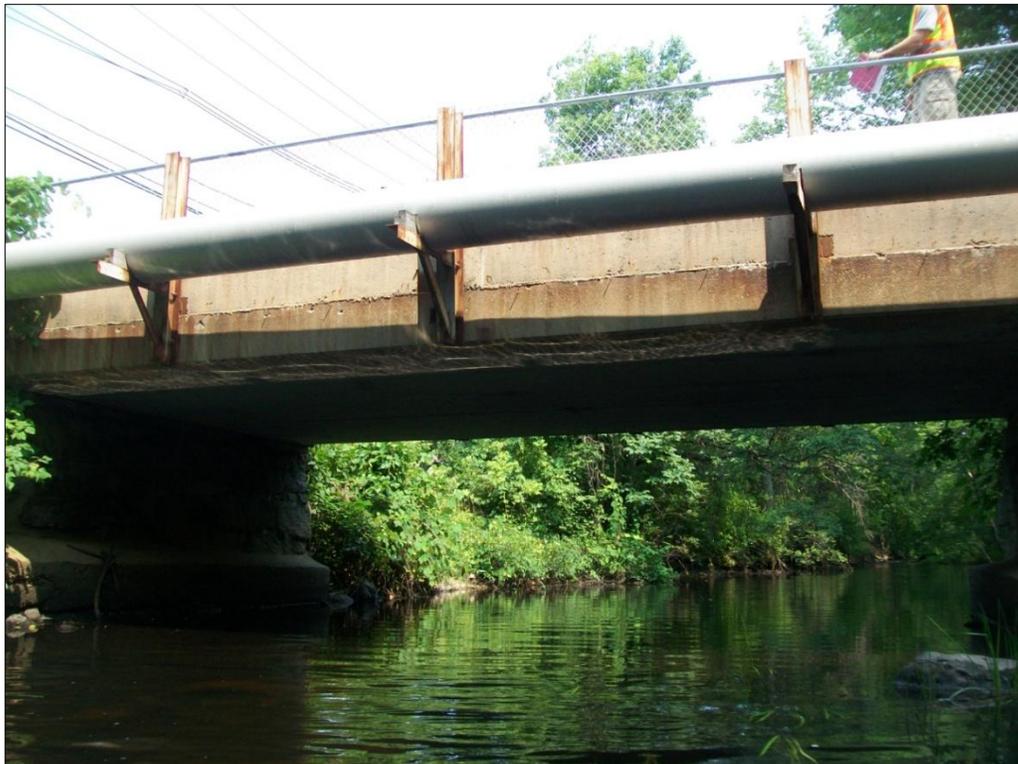
Photo 12 Looking South: North Bridge Elevation

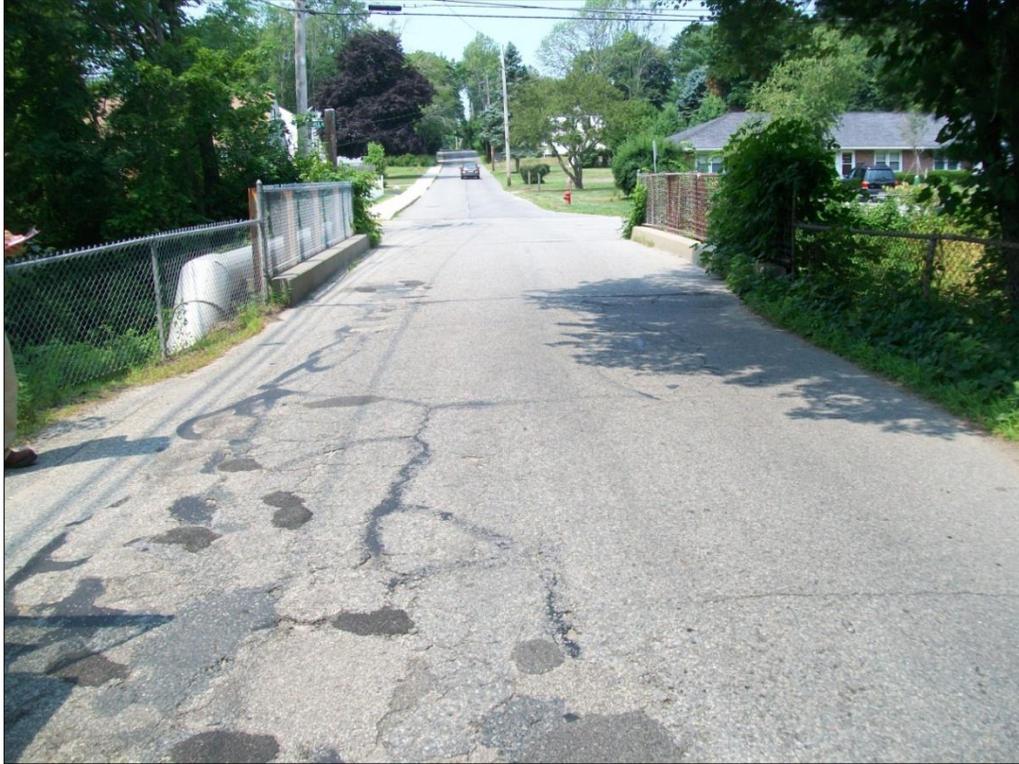
Photo 13 Looking West: East Approach

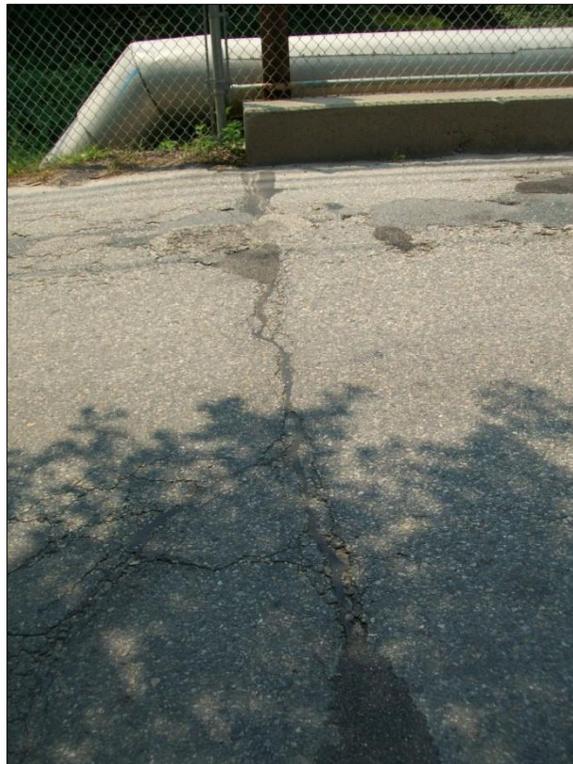
Photo 14 Looking South: Cracking at South Bridge Joint

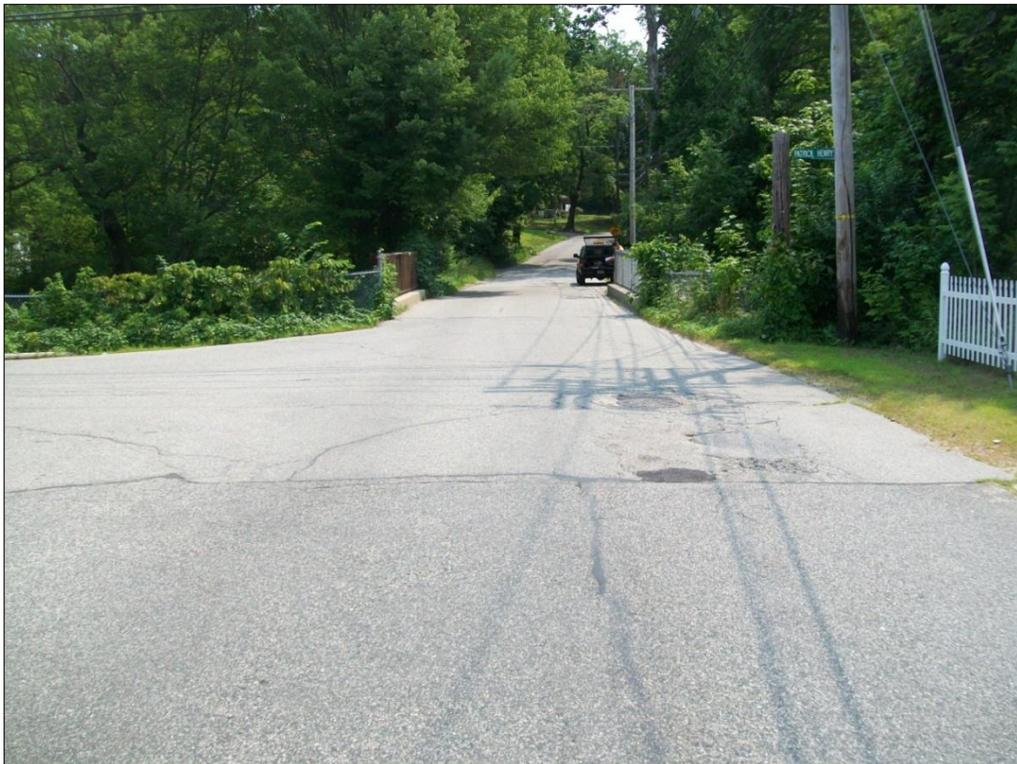
Photo 16 Looking East: West Approach

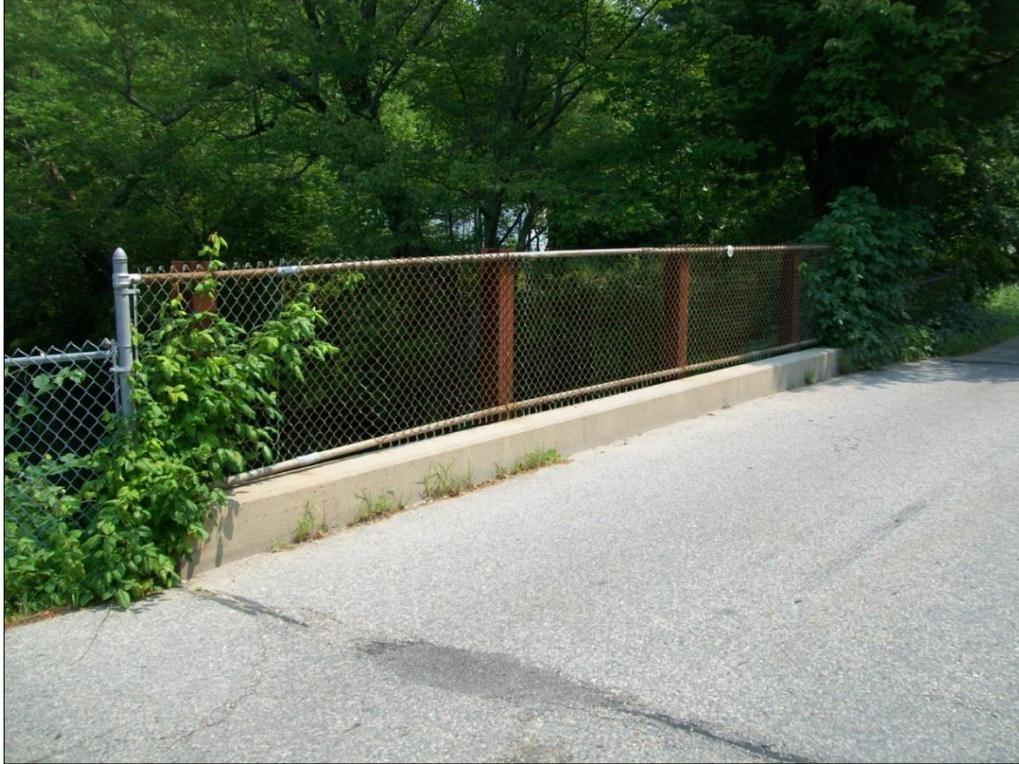
Photo 17 Looking Northeast: Typical Bridge Rail

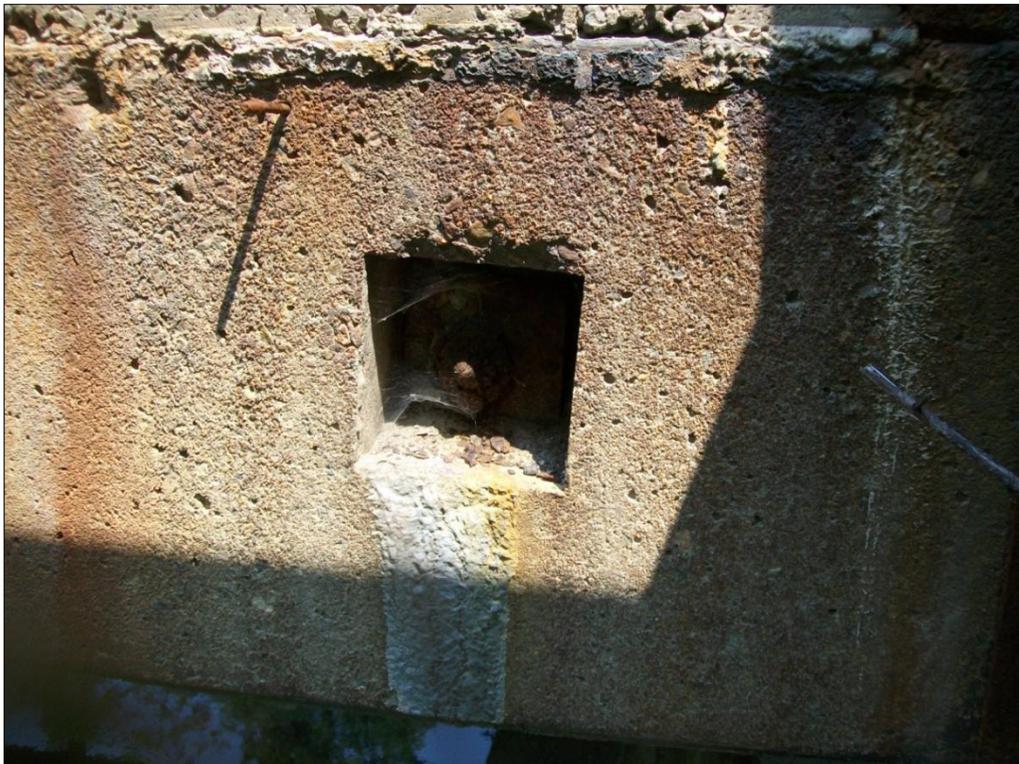
fascia were not grouted; as a result the post tension tie heads are exhibiting moderate corrosion (Photo 18).

Photo 18 Looking North: Typical Non-Grouted Post-Tensioning Port

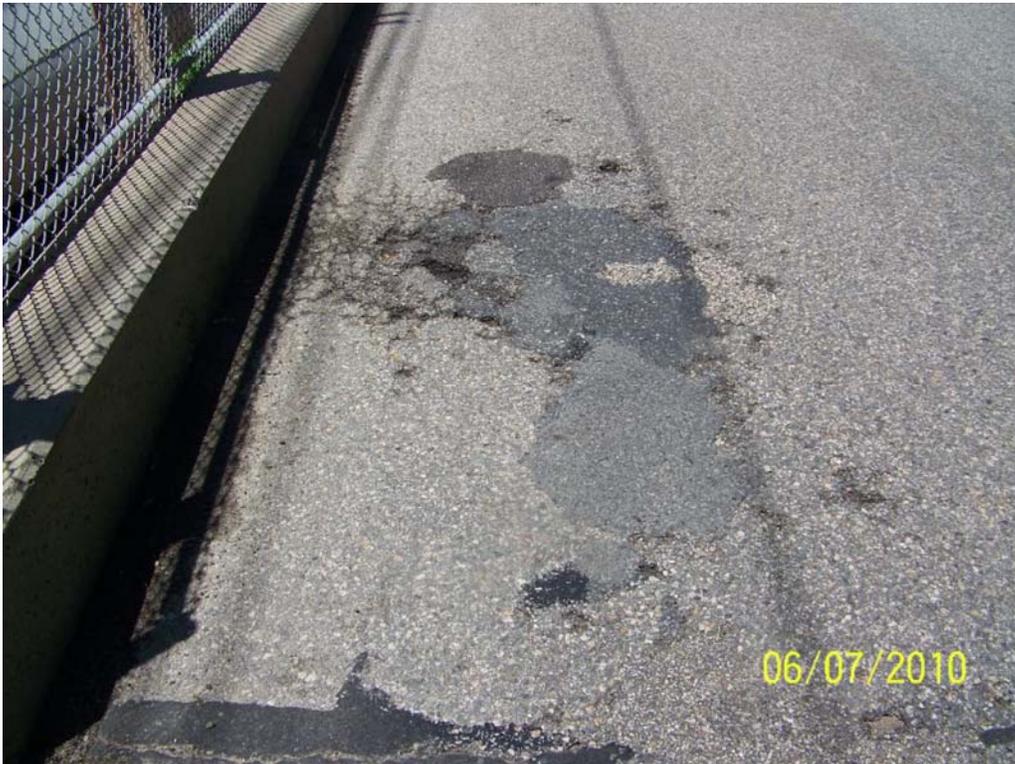
Photo 1: Pop and patch to the Southeast corner of the bit. concrete wearing surface.

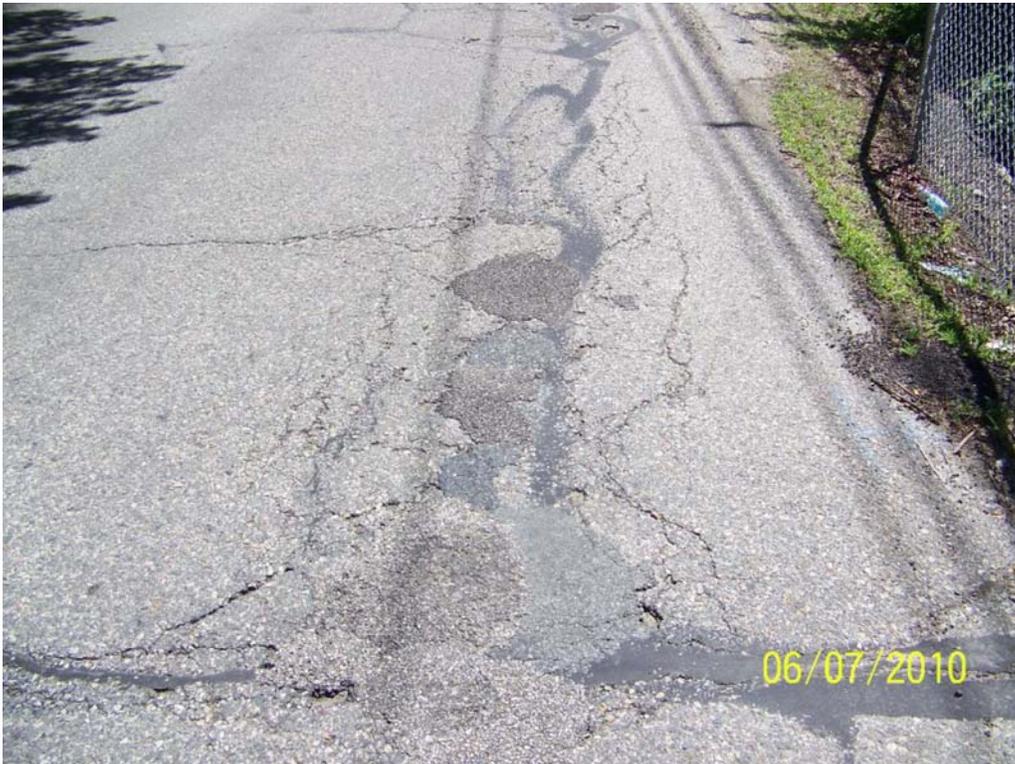
Photo 3: Moderate pop and patch at the Southeast corner approach.

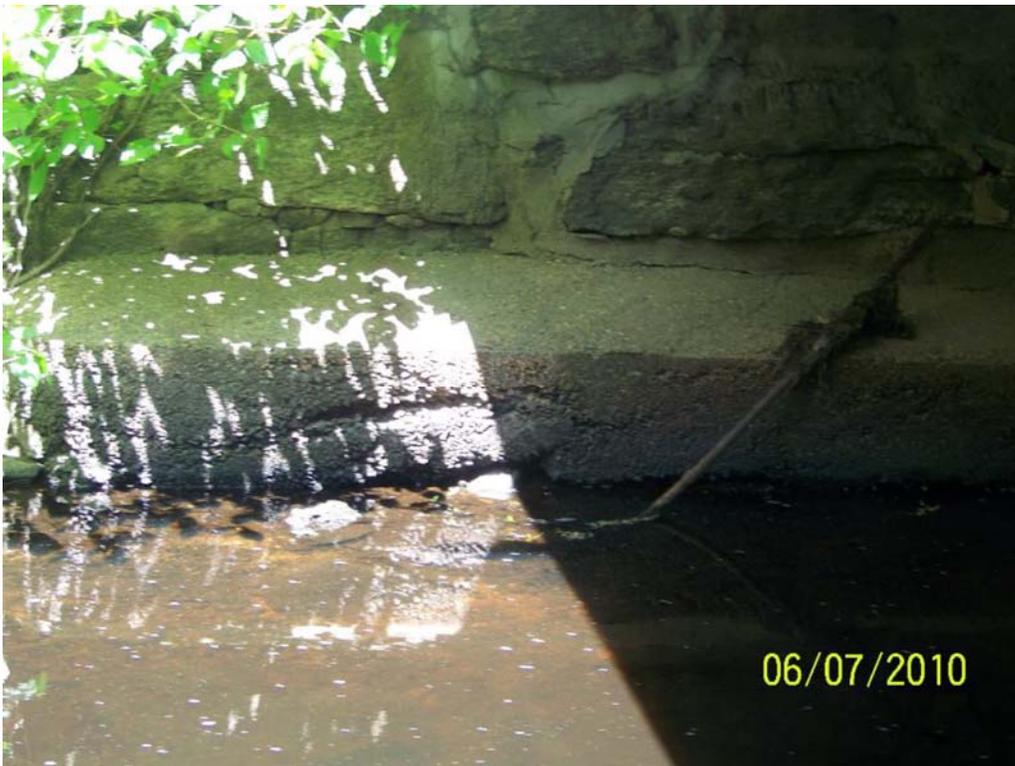
Photo 5: Abrasion and honeycombing to the Southwest corner footing.

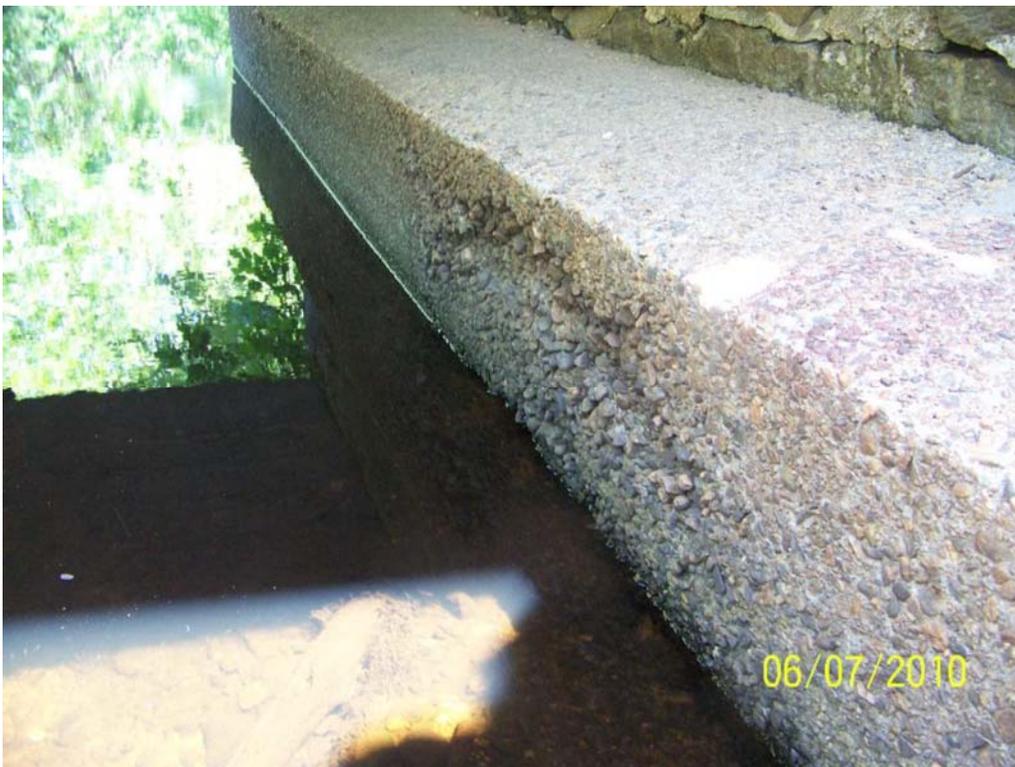
Photo 6: Abrasion and honeycombing to the Southeast corner footing.

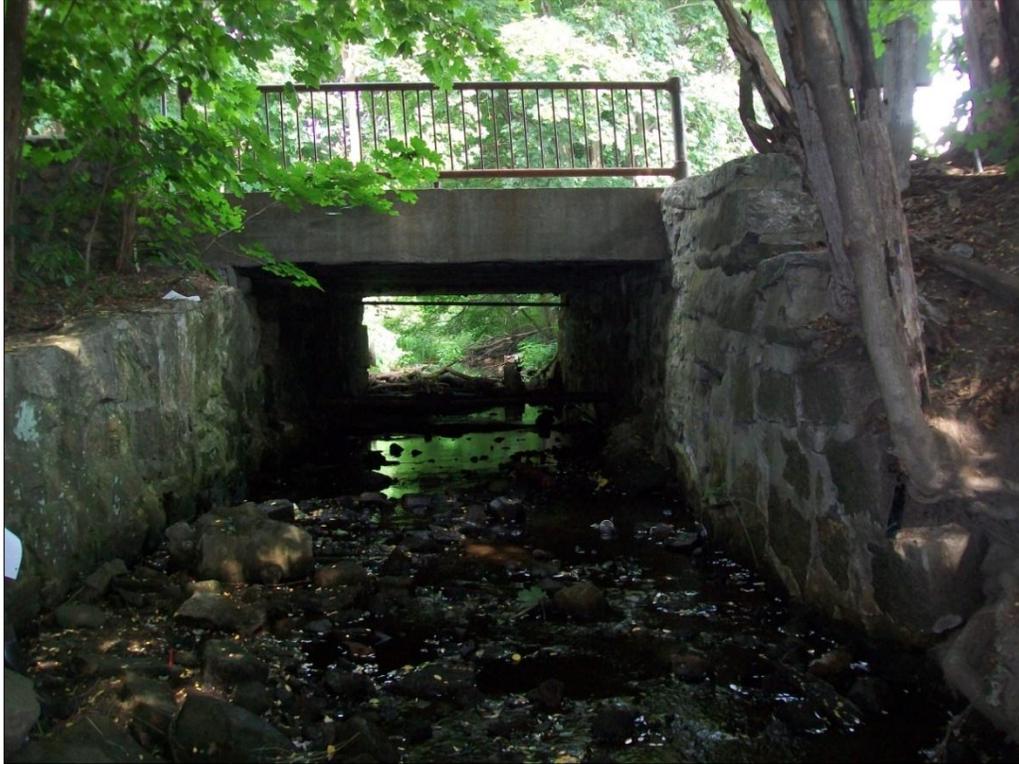
Photo 1 Looking West: East Culvert Elevation

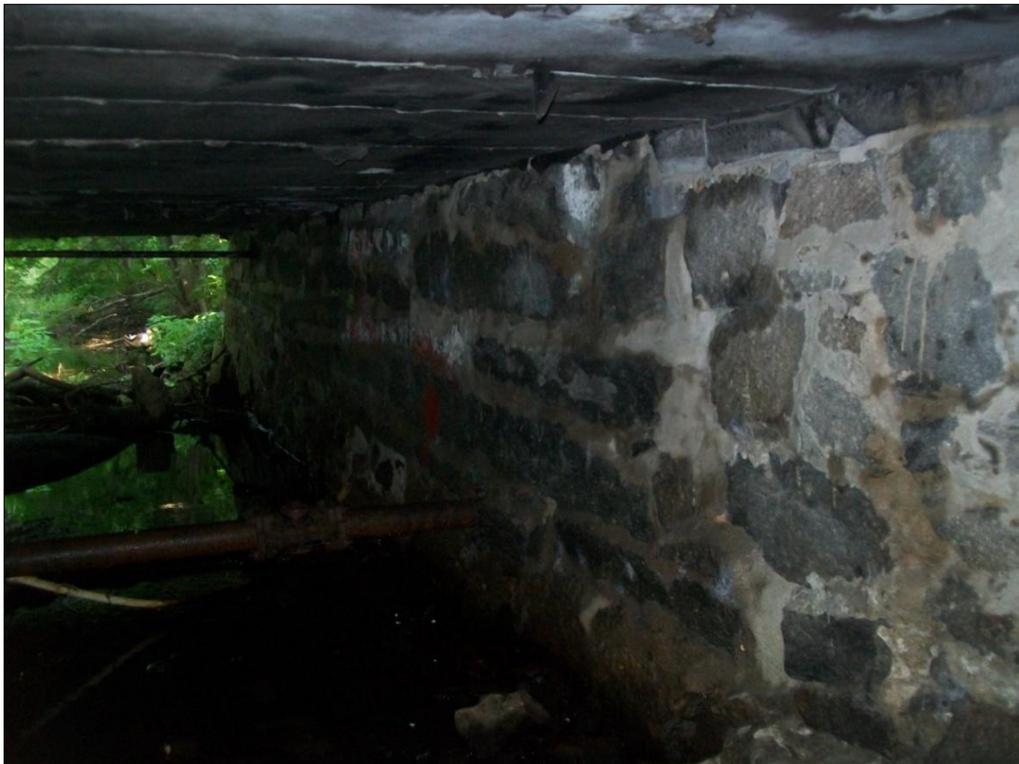
Photo 3 Looking Northwest: North Abutment Elevation

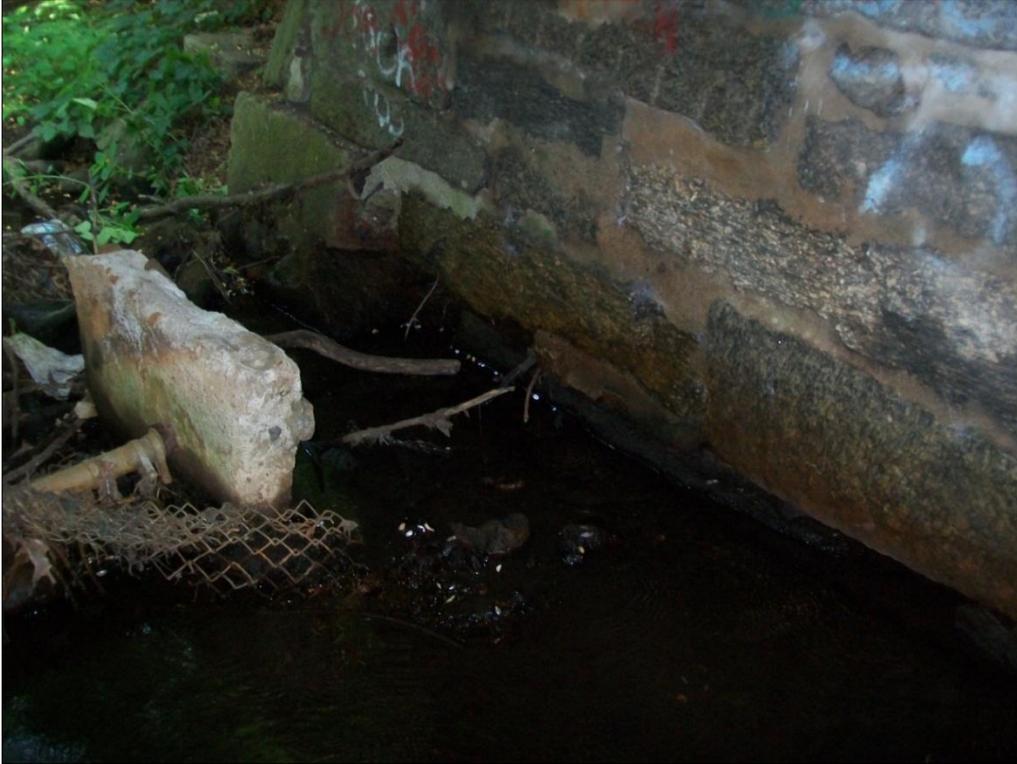
Photo 3 Looking Northwest: Crumbling of North Abutment Base at West End

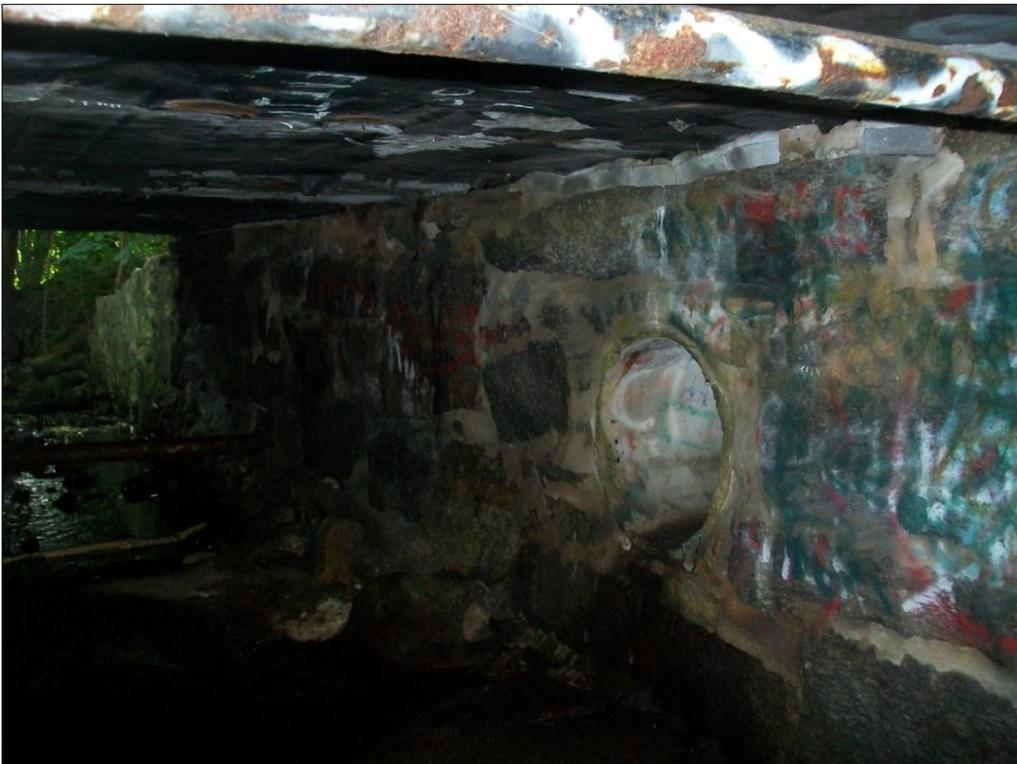
Photo 4 Looking Southeast: South Abutment Elevation

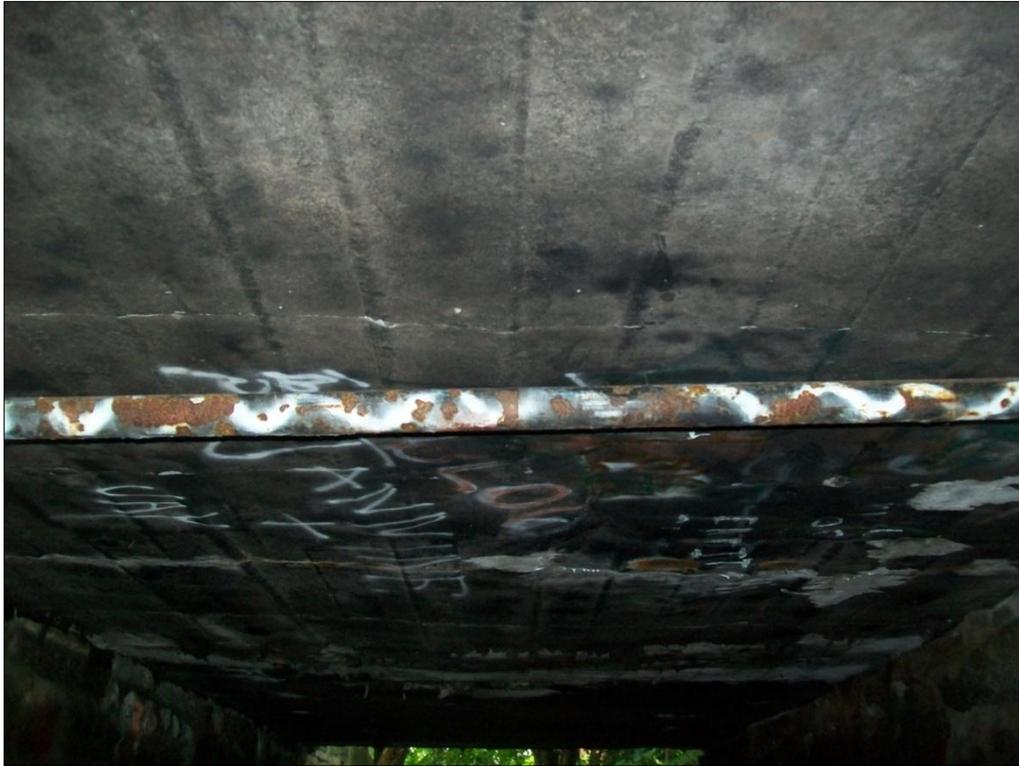
Photo 5 Looking East: Underside of Slab

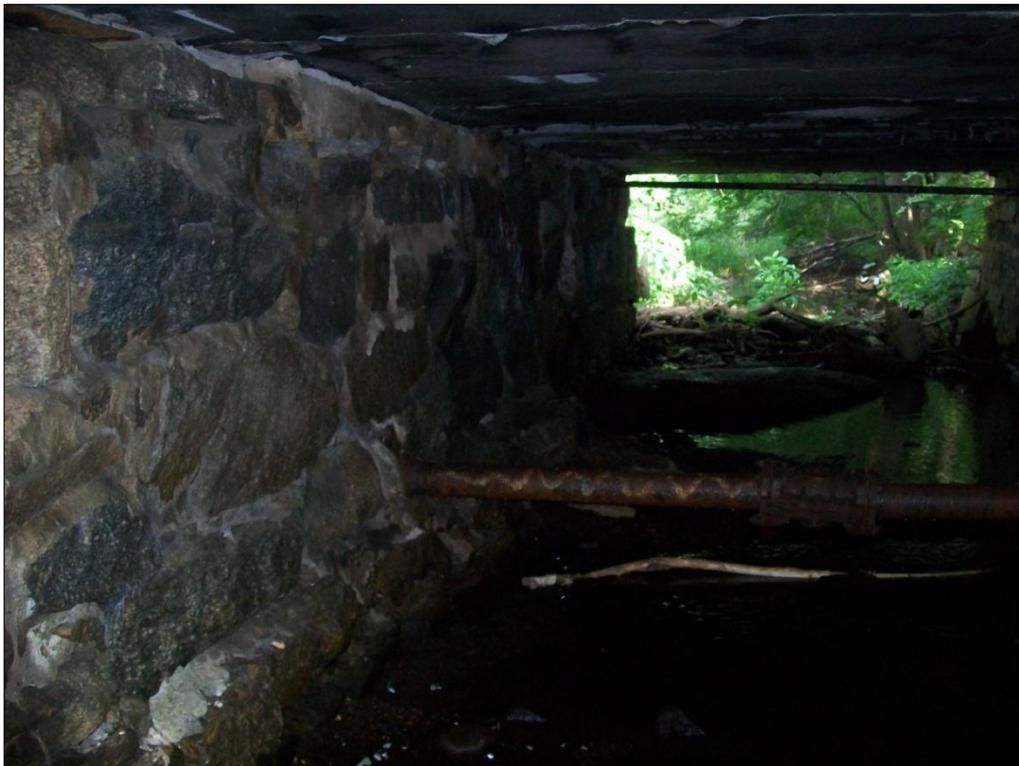
Photo 6 Looking West: South Abutment Elevation

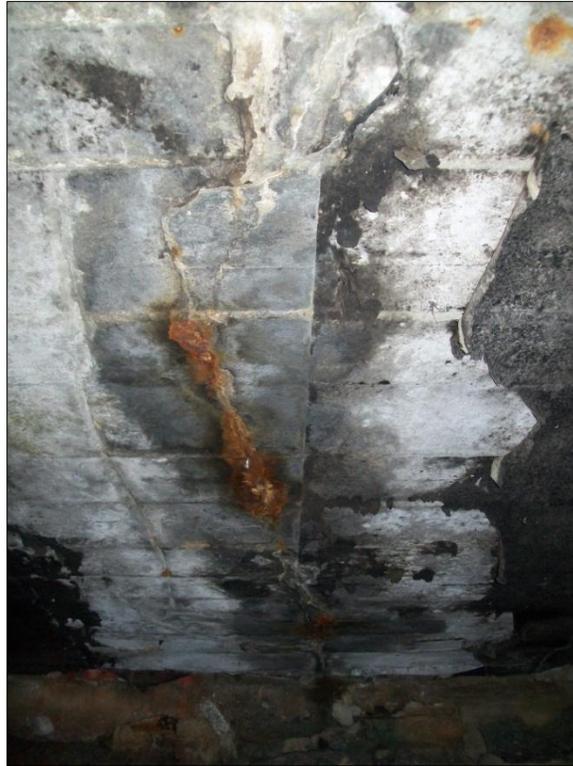
Photo 7 Looking South: Full Penetration Crack in Center of Slab

Guard Rail Type:	West: Chainlink fence mounted to headwall w/no approach rail. East: metal bridge rail w/ mortared stone wall to south.		
Guard Rail Condition:	West: Moderate surface rust. Missing post. No transition from wall to rail. Rated 1 East: fence leaning away from road, very bent. Rated 2		
Guard Rail Rating:	2 - East; 1 - West		
Guard Rail Notes:	No Curb at all on West side of roadway. Over culvert has moderate slab wear at wheel lines and light scaling (TYP). Slab has one large crack up to 1/8" wide at center (long.) Rust and efflo. Asphalt patching on top in same spot. Full depth penetration split in slab. Recommendation: Remove damp proofing and repair all cracks (especially full penetration cracks).

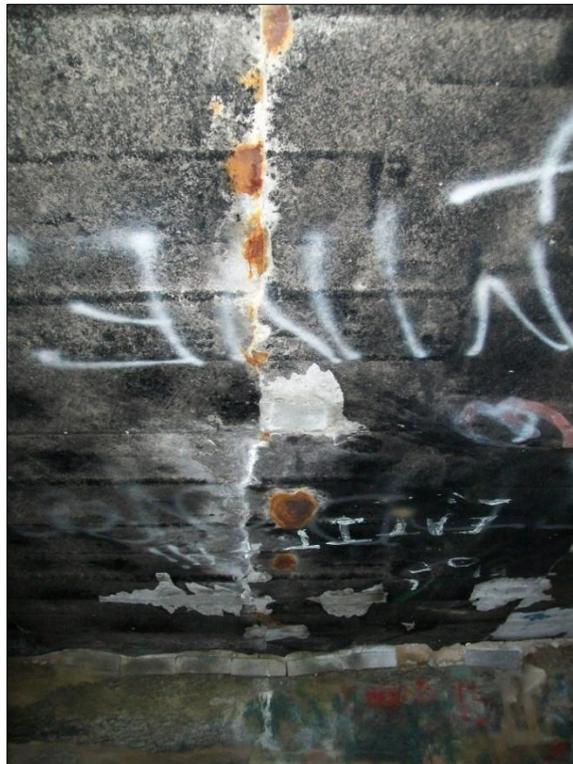
Photo 8 Looking South: Full Penetration Crack at Western Edge

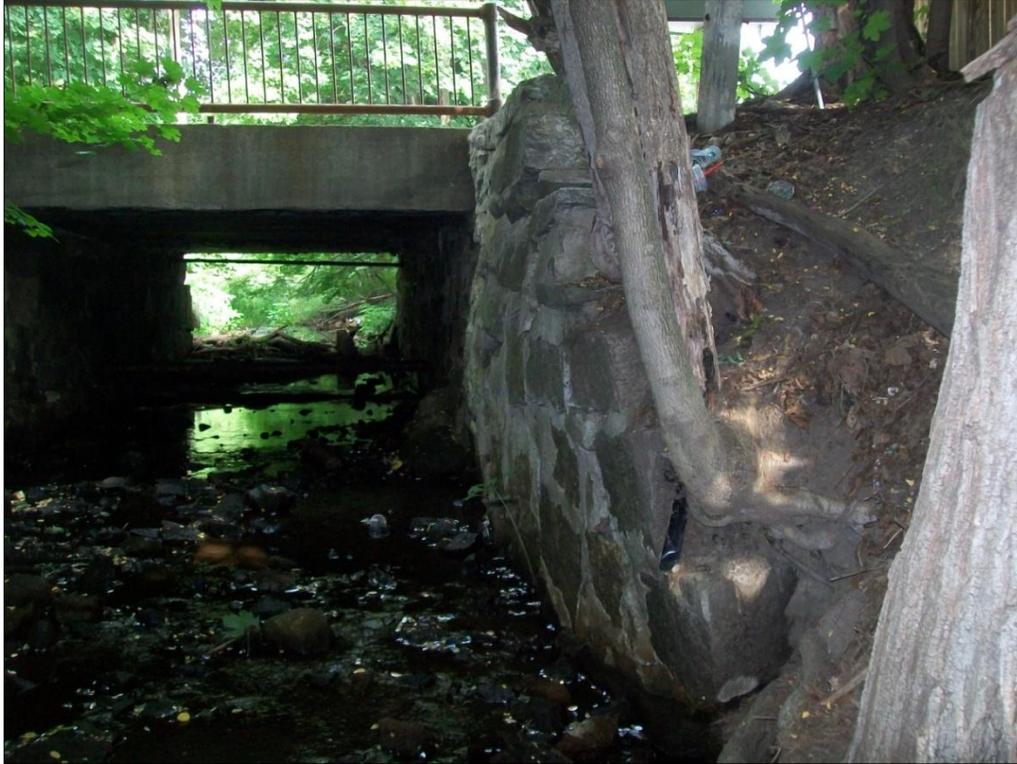
Photo 11 Looking West: Bulging of Northeast Training Wall

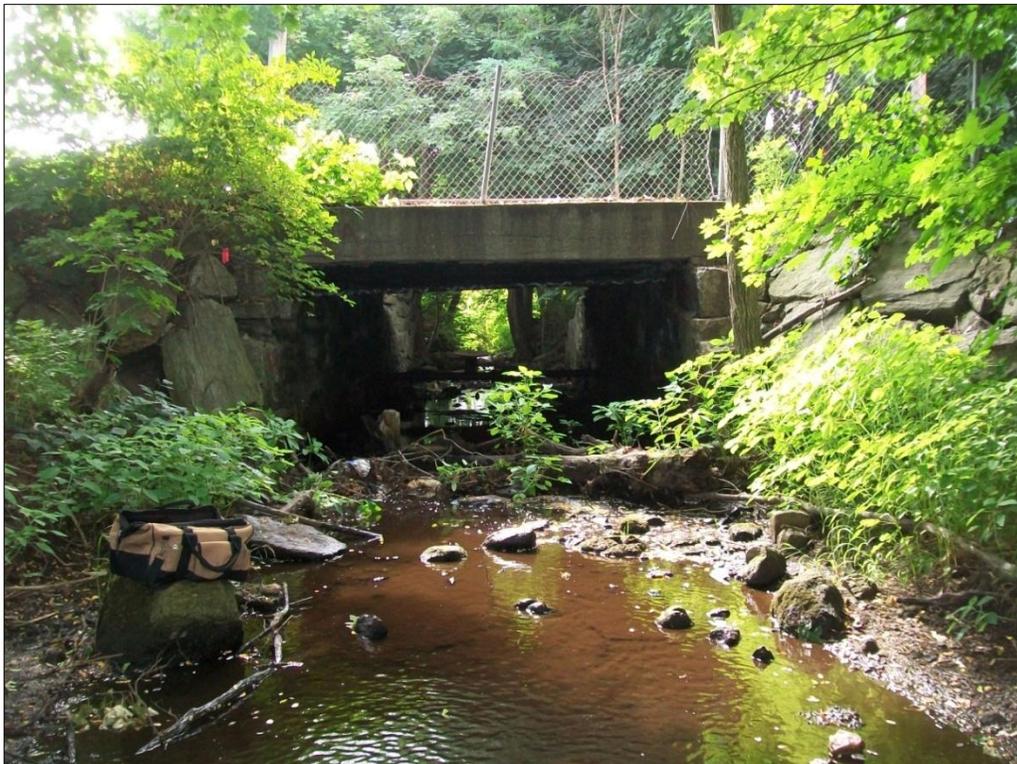
Photo 12 Looking East: West Culvert Elevation

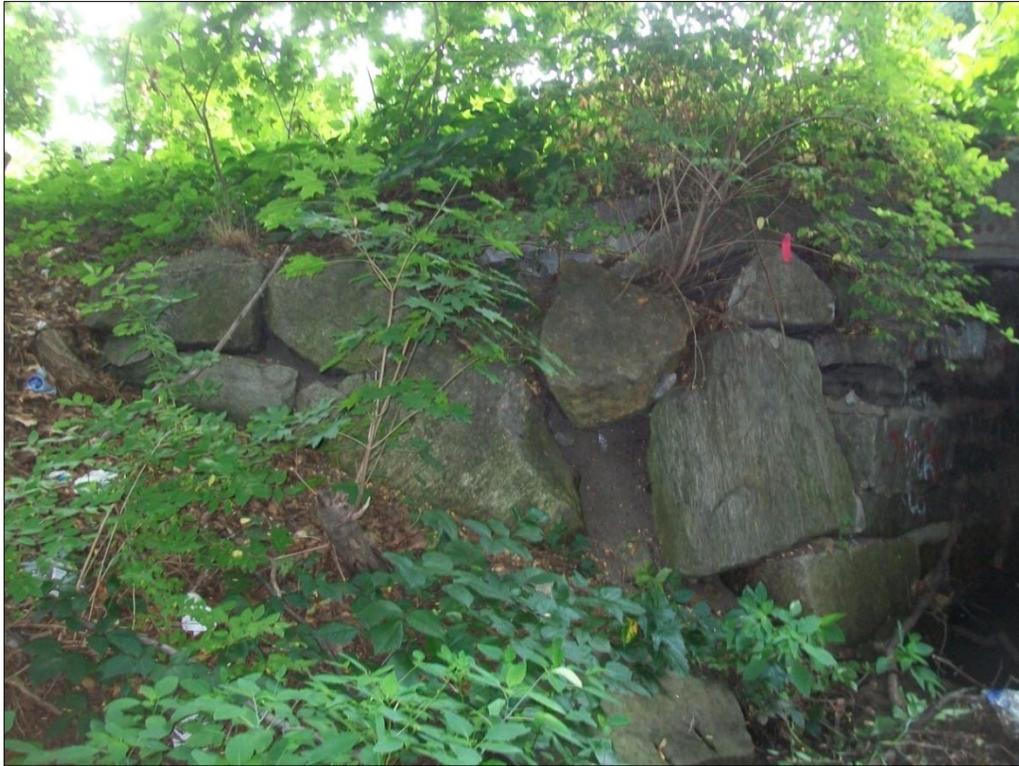
Photo 13: Typical Wingwall Vegetation Growth

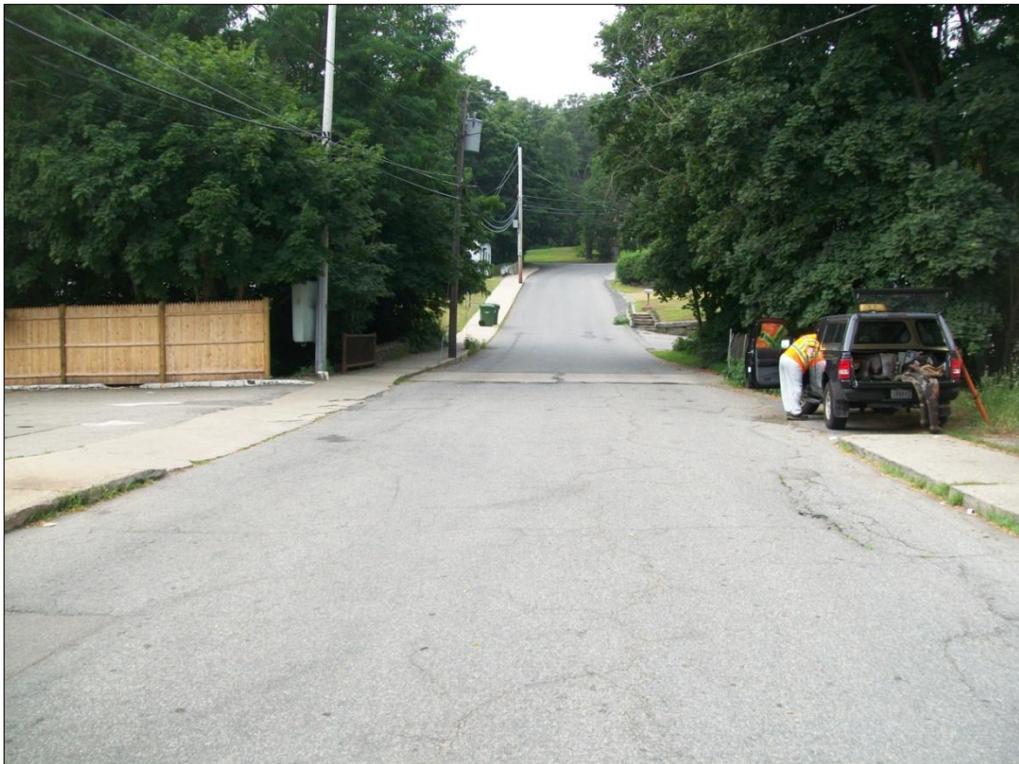
Photo 14 Looking South: North Approach

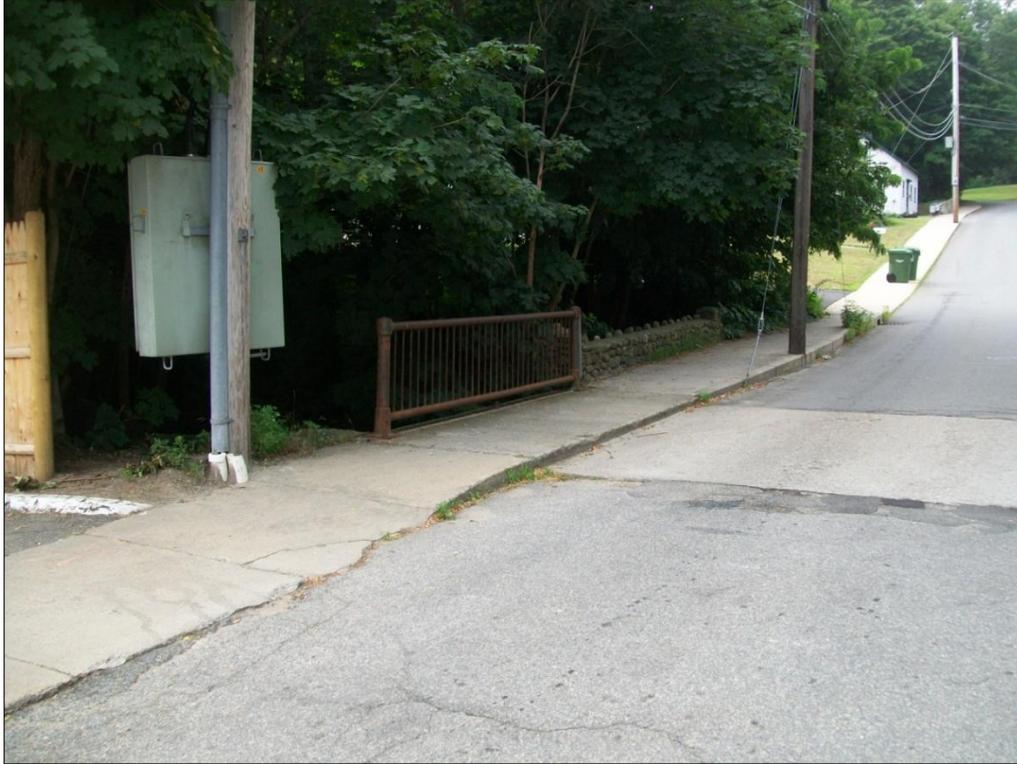
Photo 15 Looking Southeast: East Bridge Rail Elevation

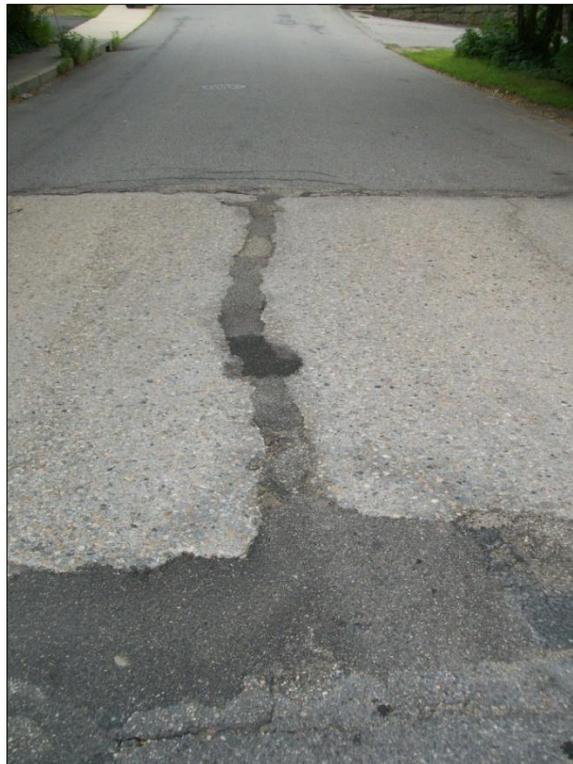
The roadway over the culvert shows settlement with patching at both ends of the exposed slab (Photos 18 and 19). The location of this settlement and patching indicates some degree of water infiltration behind the stone abutment walls, causing roadway fines to wash out. The top of the slab has moderate wear at the wheel lines and the two longitudinal cracks previously noted (Photo 16).

Photo 16 Looking South: Crack Repair in Center of Slab

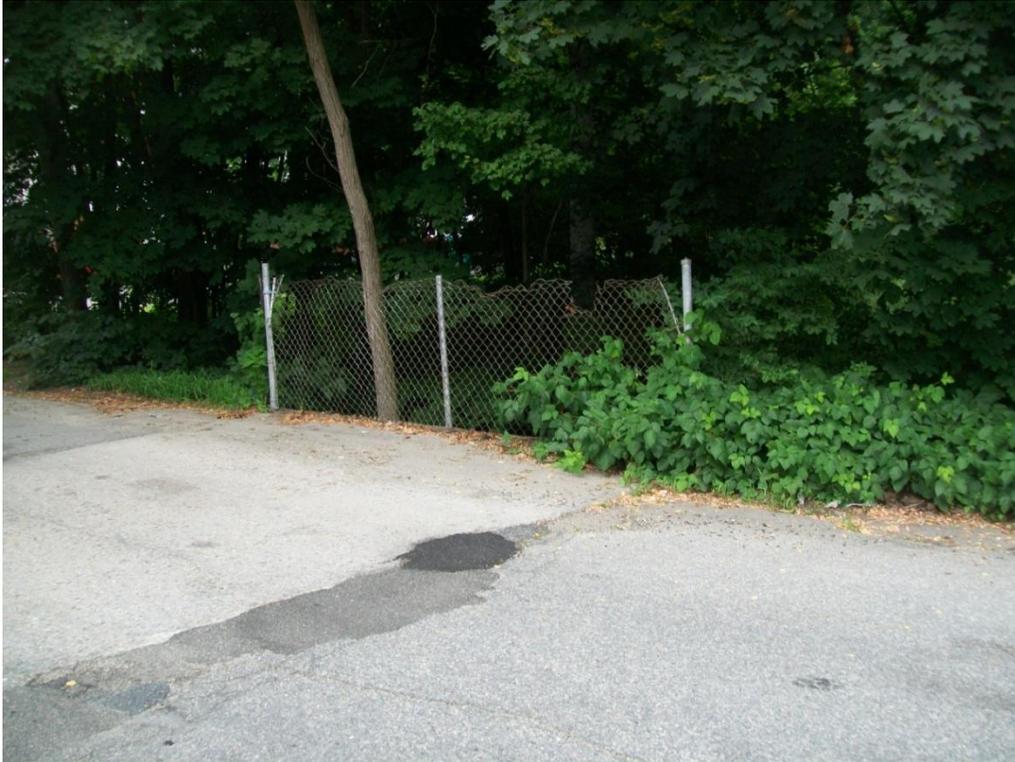
Photo 17 Looking Southwest: West Bridge Rail Elevation

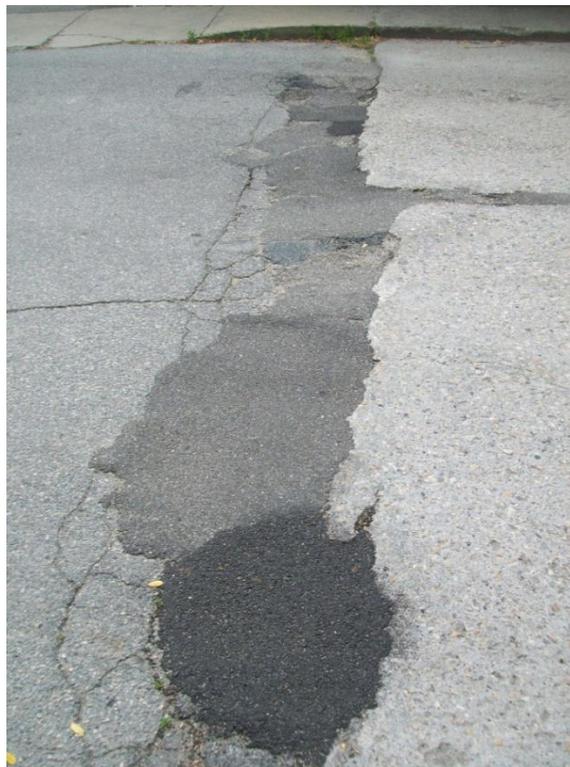
Photo 18 Looking East: Settlement and Repair at North Bridge Joint

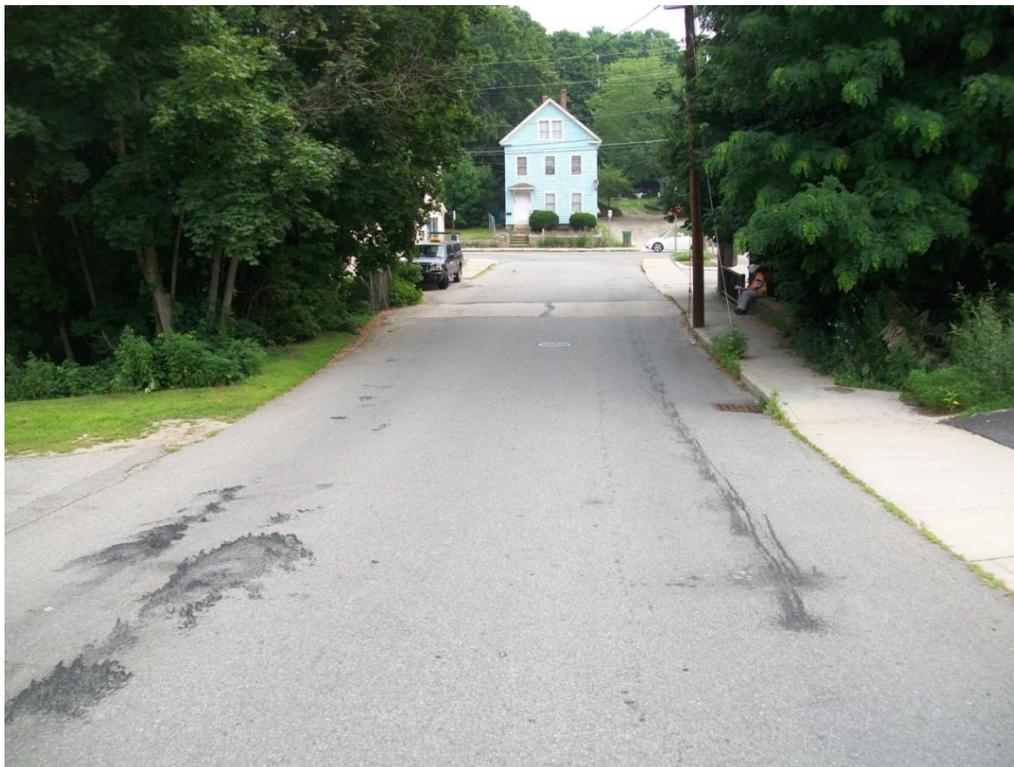
Photo 20 Looking North: South Approach
