Bridge/Culvert Management Plan

November 2011

Uxbridge
Massachusetts

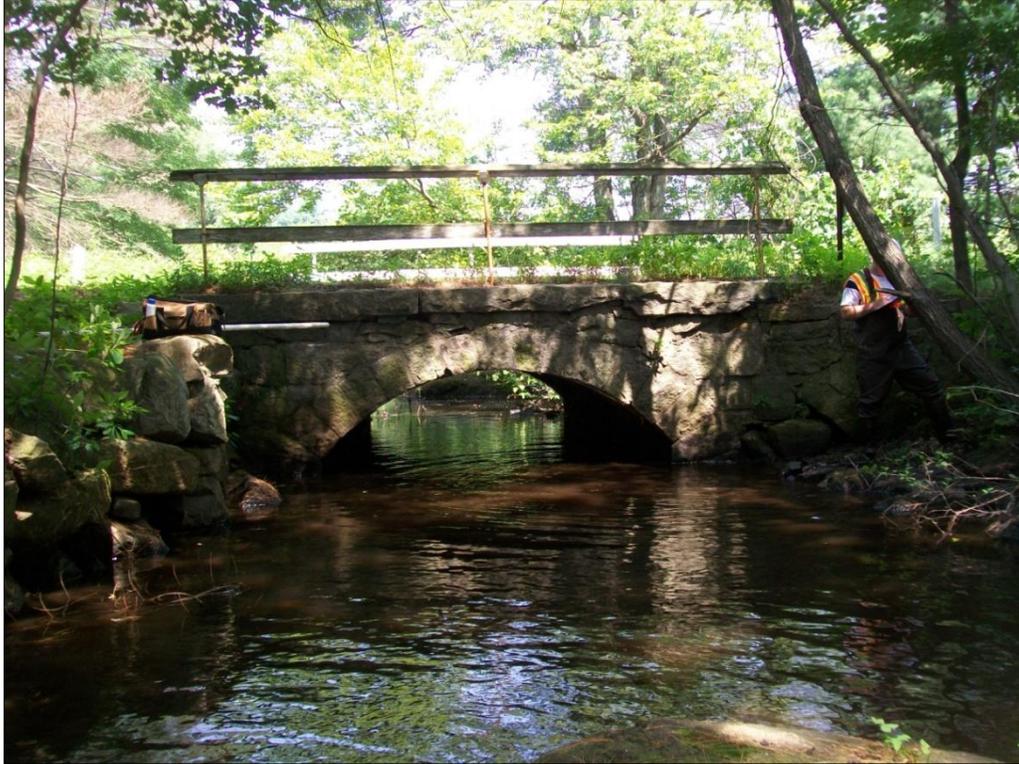
Photo 1 Looking North: South Elevation

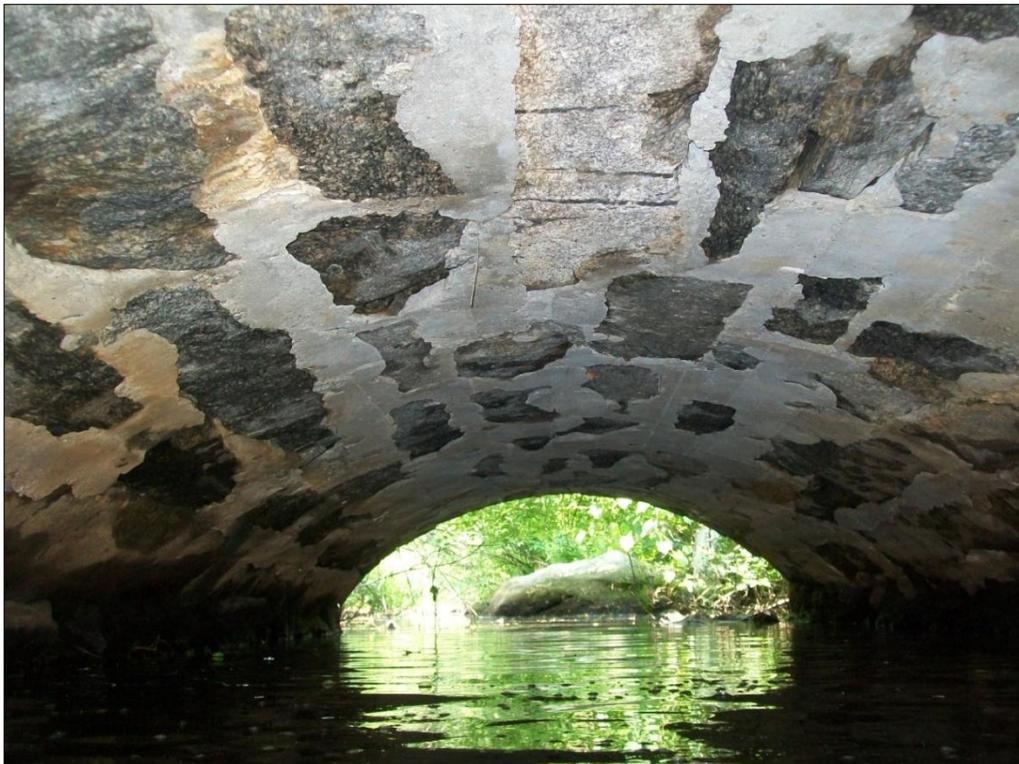
Photo 2 Looking North: Underside of Arch

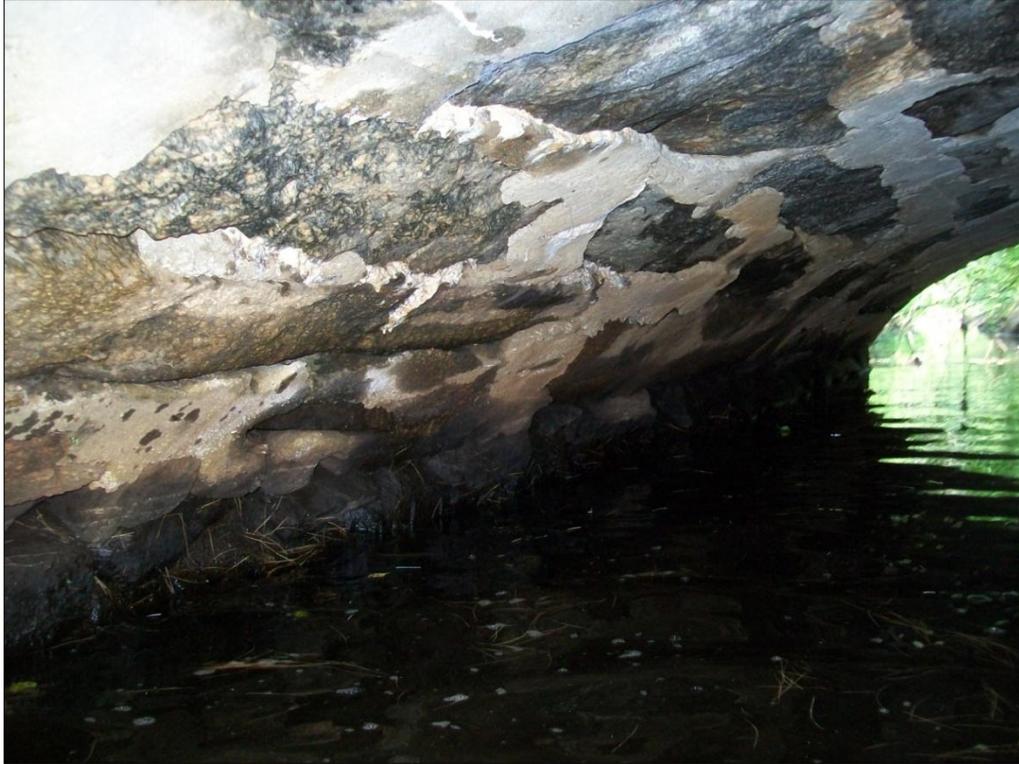
Photo 3 Looking North: West Abutment

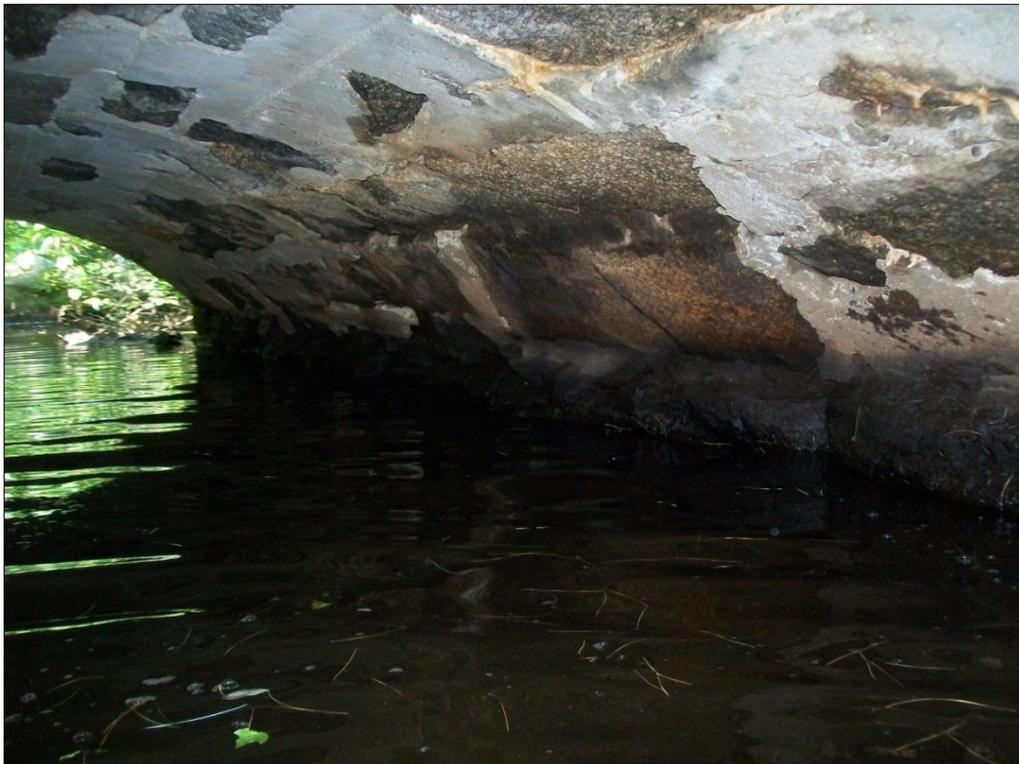
Photo 4 Looking North: East Abutment

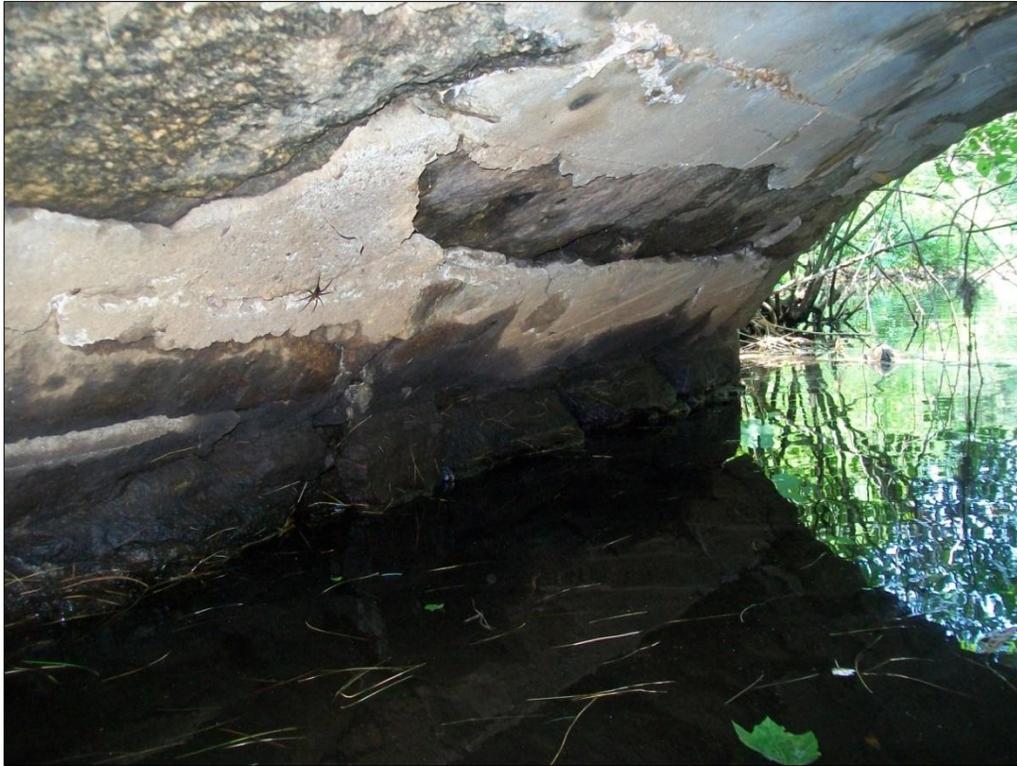
Photo 5 Looking Northwest: Crumbling of West Abutment Wall at North End

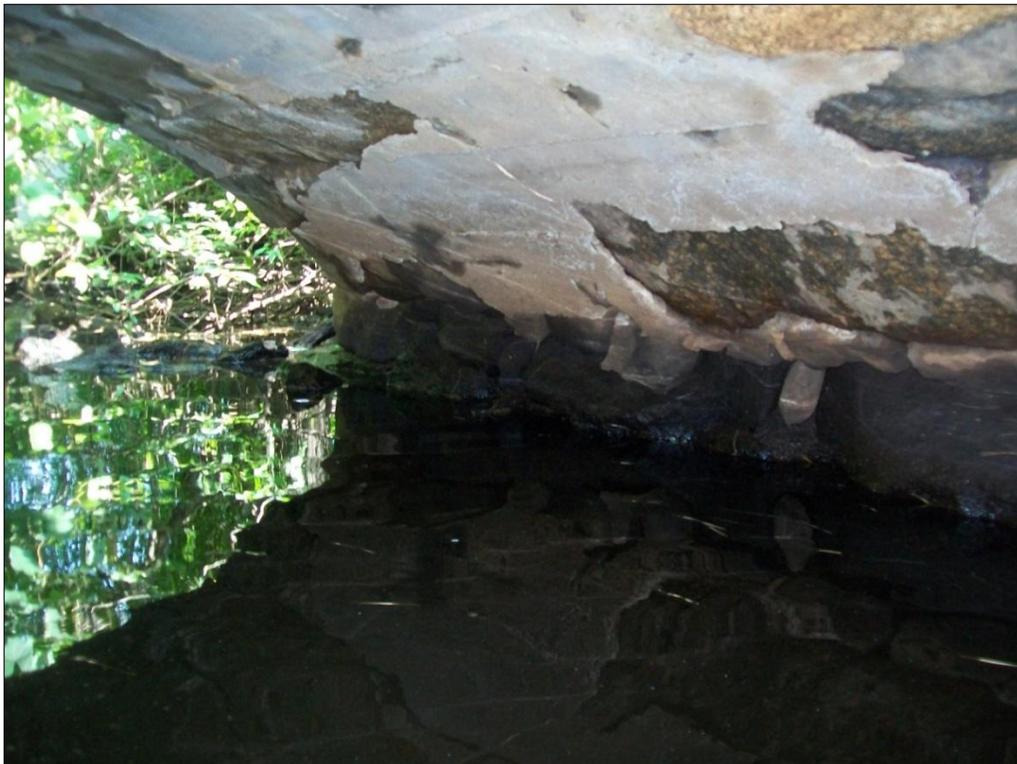
Photo 6 Looking Northeast: Crumbling of East Abutment Wall at North End

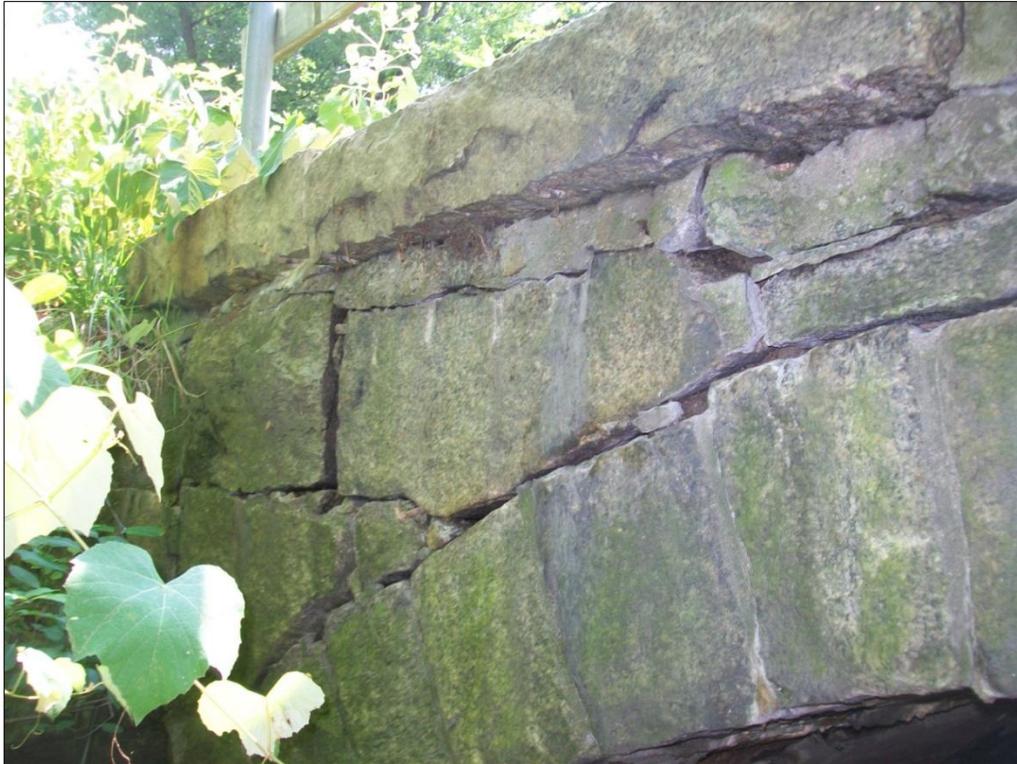
Photo 7 Looking Southeast: Voids in North Spandrel Wall

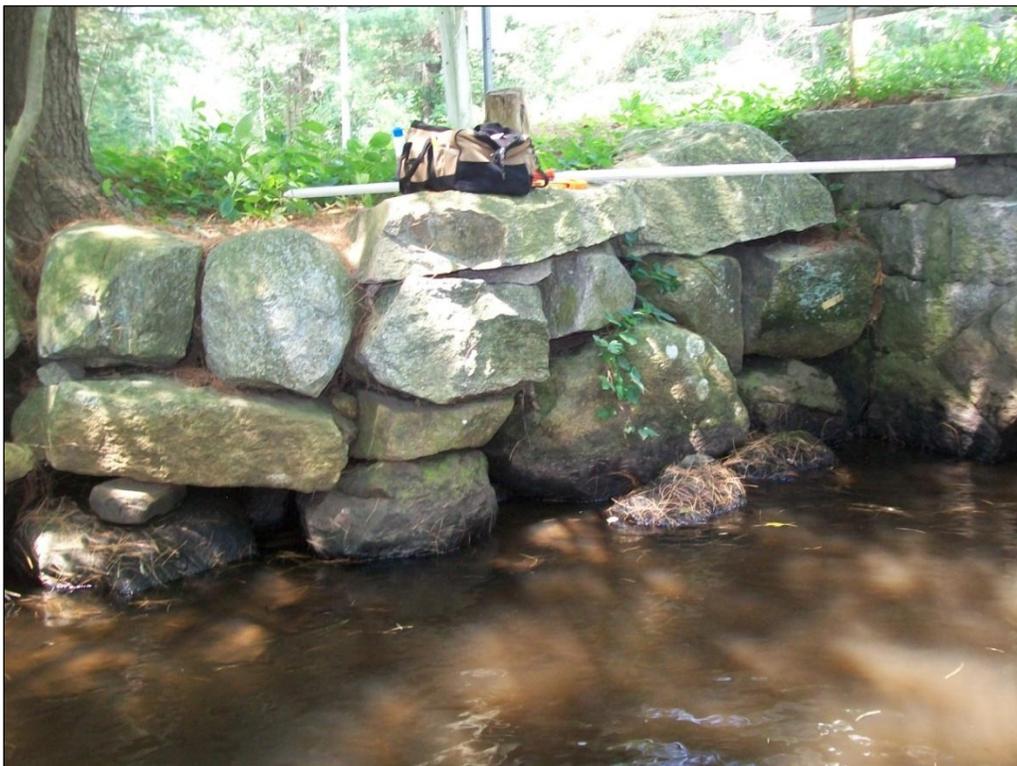
Photo 8 Looking Northwest: Southwest Training Wall Elevation

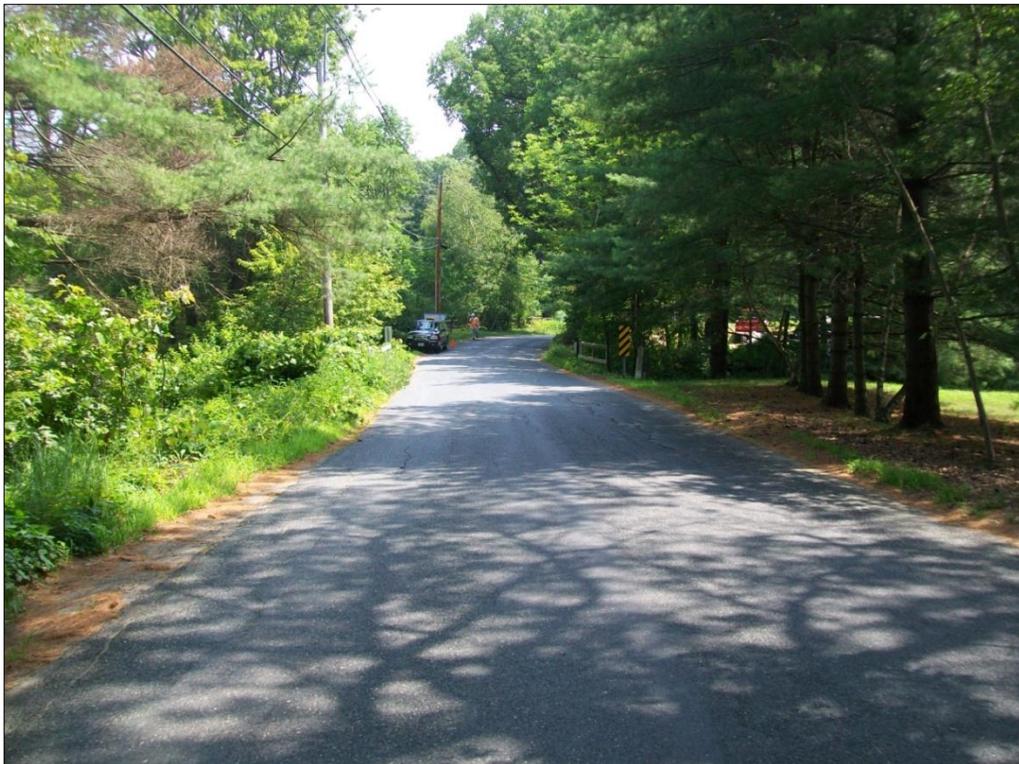
Photo 10 Looking East: West Approach

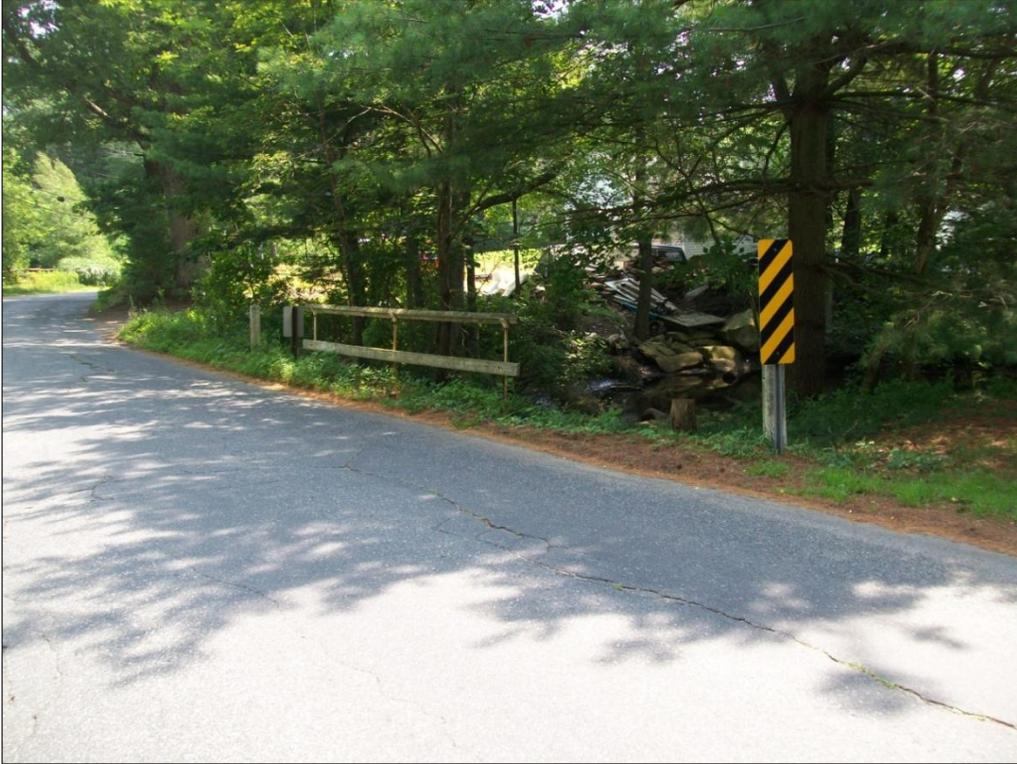
Photo 11 Looking Southeast: South Bridge Rail

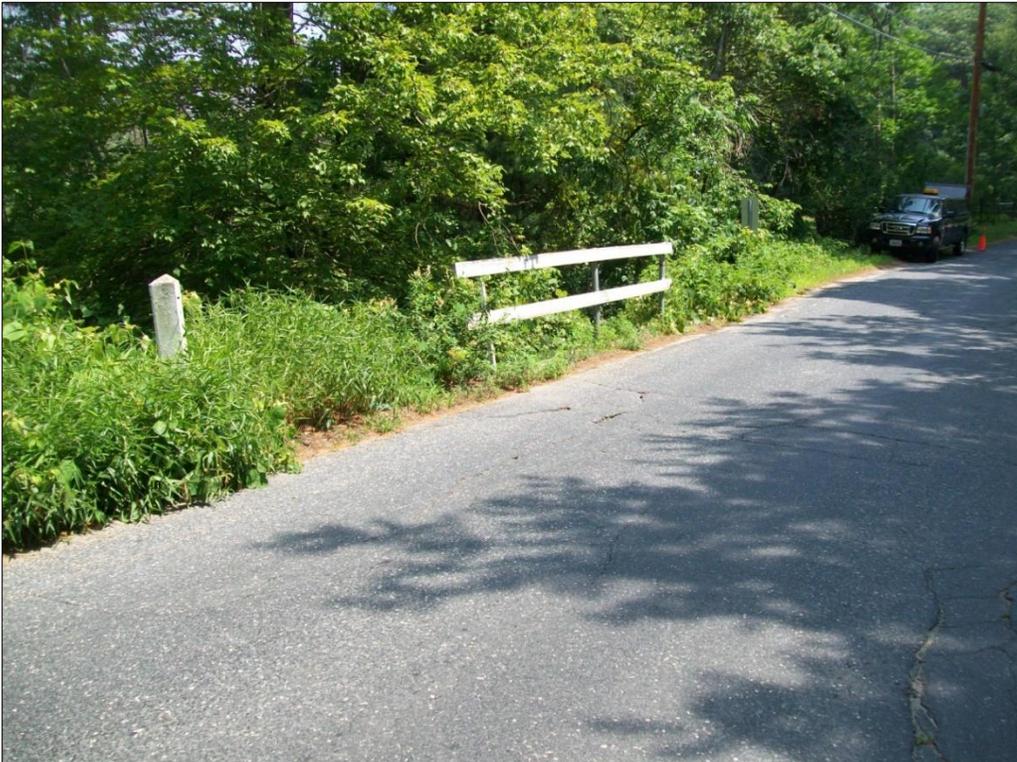
Photo 12 Looking Northeast: North Bridge Rail

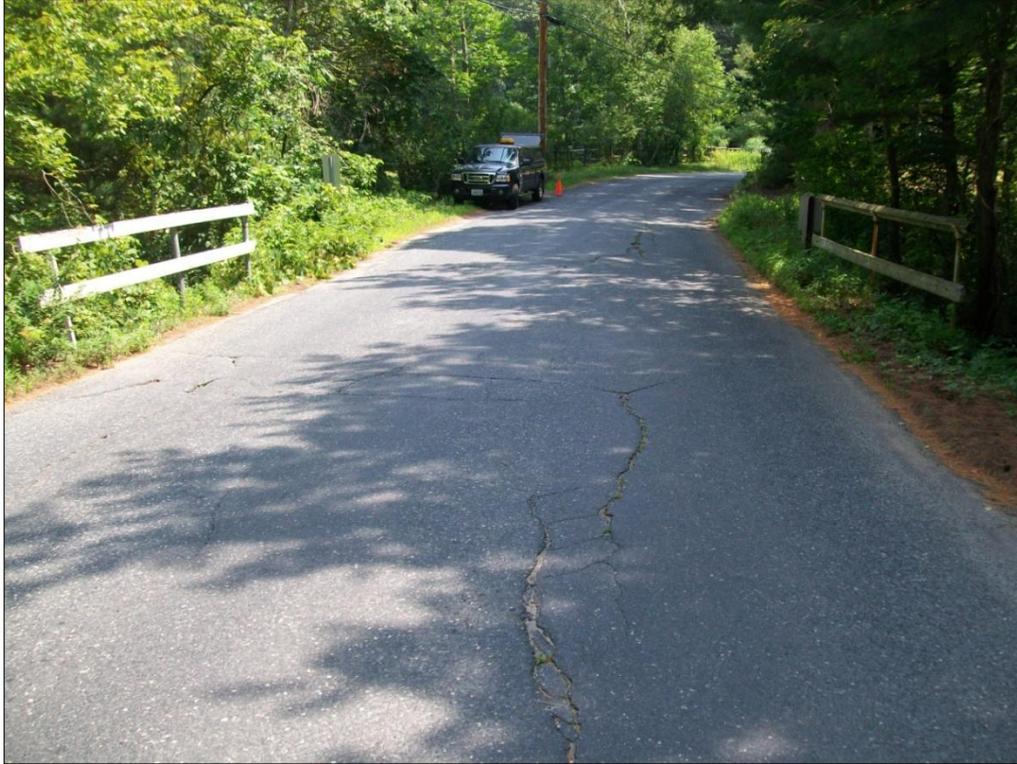
Photo 13 Looking East: Condition of Roadway Over Culvert

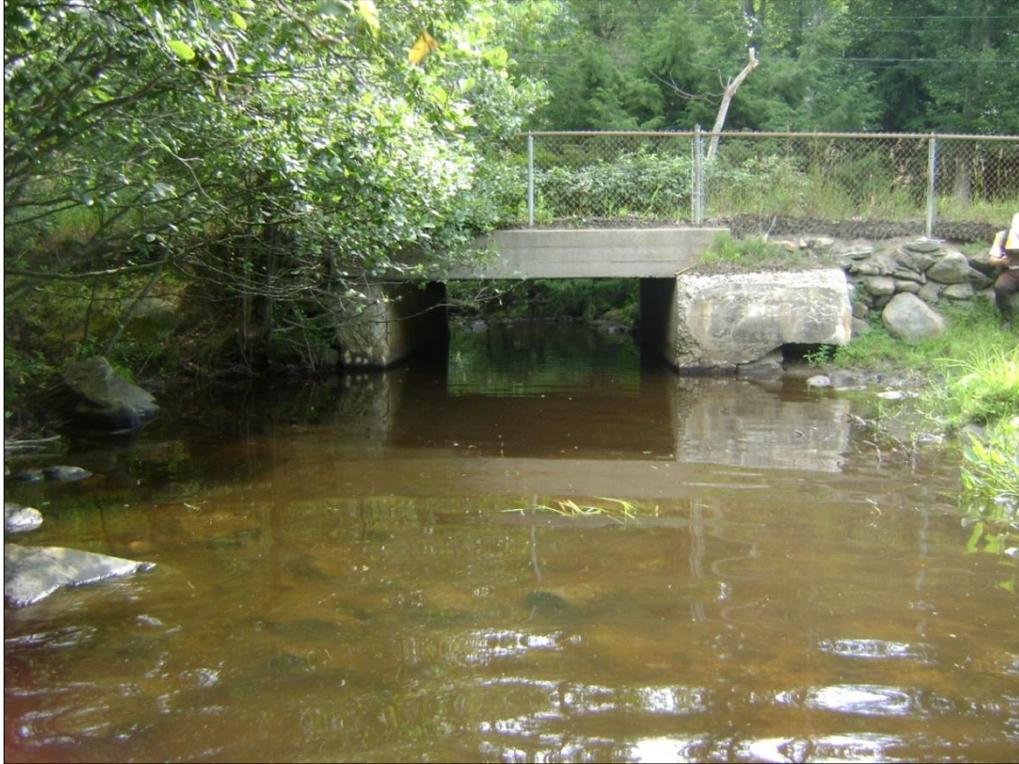
Photo 1 Looking East: West Culvert Elevation

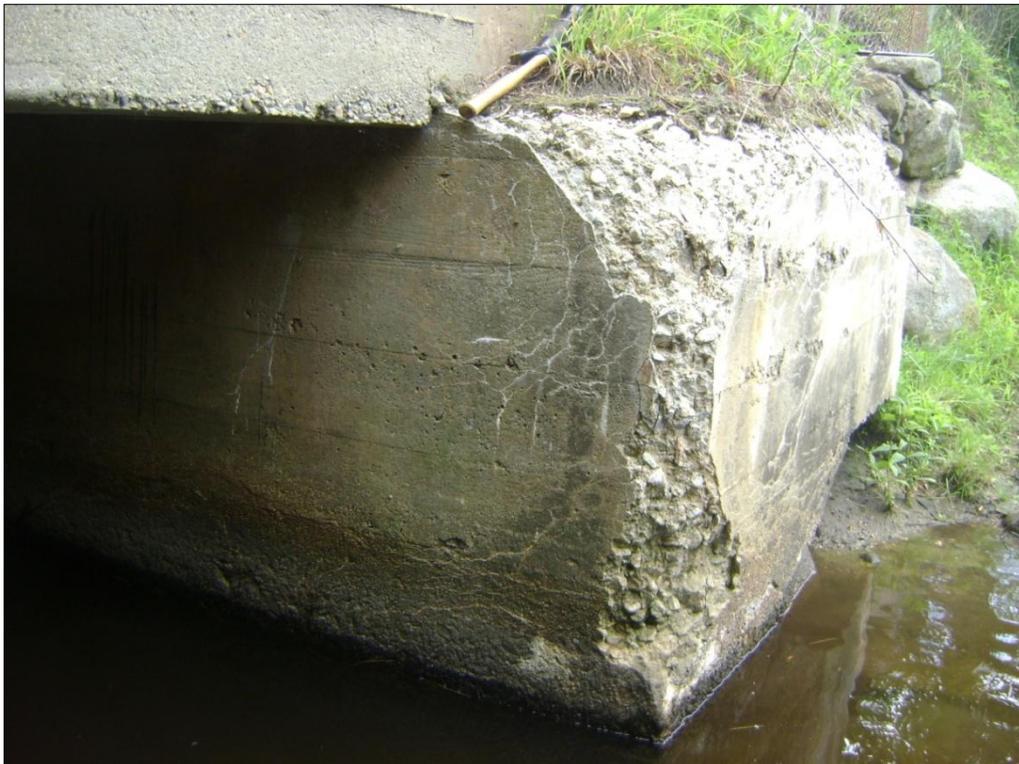
The abutments are in fair condition showing minor deterioration. Both abutments exhibit moderate concrete deterioration at the west opening. At these locations, heavy spalling and delamination is typical (Photos 2 and 8). Random hairline cracks are typical on both abutment walls. In addition, a medium width ($\frac{3}{8}$ " full height vertical crack was found at the center of the north abutment (Photo 9). There is also an 18" section of exposed footing at the north abutment (Photo 5); however, no scour was detected at either abutment.

Photo 2 Looking Southeast: West End of South Abutment

- Repair all spalls, cracks, and delaminated areas in the bridge substructure.
- Repair all spalls and cracks to the concrete slab. Also, finish and smooth all recessed block locations at the slab underside.
- Re-surface the slab top-side to prevent additional wear.
- Remove all deteriorated concrete at the northwest and southwest wingwalls, fill the scour hole at the southwest wingwall, and re-face both walls.
- Place stone riprap at exposed concrete abutment footing to prevent future scour.

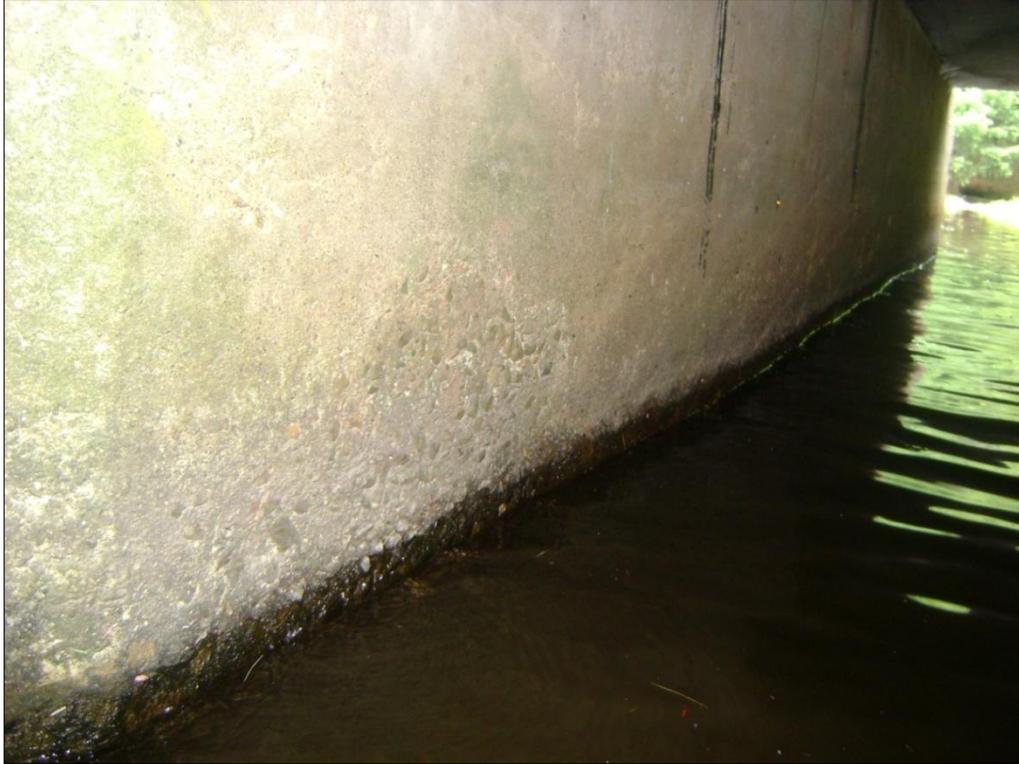
Photo 3 Looking Southwest: Scaling Above Waterline at South Abutment

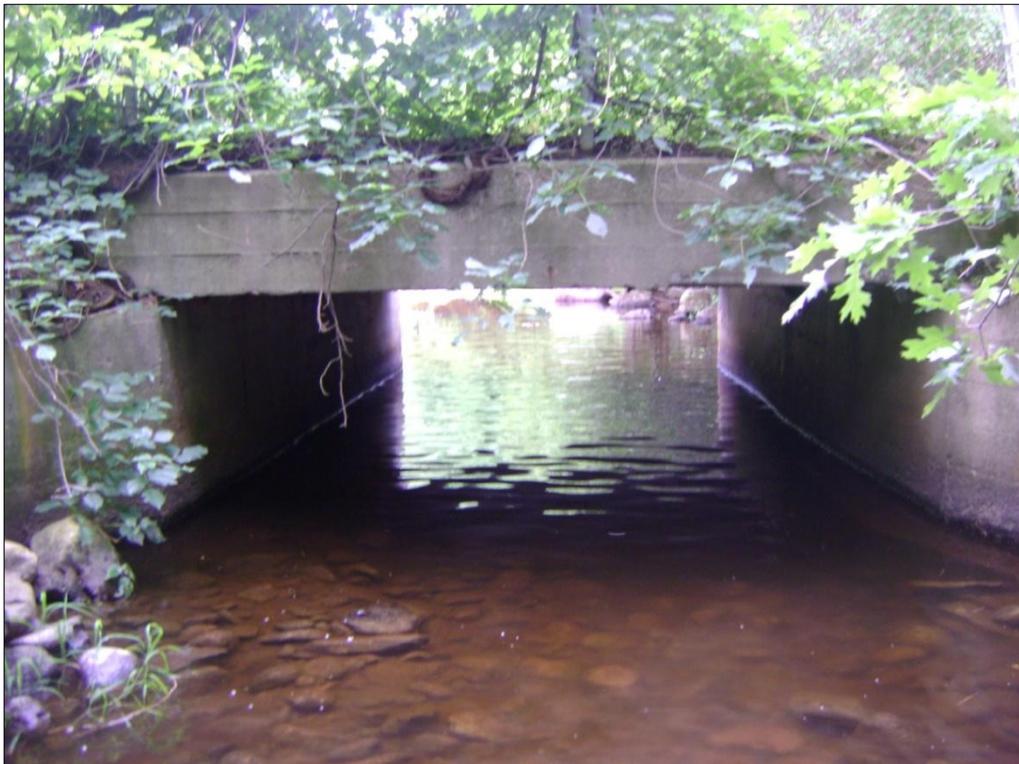
Photo 4 Looking West: East Culvert Elevation

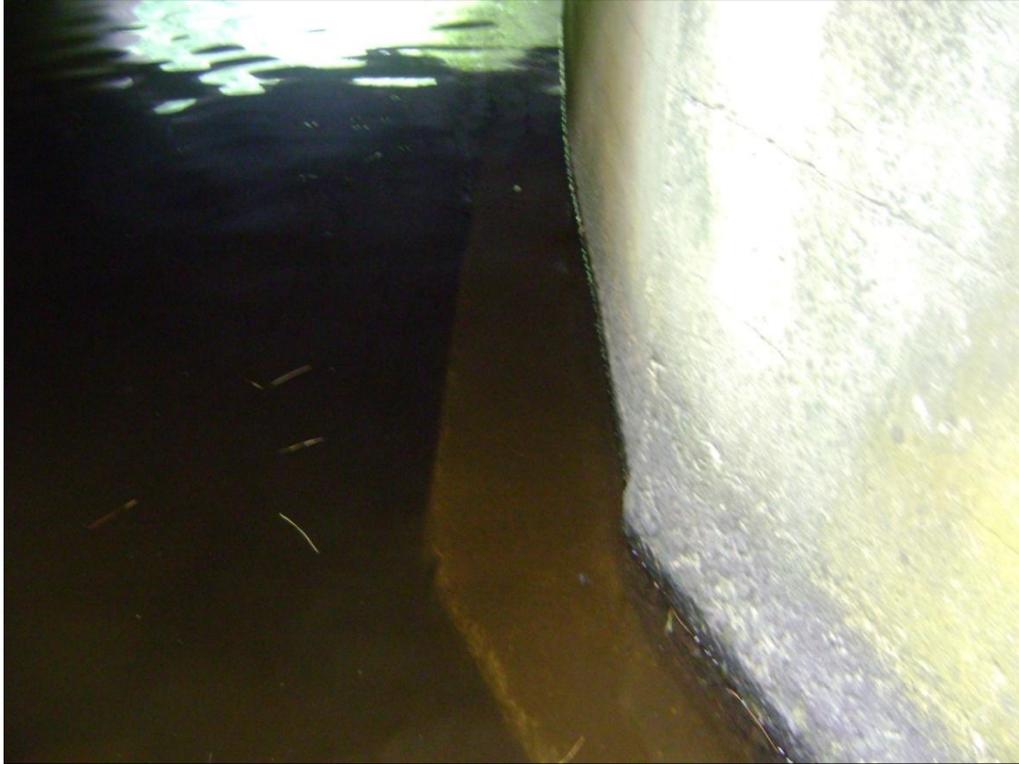
Photo 5 Looking West: Exposed Footing at North Abutment

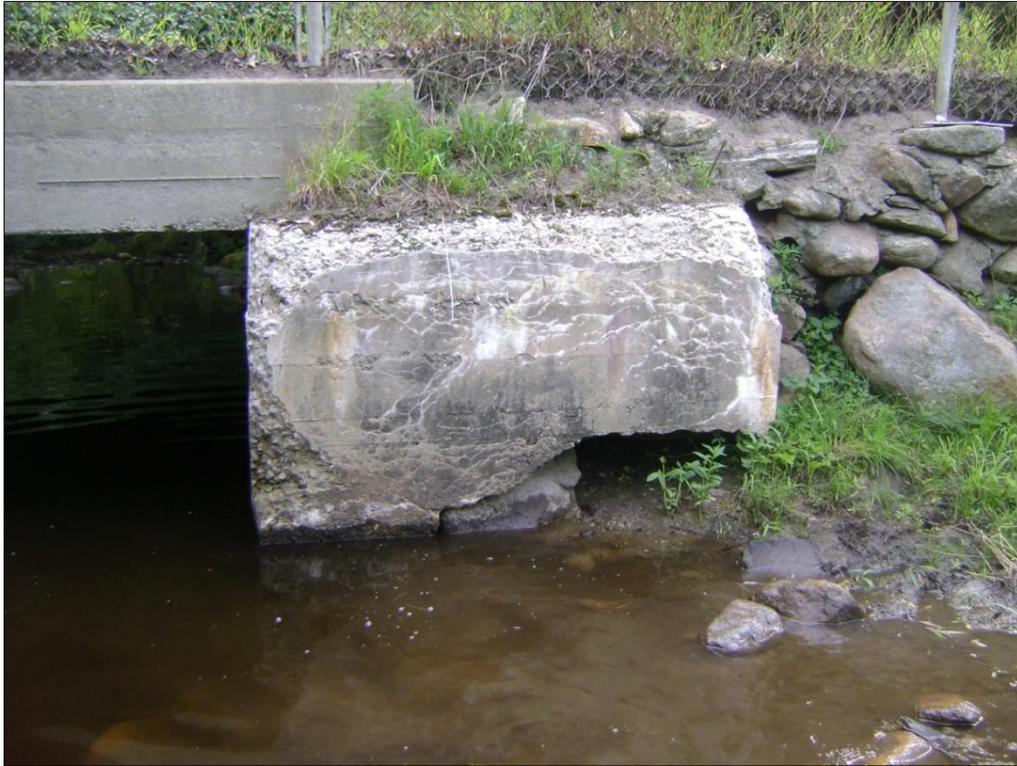
Photo 7 Looking East: Southwest Wingwall Elevation

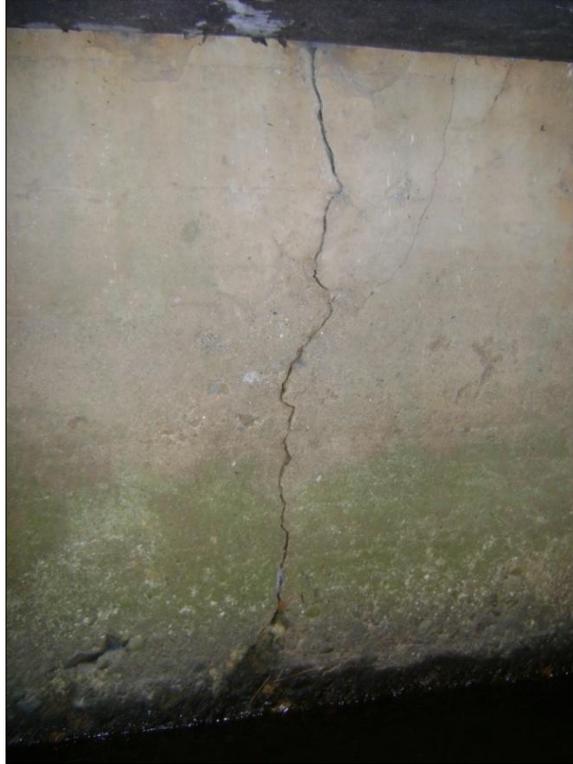
Photo 9 Looking North: Vertical Crack in North Abutment

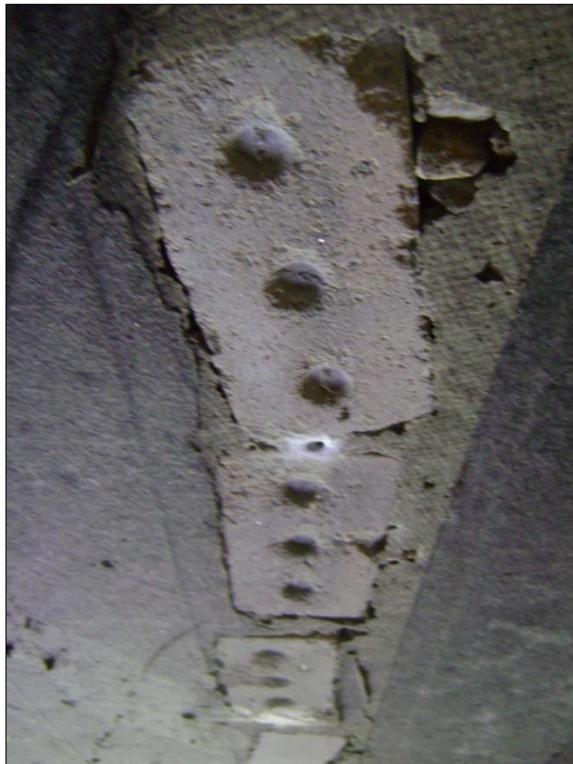
Photo 10 Looking East: Recessed Blocks in Culvert Roof

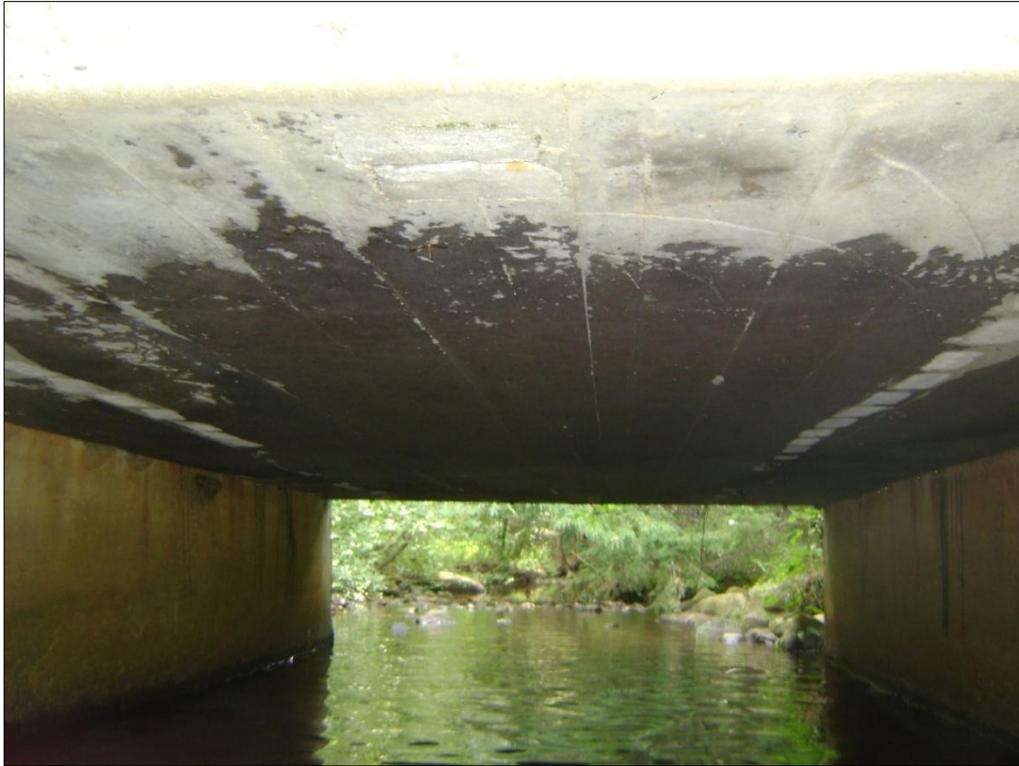
The concrete slab is in good condition showing some minor problems. Its underside is covered in moderately deteriorated damp proofing (See Photo 11). Where visible, the slab's overall condition appears good but exhibits few random hairline cracks. Two rows of concrete blocks run transversely across the slab (Photo 10). These blocks are likely construction related, used as form supports or steel reinforcing spacers. The blocks are not considered a deficiency but do allow water/moisture to penetrate the slab. The top of the slab typically exhibits moderate scaling and wear with exposed aggregate (Photo 26).

Photo 11 Looking East: Underside of Slab

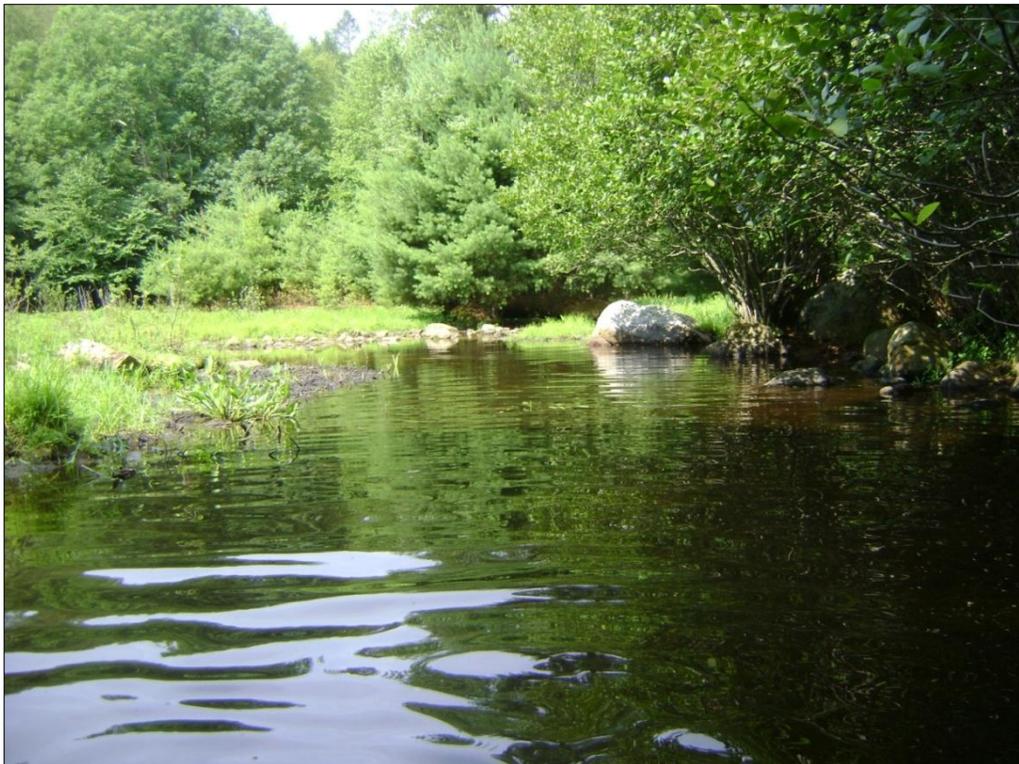
The concrete wingwalls are in poor condition. The two training walls on the east side transition from concrete into mortared masonry. Both stone wall portions show a loss of mortar and random voids at the waterline, but are in good condition. The two wingwalls at the west opening are concrete and are integrated with a stone retaining wall that supports the roadway. Both walls are in poor condition with heavy scaling, spalling, efflorescence, and delamination. A 20" deep scour void is located at the southwest wingwall for approximately half its length (Photos 6 and 7). Directly upstream of the culvert is a cattle feeding area. The congregation of cattle at this location has caused the stream to migrate away from its natural shape (Photo 12), thus altering flow and introducing potential scour issues.

Photo 12 Looking West: Upstream Migration of Brook

Conduct annual inspections to monitor overall bridge conditions and possible scour resulting from stream migration.

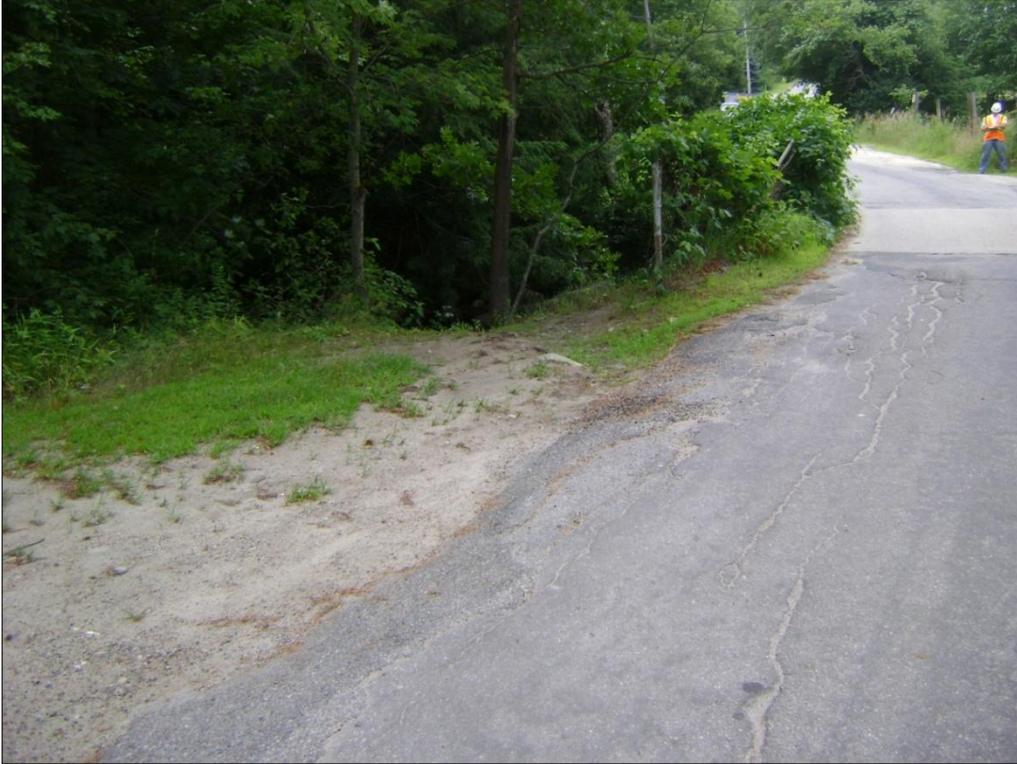
Photo 13 Looking Northwest: Drainage Path at Northeast Approach

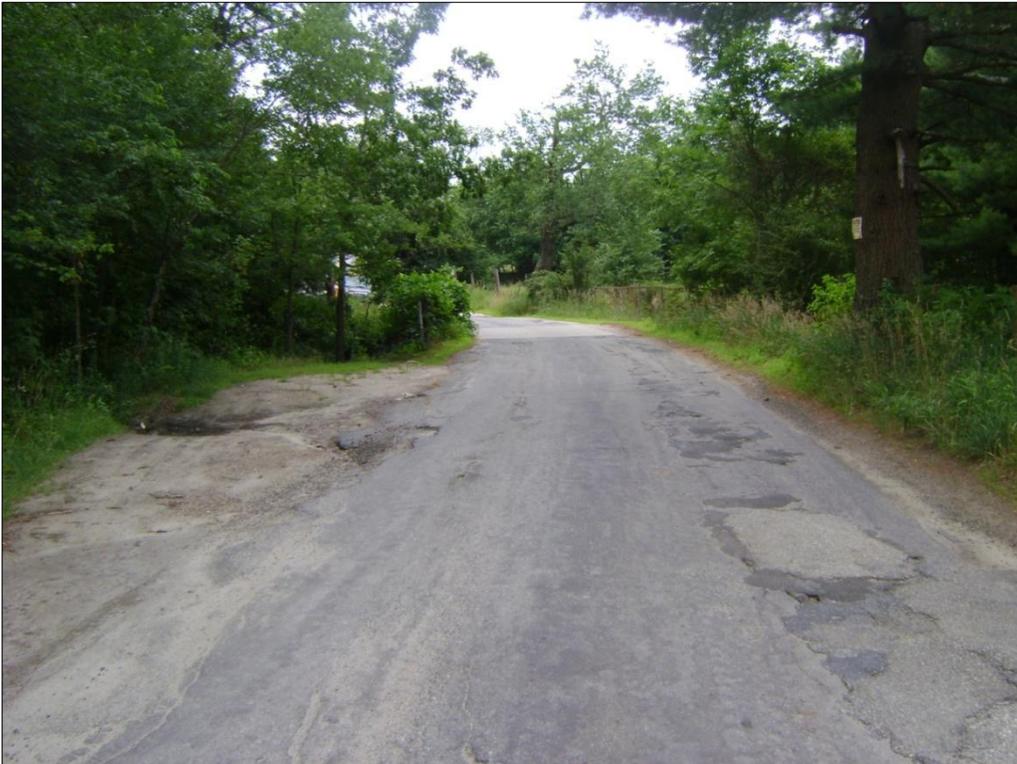
Photo 14 Looking South: North Approach

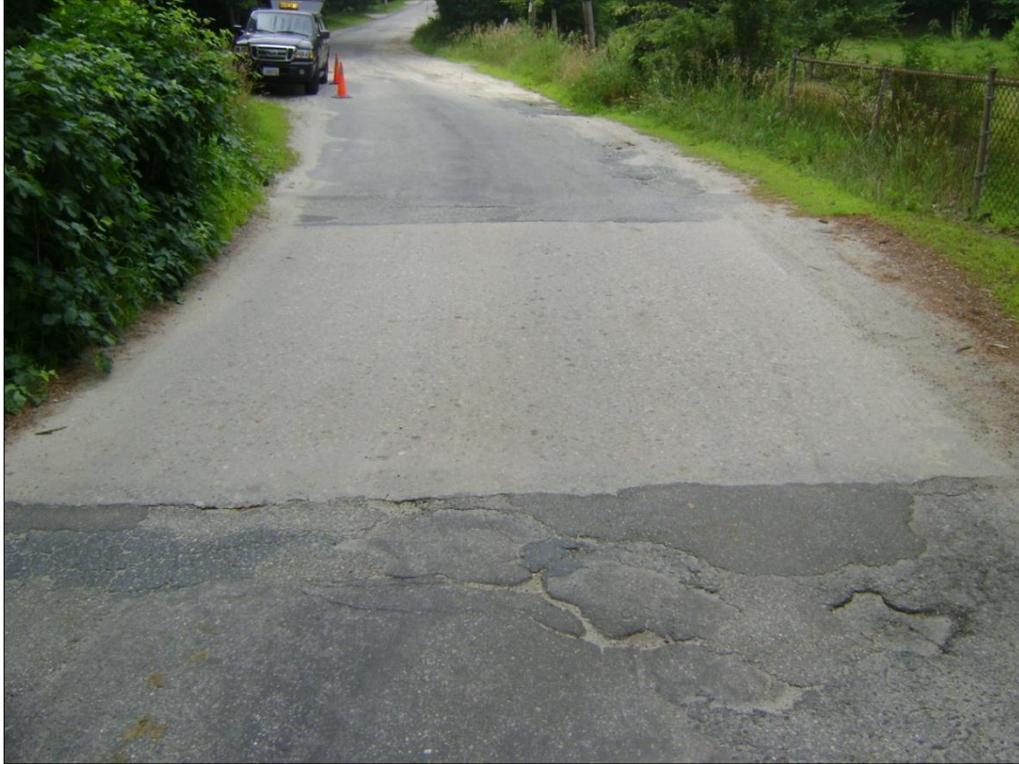
Photo 15 Looking South: Top of Slab

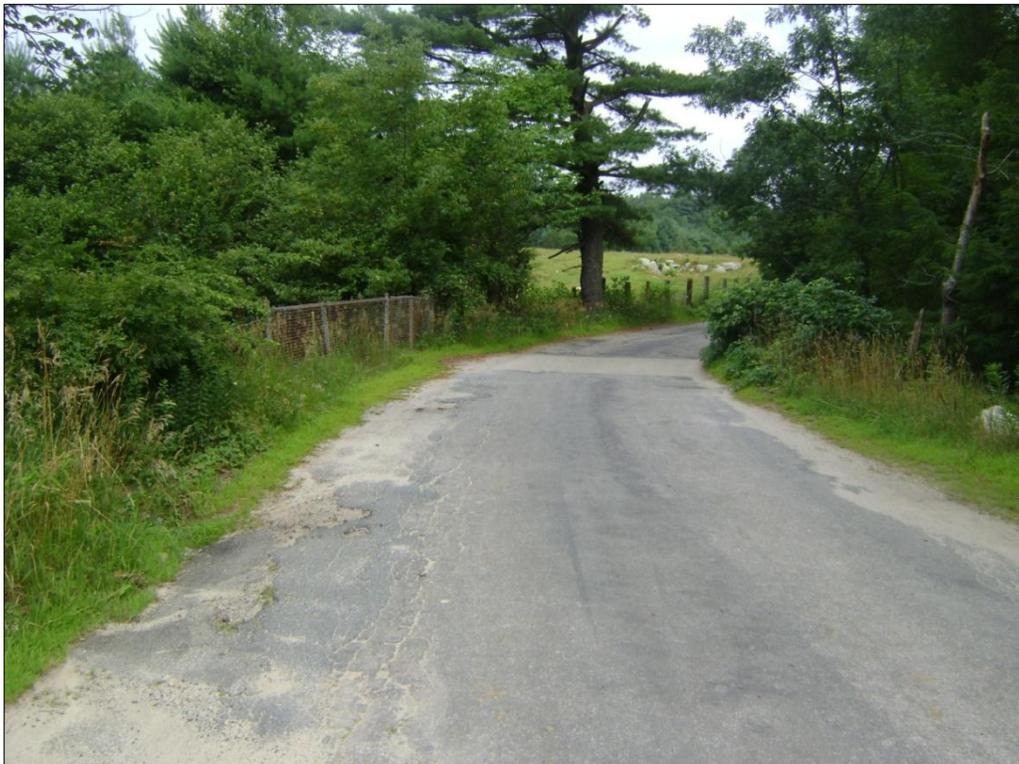
The approach roadway is in poor condition. The pavement joints at the concrete slab have been patched and show advanced deterioration. Both approaches typically exhibit alligator cracking, roadway debris, and moderate wheel line rutting (Photos 15 and 19). A narrow horizontal curve at the north approach makes for poor visibility (Photo 16).

Photo 16 Looking North: South Approach

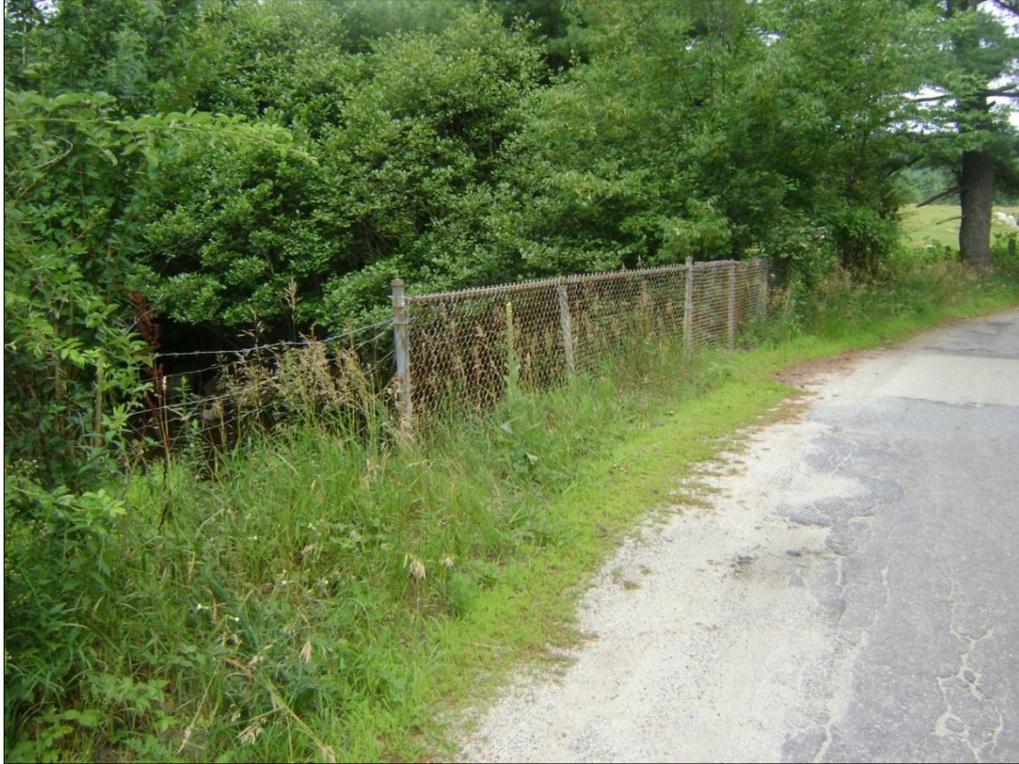
Photo 17: Typical Bridge Rail

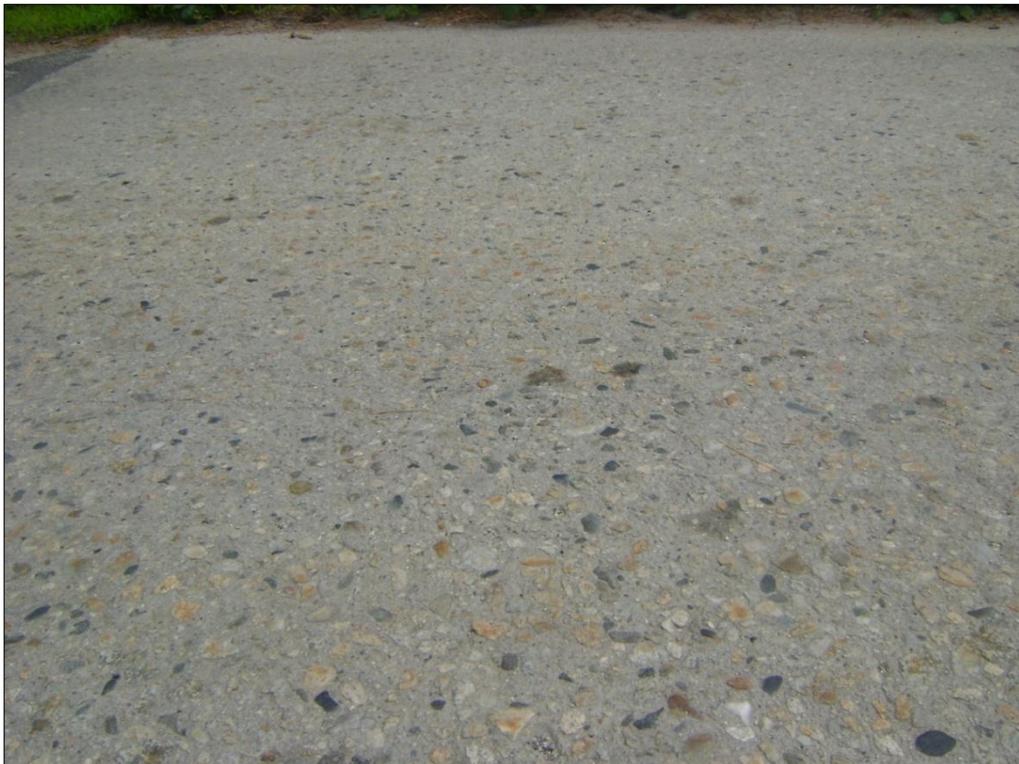
Photo 18 Looking West: Scaling at Top of Slab

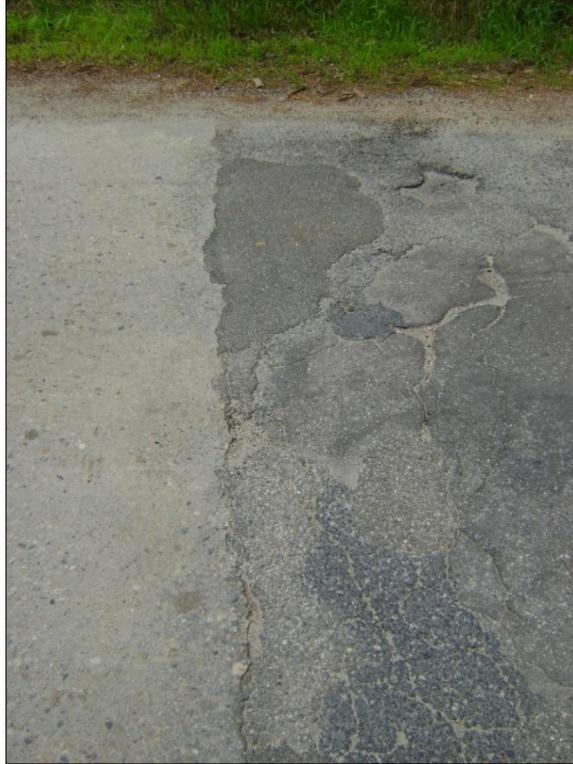
Photo 19: Typical Roadway Joint
