Bridge/Culvert Management Plan

November 2011

Uxbridge
Massachusetts

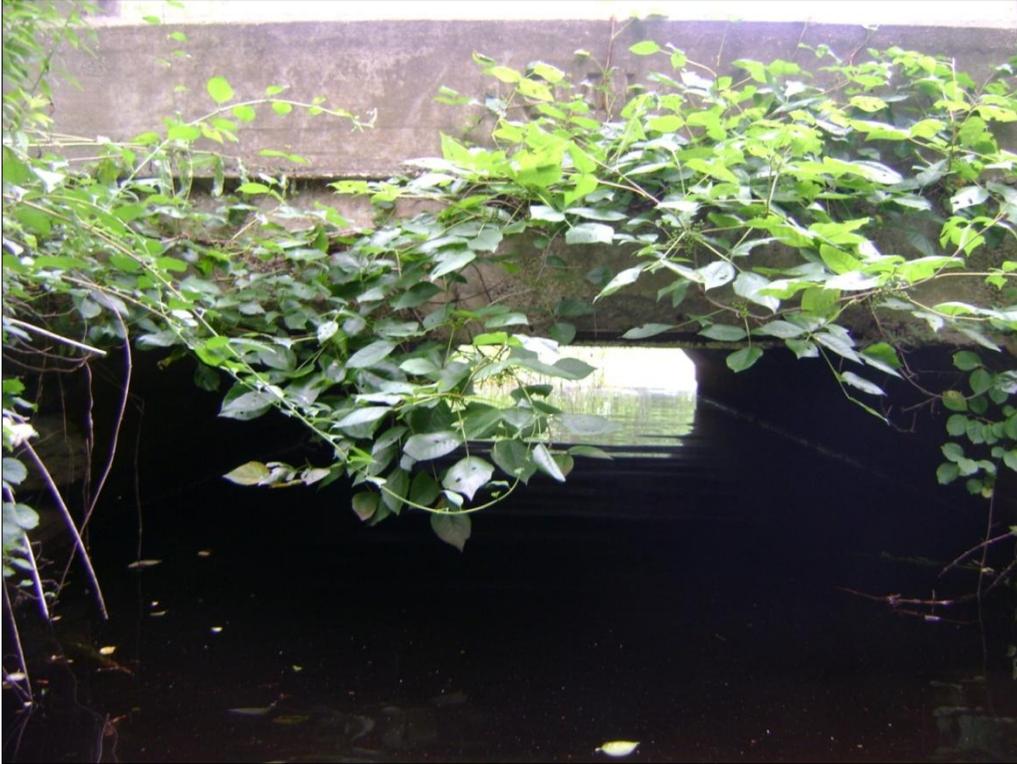
Photo 1 Looking North: South Culvert Elevation

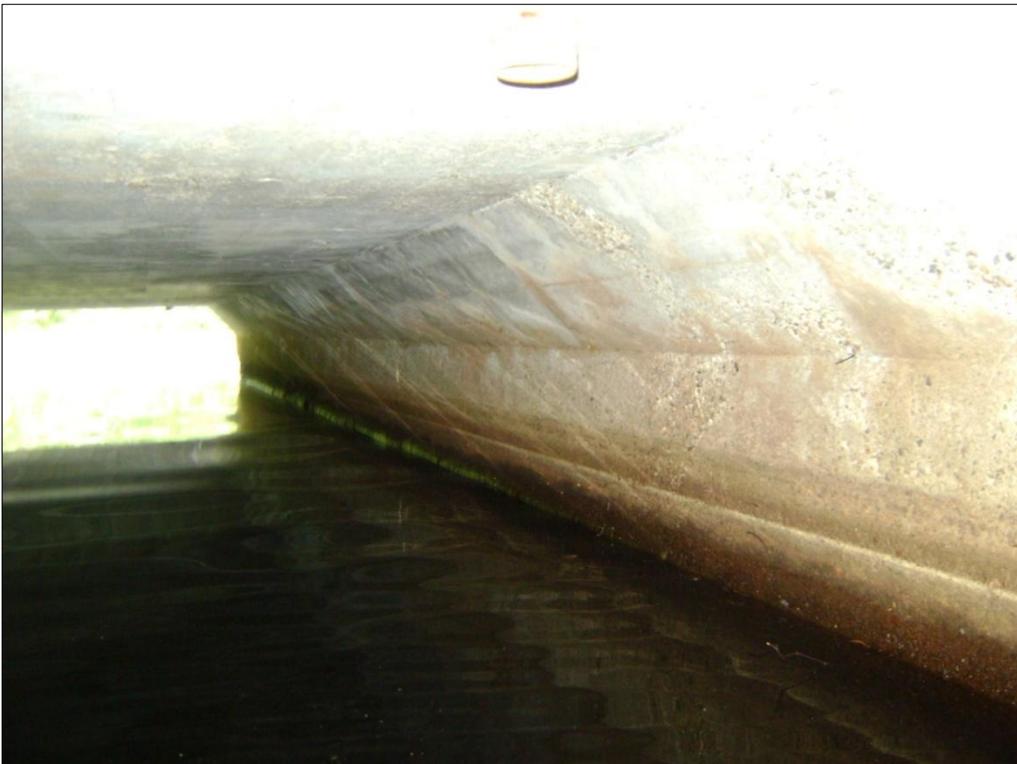
Photo 2 Looking North: East Culvert Wall

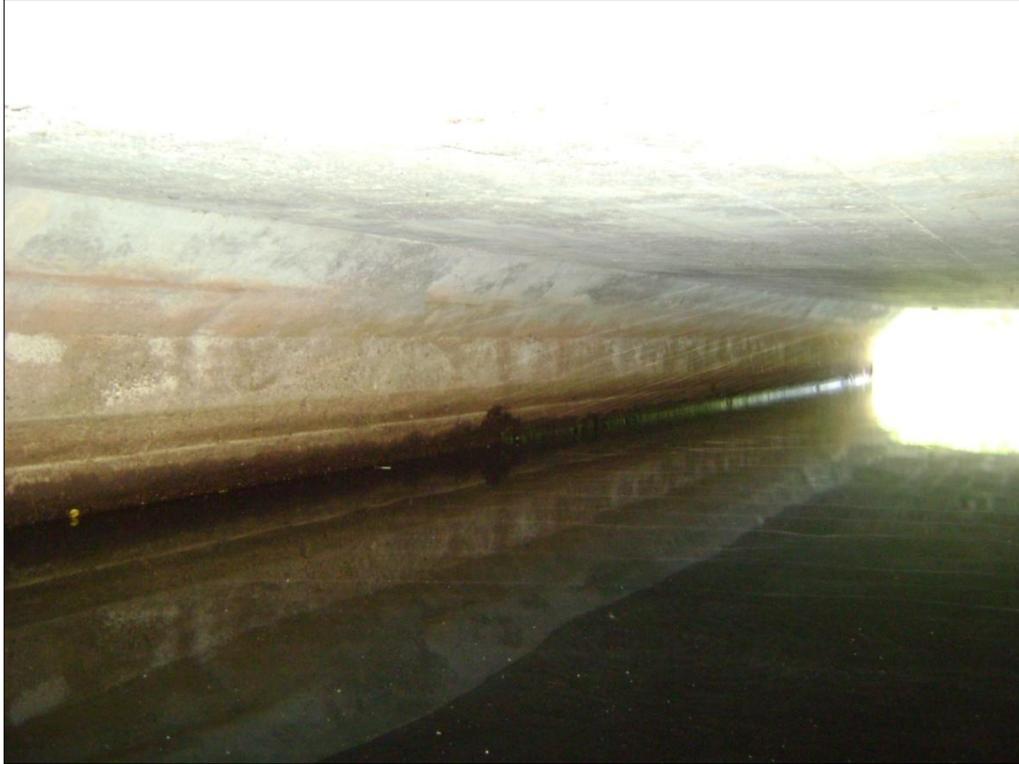
Photo 3 Looking North: West Culvert Wall

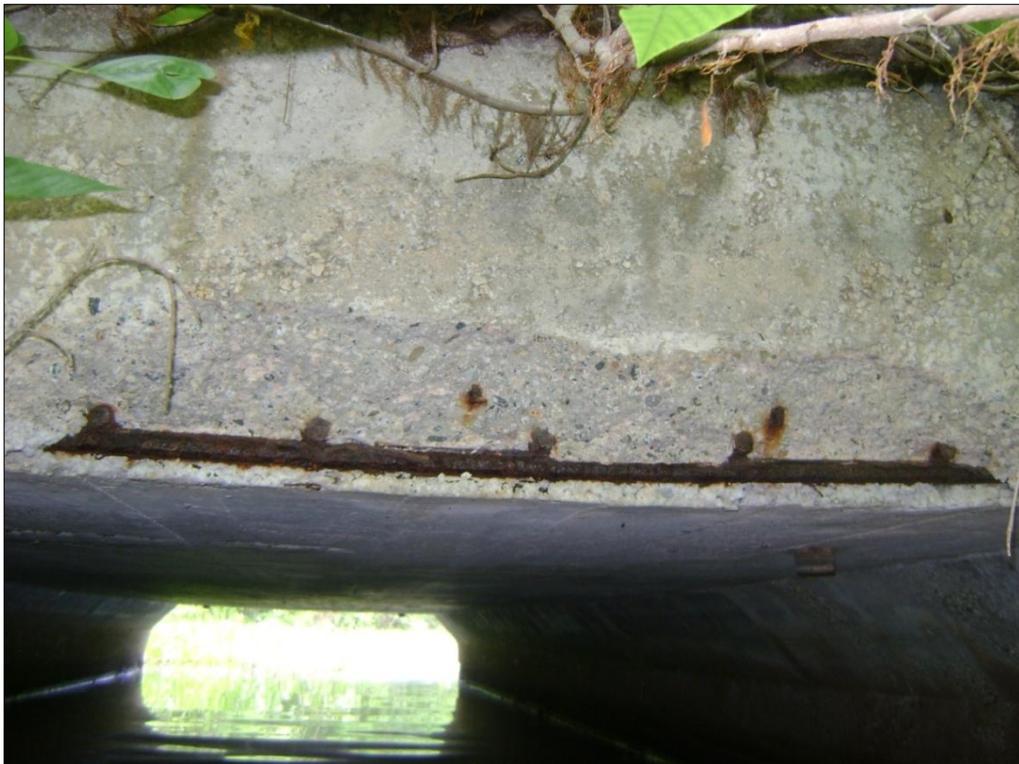
Photo 4 Looking North: South Headwall

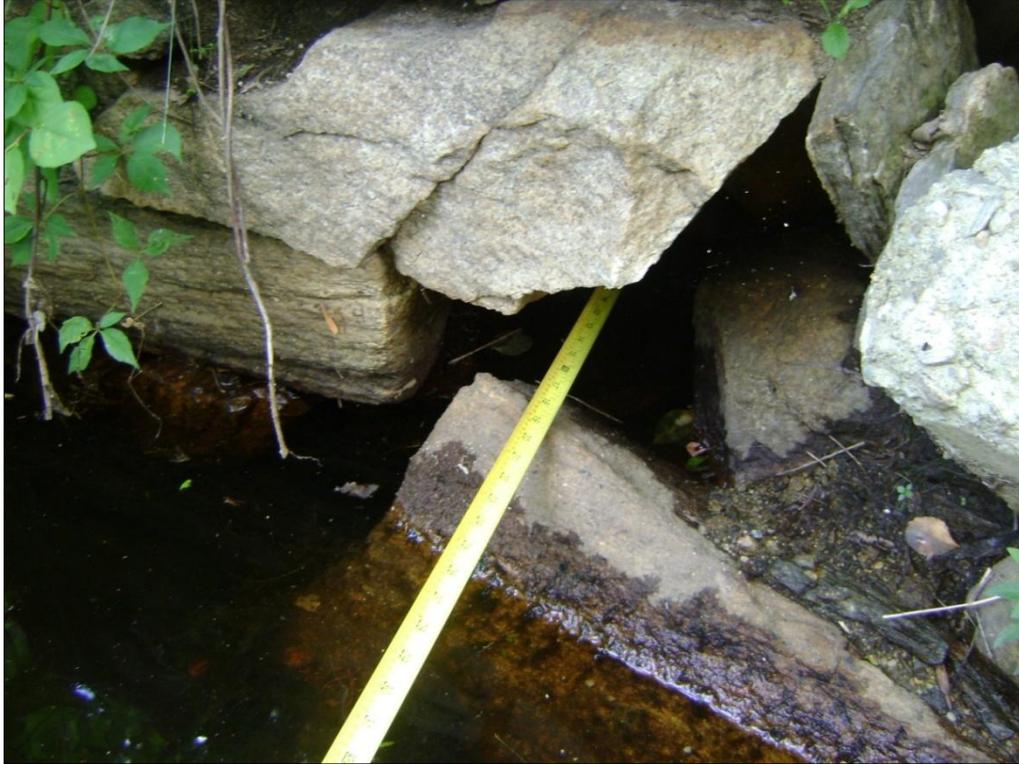
Photo 5 Looking East: Large Void in Southeast Training Wall

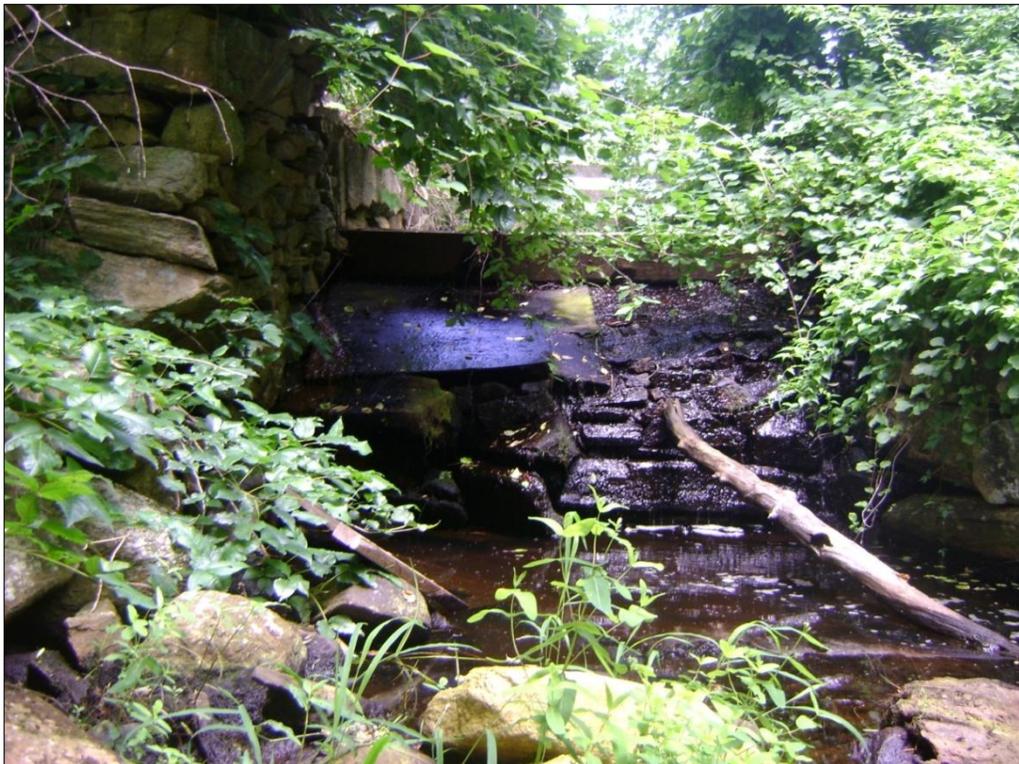
Photo 6 Looking North: Man-Made Dam Elevation

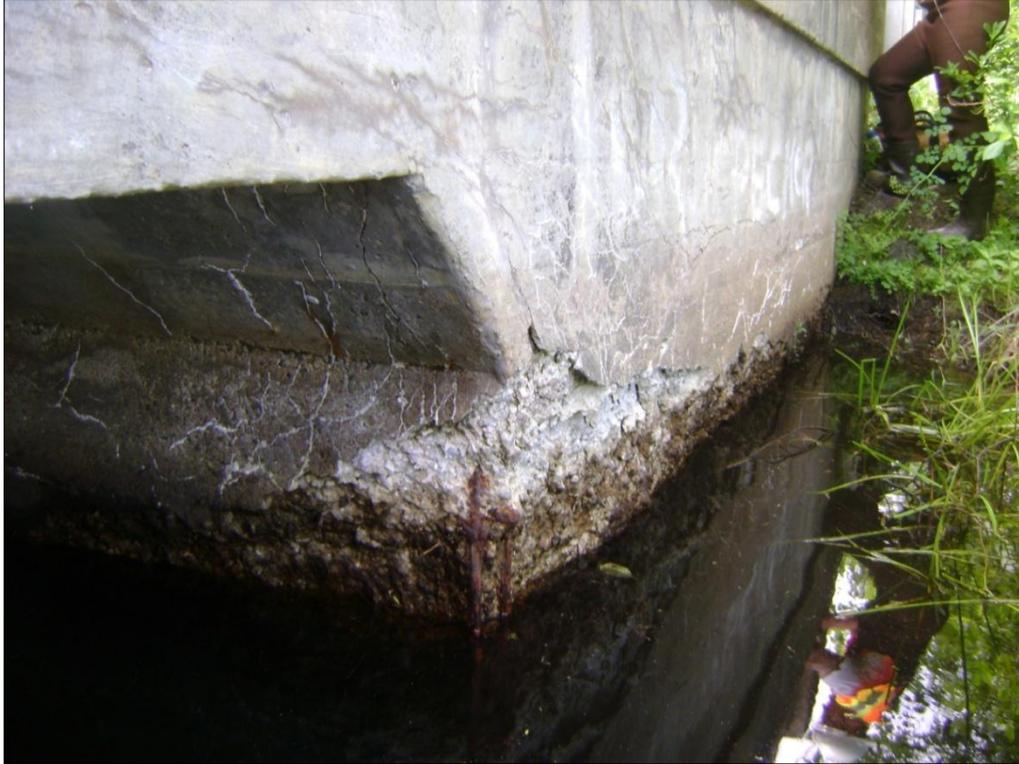
Photo 7 Looking West: Northwest Wingwall

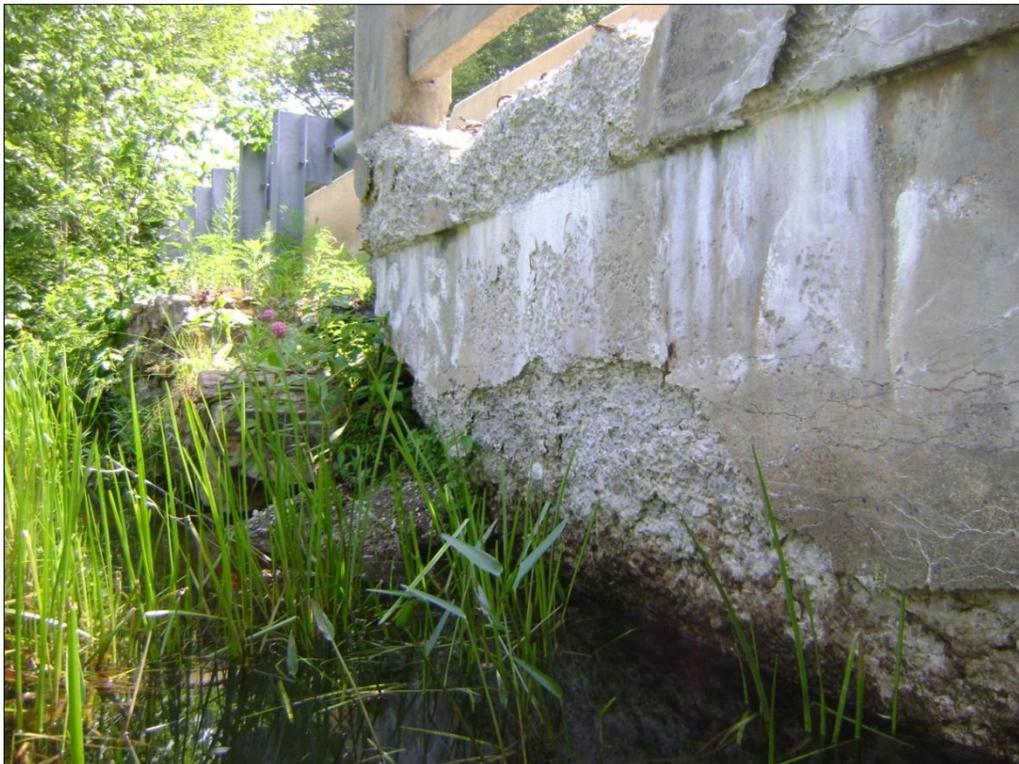
Photo 8 Looking Southeast: Northeast Wingwall

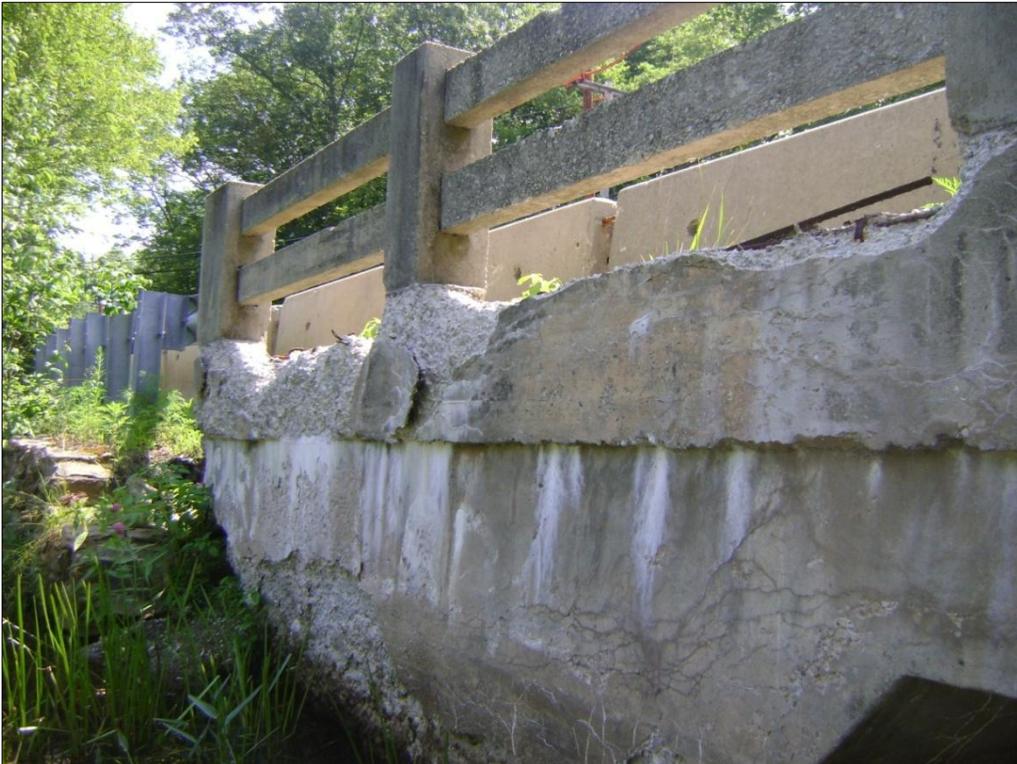
The roadway is in good condition with some sealed linear cracking. The north concrete bridge rail typically shows heavy scaling at the post bases and heavy deterioration throughout (Photos 12, 19, and 20). Jersey barriers are present along the northern curb line to protect the deteriorated bridge rail (Photo 17). As a result of severe embankment erosion on the north side of the culvert, larger voids and undermining is present under the Jersey barriers (Photo 18). The south ridge rail is in better condition with only minor scaling at the base. Collision damage to the northeast approach guardrail was also noted (Photo 16).

Photo 12 Looking Southeast: Deterioration of North Bridge Rail Base

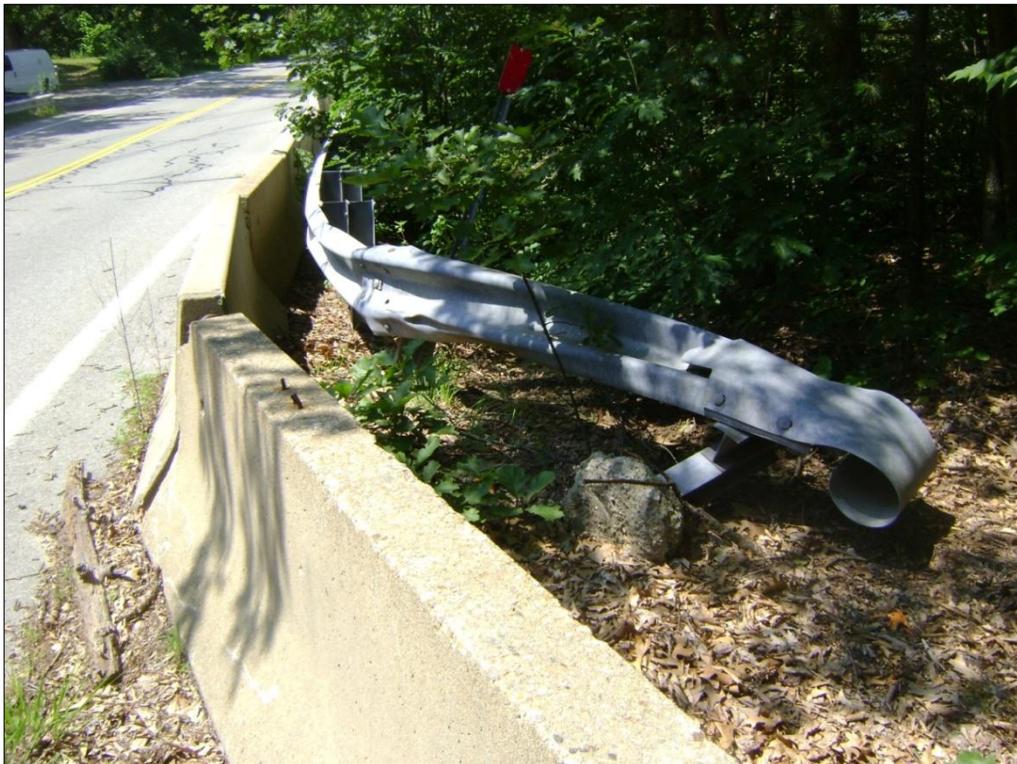
Photo 16 Looking West: Northeast Guardrail Collision Damage

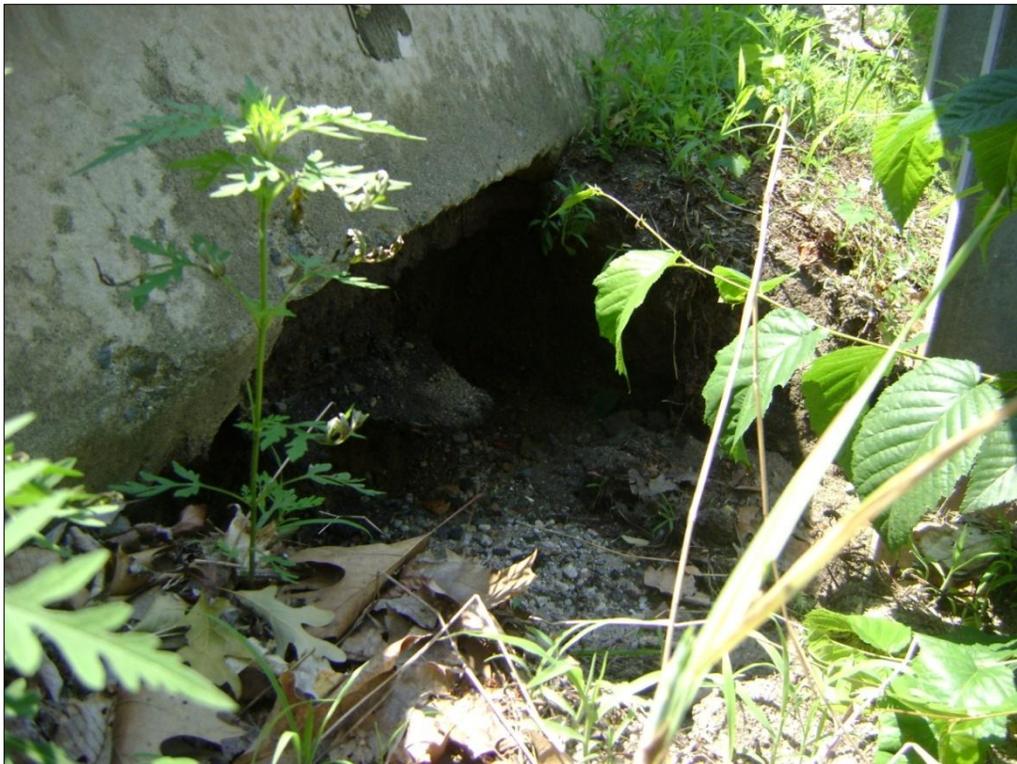
Photo 18 Looking West: Void Under Jersey Barrier at Northeast Approach

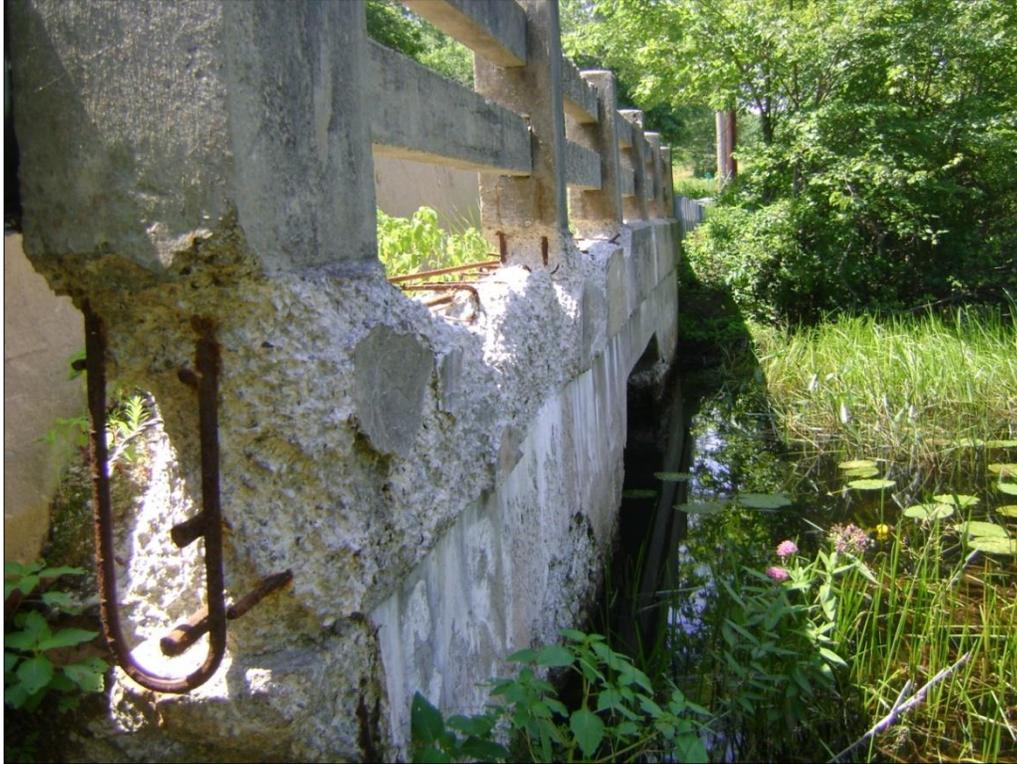
Photo 19 Looking West: Deterioration of North Bridge Rail Base

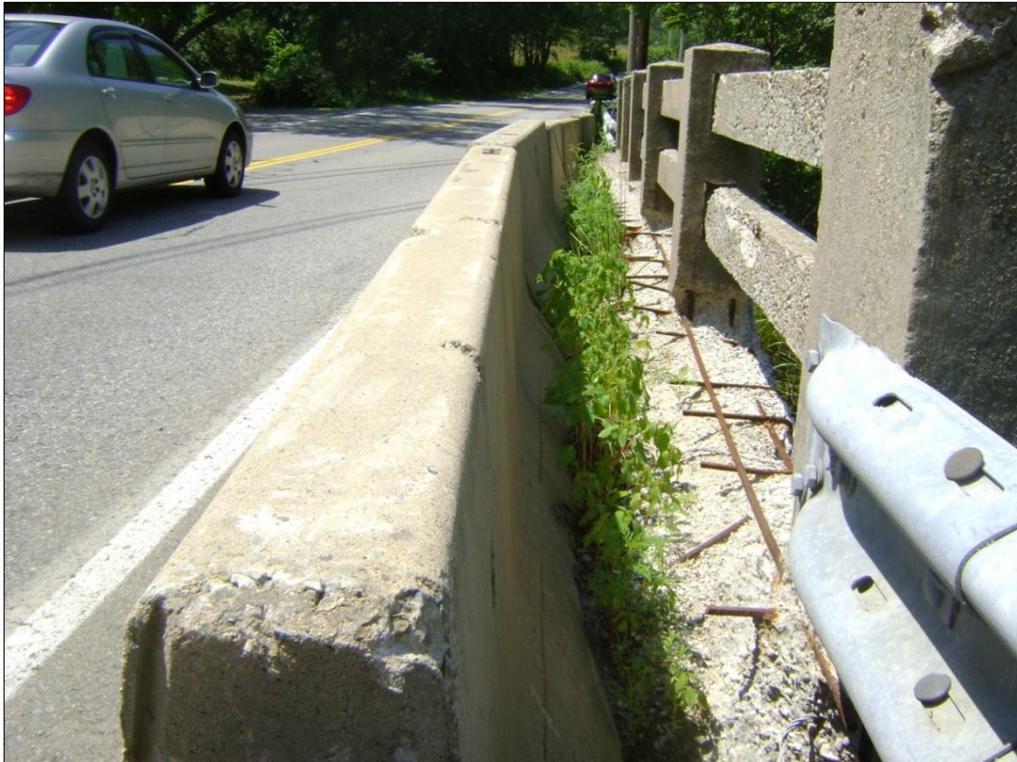
Photo 20 Looking West: Deterioration of North Bridge Rail Base

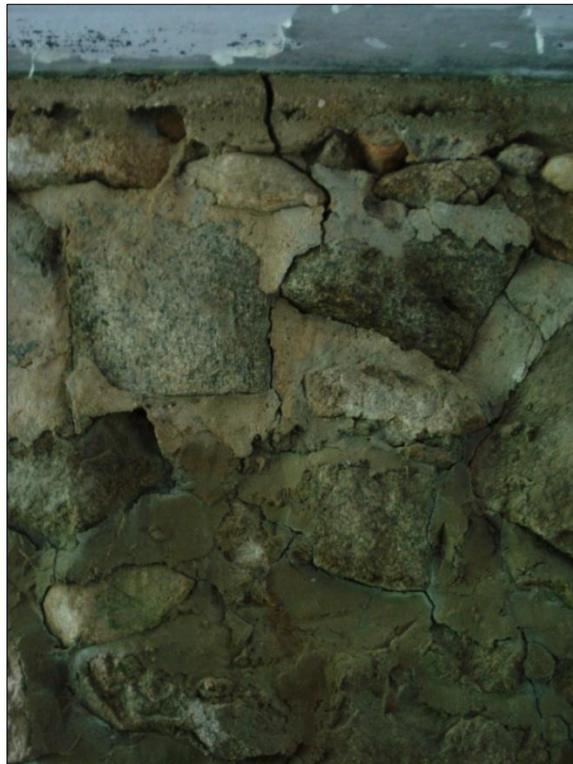
The abutments are also in fair condition with a few minor problems. Both abutments exhibit missing pointing and chinking stones at the waterline. A full height vertical crack was recorded at the west abutment. Additionally, three wide vertical cracks in the beam seat were located at the west abutment (See Photo 2). There is also a large void at the north end of the east abutment, which extends 33" into the wall. Similarly, a void at the south end of the west abutment was recorded and measured 12" x 2" x 24" deep (Photo 7).

Photo 2 Looking East: Vertical Crack at East Abutment

- Repair all spalls and cracks to the concrete slab. Also, finish and smooth all recessed block locations at the slab underside.
- Fill all voids, repair all cracks and repoint the existing stone masonry abutments.
- Remove all vegetation from the existing wingwall. Fill all voids and repoint as required. All voids noted in the walls should be filled to prevent further erosion of the embankment and loss of roadway fines.
- Resurface immediate approaches and strip deteriorated wearing surface from concrete slab. Repair any visible concrete deterioration and apply new wearing surface.
- Place proper signage such as "BE PREPARED TO STOP," as the roadway width over the structure is not adequate to carry two lanes of traffic. The roadway centerlines should be striped accordingly. All signage and striping should be fabricated and placed in accordance with current MUTCD standards.

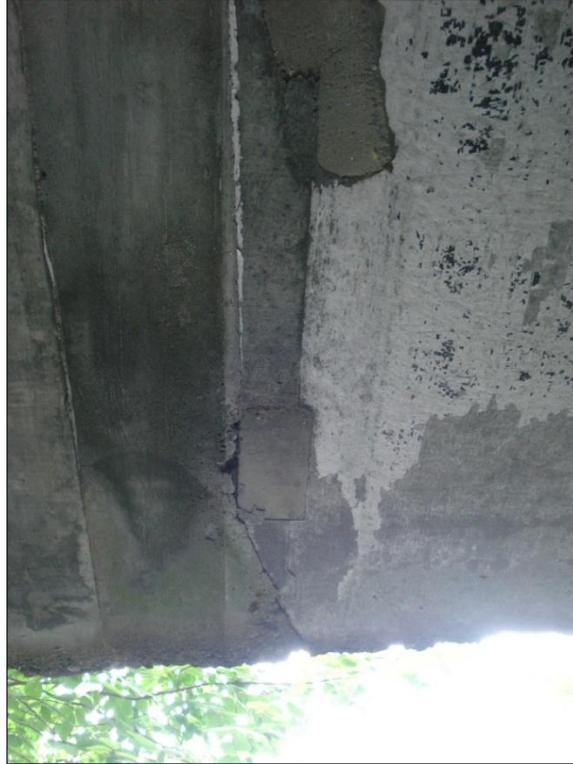
The concrete slab is in fair condition with a few minor problems. Transverse cracking on the underside of the slab is present and appears to be sealed and/or repaired. There are also several concrete blocks recessed into the underside of slab. These blocks are likely construction related, used as form supports or steel reinforcing spacers. The blocks are not considered a deficiency but do allow water/moisture to penetrate the slab.

Photo 3 Looking Up: Crack in Slab Underside at North Opening

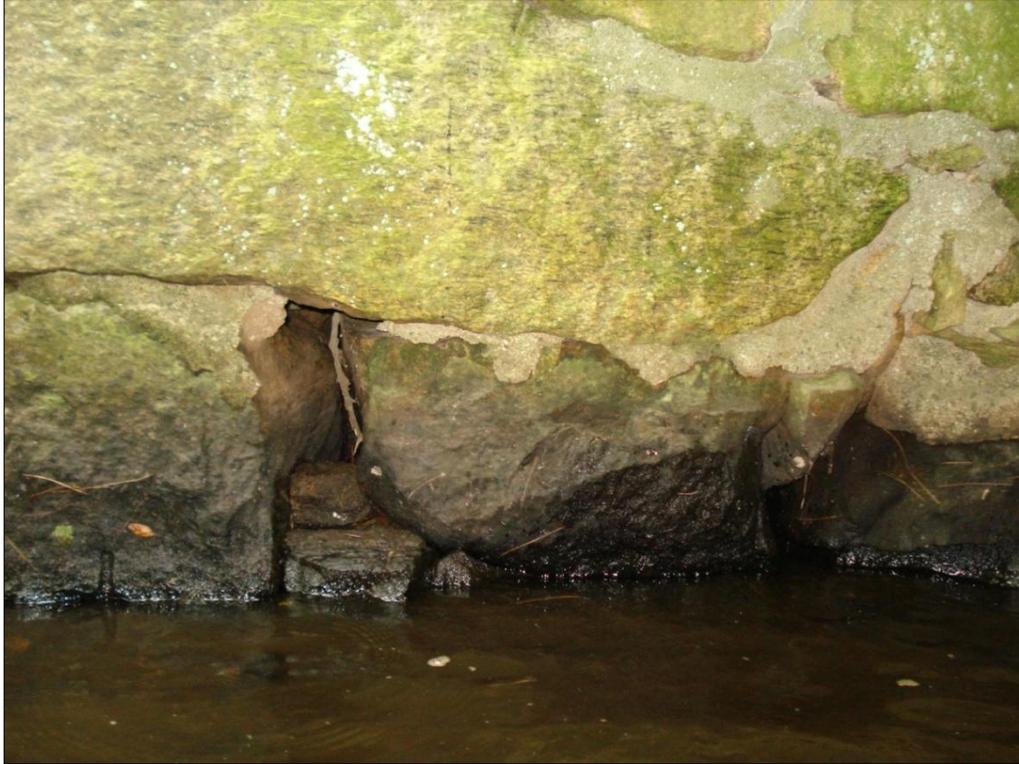
Abutment West Sidewall:	Large void at South end 12" x 24" x 2' deep. Mortared stone masonry w/missing mortar and chink stones at WL.	
Abutment North Sidewall Rating: N/A	Abutment South Sidewall Rating: N/A	
Abutment East Sidewall Rating: N/A	Abutment West Sidewall Rating: 3	
Culvert Roof:		
Culvert Roof Notes:	Several concrete repairs. Otherwise good condition. What looks like a full length, transverse crack that's been sealed. Possible construction joint.	
Culvert Roof Rating: 4		
Culvert Floor, Entrance, Exit		
Floor Scour: None detected	Debris: Cobbles, Boulders, Sediment	Floor Rating: 3
Floor Notes: Sediment at North opening. Voids at base of wall.

Photo 7 Looking West: Void at Base of West Abutment

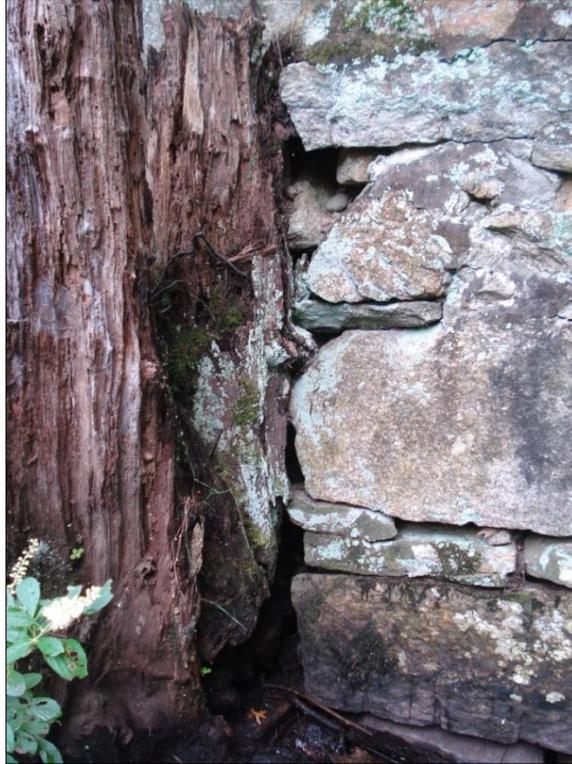
Two stone masonry wingwalls on the south side, although heavily covered in vegetation, are in good condition with some missing pointing and chinking stones. Two stone masonry wingwalls on the north side are also covered with heavy vegetation. A tree was found growing from the northeast wall (Photo 9) in addition to several large voids. Additionally, the top of the northwest wall is crumbling.

Photo 9 Looking Southeast: Void in Northeast Wingwall at Tree

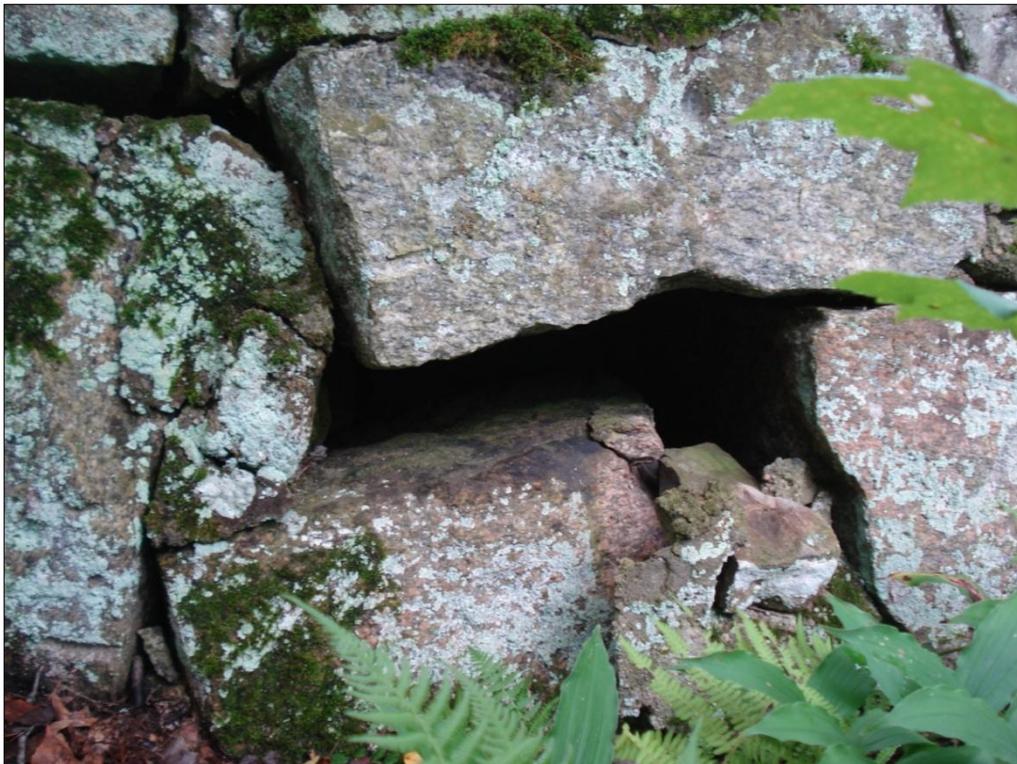
Photo 10 Looking South: Void in Northeast Wingwall

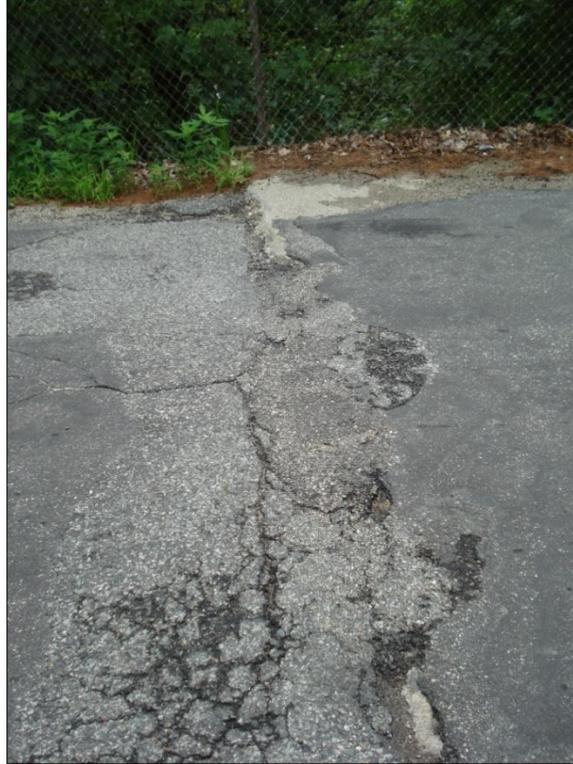
The roadway over the bridge is extremely narrow and nearly 100% covered in map cracking. There is heavy wheel line rutting in both approaches and some potholes. The bridge joints show settlement and cracking (Photo 13). The chain-link fence bridge rail is wobbly and not crash tested. There is a steep embankment and the lack of approach guardrail makes this a safety hazard.

Photo 13: Typical Approach Roadway Joint

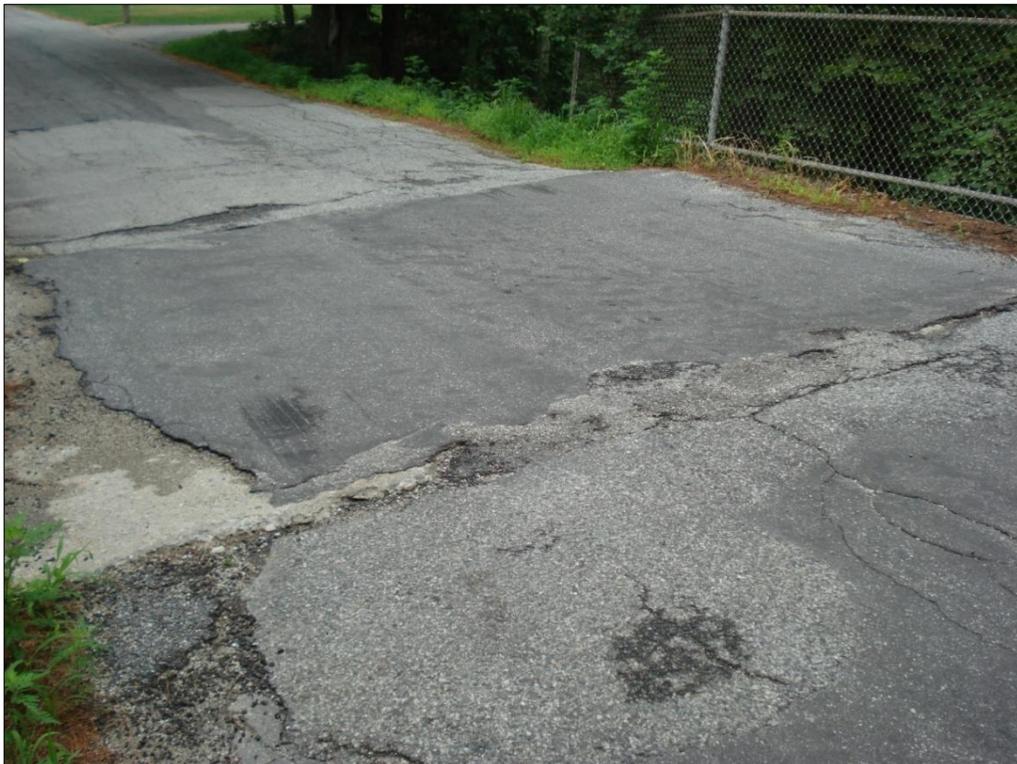
Photo 14 Looking Northwest: Condition of Pavement over Culvert

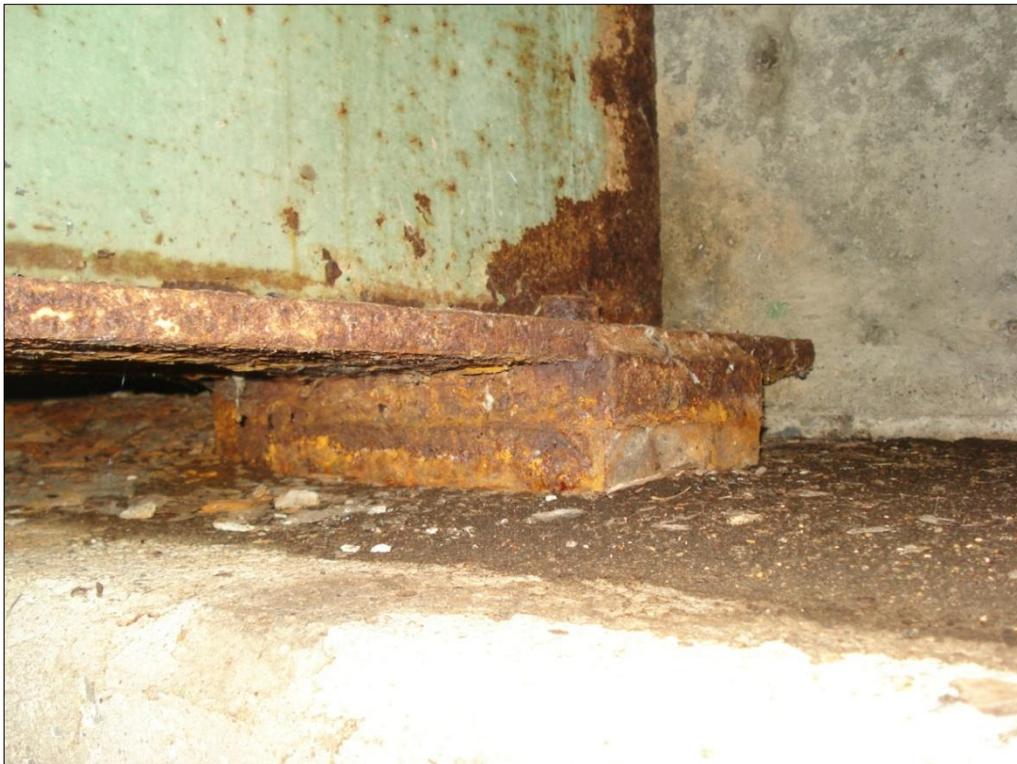
Photo 6 Looking East: Steel Bearing Deterioration of Beams #1 and #2 at West Abutment

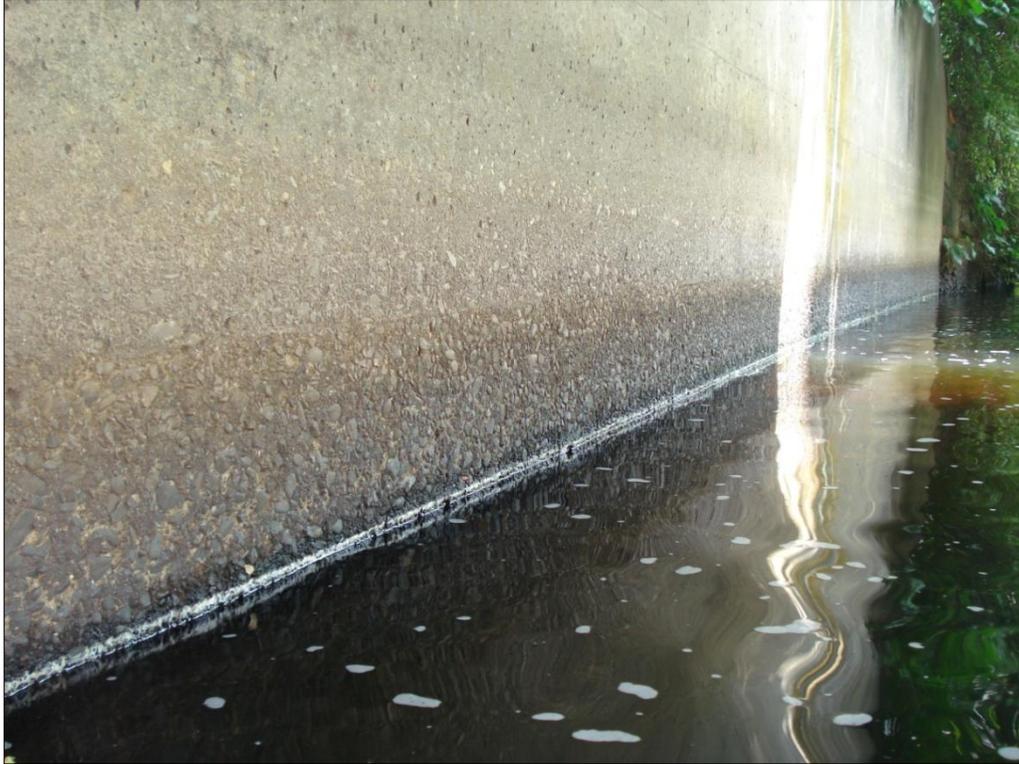
Photo 9 Looking South: Typical Scaling of Abutment at Waterline

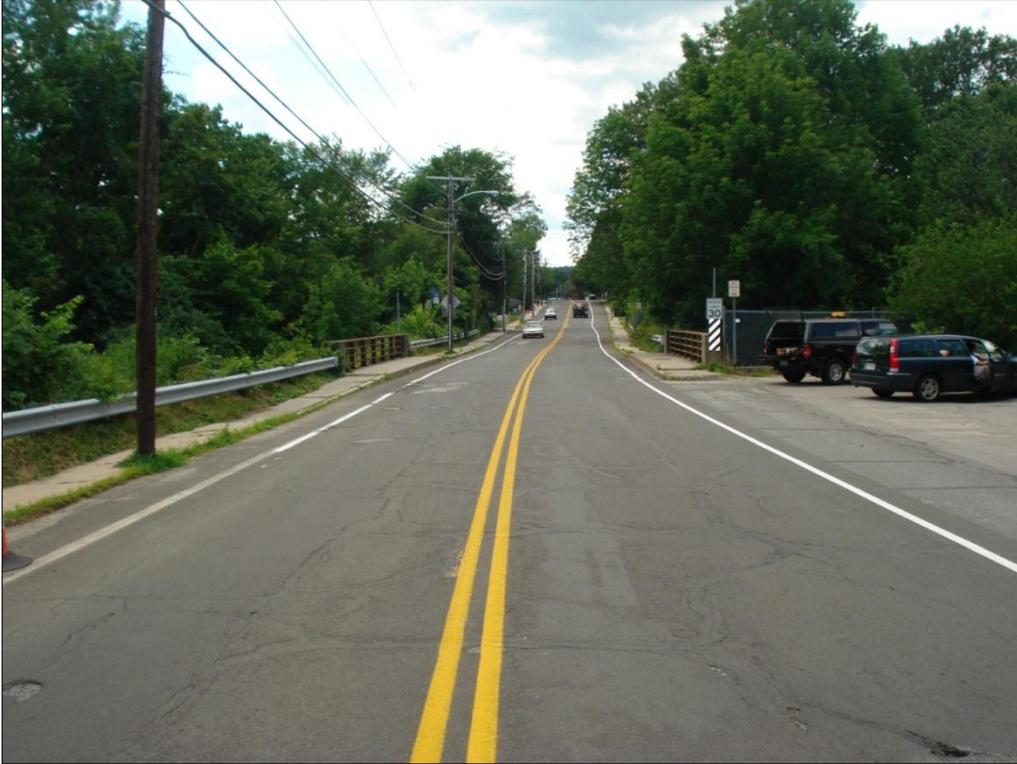
Photo 13 Looking West: East Approach

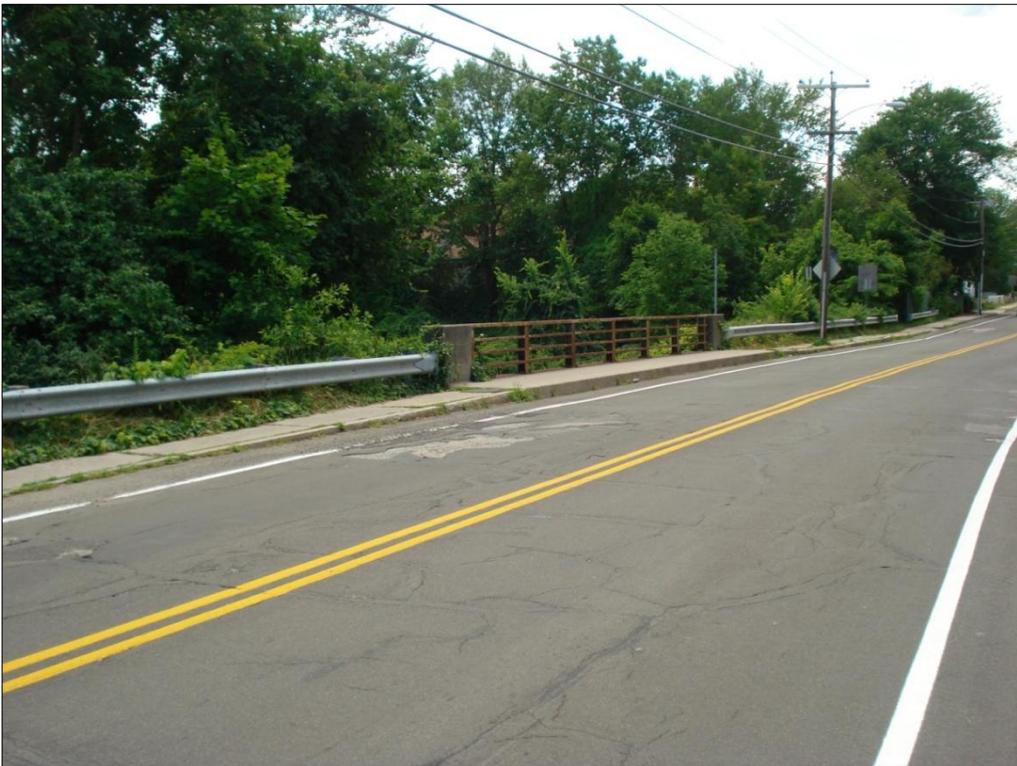
Photo 14: Typical Guardrail Transition

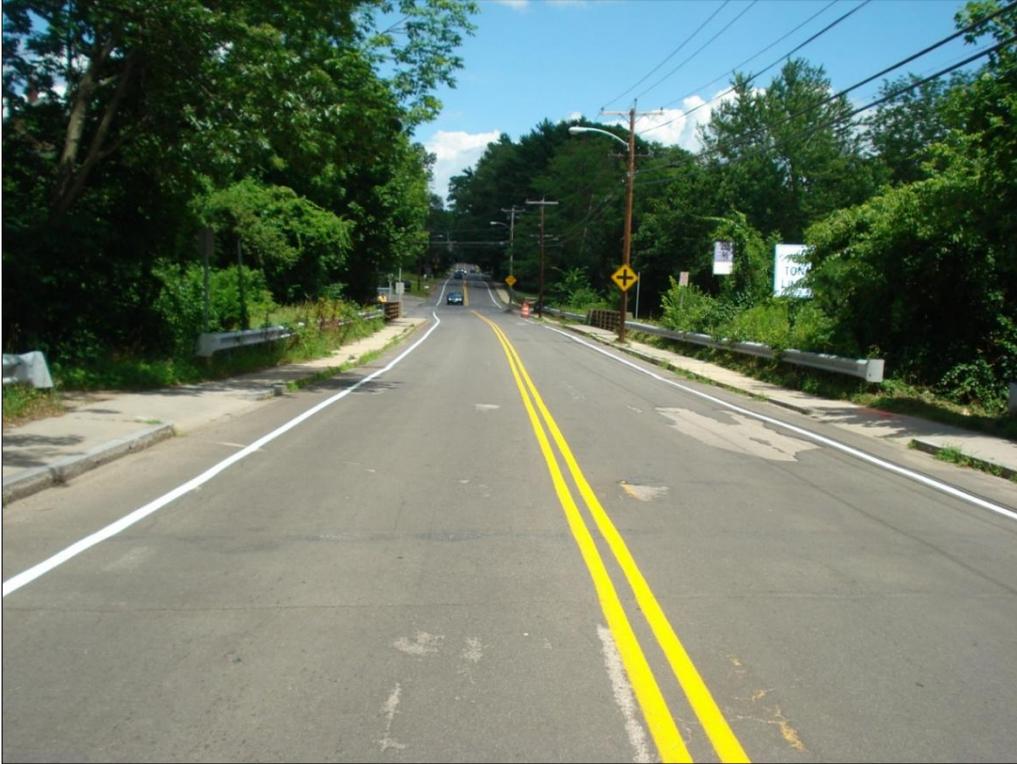
Photo 15 Looking East: West Approach

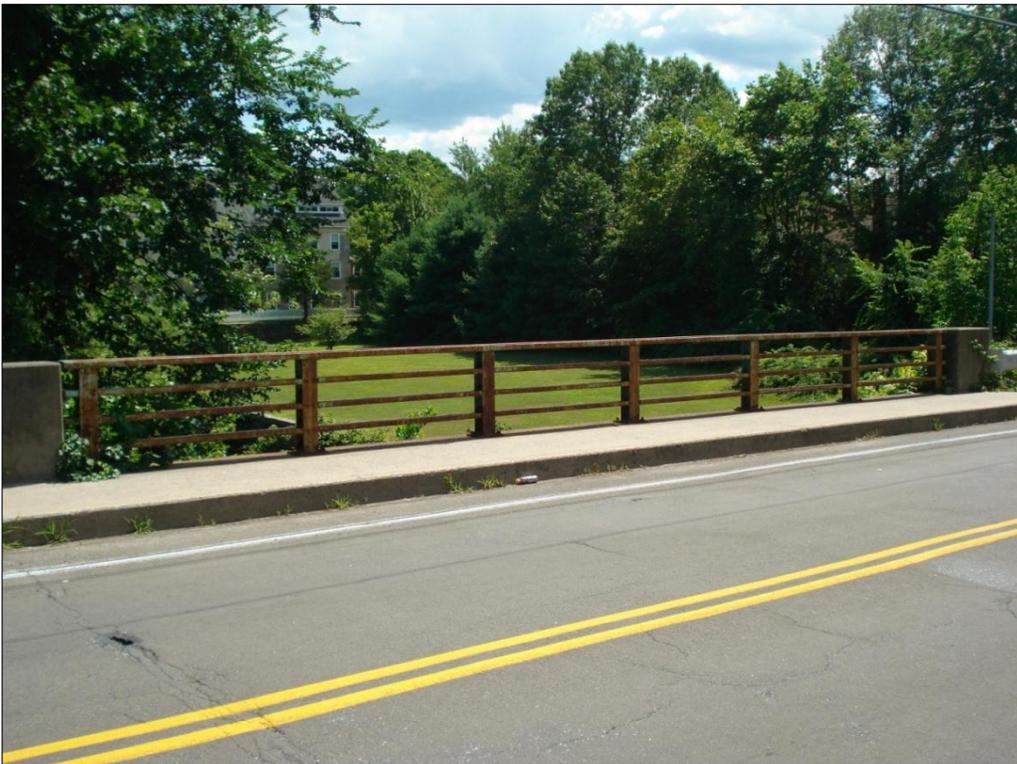
Photo 16: Typical Bridge Rail Elevation

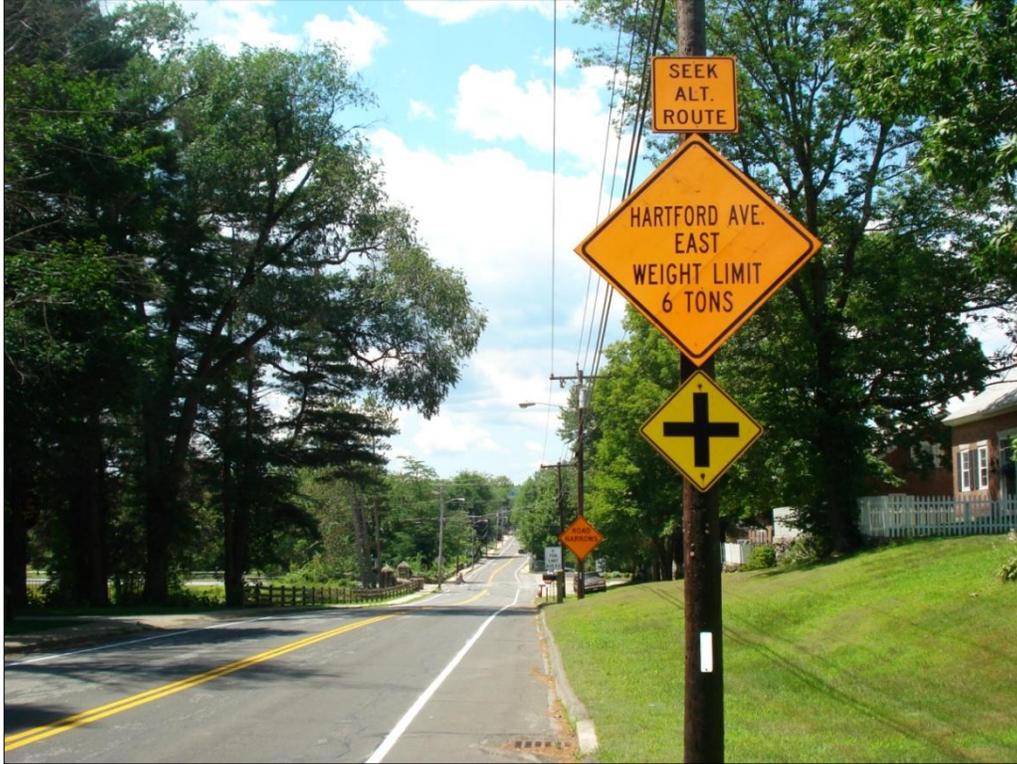
Photo 17 Looking West: Posted Signs at East Approach

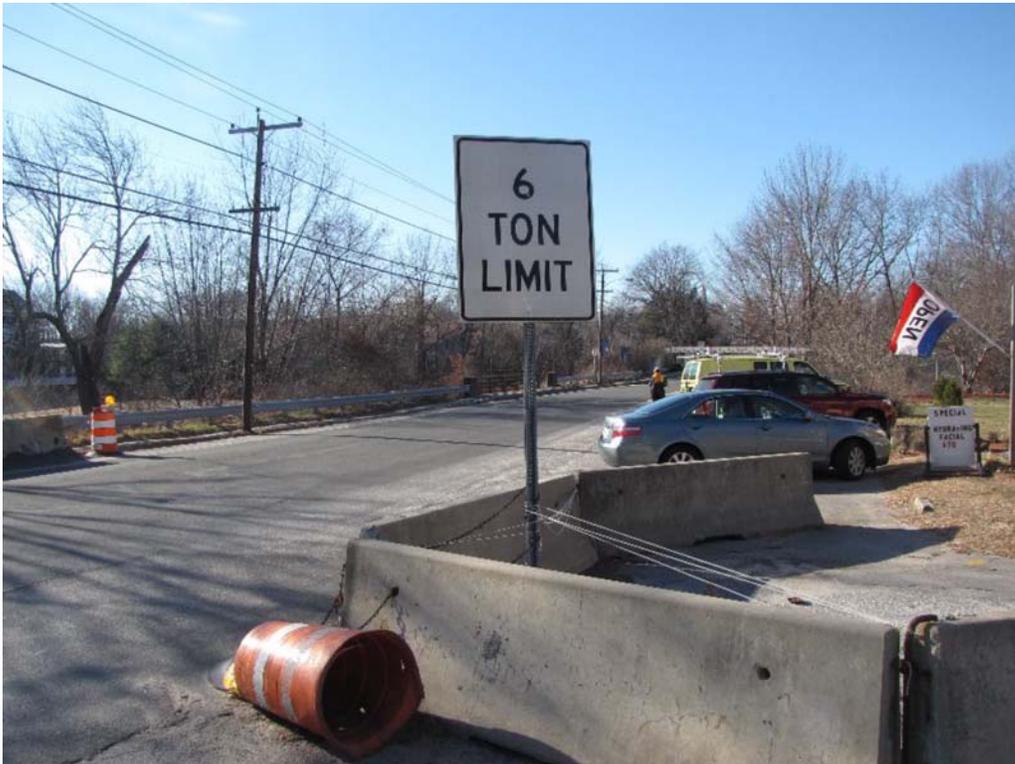
Photo 1: Weight posting sign.

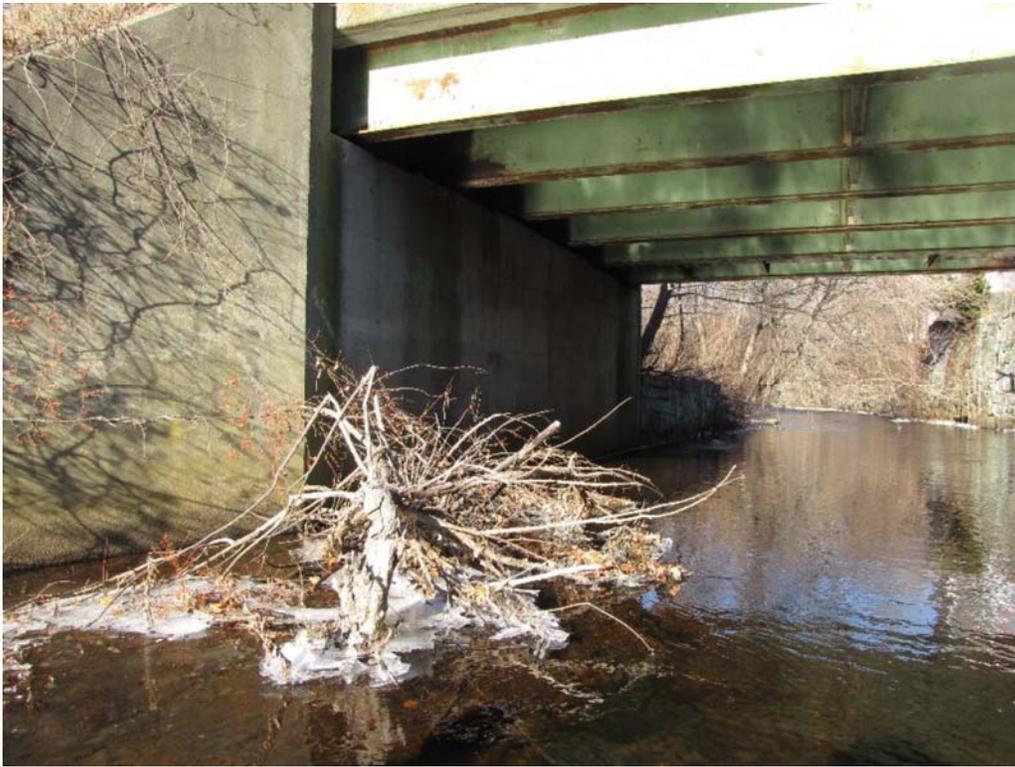
Photo 7: Tree and brush growth at Southwest channel.
