Bridge/Culvert Management Plan

November 2011

Uxbridge
Massachusetts

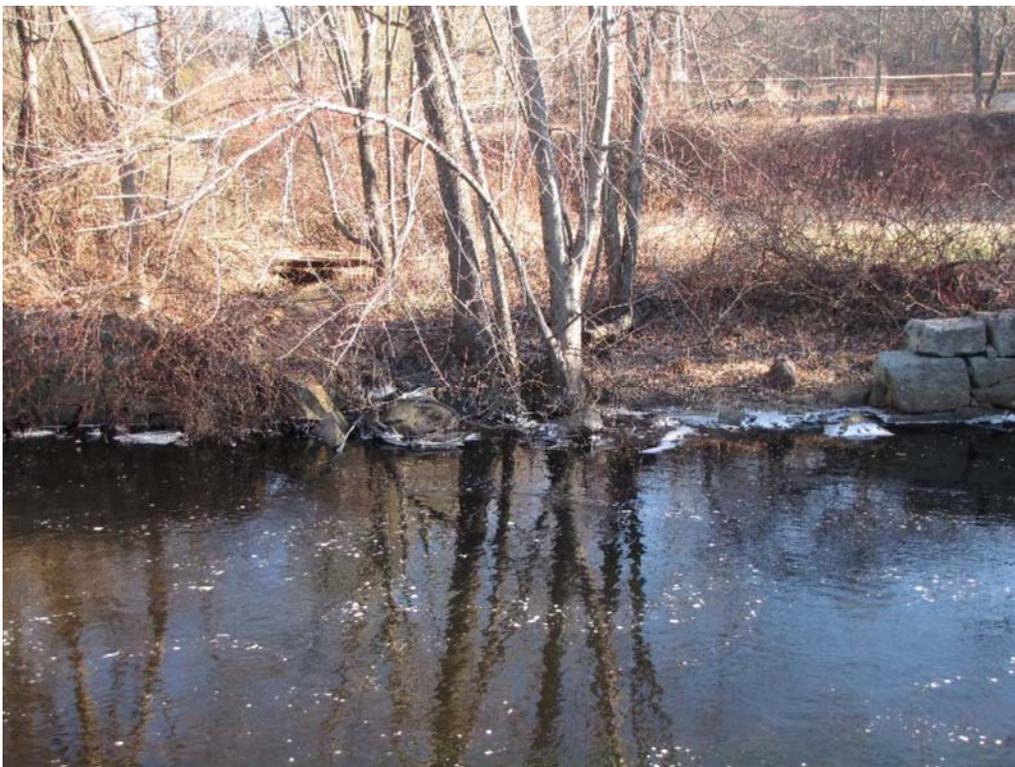
Photo 8: Collapsed wall at Southeast channel.

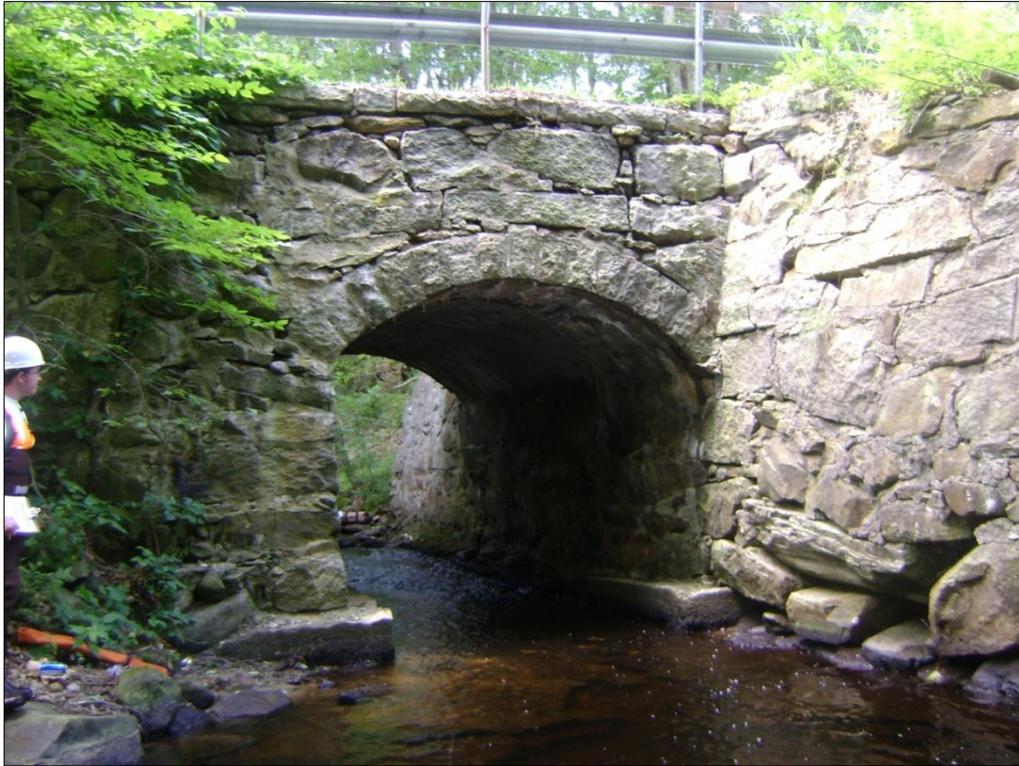
Photo 1 Looking North: South Culvert Elevation

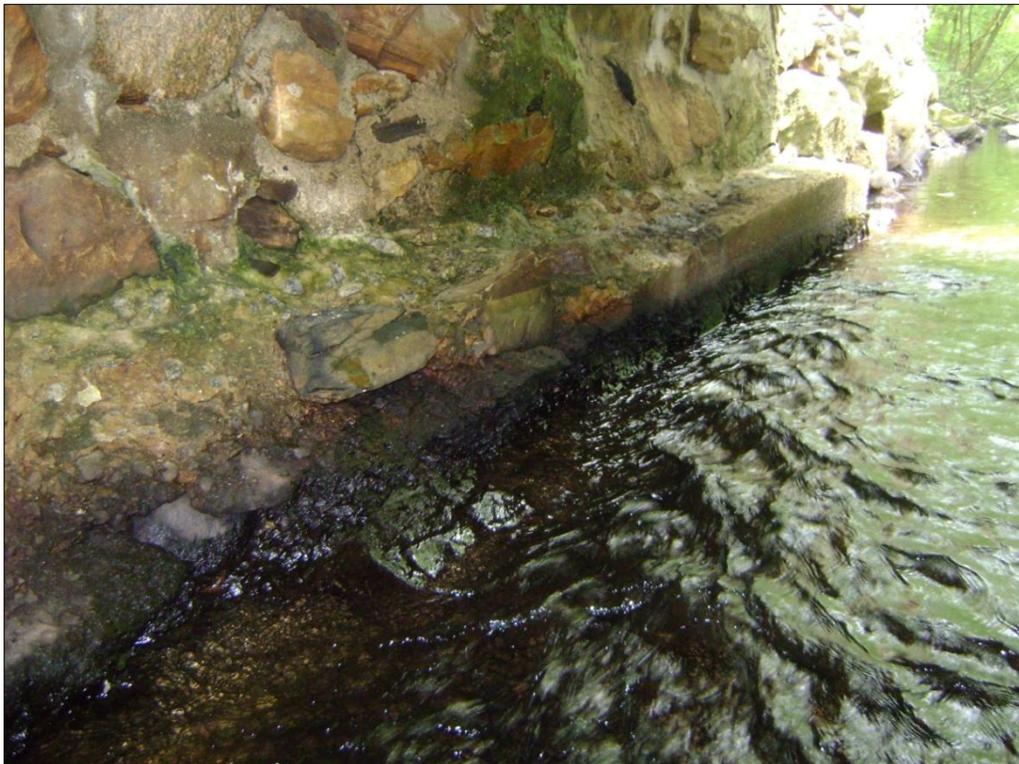
Photo 2 Looking South: East Abutment Footing

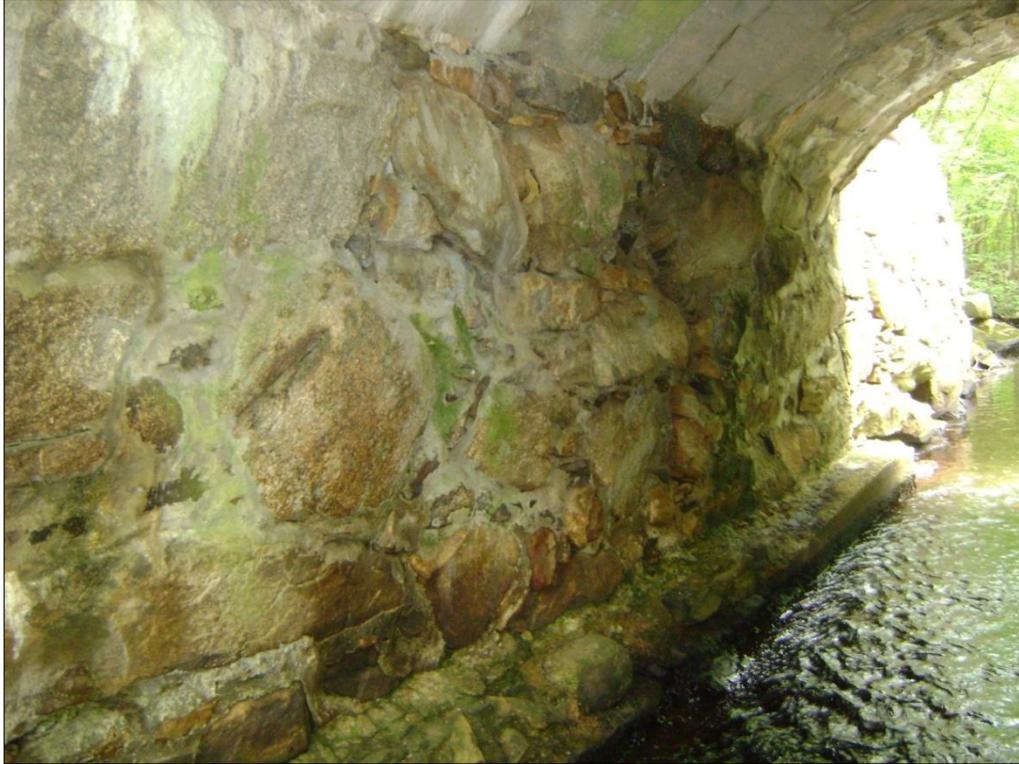
Photo 3 Looking South: East Culvert Wall

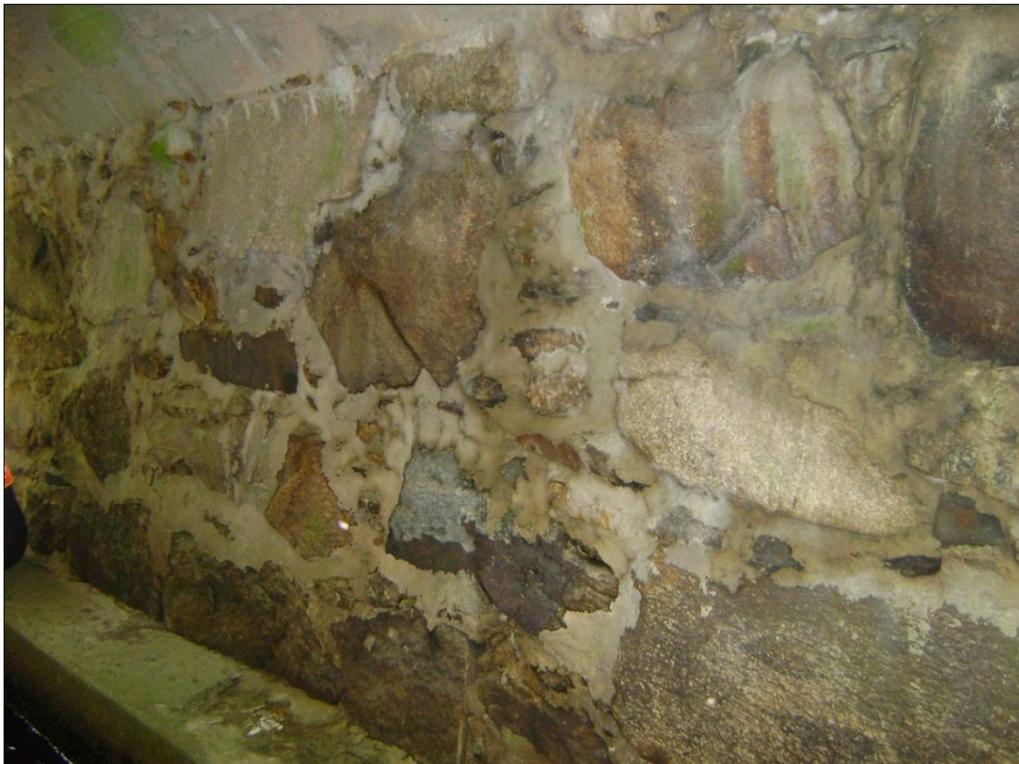
Photo 4 Looking South: West Culvert Wall

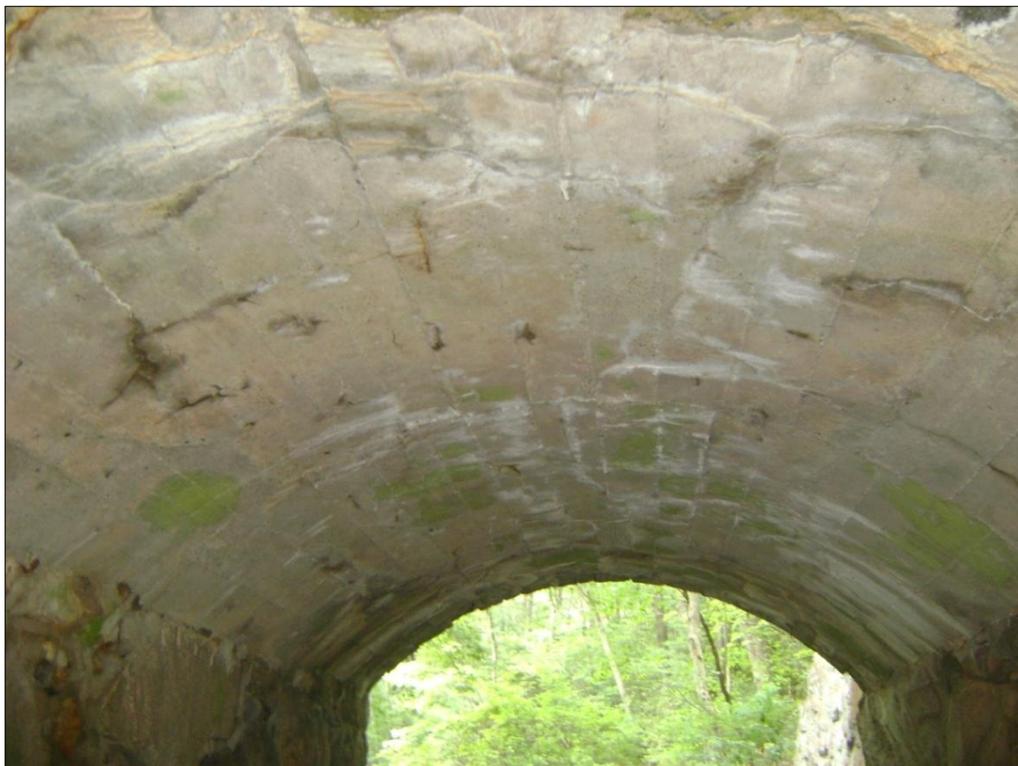
Photo 6 Looking North: Underside of Arch

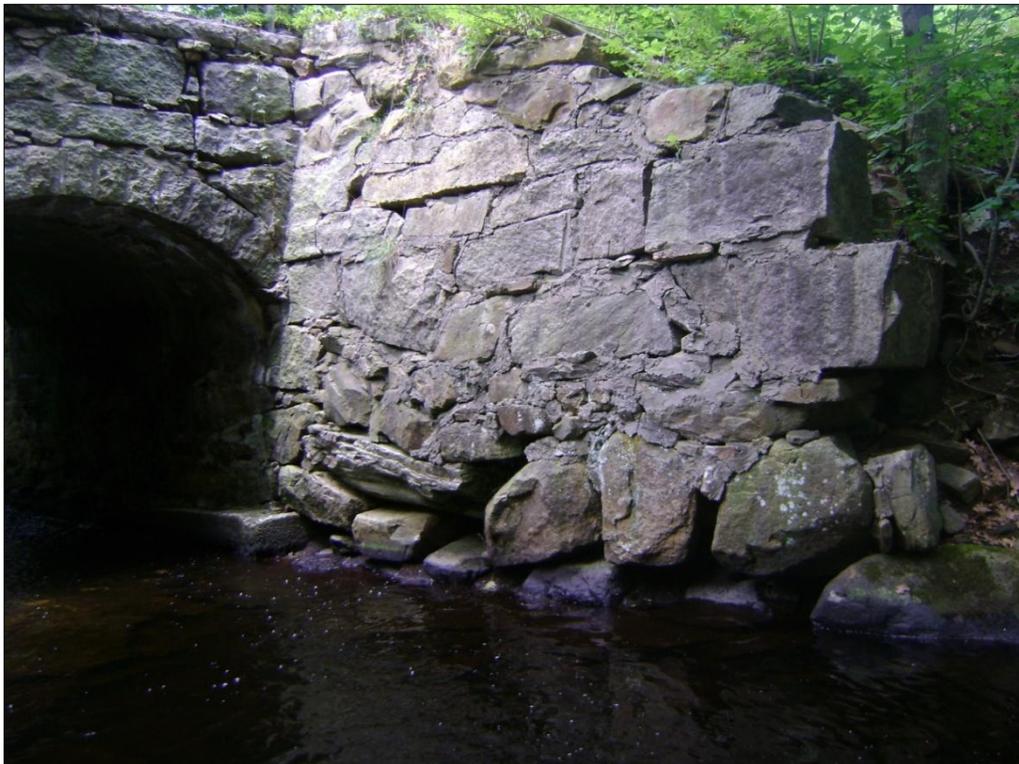
Photo 8 Looking Northeast: Southeast Wall Elevation

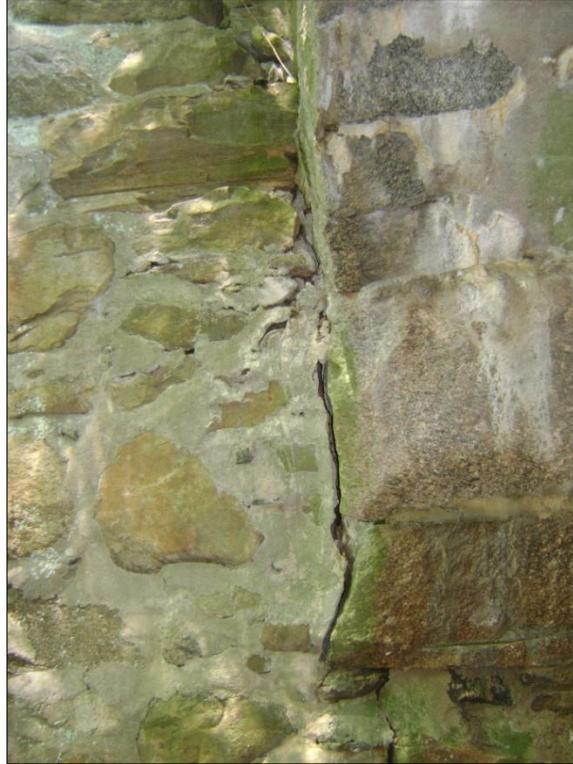
Photo 9 Looking East: Crack Between East Culvert Wall and Northeast Training Wall

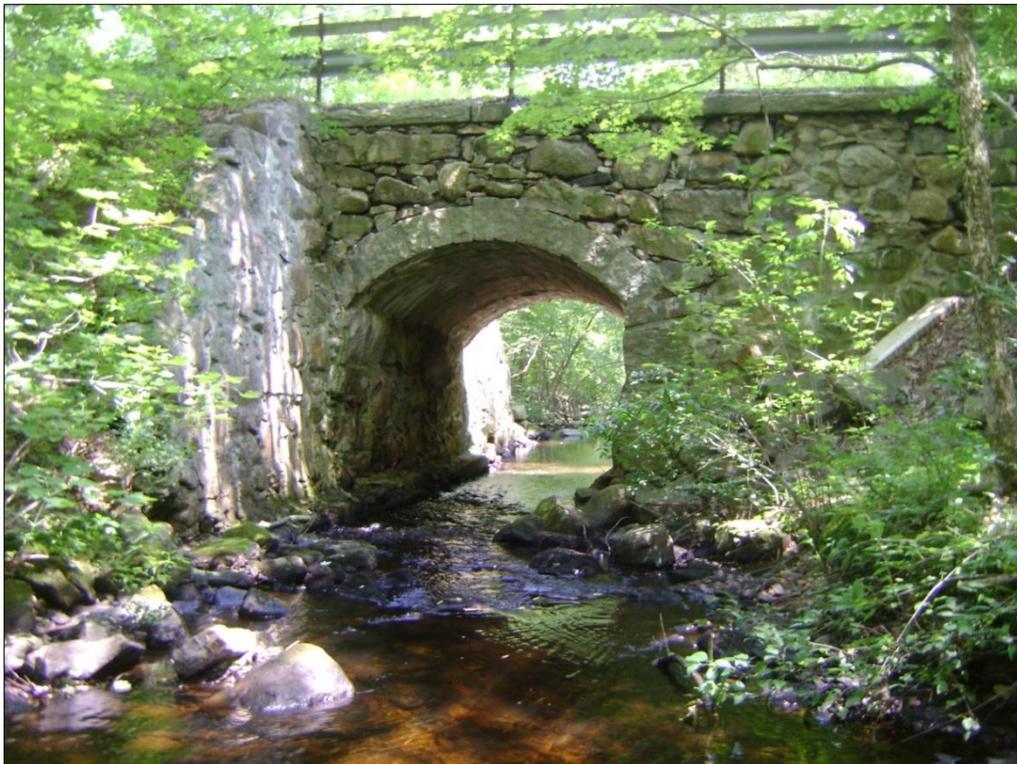
Photo 10 Looking South: North Culvert Elevation

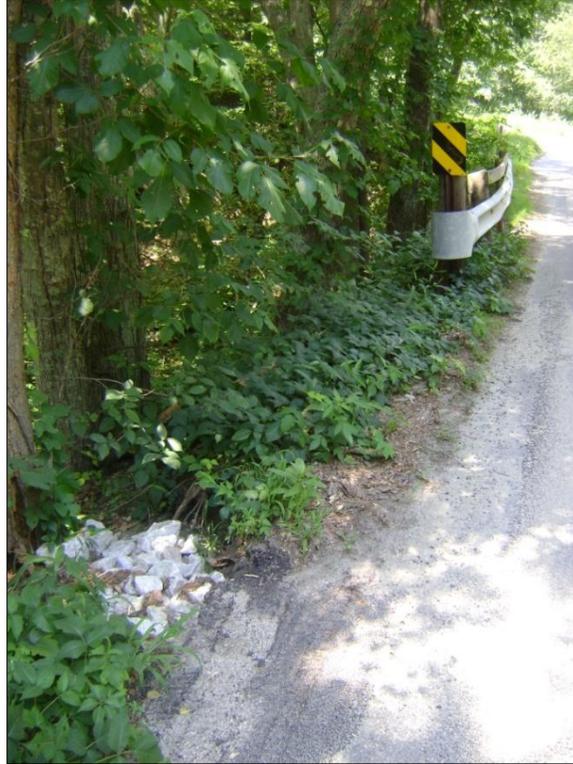
Photo 11 Looking East: Rip-Rap Drainage Path at Northwest Approach

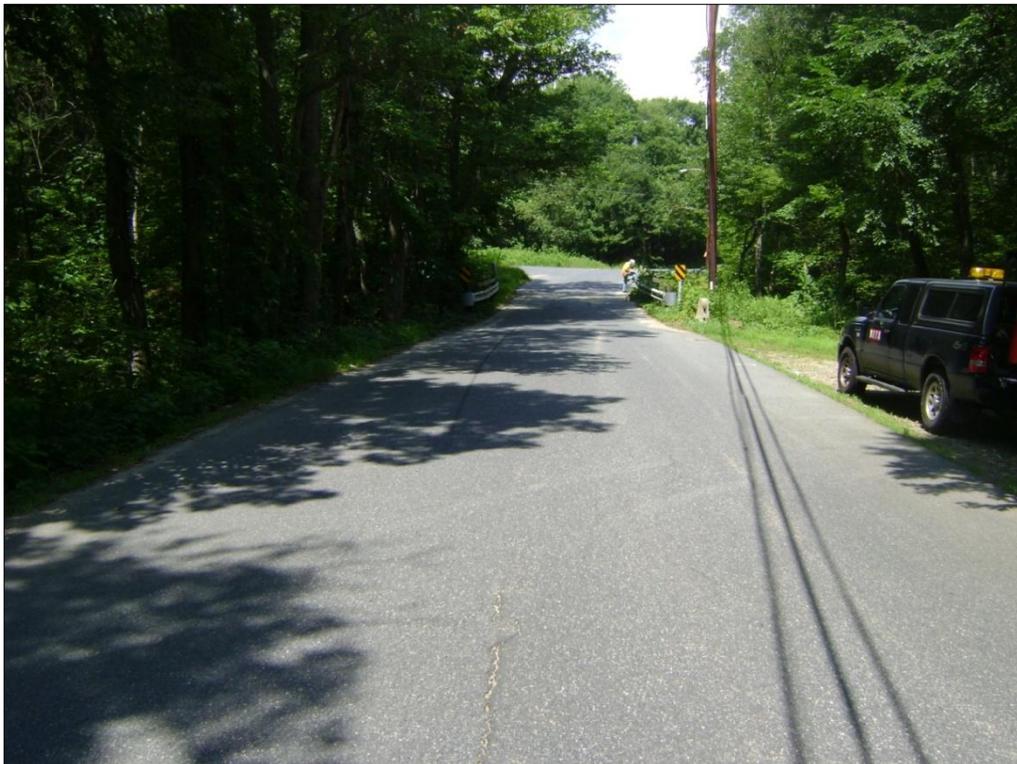
Photo 12 Looking East: West Approach

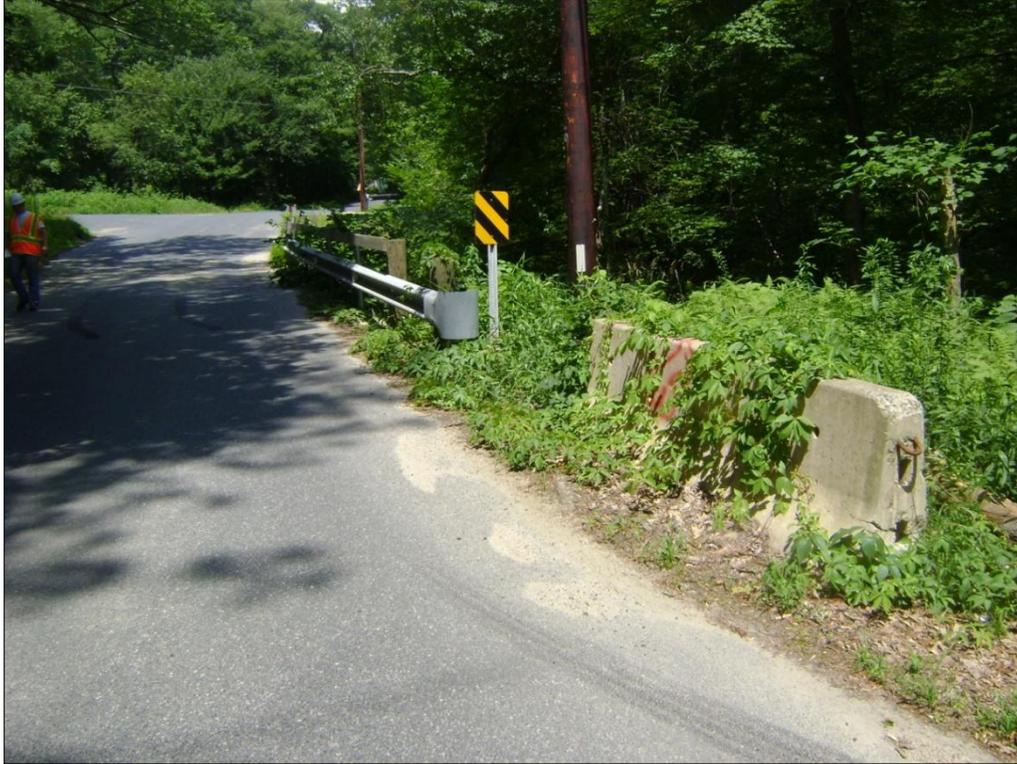
Photo 13 Looking East: Southwest Approach with Jersey Barrier

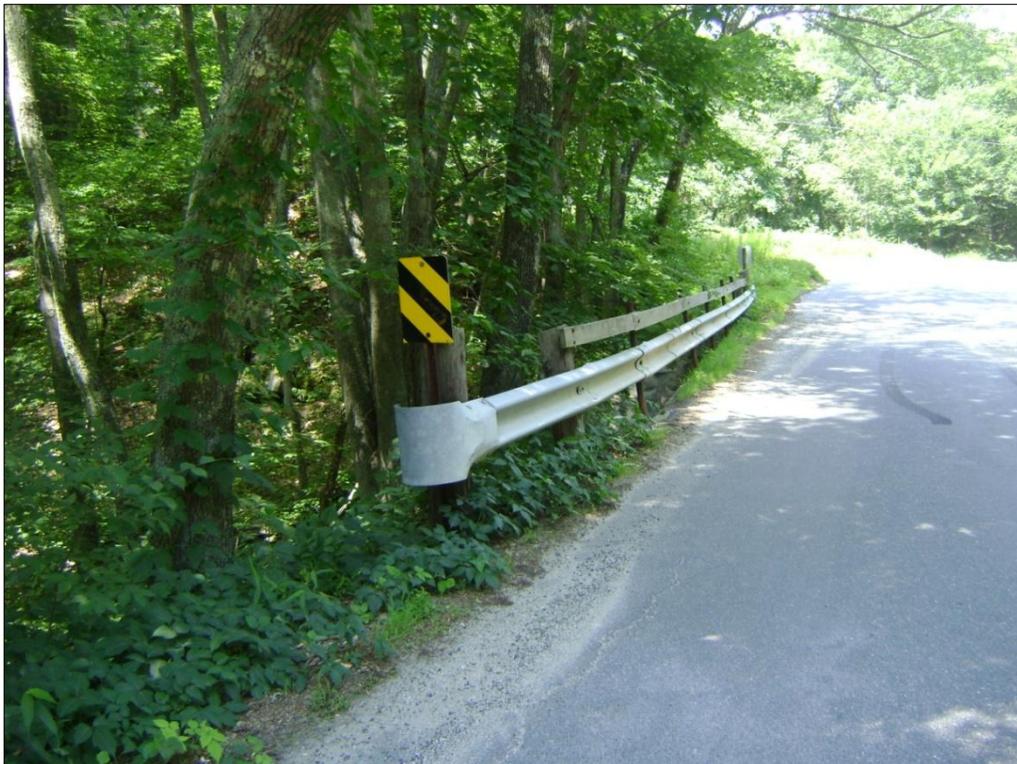
Photo 14: Typical Bridge Rail

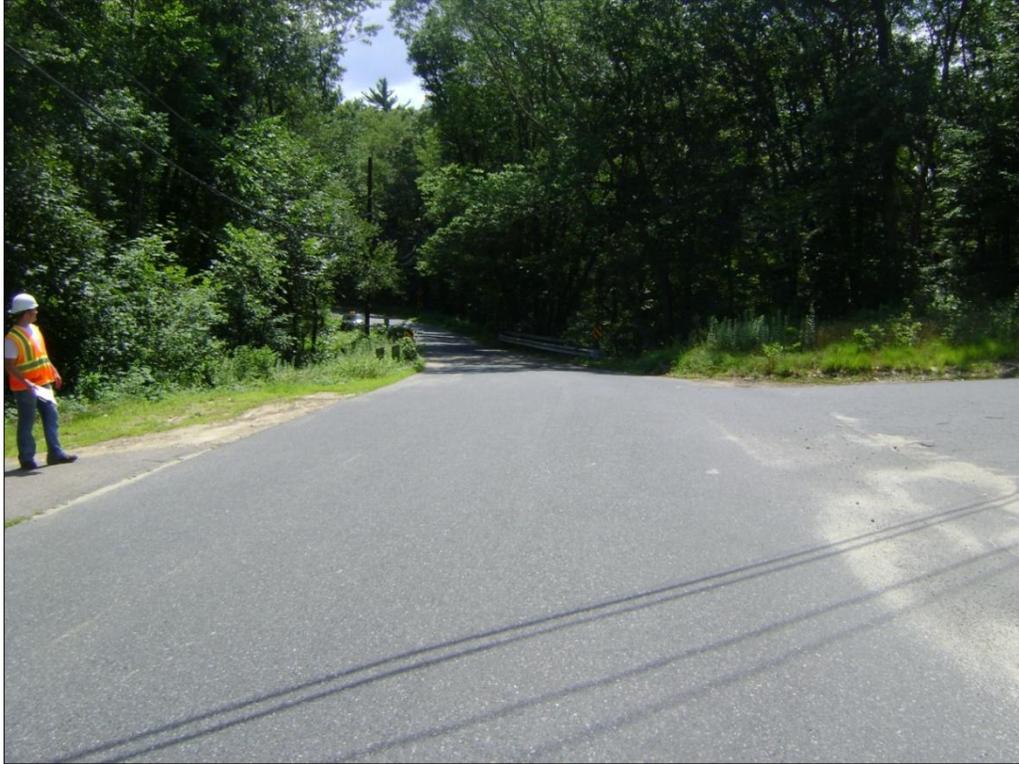
Photo 15 Looking West: East Approach

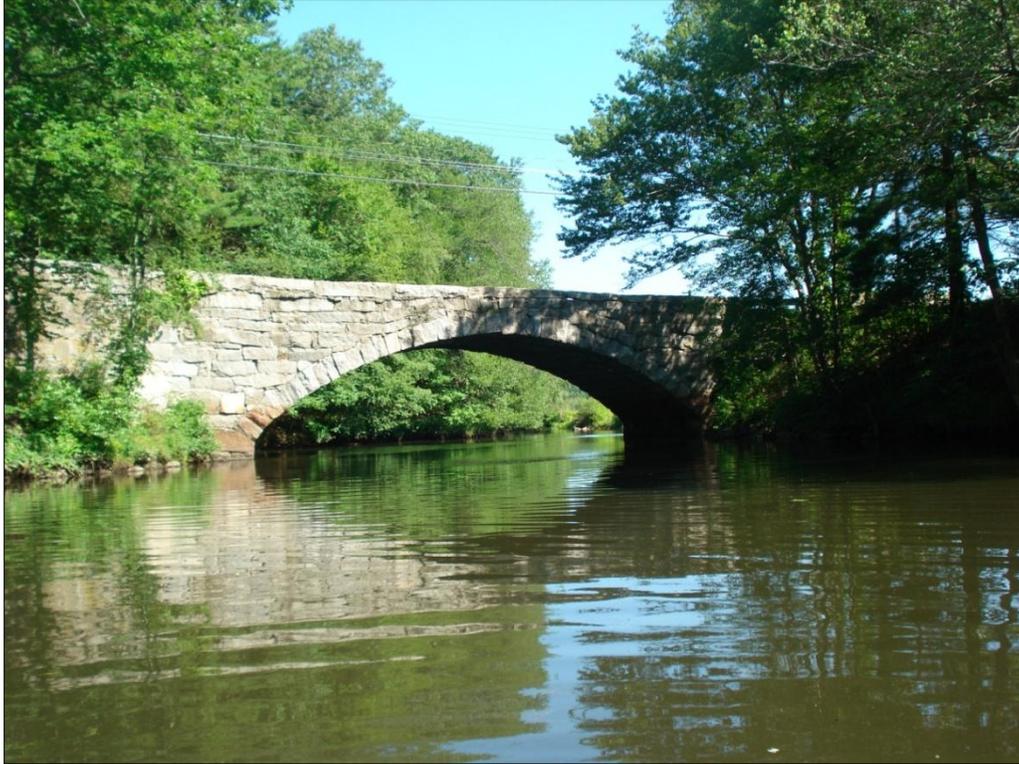
Photo 1 Looking North: South Bridge Elevation

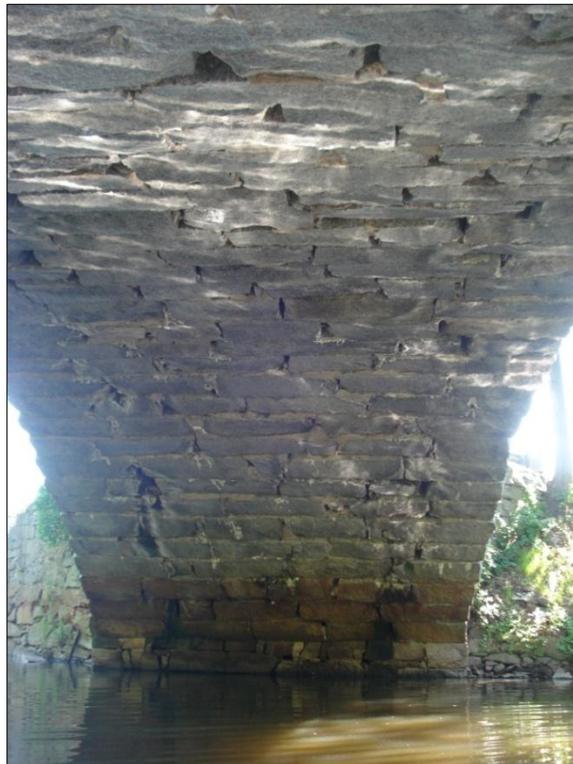
Photo 2 Looking East: Underside of Arch and East Abutment

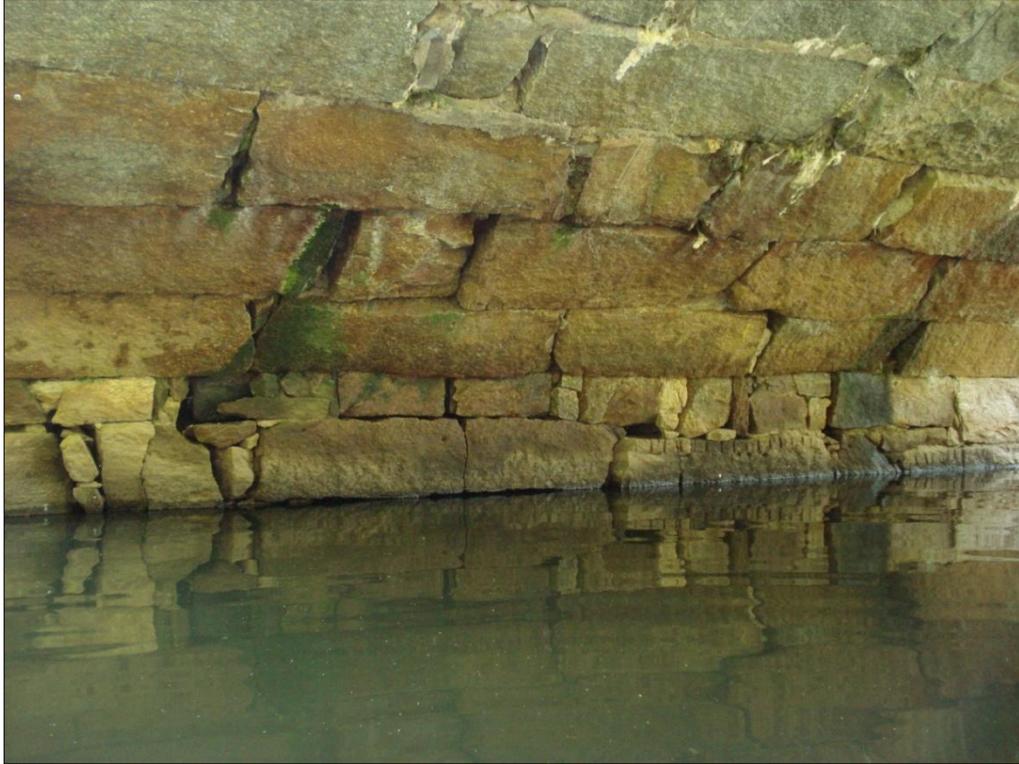
Photo 3 Looking East: East Abutment Elevation

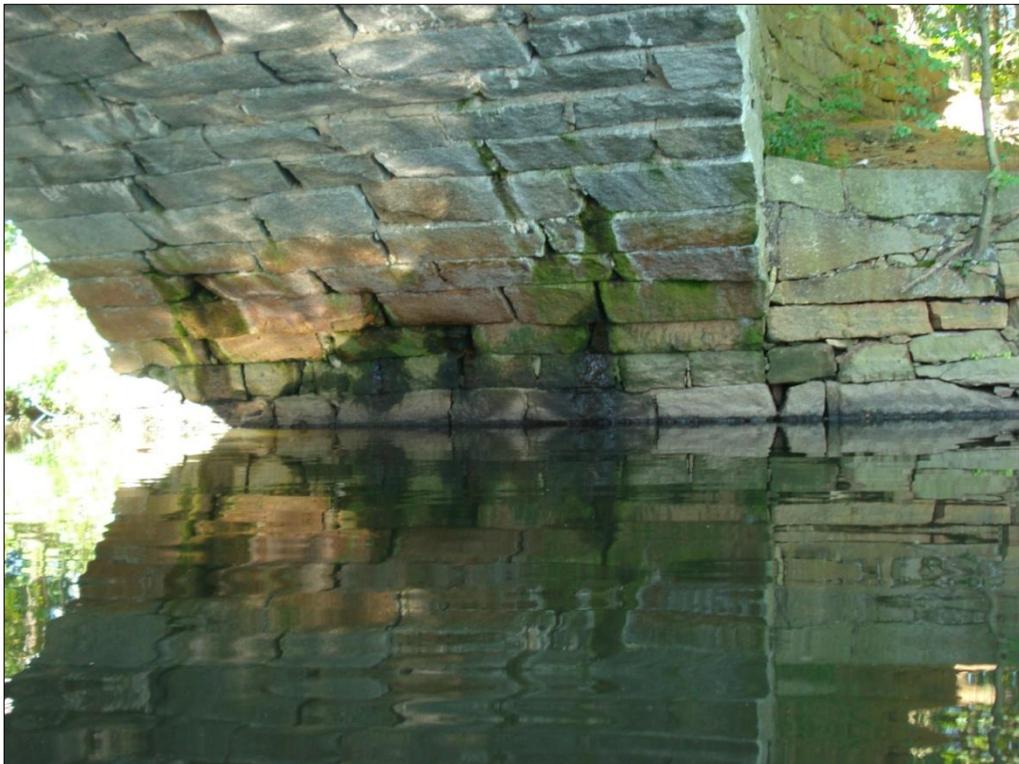
Photo 4 Looking West: West Abutment Elevation

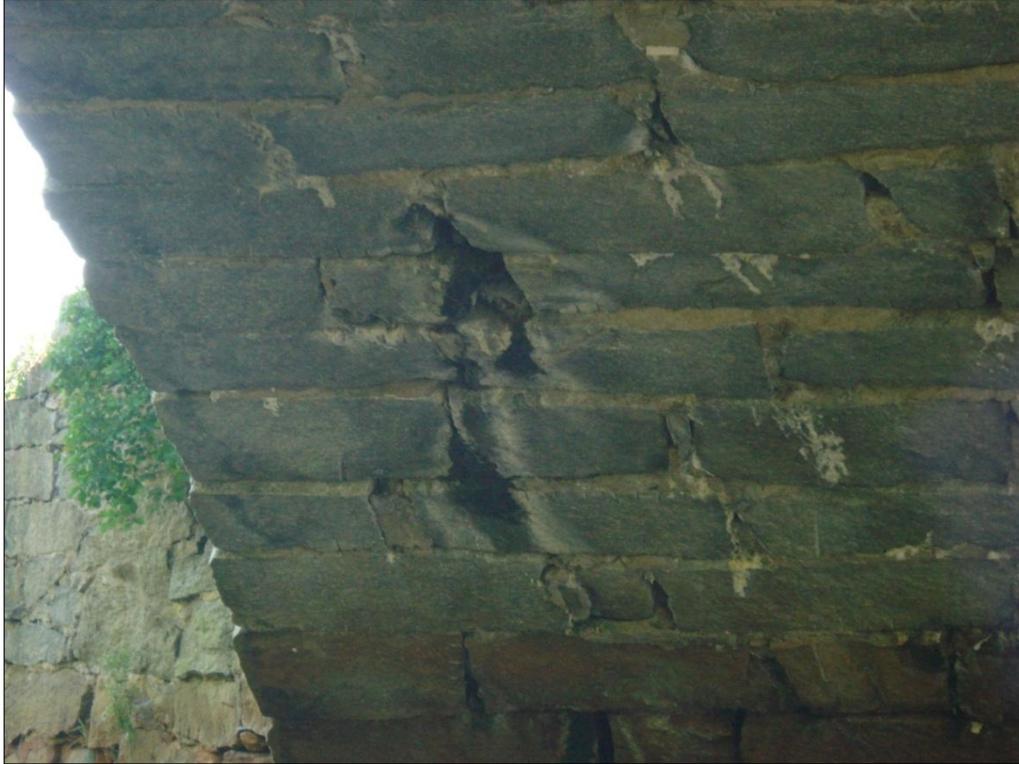
Photo 5 Looking East: Typical Voids in Arch Underside

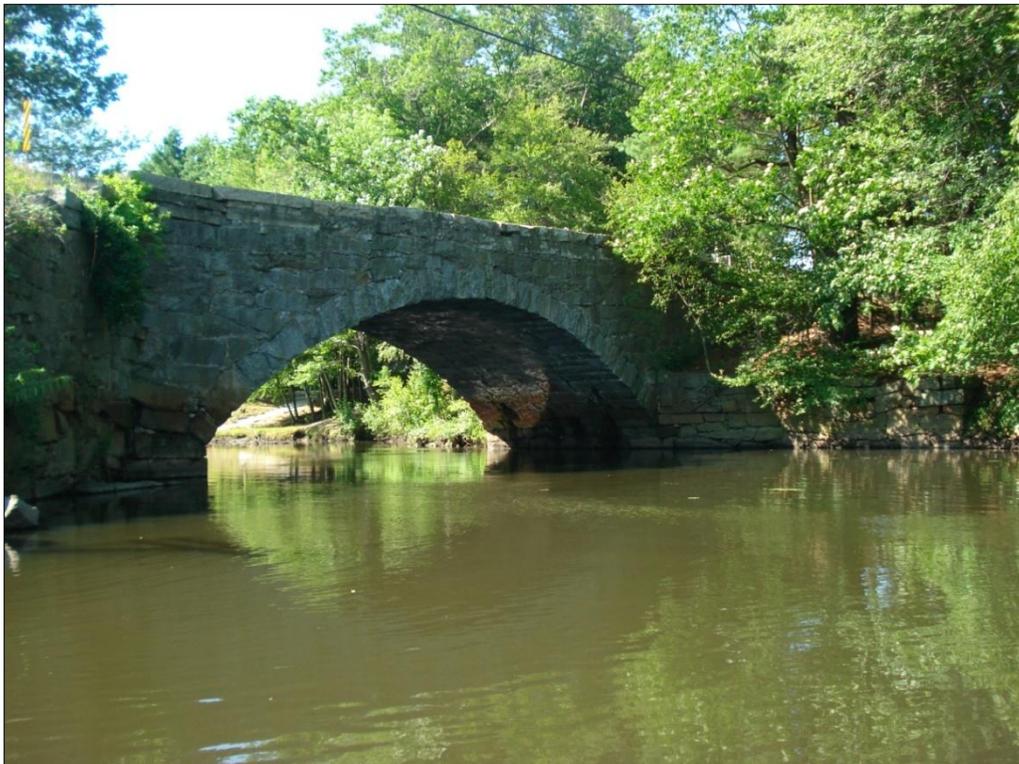
Photo 6 Looking Southwest: North Bridge Elevation

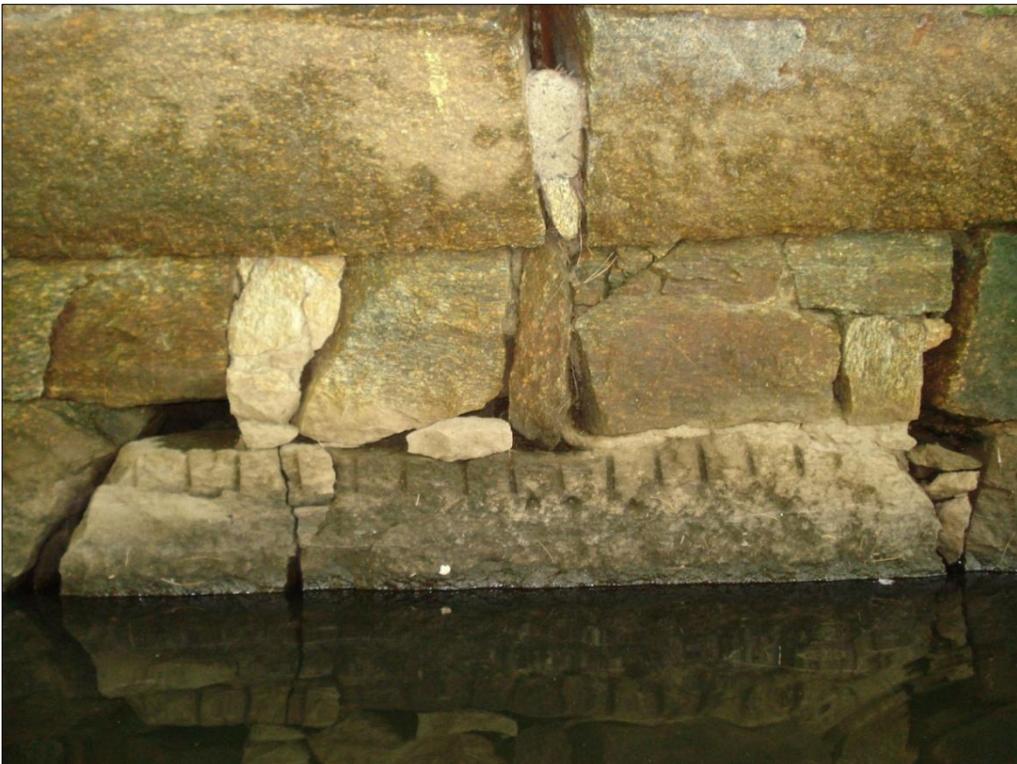
Photo 8 Looking East: Cracked Stones at East Abutment

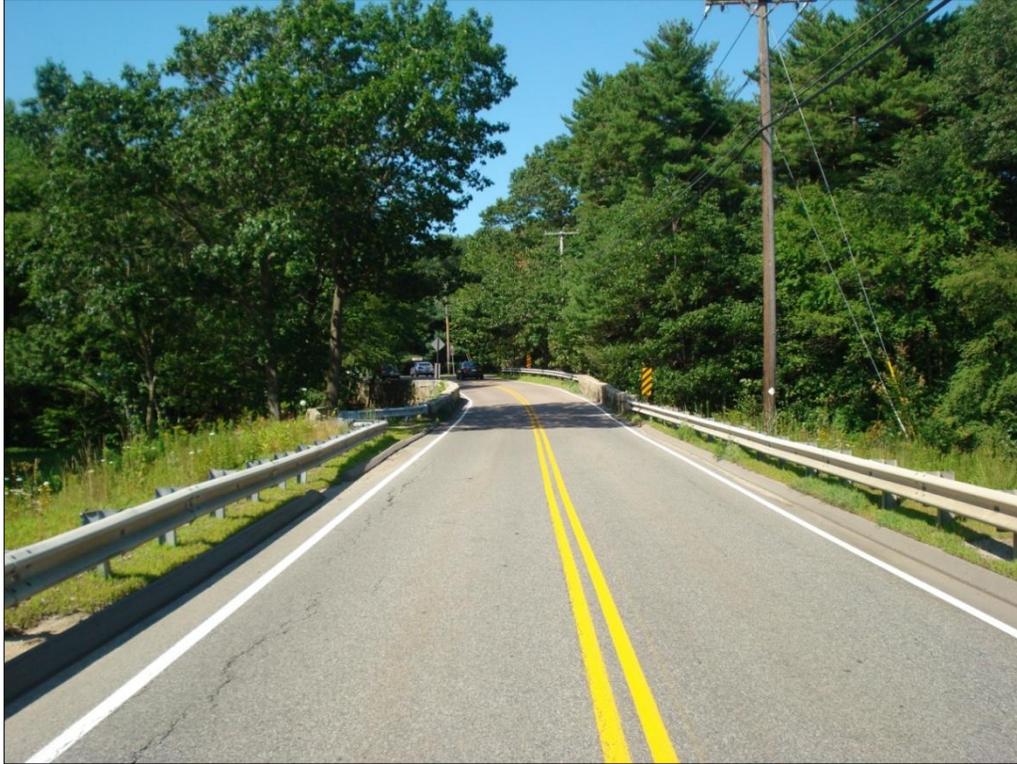
Photo 9 Looking West: East Approach

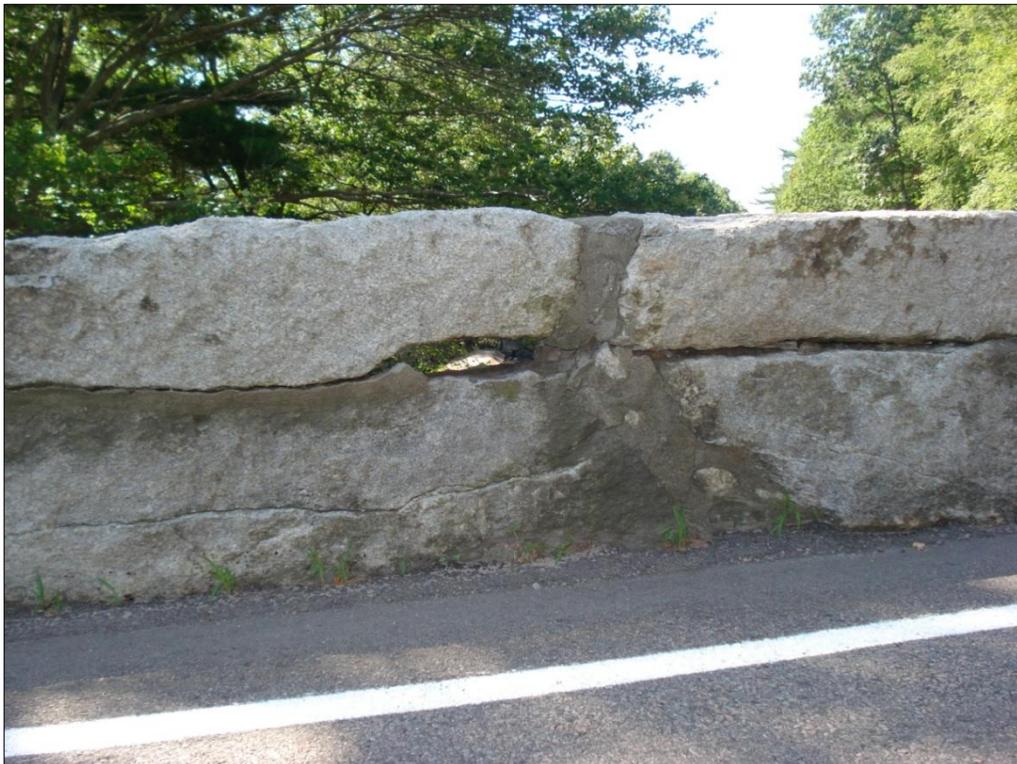
Photo 10 Looking South: Void in South Bridge Rail

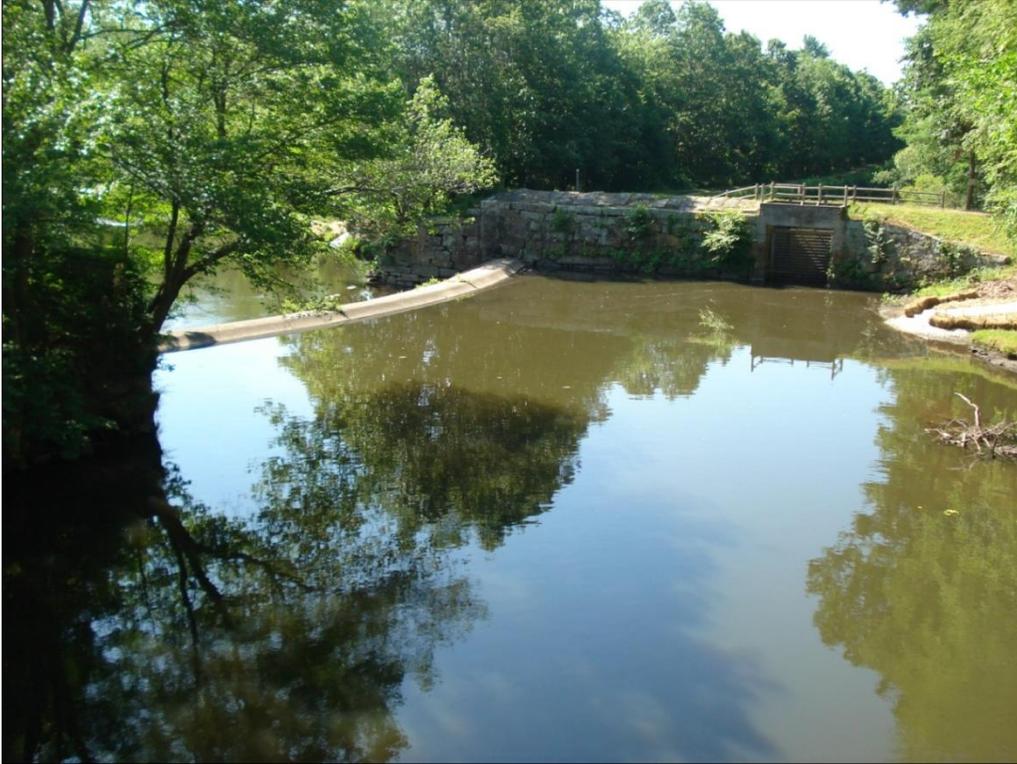
Photo 11 Looking South: Looking Downstream at Dam

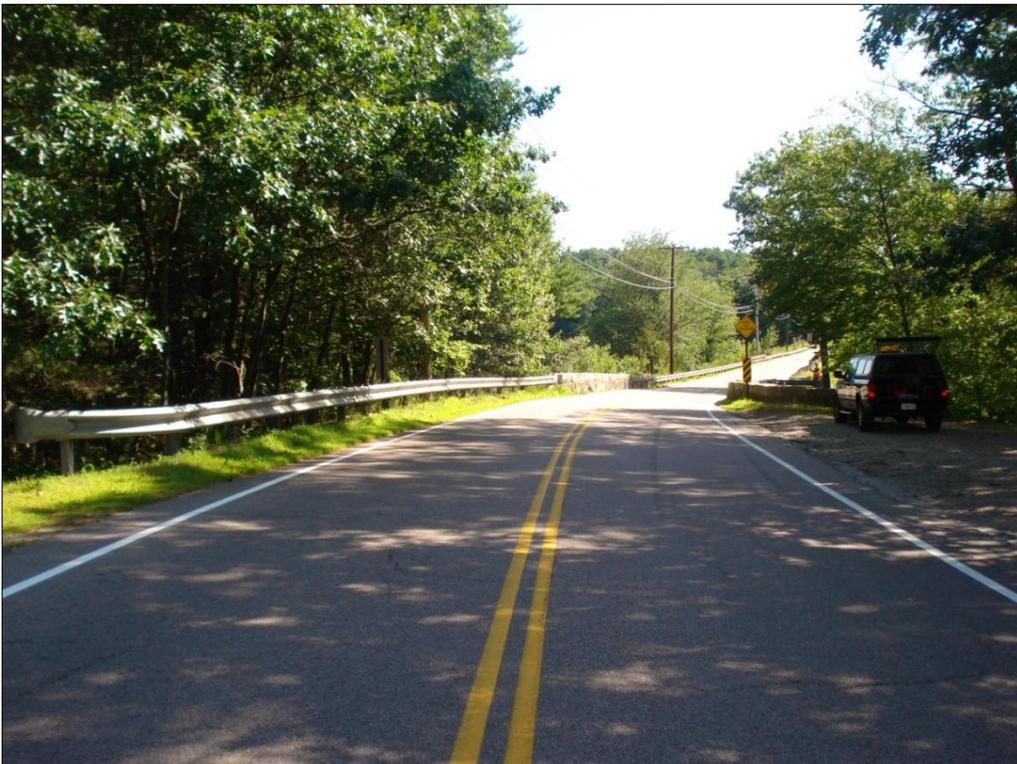
Photo 12 Looking East: West Approach

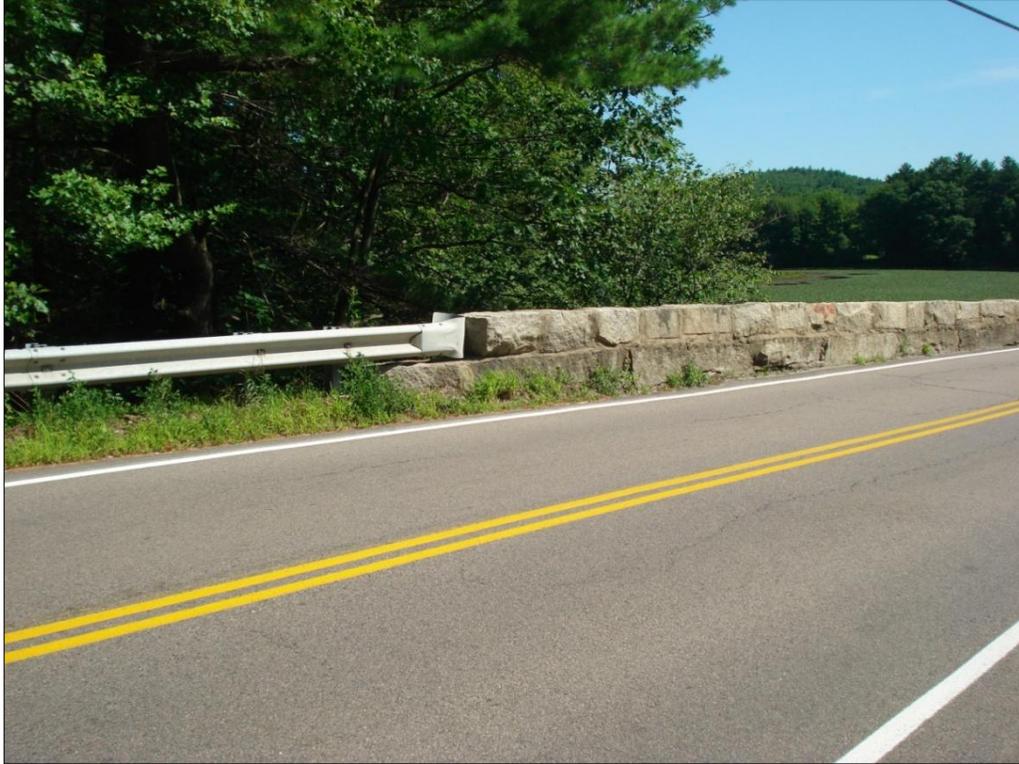
Photo 13: Typical Guardrail Transition

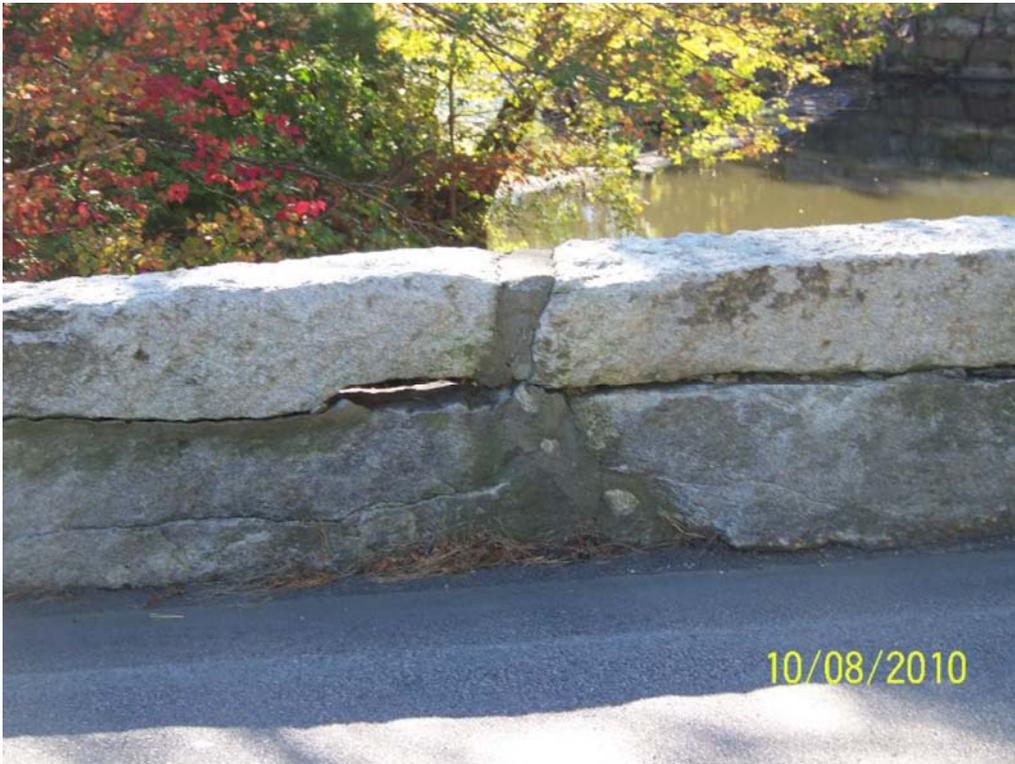
Photo 1: Void completely through the South masonry bridge rail, typical of several.

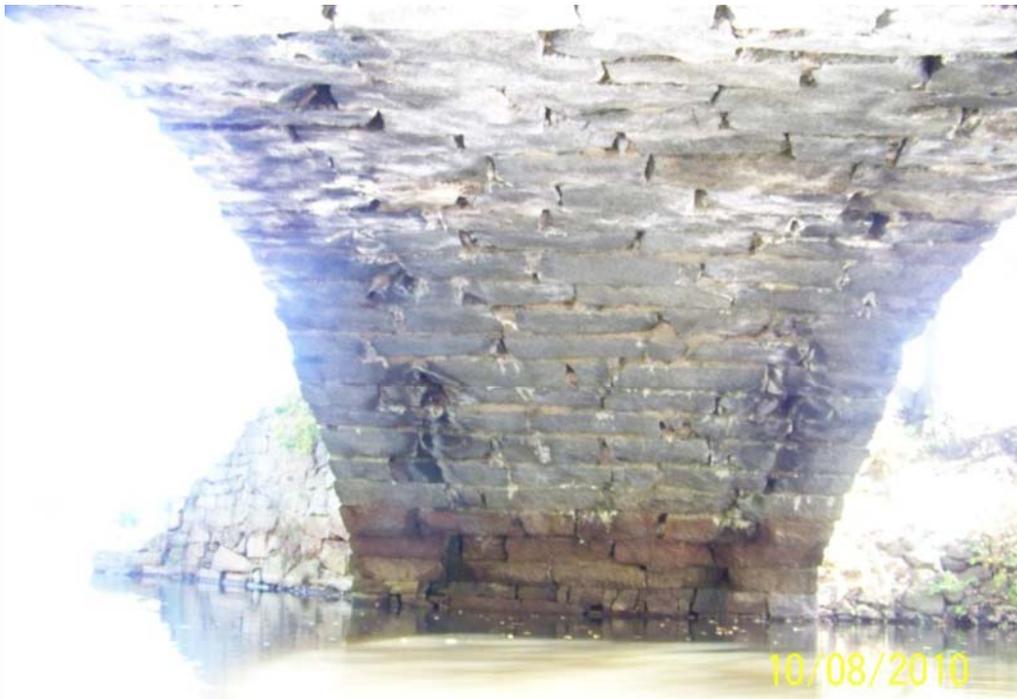
Photo 3: Typical missing chink stones, voids, efflorescence, and efflorescence icicles throughout the arch underside.

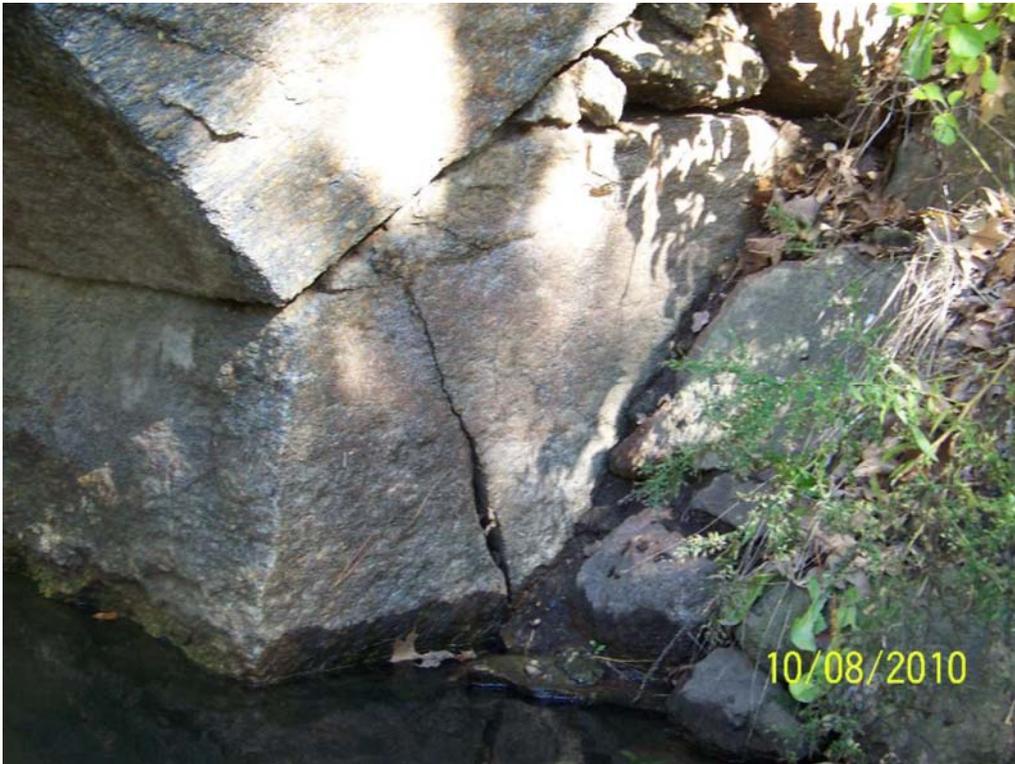
Photo 5: Cracked stone to the outside South end of the East breastwall.

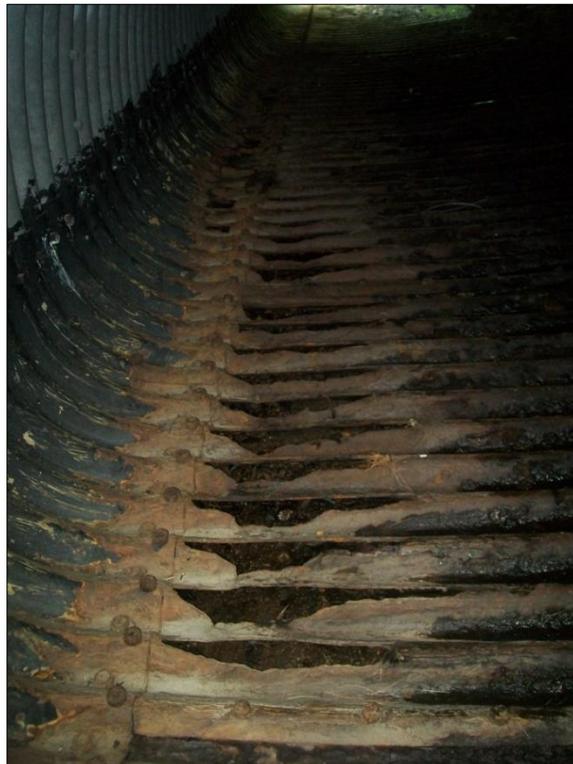
The corrugated pipe sidewalls and roof are in good condition with no deficiencies noted. However, the pipe floor typically shows heavy corrosion with 100% section loss in some areas. Several holes in the floor (See Photos 2 and 7) were found to be typical due to advanced corrosion.

Photo 7 Looking East: Corrosion in Culvert Floor

Due to the advanced deterioration of the pipe floor, BETA recommends this structure be slip-lined with a new corrugated pipe arch of similar dimensions. Until slip-lining can be performed, it is recommended that the existing posting be enforced and that the Town follow up and confirm the origins and validity of current posting and/or loading restrictions. BETA also recommends that the existing concrete post and steel wire guardrail assembly be removed and replaced at all approaches and over the culvert. The new guardrail shall be Type SS or approved equal and in conformance with current MassDOT standards.
