Bridge/Culvert Management Plan

November 2011

Uxbridge
Massachusetts

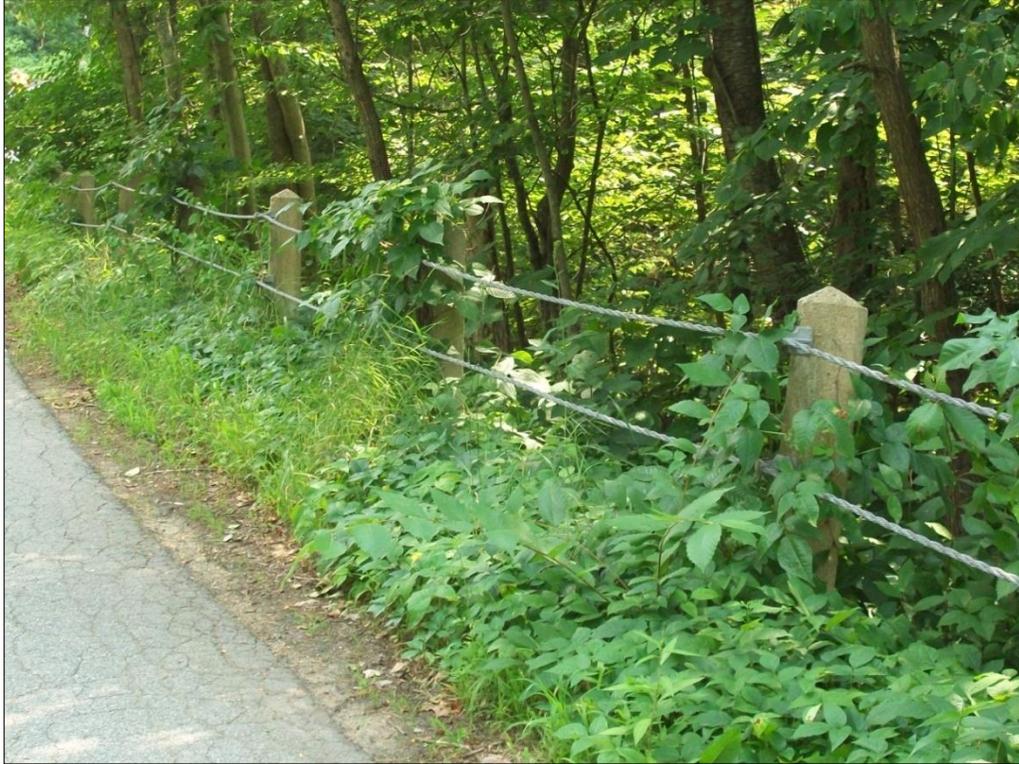
Roadway embankments at both openings show moderate to severe erosion. The erosion is causing guardrail posts to shift and lean (Photo 10). Additionally, the concrete posts are in poor condition with up to 75% showing heavy spalling with exposed reinforcing (Photos 11 and 12).

Photo 10: Typical Guardrail

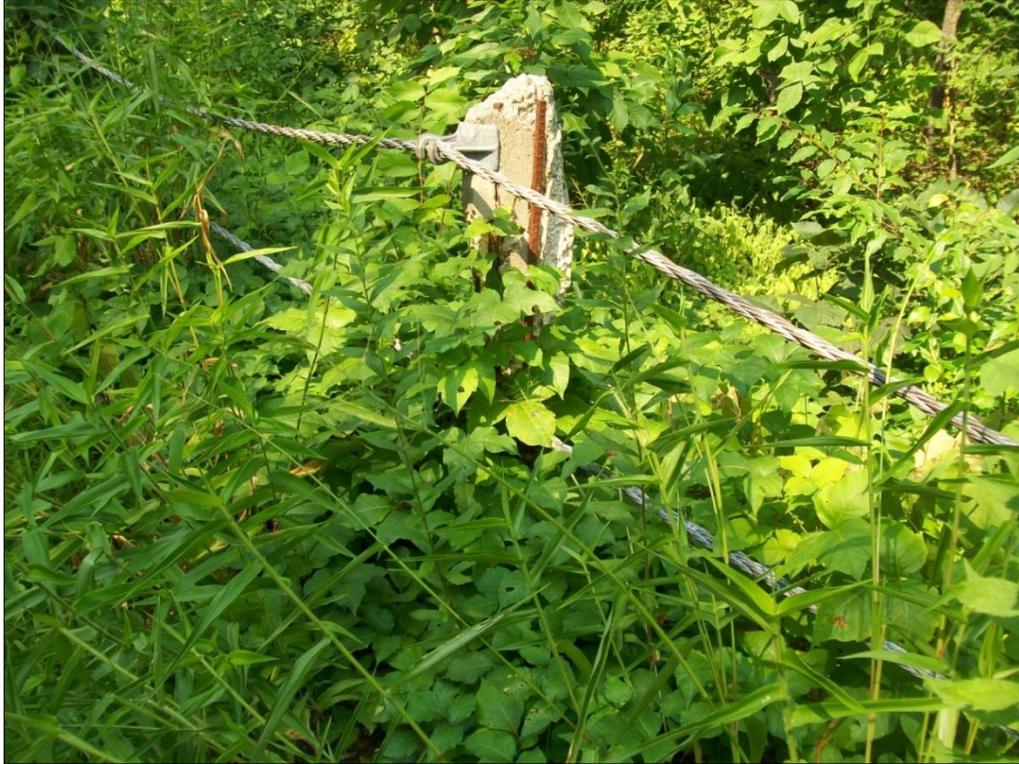
Photo 12 Looking Northeast: Typical Guard Rail Post Condition

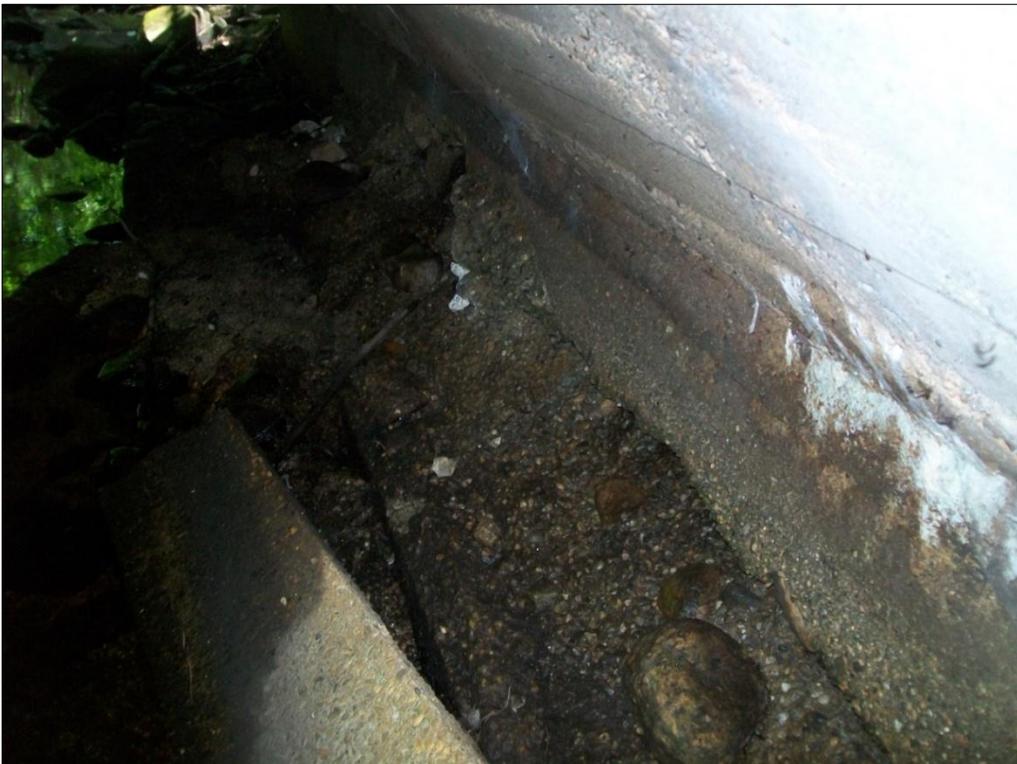
Photo 2 Looking East: Deterioration of South Footing at West End

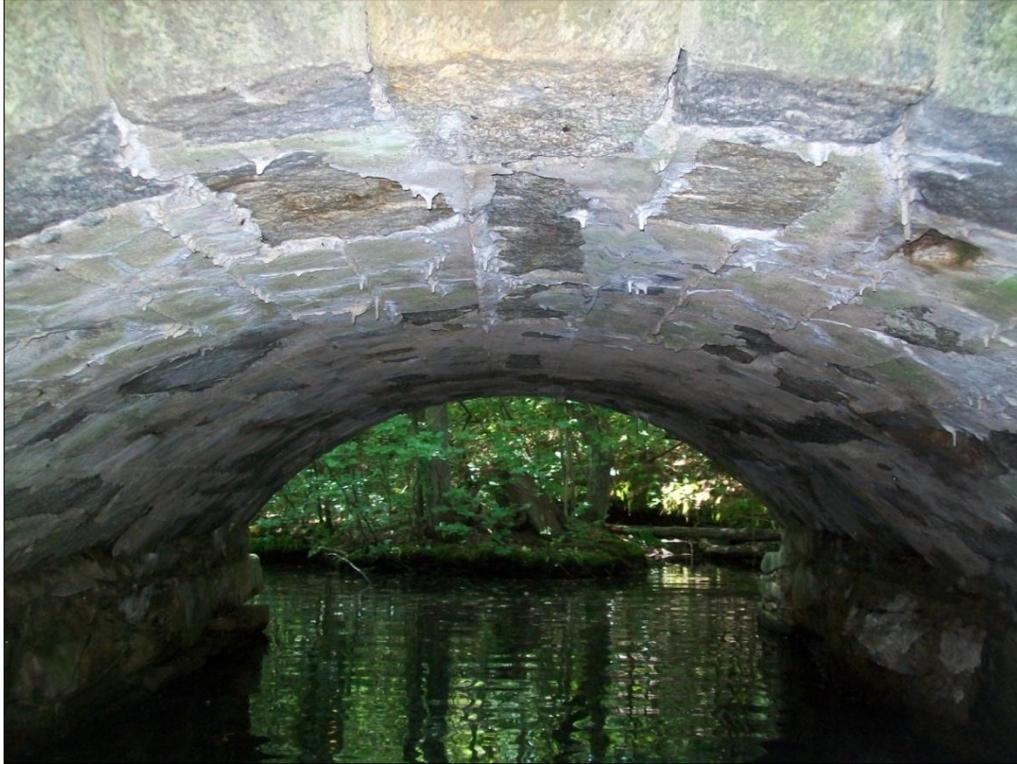
Photo 3 Looking West: Underside of Arch Showing Efflorescence

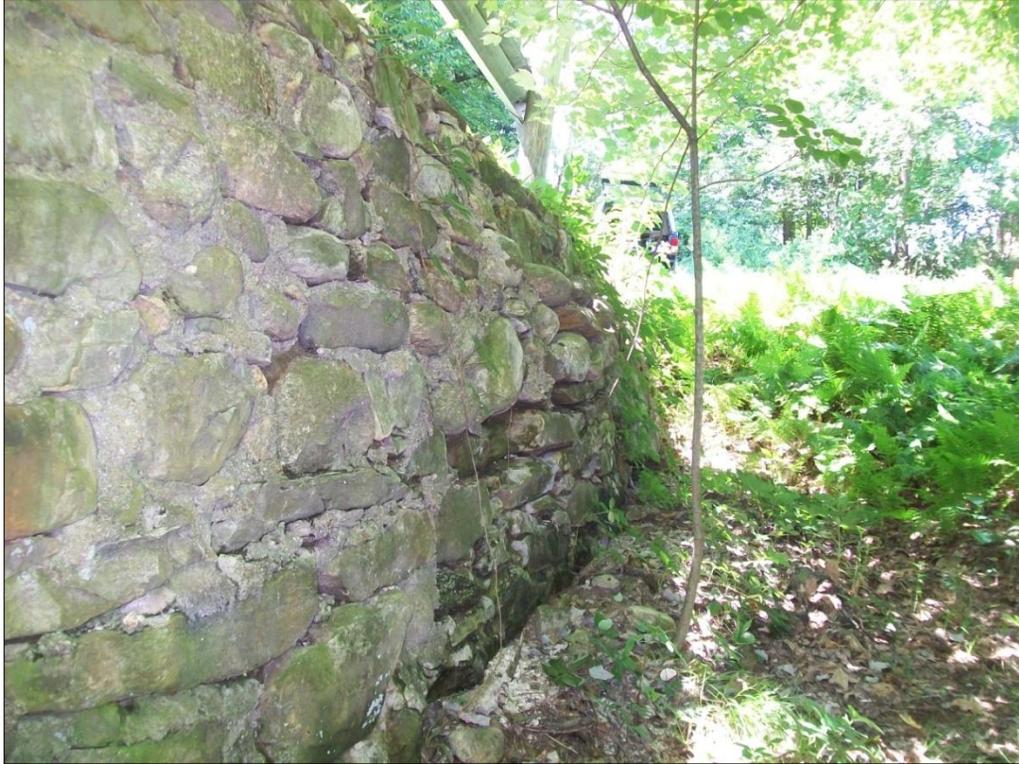
Photo 7 Looking North: Lateral Displacement of Northeast Wingwall

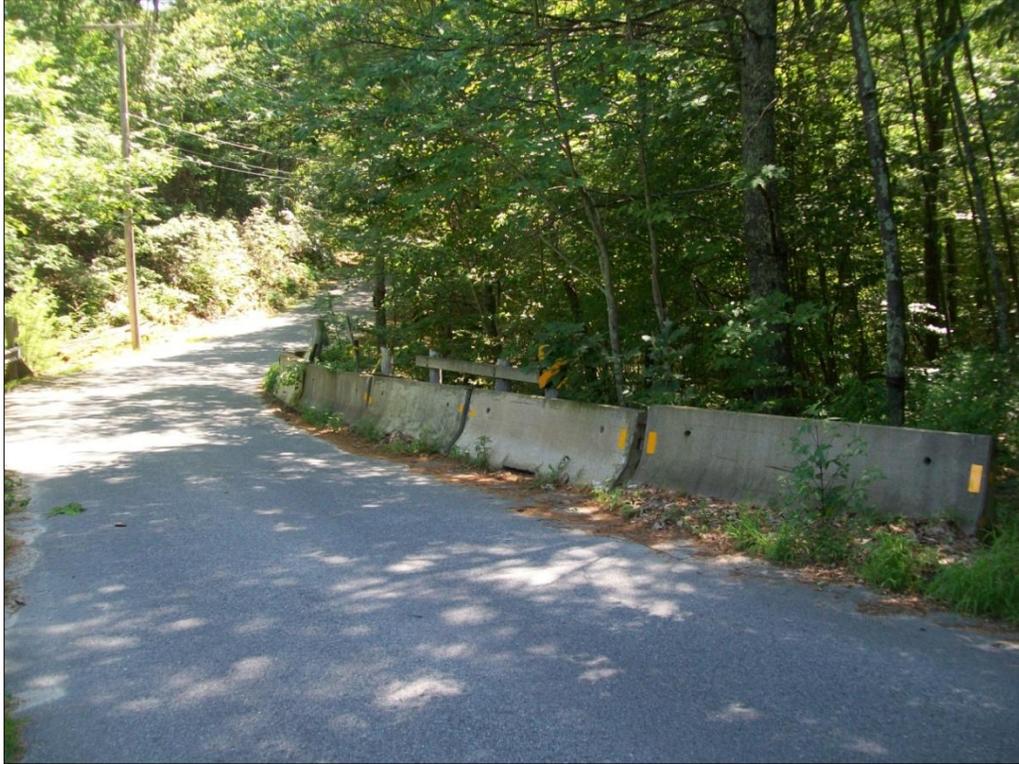
Guard Rail Type:	Wooden bridge rail. Standard highway guardrail, Jersey barrier on West side.		
Guard Rail Condition:	Severe collision damage on west rail. Jersey barriers covering		
Guard Rail Rating:	1		
Guard Rail Notes:	No approach guardrail at north approach but probably not required.

Photo 9 Looking Southwest: West Bridge Rail Elevation

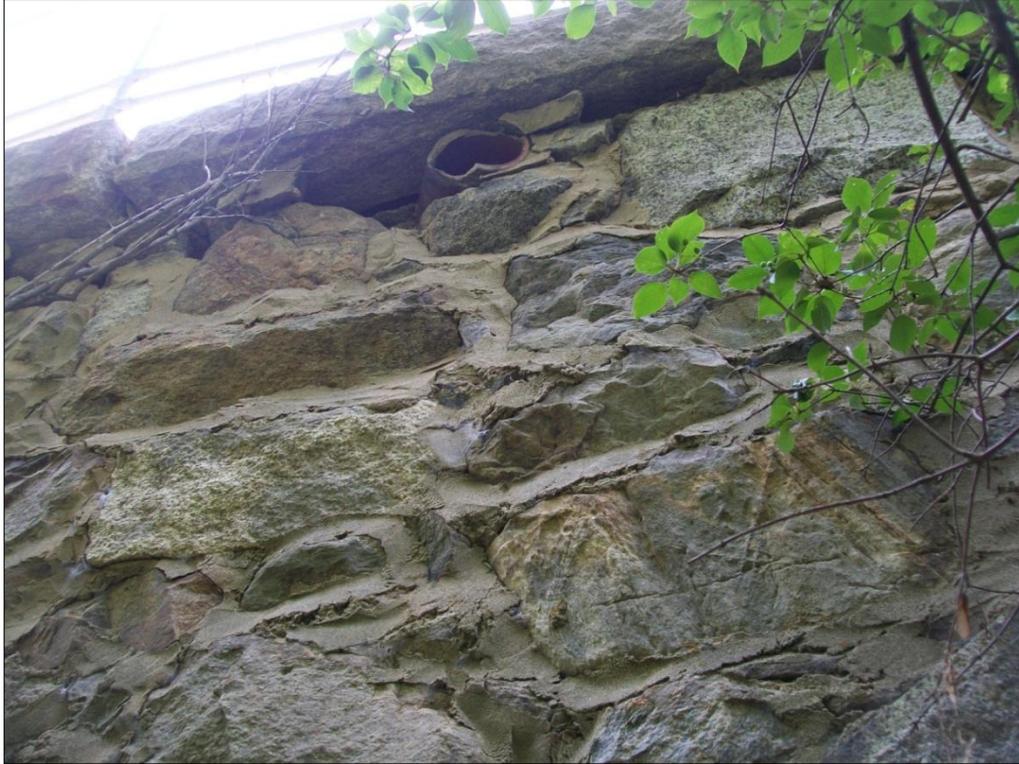
Photo 5 Looking West: Drain Pipe at Southeast Spandrel Wall

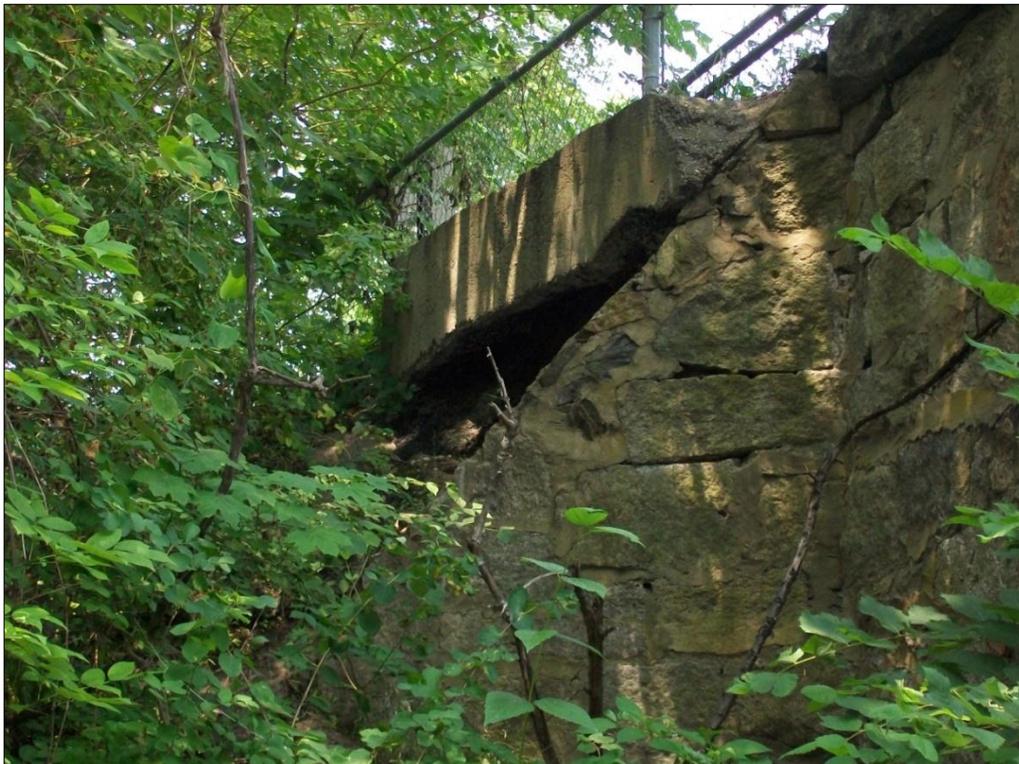
Photo 6 Looking North: Undermining of Concrete Slab Above Northwest Wingwall

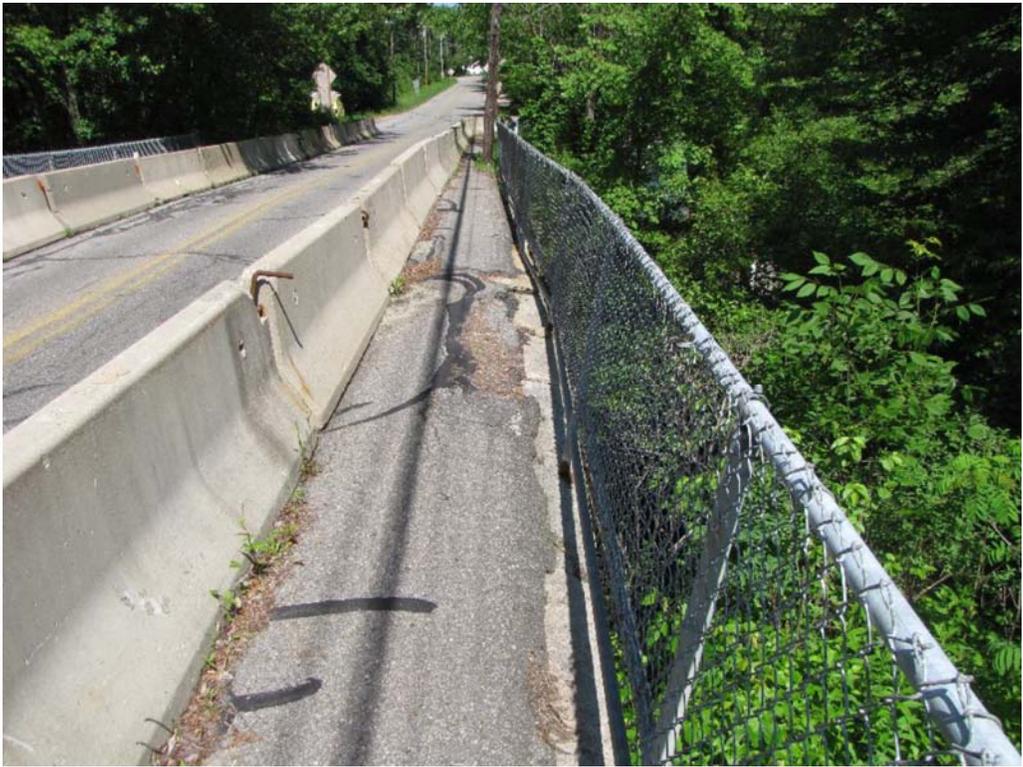
Photo 3: South end of the East rail, up to 3 feet out of alignment.

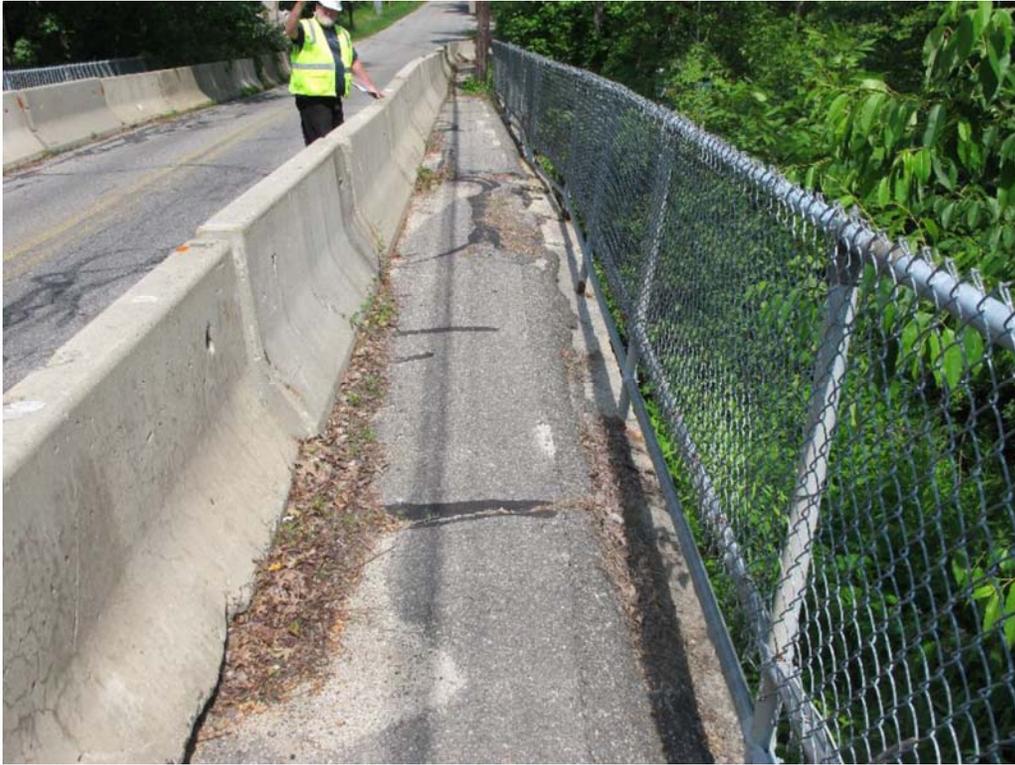
Photo 3: Cap stones displaced outward (South of the Arch ring).

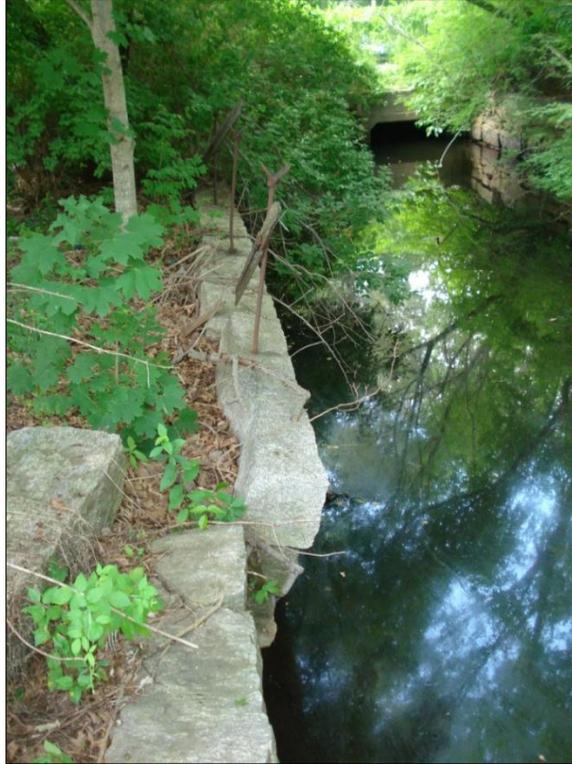
Photo 7 Looking North: Lateral Movement of Southwest Training Wall

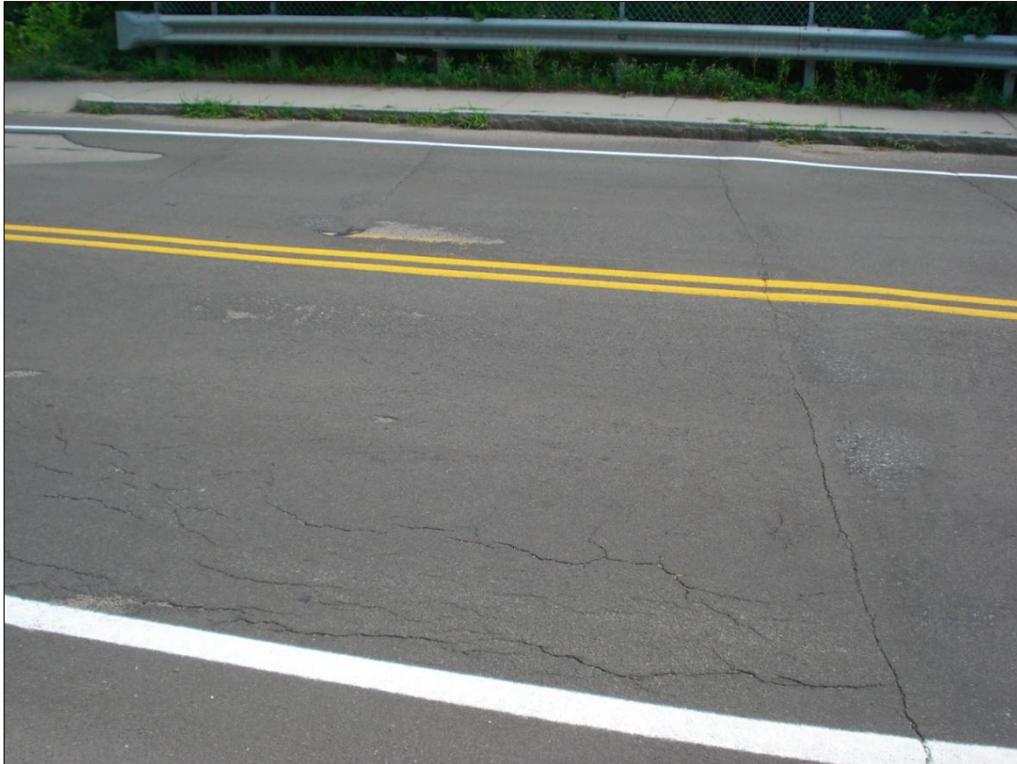
Photo 9 Looking South: Cracks in Pavement Over Culvert

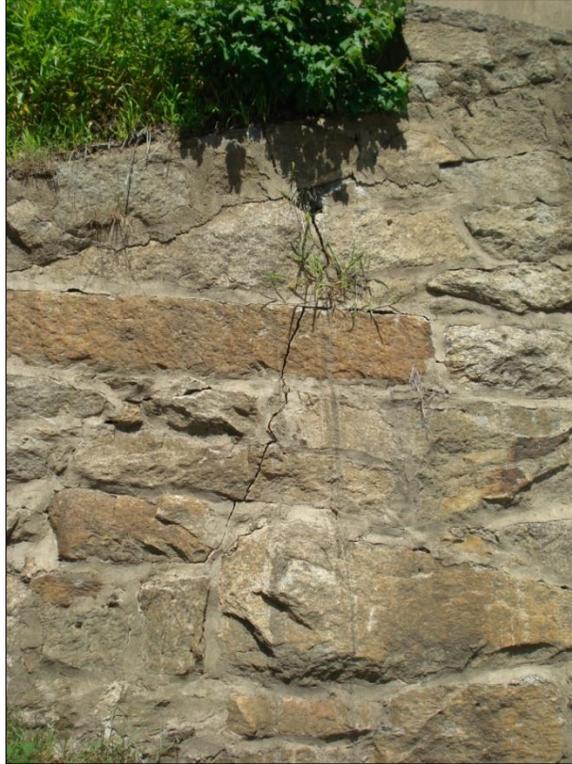
The abutments were also found to be in good condition with some minor problems. All wingwall and abutment faces exhibit random areas of missing mortar and chinking stones. Also, a full height vertical crack approximately ½" wide (Photo 3) was found at the

west end of the southwest spandrel wall. The concrete parapets typically exhibit areas of minor scaling. A spall with exposed reinforcement was also recorded at the southeast corner of the south parapet.

Photo 3 Looking North: Crack in Southwest Wingwall

- Replace all missing and/or loose chinking stones in the stone arch, wingwalls, and abutments.
- Repoint all masonry joints as required.
- Repair all concrete deficiencies to concrete bridge railing and parapet.

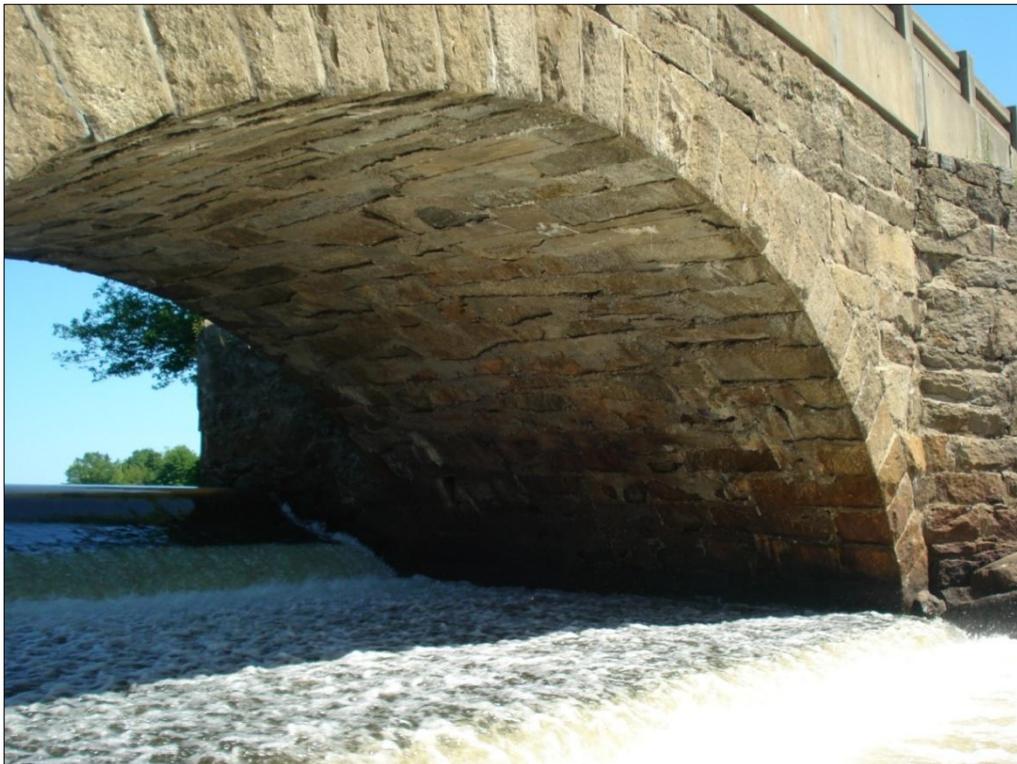
The underside of the arch has few areas of missing mortar with minor to moderate efflorescence (See Photo 4).

Photo 4 Looking Northeast: Arch Underside and East Abutment

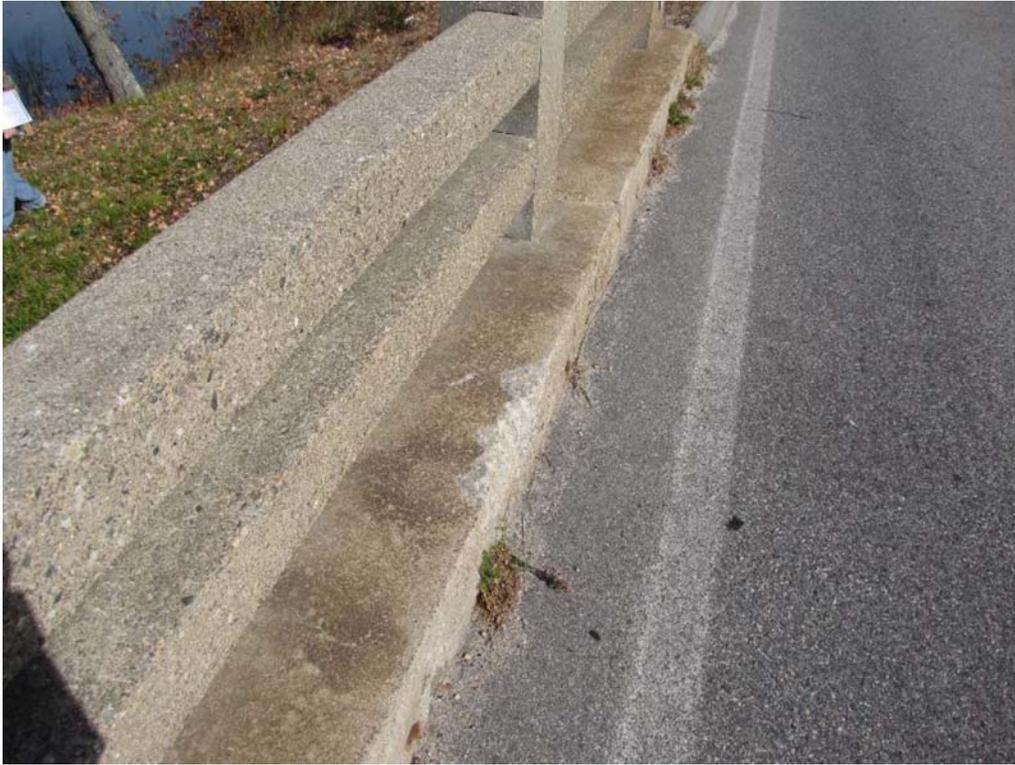
Photo 1: Spalling throughout the North curb.

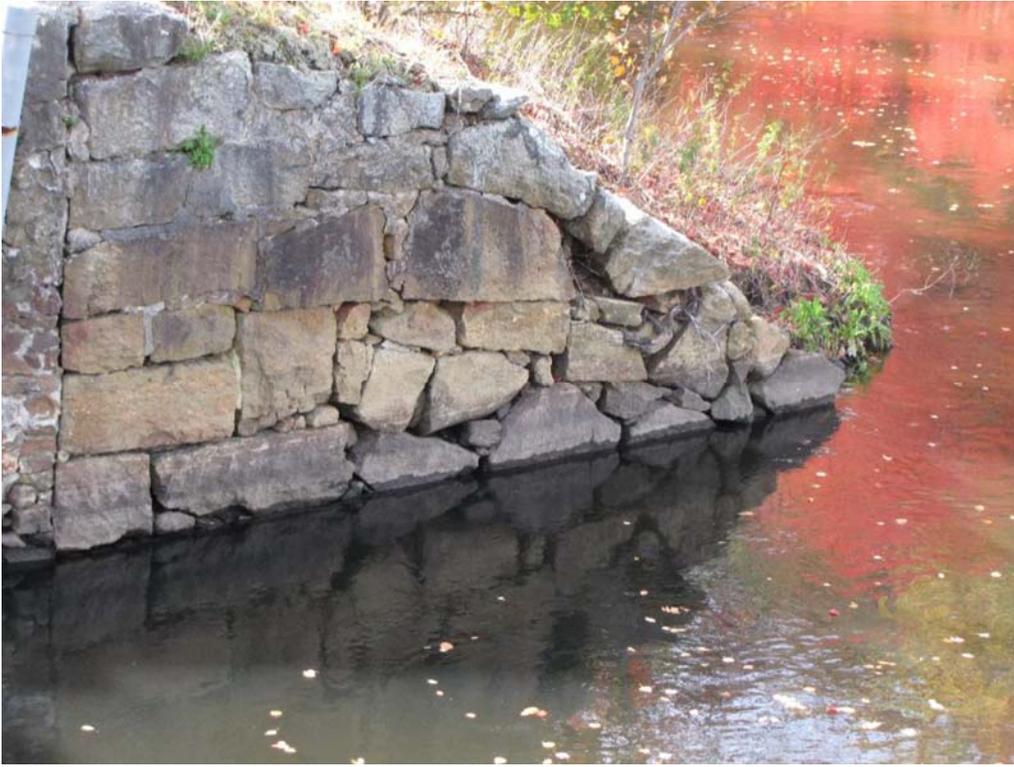
Photo 7: Missing pointing and chinking stones to the Northwest wingwall.

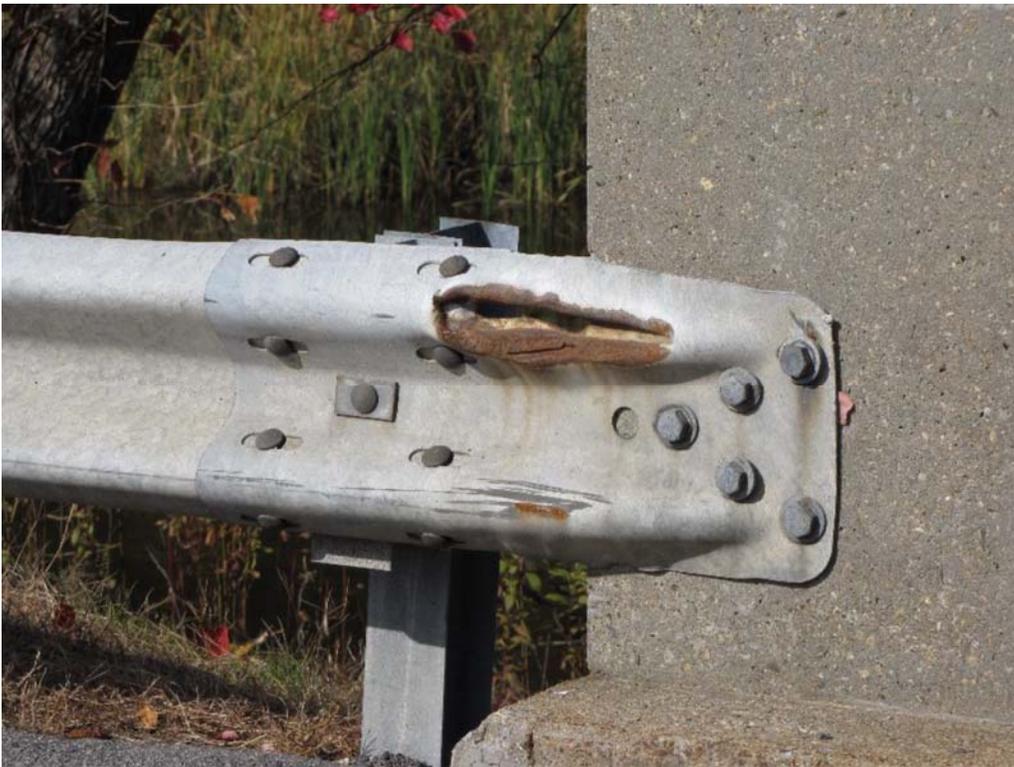
Photo 8: Collision damage and tear to the Northwest transition.

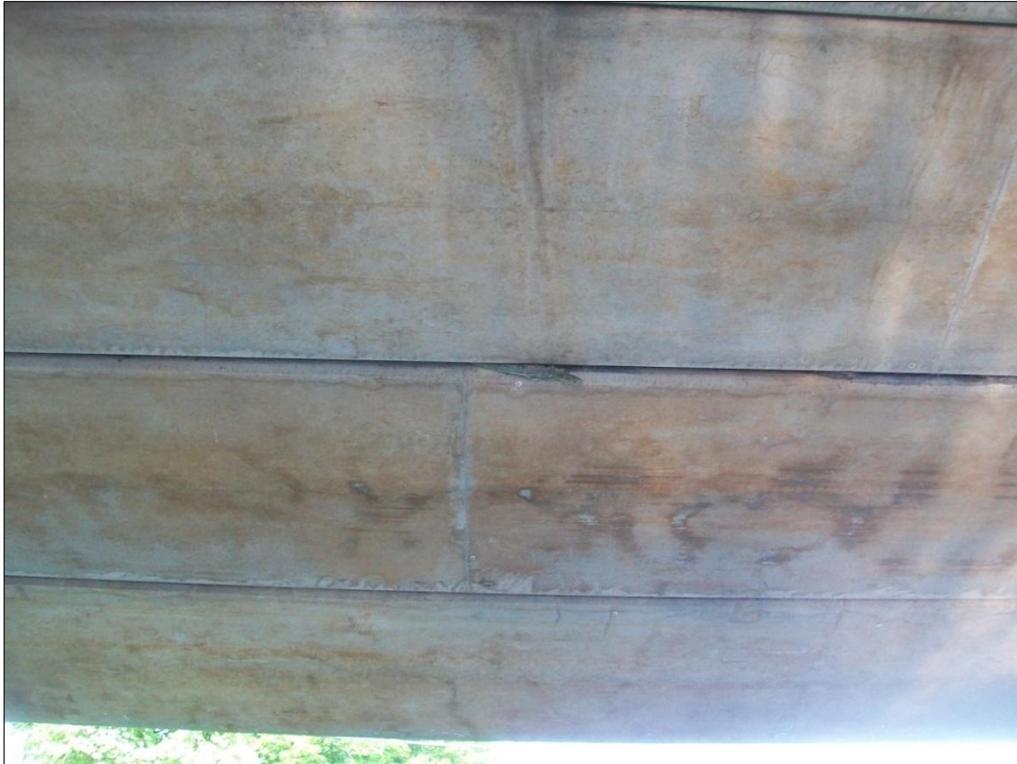
Photo 3 Looking West: Backer Rod Hanging Between Beams #2 and #3

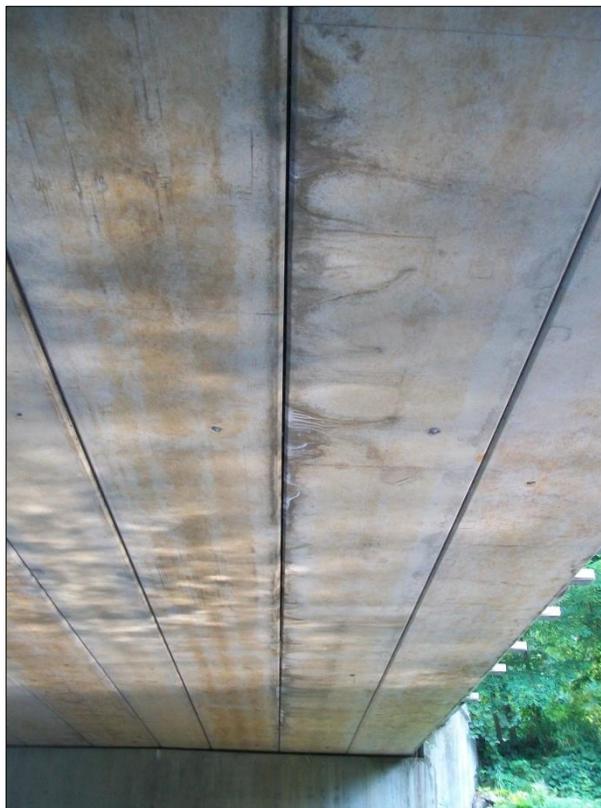
Photo 4 Looking North: Moisture and Efflorescence at Beam #7 and #8 Shear Key

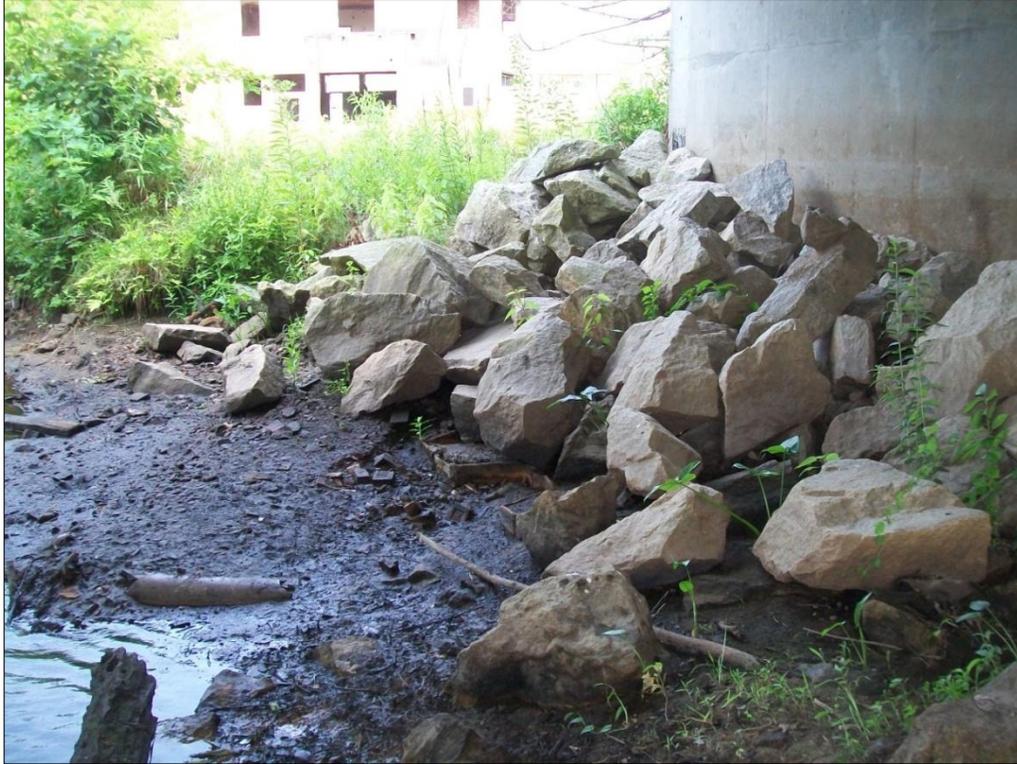
Photo 7 Looking Northwest: Exposed Sheeting at North Abutment

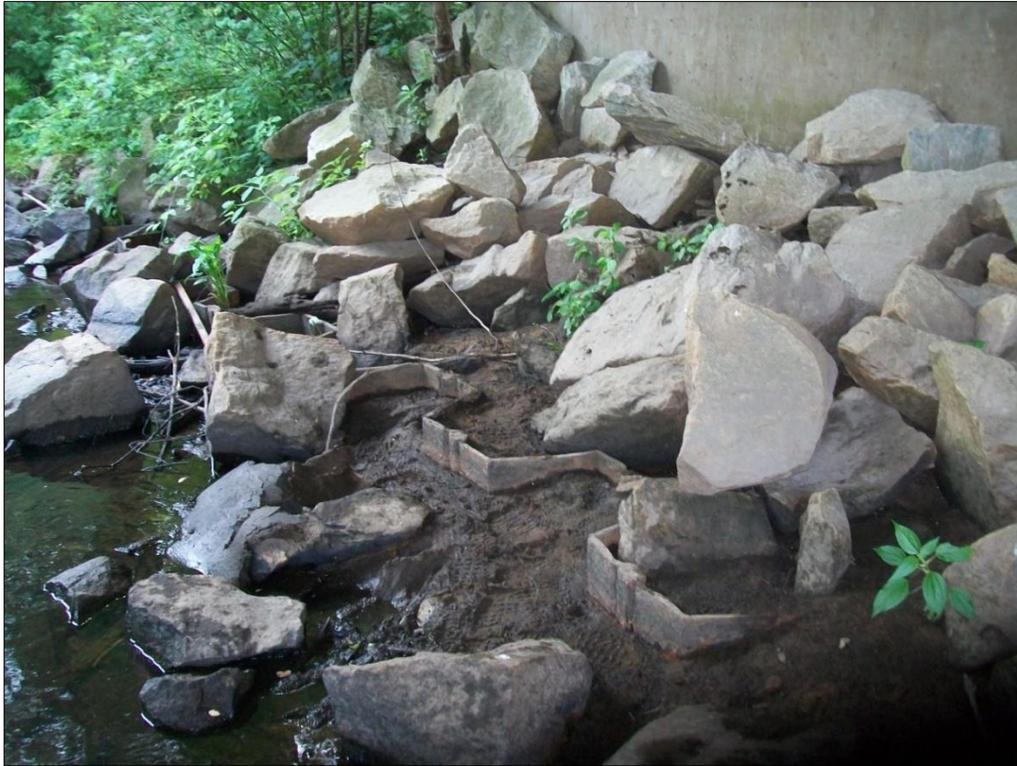
Photo 9 Looking East: Exposed Sheeting at South Abutment

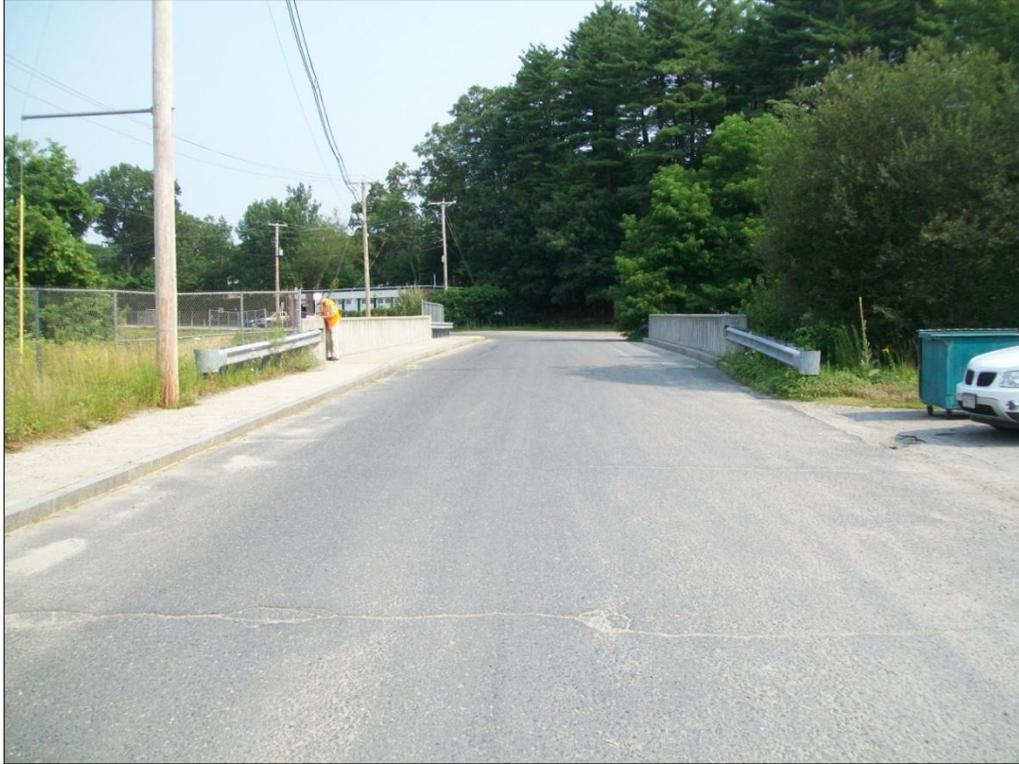
Photo 13 Looking North: South Approach

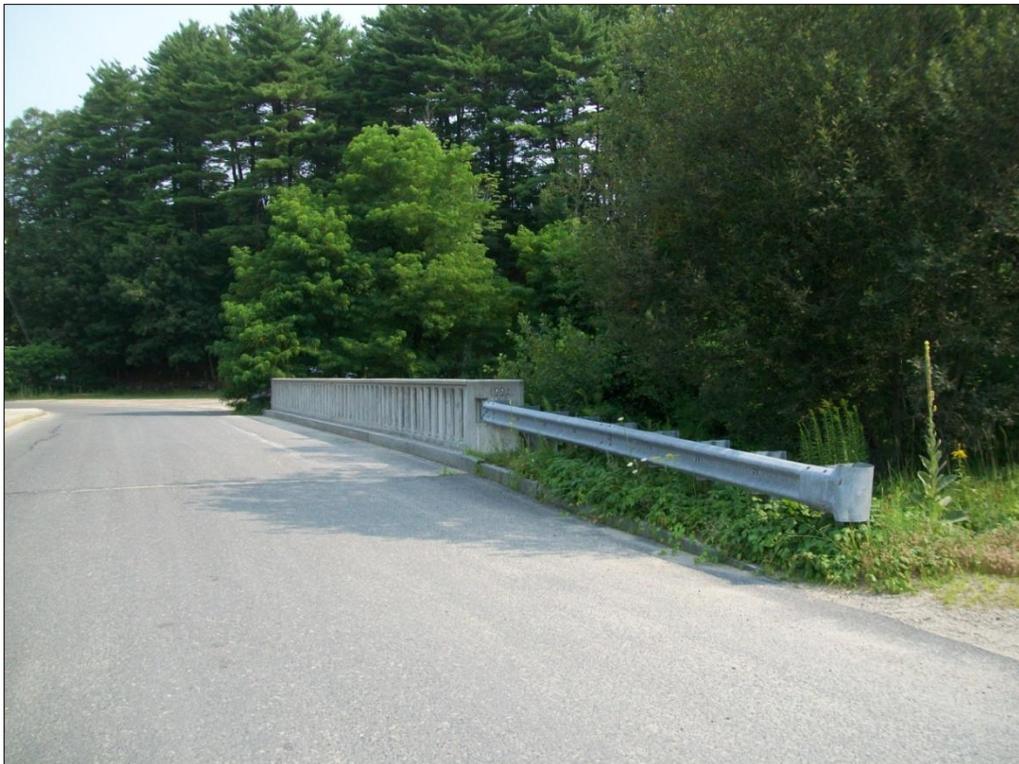
Photo 14 Looking Northeast: Southeast Approach Guardrail

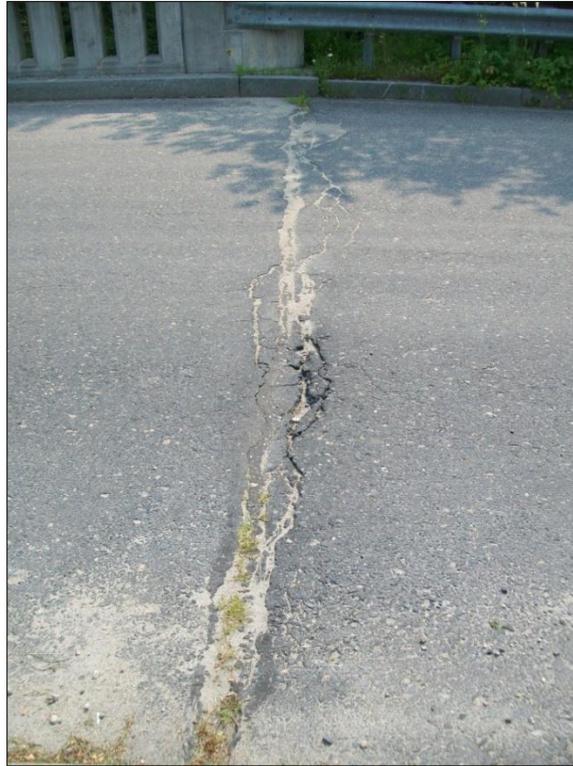
Photo 15 Looking East: Typical Bridge Joint

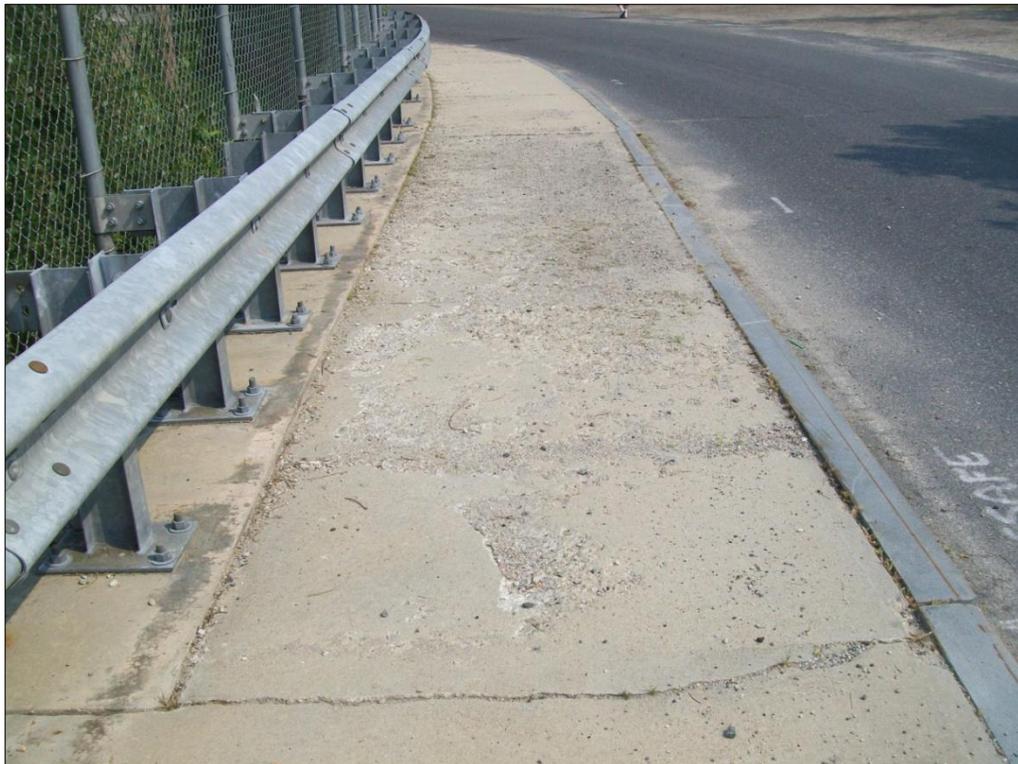
Photo 16 Looking North: Severe Scaling of Northwest Approach Sidewalk

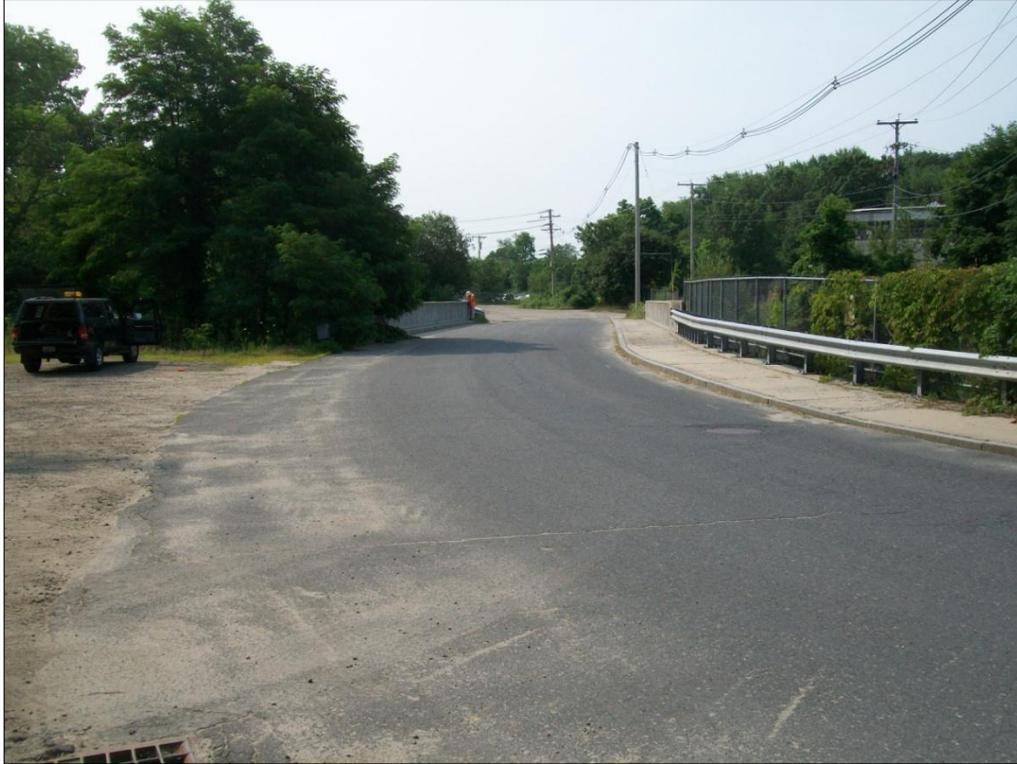
Photo 17 Looking South: North Approach

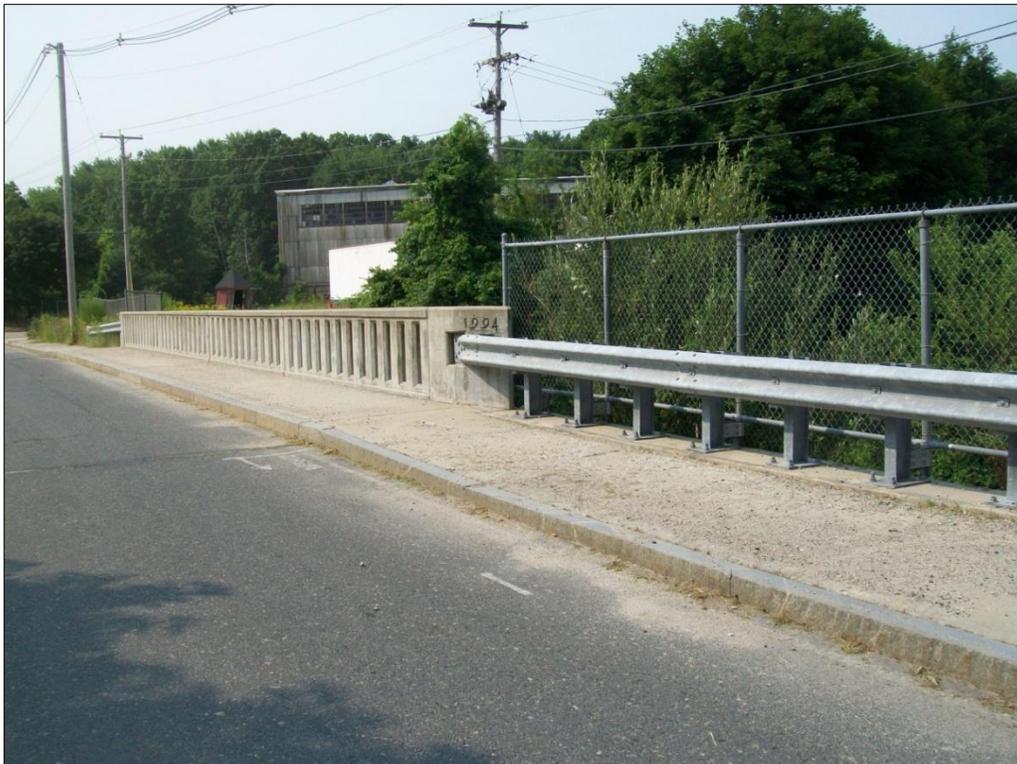
Photo 18 Looking Southwest: Typical Guardrail Transition

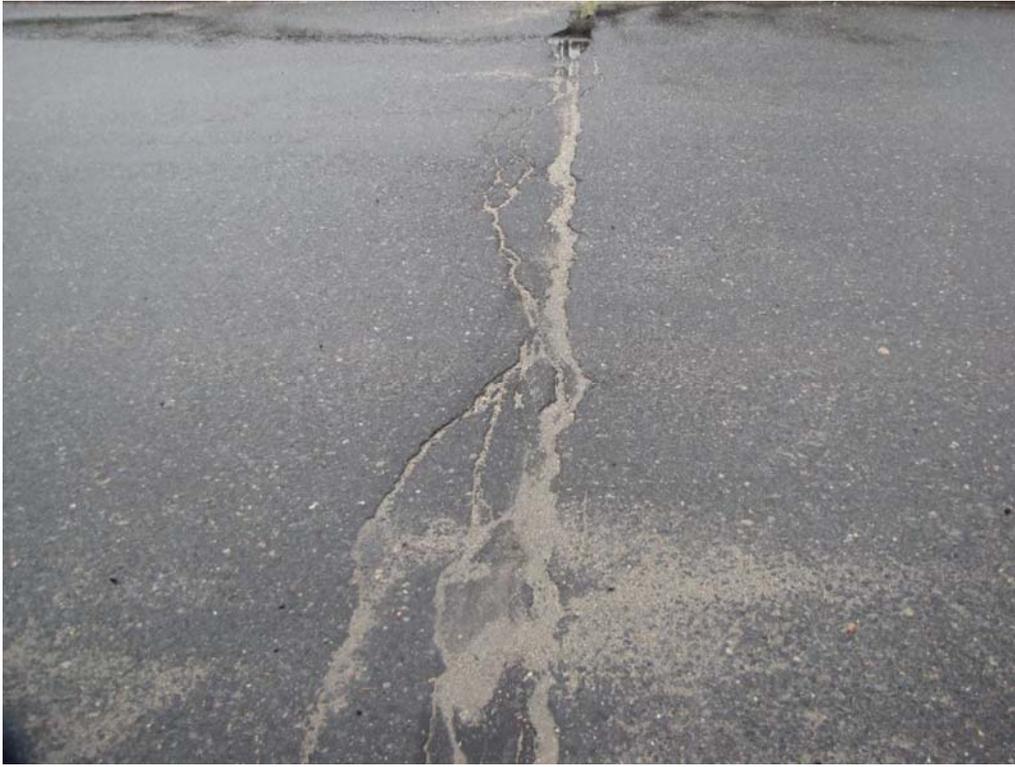
Photo 1: Typical cracking to the approach to deck transitions.

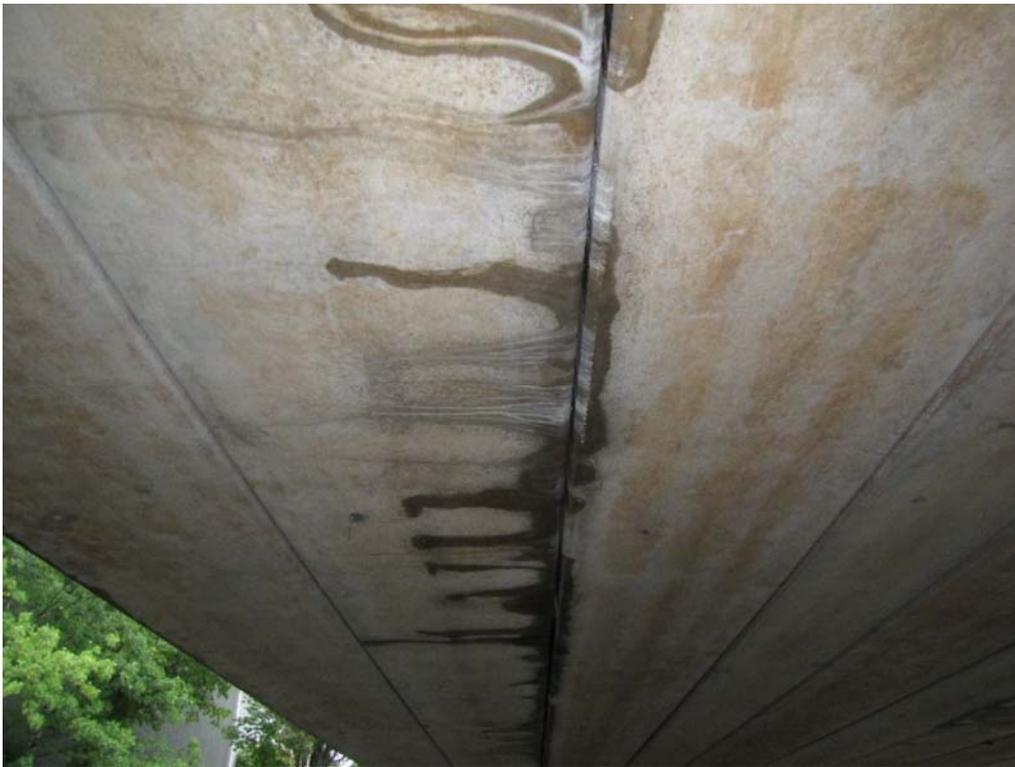
Photo 2: Leakage and efflorescence along joint #7, typical of joint #3.

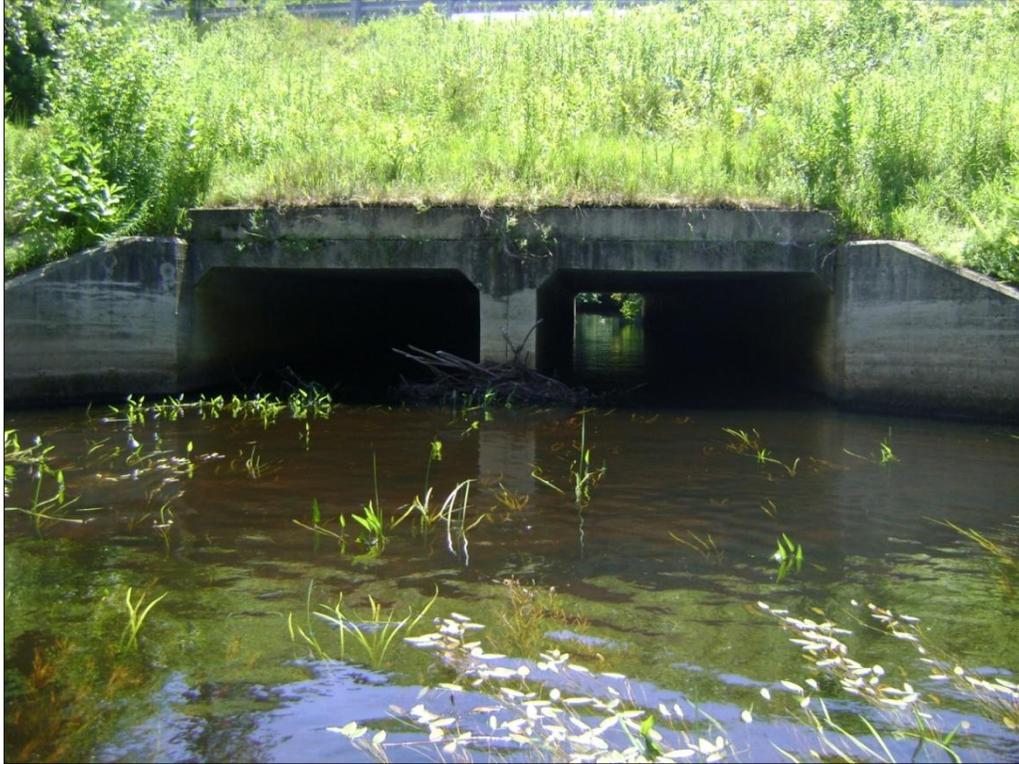
Photo 1 Looking South: North Culvert Elevation
