Bridge/Culvert Management Plan

November 2011

Uxbridge
Massachusetts

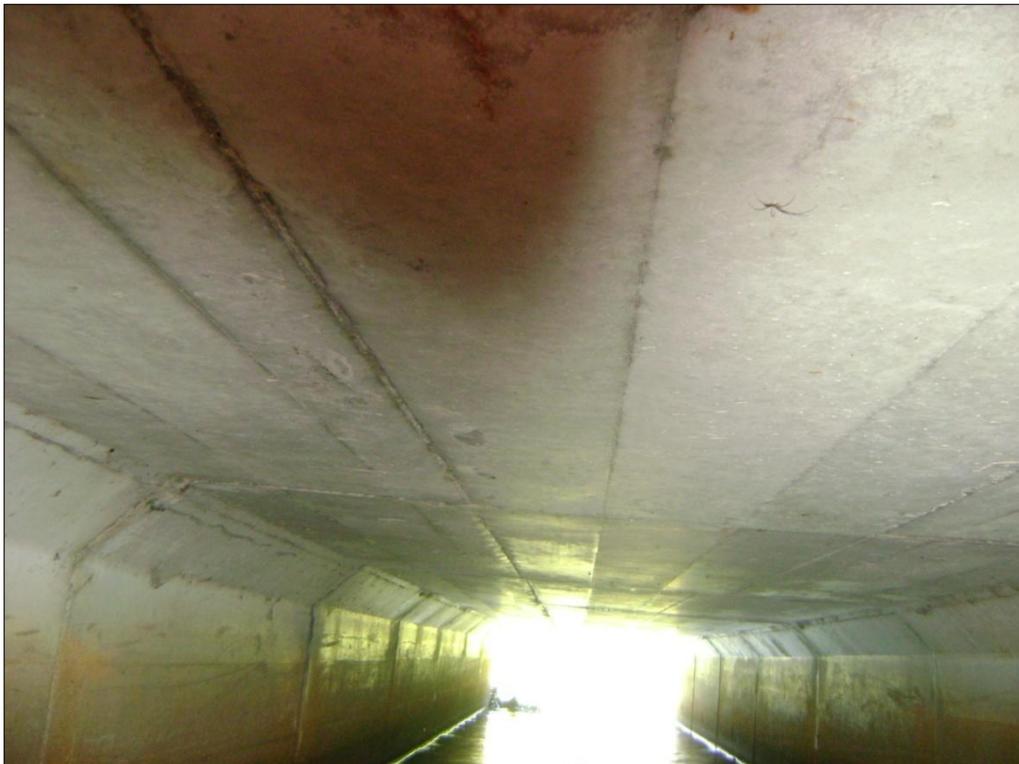
Photo 2 Looking North: Underside of East Box

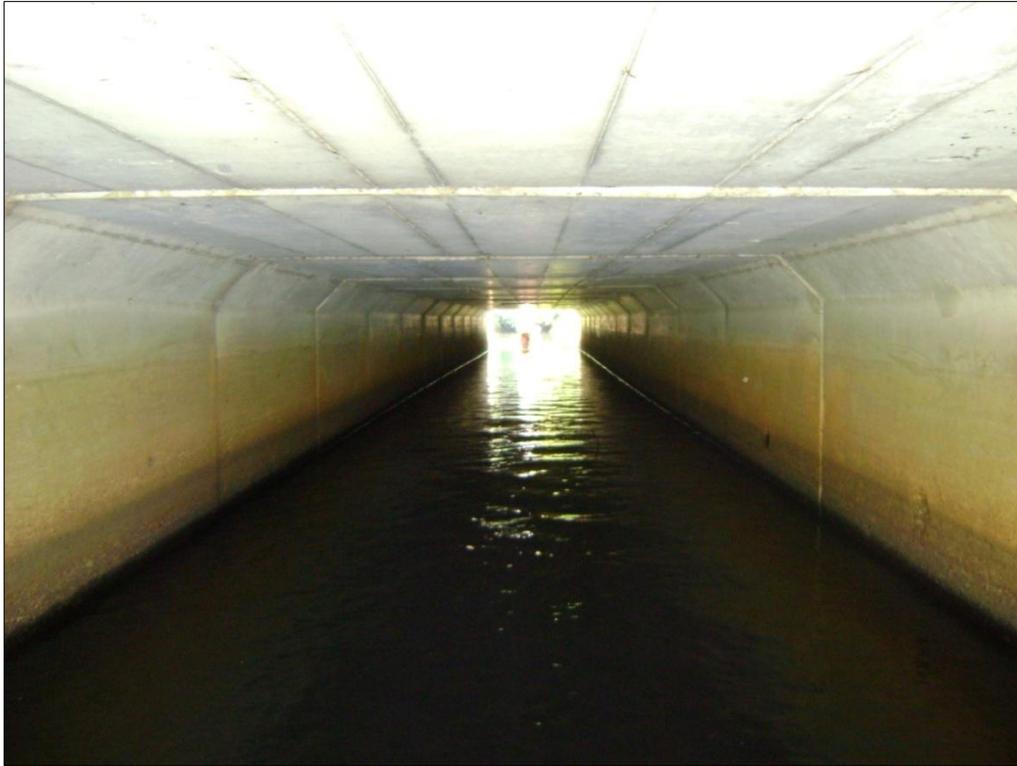
Photo 3 Looking South: Underside West Box

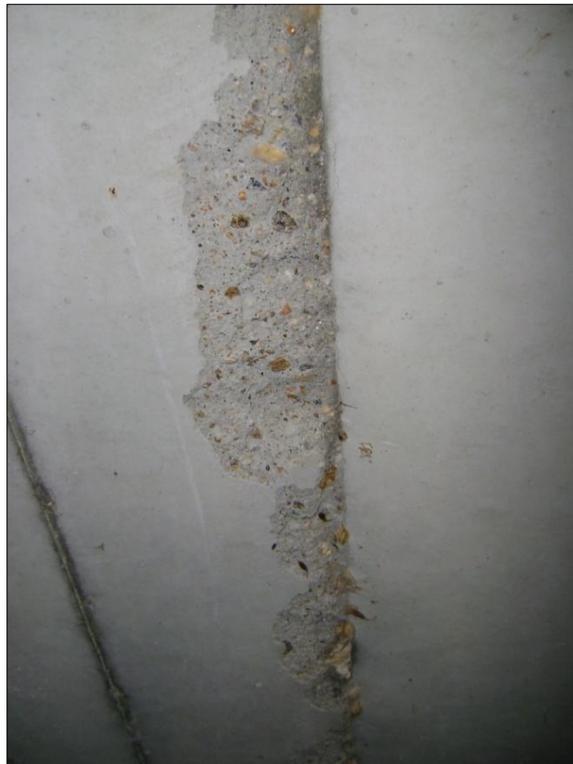
Photo 4 Looking Up: Random Spall in Roof of West Box

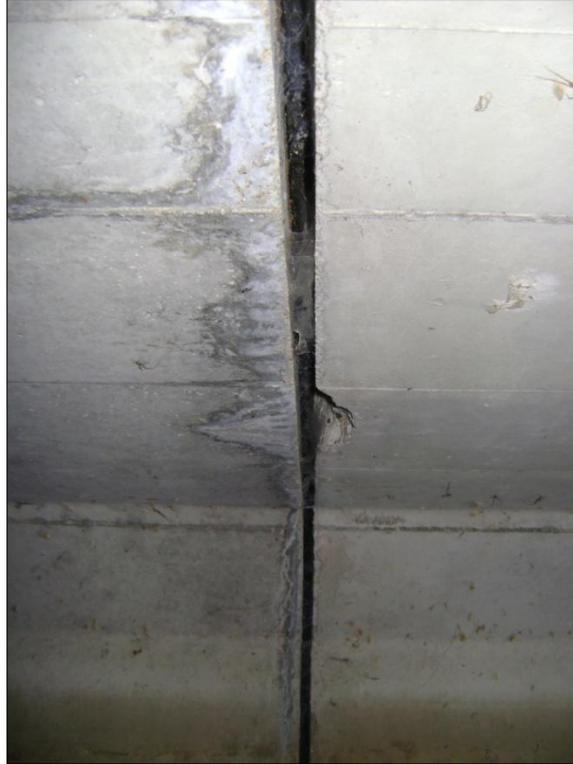
Photo 5 Looking West: Typical Deterioration of West Box Joint

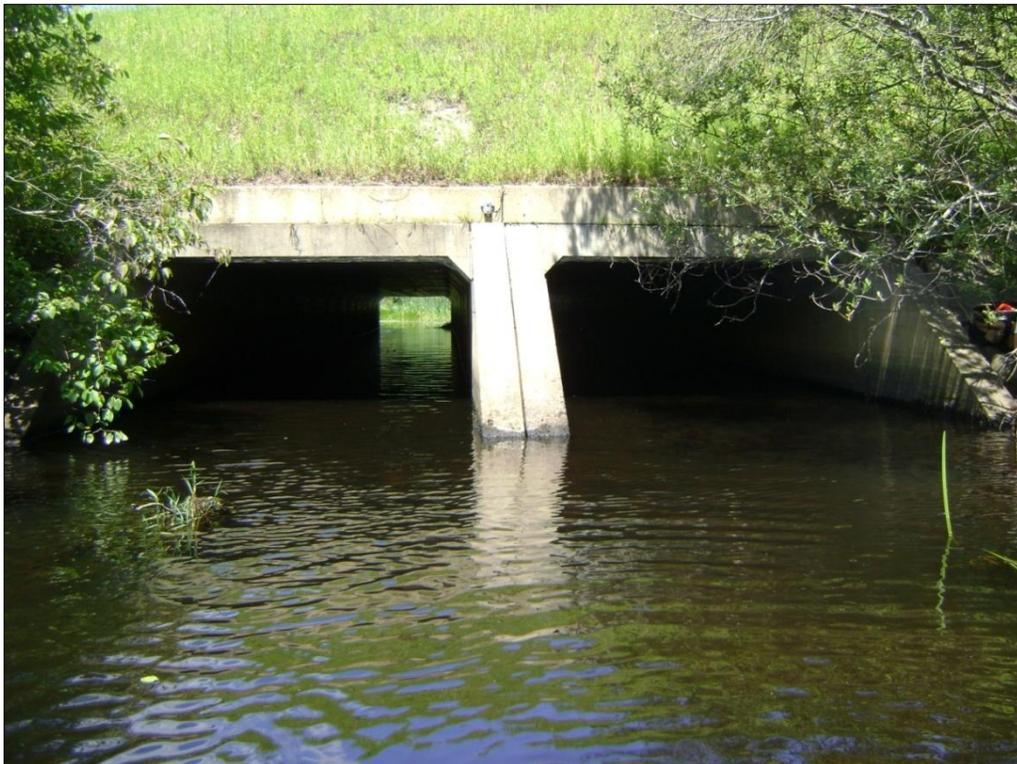
Photo 6 Looking North: South Culvert Elevation

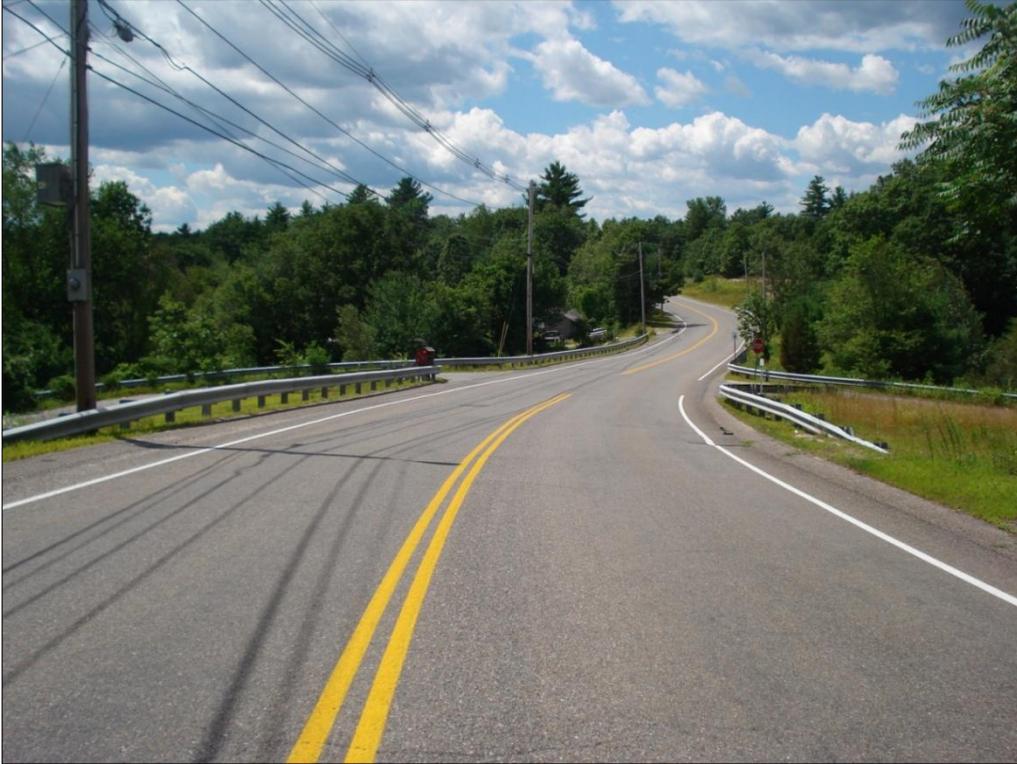
Photo 7 Looking West: East Approach

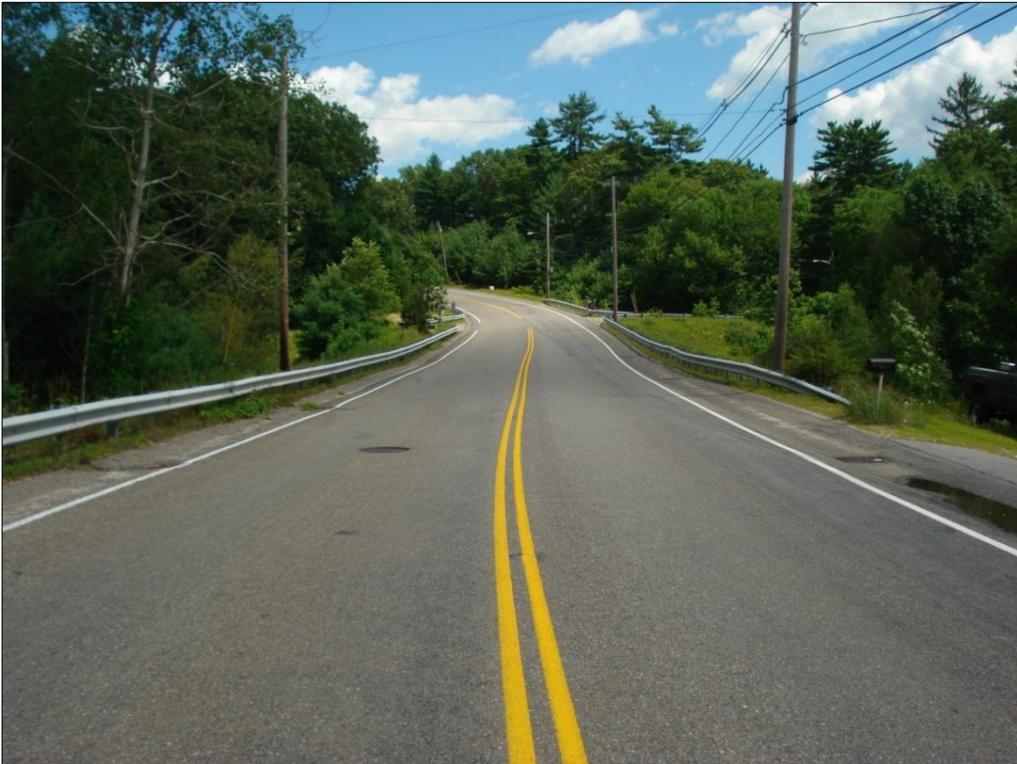
Photo 8 Looking East: West Approach

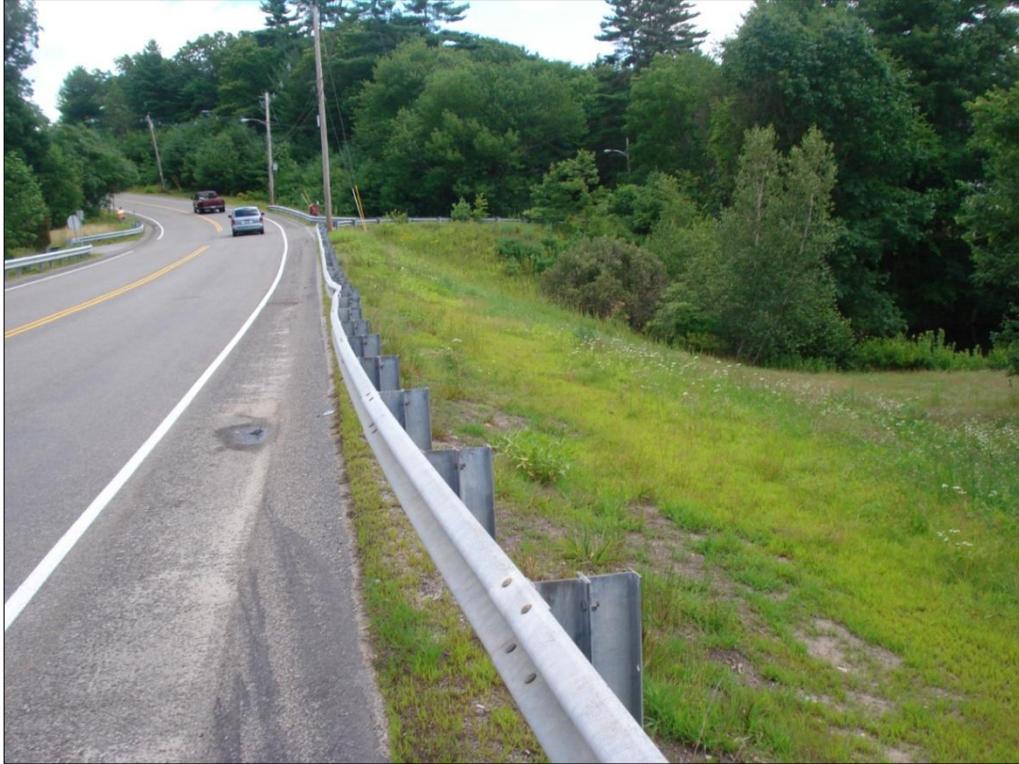
Photo 9 Looking East: Typical Guardrail over Culvert

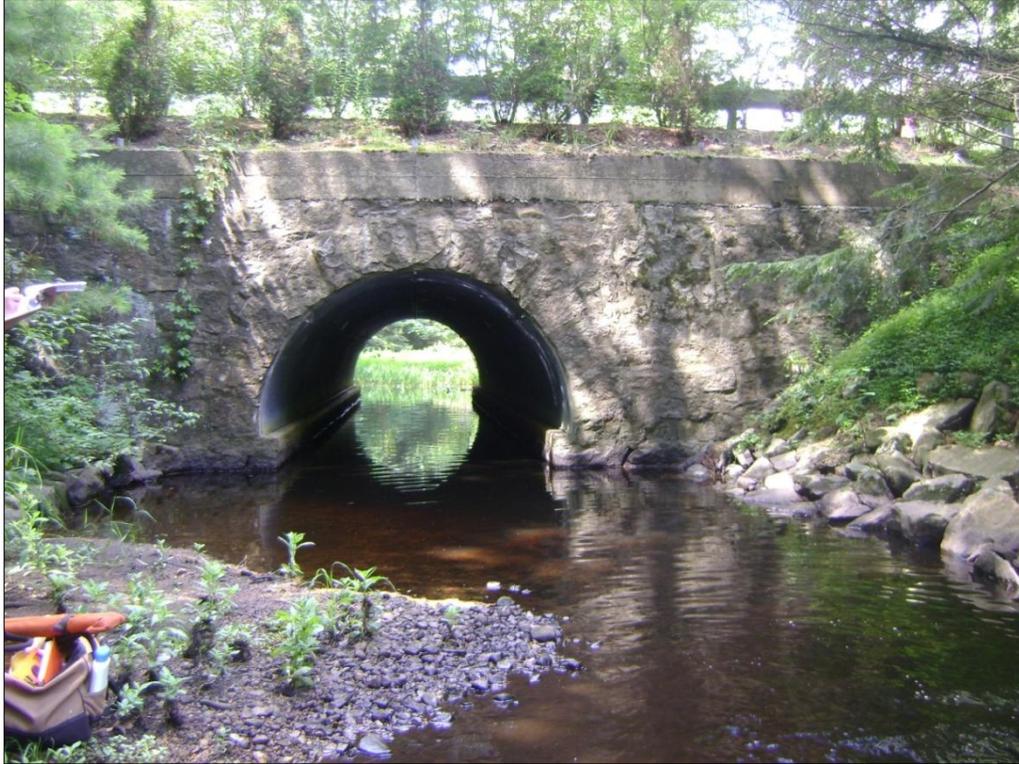
Photo 1 Looking West: East Bridge Elevation

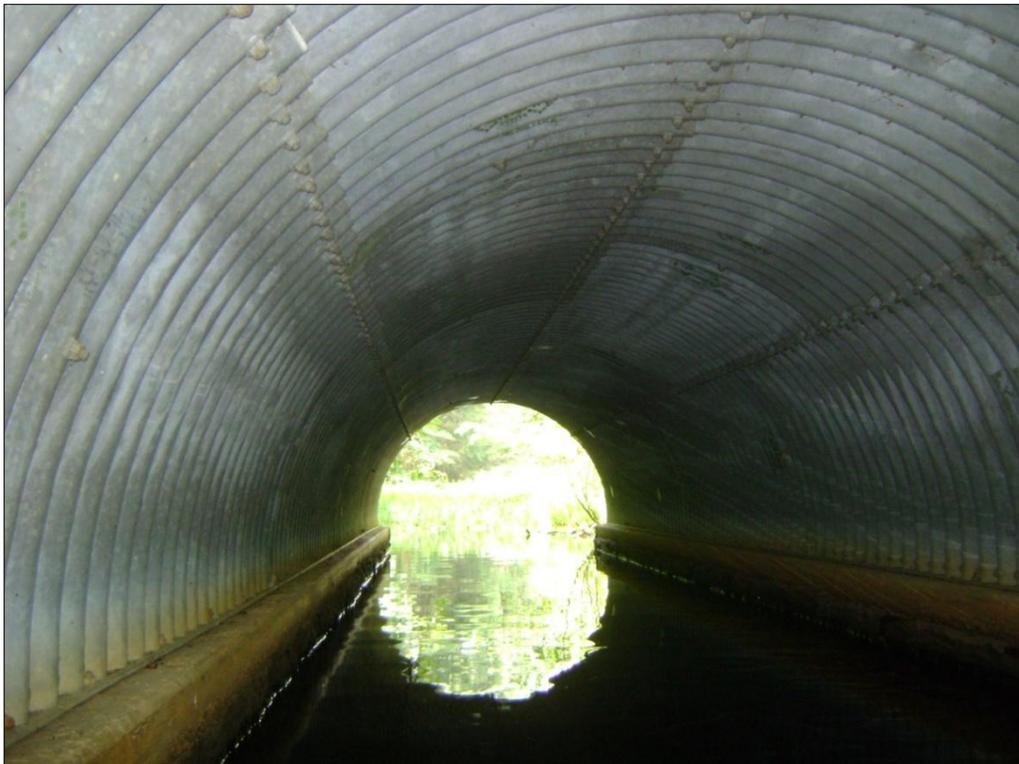
Photo 2 Looking West: Typical Inside of Culvert

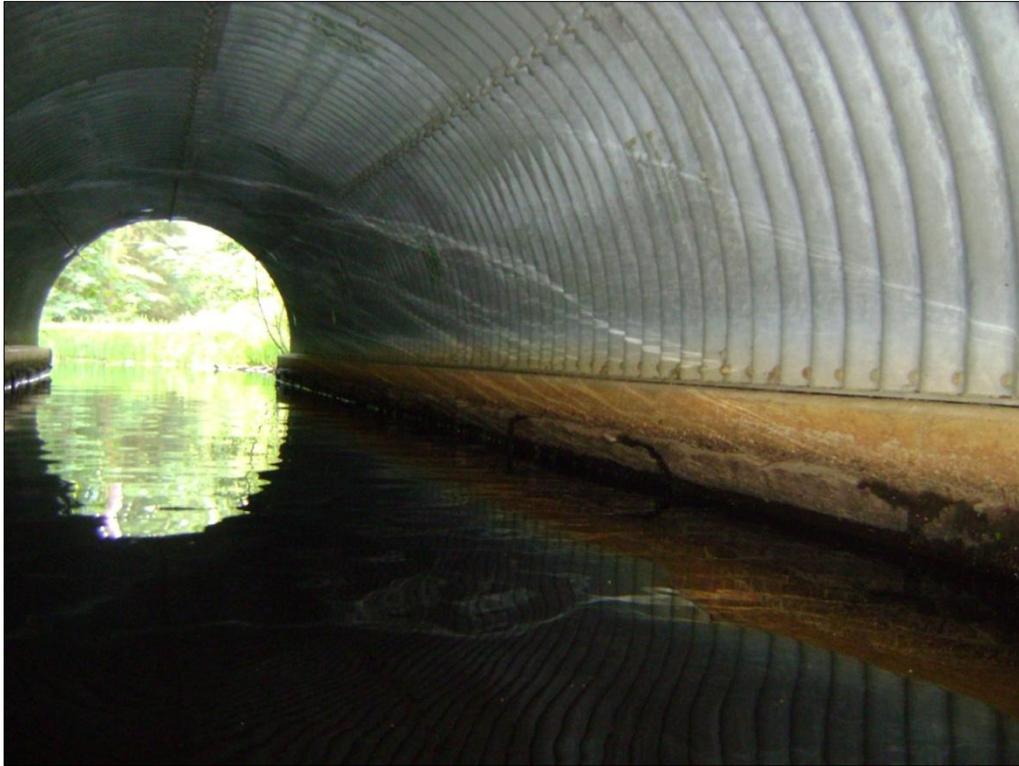
Photo 3 Looking West: North Channel Wall

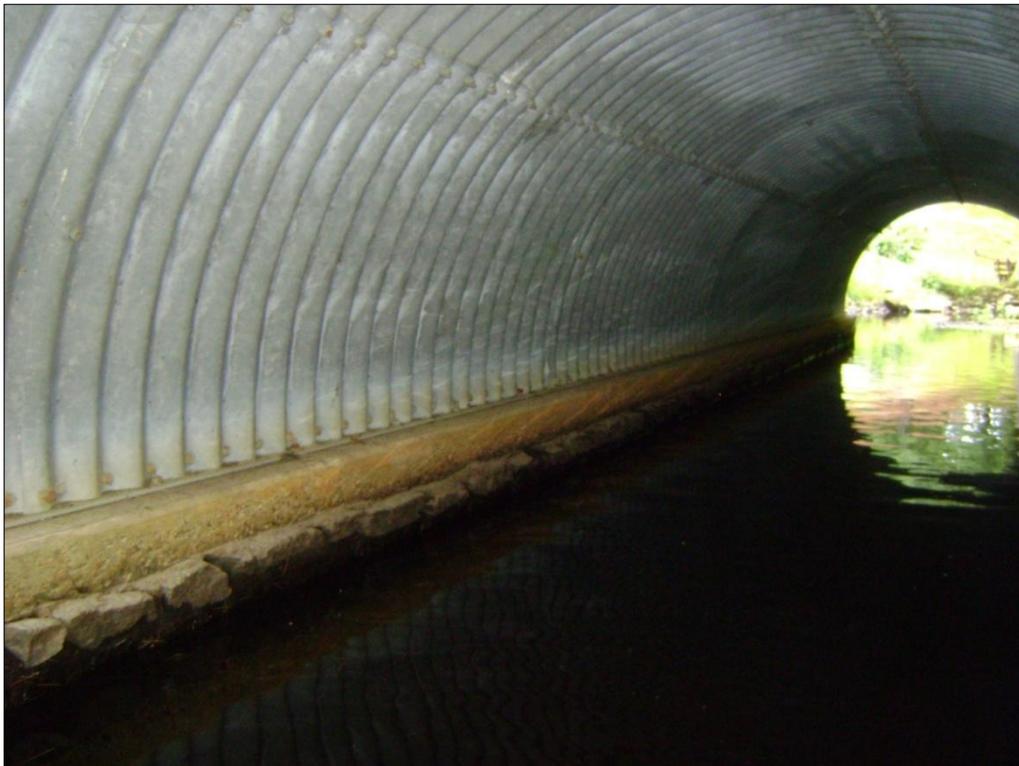
Photo 4 Looking West: South Channel Wall

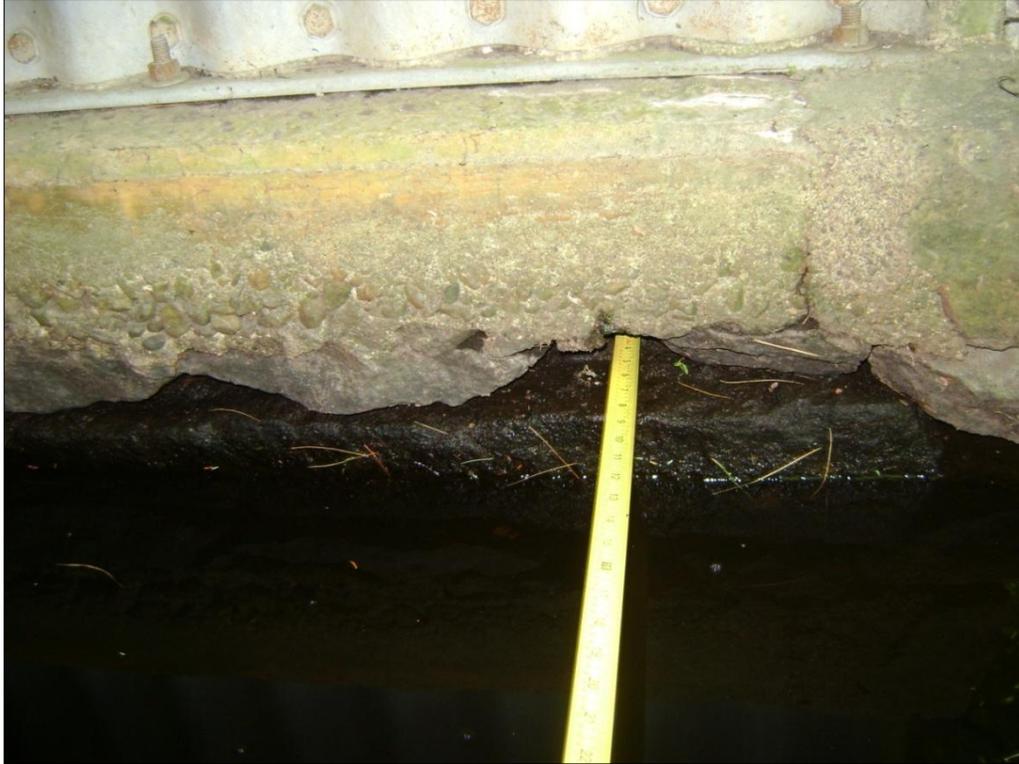
Photo 5 Looking Southeast: Void in South Channel Wall at West Opening

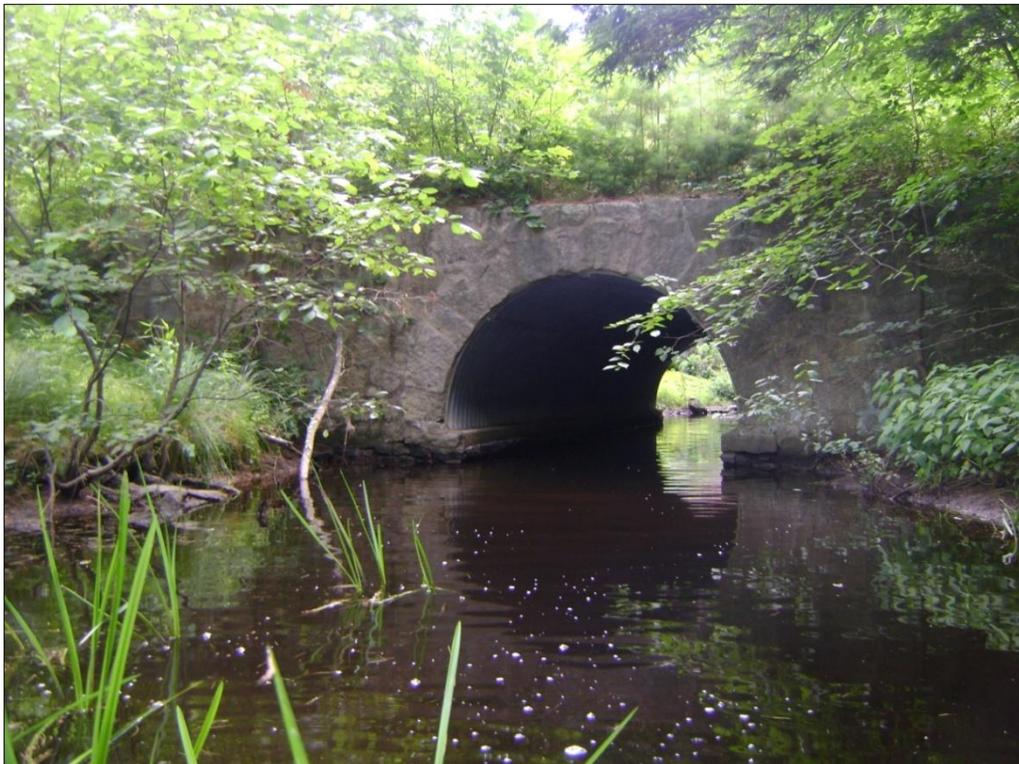
Photo 6 Looking Northeast: West Elevation

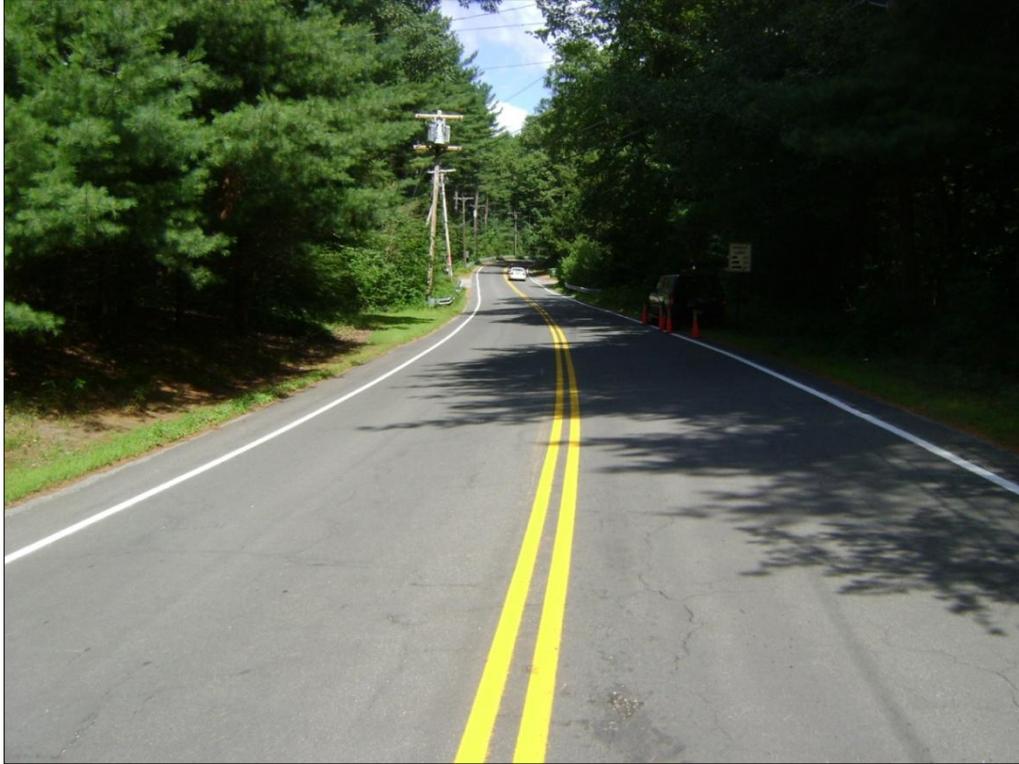
Photo 7 Looking North: South Approach

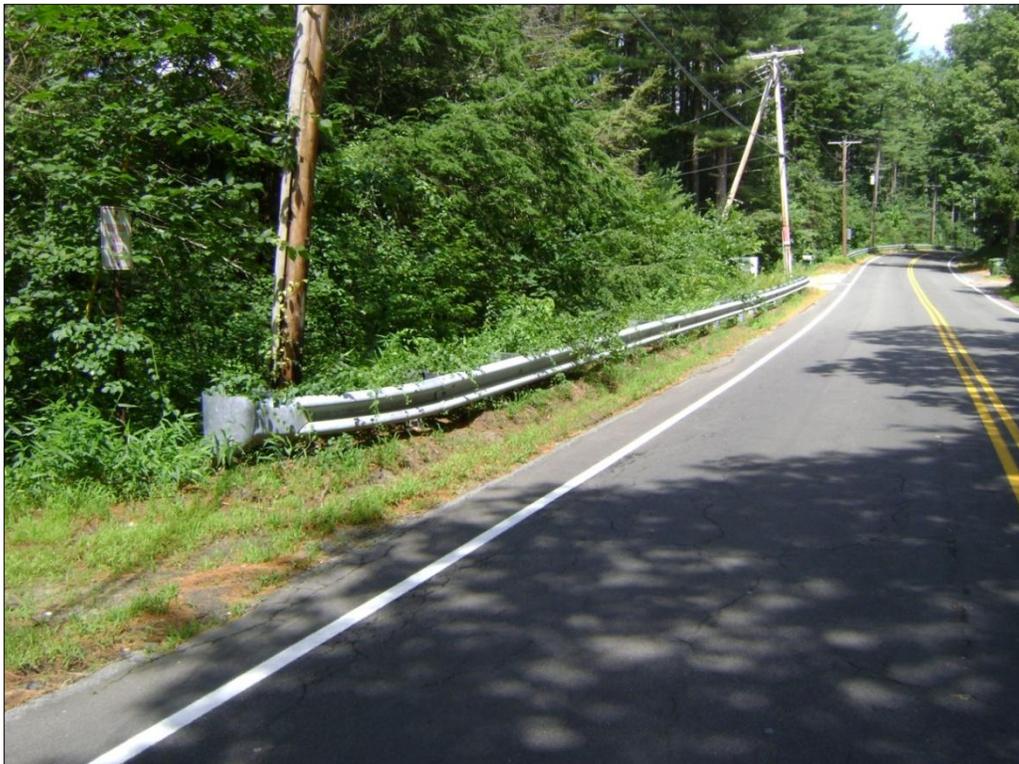
Photo 8 Looking North: Typical Guardrail Over Culvert

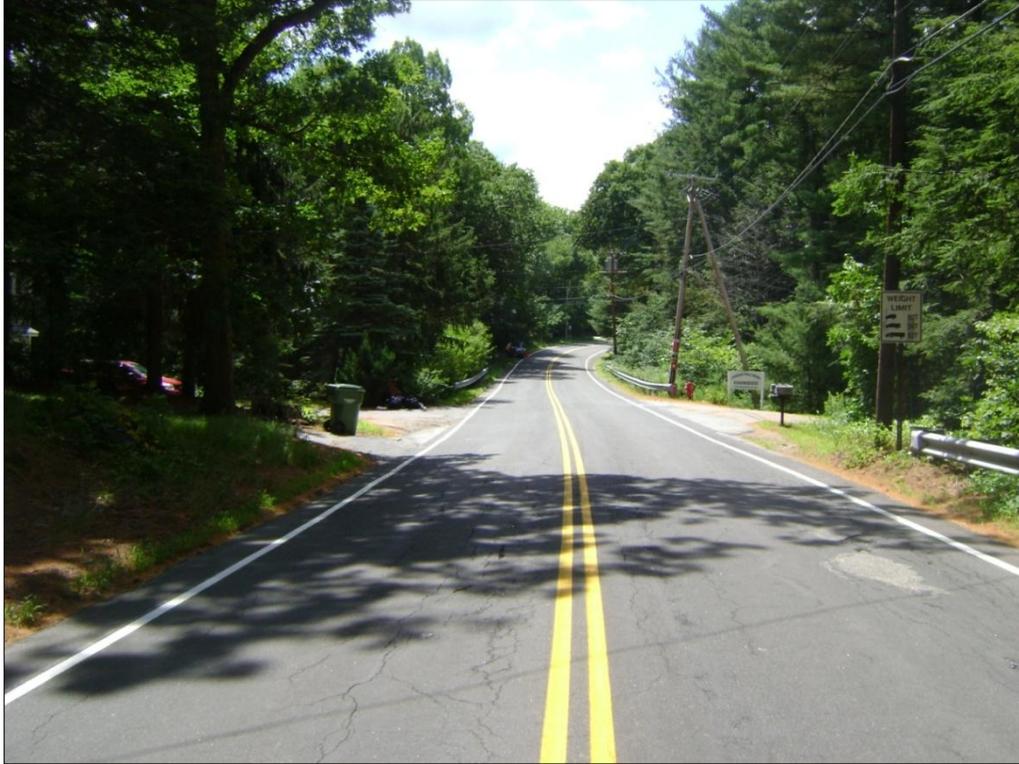
Photo 9 Looking South: North Approach

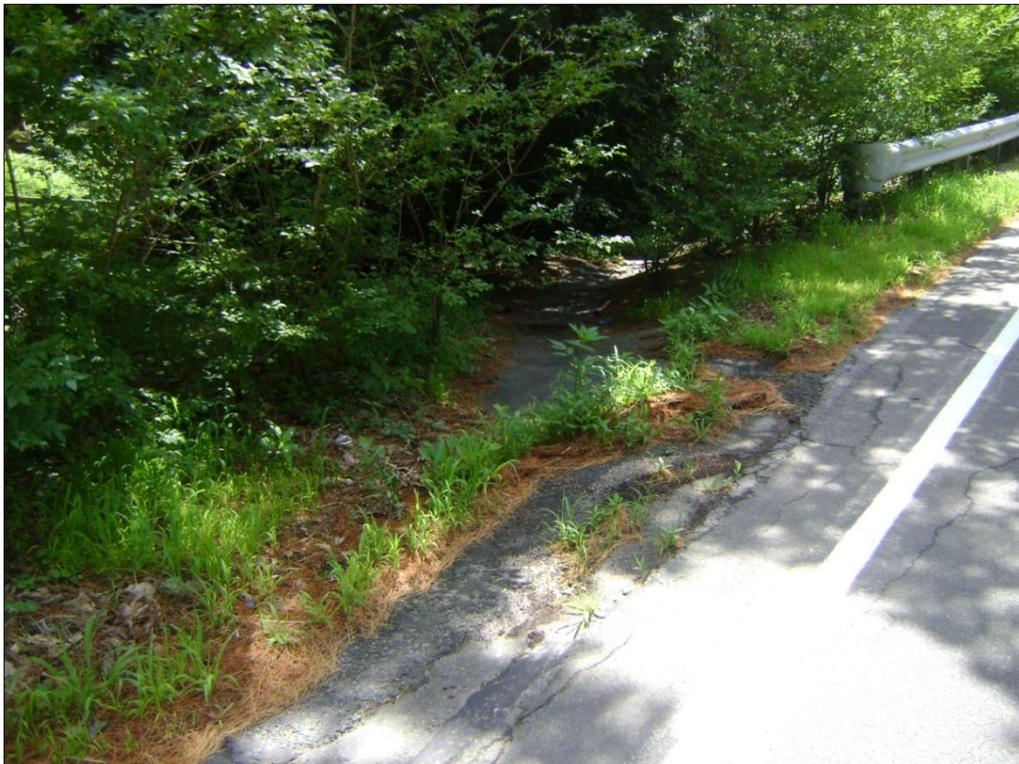
Photo 10 Looking Southeast: Paved Waterway at Northeast Corner

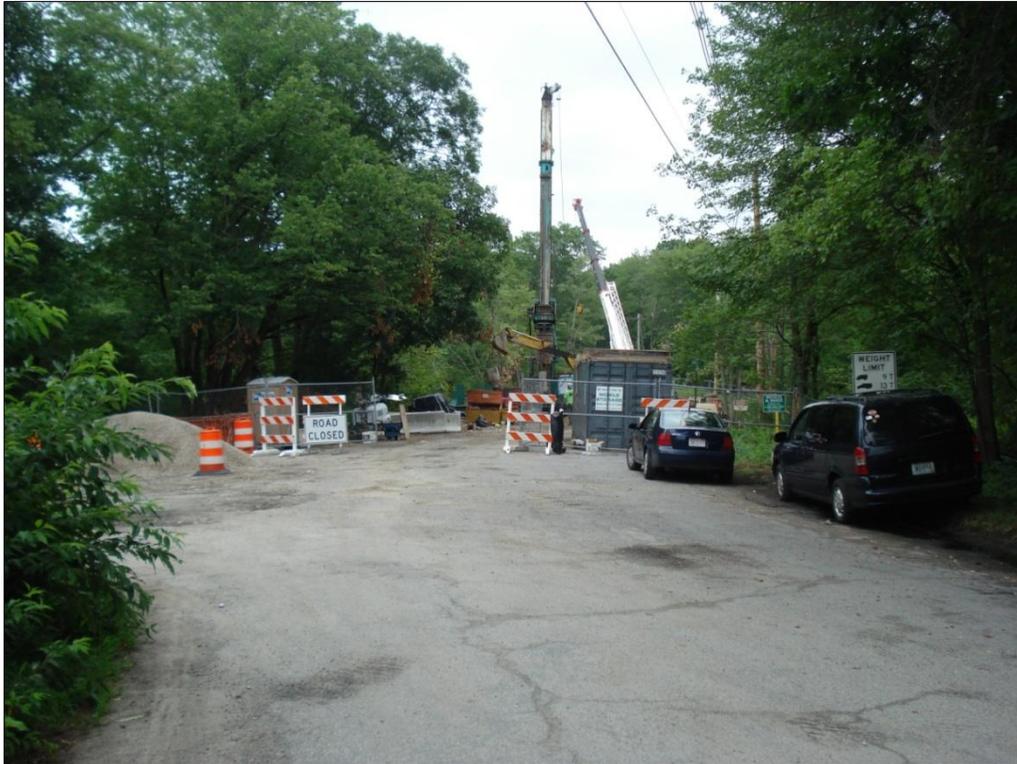
Photo 1 Looking East: Construction at River Road over Ironstone Brook
