Uxbridge, Massachusetts Evaluation Report

Project Number: 7533 June 2021

BRIDGE / CULVERT MANAGEMENT PLAN

Hartford Avenue East over the Mumford River (Bridge No. U-02-020)

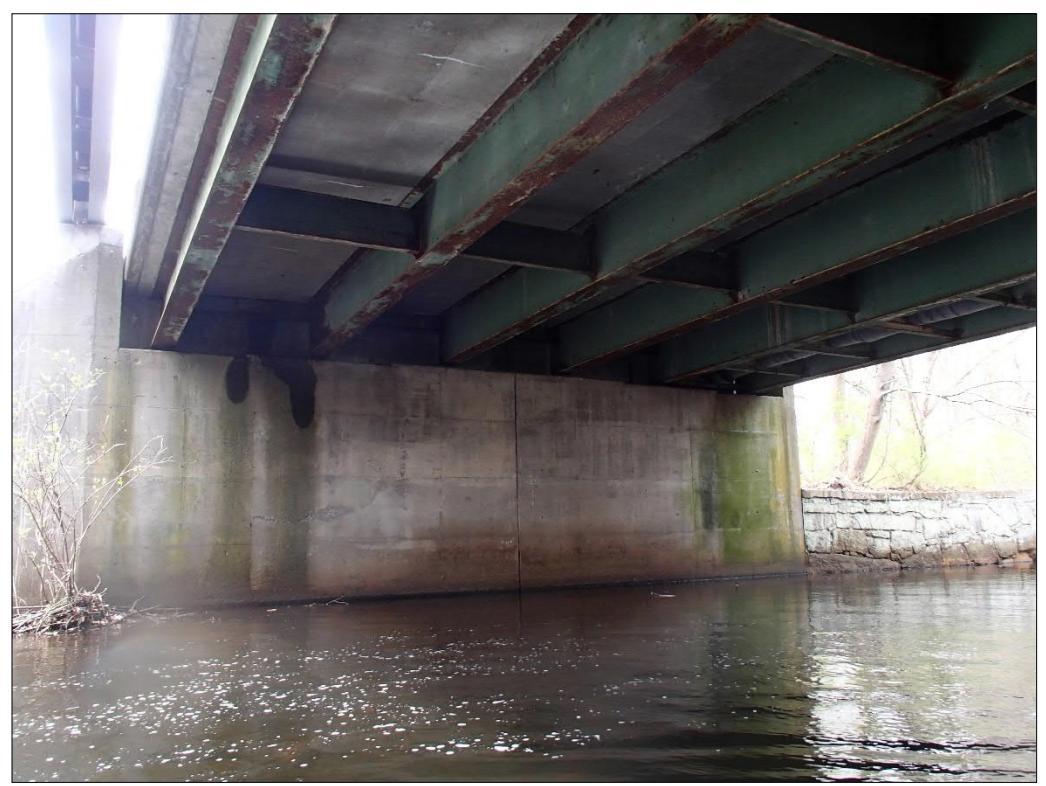
Photo 2 Looking West: West Abutment

The abutment concrete is in good condition with only minor problems noted. An area of water staining was present at bay 1 on the west abutment, which continues over the beam seat onto the abutment face (Photo 12). Full height water stains are also present under bay #5. Moderate amounts of debris were typically found on the beam seats. The east abutment has minor honeycombing throughout as well as minor scaling at the waterline. The channel has shifted and flows swiftly in front of the east abutment, leaving most of the abutment susceptible to scour.

- Remove sediment in front of the west abutment and fill scour hole at east abutment. This should be considered priority because of the high risk to undermining of the east abutment.
- Repair void at base of northeast training wall to prevent crumbling of wall above.

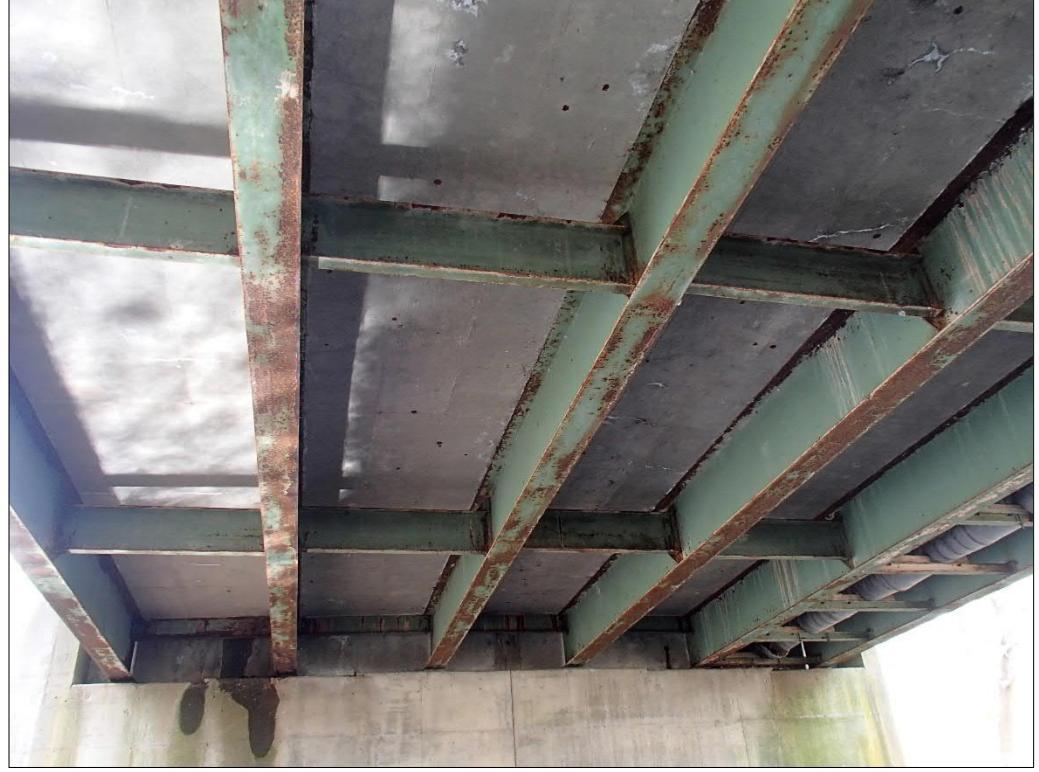
Photo 3 Looking West: Underside of Beams

The underside of the concrete deck slab was found to be in fair condition. There are longitudinal and transverse cracks typical throughout (Photo 3 and 5). The steel beams were in fair-to-poor condition with areas of deterioration noted. Heavy paint failure is typical on all steel beam flanges. Moderate to heavy corrosion of beams, diaphragms, and plates are typical throughout (Photos 3 and 5). Beam 4 was noted to exhibit heavier corrosion. The bearings are in fair condition but do exhibit some deterioration. Bearing plates and anchor bolts at both abutments typically show moderate paint failure and surface rusting. However, bearing plates at beams #1 and #2 at the west abutment show more advanced signs of deterioration.

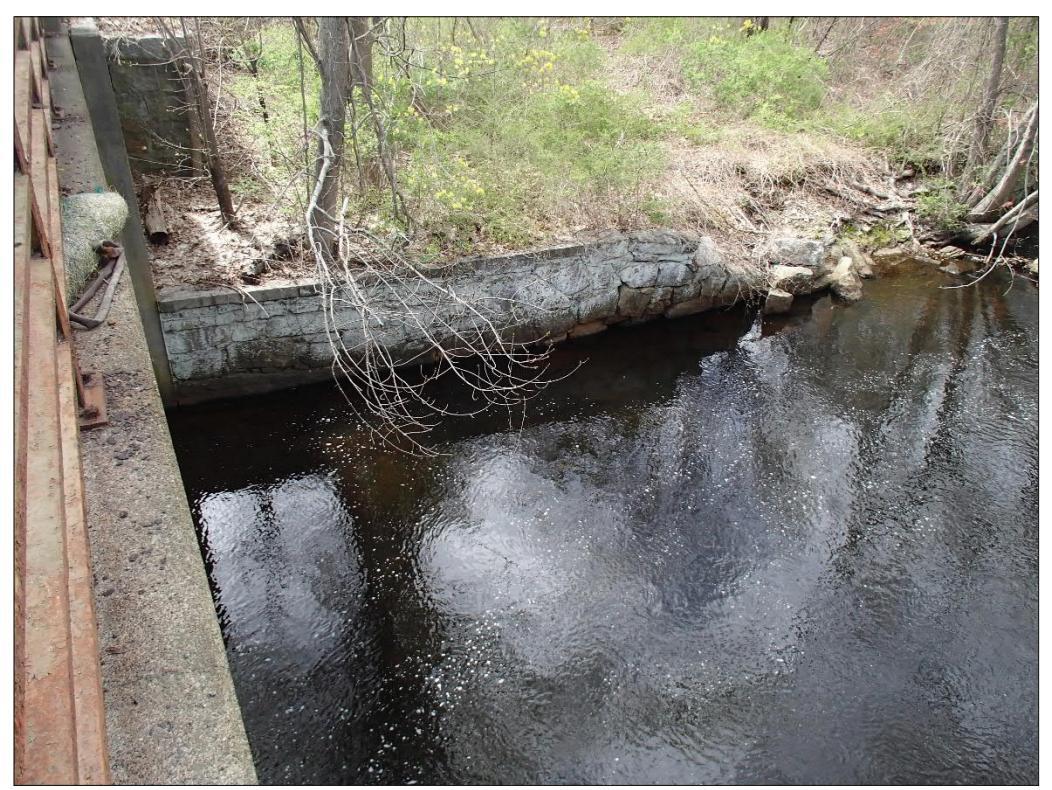
Photo 6 Looking Northwest: Northwest Training Wall

The northeast and northwest training walls show loss of pointing and chinking stones at the waterline. Approximately 60' upstream, the northeast wall has a 6'x3'x2' deep void at the base that is causing the wall above it to crumble (Photo 6). The southeast and southwest walls exhibit heavy loss of mortar and chinking stones along with heavy vegetation growth. The southeast wingwall corner has a spall and vegetation growth at the joint (Photo 13). The southeast training wall is also crumbling at the end (Photo 14).

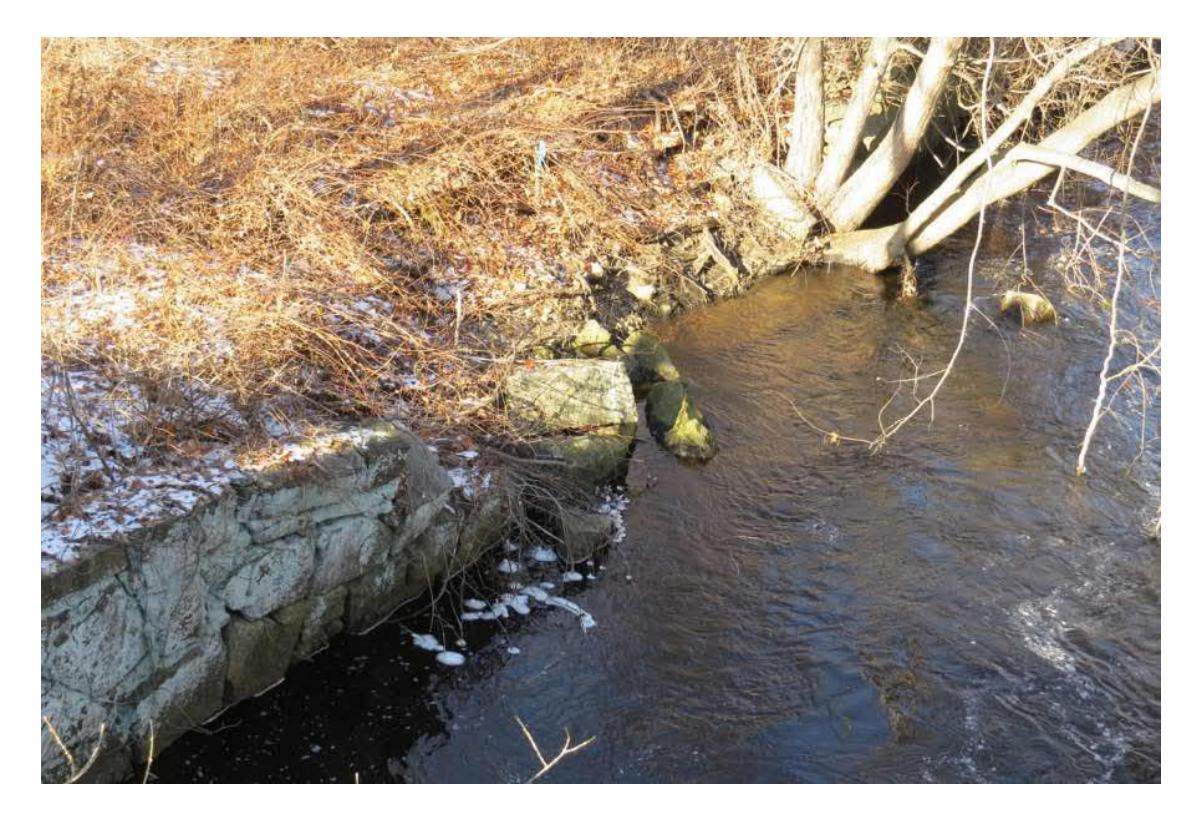
Photo 12: Collapsed section of channel wall at the Northwest corner of the bridge.

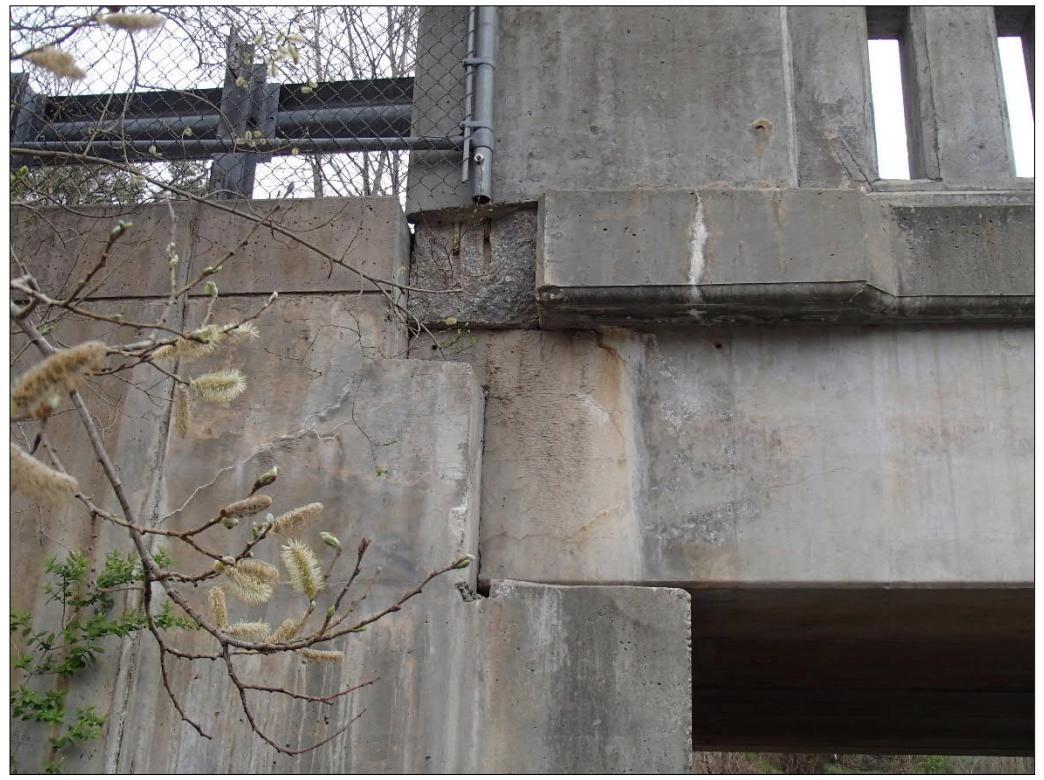
Photo 5 Looking East: Northwest Coping Spall

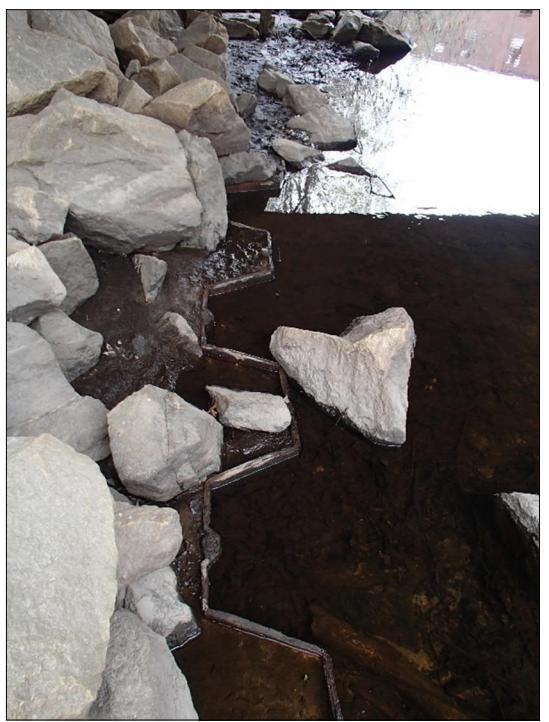
Photo 8 Looking West: Steel Sheeting Visible on South Side

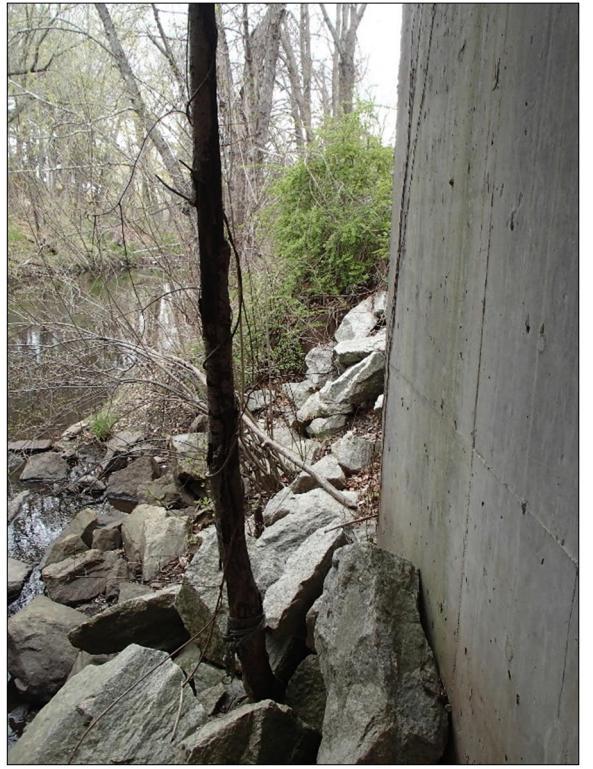
Photo 9 Looking East: Southeast Riprap Vegetation

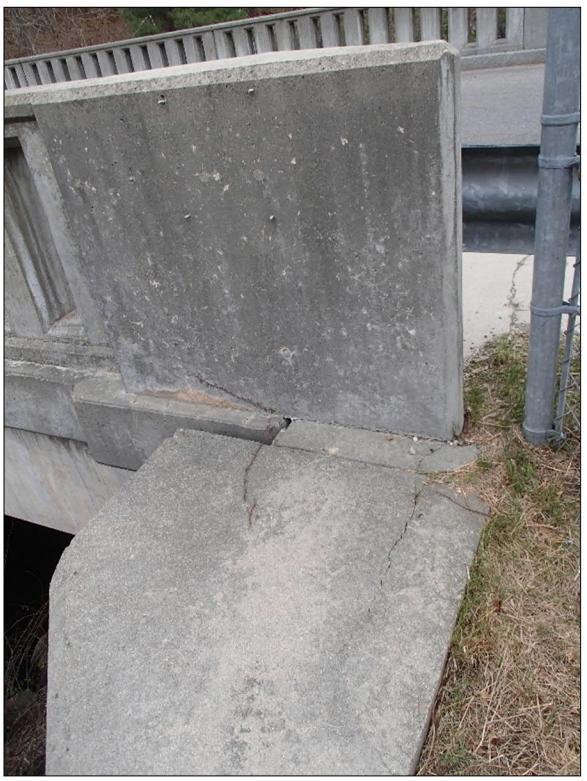
Photo 10 Looking East: Southwest Endpost Movement

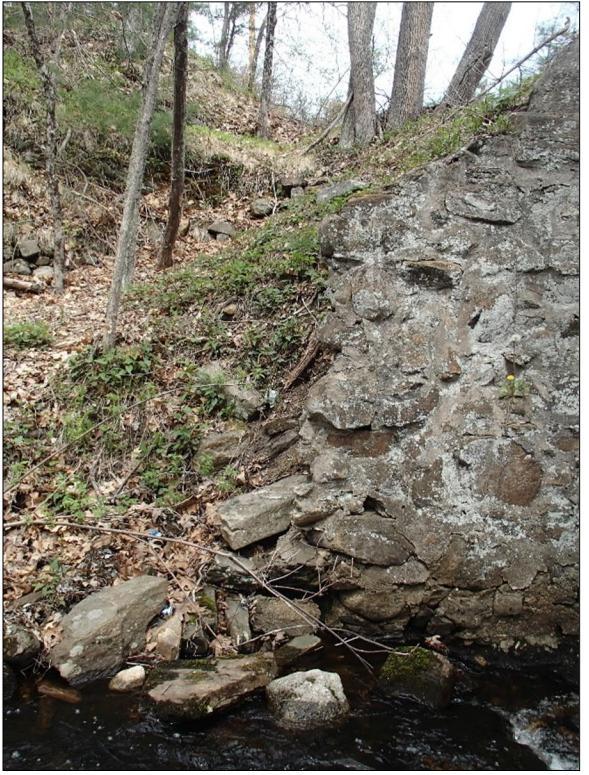
Photo 5 Looking North: Northwest Wingwall

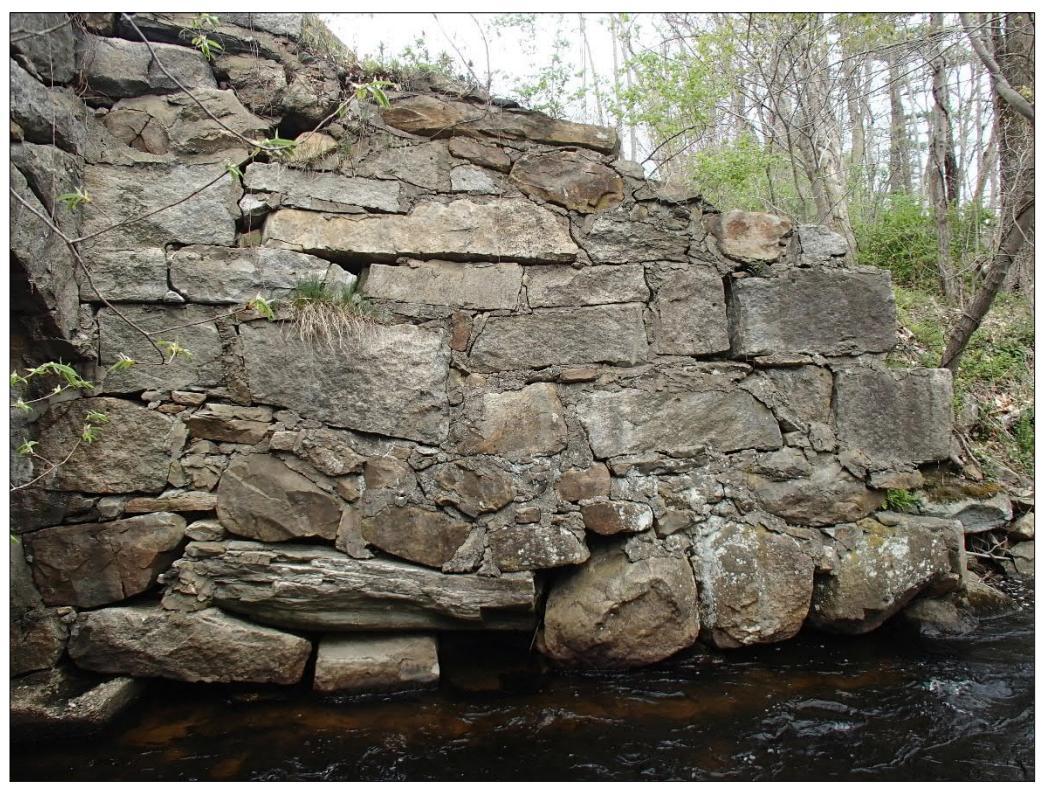
Photo 6 Looking North: Northeast Wingwall

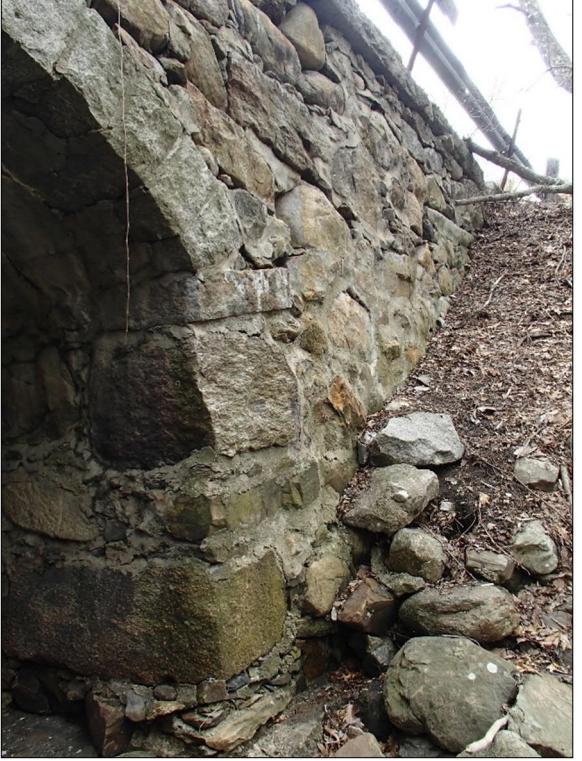
Photo 7 Looking South: Southwest Wingwall

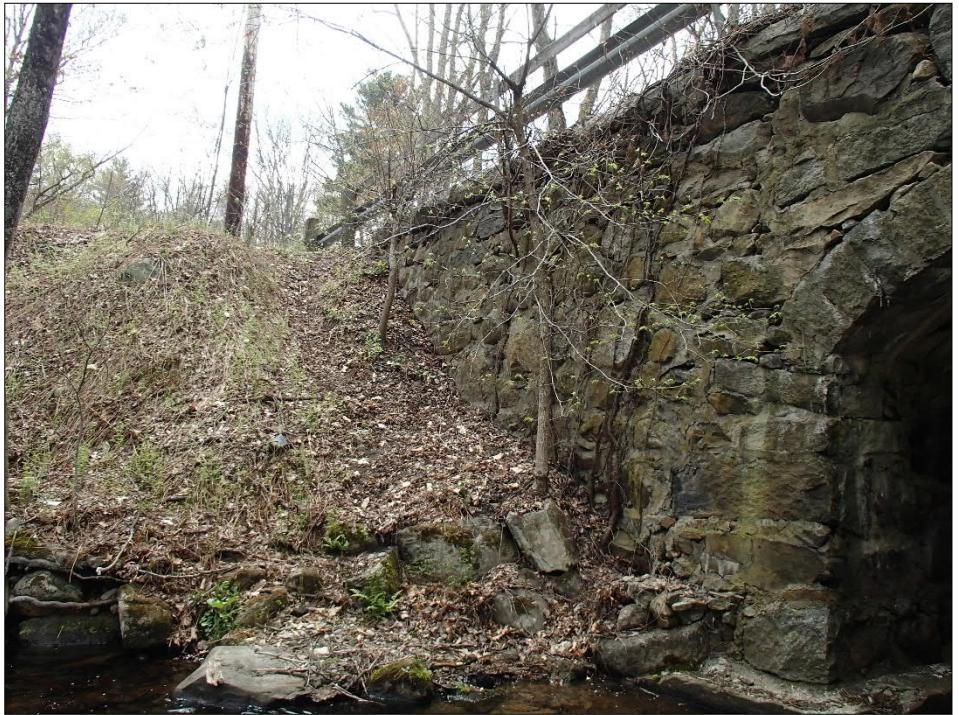
Photo 8 Looking South: Southeast Wingwall

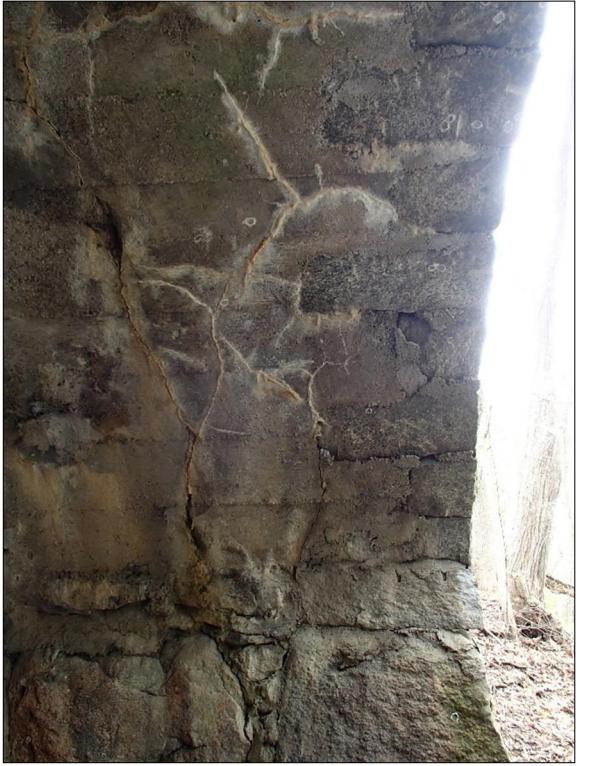
Photo 9 Looking South: Culvert Roof at Southwest Corner

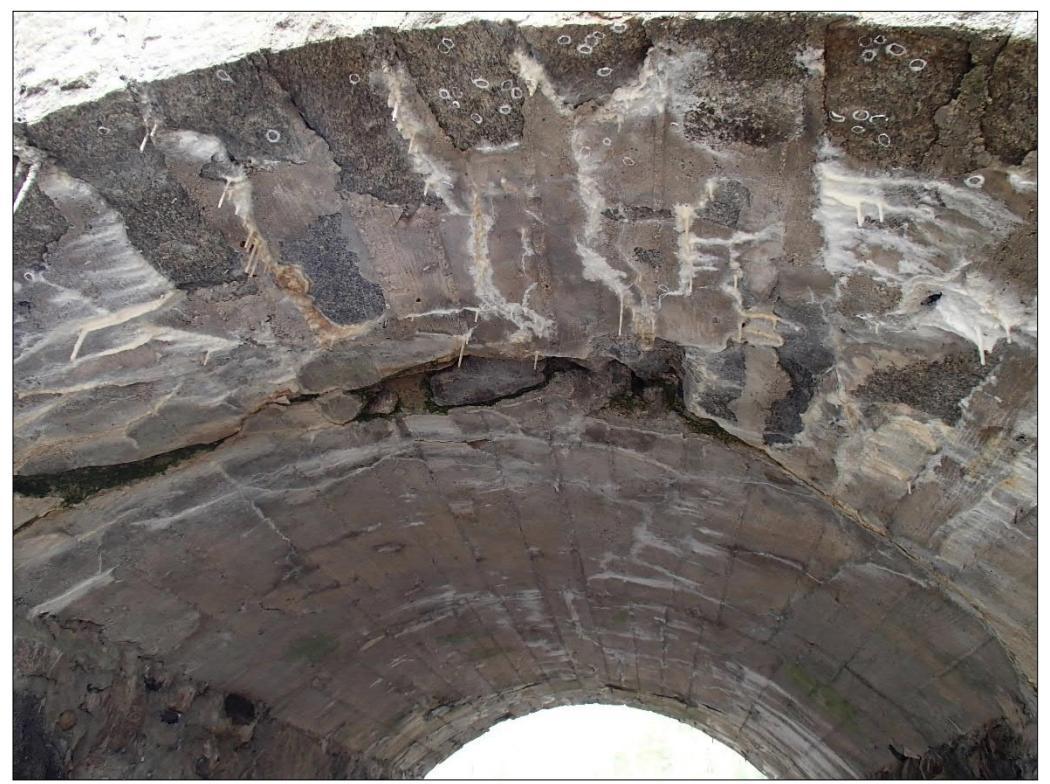
Photo 10 Looking West: Culvert Roof at East Entrance

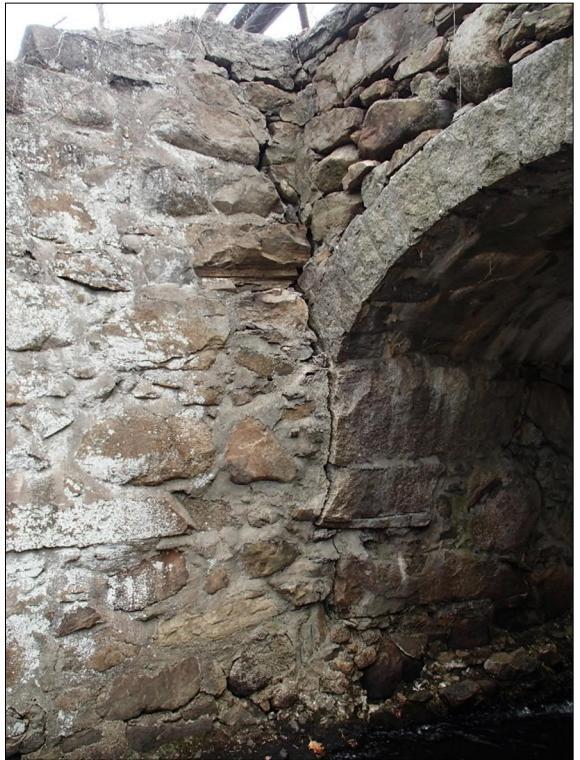
Photo 11 Looking North: Separation at Northwest Wingwall

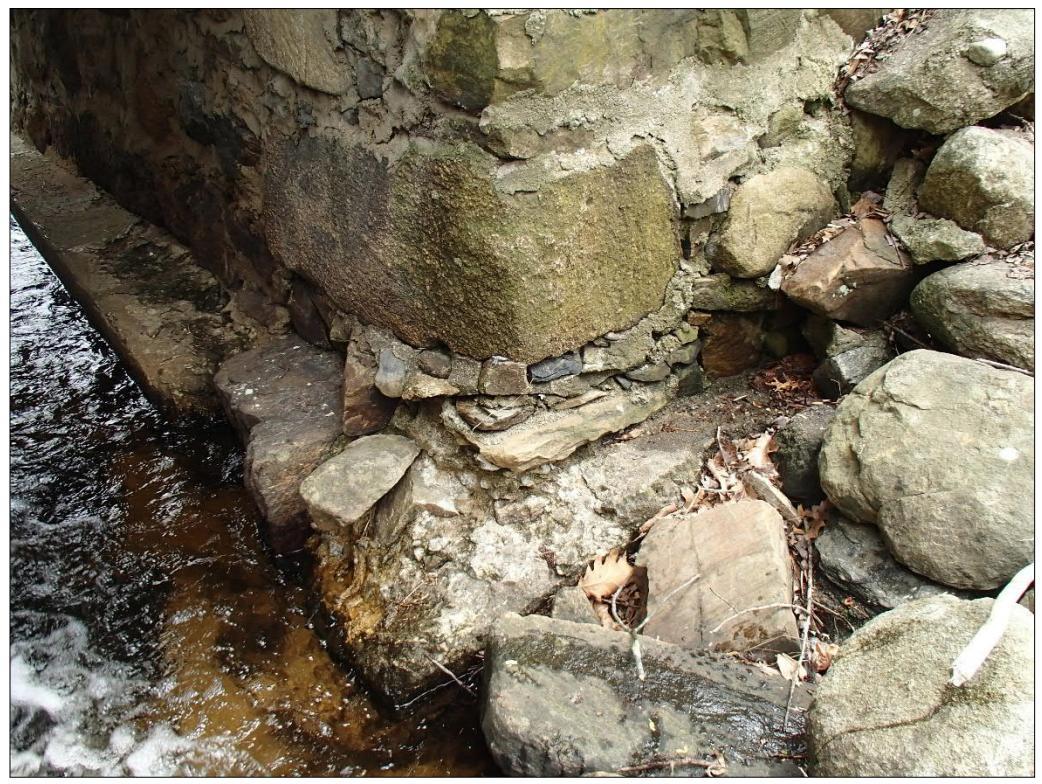
Photo 12 Looking Southeast: Southwest Abutment Corner

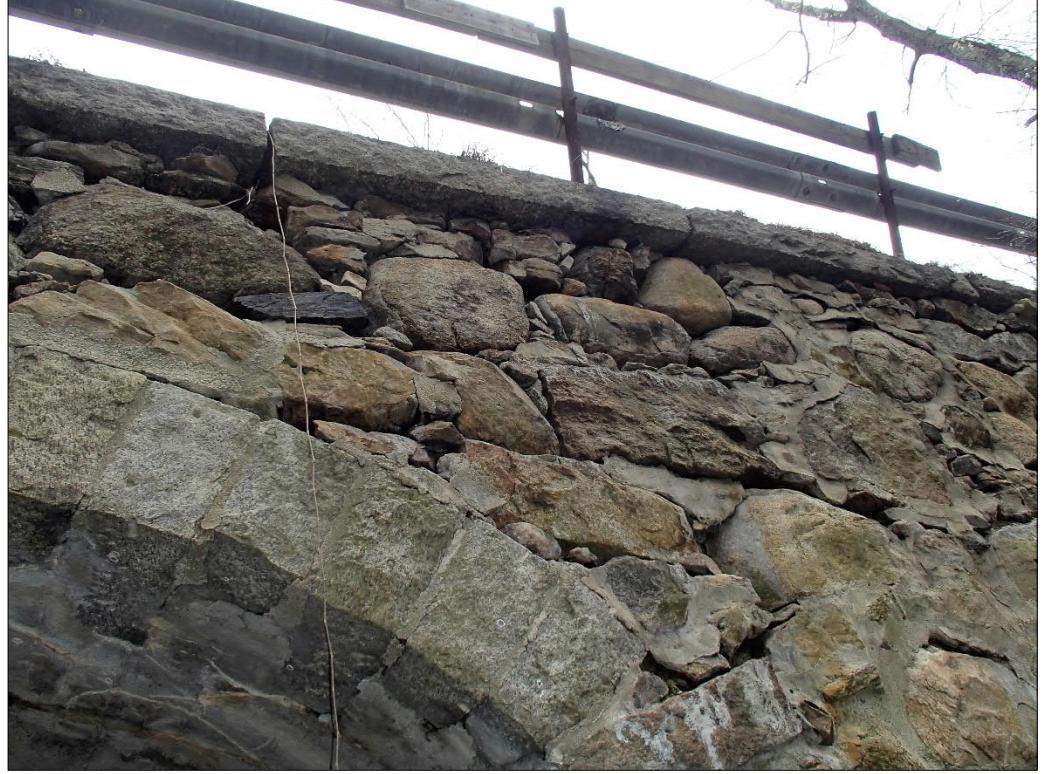
Photo 13 Looking West: East Arch Face

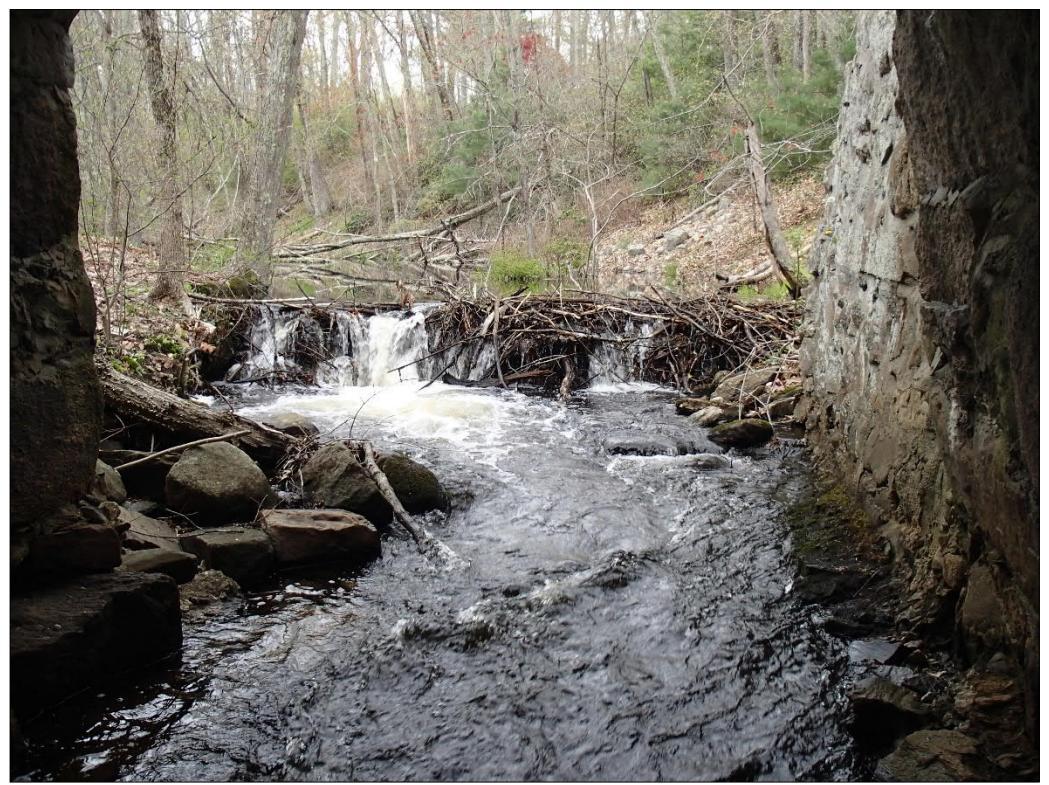
Photo 14 Looking West: Dam in Brook

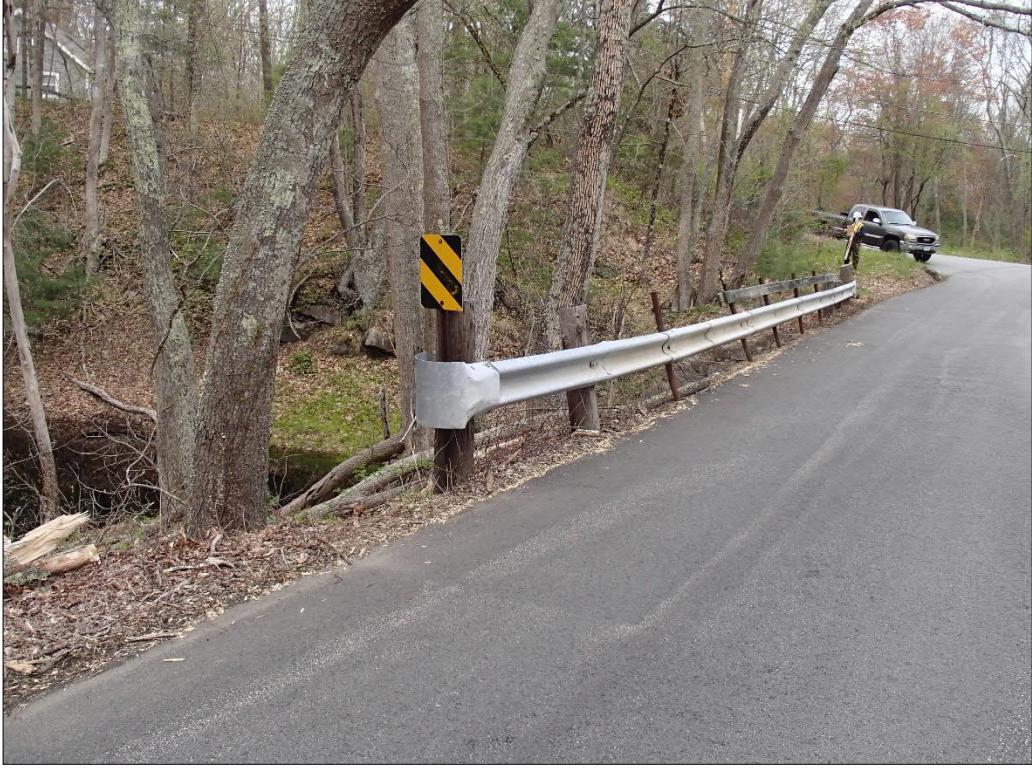
The pavement over the arch and at the approaches is in good condition. There is a sharp horizontal and vertical curve with poor visibility. The guardrail is in poor condition and is leaning away from the roadway on the west side (Photo 17). The guardrail also has areas where it is not fully connected to the posts. There is slight collision damage at the northeast approach. The roadway geometry, poor condition of the guardrails, and lack of any approach rail make this a safety hazard.

Photo 17 Looking Northwest: West Barrier

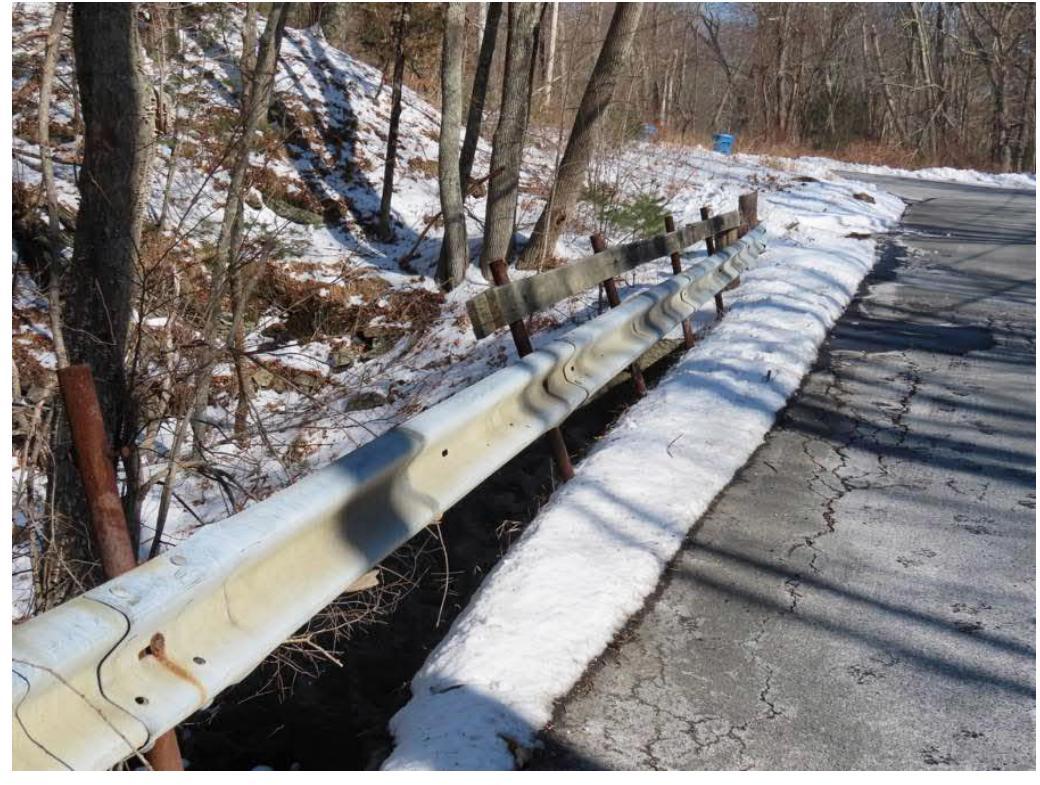
Photo 2: West bridge rail.

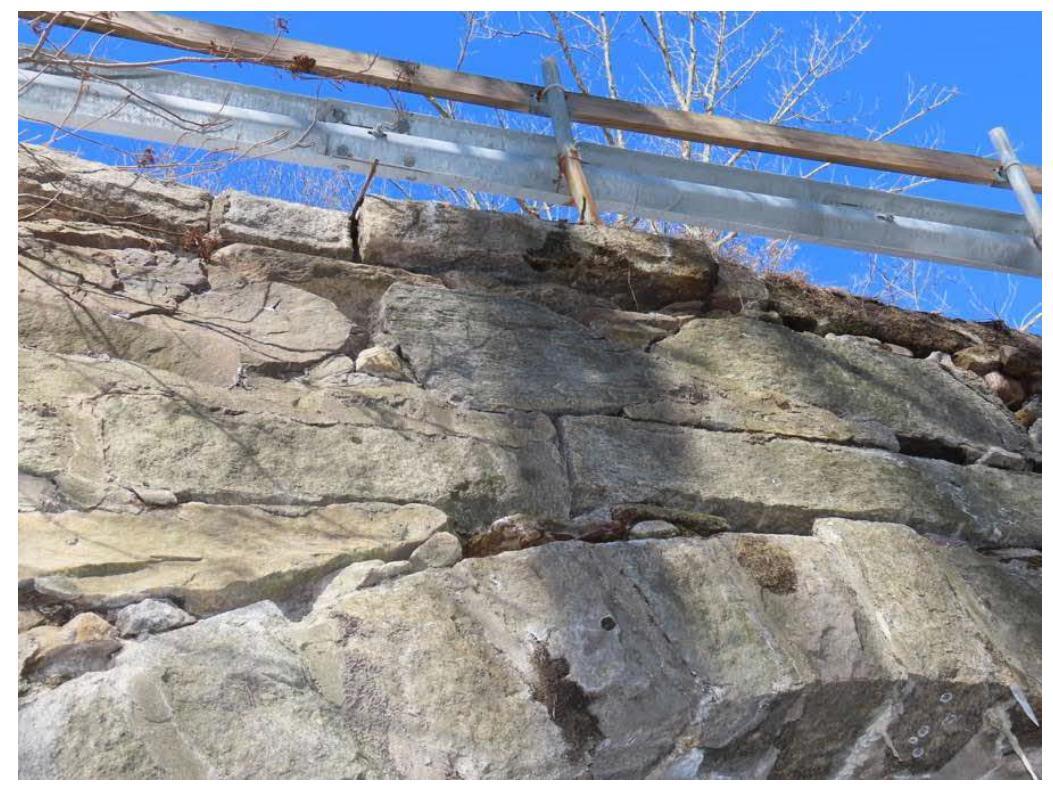
Photo 3: West spandrel wall.

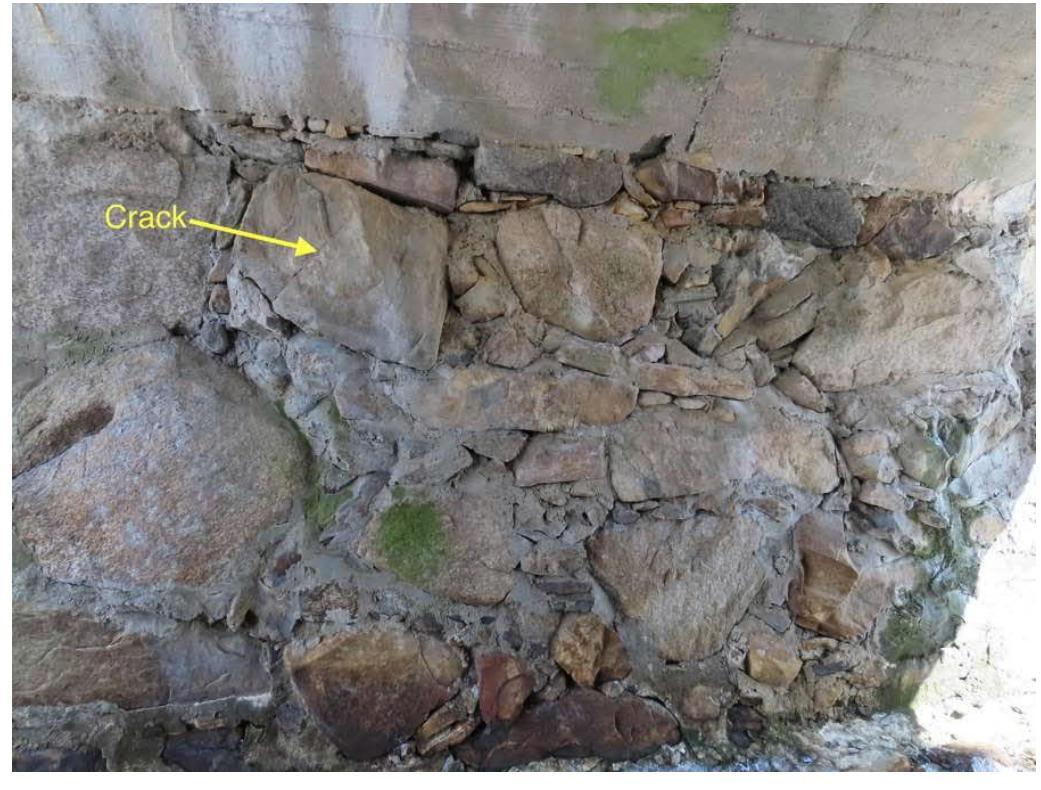
Photo 7: East side of arch.

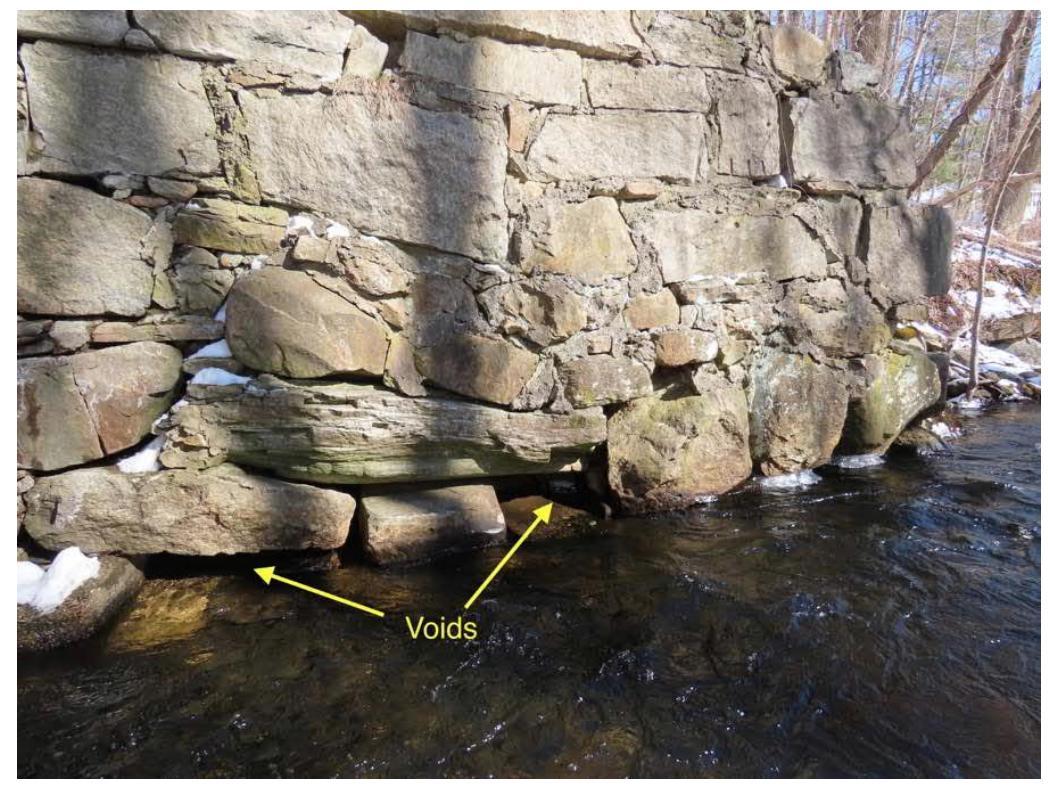
Photo 9: Northwest wingwall.

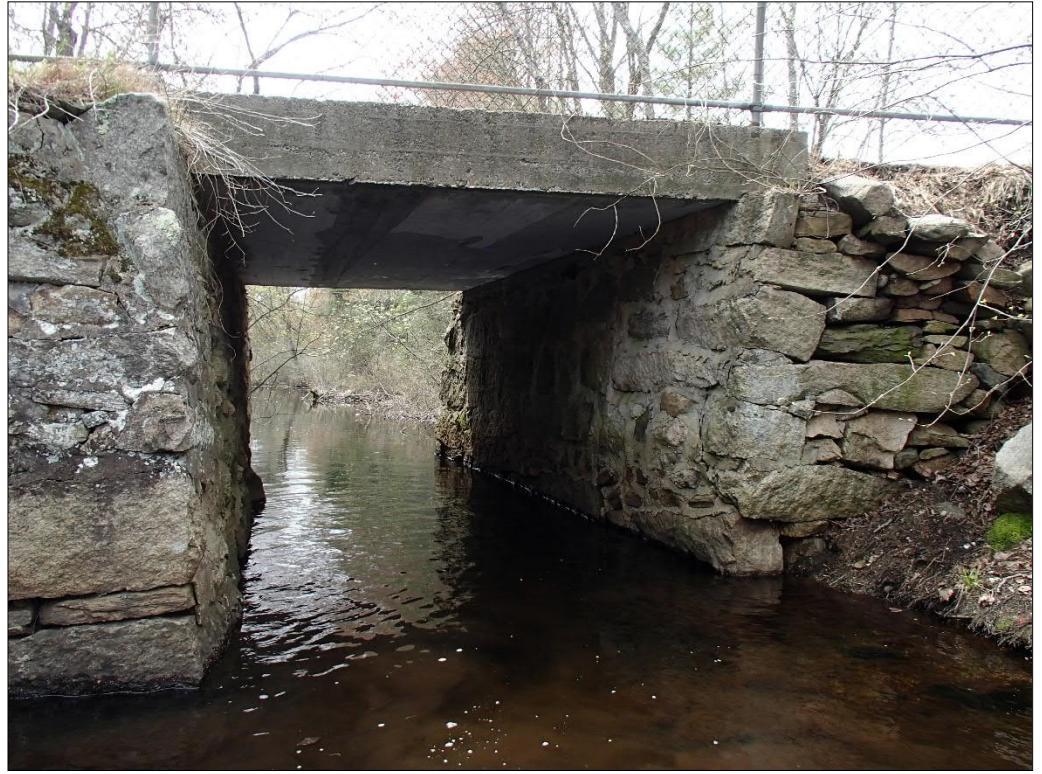
Photo 1 Looking South: North Bridge Elevation

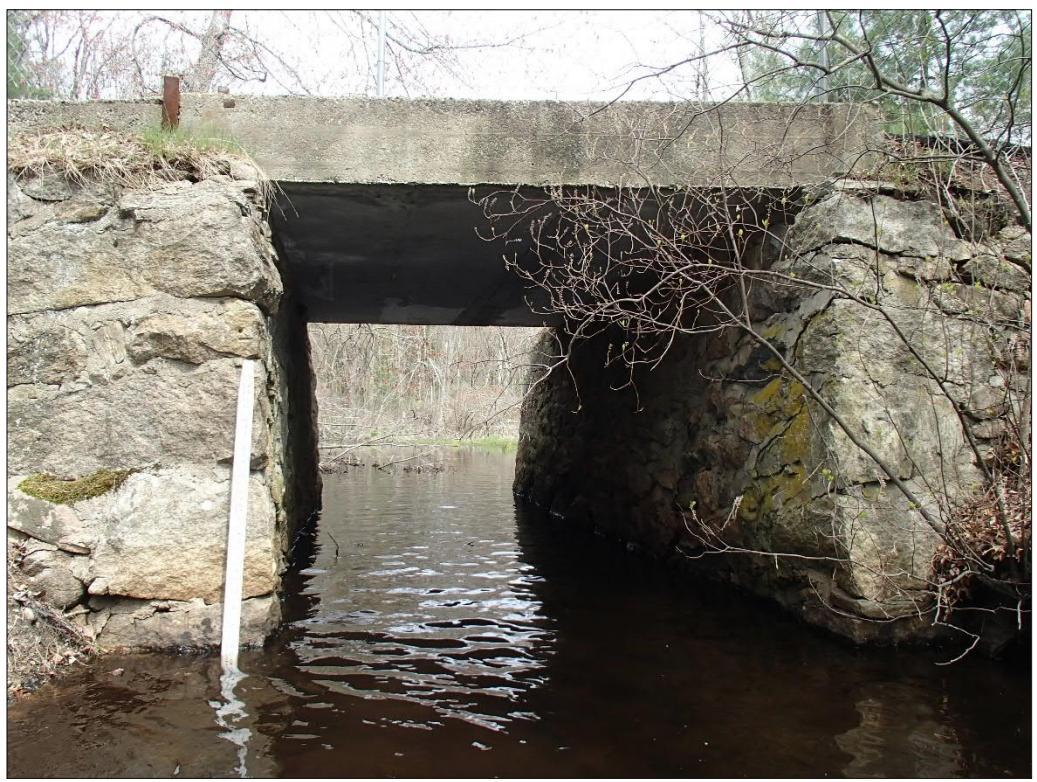
Photo 2 Looking North: South Bridge Elevation

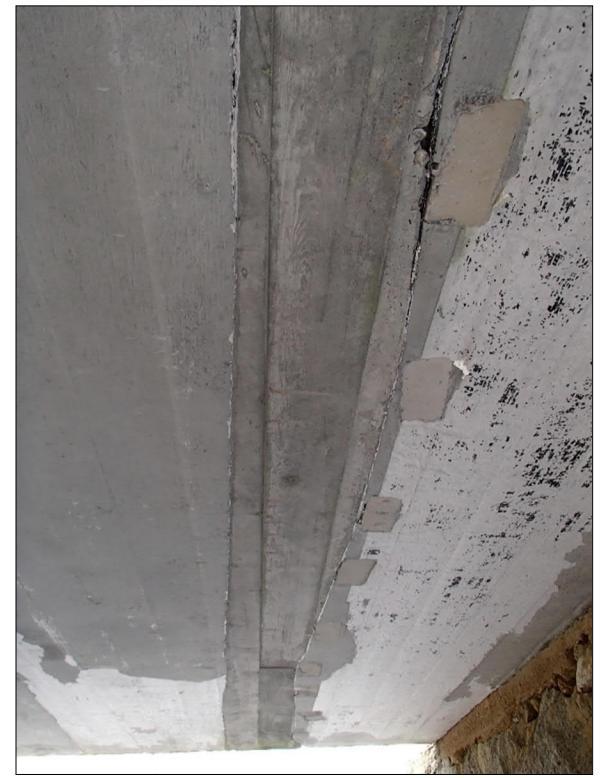
Photo 3 Looking North: Roof

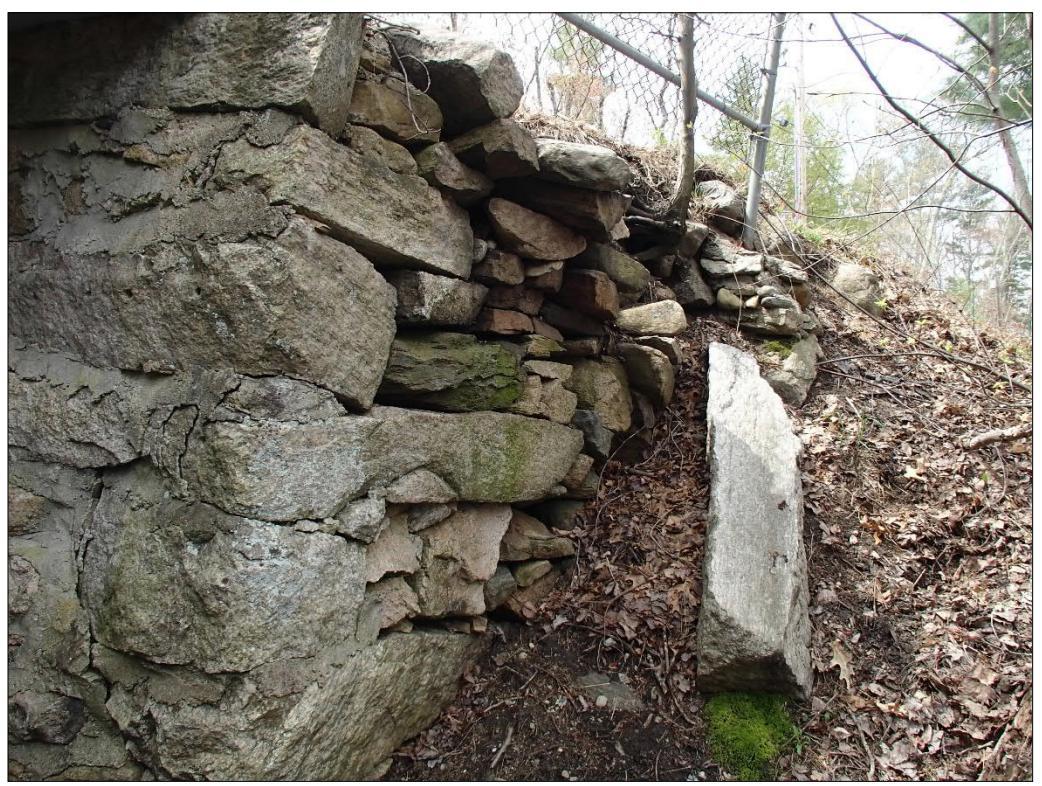
Photo 4 Looking Southwest: Northwest Wingwall

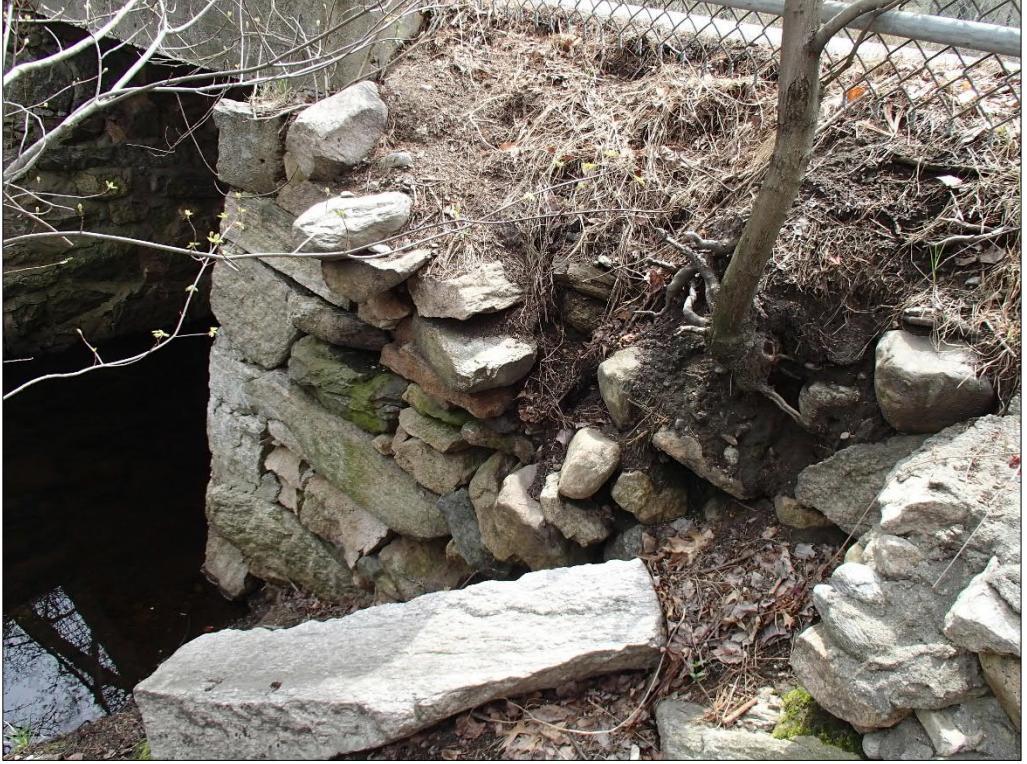
Photo 5 Looking Southeast: Northwest Wingwall

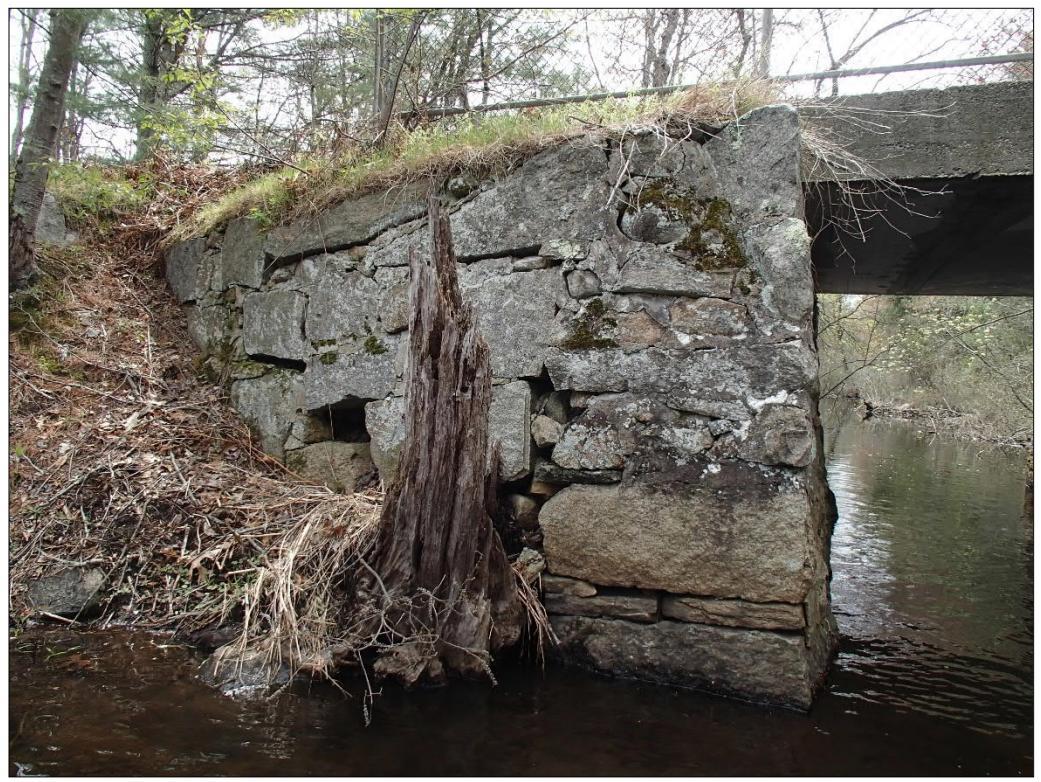
Photo 6 Looking South: Northeast Wingwall

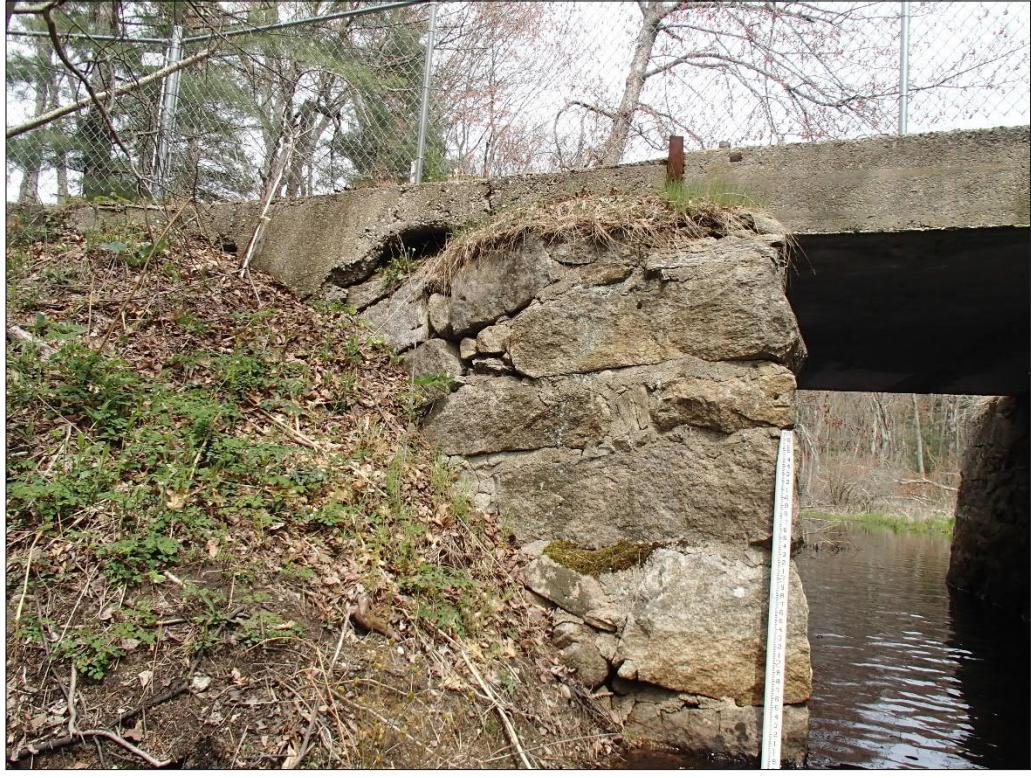
Photo 7 Looking North: Southwest Wingwall
