Uxbridge, Massachusetts Evaluation Report

Project Number: 7533 June 2021

BRIDGE / CULVERT MANAGEMENT PLAN

Hartford Avenue East over the Mumford River (Bridge No. U-02-020)

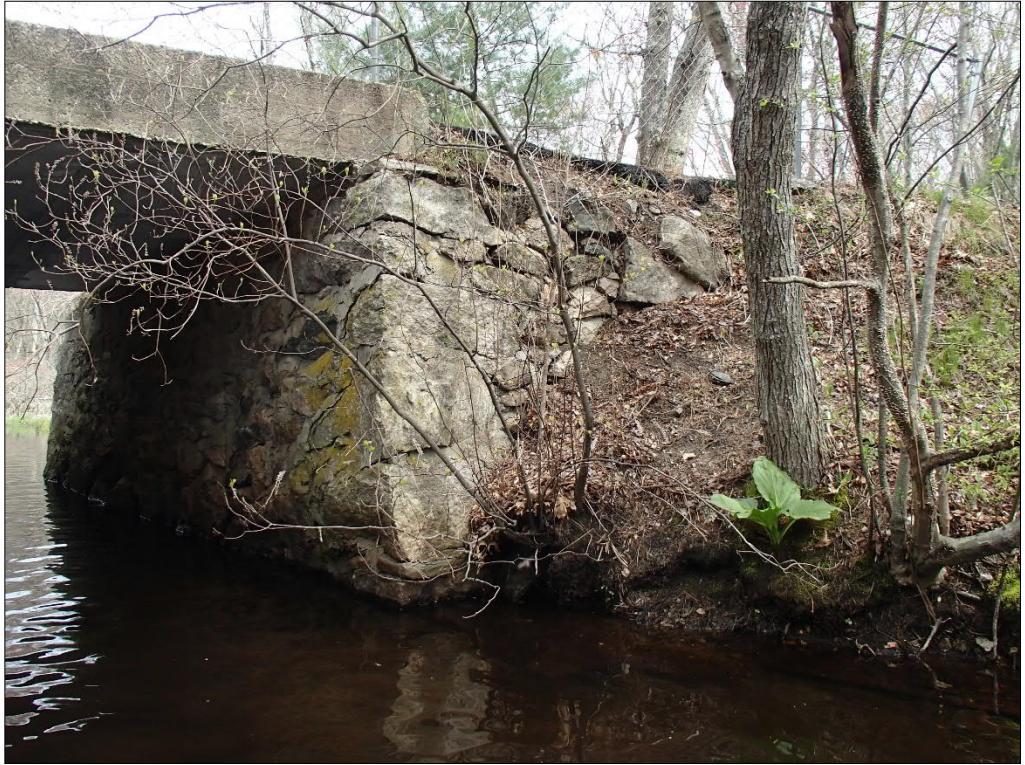
Photo 8 Looking North: Southeast Wingwall

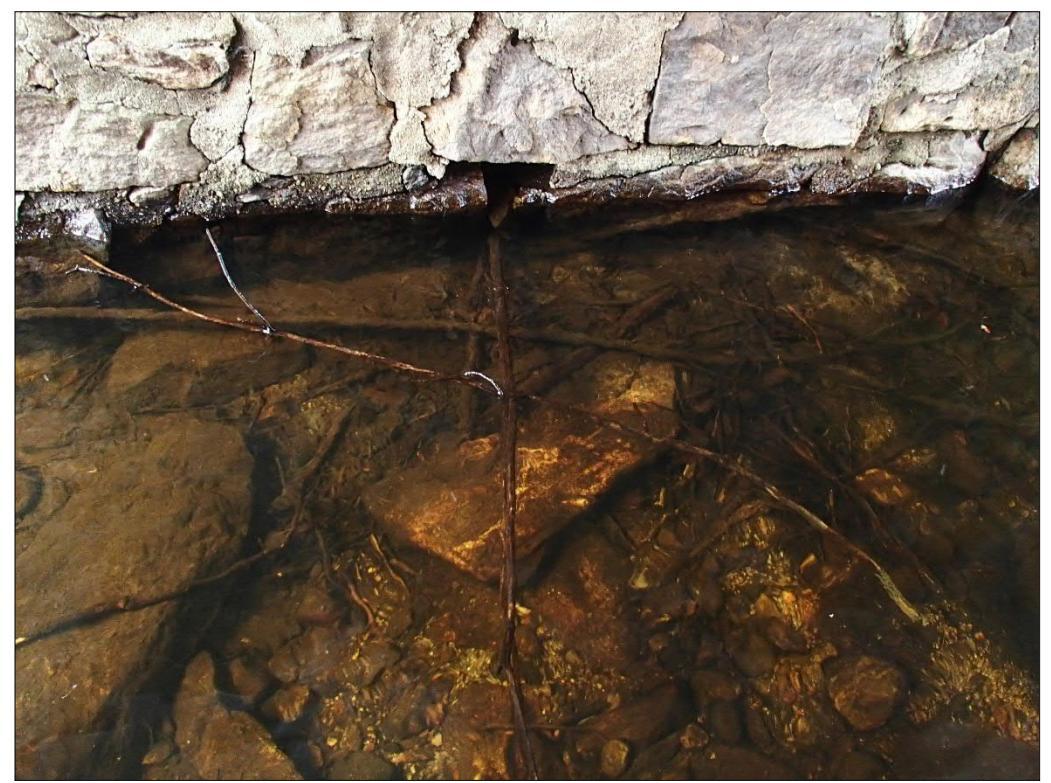
Photo 12 Looking West: Debris in Brook

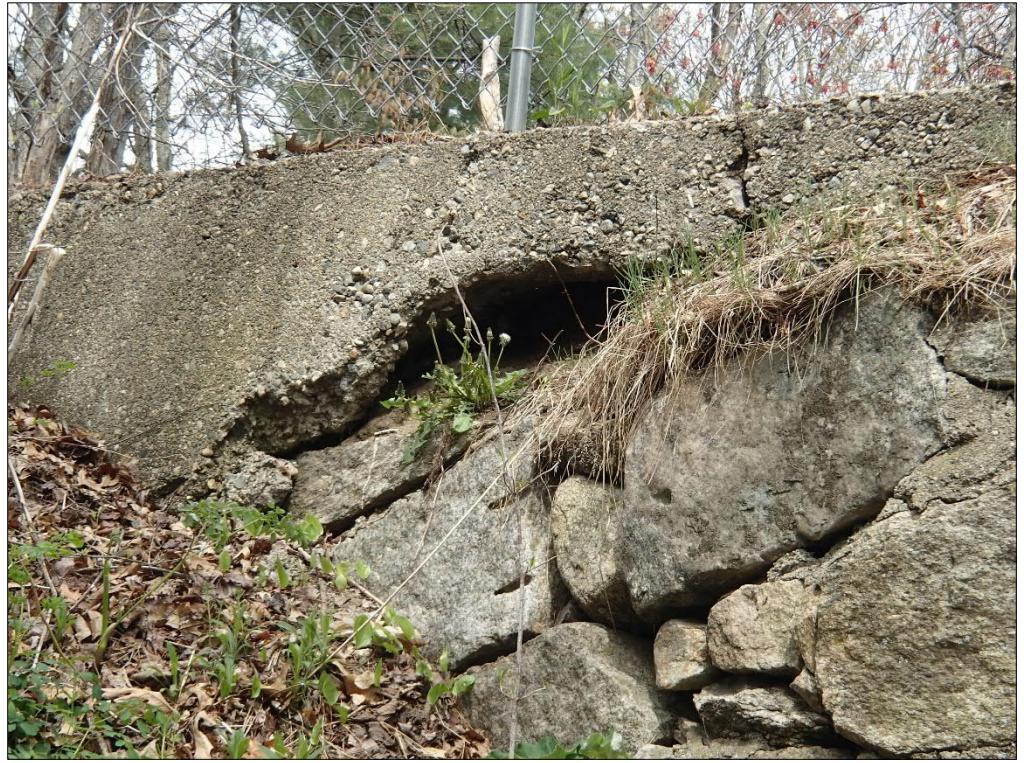
Photo 13 Looking North: Large Void on Parapet near Southwest Wingwall

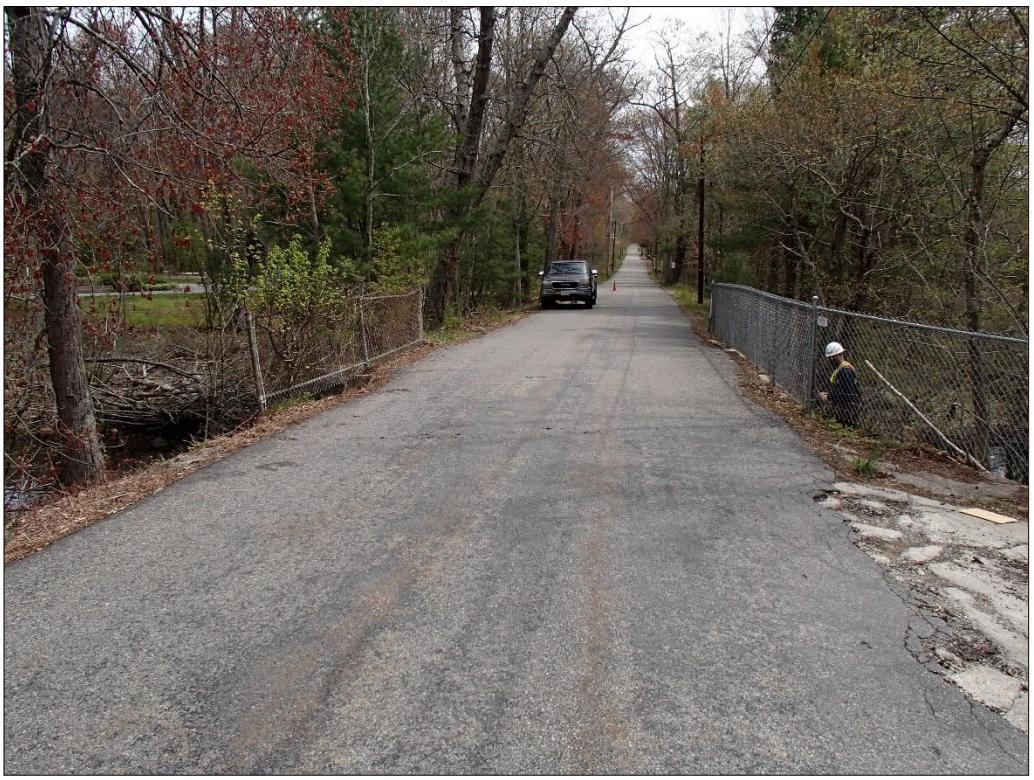
Photo 14 Looking East: West Approach

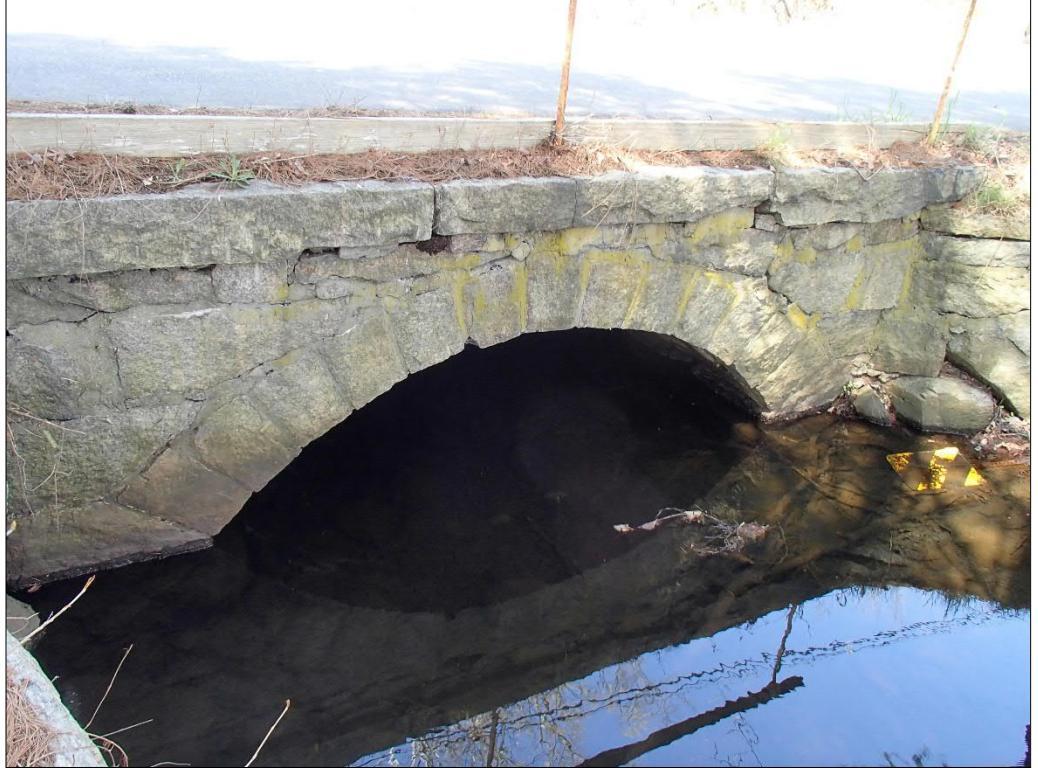
Photo 1 Looking North: South Culvert Elevation

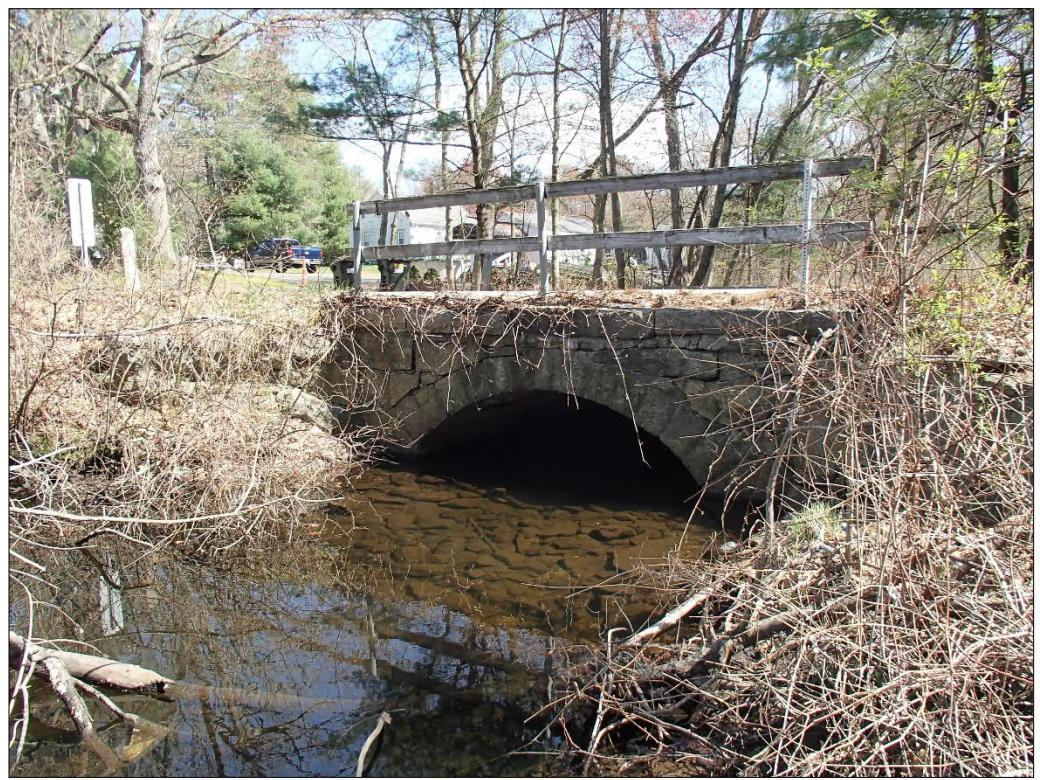
Photo 2 Looking South: North Culvert Elevation

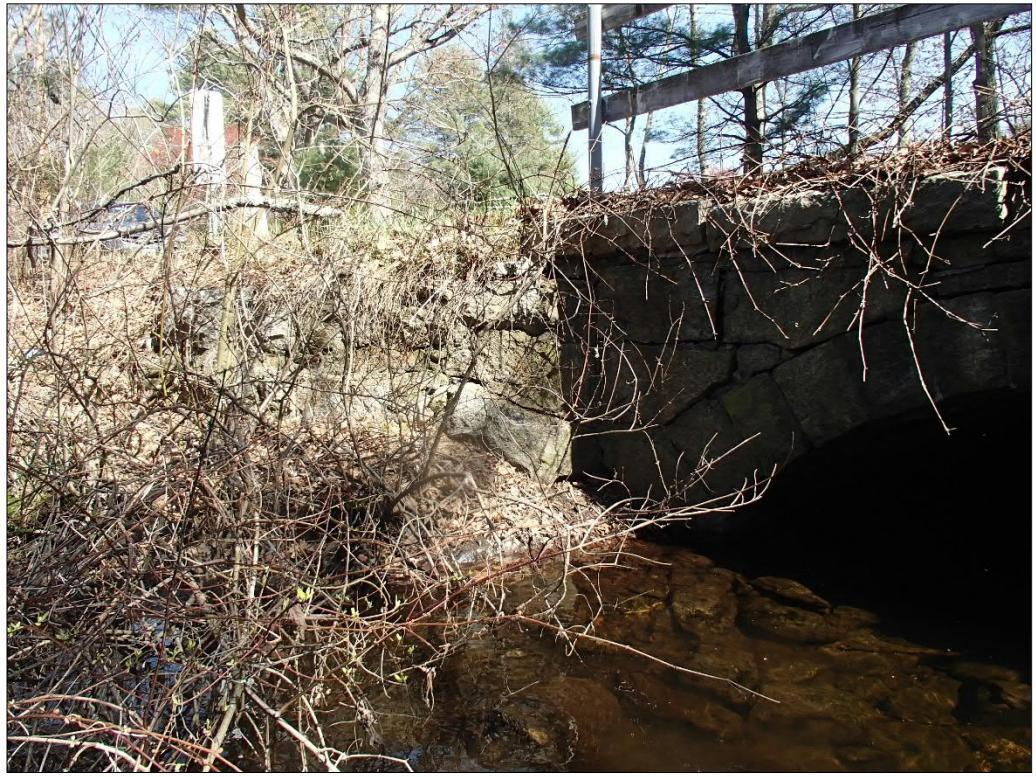
Photo 3 Looking Southeast: Northeast Wingwall

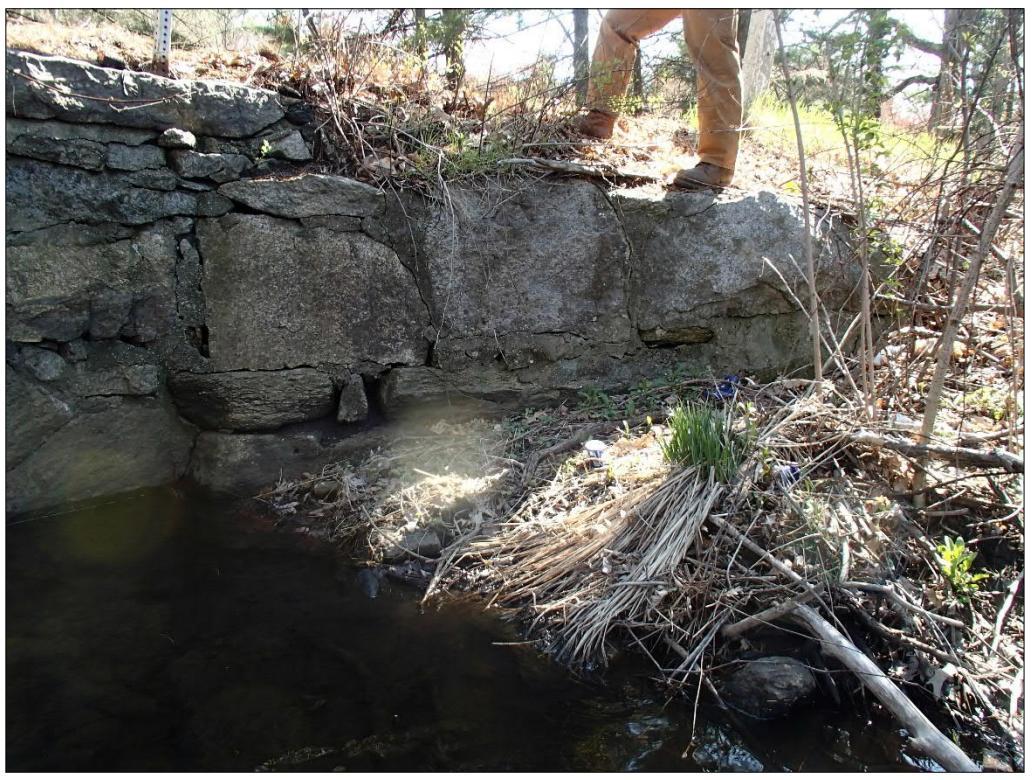
Photo 4 Looking Southwest: Northwest Wingwall

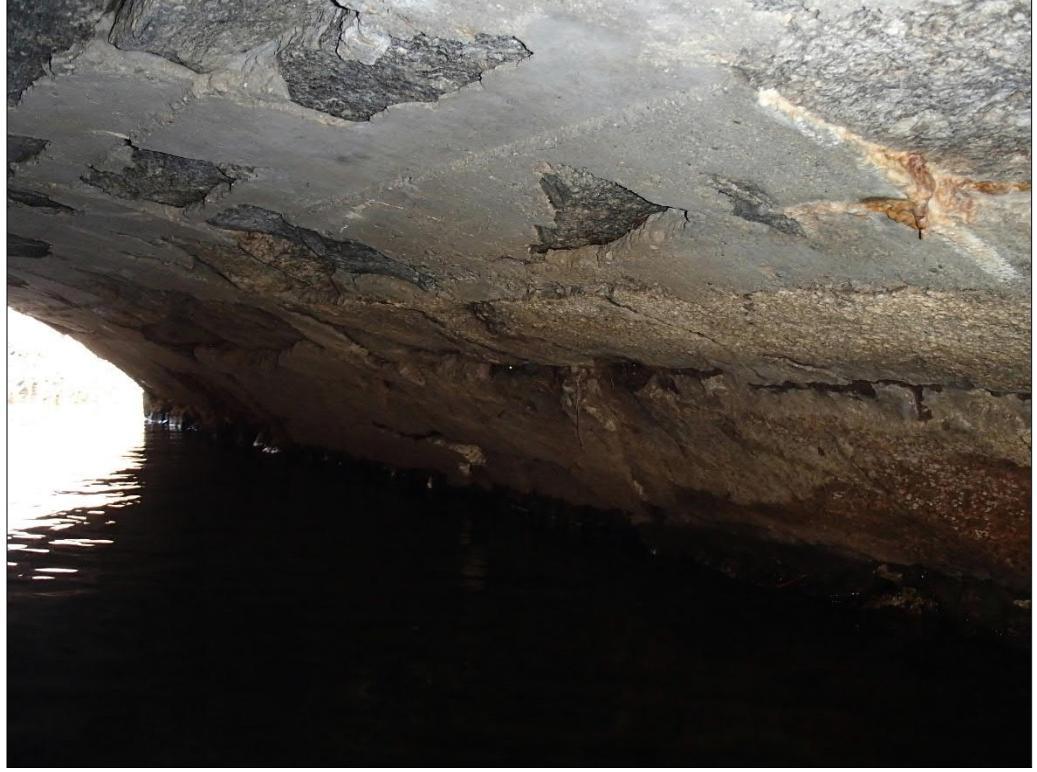
Photo 5 Looking Northeast: Culvert Roof

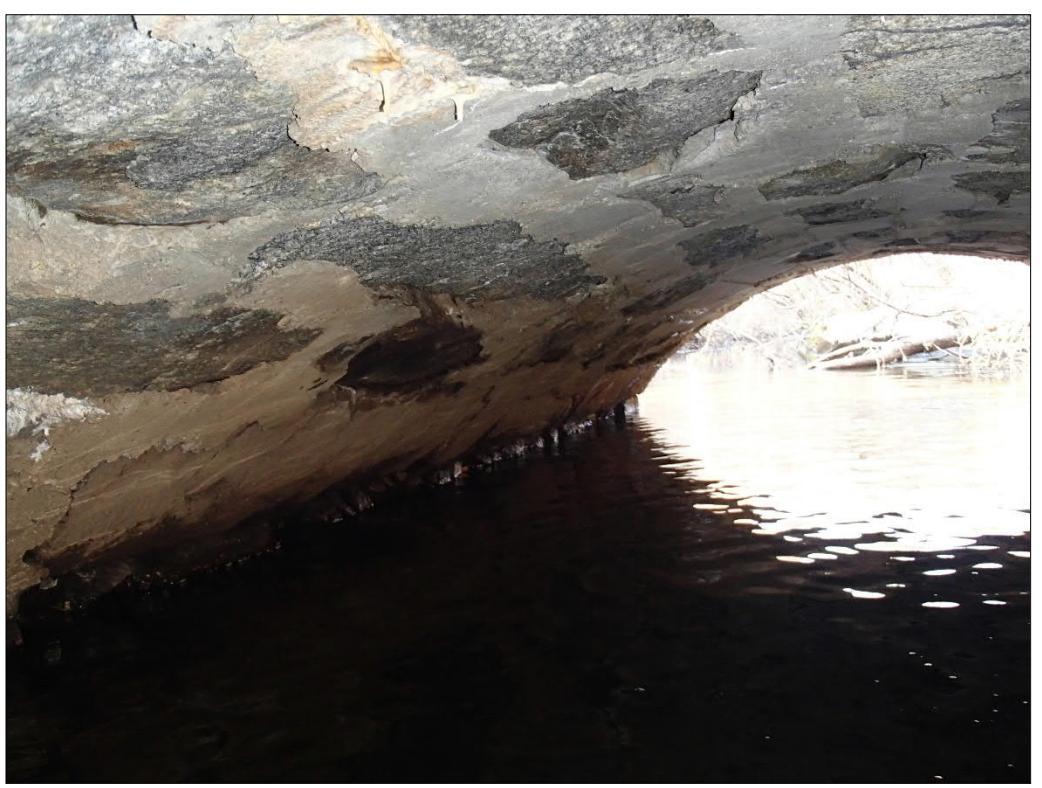
Photo 6 Looking Northwest: Culvert Roof

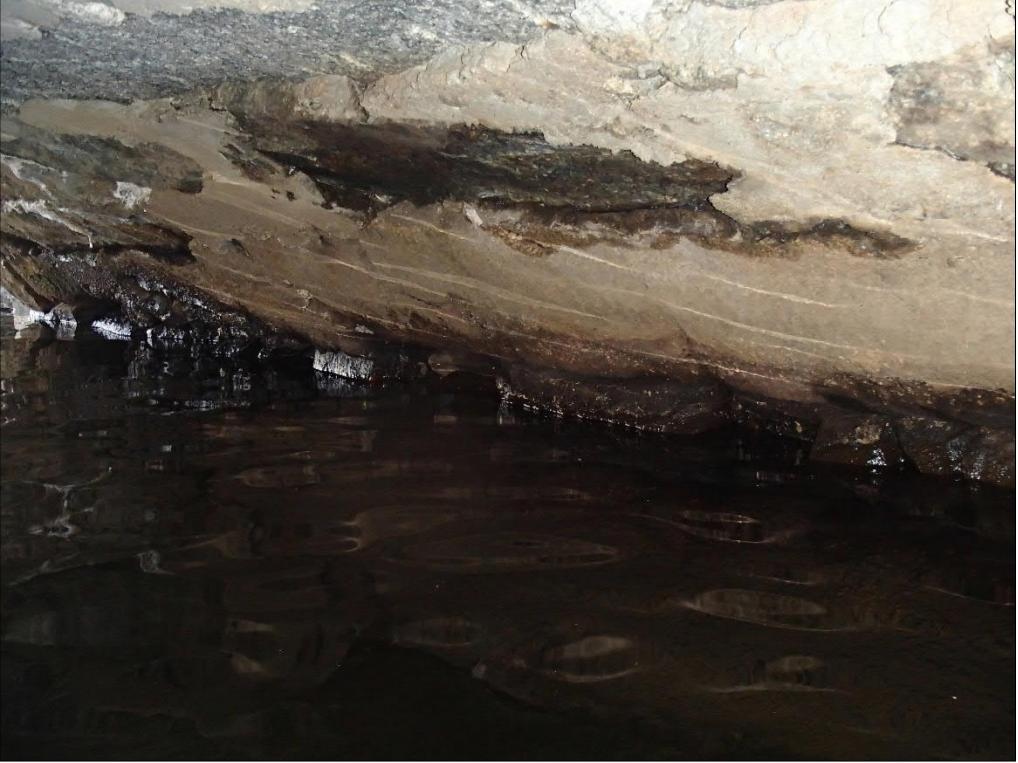
Photo 7 Looking East: Voids at the Water Line

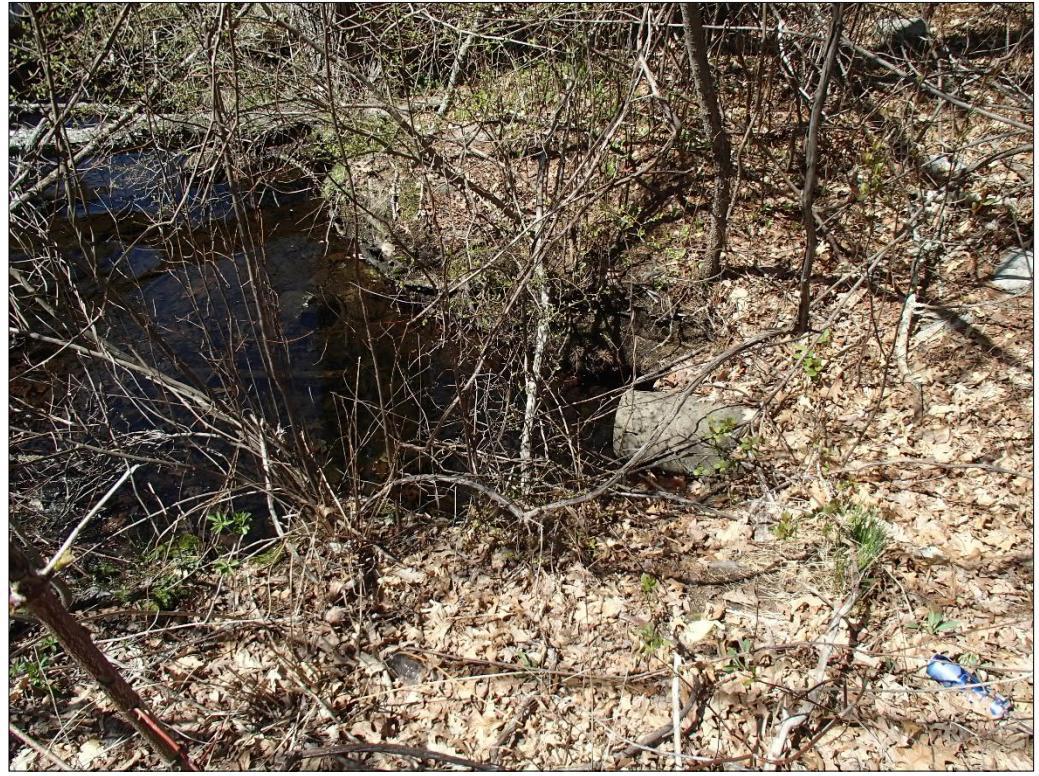
Photo 10 Looking East: Drainage Pipe

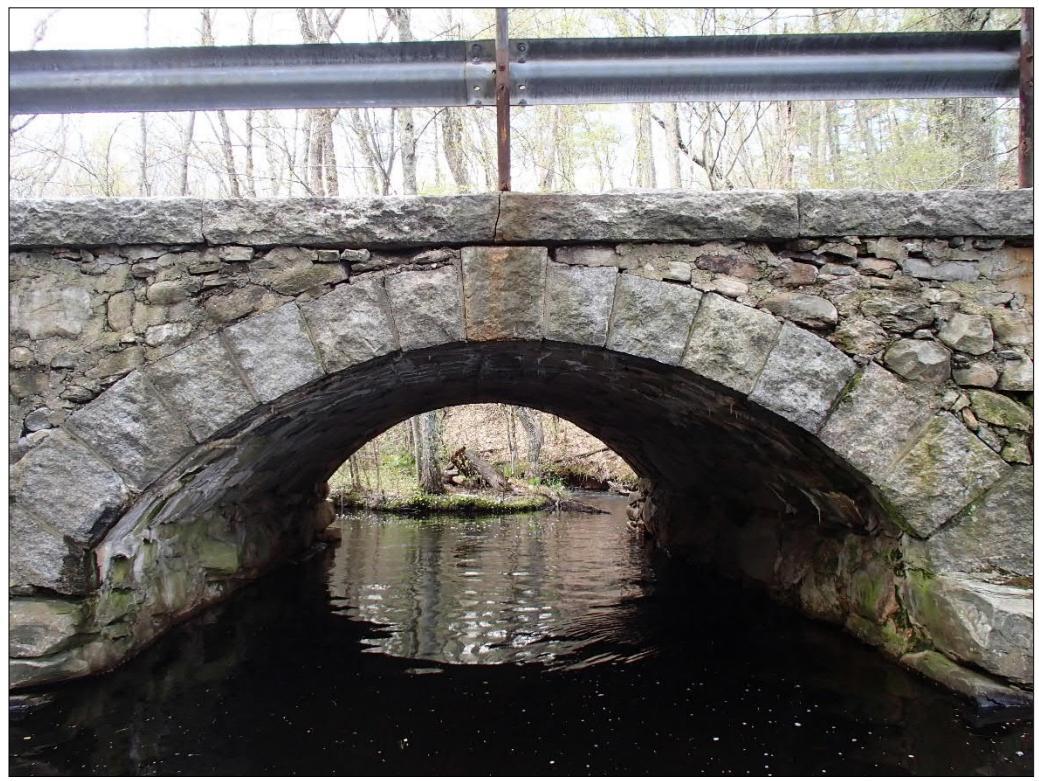
Photo 1 Looking West: East Culvert Elevation

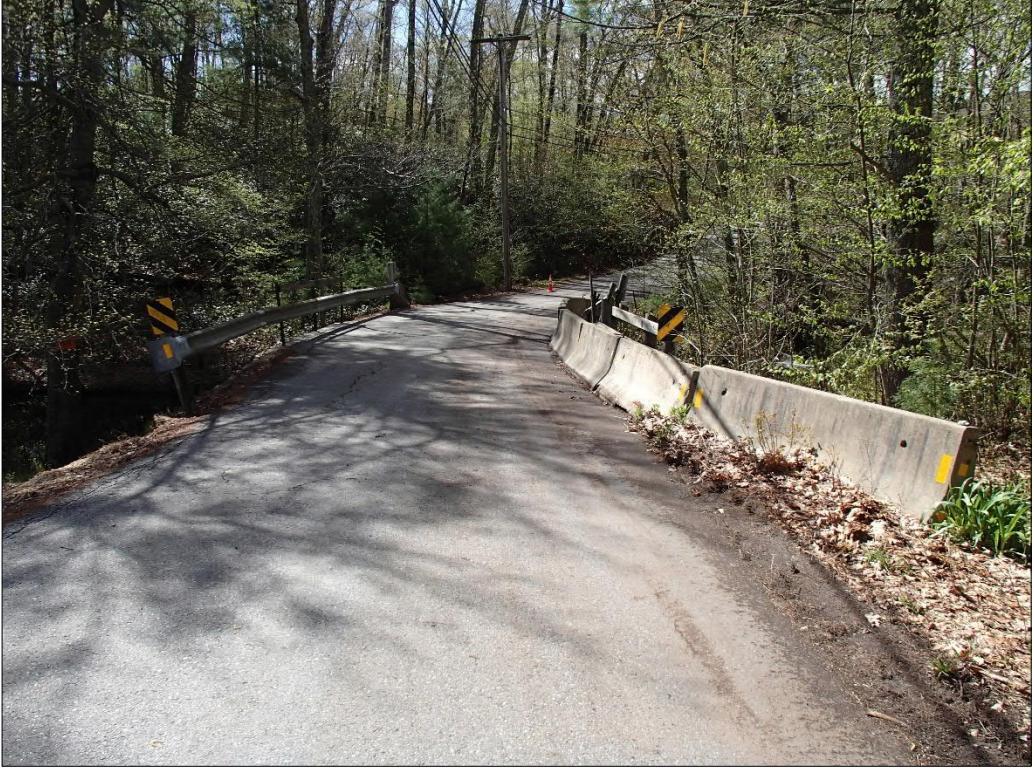
Photo 15 Looking South: North Approach

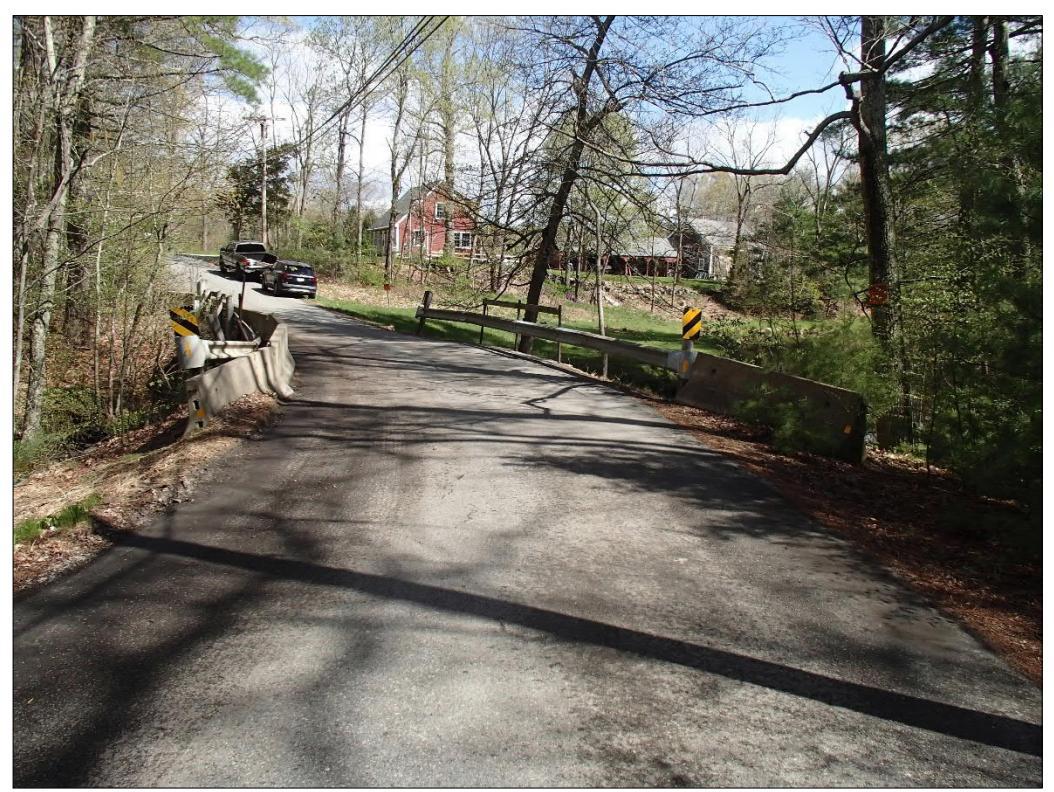
Photo 16 Looking North: South Approach

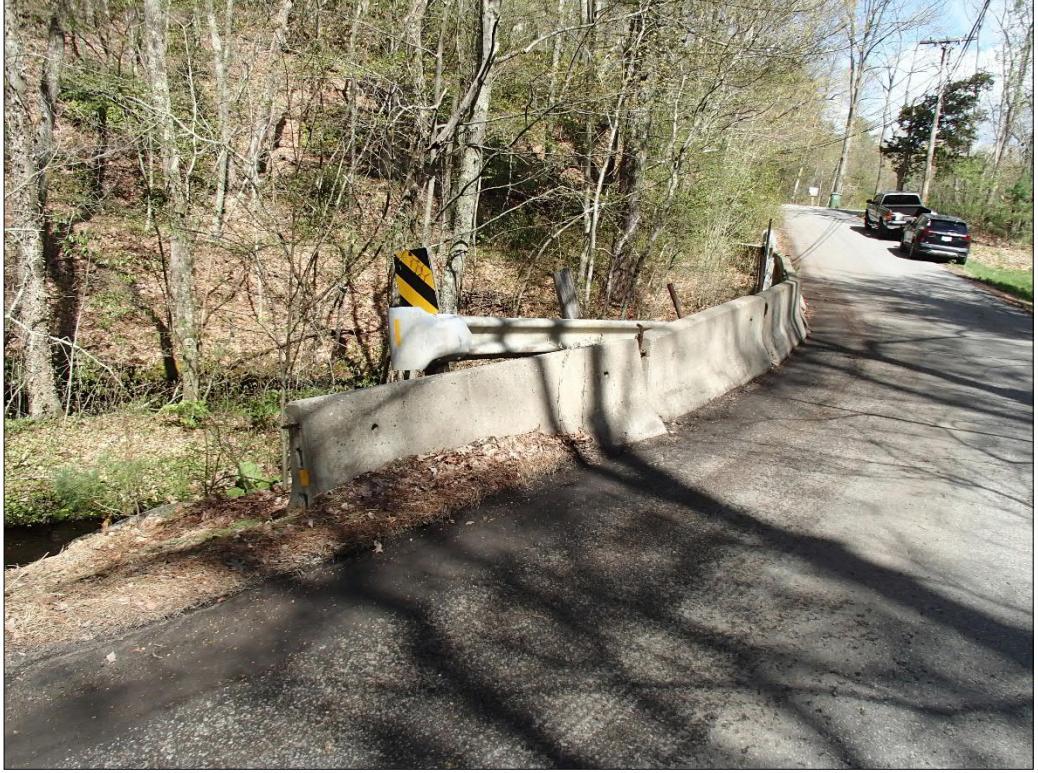
The pavement over the arch and at the approaches is in good condition. There is a sharp horizontal and vertical curve with poor visibility. The guardrail is in poor condition and is leaning away from the roadway on the west side (Photo 17). The guardrail also has areas where it is not fully connected to the posts. There is slight collision damage at the northeast approach. The roadway geometry, poor condition of the guardrails, and lack of any approach rail make this a safety hazard.

Photo 17 Looking Northwest: West Barrier

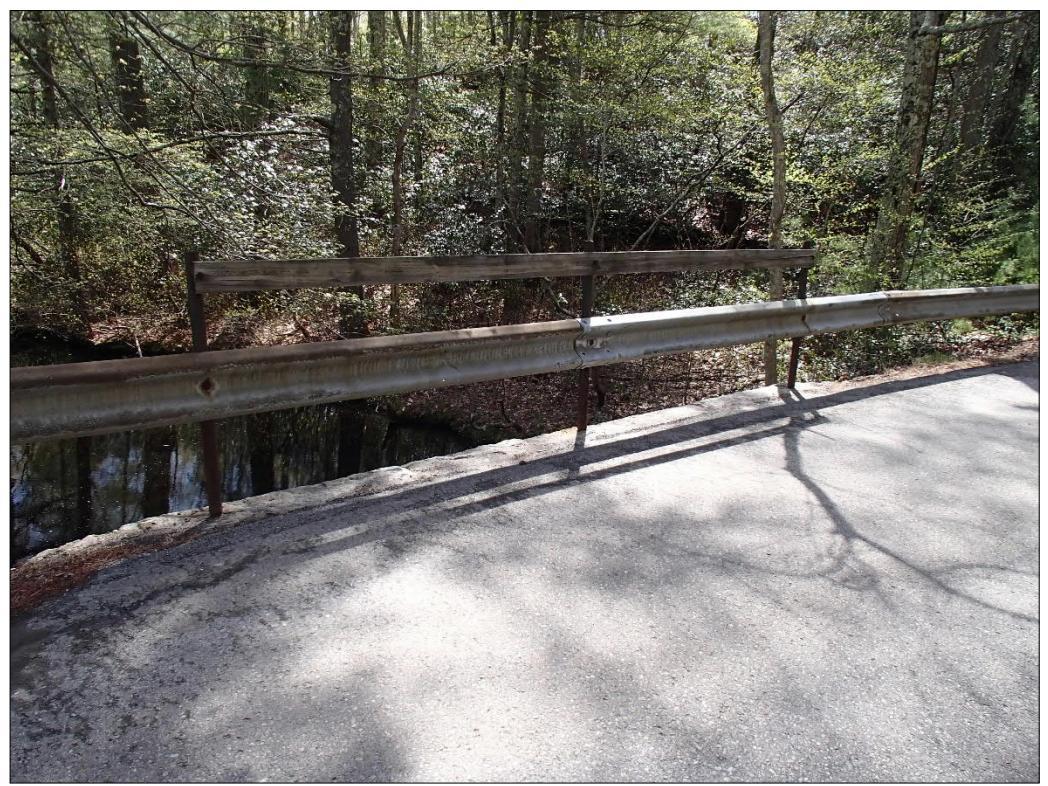
Photo 18 Looking East: East Barrier

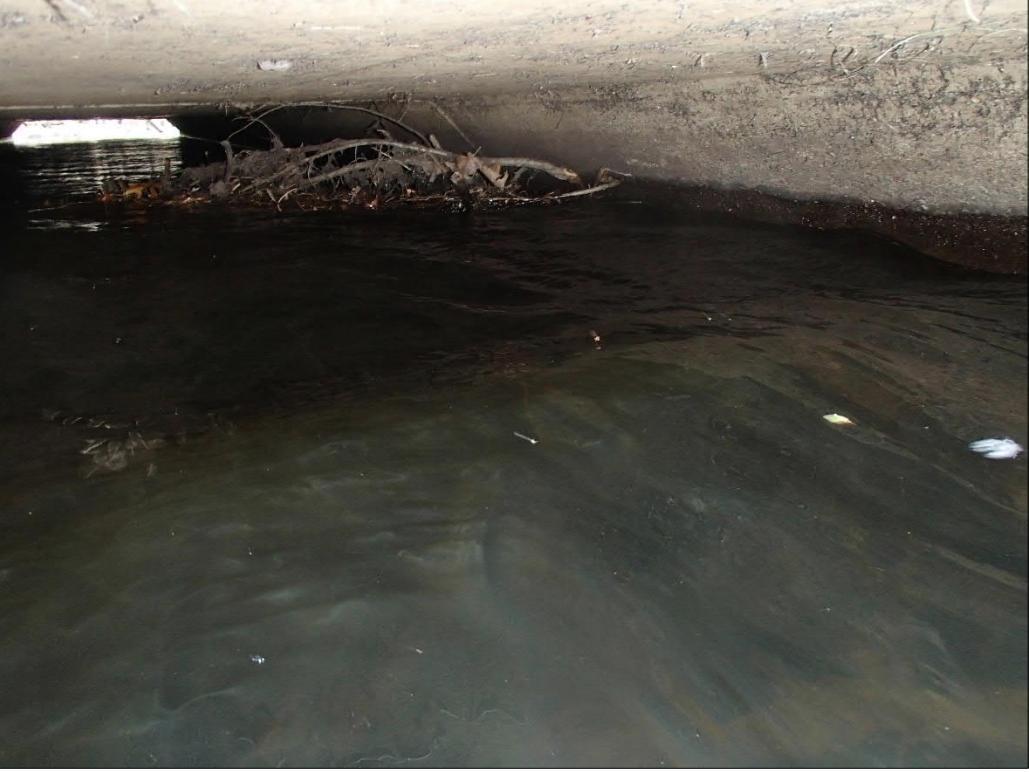
Photo 13 Looking South: Debris in River

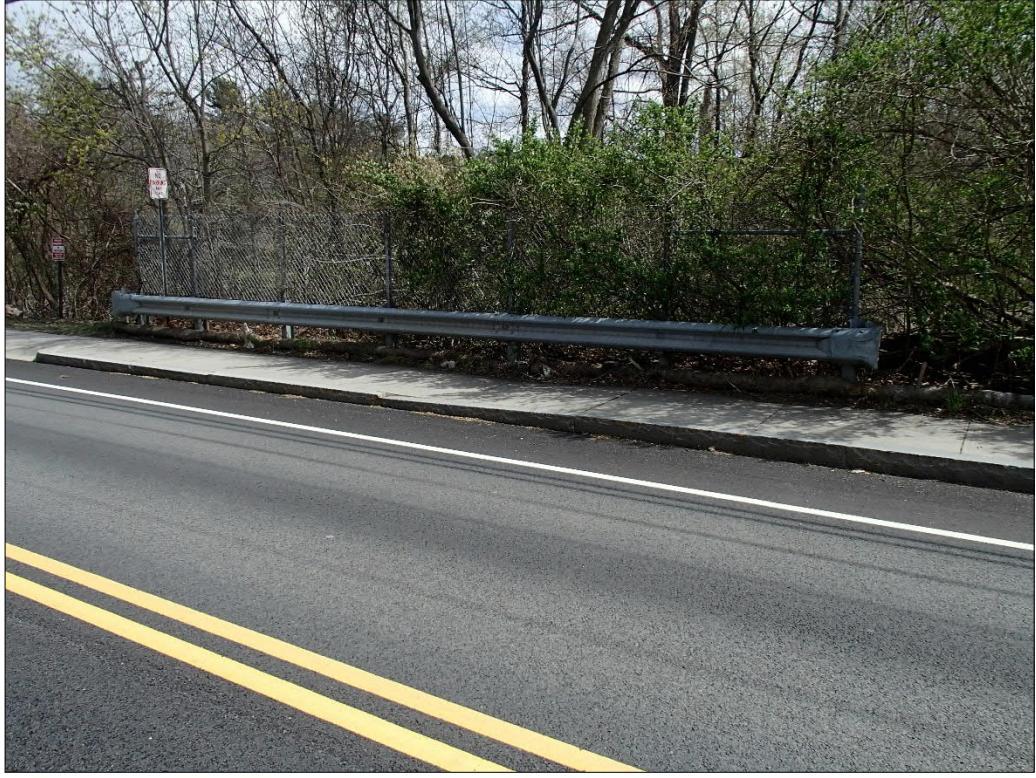
Photo 17 Looking South: South Barrier

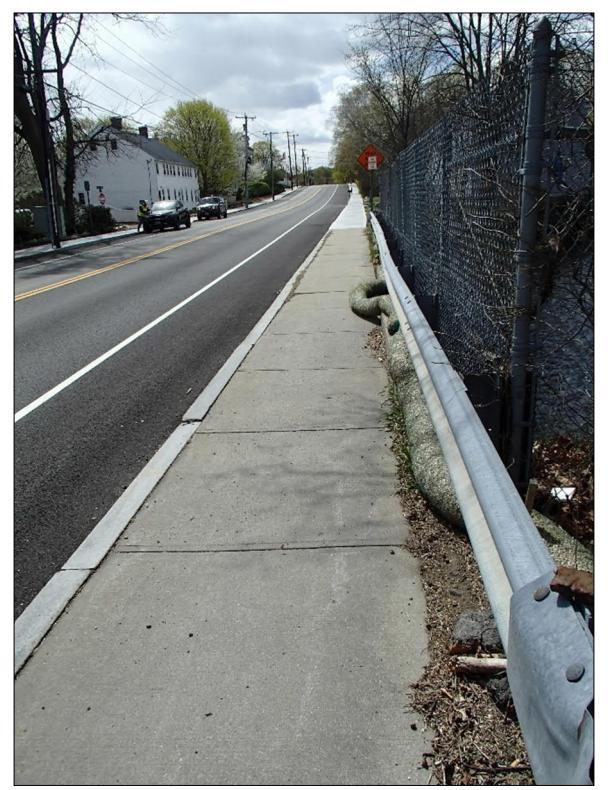
Photo 18 Looking West: North Sidewalk

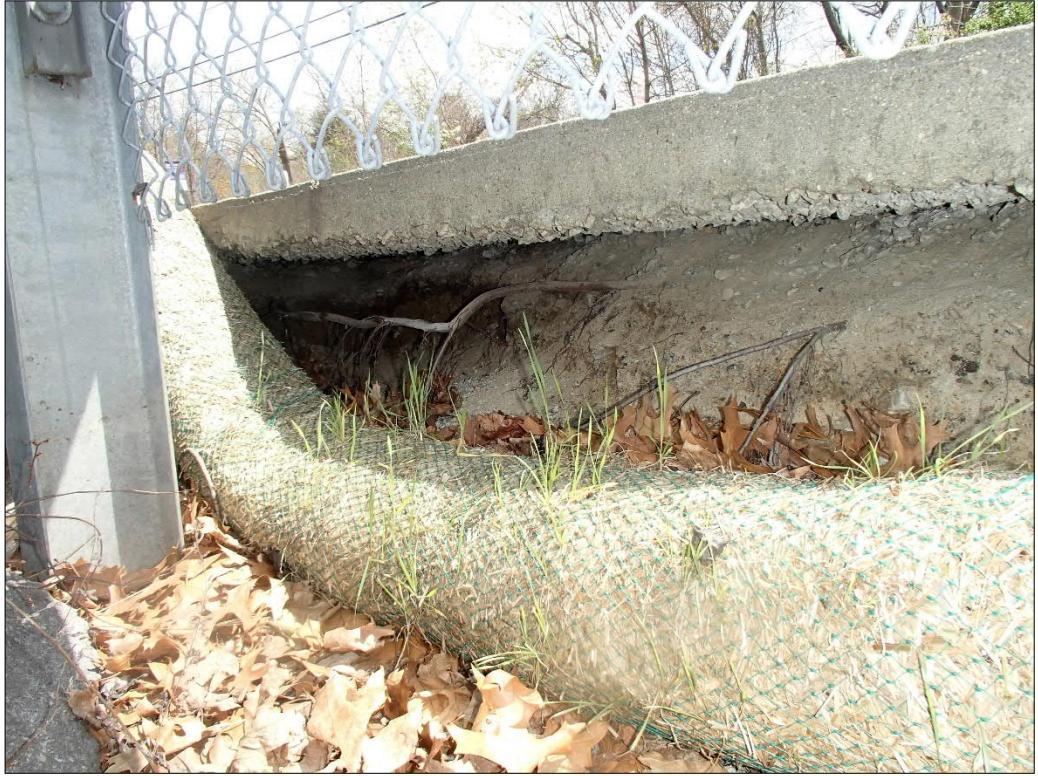
The roadway over the culvert and at the approaches are newly paved and are good condition. The north sidewalk is completely undermined in an area near the northwest wingwall (Photos 19 and 20). The SS guardrail is in good condition other than minor collision damage at the northeast corner. The alignment of the roadway is straight with clear visibility.

Photo 19 Looking South: Undermining of North Sidewalk

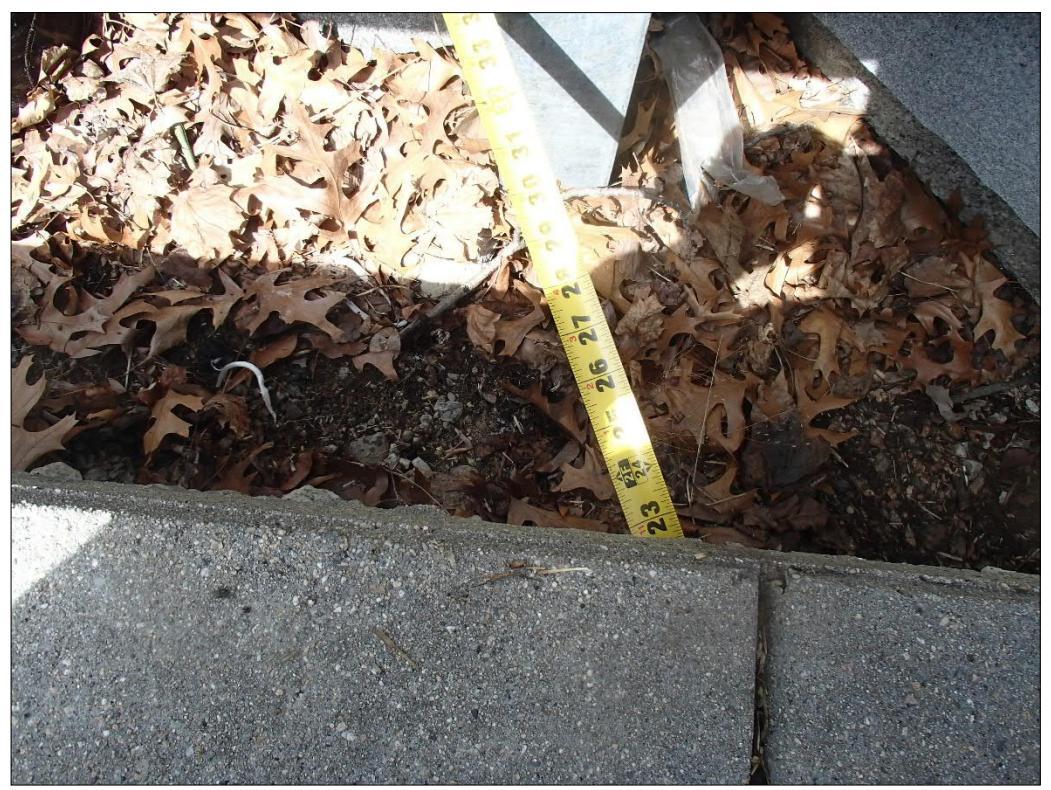
Photo 20 Looking North: Undermining of North Sidewalk

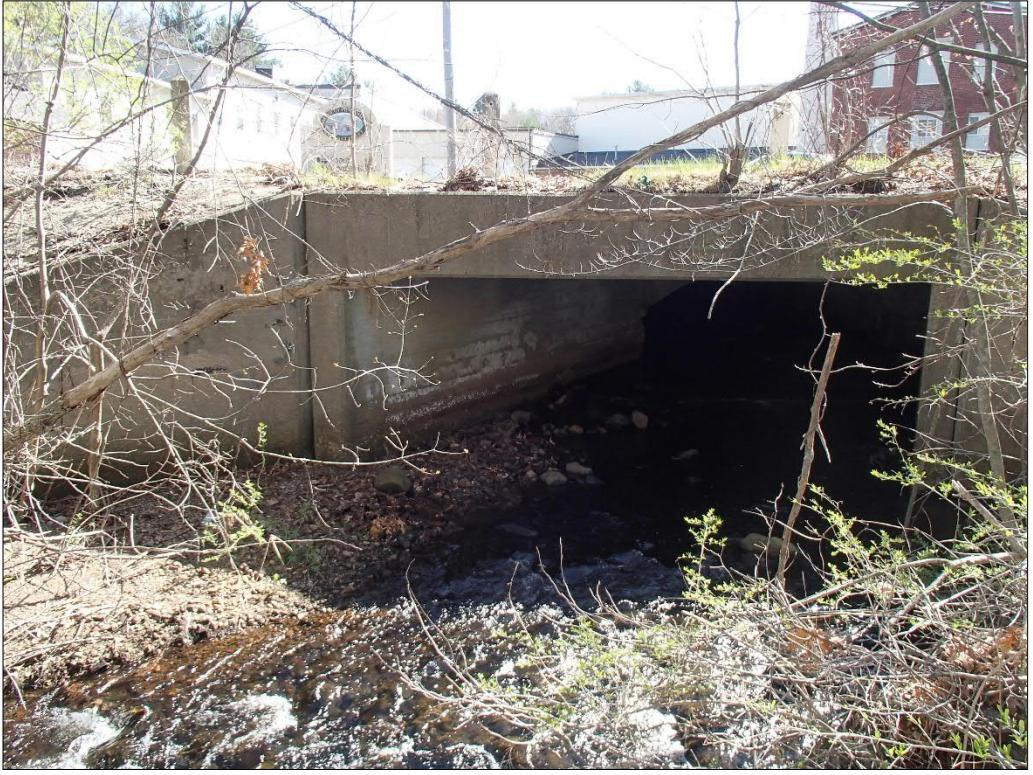
Photo 1 Looking West: East Elevation of Structure 1

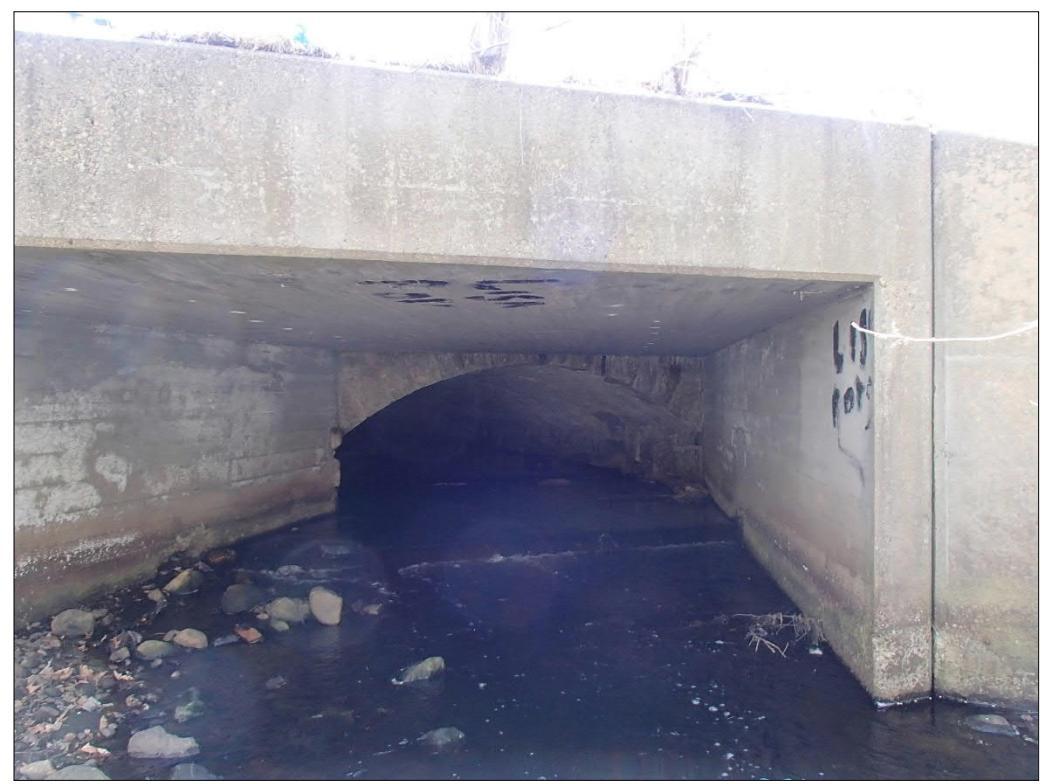
Photo 2 Looking Northwest: North Abutment of Structure 1

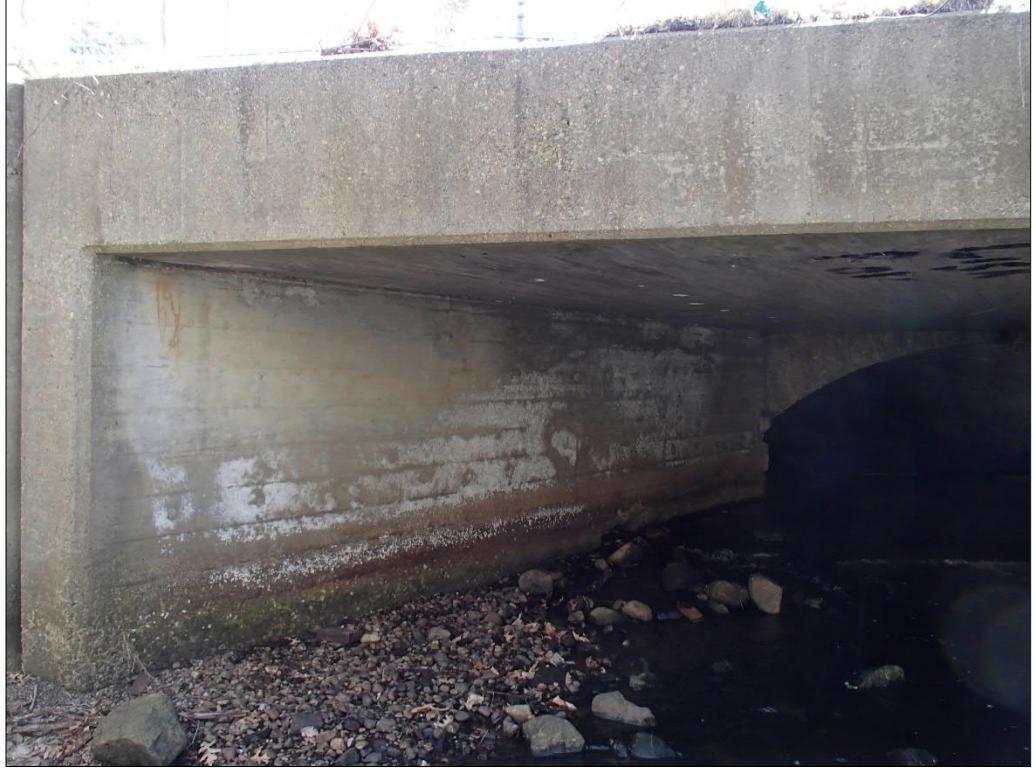
Photo 3 Southwest: South Abutment of Structure 1

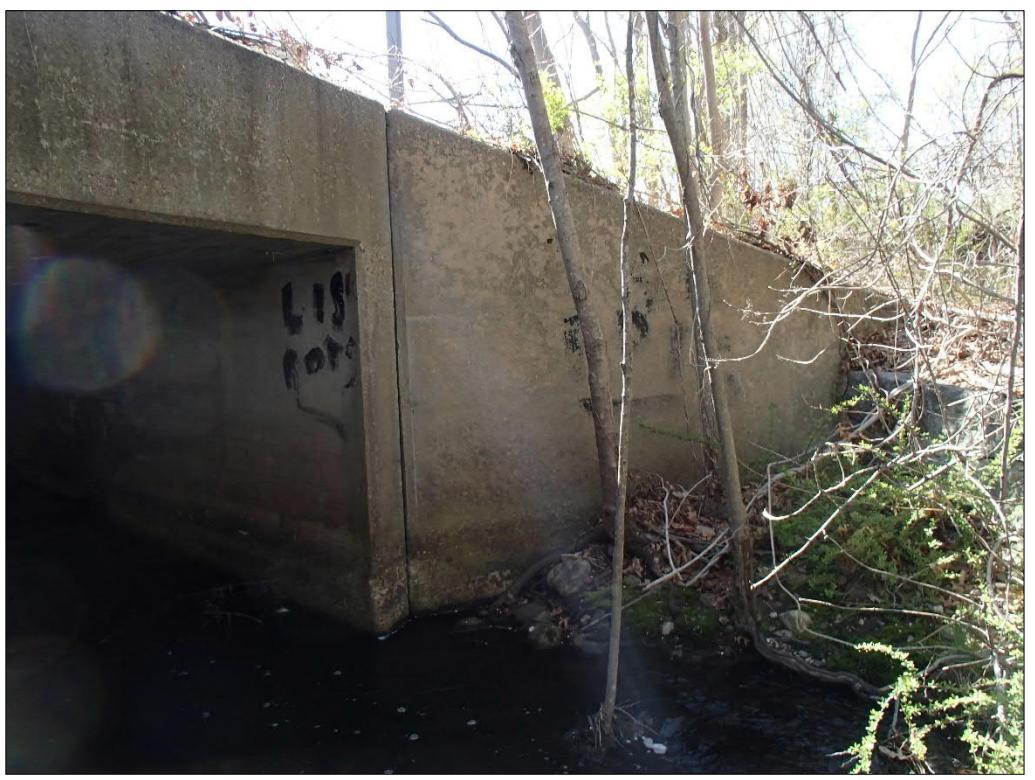
Photo 4 Looking North: Northeast Wingwall

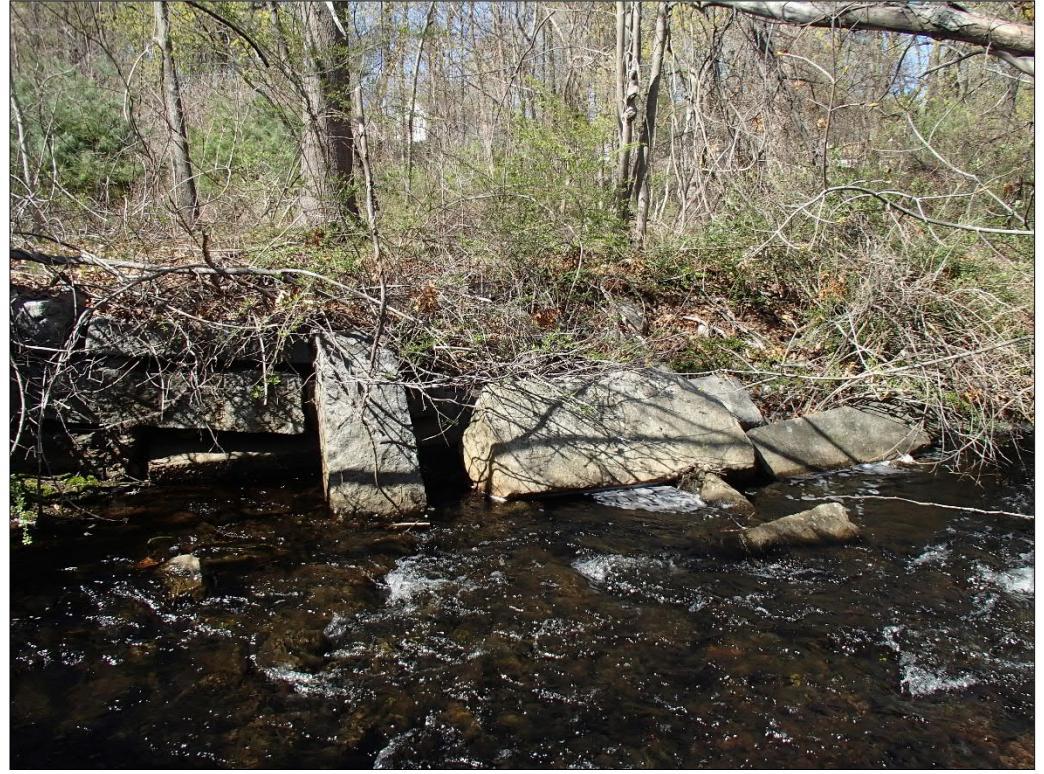
Photo 5 Looking Northeast: Northeast Training Wall

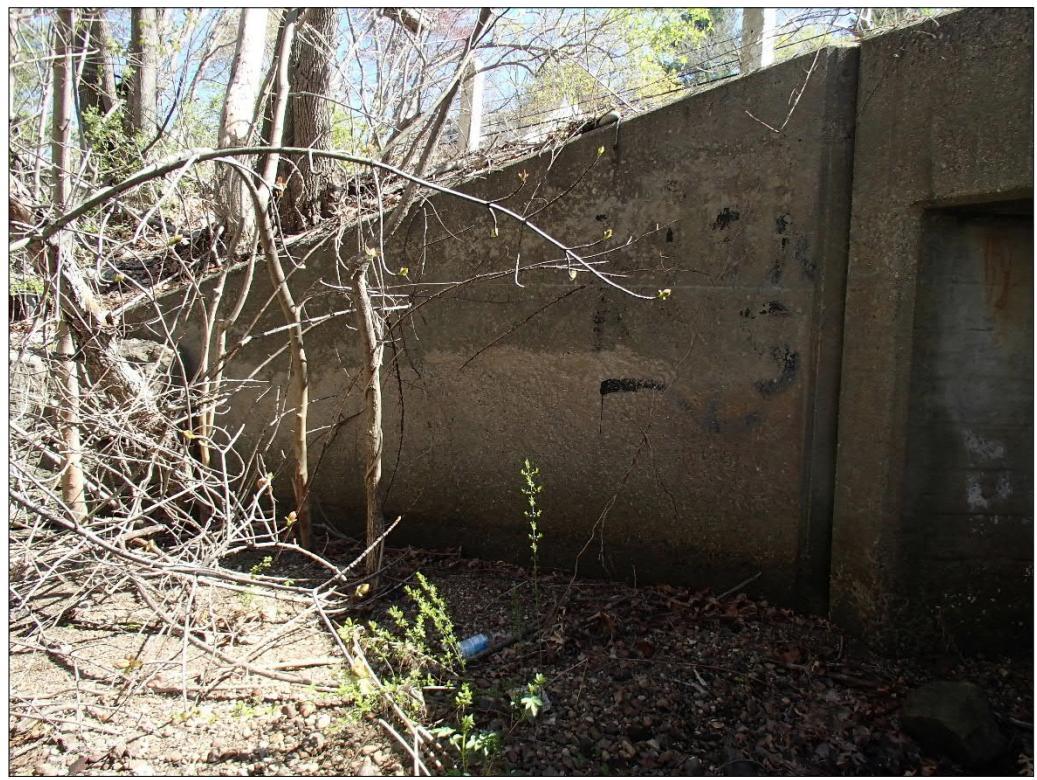
Photo 6 Looking Southwest: Southeast Wingwall
