Uxbridge, Massachusetts Evaluation Report

Project Number: 7533 June 2021

BRIDGE / CULVERT MANAGEMENT PLAN

Hartford Avenue East over the Mumford River (Bridge No. U-02-020)

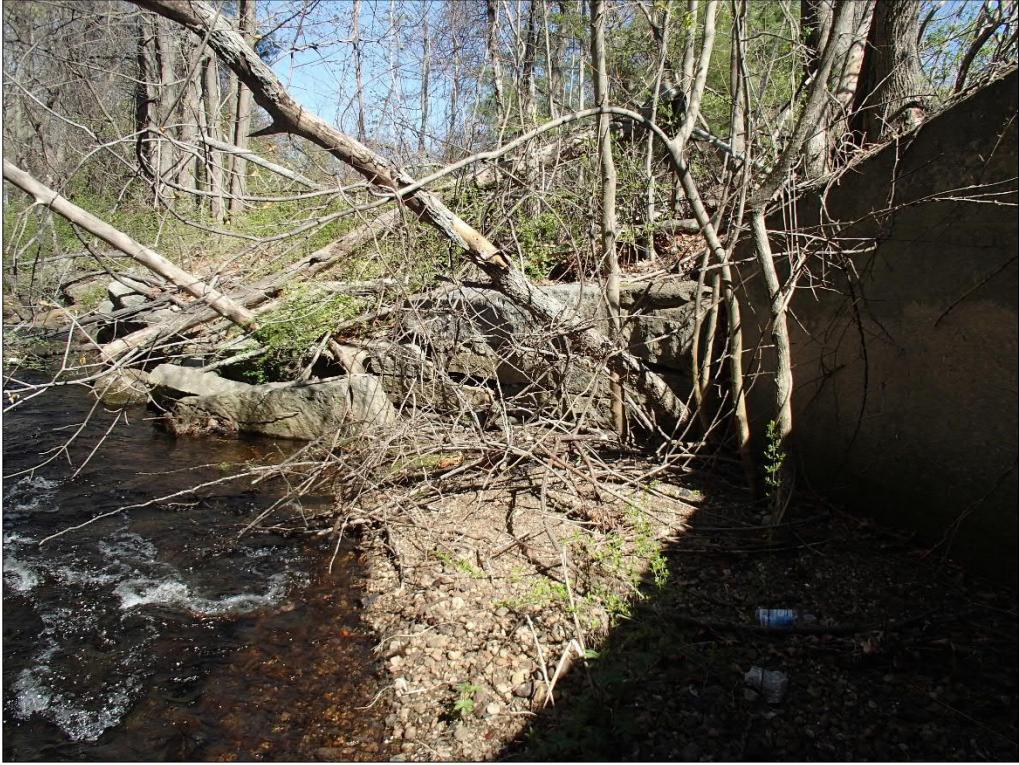
Photo 7 Looking South: Southeast Training Wall

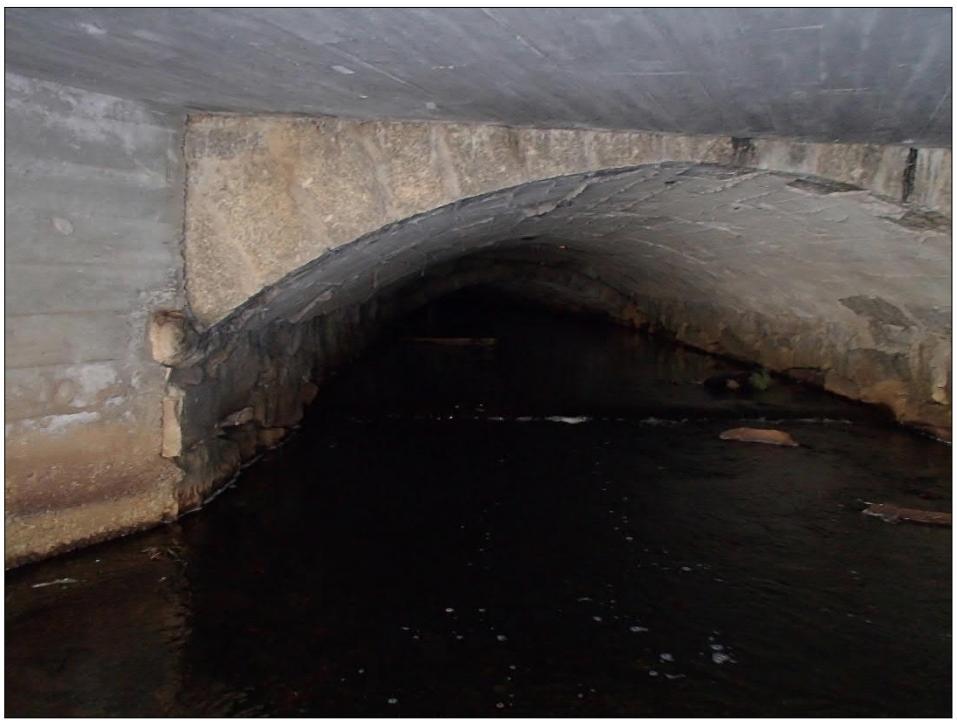
Photo 8 Looking West: Elevation of Structure 2

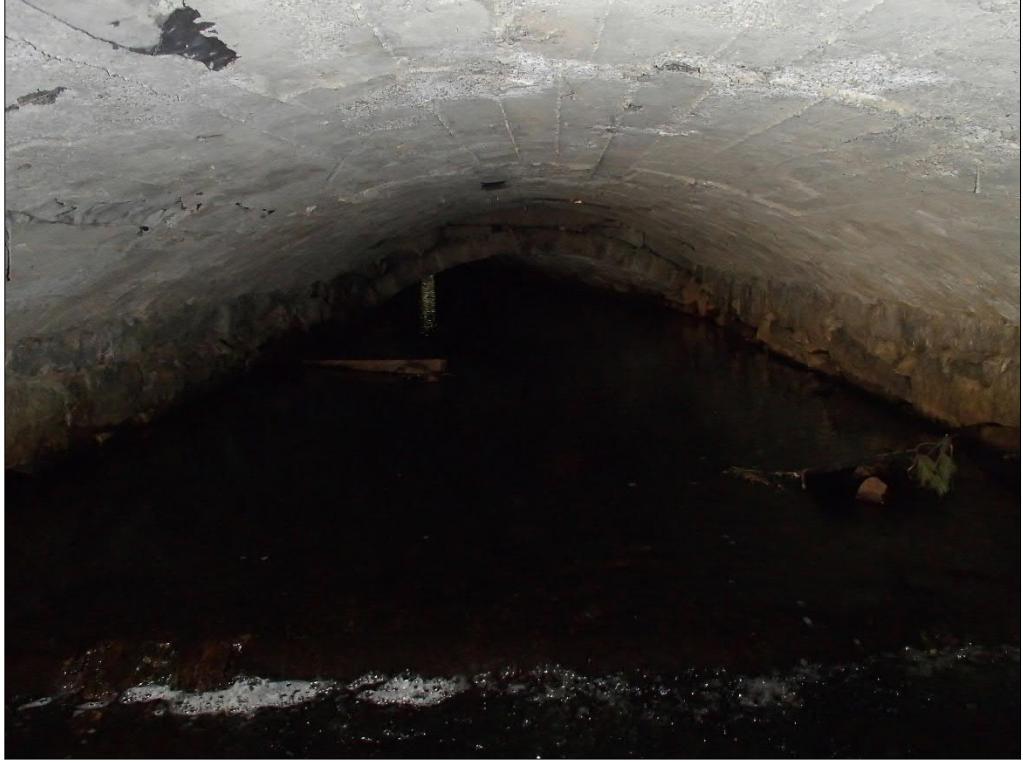
The stone arch underside of structure 2 shows random voids and some loss of pointing but is otherwise in fair condition (Photo 9). There are voids up to 2' deep present at the entrance from structure 1. The stone abutment walls show some loss of mortar and chinking stones with several voids along the water line up to 3' deep (Photo 14). The arch ring at the west end of structure 2 has areas of missing stones (Photos 16).

Photo 9 Looking West: Structure 2 Roof

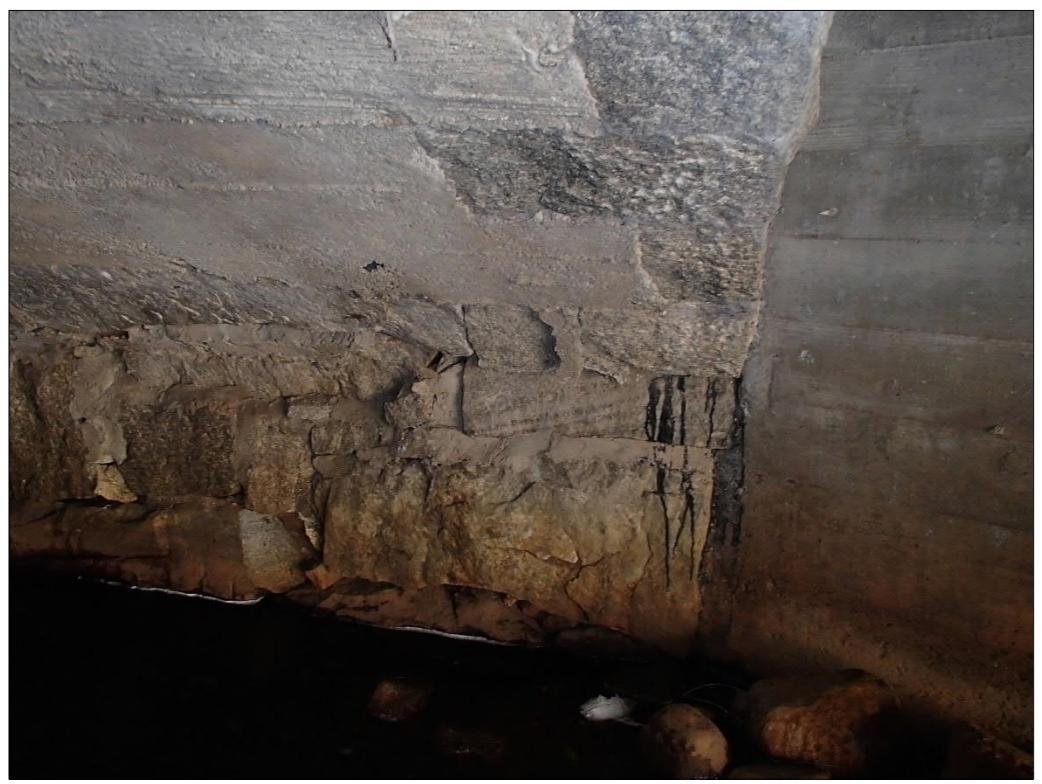
Photo 10 Looking Northwest: North Abutment Wall of Structure 2

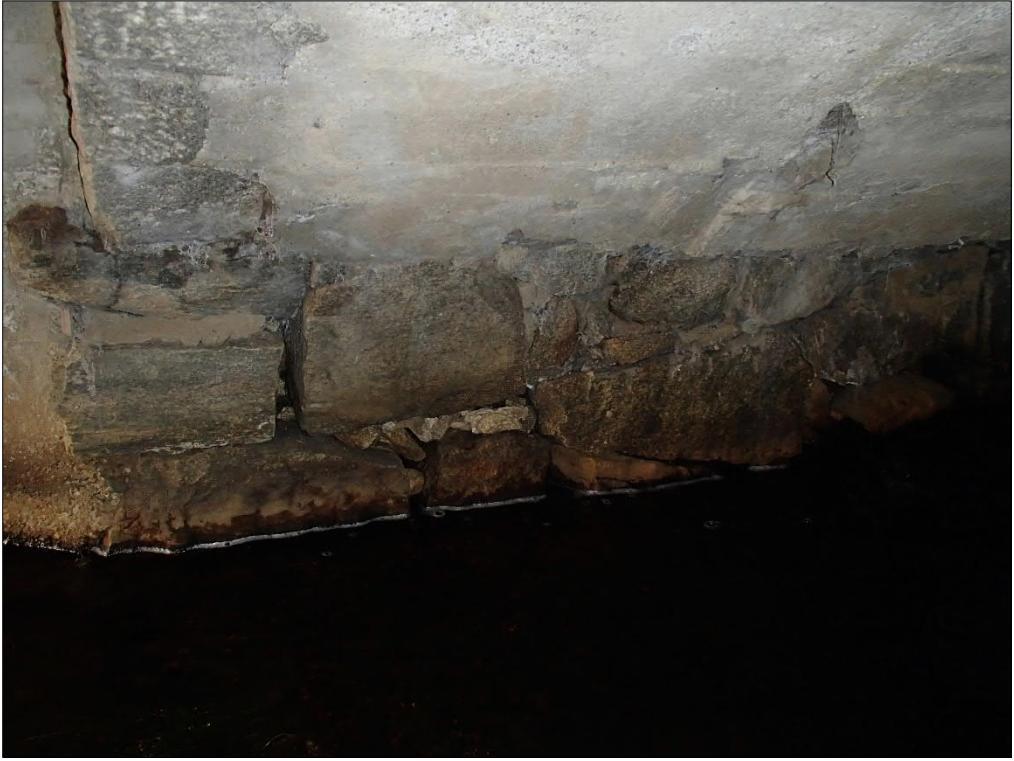
Photo 11 Looking Southeast: South Abutment Wall of Structure 2

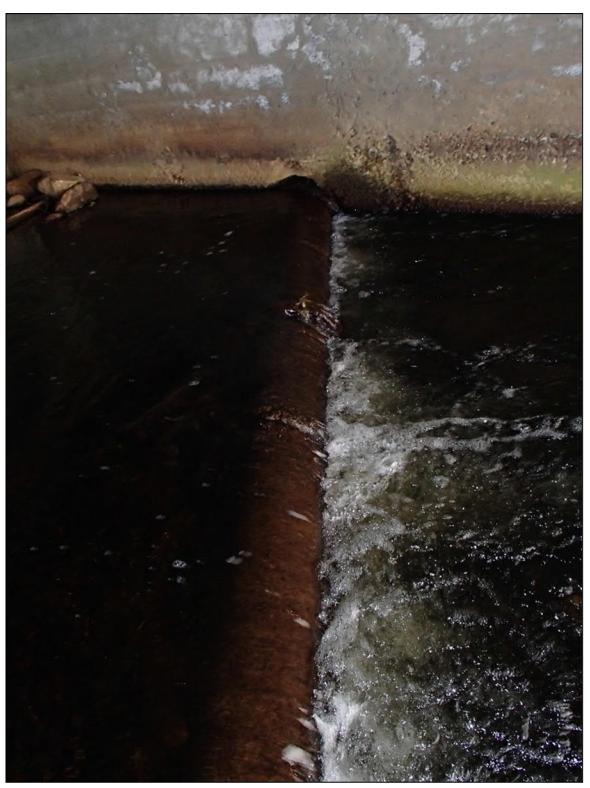
Photo 12 Looking North: Pipe Running Across Structure 1

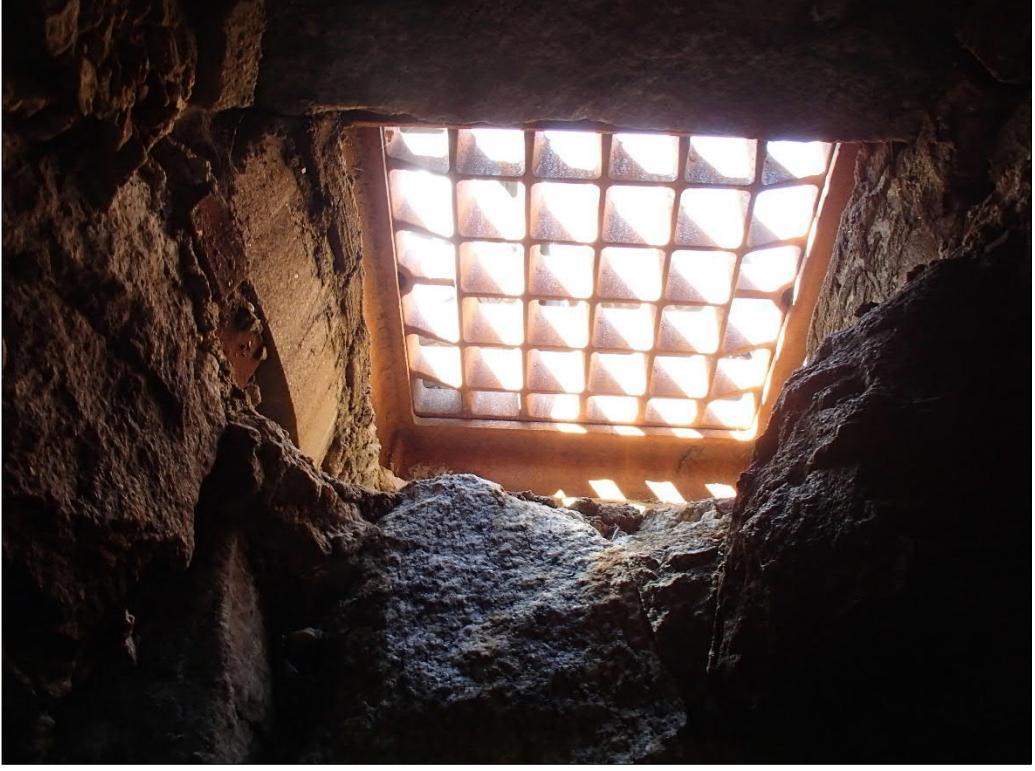
Photo 13 Looking Up: Catch Basin Present in Structure 2

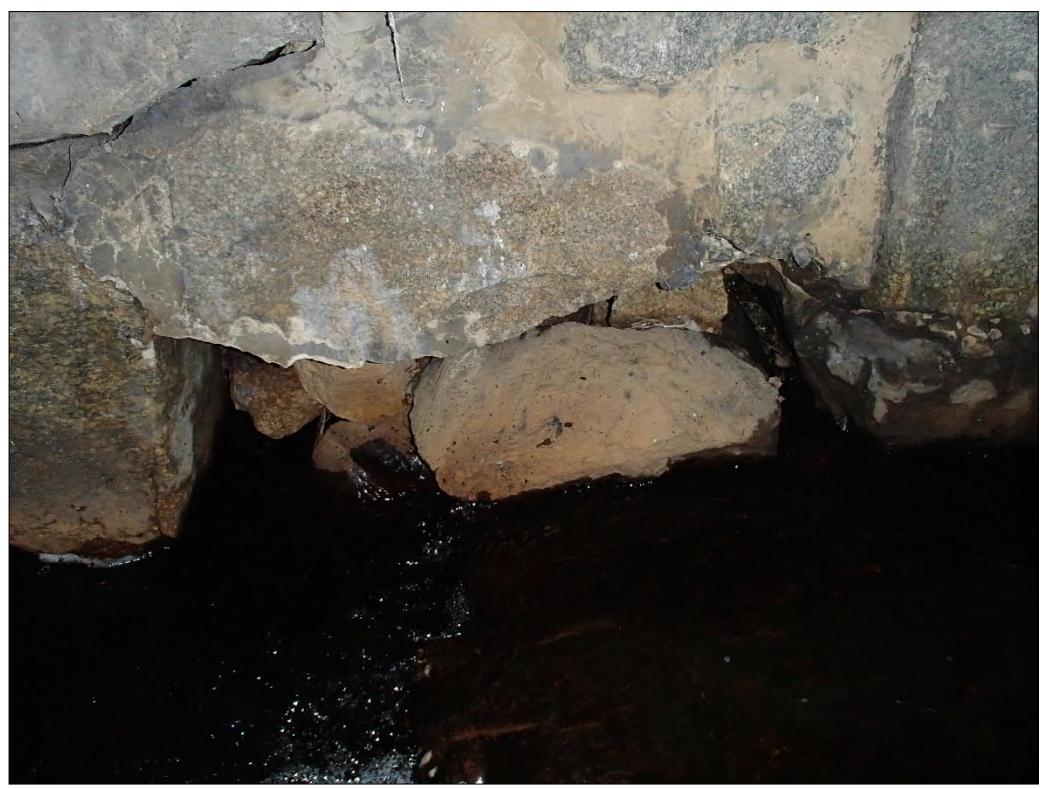
Photo 14 Looking South: Voids at Water Line on Structure 2

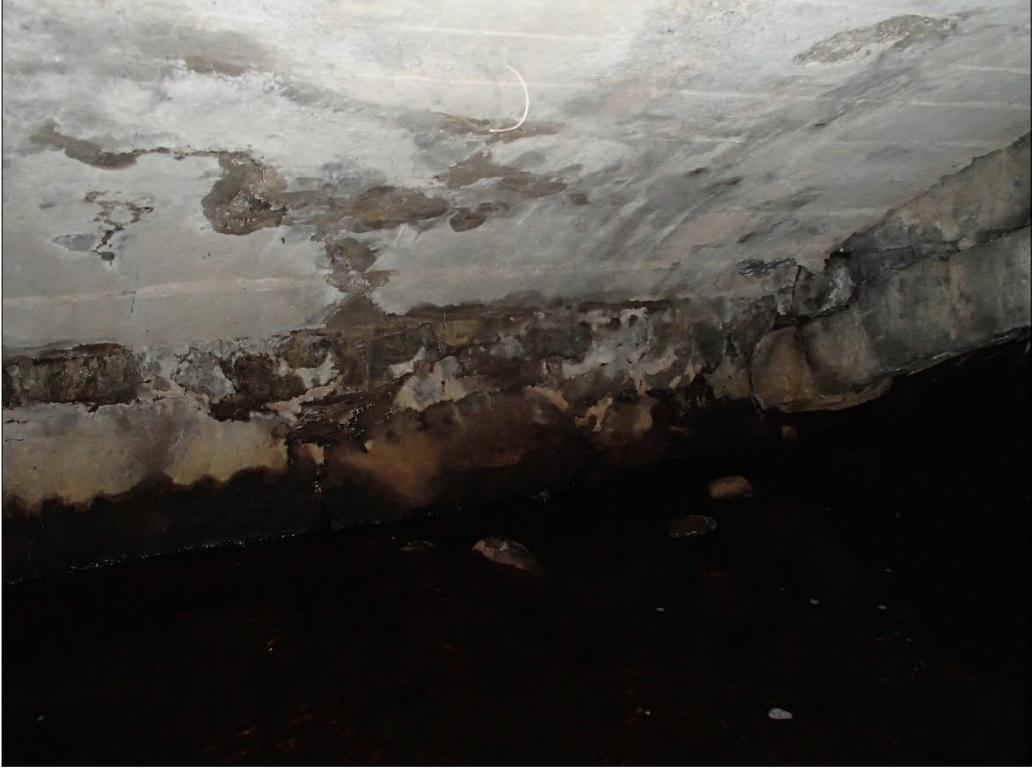
Photo 15 Looking South: Effloresce at Southwest End of Structure 2

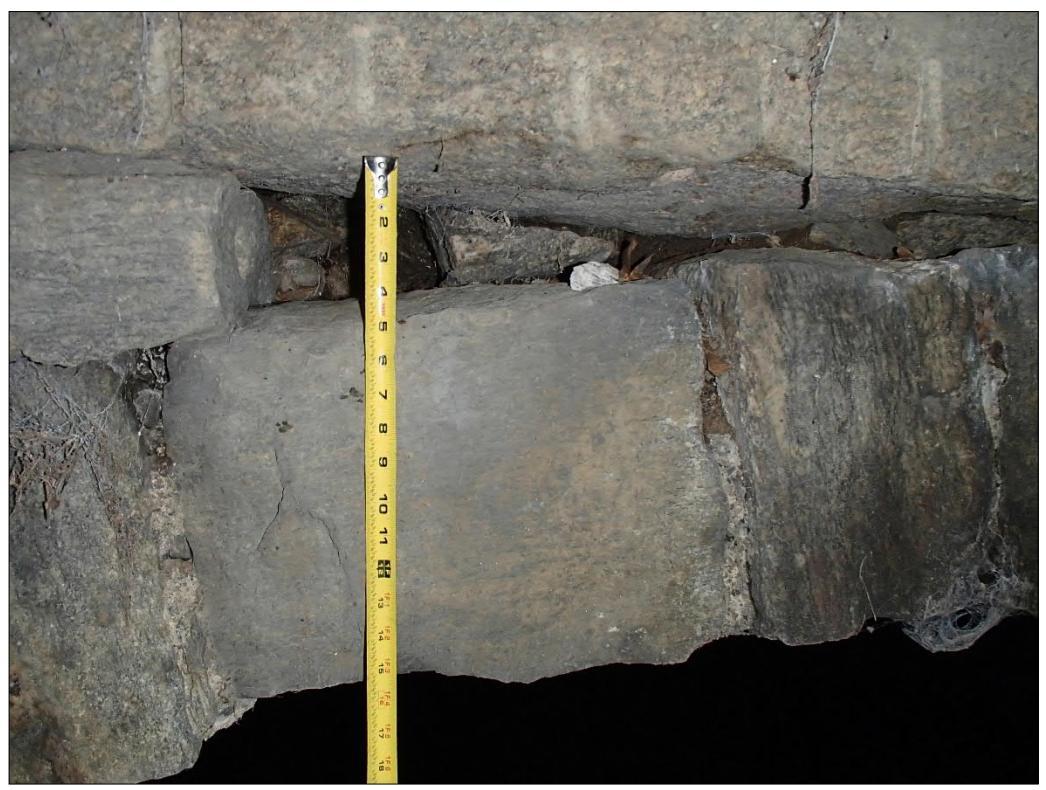
Photo 16 Looking West: Voids at West Arch Ring of Structure 2

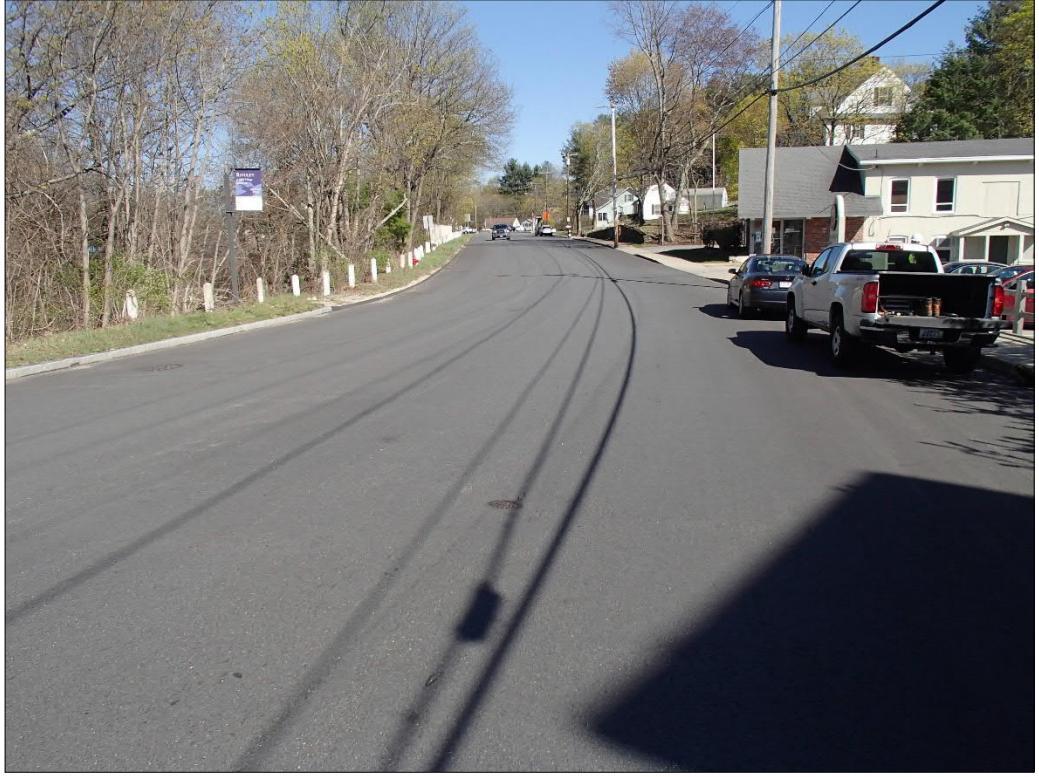
Photo 17 Looking South: North Approach

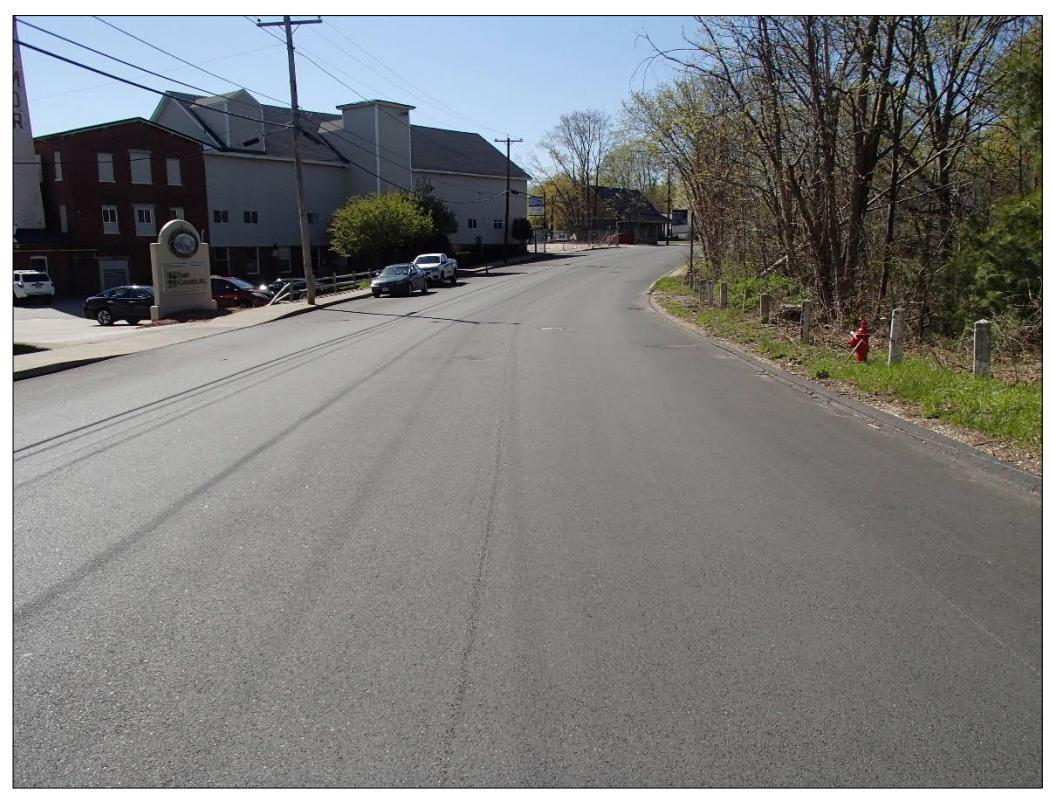
Photo 18 Looking North: South Approach

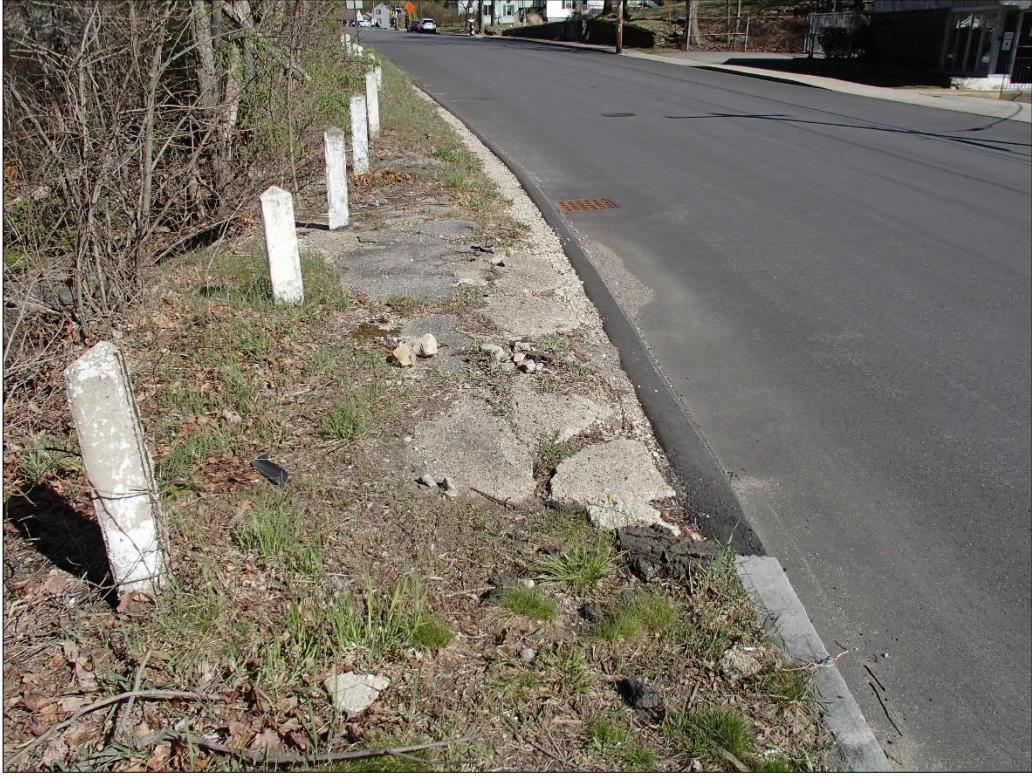
The roadway over the structure is in good condition with minor cracking. The bridge rail only consists of concrete posts on the east side. This poses a safety hazard due to the presence of a 15' vertical drop that cannot be seen from the roadway. Structure 2 is visible from the parking lot to the west side (Photo 20).

Photo 19 Looking South: Concrete Posts on East Side

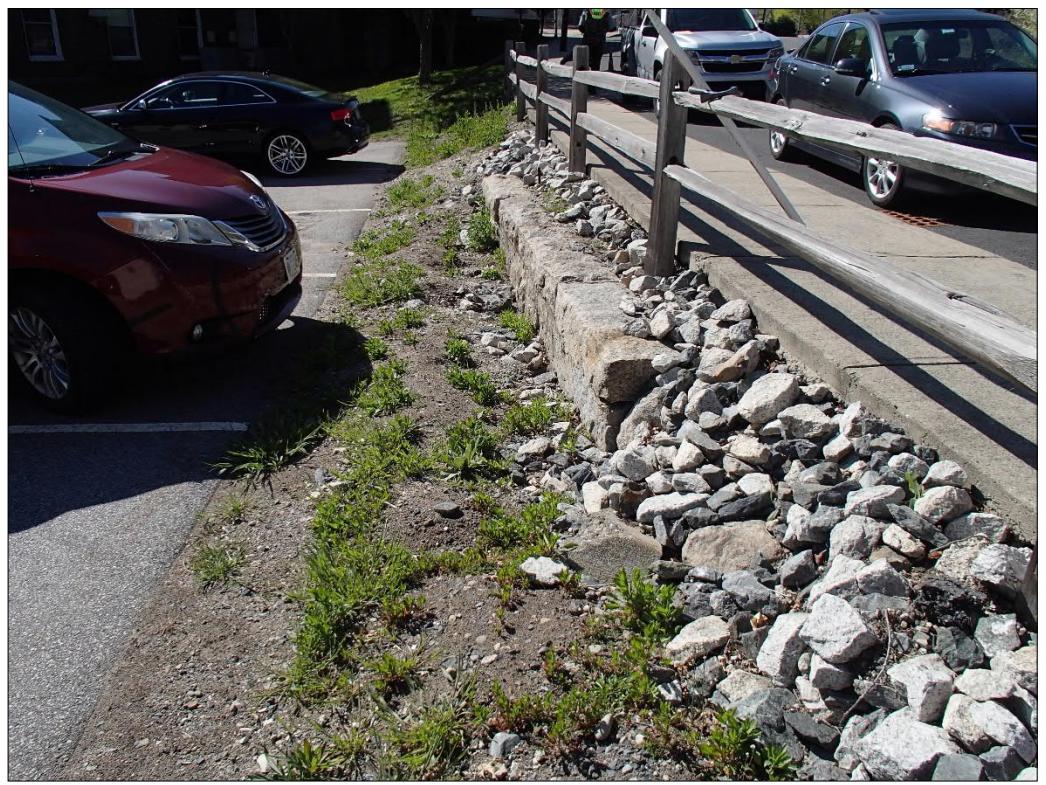
Photo 20 Looking North: Structure 2 Visible in Parking Lot on the West
Hartford Avenue East over the Blackstone River (Bridge No. U-02-018)

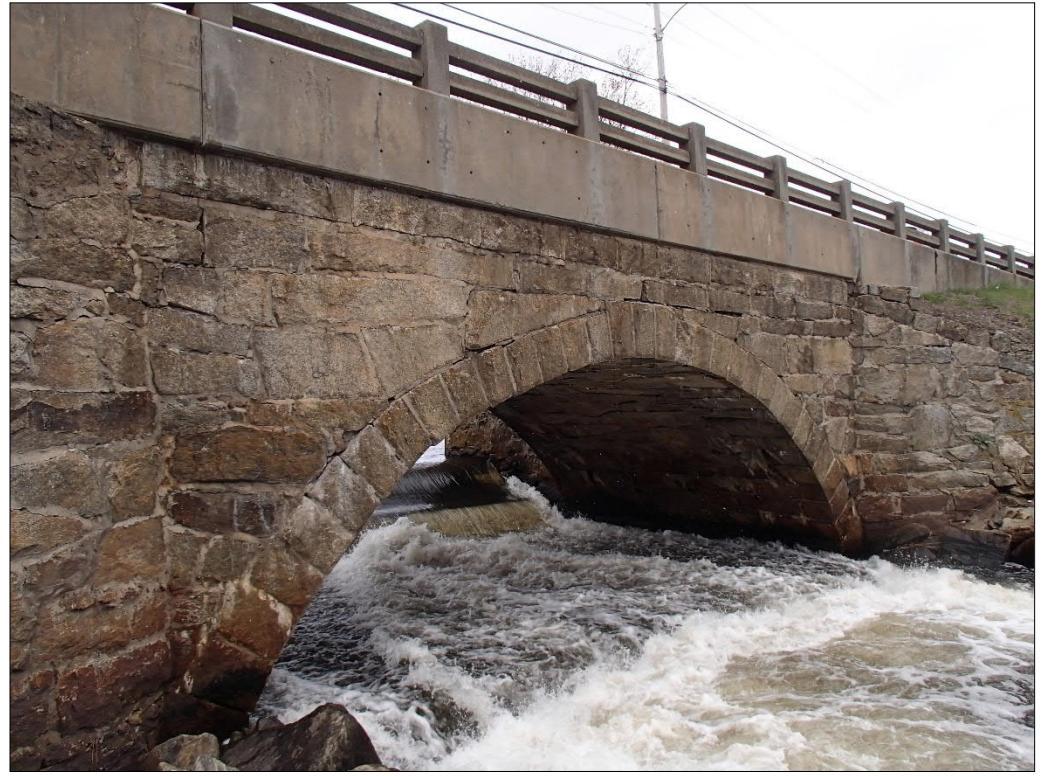
Photo 1 Looking Northeast: South Bridge Elevation

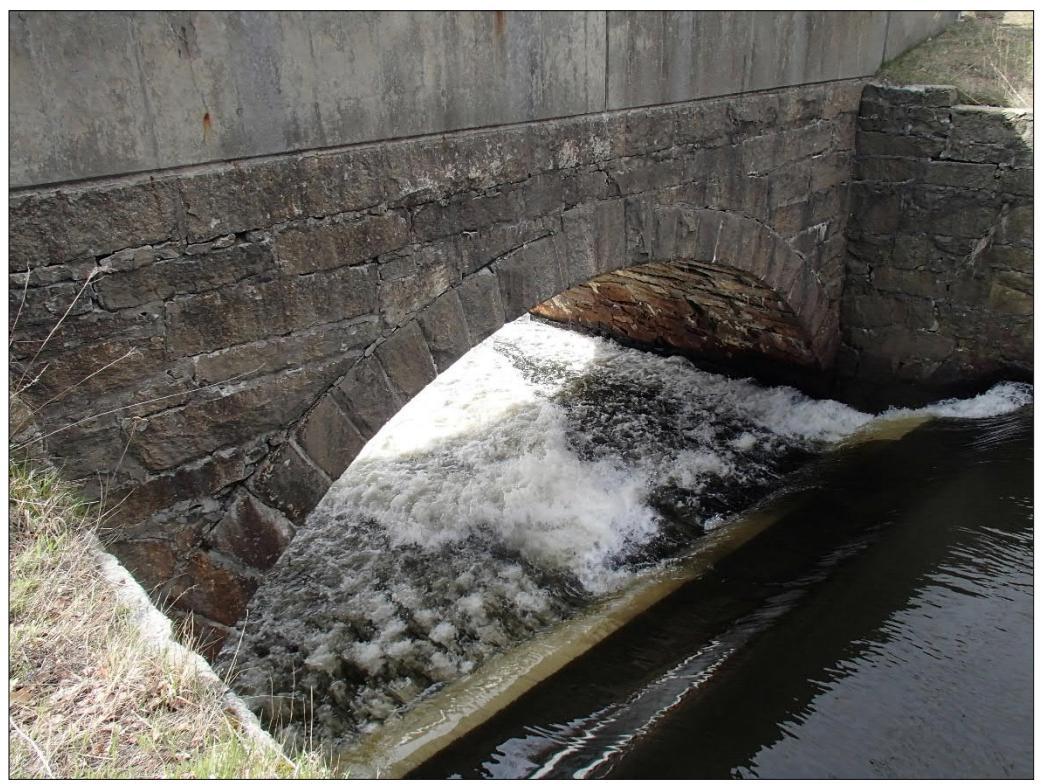
Photo 2 Looking Southwest: North Bridge Elevation

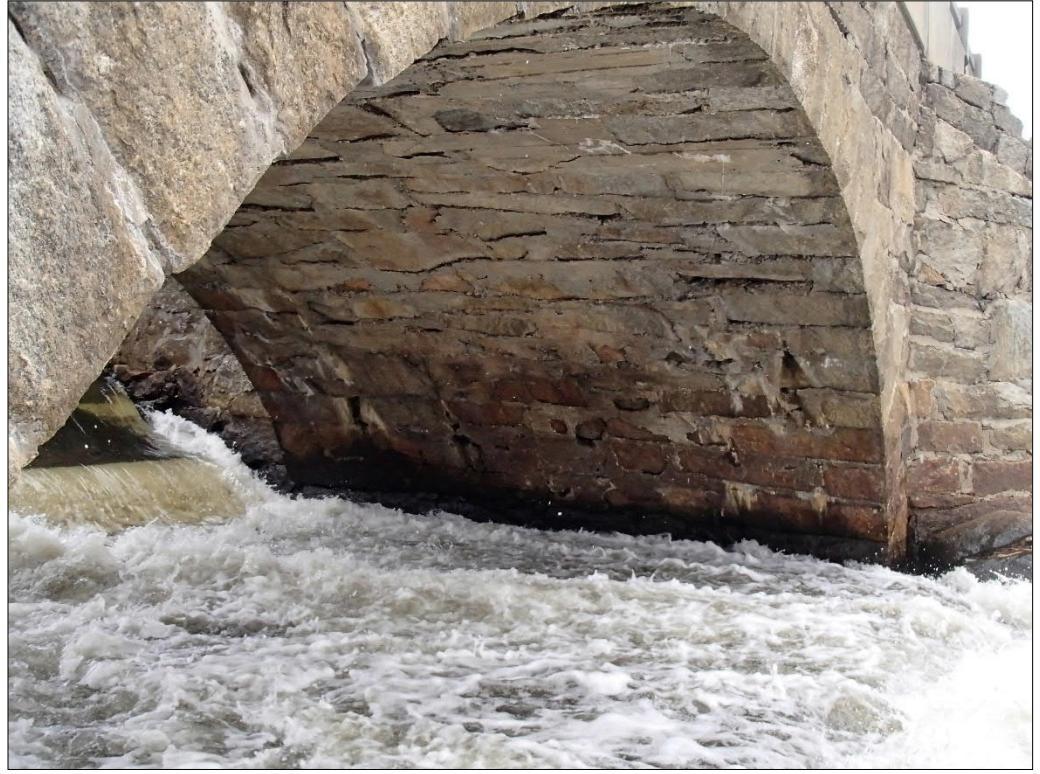
Photo 3 Looking Northeast: Underside of Arch

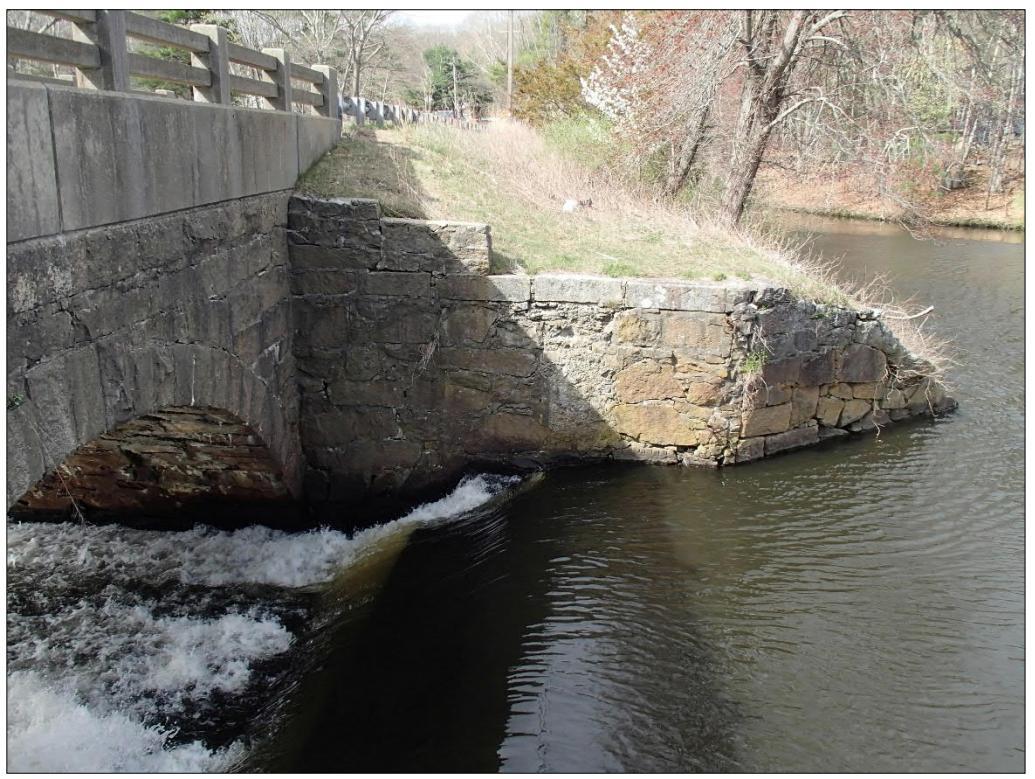
Photo 4 Looking West: Northwest Wingwall

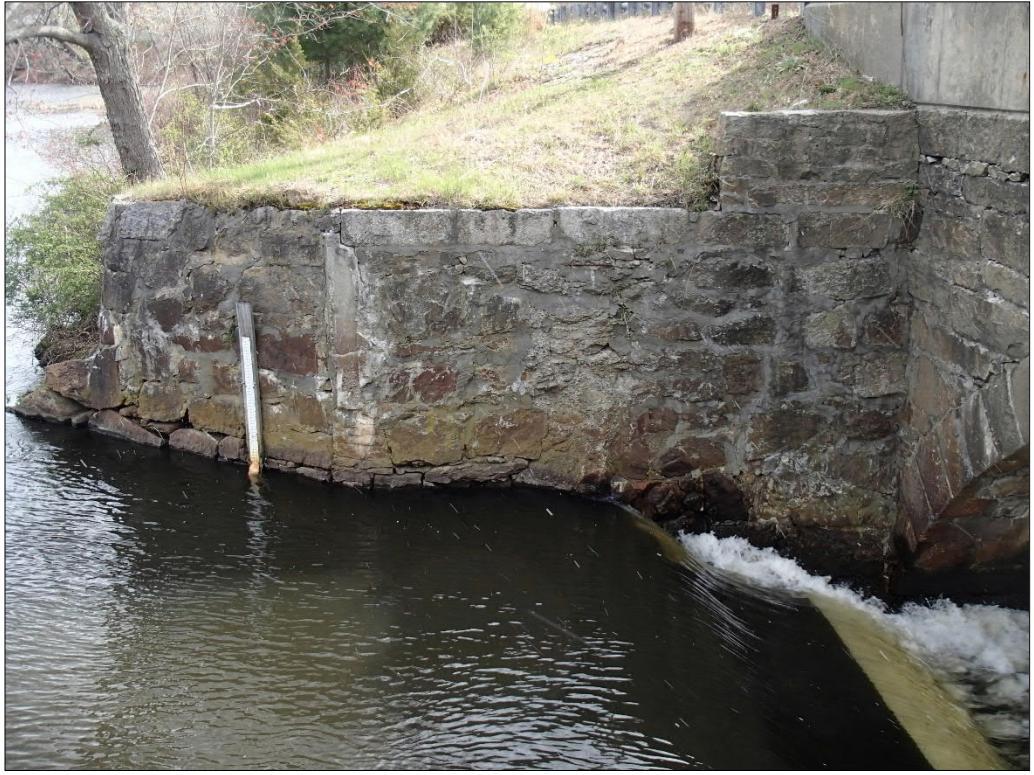
Photo 5 Looking East: Northeast Wingwall

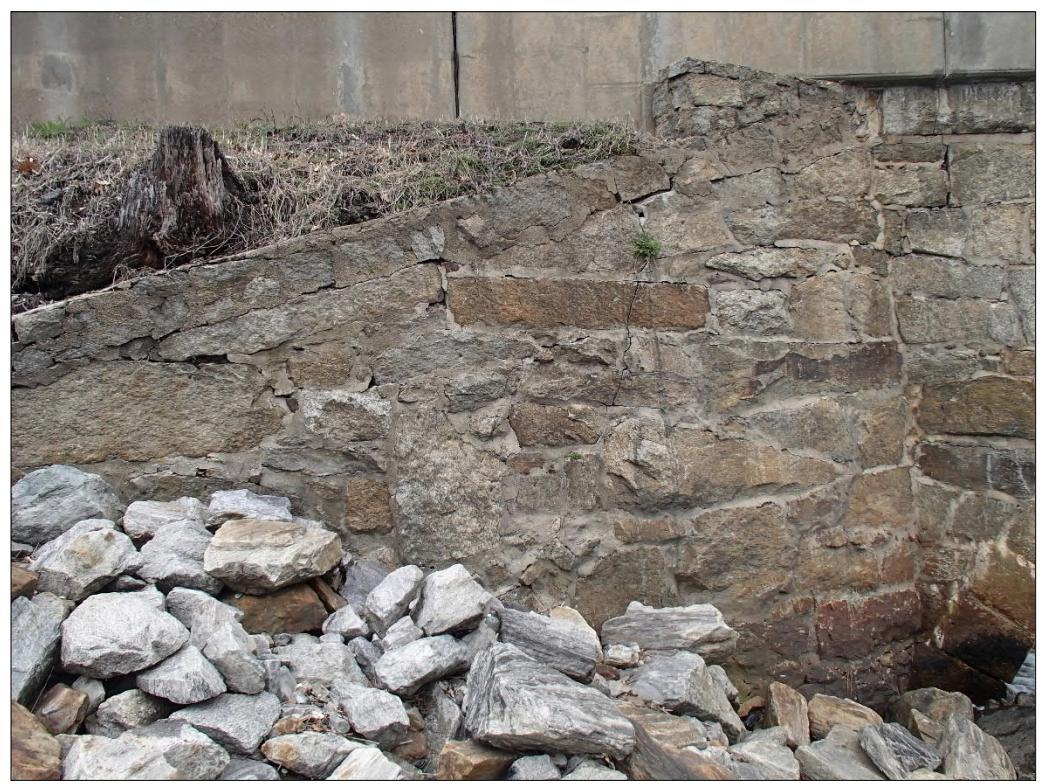
Photo 6 Looking North: Southwest Wingwall

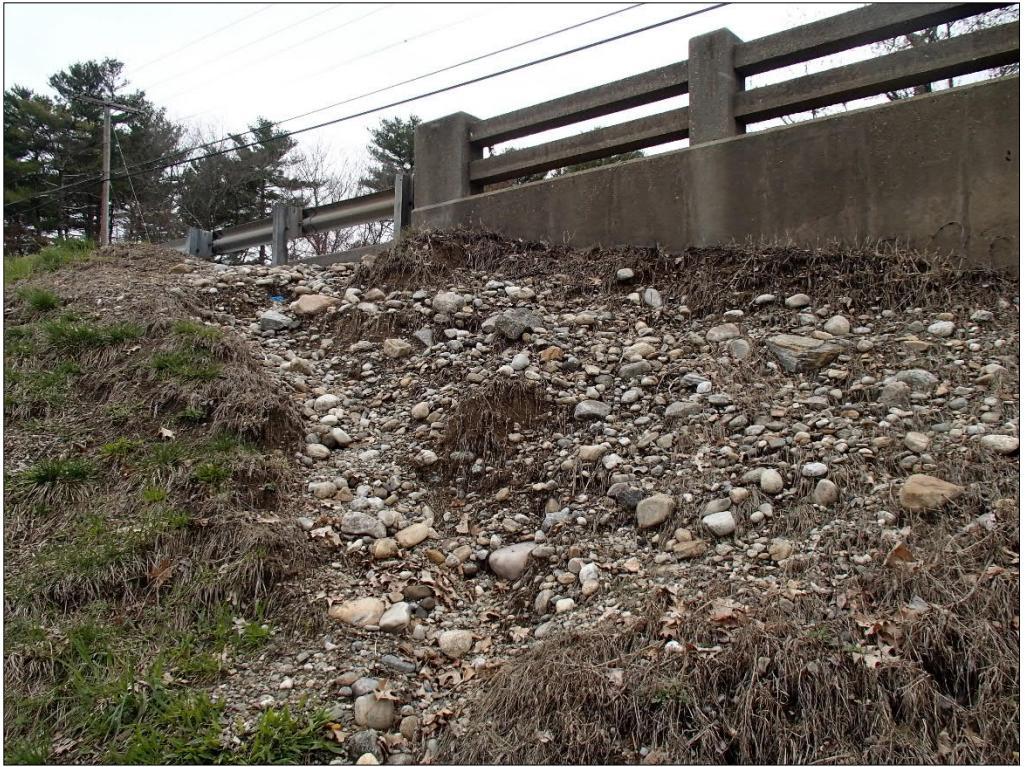
Photo 7 Looking South: Northwest: Southwest Embankment

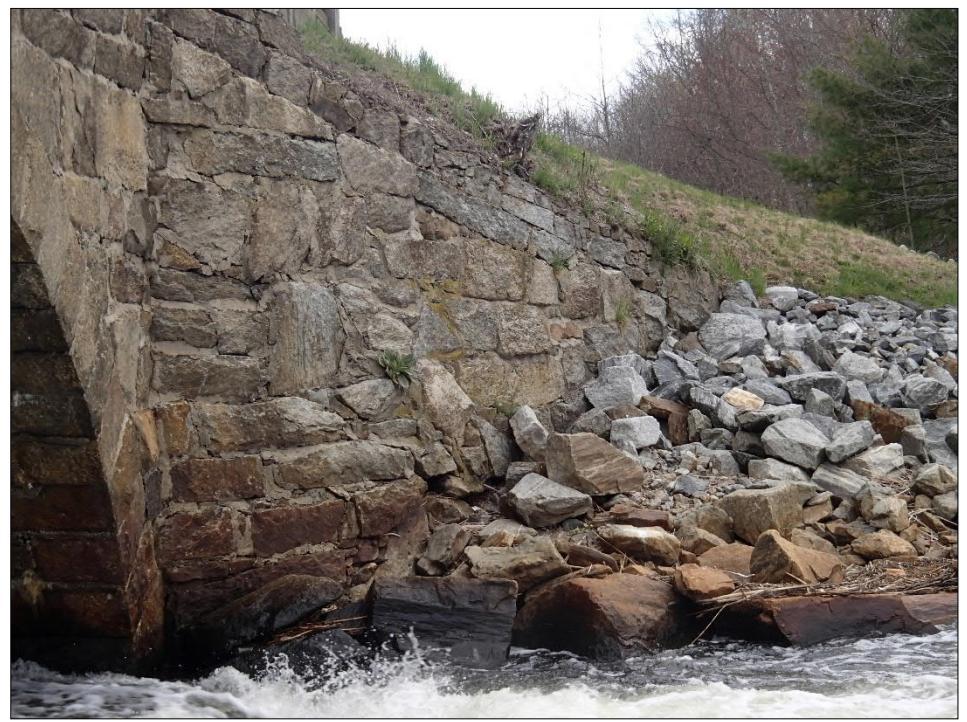
Photo 8 Looking East: Southeast Wingwall

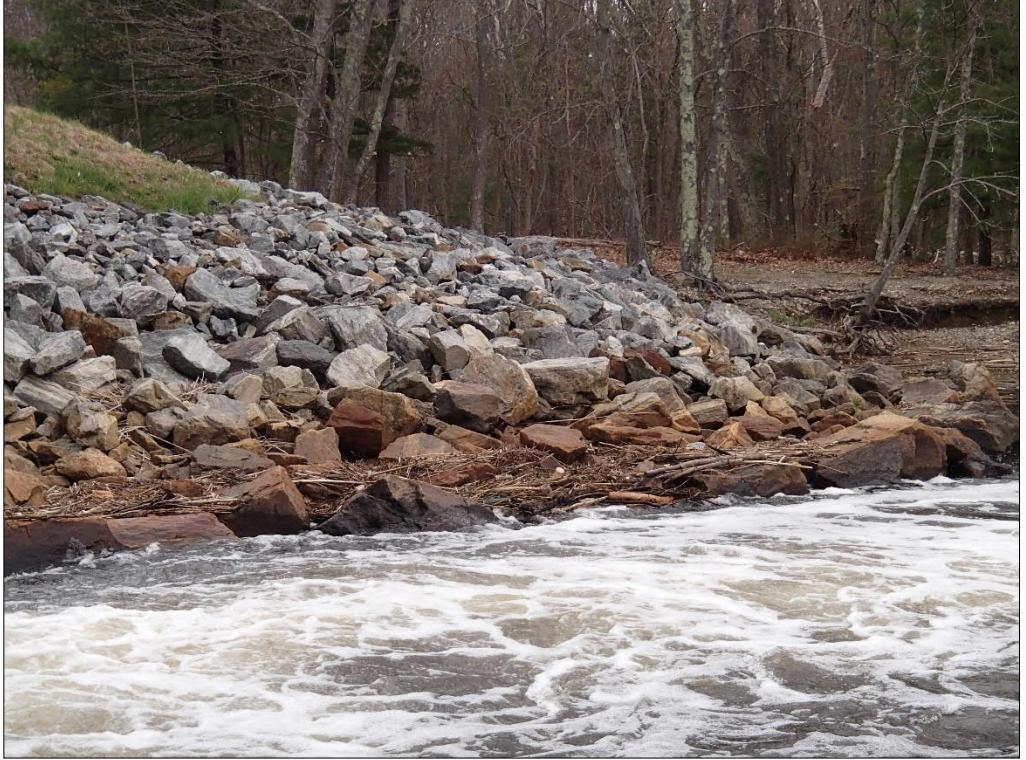
Photo 9 Looking Southeast: Southeast Riprap

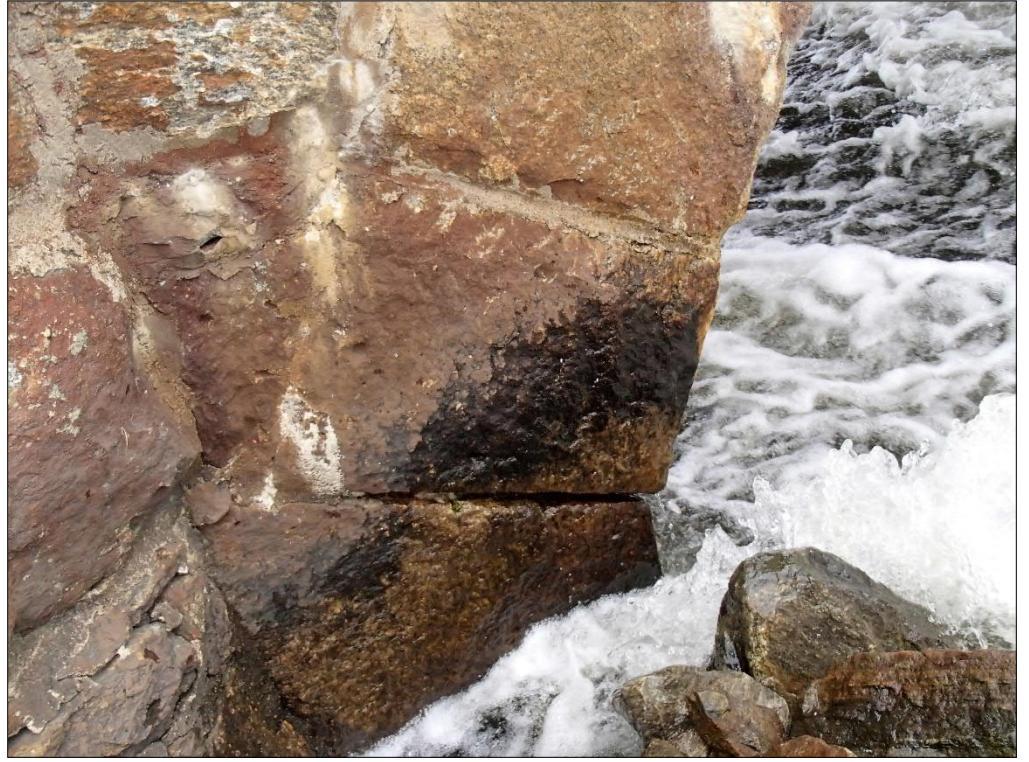
Photo 11 Looking Northeast: Southwest Arch Corner

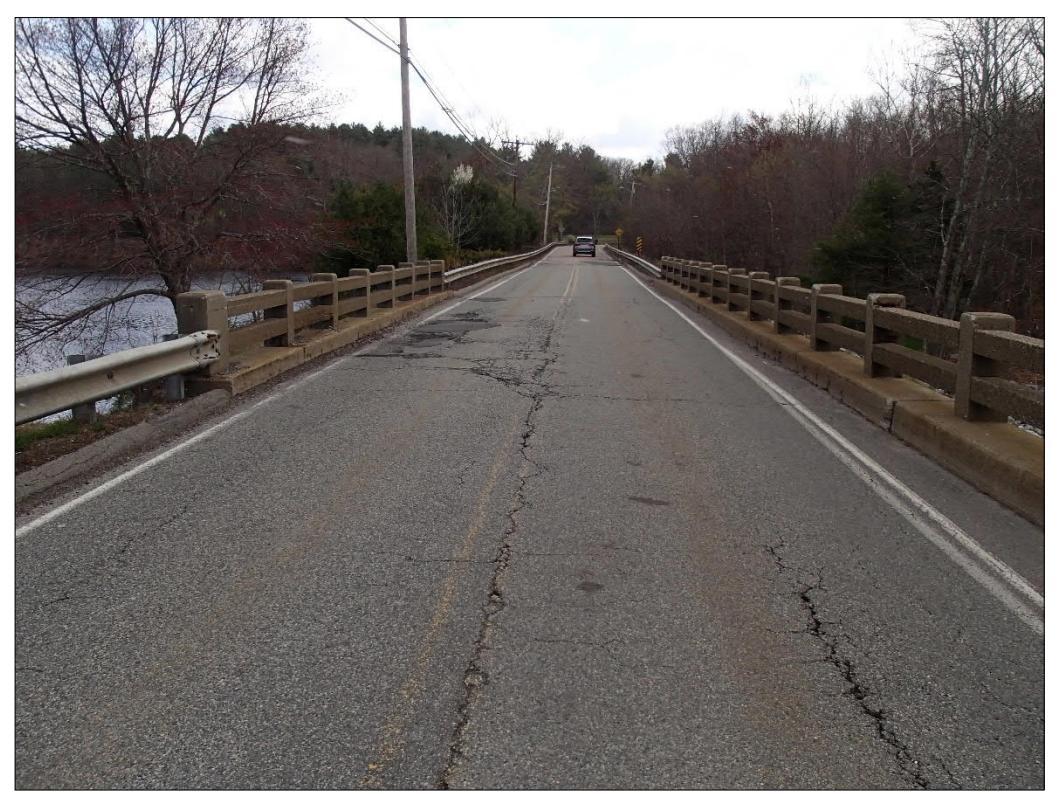
Photo 14 Looking East: West Approach

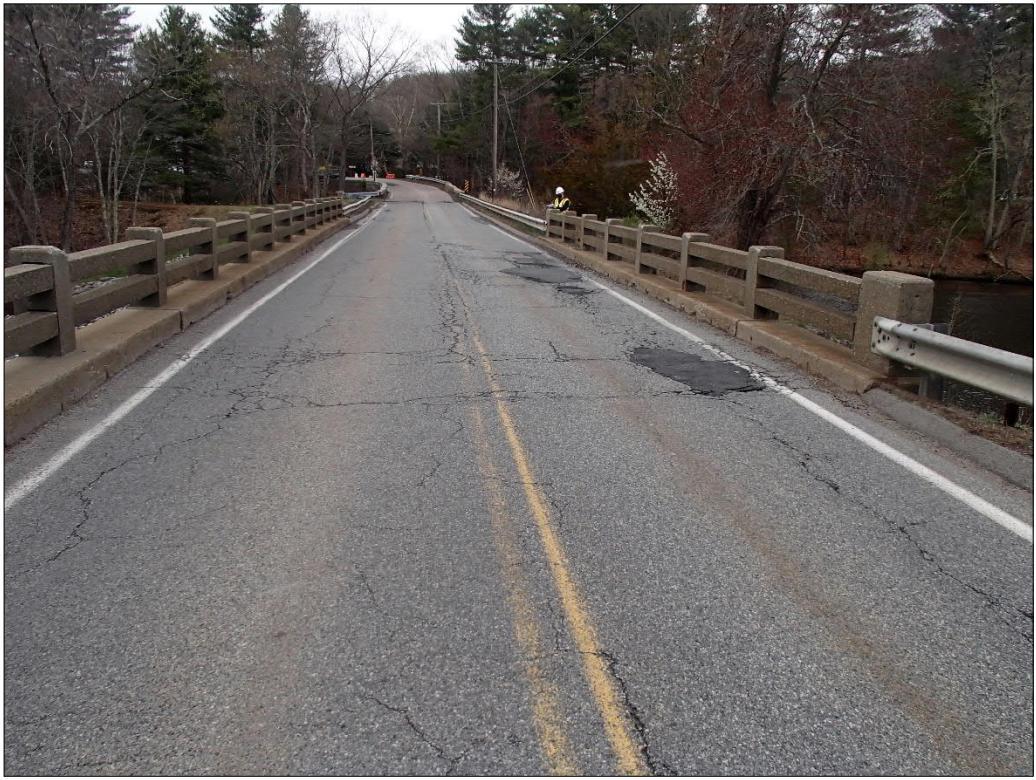
Photo 15 Looking West: East Approach

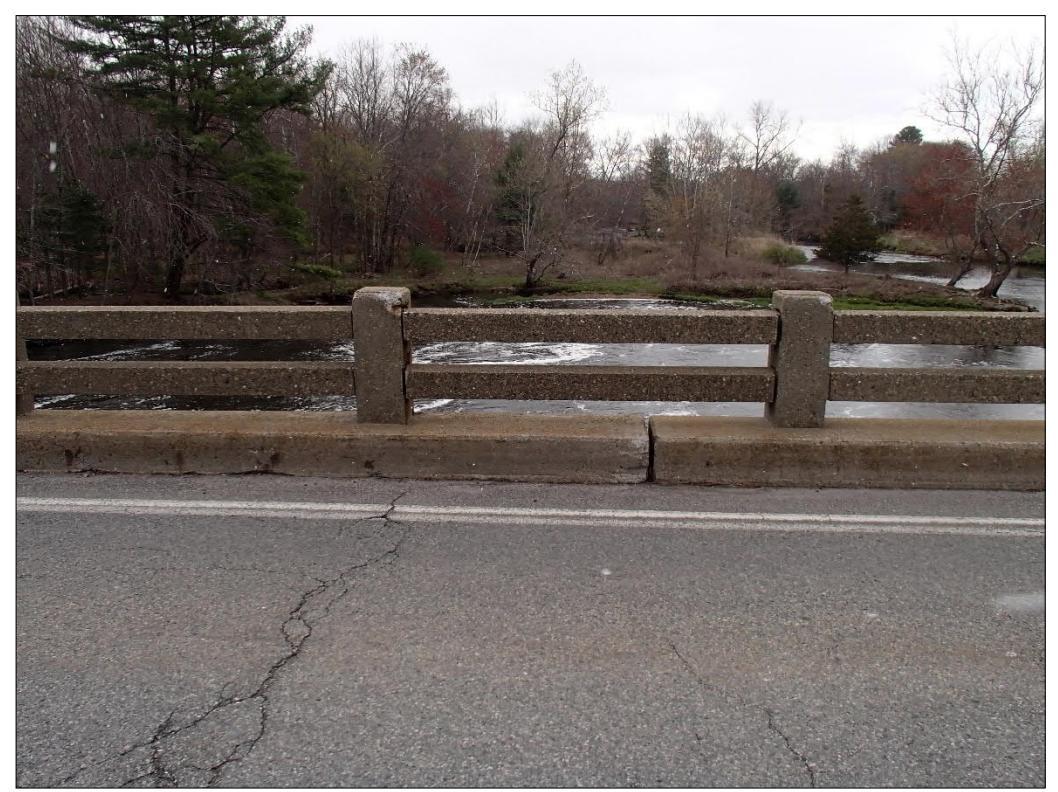
Photo 16 Looking South: South Barrier

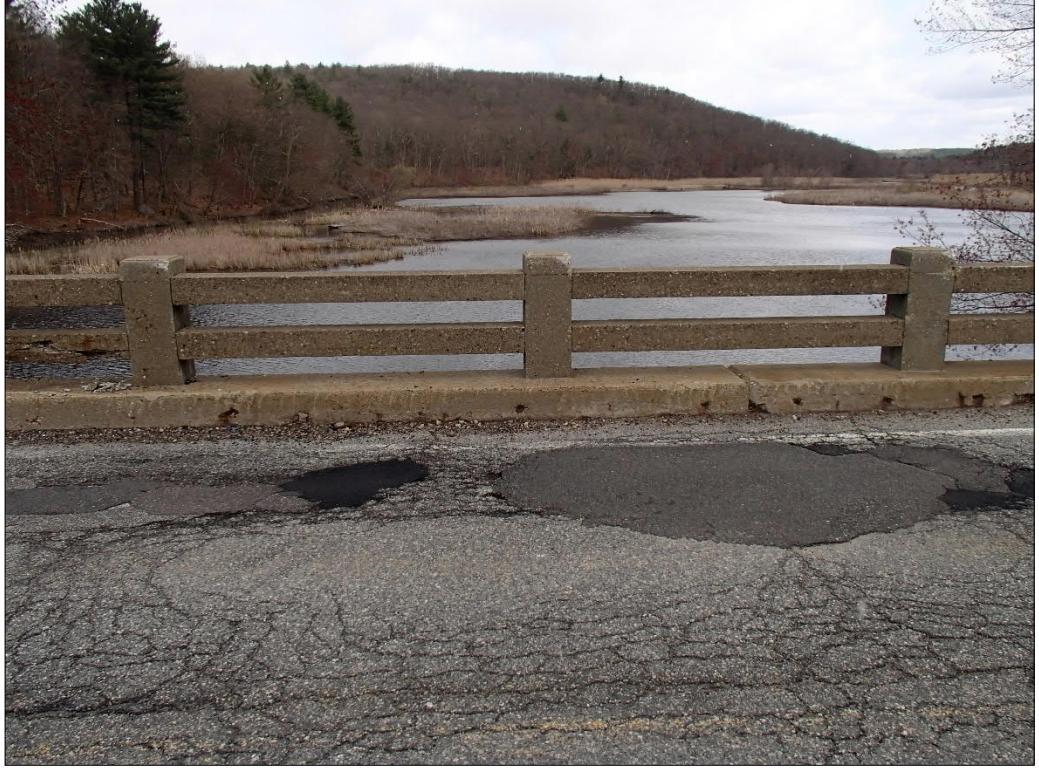
Photo 17 Looking North: North Barrier
