Uxbridge, Massachusetts Evaluation Report

Project Number: 7533 June 2021

BRIDGE / CULVERT MANAGEMENT PLAN

Hartford Avenue East over the Mumford River (Bridge No. U-02-020)

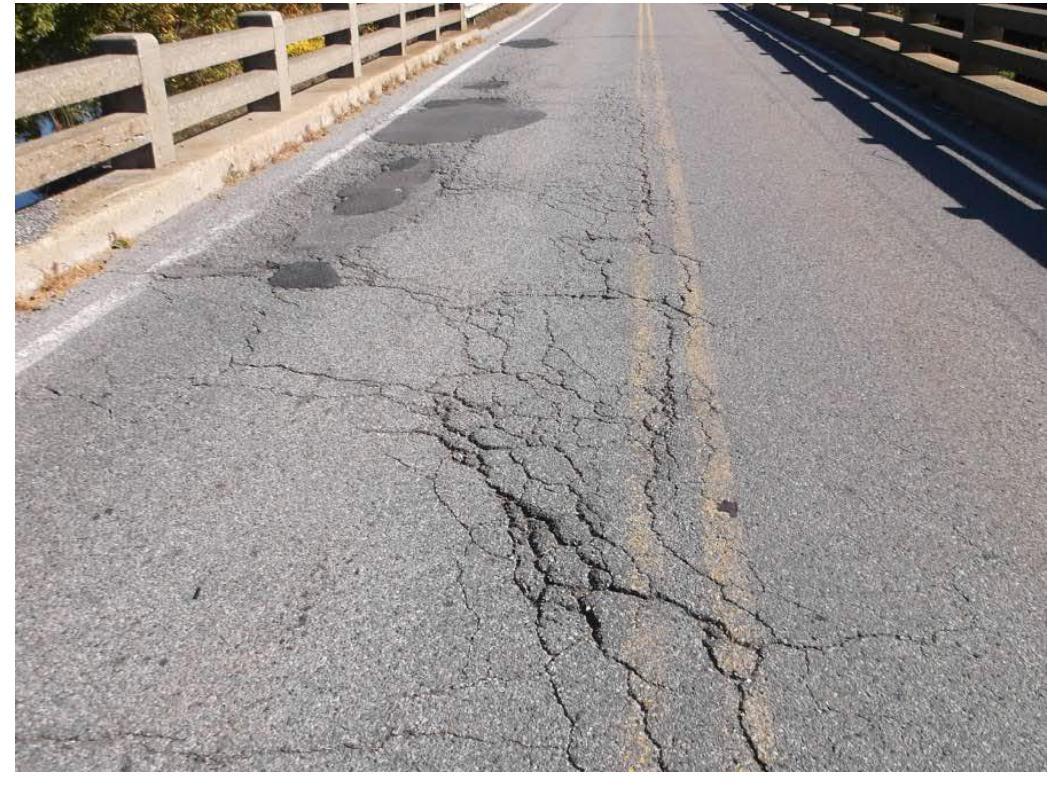
Photo 1: Wearing surface overview, looking northeast.

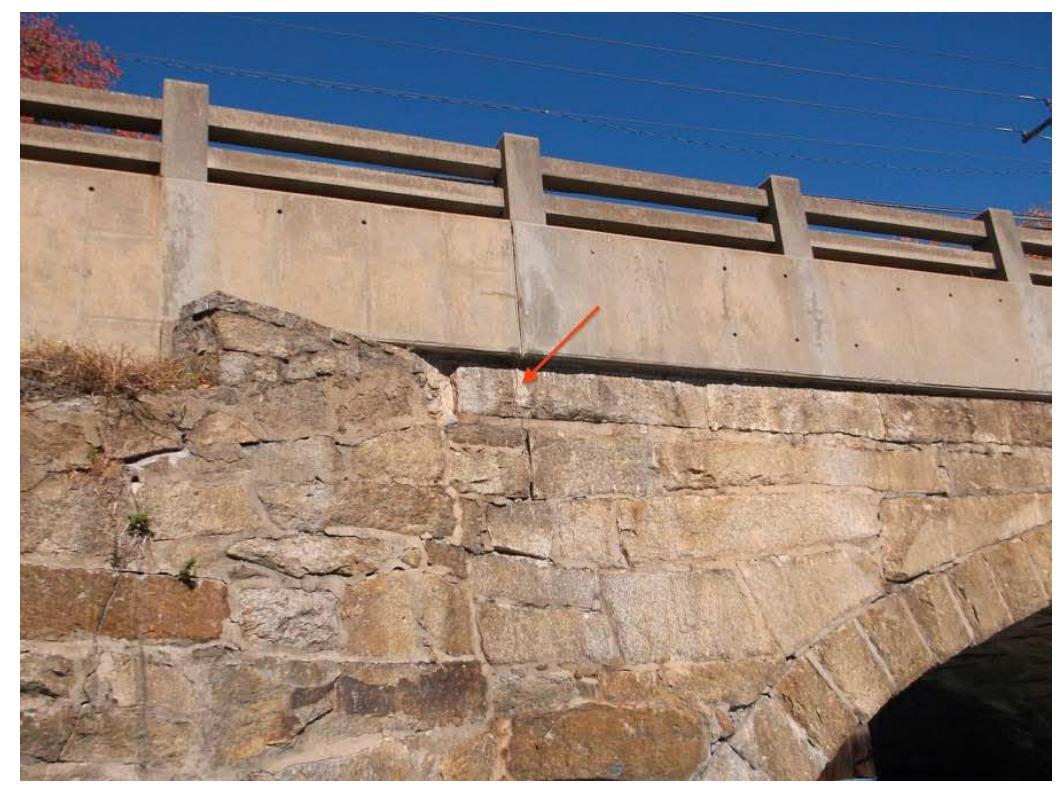
Photo 5: East half of arch.

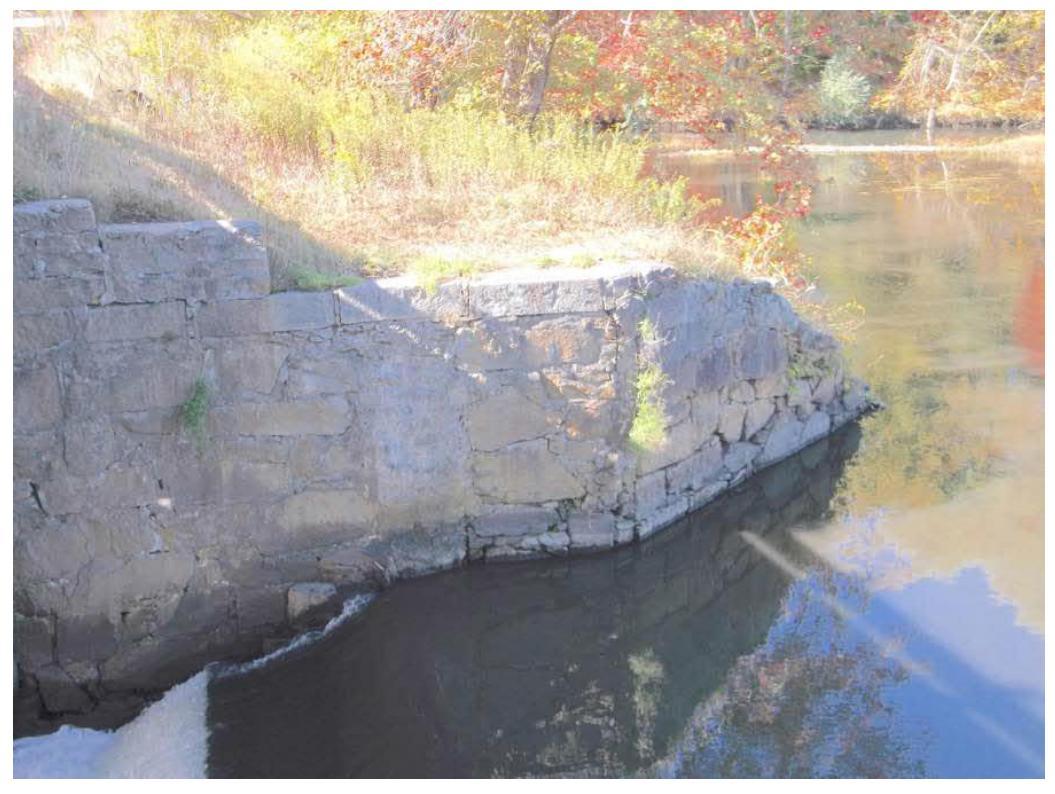
Photo 7: South spandrel wall, typical missing pointing.

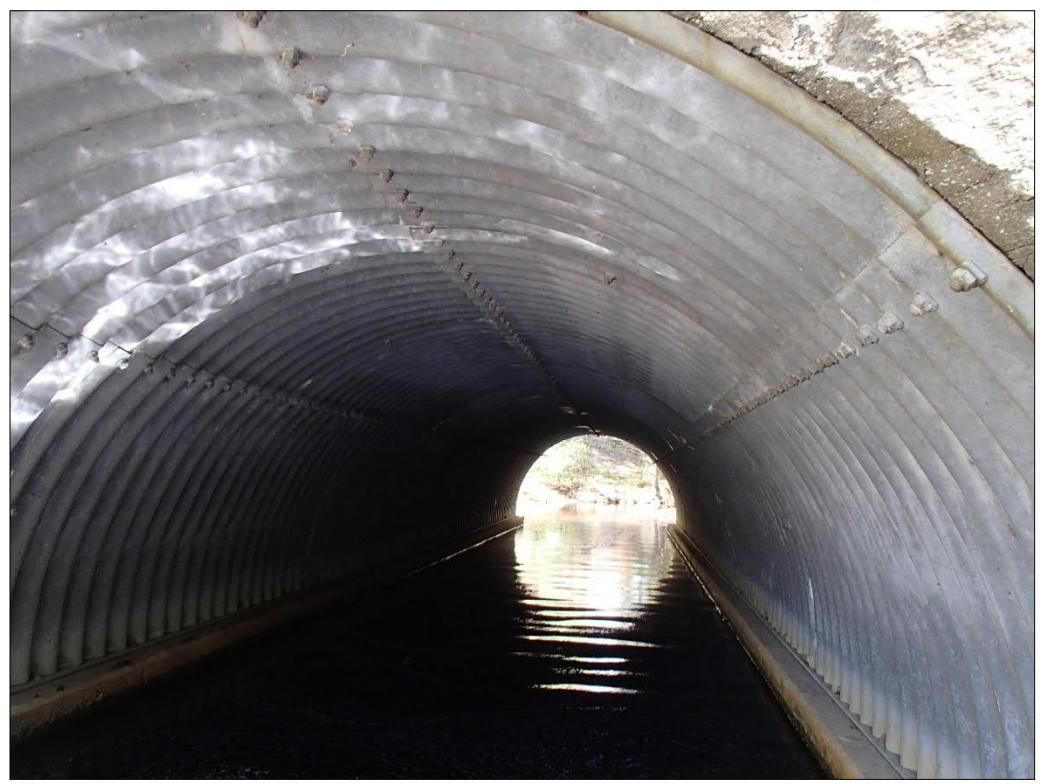
The corrugated lining at the underside of the arch shows no signs of corrosion or missing connection bolts (Photos 2 and 4).

Photo 2 Looking East: Culvert Pipe

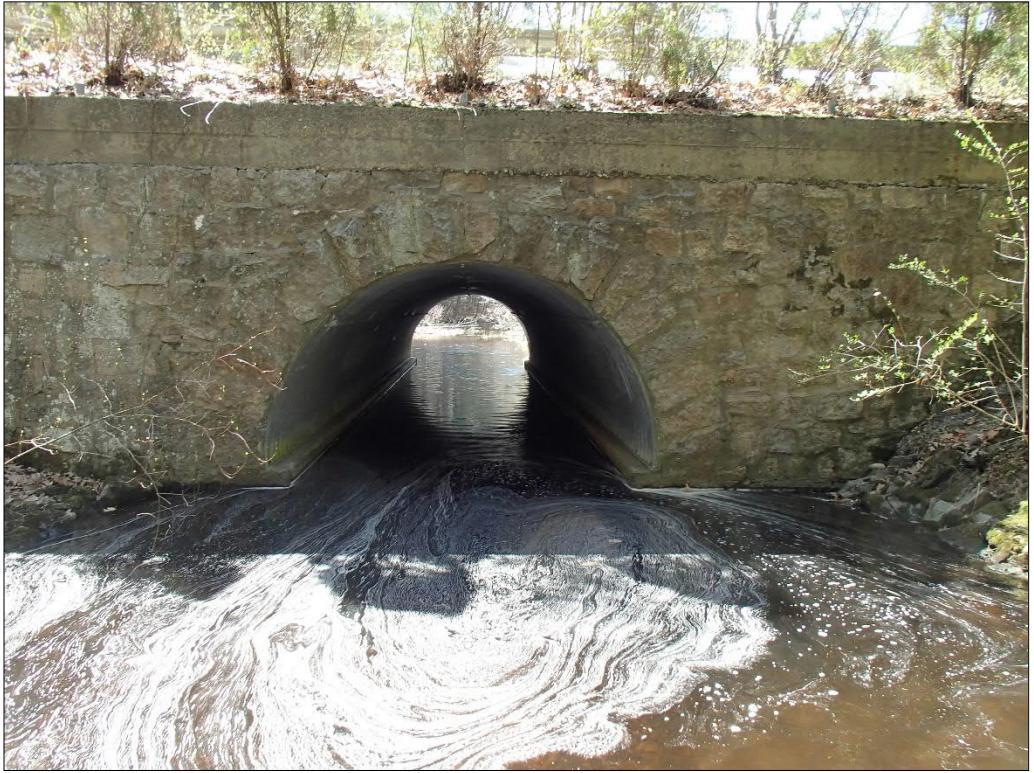
Photo 3 Looking West: East Culvert Elevation

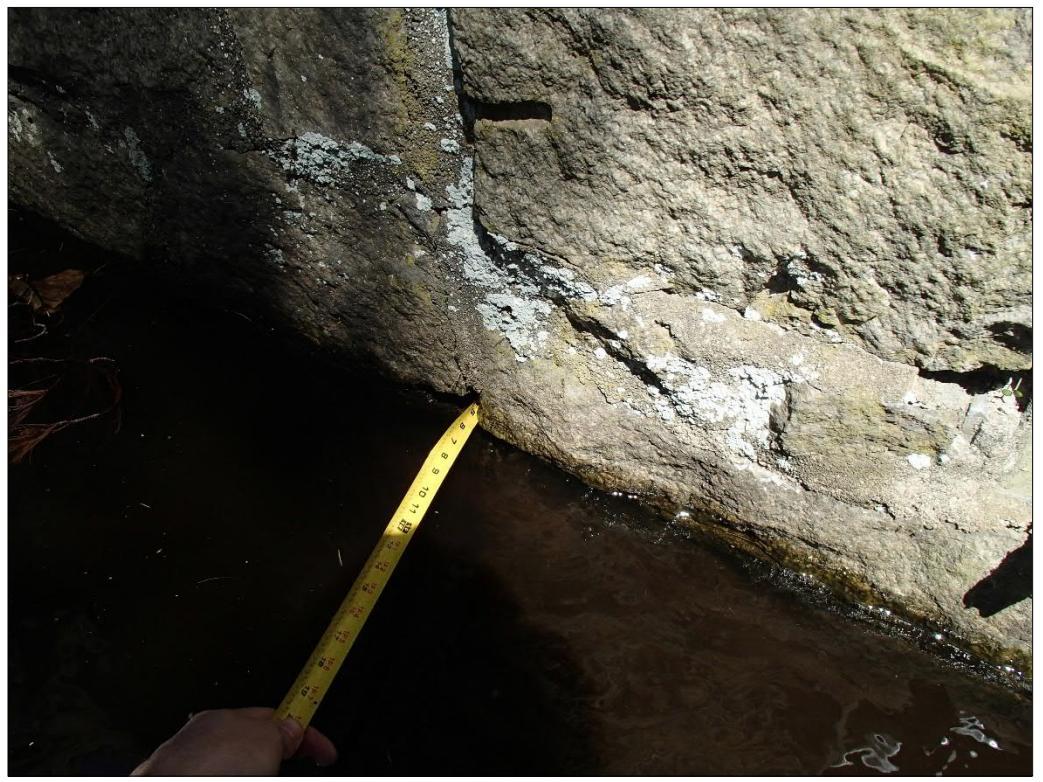
The concrete abutment caps are also in good condition. However, both typically exhibit light-to-moderate scaling and abrasion at the waterline. There is a spall on the south abutment at approximately midspan (Photo 11). Also noted on the masonry portion of the abutments are large voids, up to 7" deep, specifically at the northwest corner (Photo 10).

Photo 10 Looking East: Void at Northwest Water Line

- Fill all voids and re-point masonry wingwalls.
- Repair cracks and spalls on concrete footings
- The Town should follow up and clarify the origins and validity of current posting and/or loading restrictions.
- Replace existing wearing surface to minimize possible water infiltration through the structure.

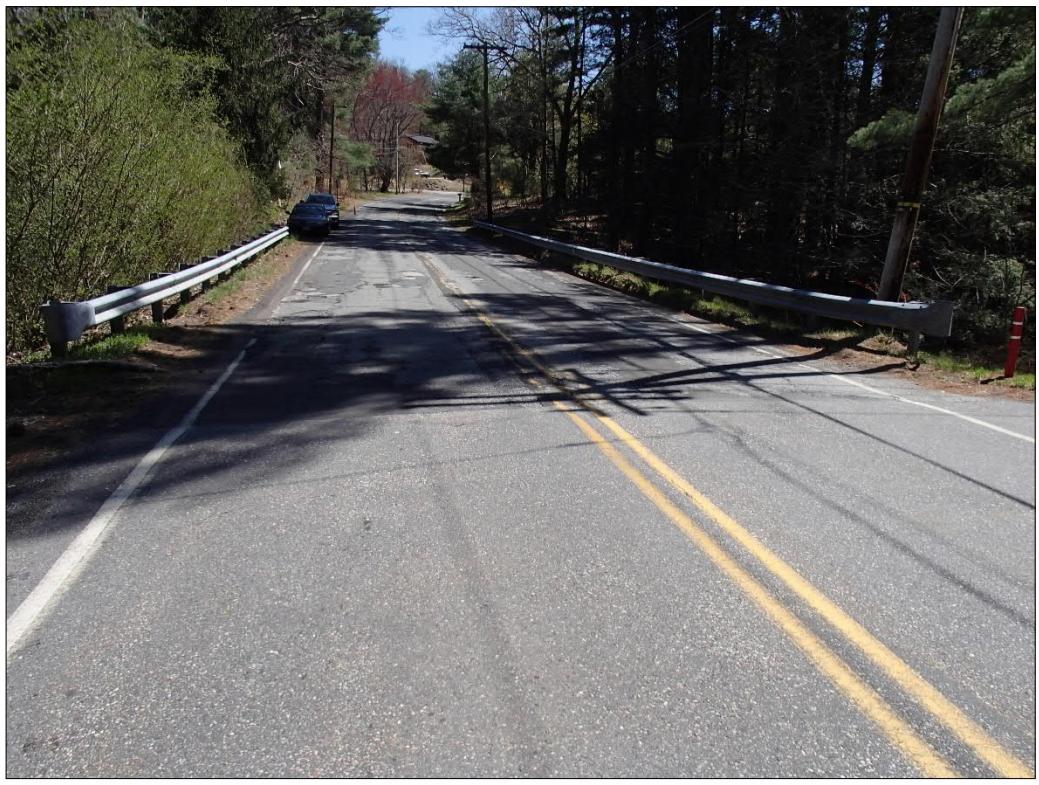
Photo 12 Looking South: North Approach

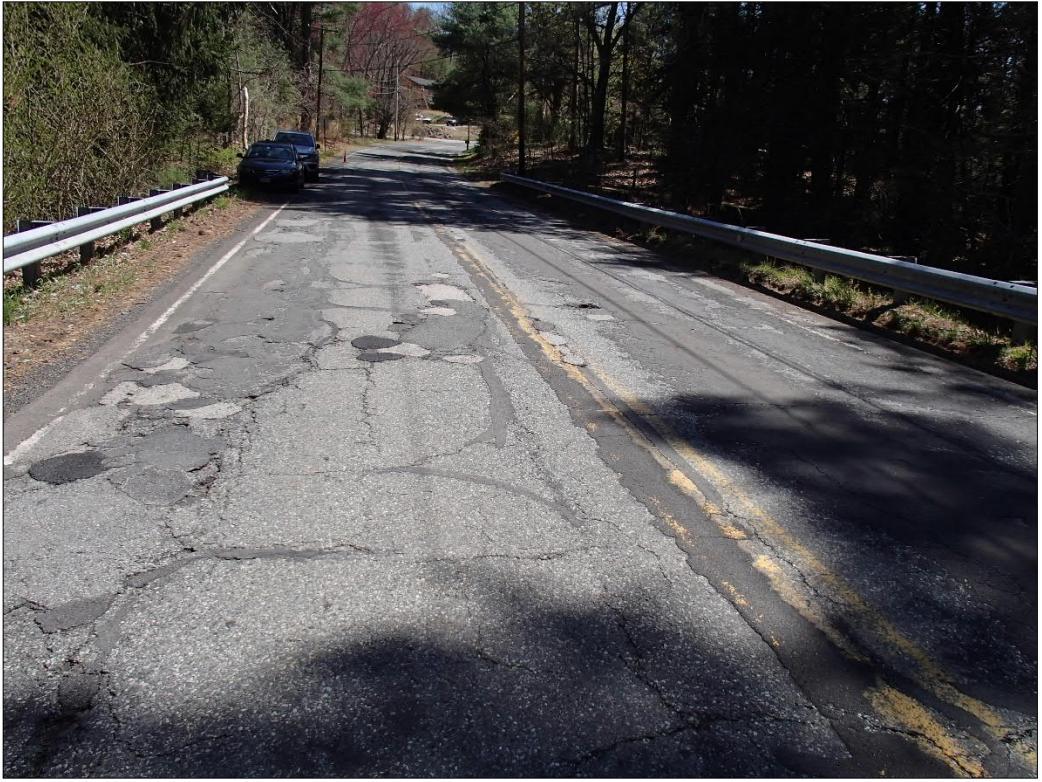
The approach roadway shows moderate cracking throughout. The roadway over the culvert is slightly worse with cracking and areas of patching (Photo 13). Both approaches have limited visibility as a result of the horizontal curves. The SS guardrail is also in good condition. It is also noted that the roadway is narrower than the bridge. As a result of the roadway width and depth of fill over the bridge, steep embankments extend down the structures headwalls at both openings.

Photo 13 Looking South: Roadway Over Culvert

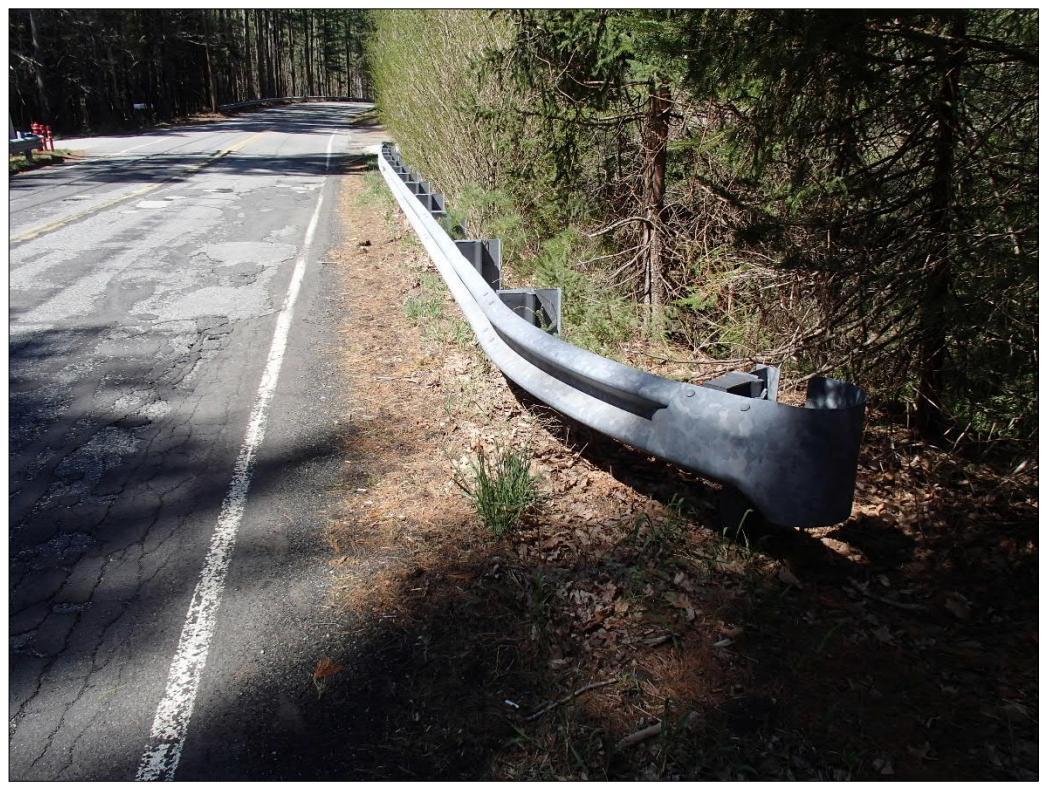
Photo 15 Looking North: East Guardrail

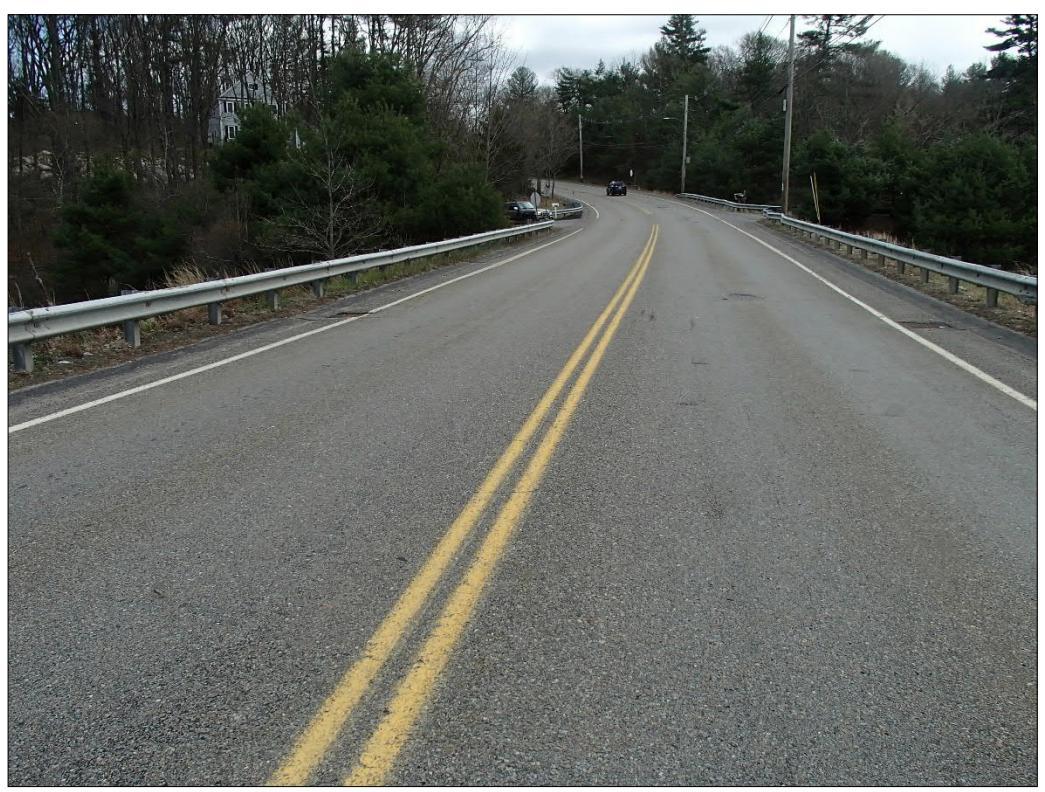
Photo 12 Looking East: West Approach

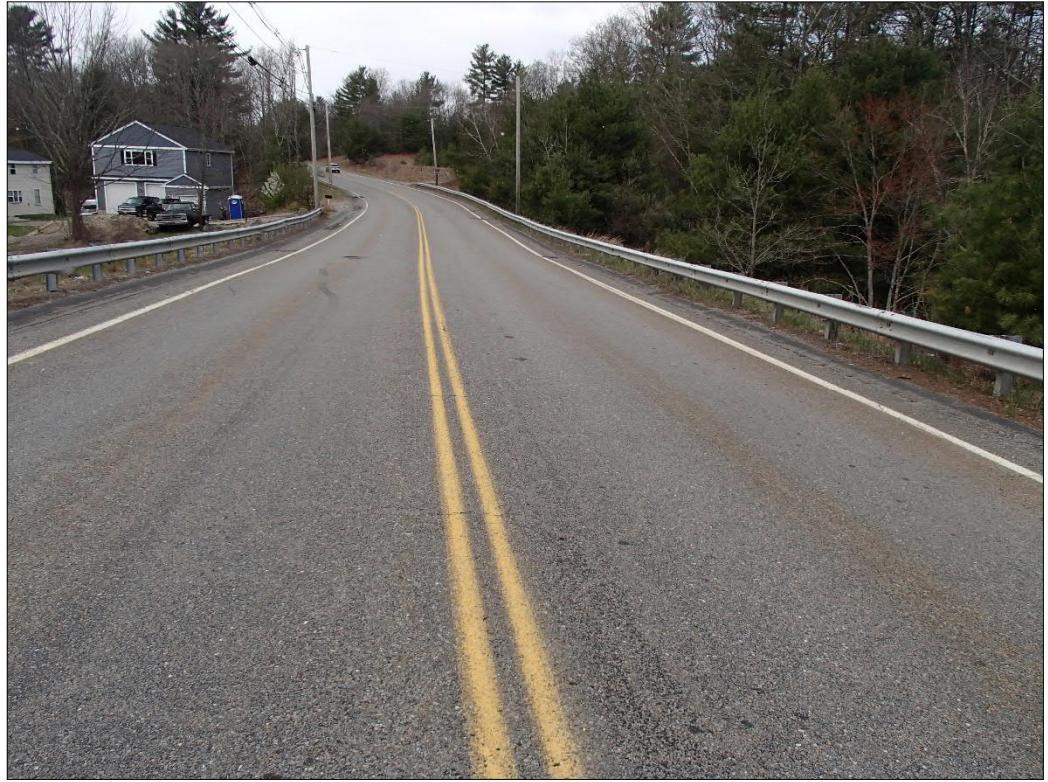
Photo 13 Looking West: East Approach

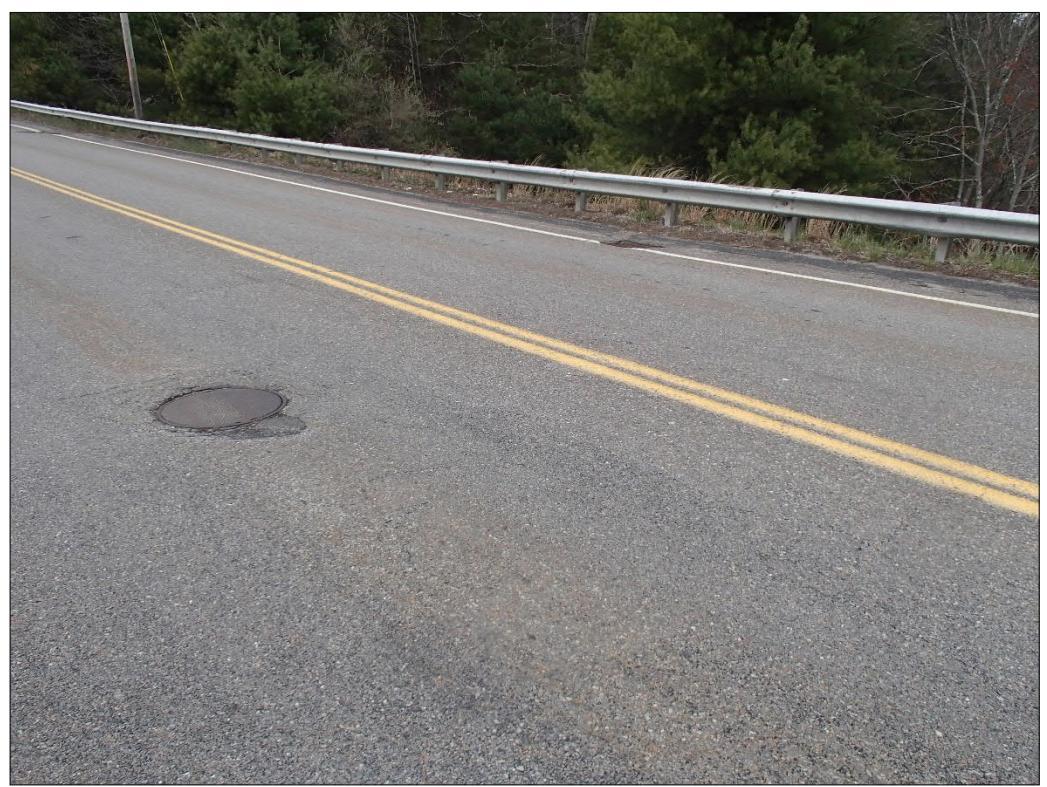
Photo 14 Looking North: North Guardrail

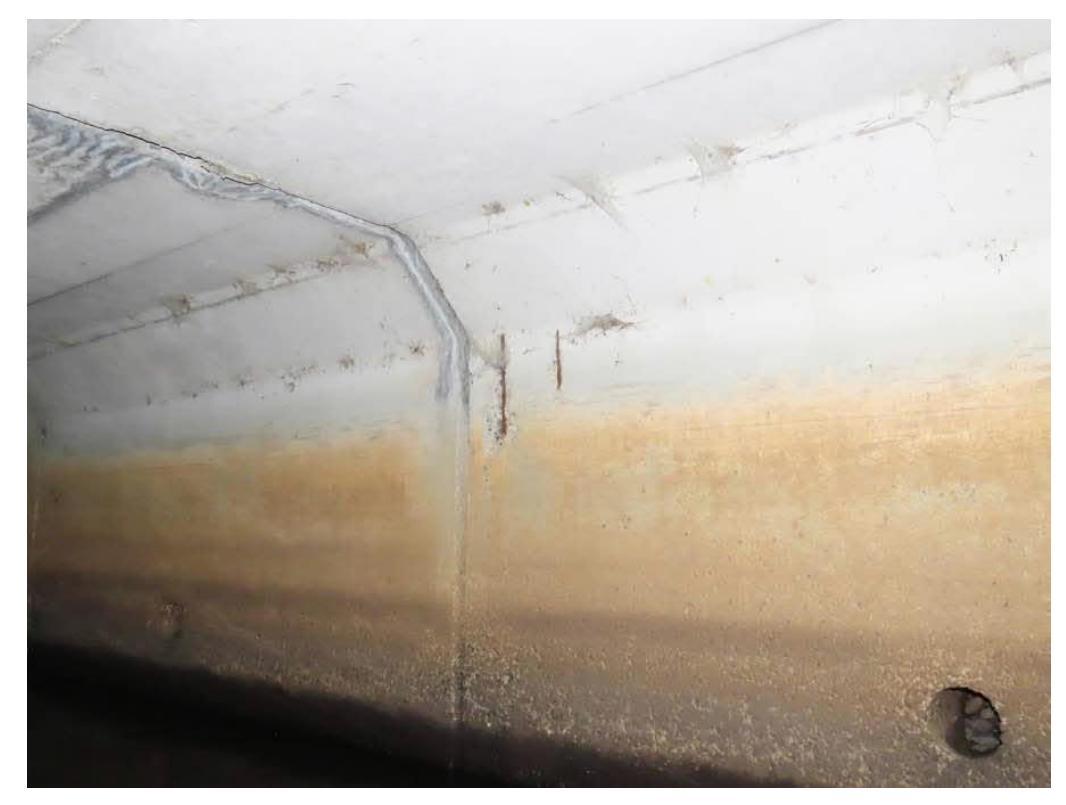
Photo 1: Joint #8 in barrel #1.

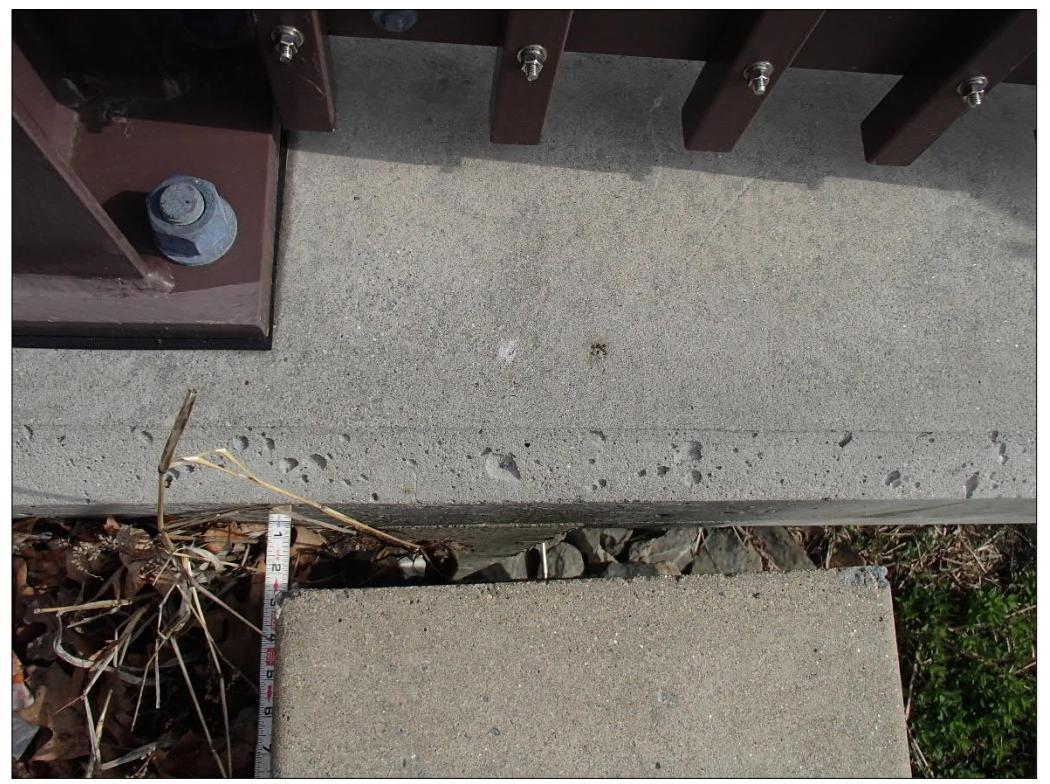
Photo 6 Looking North: Southwest MSE Wall Gap

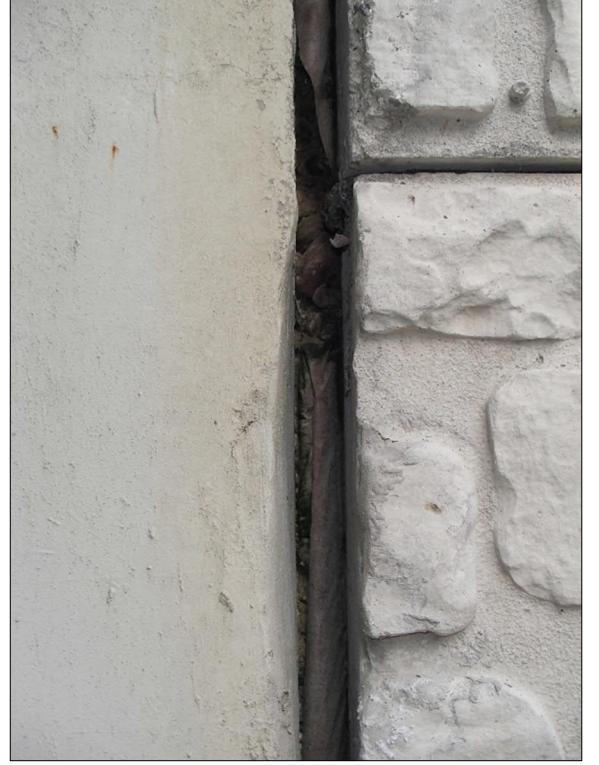
Photo 7 Looking West: Northwest Joint

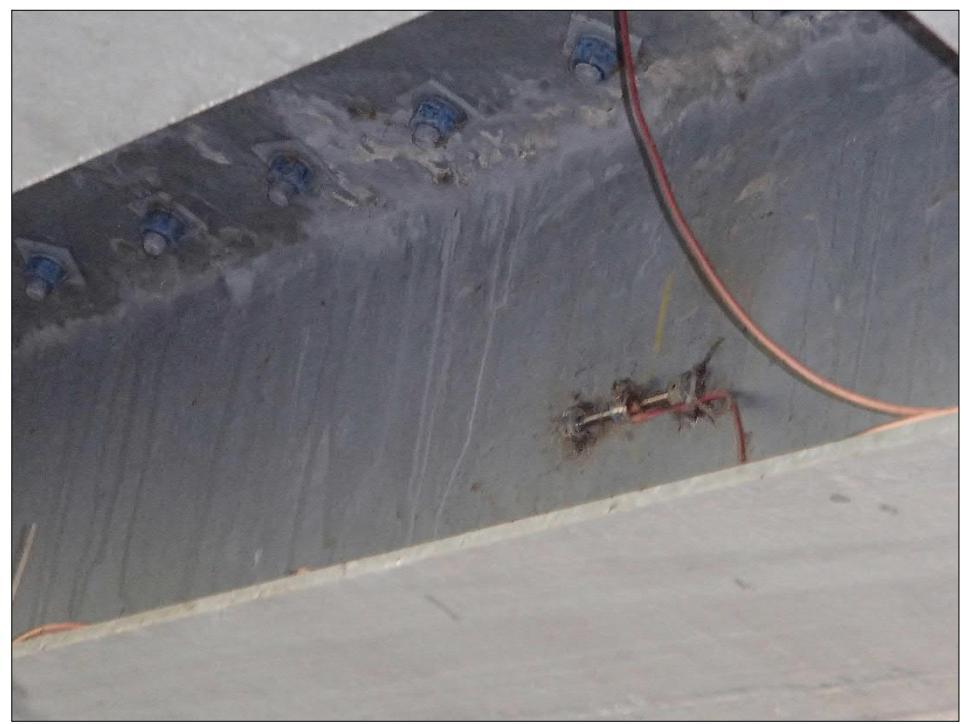
Photo 8 Typical Bridge Equipment

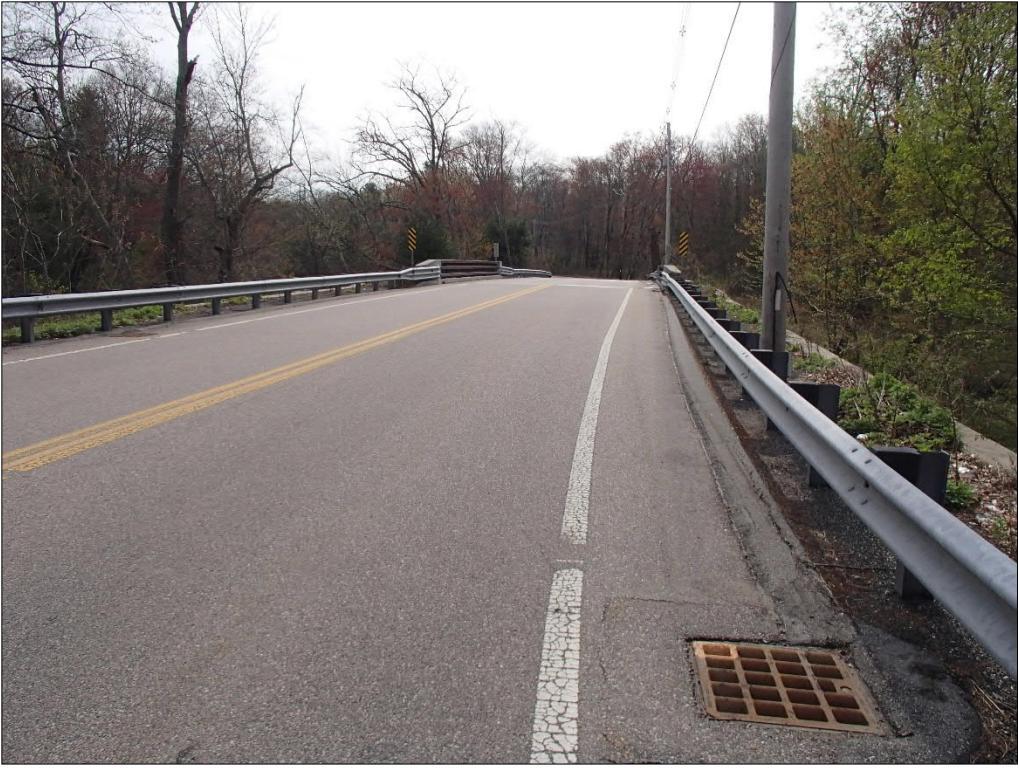
Photo 9 Looking East: West Approach

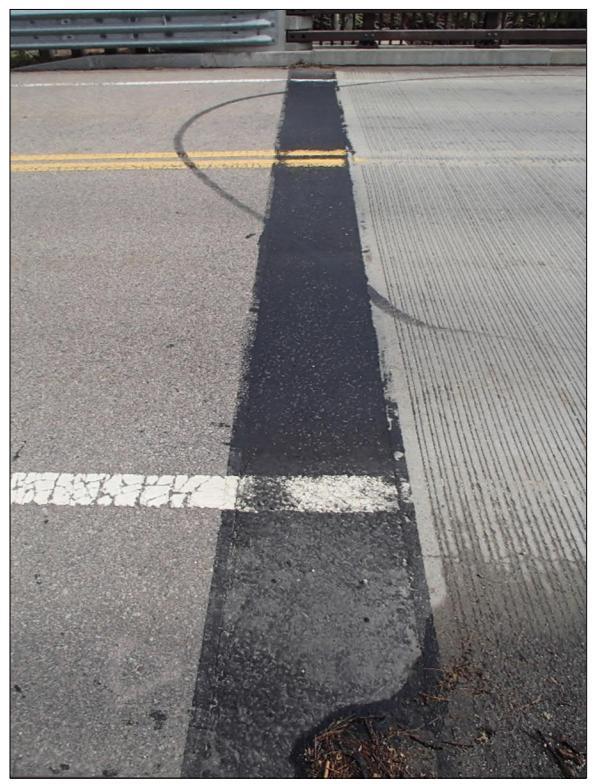
Photo 10 Looking North: Roadway Condition

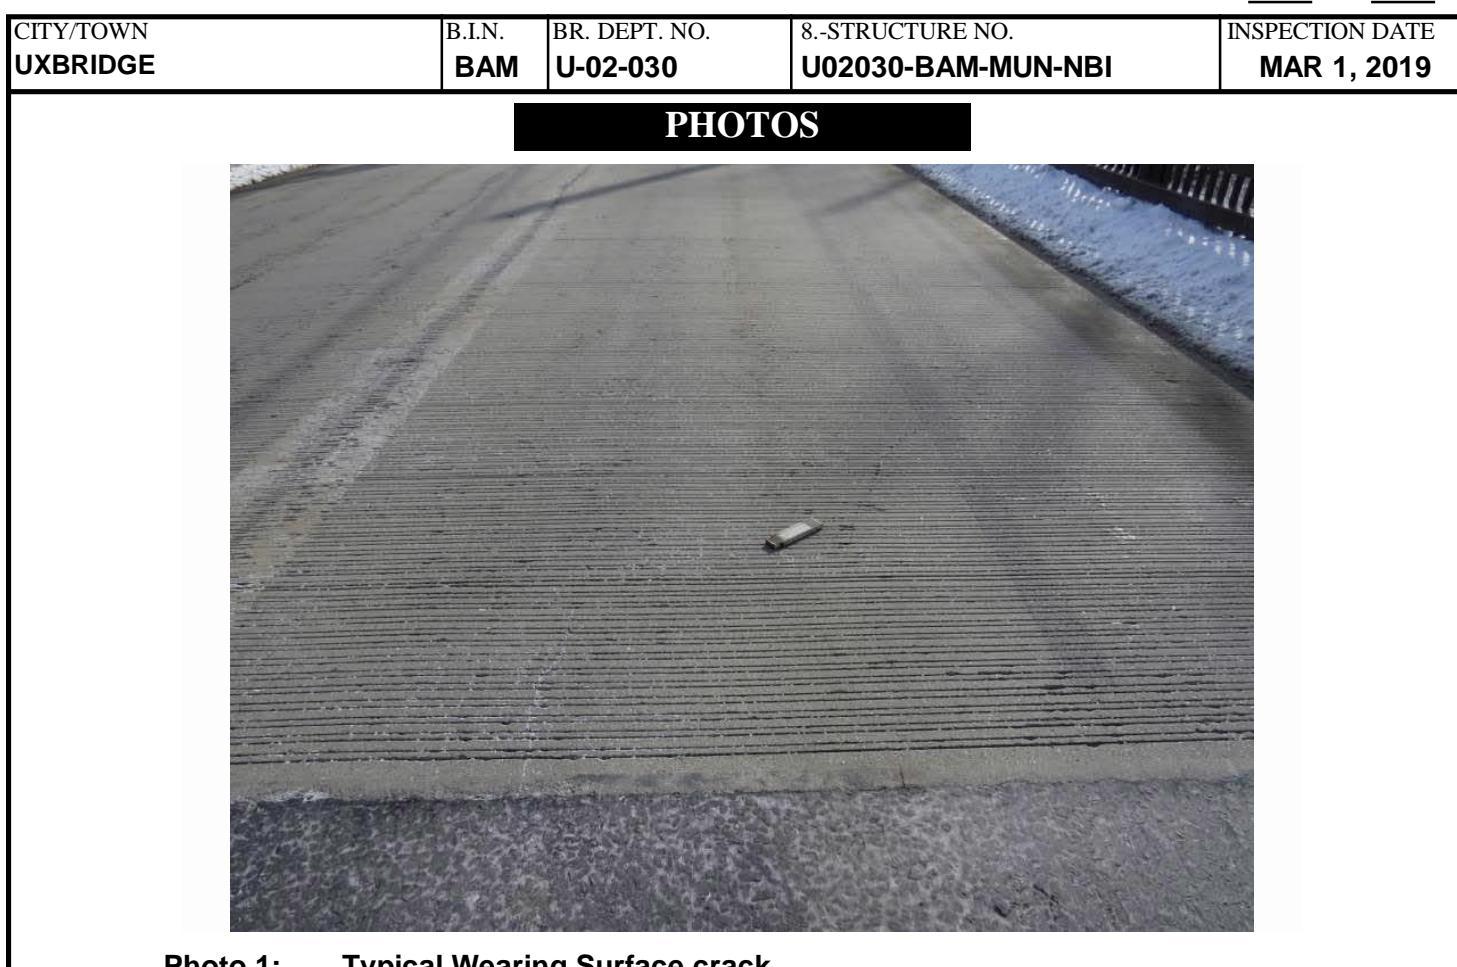
The concrete wearing surface has several up to 6 ft. long x 0.02 in. wide longitudinal cracks at both ends. **See Photo 1.**

Photo 1: Typical Wearing Surface crack.
